**The Parish Church of Asterby St Peter  
Archaeological Excavation and Recording**

**ARCHAEOLOGICAL EXCAVATION AND RECORDING**

**December 1997**

*LAS Report NO 271*

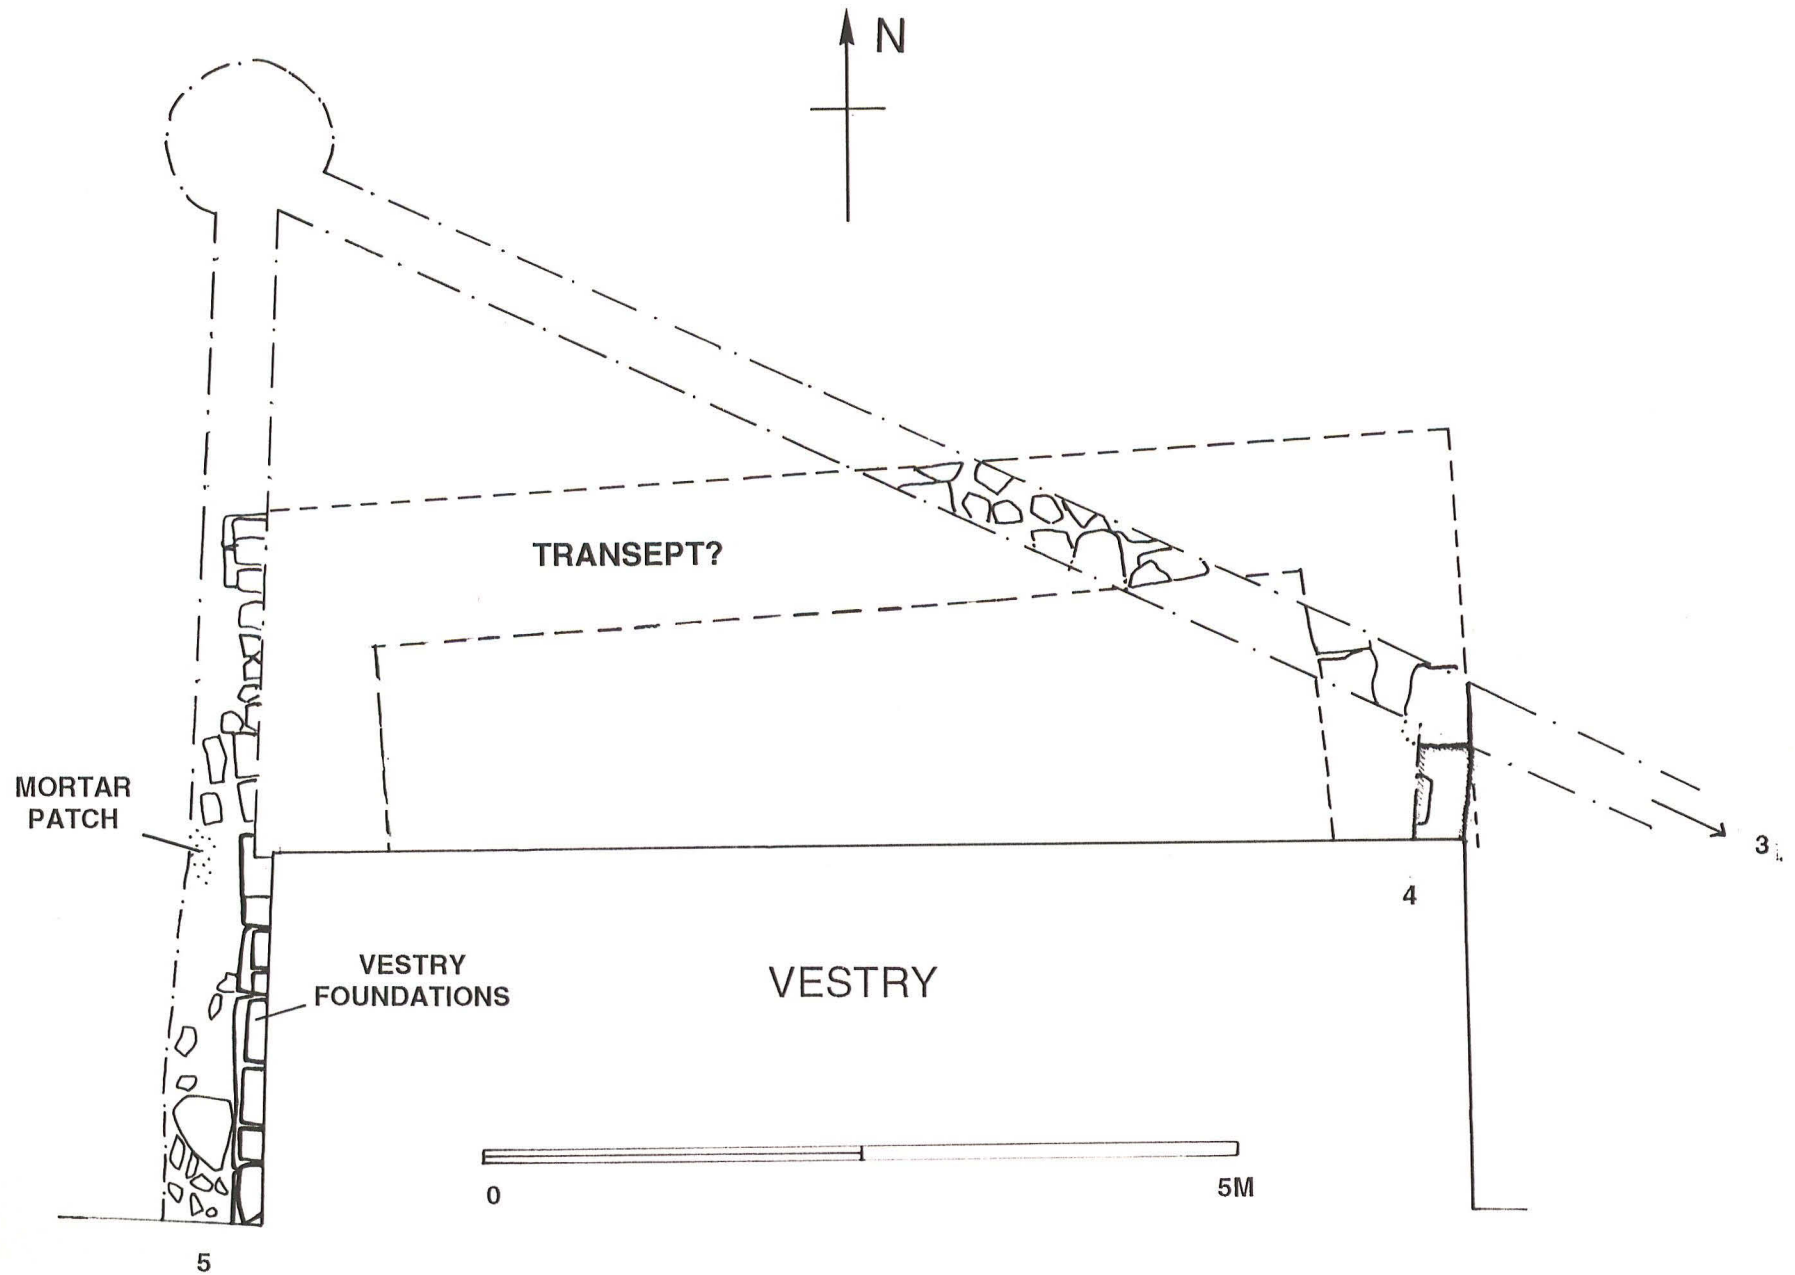
Fig. 3. Features recorded on the north side of the church. (N. Field/  
M.McDaid)

A short trench less than 1m in length was dug north of the rainwater pipe at the north-east angle of the vestry to join Trench 3 (Pl. 8). It was at this point that blocks of sandstone were encountered at a depth of c.300mm beneath the ground surface (Fig. 2). There was a possible chamfer on the block which straddled the junction between Trenches 3 and 4 suggesting that this was the external face of a wall. The stones continued west from Trench 4 along Trench 3 for 1.20m. There was a gap of 1.30m along the south side of the trench and 0.70m on the north side which appeared free of stones. The soil recorded in this part of the trench contained mortar flecks and was light brown in colour, lighter than the soil in the rest of the trench. Beyond the gap further stonework was recorded crossing the trench at an angle and extending north-west for 1.80-2m (Pl. 9).

Despite the limited scope of investigations it has been established that the foundations for an earlier building lie beneath and north of the existing vestry. The size of the trenches allowed only a glimpse at these earlier remains and makes interpretation only tentative. It is possible that the foundations are those of the demolished north aisle. However, this would make its width c.5.50m (to the external face of the wall) and the external width of the present nave is only 6.50m. Normally one might expect an aisle to be about half the width of the nave; in this case perhaps closer to 3.5m.

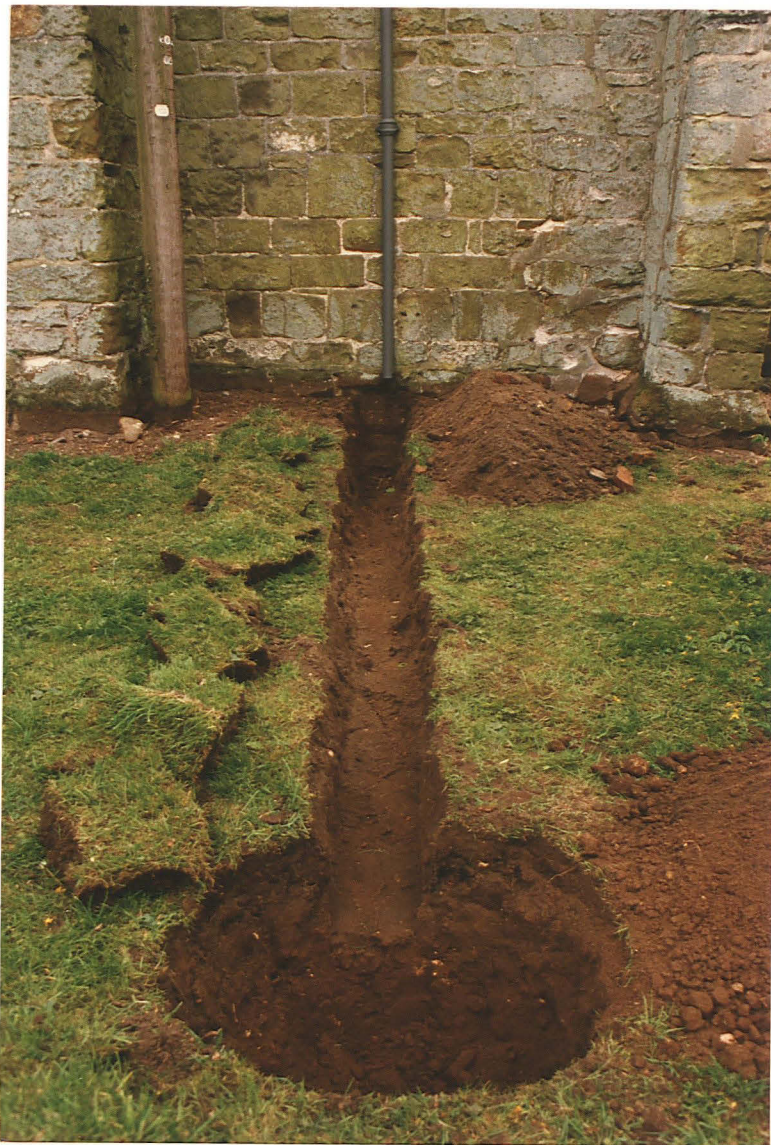
A trench was dug north from the north wall of the tower leading to a circular soakaway (Pl. 1). A sandstone chamfered plinth course was exposed at the base of the tower below the modern ground level. A further stone course was exposed beneath the chamfered block (Pl. 2). The tower foundations extended below the base of the trench.

**Pl. 1 Trench 6 and soakaway running north from tower**

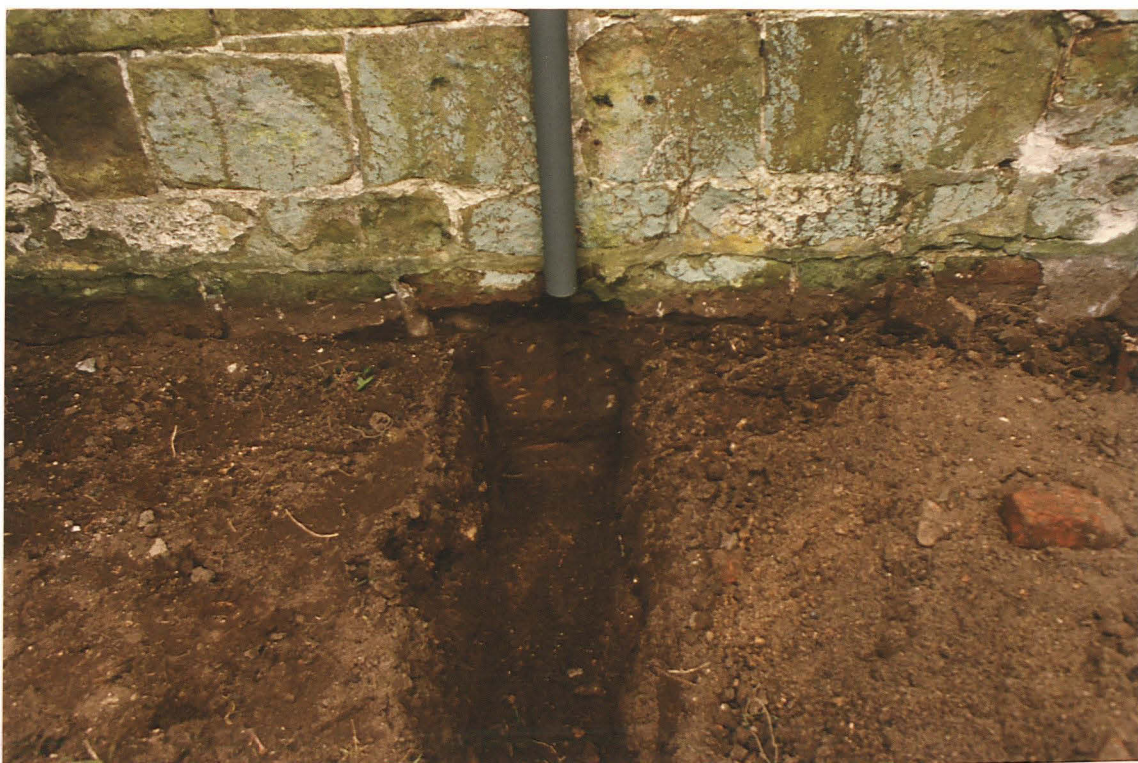
**Pl. 2 Trench 6 at junction with tower north wall showing chamfered plinth**

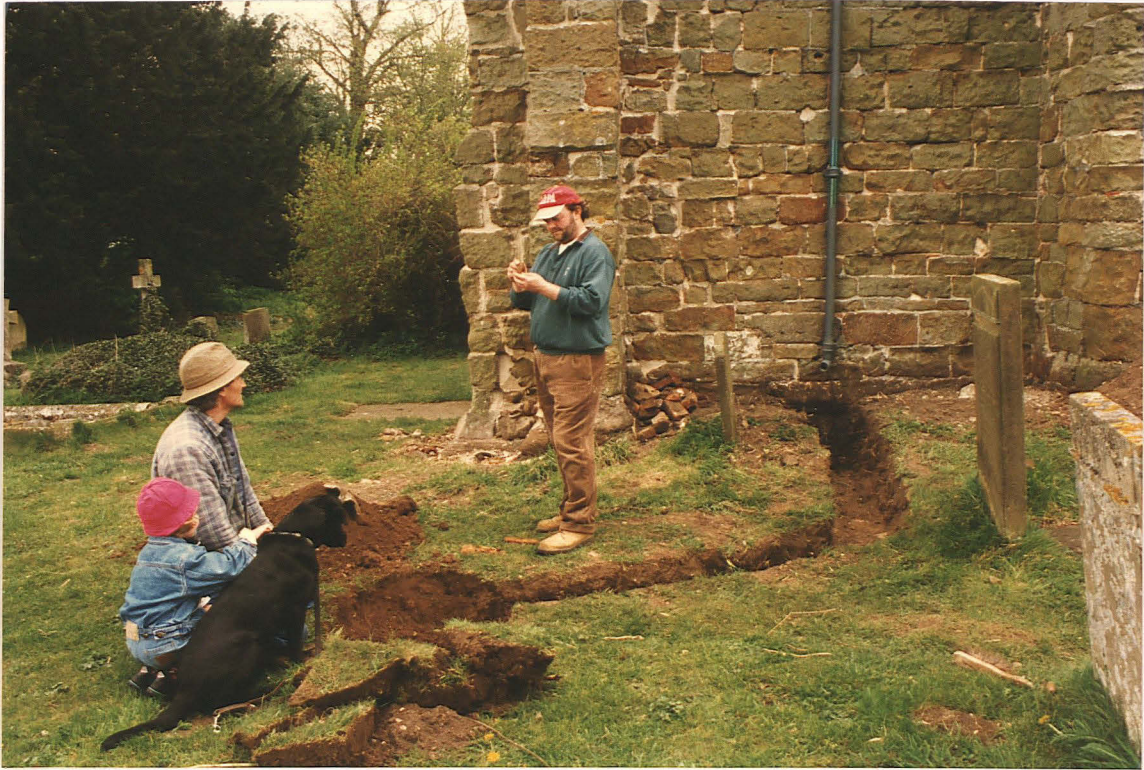
A trench was dug south from the south wall of the tower turning south-west towards a circular soakaway (Pl. 3). A chamfered plinth, identical to that found on the north side of the tower was observed just above the existing ground level (Pl. 4). A further stone course was visible beneath the chamfered course and again the base of the trench did not reach the bottom of the tower foundations.

**Pl. 3 Trench 1 running south from tower**

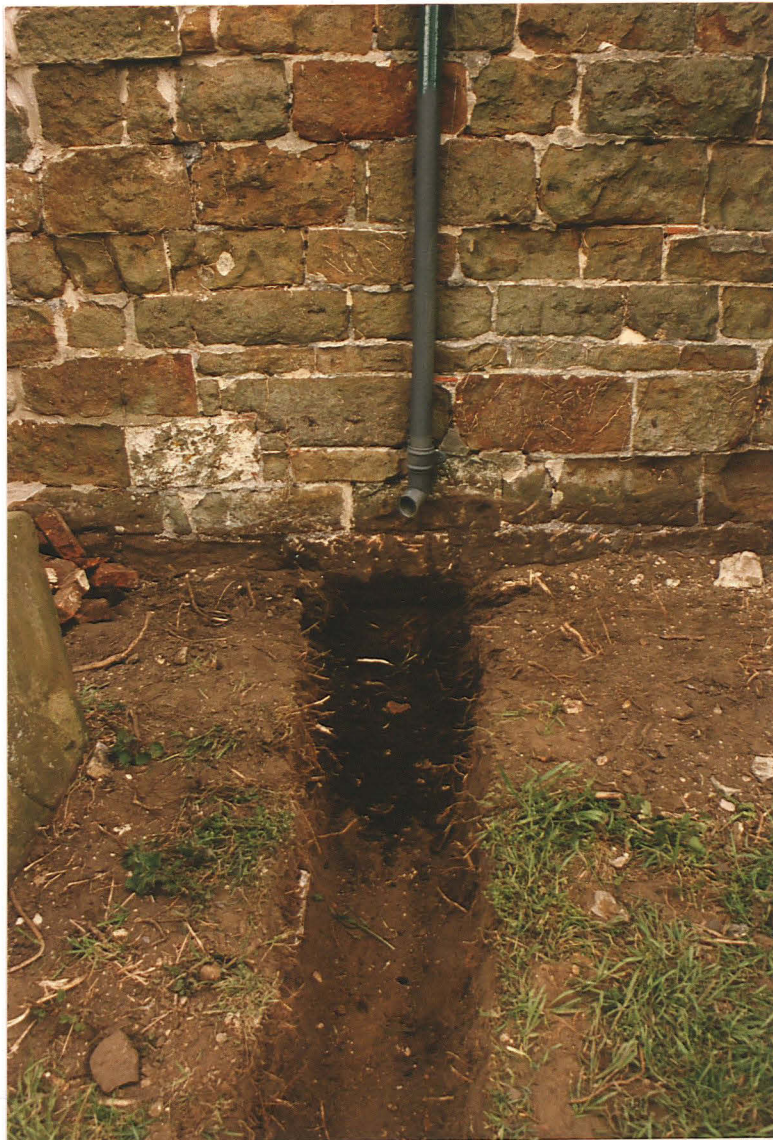
**Pl. 4 Trench 1 at junction with tower south wall showing chamfered plinth**

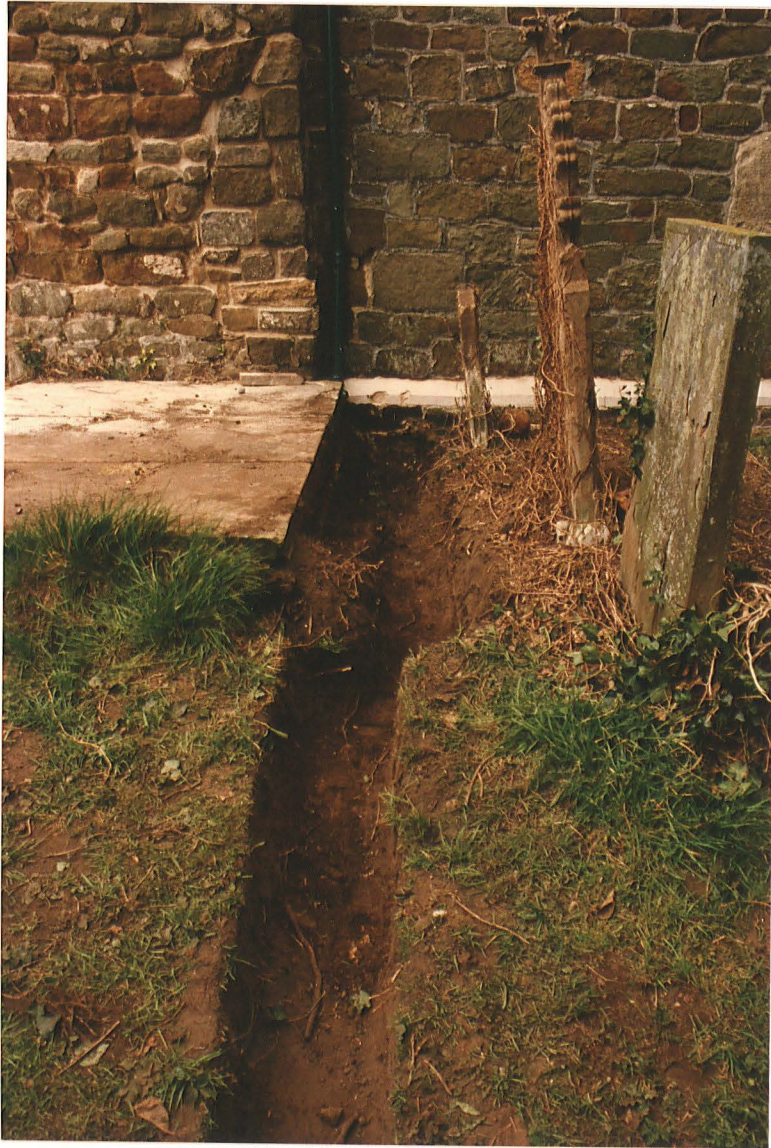
Trench 2 was dug south from the chancel, adjacent the south-east angle of the nave, running between a vault to the west and a line of gravestones (Pl. 5). The trench turned south-east towards the soakaway (Pl. 6). A skull was found next to the vault but was not in situ. Arrangements were made for its reinterment.

**Pl. 5 Trench 2 at junction with chancel east of stone capped brick vault**

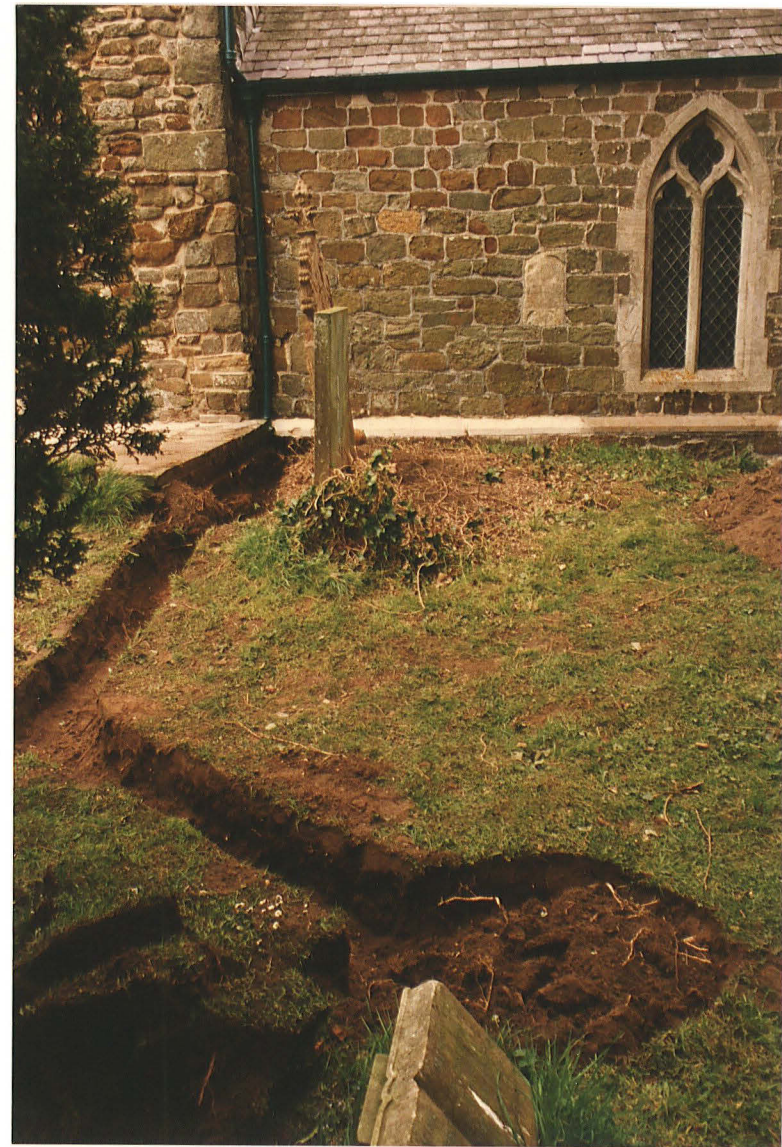
**Pl. 6 Trench 2 and soakaway running south from chancel south wall**

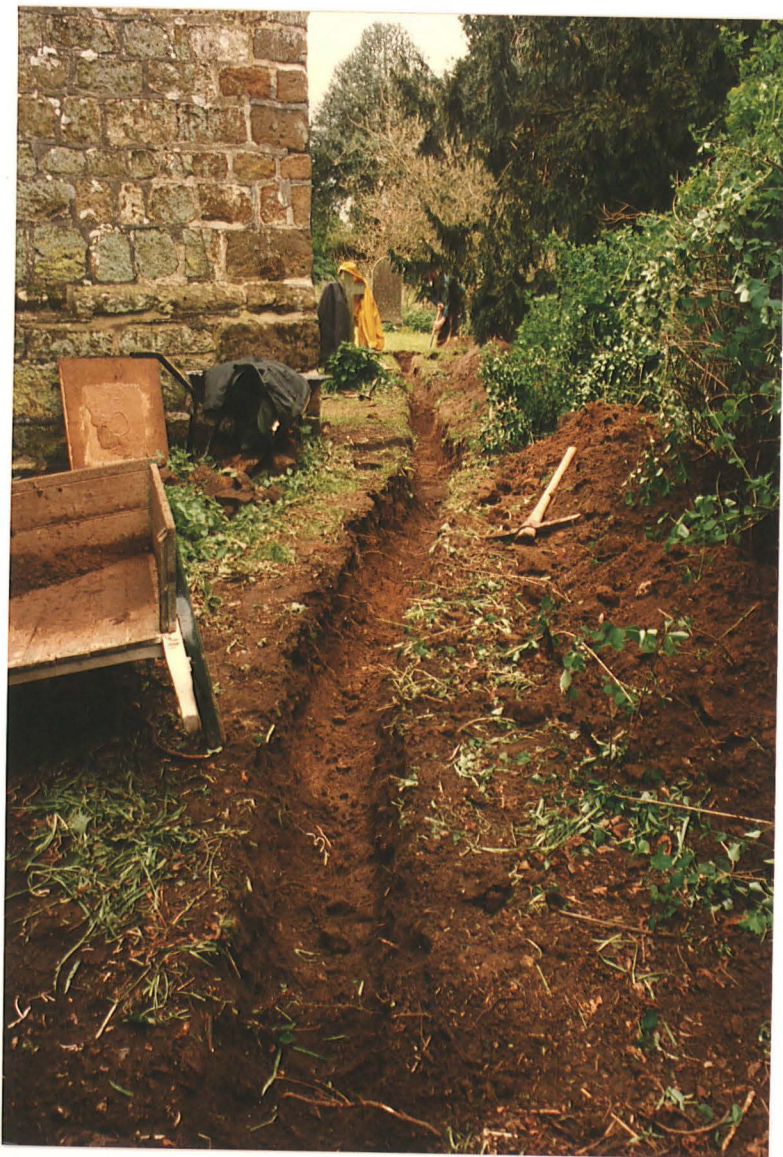
Trench 3 ran north-west from the rainwater pipe on the north side of the chancel towards a soakaway north of the vestry which was also joined by Trench 5 (Pl. 7).

**Pl. 7 Trench 3 to north of chancel looking north-west**

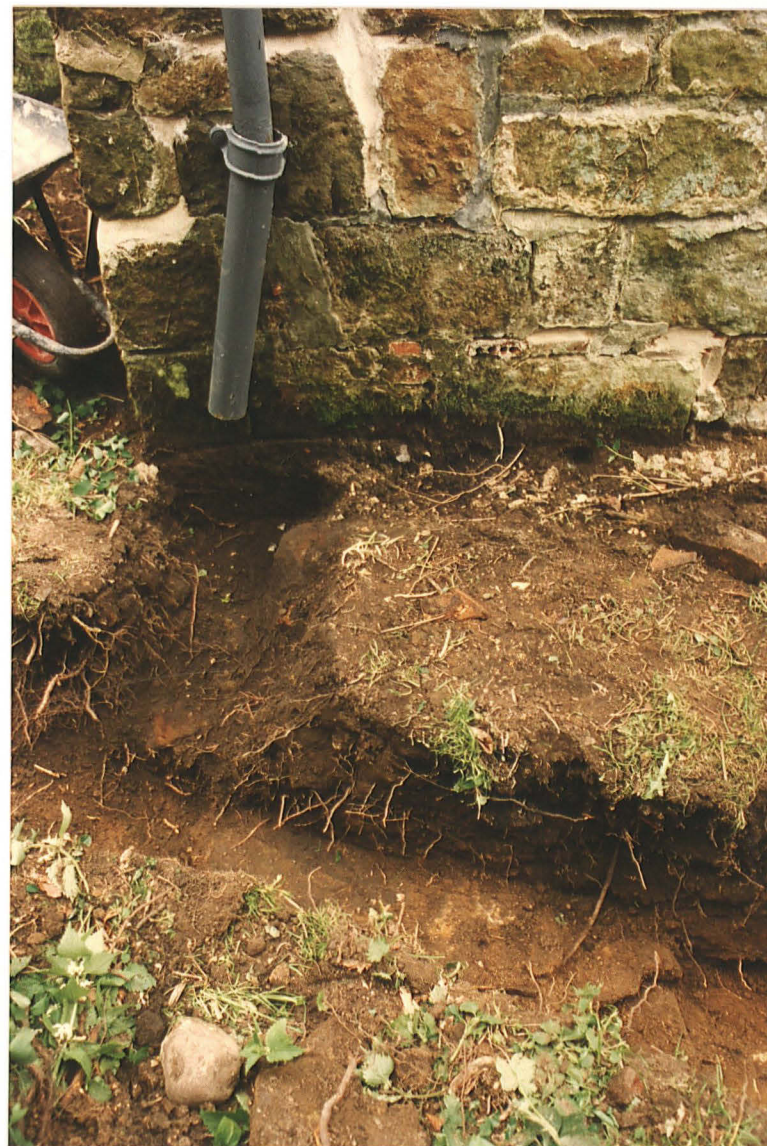
**Pl. 8 Trench 4 at north-east angle of nave running into trench 3 with remnants of sandstone foundations in Trench 3**

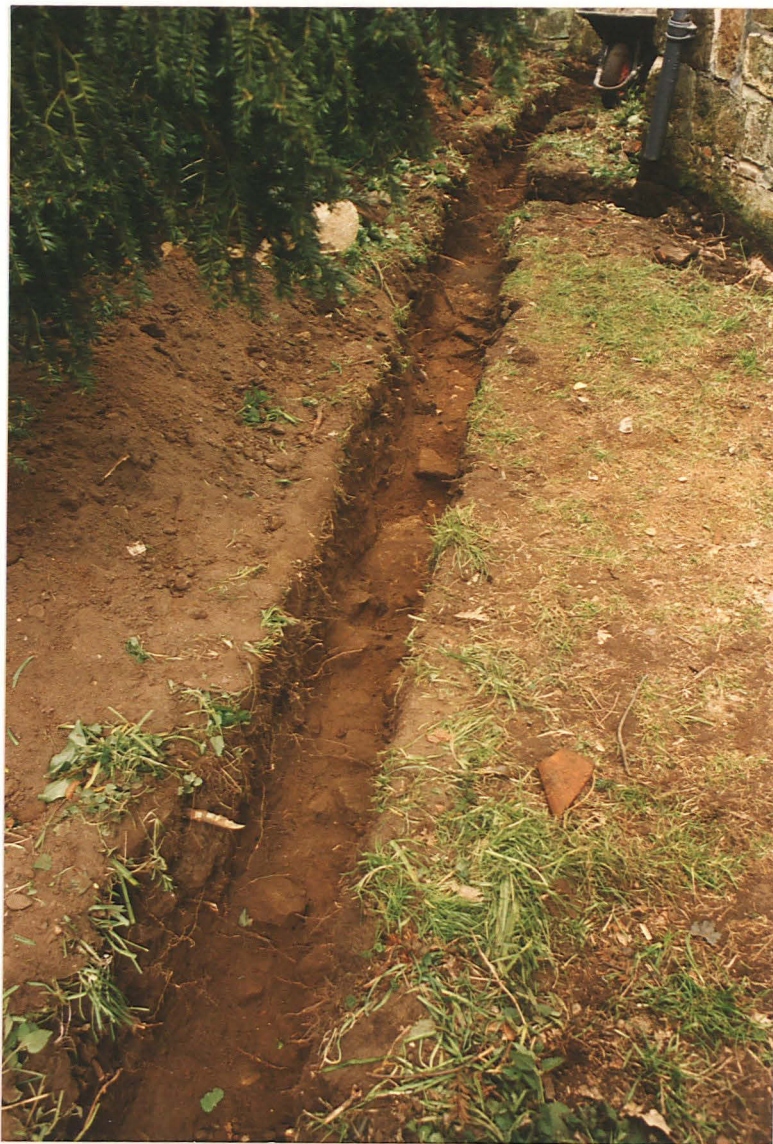
The gap in the stonework may represent the internal angle of a building which was crossed diagonally by Trench 3. The mortar flecks may have come

from soil contained within a foundation trench for the walls or were possibly the remnants of an internal floor surface.

**Pl. 9 Trench 3 west of Trench 4 showing sandstone foundations**

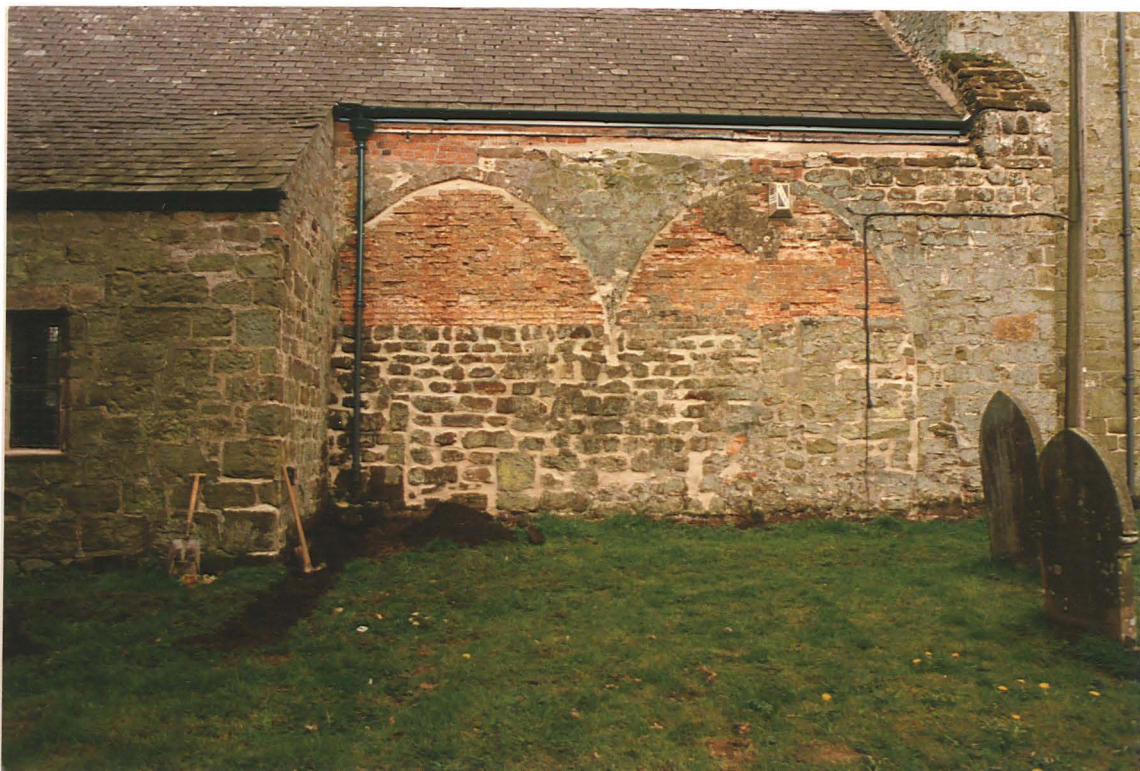
The wall west of the vestry also requires explanation. The standing fabric shows that the aisle extended the full length of the nave (Pls. 10 and 13) so the foundations located half way along the nave probably belong to an earlier structure, unless the aisle was divided into two chapels and the foundations represent an internal dividing wall. Alternatively, it is possible that the stonework found in Trench 5 was an external wall and that the foundations represent the west wall of a north transept. The presence of a transept which pre-dates the 13th century aisle raises the possibility that a church of some status existed on this site.

**Pl. 10 General view of blocked north aisle arcade with vestry to left, showing Trench 5**

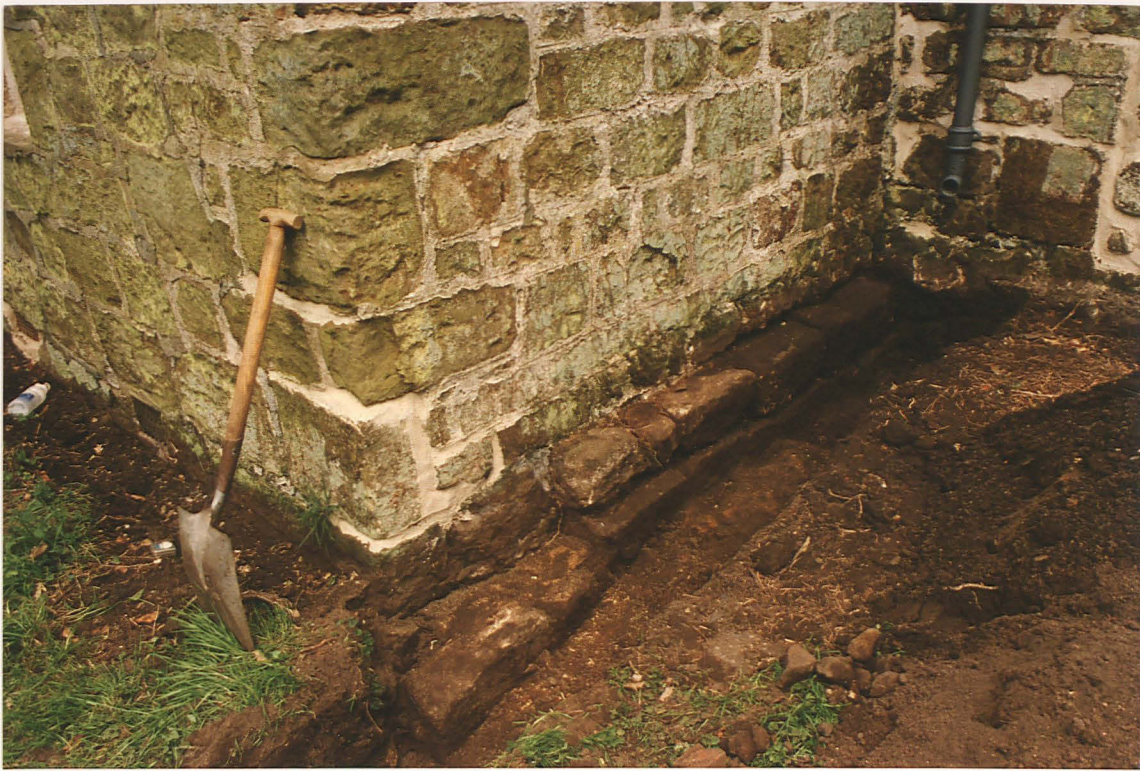
Trench 5 was dug north from the rainwater pipe at the junction between the nave and vestry west wall. The vestry west wall is 2.5m long and immediately beneath the topsoil were two foundation courses of stone blocks beneath the wall projecting west by c.0.20m, and 0.17m north of the north wall (Pl. 11). They were sitting on less distinct stonework which extended west beyond the limits of the trench and northwards 2.30m beyond the vestry north wall (Pls. 11 and 12). There was a possible edge to the stonework at this point although further loose stones were found in the trench beyond. Unlike the vestry foundations the stones were irregular in shape and much thinner. In character they were similar to the foundations recorded in Trench 3.

**Pl. 11 Trench 5 running along vestry west wall showing two courses of stepped foundations for the vestry overlying foundations of an earlier structure**

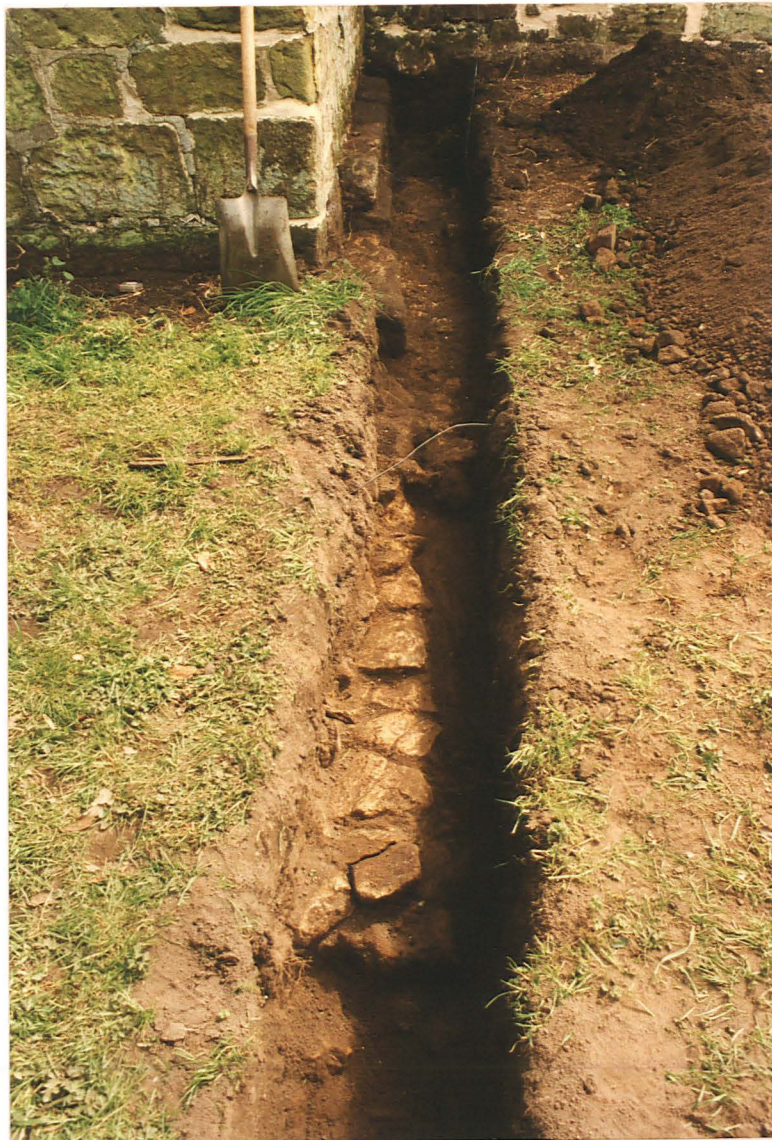
**Pl. 12 Trench 5 showing sandstone foundations, possibly for transept, north of the vestry**

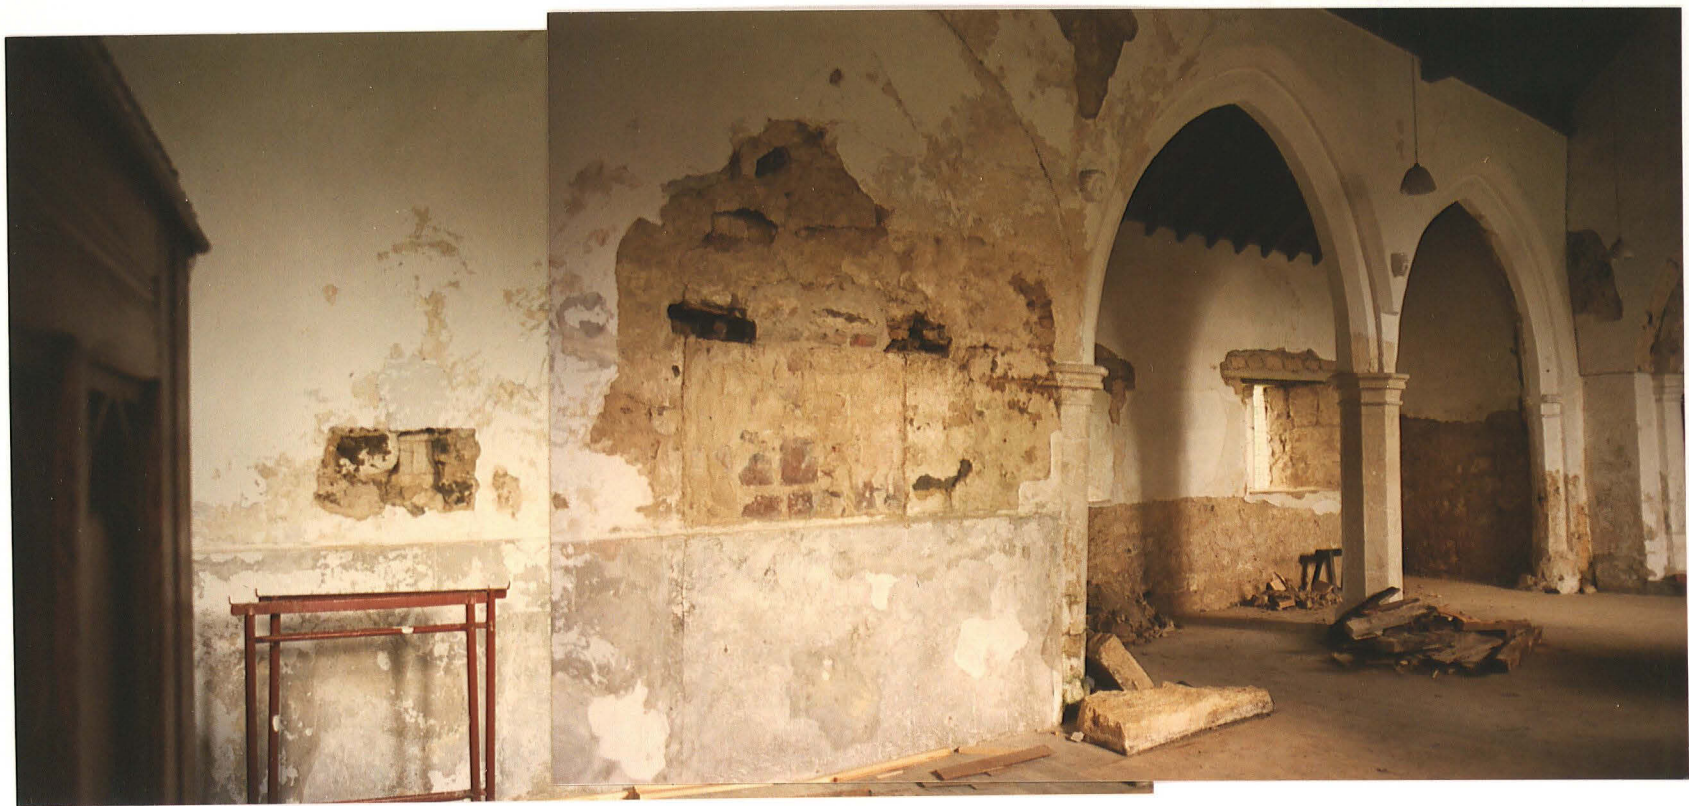
**Pl. 13 North wall of nave showing aisle arcade, blocked left and open right with former vestry**
