8, ST. LAWRENCE STREET, HORNCASTLE

PHOTOGRAPHIC BUILDING SURVEY

NGR: TF 2589 6963
PCA job no. 08-569
Site code: SLHL 09
LCNCC Acc No: 2009.119

September 2009

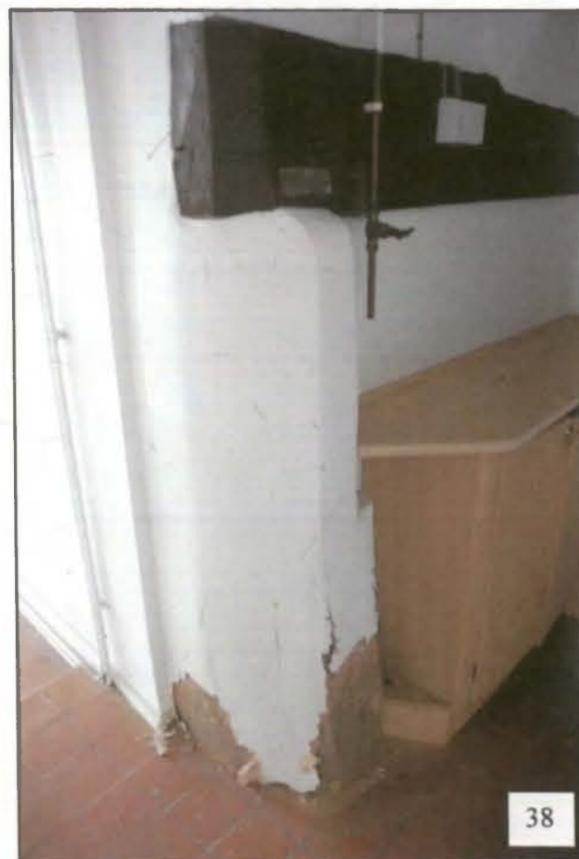
A heavy horizontal beam (12" high x 7" wide) was present in the west wall of the north alcove: this had a deep chamfer on its exposed east face, with a diagonal stop at the south end. Its southern end had clearly been sawn off flush with the wall, and the wall itself was angled here, with a narrower part extending beyond the beam. The purpose of this timber element is unclear, the immediate impression is of a fireplace lintel – but this is conjecture.

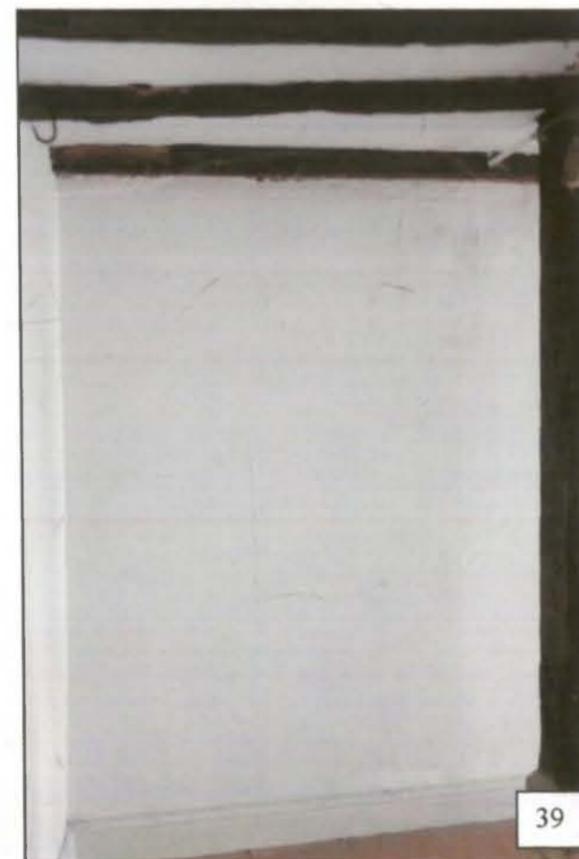
At the east side of the south wall, a timber lintel was present just below the ceiling; this was hollowed out on its underside, and a vertical crack in the wall plaster near its western extent was suggestive of a blocked door opening.

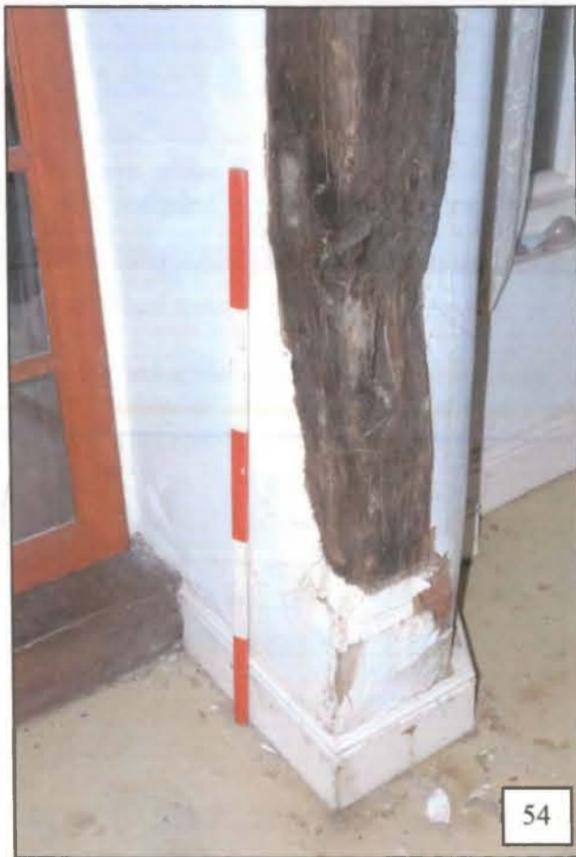
This room again displayed elements of the timber-framed origins of the property. Three posts were present in the room. Two posts were present in the south wall, the western of which was built into the wall adjacent to the stair door. This post was 5½" (N-S) x 9" (E-W) and had a 4" x 3" (plaster-filled) mortise near to the ceiling. A further 8" high mortise was present 38" from its base on the east side, which had a hole for a peg on the north face.

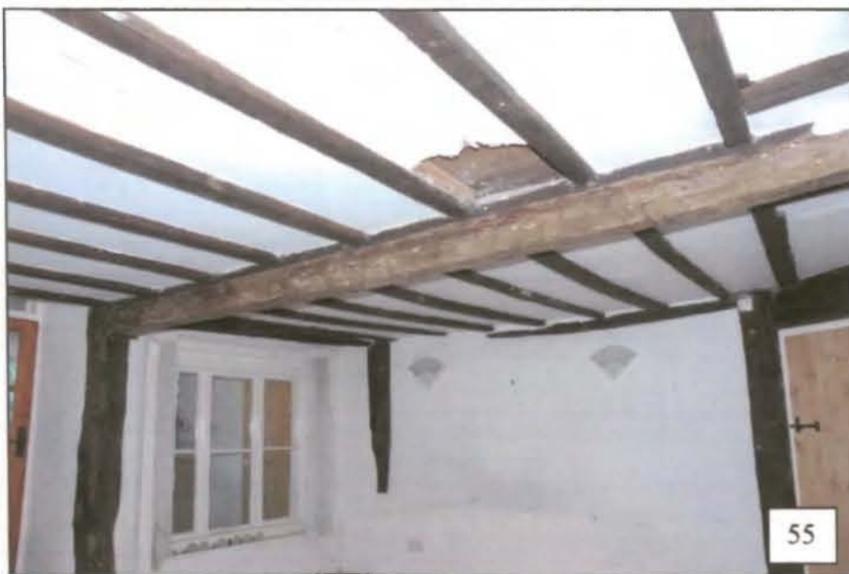
The third post was located in the east wall, between the window and the door to Room 4. This was 6½" (N-S) x 7" (E-W) and had a 4" x 1½" mortise on its northern side, 20" from its base and a further badly damaged mortise on its west face, 12" from its base.

A similarly-sized ceiling beam ran west from this post; this was chamfered on its underside, with stops 6" from the post, but was extended at its west end with a scarf joint further secured by a bolt. The exposed joists of the first floor were of sawn 3" timber, suggesting that this floor, and perhaps the beam, had been renewed.

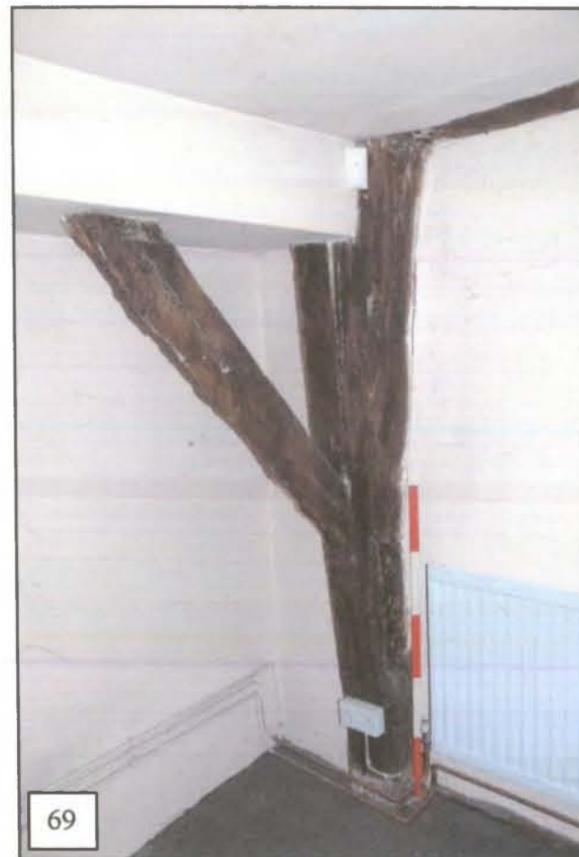
A further beam ran from the top of the post to the north across the full width of the room. Exactly how this was joined to the post was obscured, but a 4" x 1½" mortise was present adjacent to the post, with a sawn off tenon still in situ. Further along the beam, another sawn-off tenon was present in the soffit of the beam above the door to Room 6; this occupied a mortise 12" in length.

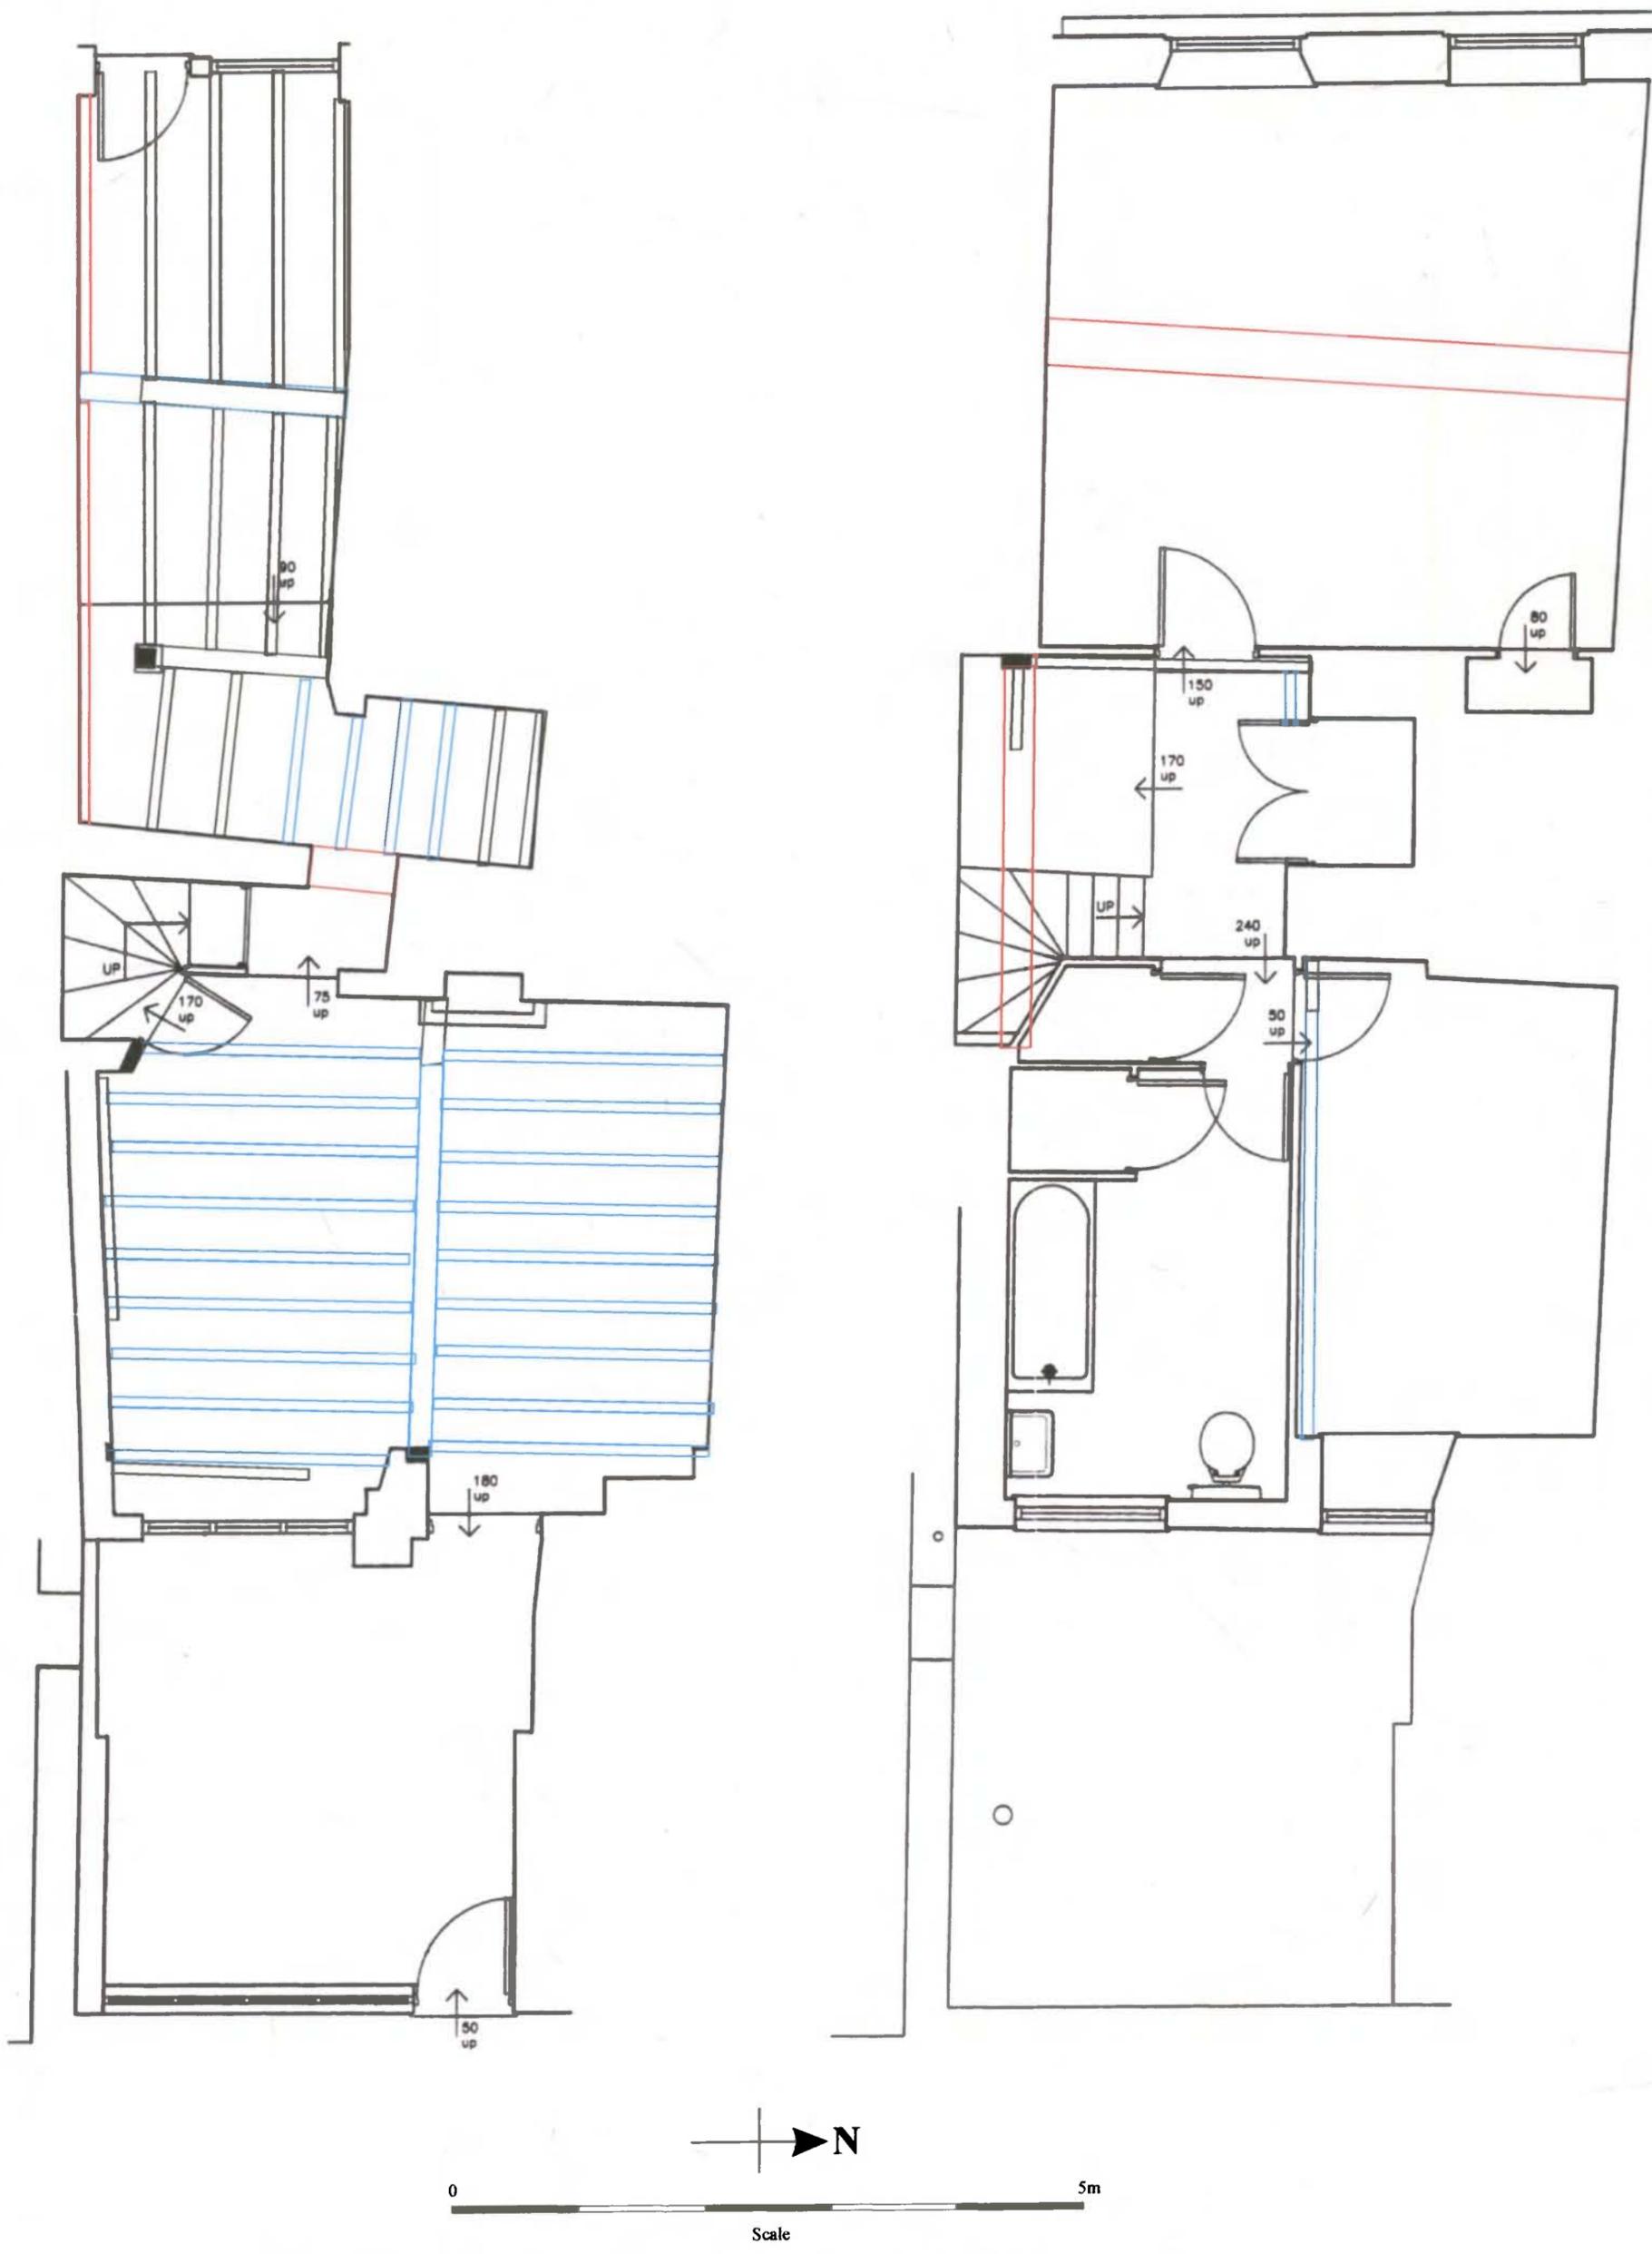
Fig. 6: Floor plans of No.8, St. Lawrence Street, showing the arrangement of the timber frame within the building. Original timbers are shown in black: posts solid, beams open; replacement beams and joists are shown in blue, while false beams and boxed beams are shown in red. Scale 1:50.

It is certainly the case that elements of the first floor were renewed when the building was altered, as evidenced by the inserted beams with bolted scarf joints in Rooms 3 and 7, and the sawn timber replacement joists seen in Rooms 2 and 3. It is also clear that this reorganisation of the building involved excavation of new ground floor levels: as no sill beams were observed and none of the extant posts reach to ground level, it remains unclear if the timber frame had become rotten at ground level, or excavation was deemed necessary to raise the height of the ground floor ceilings.
