**93/95, EASTGATE, LOUTH,
LINCOLNSHIRE**

**PHOTOGRAPHIC BUILDING
SURVEY REPORT**

| Site code | EGLO 03 |

Report prepared for George Smith (Alford) Ltd.

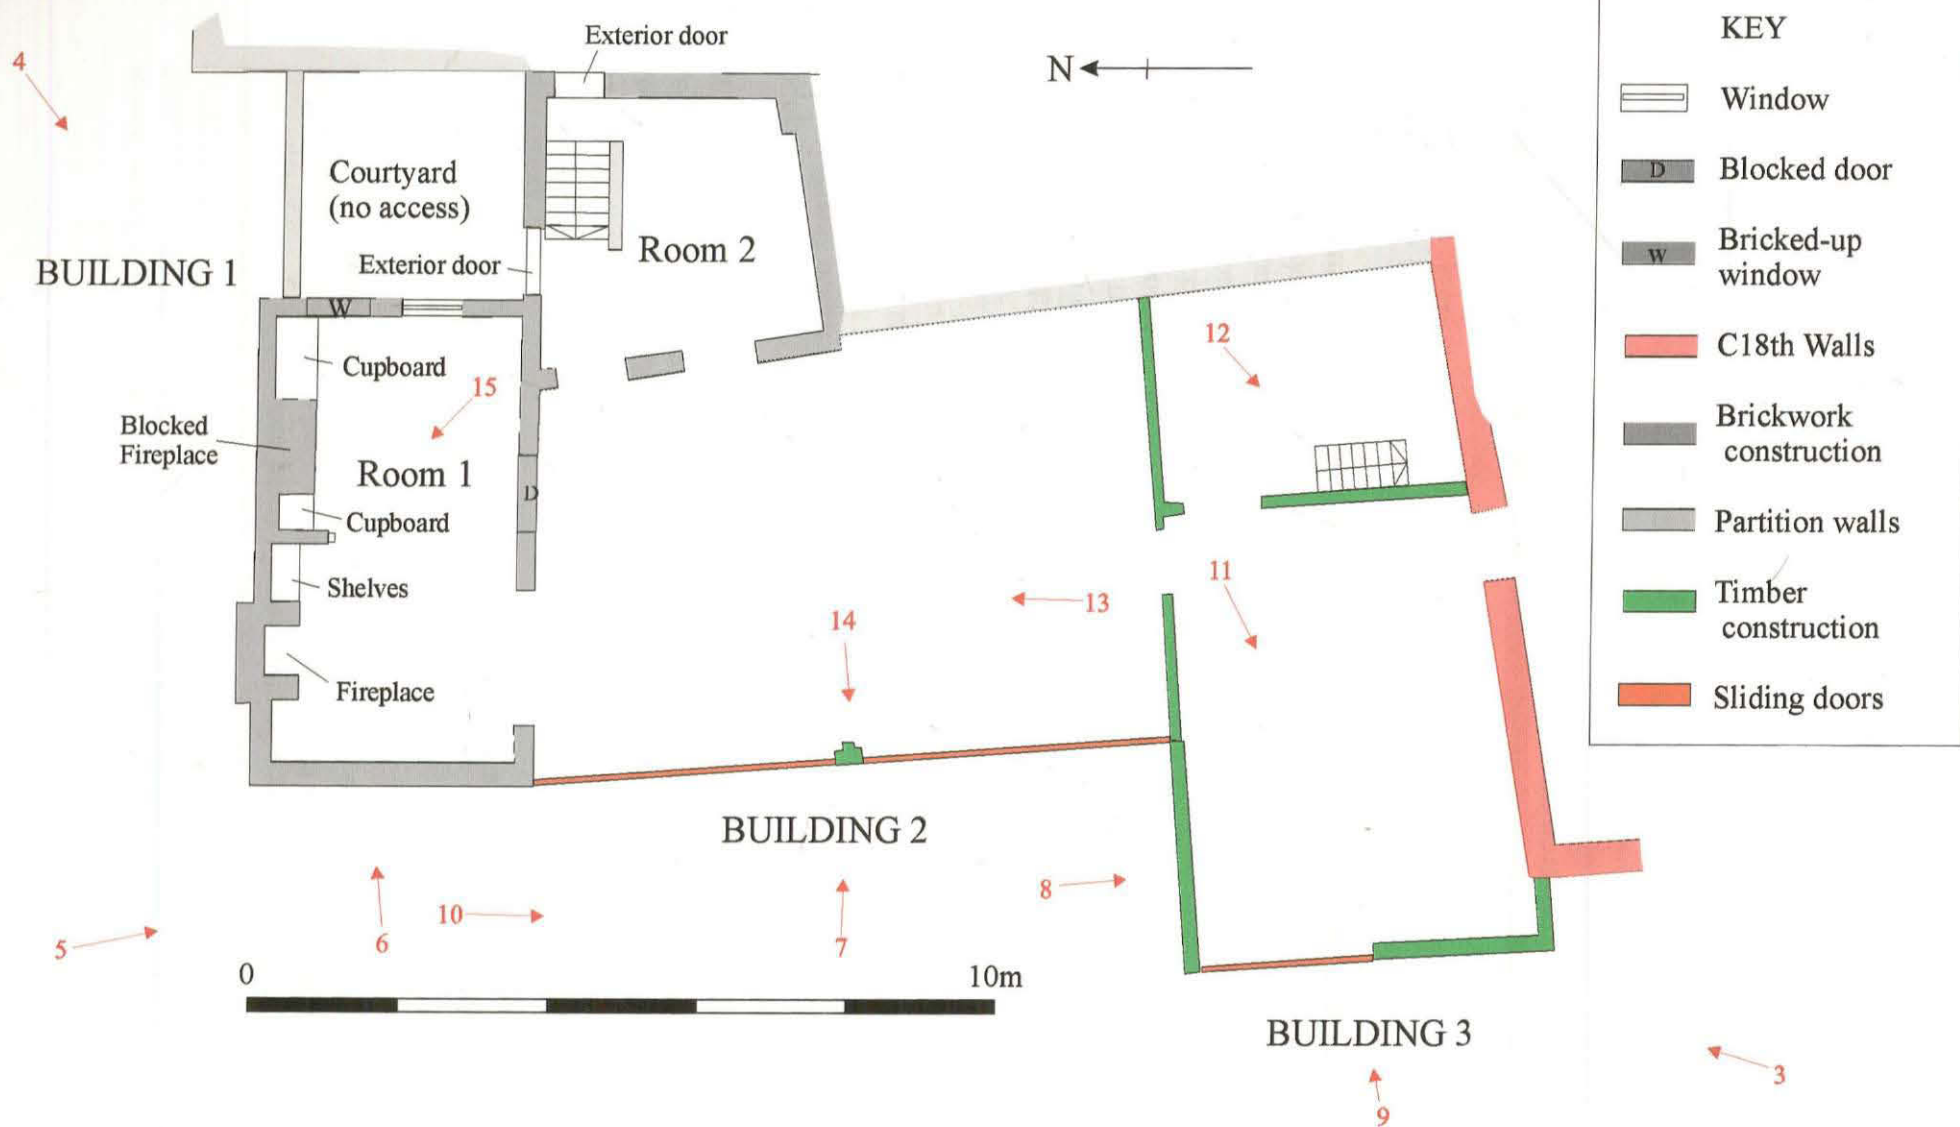
Fig. 3: Plan of the ground floor level of Buildings 1-3. Scale 1:100. Approximate positions and directions of illustrated plates are shown as numbered arrows in red.

The buildings surveyed comprised a two-storey brick structure to the north (building 1), with a range of ancillary buildings (buildings 2 & 3) extending to the south, the southernmost of which abutted the rear of the 18th century brick buildings which front onto Eastgate.

Building 1. Approaching from the north, the first building comprised a two-storey brick structure. This was irregular in plan, the northern part being rectangular and aligned east-west, and the southern part sub-square (where the south and west walls have been forced into a different alignment to fit within the property boundaries). It was constructed of brick (brick dimensions 230x115x70mm), in an irregular 'English garden wall' bond, where a course of headers was built on average every seven courses of stretchers (although this was not the case lower in the walls where the header courses came every 3 or 4 courses), with a slate roof. This building appears to have been built as a detached structure, which was later incorporated into the rest of the plot. Hence, it exhibits extensive signs of alteration: blocked doors, bricked up

windows, etc. The floors within Building 1 were constructed of timber floorboards and joists and the ceilings were of plastered lathe construction. Internal walls, including stud and lathe partition walls were mostly plastered, although in many cases plasterwork had become damp and was badly deteriorated. The exterior of the north wall had a modern render.

Room 1. This room was located in the northern part of building 1, on the ground floor. It appears to have originally been built as two rooms (part of the partition survives on the north side and there is evidence of a blocked-up fireplace), but had been knocked-through and was in use as a large storeroom/workshop. One window survived in the east wall, and there was evidence that another window here had been bricked-up. The modern entrance, double doors from building 2, appeared to be recent inserts (with a timber lintel), while an original doorway (with a brick arched lintel) approximately 1m to the east had been bricked-up.

Room 2. This room was located in the southern part of building 1, on the ground floor. It was most recently used as a storeroom and had no exterior light sources. Two exterior doors remain, one on the north side, and one on the east: neither could be opened. The room was divided by a stud and lathe wall, to the north of which a staircase gave access to the first floor. The foot of the staircase was located immediately opposite the door in the east wall, suggesting that this door was once the main entrance to the building.

Modern access to this room was gained from building 2, through two doorways in the west wall: these appear to have been original, as both openings have trapezoidal stone lintels.

Building 2. This structure lies immediately to the south of Building 1; it was 8.5m long and sub rectangular in plan. It was built as a lean-to structure against the south side of Building 1, its east side partly against Building 1 and partly against the property boundary wall. It was constructed from timber posts with a corrugated iron cladding, and a corrugated iron roof. It had a poured concrete floor. A timber platform, occupying the eastern third of its area, represented a makeshift second storey, which was probably of recent origin.

The west wall of this structure appeared, as originally constructed, to have been open, suggesting an earlier use of this building as stabling/garaging. A central wooden post on the west side, which now divides two sliding doors, evidences this. The most recent use of this structure was as storage space.

Building 3. This appears to be the most recent of the three structures, and was again a lean-to that utilized the north wall of the 18th century structure and the eastern property boundary (which was heightened with breeze blocks). Its exterior walls (on the north and west sides) were constructed of timber on a three-course brick dwarf wall. It had a corrugated asbestos roof and a poured concrete floor. It was divided into two rooms (and from building two) by timber stud walls. In the eastern room, a staircase led to a first floor storeroom. The western room had a plasterboard ceiling. It appeared to be in use as overflow storage space from the electrical appliance shop which occupied the rest of the property, although a former use as a workshop was evidenced by the benches and tools left here.

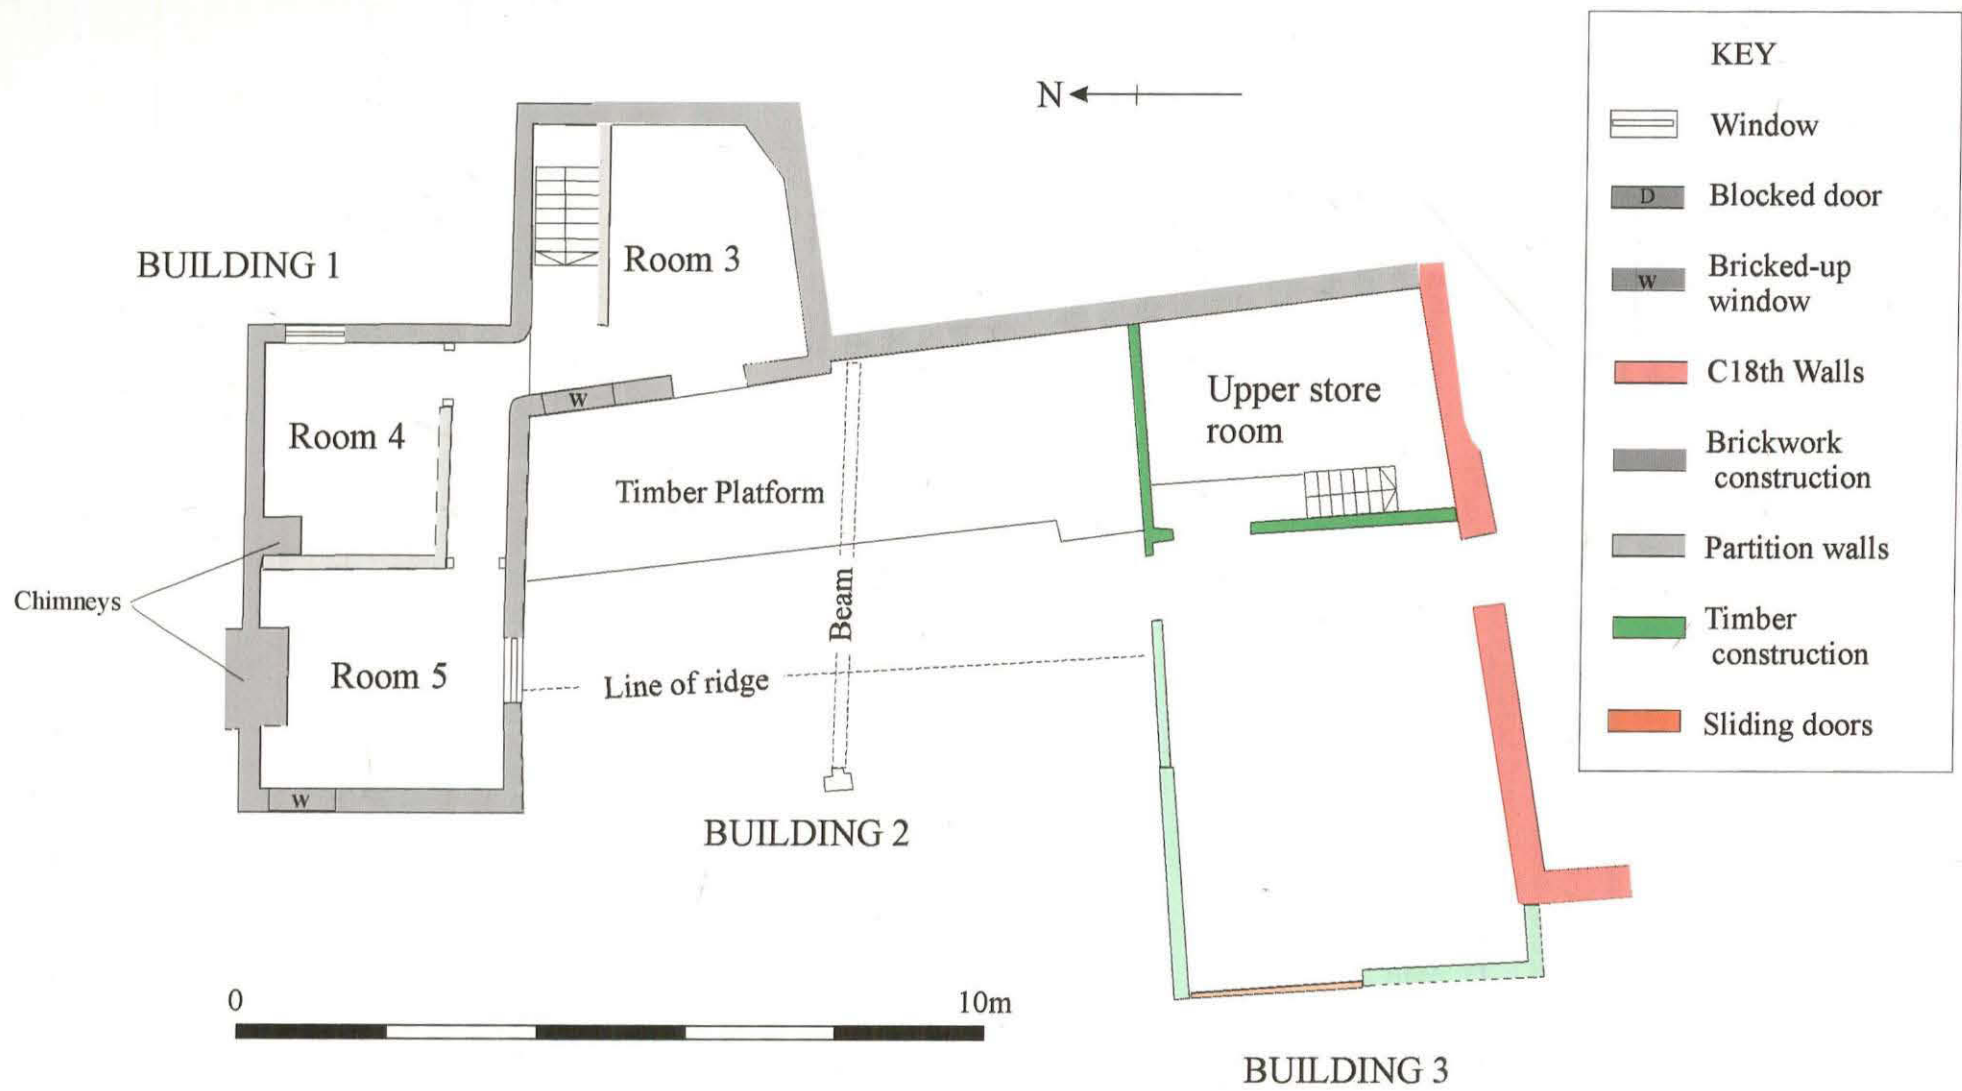
Fig. 4: Plan of the first floor level of Buildings 1-3. Scale 1:100

Room 3. This room was located in the southern part of building 1, on the first floor, immediately above room 2. Modern access to this room was gained from the timber platform in Building 2, through an opening in the west wall. This opening appears to have originally been a window with a timber lintel. The west wall exhibited another bricked-up window to the north of the modern opening.

Rooms 4 & 5. The upper storey of the northern part of Building 1 consisted of two rooms and a short corridor linking them to the landing at the top of the stairs from room 2. The smaller of the two rooms (4) had a window in the east wall, and, excluding some shelving, was empty. The western of these rooms (5) had a window in the south wall and evidence of a blocked up window in the west wall. This room was also empty.

It is interesting to note that the corners of the walls linking this part of the building to the landing at the top of the stairs had been rounded off.

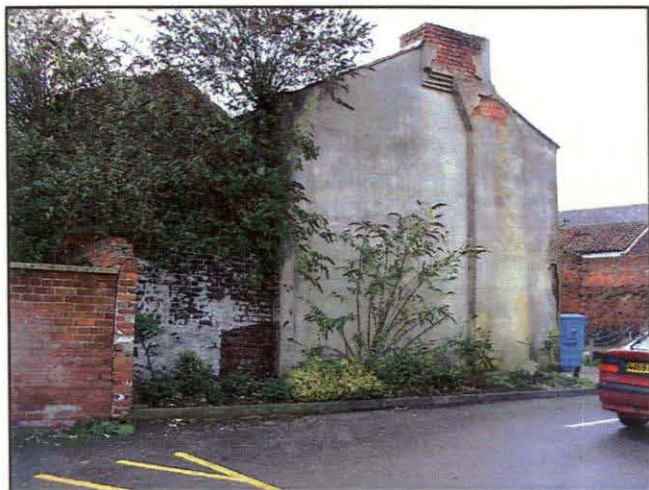
Plate 4 (left): General view of the north elevation of building 1, looking SW.

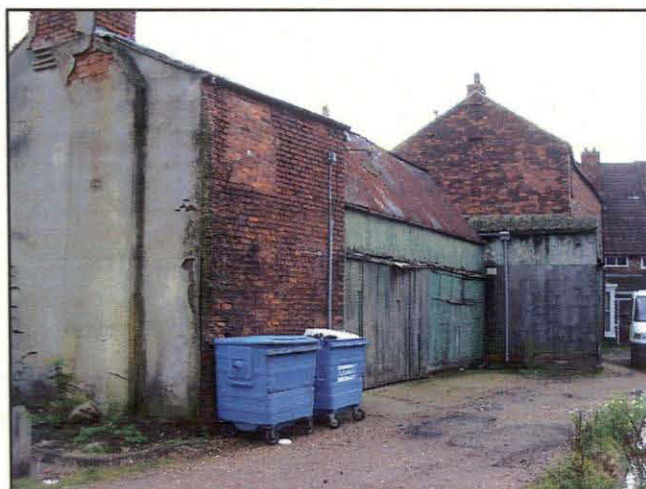
Plate 5 (right): General view of the surveyed buildings, looking SE.

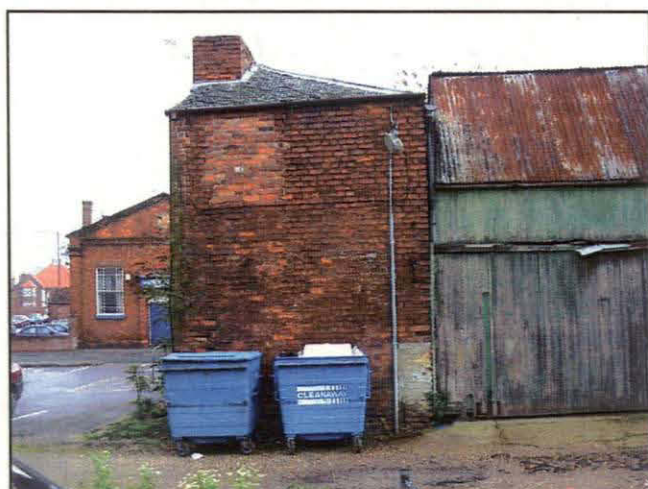
Plate 6 (left): West facing elevation of building 1, looking east.

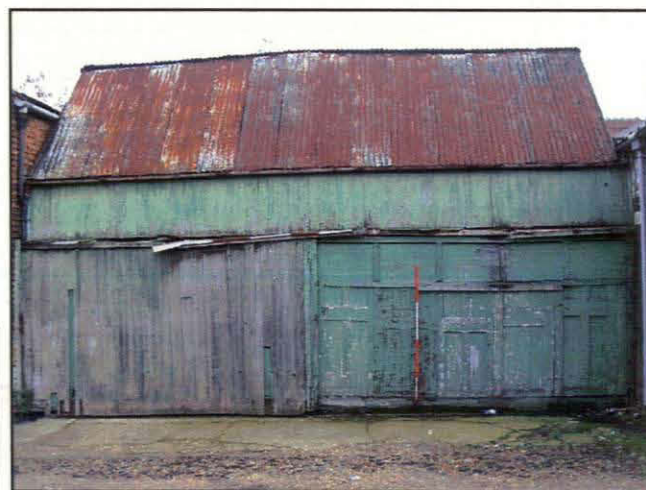
Plate 7 (right): West facing elevation of building 2, looking east.

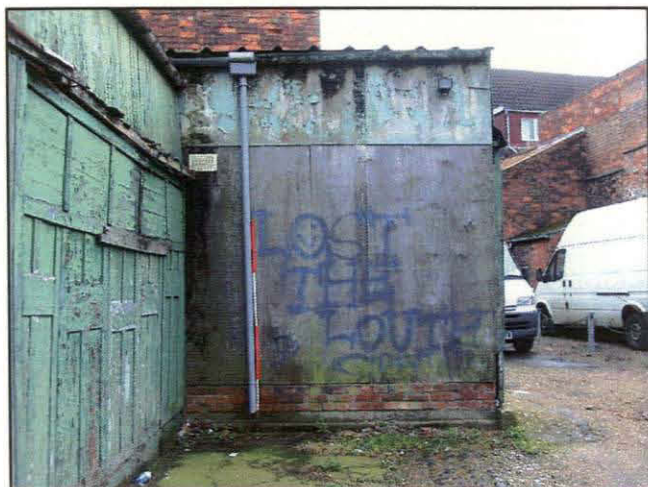
Plate 8 (left): North facing elevation of building 3, looking south.

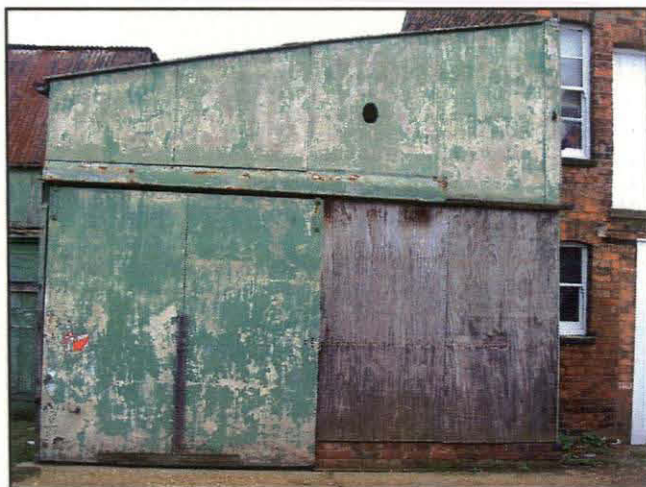
Plate 9 (right): West facing elevation of building 3, looking east.

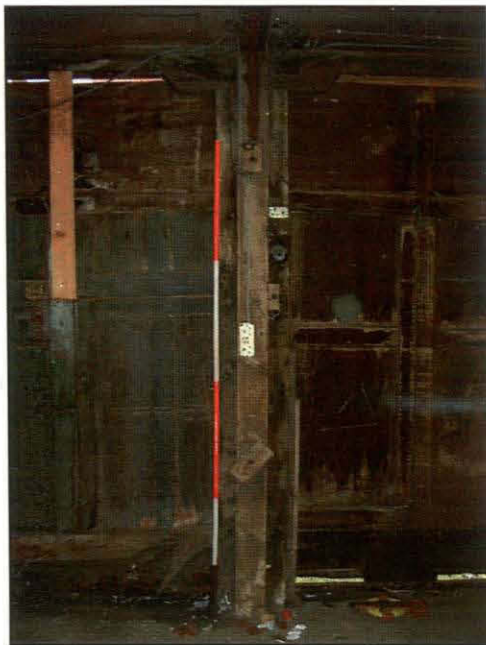
Plate 14 (left): Timber
supporting post in the
middle of the west side
of building 2.

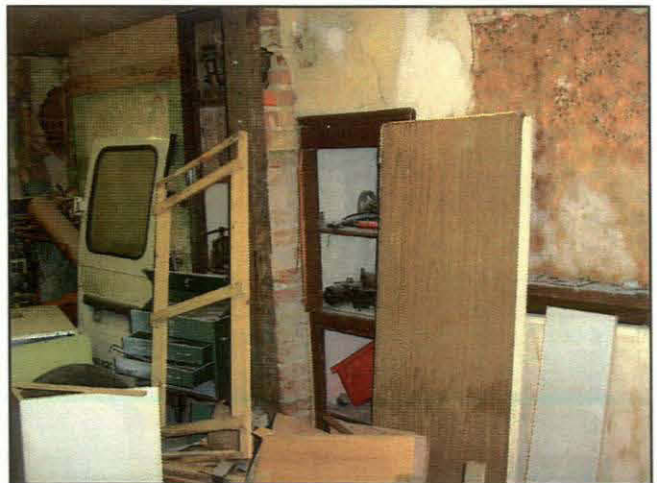
Plate 15 (right): Interior
view of room 1 in
building 1, looking NW.
