**Cranwell, St. Andrew's Church
Archaeological Watching Brief**

NGR: TF 0328 4996

Site Code: CSA 96

**LAS Report 304
July 1998**

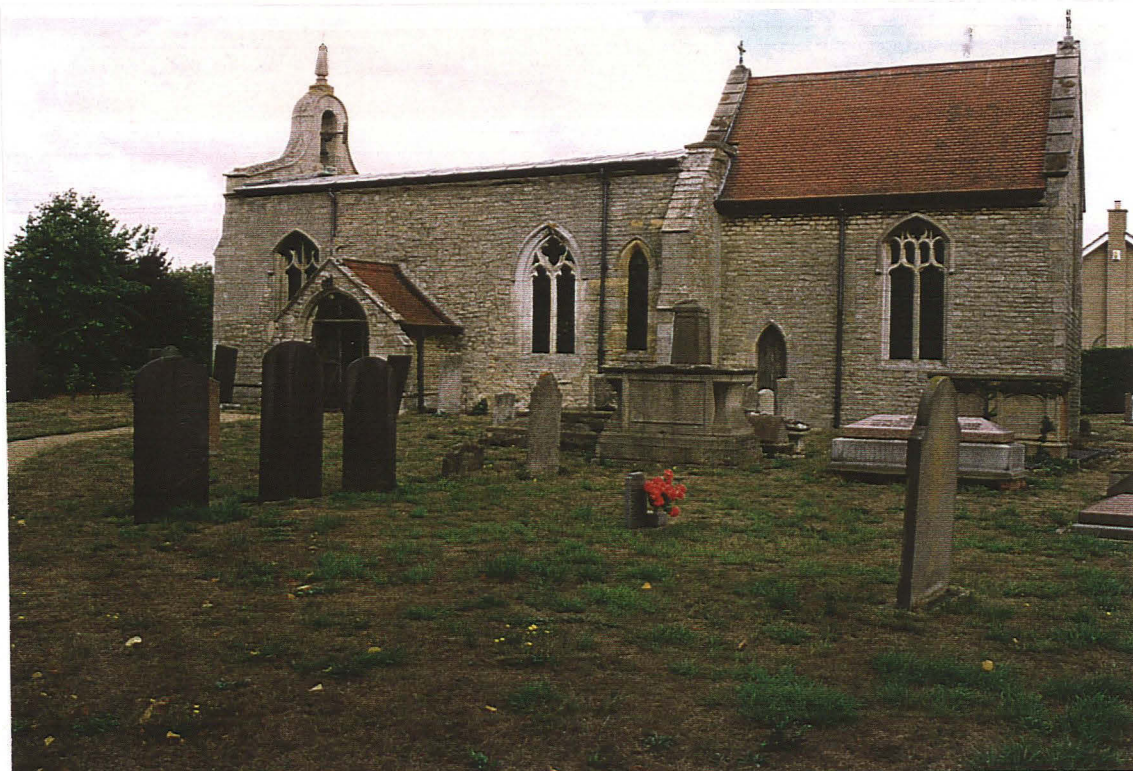
St Andrew's church comprises a chancel and nave with a north aisle, south porch and bellcote at the west end of the nave (Pl. 1). The three-bay arcade is an opening out of the Saxon nave dating to the early 12th century that was extended westward in the 13th century, together with an extension to the nave. The aisle north wall was rebuilt in 1812 and the chancel was rebuilt in 1902-3 when an organ chamber/vestry was also constructed on its north side. The chancel arch is Early English in style. The bellcote at the west end of the nave is in an unusual Dutch-influenced style and of probable 17th century date (Fig. 2). Plans, elevations and section drawings of the church, prepared in 1899 by the architect C. H. Fowler, are held at the Lincolnshire Archives Office, showing existing layout and proposed alterations (ref. Fowler plans 24).

The chancel was rebuilt at the same time as the construction of the organ chamber and vestry although five larger blocks forming a straight joint behind the drainpipe on the south wall may be the west side of a blocked window, denoting earlier fabric *in situ* (Pl. 1). Removal of the concrete and rubble revealed a slight offset stone foundation with a concrete underpinning (Pl. 17).

Pl. 1 St Andrew's Church Cranwell, general view from south showing bellcote, south porch, nave and chancel.

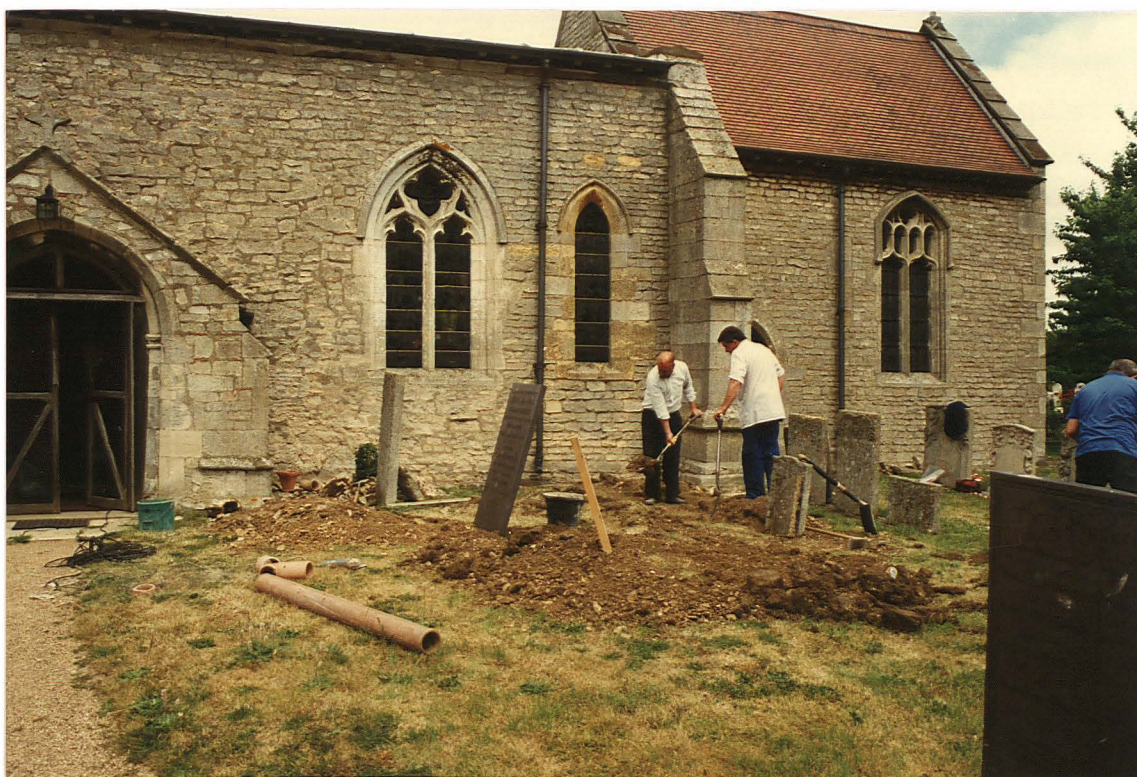
Two drainage trenches were dug south of the nave wall leading to a soakaway (Pl. 2). The trenches were shallow and nothing except for a few pieces of human bone were found in them and the soakaway.

Pl. 2 Excavation of drains and soakaway south of nave

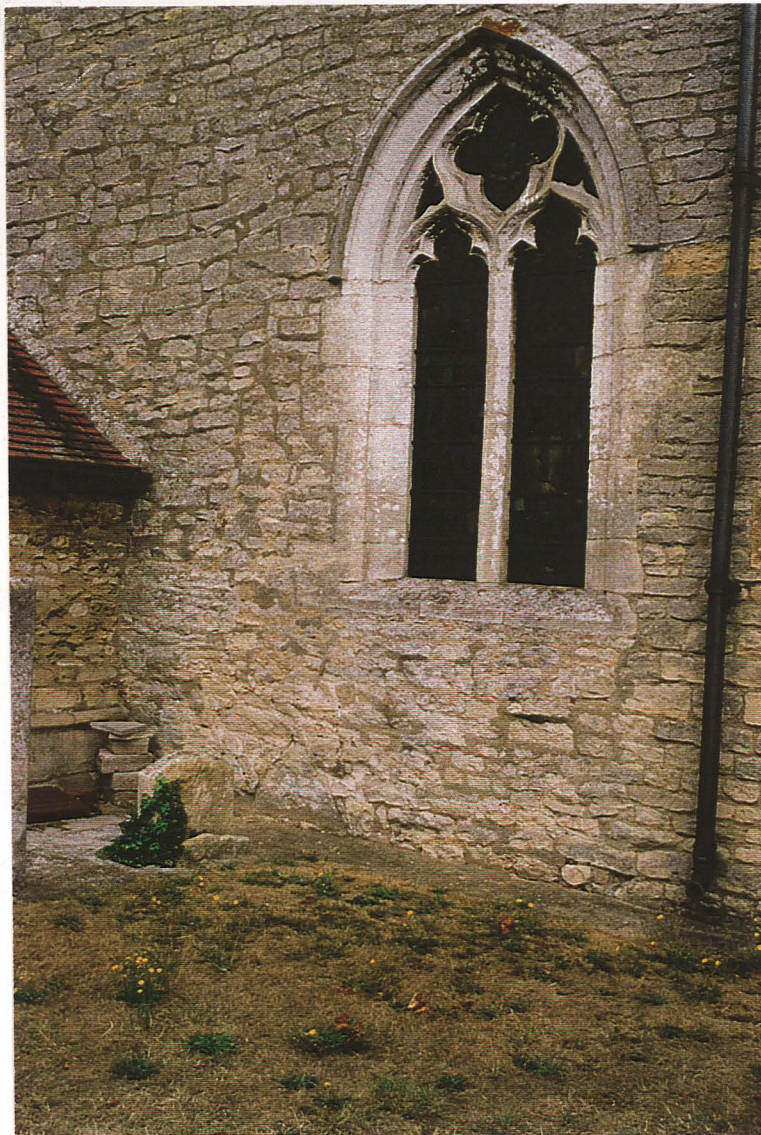
Removal of the concrete apron and underlying hardcore along the nave wall exposed dark brown soil with limestone fragments in the shallow trench (Pls 3 and 4). There was no evidence of an offset foundation course at this level but the lowest visible courses were of thinner stones than those used above.

Pl. 3 Nave south wall showing concrete apron and triangular stone at base of wall below, and left of, window.

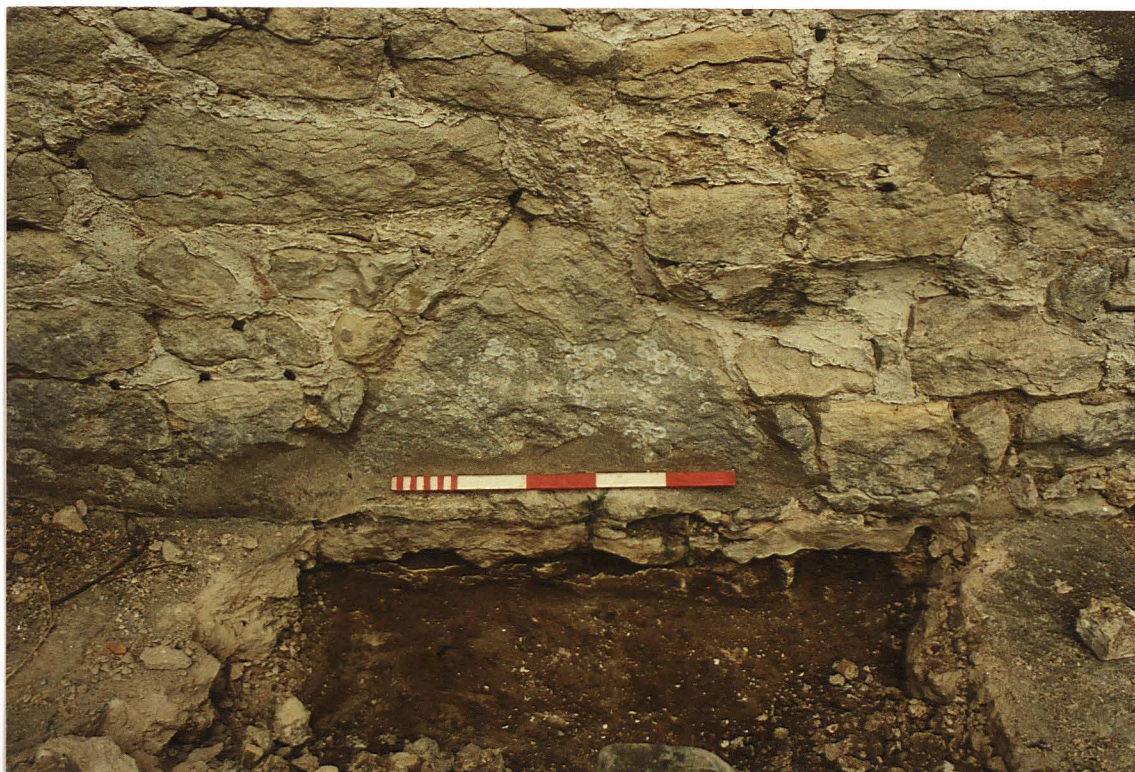
A triangular piece of limestone was seen in the fabric at the base of the wall east of the porch and below the window (Pl. 4). The exposed face is not dressed but its unusual shape suggests that this may be part of an architectural fragment or other piece of worked stone.

Pl. 4 Detail of triangular stone in nave south wall, after removal of concrete apron

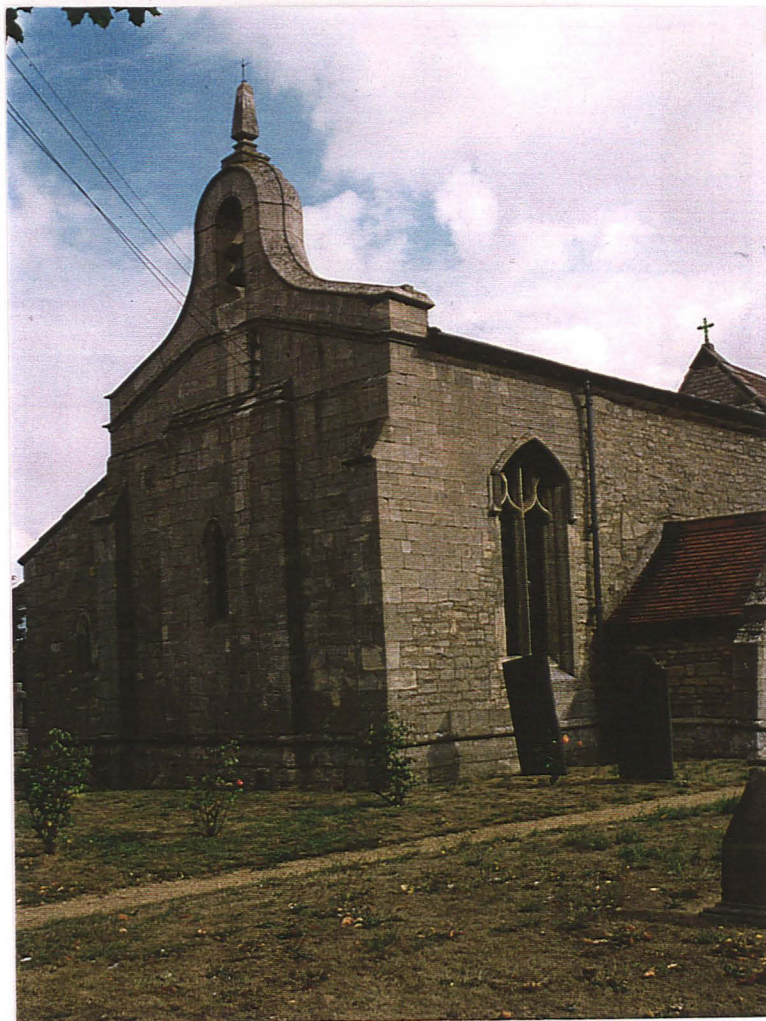
There is a chamfered double plinth, with taurus moulding above, at the base of the porch walls which continues along the nave south wall west of the porch and along the nave and aisle west walls. The plinth is not present east of the porch. This suggests that the porch was built at the same time as the extension to the nave and aisle in the 13th century. (Pls.1-3, 5). No features

The nave west wall was entirely rebuilt above plinth level in the 17th century when the present bellcote was constructed. The distinctive ashlar blocks extend around the upper part of the nave south wall and are quite different from the poorly dressed narrowly coursed stonework below (Pl. 5). In contrast, there is no clear distinction between the 13th century extension and the presumed earlier fabric of the nave on the south wall. This wall has been heavily during construction of the porch and insertion of two windows, with extensive rebuilding above them.

The unusual buttressing arrangement of the nave west wall at first appears to relate to the strengthening required for the 17th century bellcote but the plinth courses follow uninterrupted around the buttresses and appear to be part of the 13th/₁₄th century fabric of the wall. The inference is that the original nave west wall also needed to support a considerable load and/or absorb the vibration generated by the ringing of bells and that the existing bellcote may be a rebuild of an earlier bellcote or tower.

Pl. 5 General view of west end of nave showing plinth continuous around the porch, nave west and south walls and north aisle. Note rebuild of nave west wall above the plinth and upper corner of south wall associated with construction of the late 17th century bellcote.

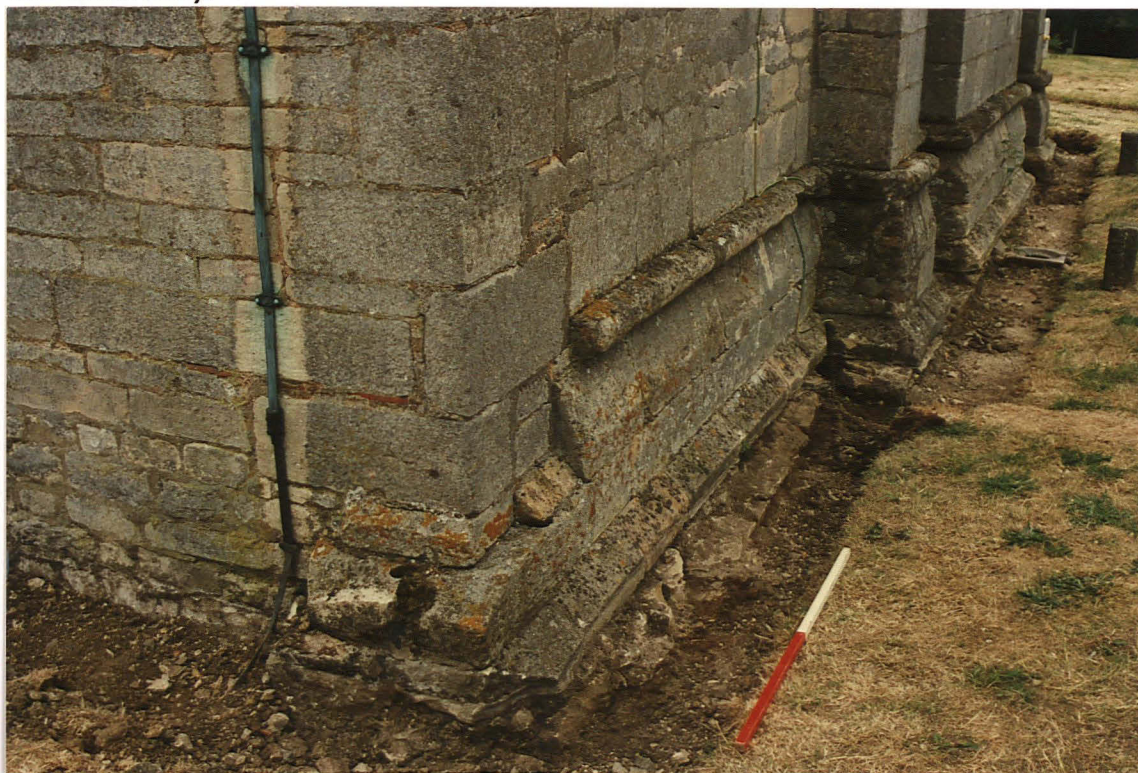
The drainage trench along the west side of the church revealed the neatly laid foundation on which the 13th century nave and aisle west walls were constructed, on a slightly askew alignment (Pl. 6). The foundation continues uninterrupted beneath the recesses between the nave wall buttresses (Pls. 7 and 8).

The north wall of the aisle was rebuilt in 1812 and the junction between the medieval and the 19th century fabric can clearly be seen at the north west angle, where the upper plinth and moulding have been removed (Pls 6 and 9). Removal of the concrete apron revealed the limestone foundation extending 0.30m to the north of the existing north wall (Pls. 10 and 11). A large damaged stone on the uppermost surviving course of this projection is chamfered on its north face. Beneath the chamfered block was a thinner stone course. This projection was probably the remains of a corner buttress.

Pl. 6 North west corner of aisle looking south along the west wall of aisle and nave after removal of concrete apron. Note continuous off-set foundations below plinth beneath aisle (foreground) and nave (beyond the buttress).

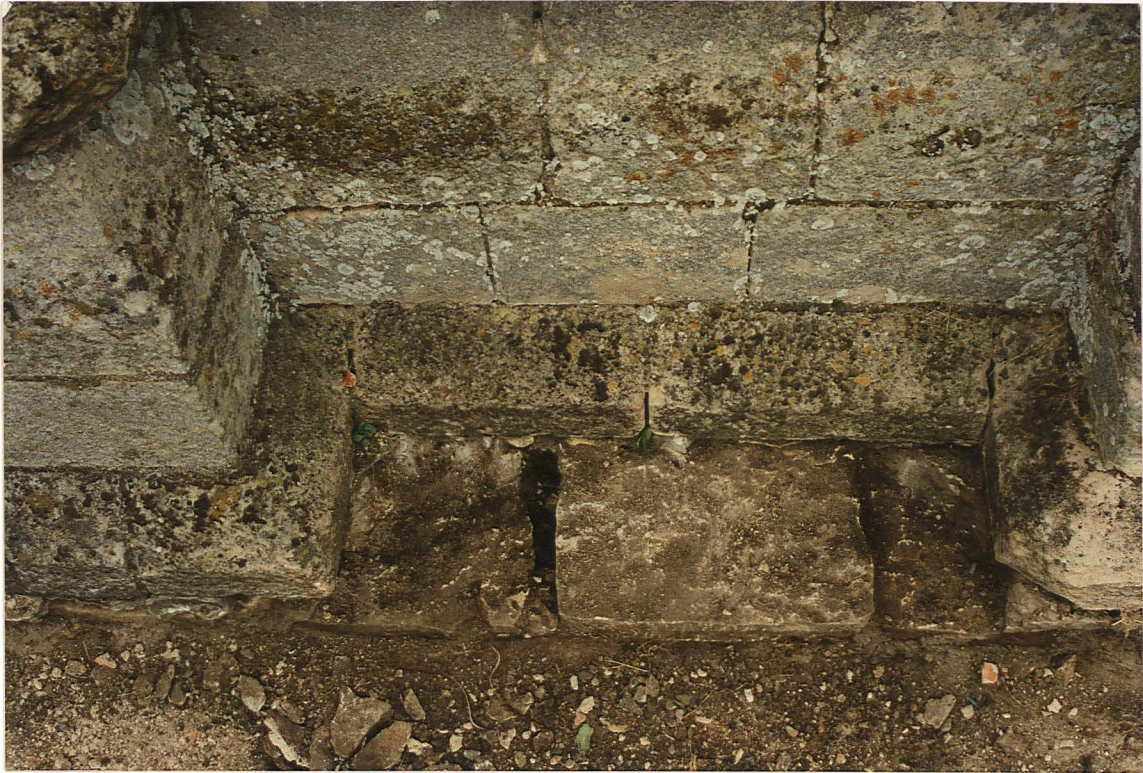
Pl. 7 Detail of foundation between north and central nave buttresses.

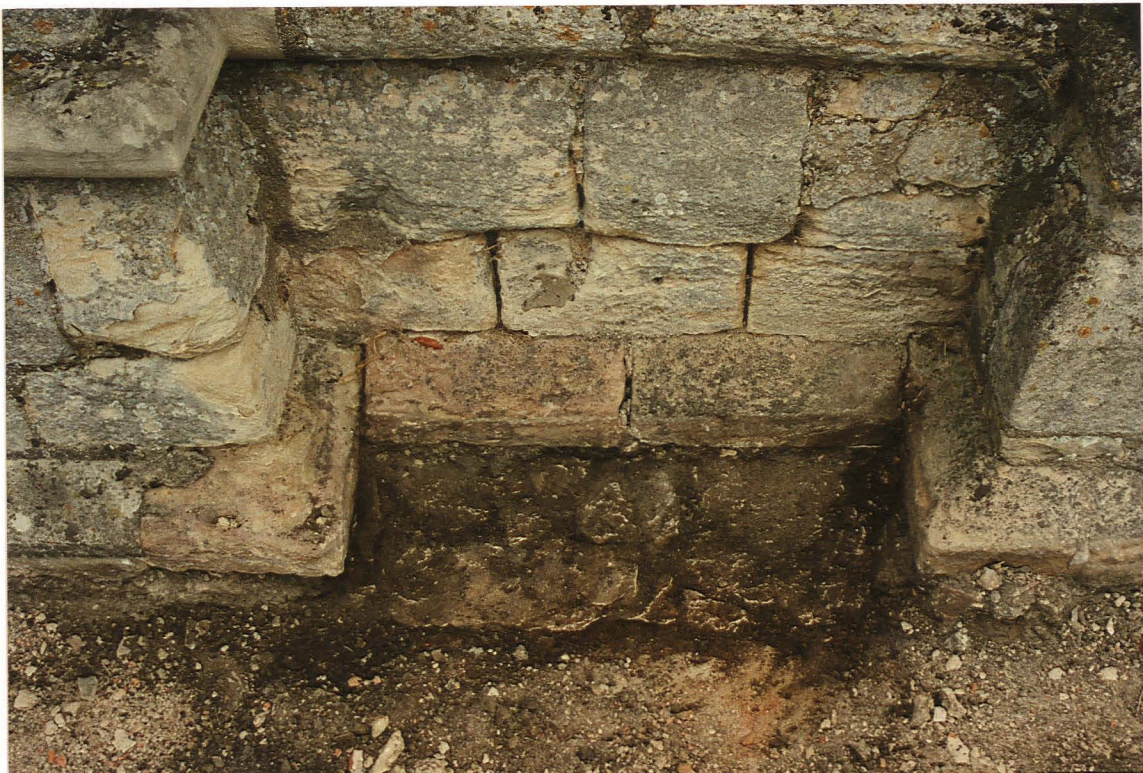
Pl. 8 Detail of foundation between central and south nave buttresses.

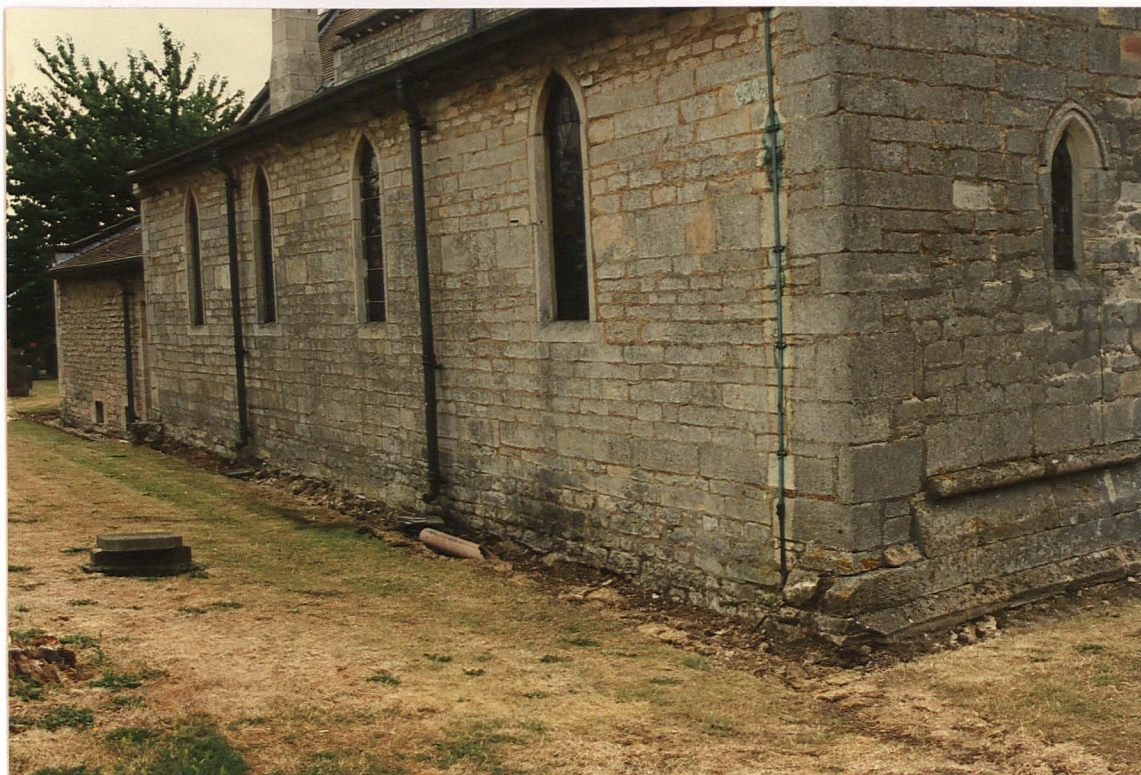
The aisle north wall was rebuilt in 1812 with a probable later rebuild/repair below eaves height (Pl. 9). At ground level the foundation is ragged and broken (Pl. 12). Insertion of graves alongside the wall could have caused this damage but no graves were identified within the shallow trench. At its junction with the vestry were the foundations, with chamfered plinth above, belonging to the medieval buttress at the north-east angle of the aisle (Pl. 13). The chamfered corner plinth rested on a foundation of small limestone lumps, which extended at least 0.25m beyond the limit of the trench. The rubble

Pl. 9 General view of north aisle showing north wall rebuild over removed medieval plinth at north west angle.

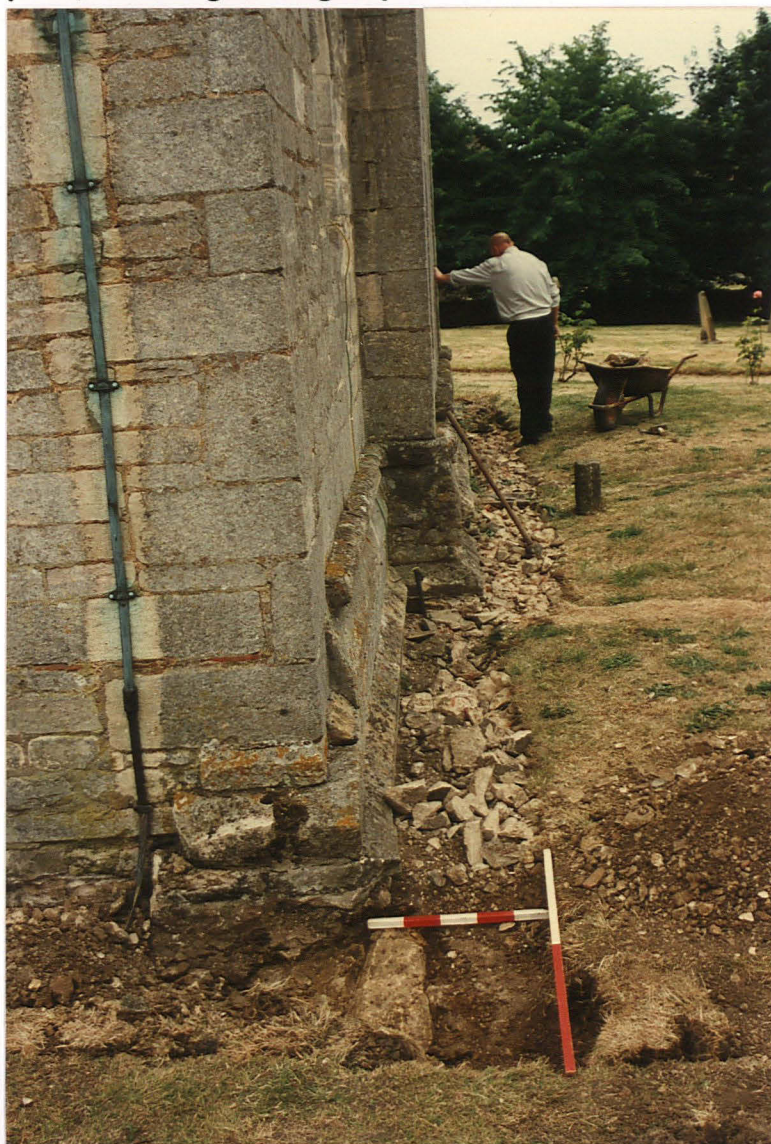
Pl. 10 North west angle of aisle looking south, during removal of concrete apron, showing damaged plinth stone of corner buttress.

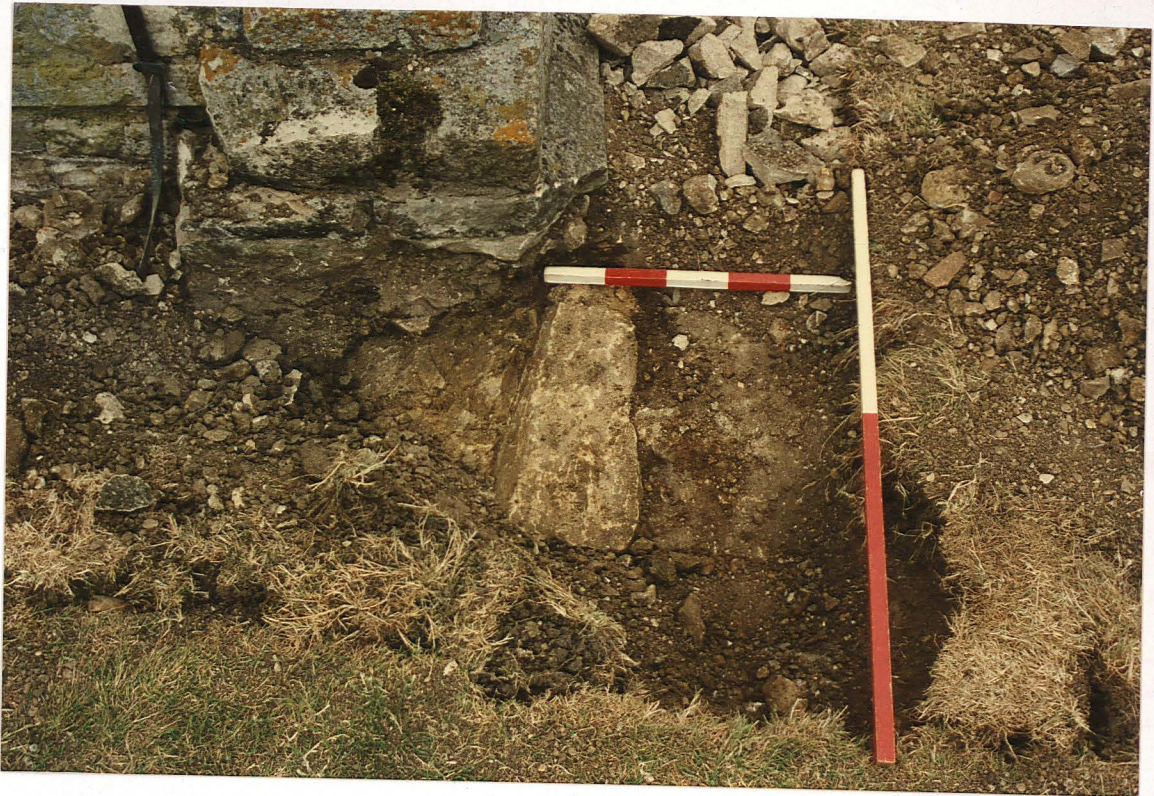
Pl. 11 Detail of damaged plinth stone of the aisle corner buttress.

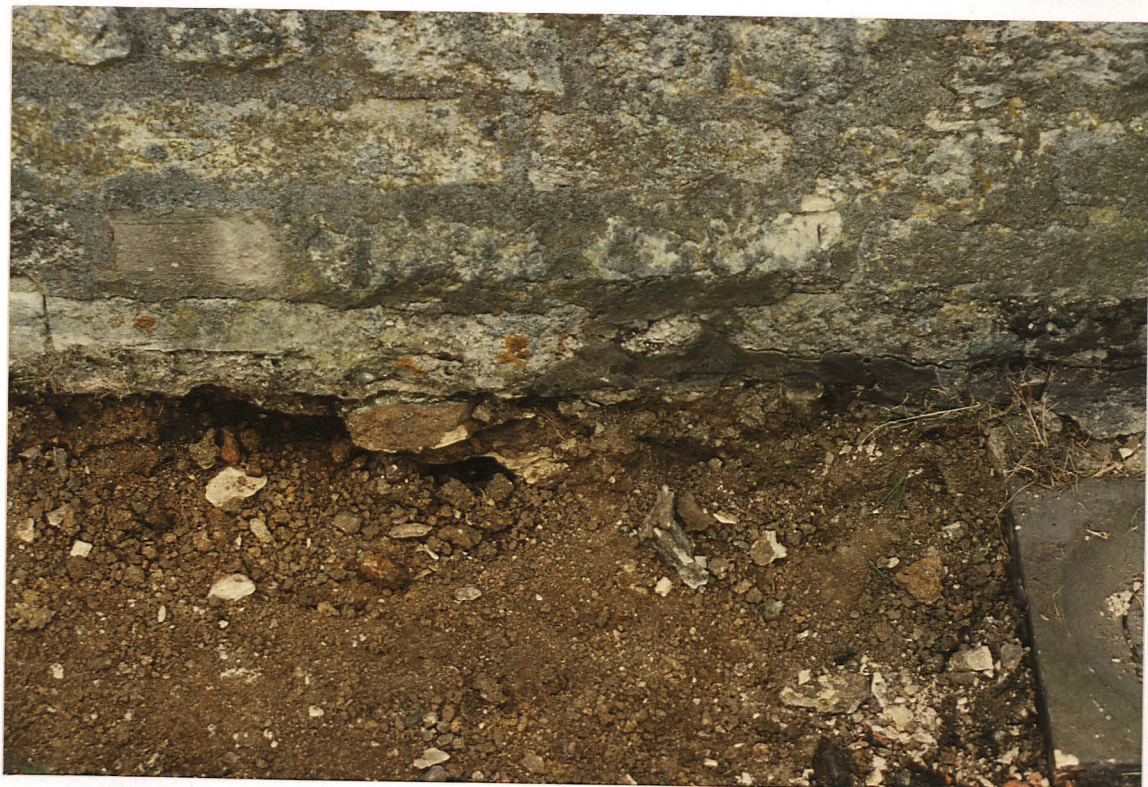
Pl. 12 Detail of trench along aisle north wall showing poor foundations

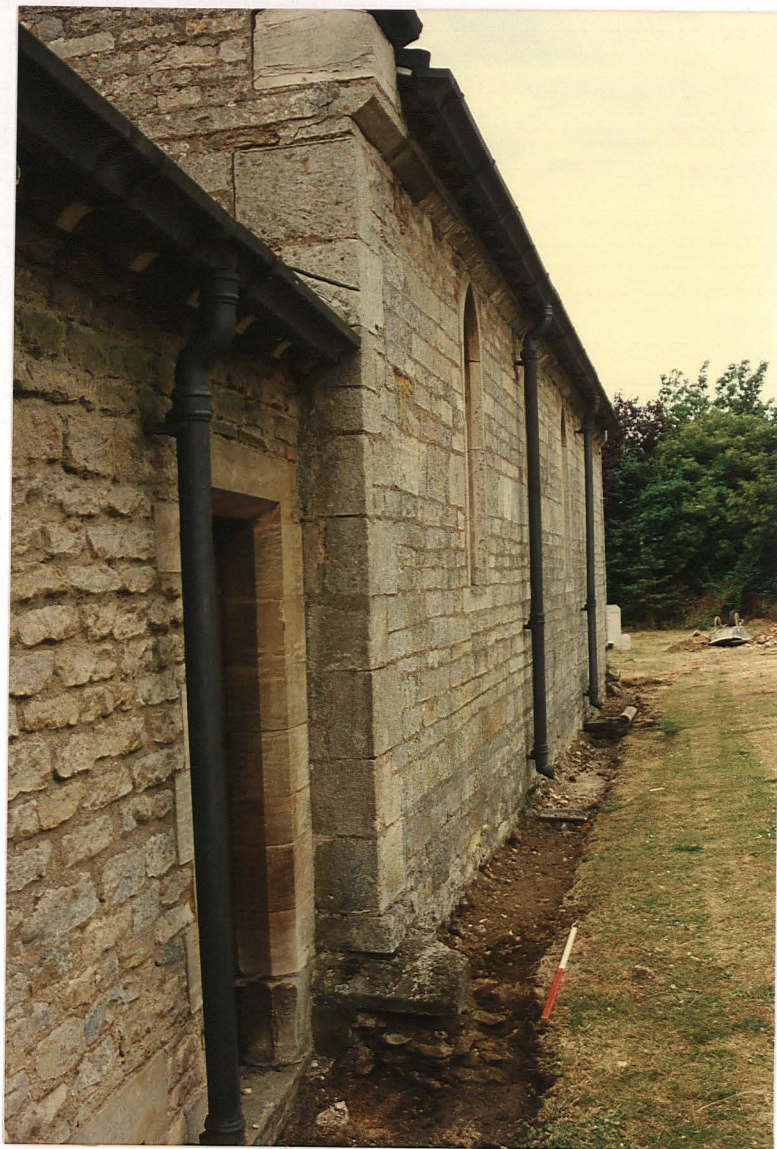
Pl. 13 General view, looking west, along aisle north wall with buttress foundation and plinth in foreground

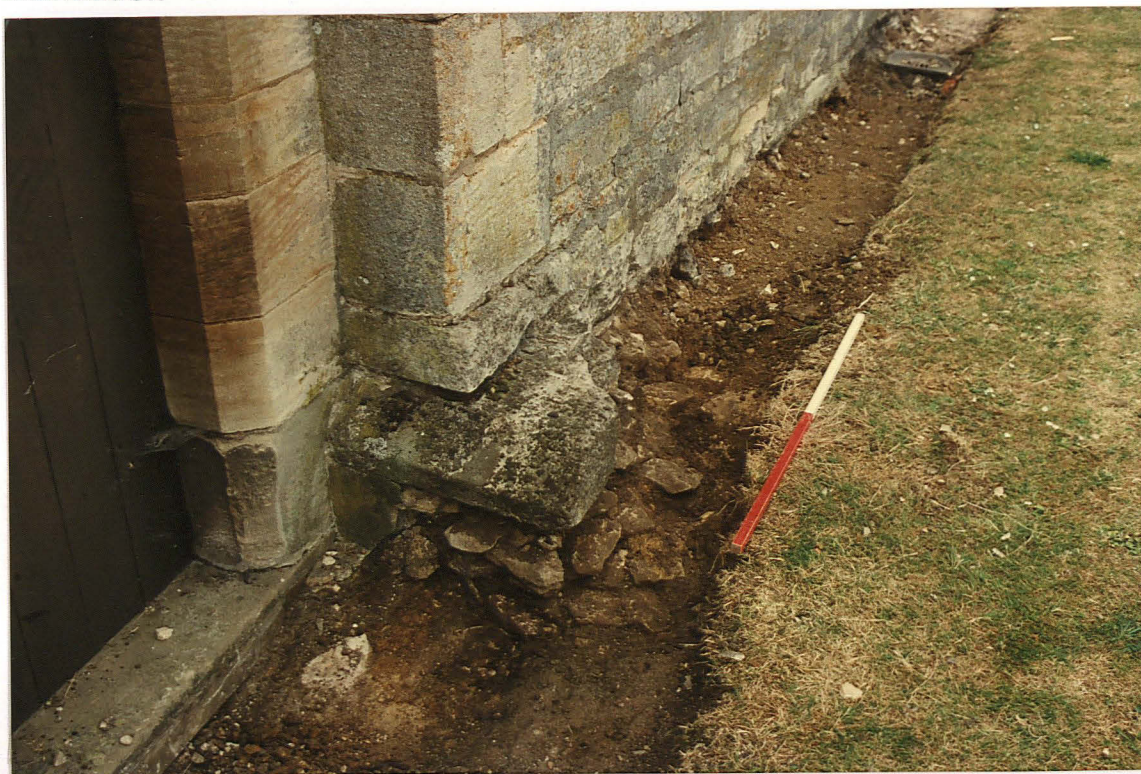
foundations were 0.7m wide and at least 0.2m thick. As the north face of the chamfered is plain presumably at least one similar stone has been removed. The chamfered block has been crudely cut away on its west face to try to blend it in with the line of the rebuilt wall (Pl. 14).

Pl. 14 Detail of aisle north east corner buttress and its rubble foundation

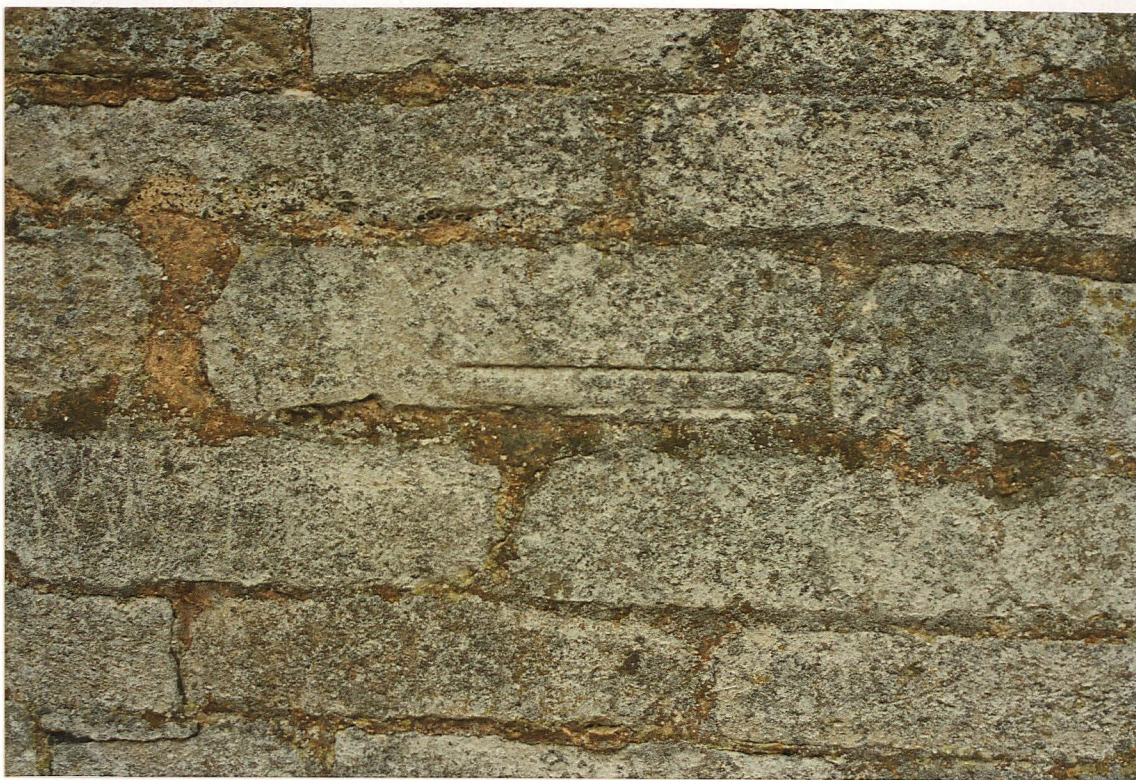
Parallel incised lines were observed on two adjacent stones at the west end of the aisle north wall at sill height (Pls. 9 and 15). It is not clear whether the stones were originally a single piece of unknown function which had been broken and re-used in the wall or if the lines are of recent date.

Pl. 15 Incised lines on stonework in aisle north wall

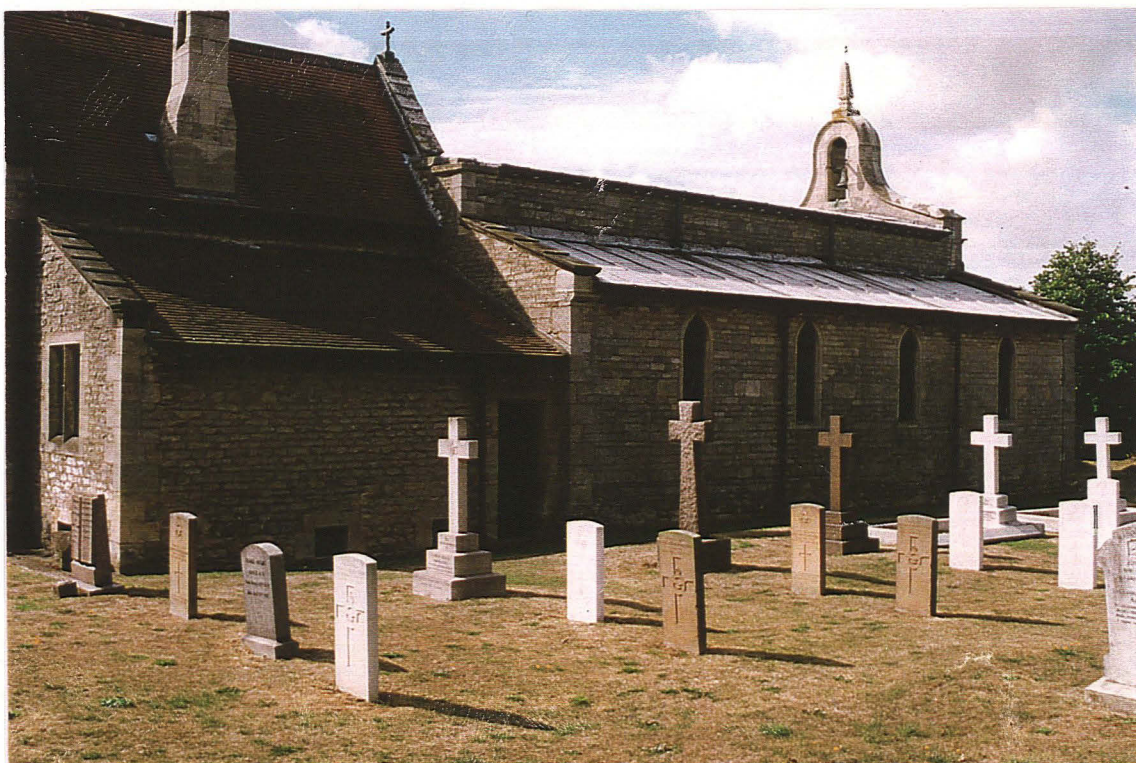
This part of the church was built in 1902-3, between the chancel and the north aisle, and constructed in narrow courses of roughly dressed limestone (Pl. 16). A brick foundation course was seen beneath this part of the building. There is a boiler house below which has probably destroyed all archaeological remains on this part of the site.

Pl. 16 General view of north side of church showing vestry with entrance to boiler house.

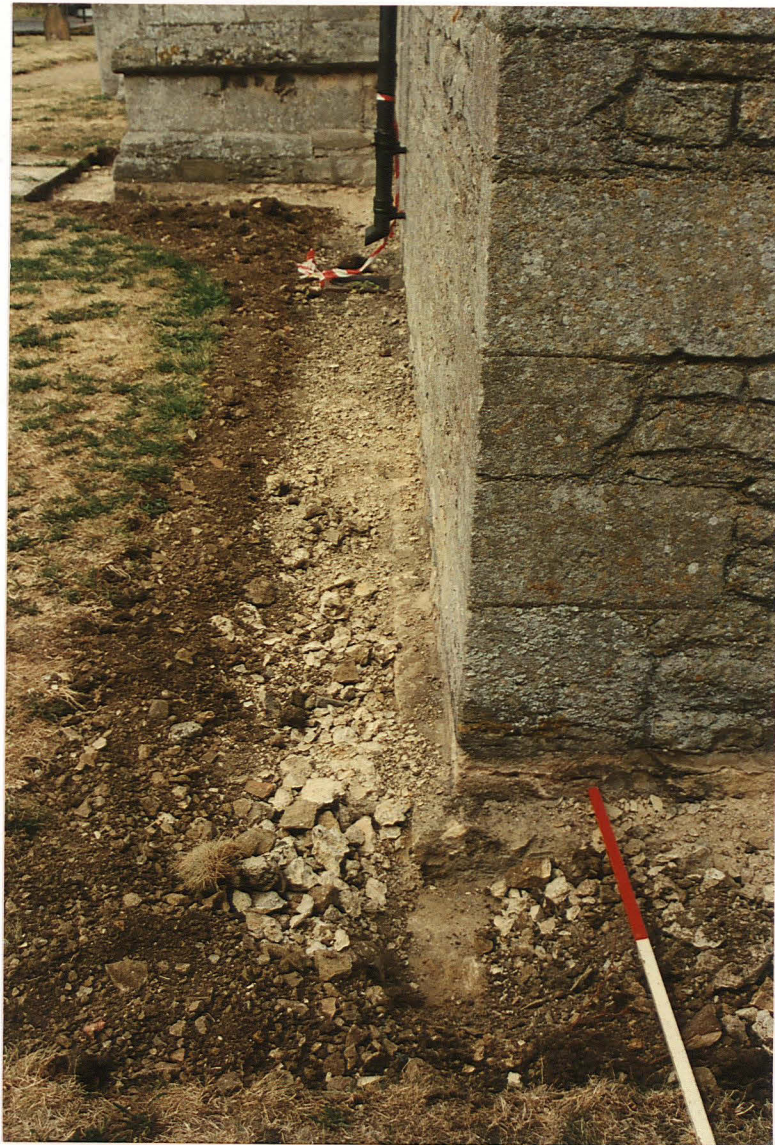
Pl. 17 South east angle of chancel, looking west showing off-set foundation with concrete underpinning below.
