**RESULTS OF AN ARCHAEOLOGICAL PHOTOGRAPHIC RECORDING  
AND WATCHING BRIEF OF FARM HOUSE, HIGH ROAD, MOULTON,  
LINCOLNSHIRE**

NGR TF 3030 2492

PLANNING APPLICATION REFERENCE: H13/0724/03/OUTL

Site Code: FHHRM06  
Accession No.: LCNCC 2006.104  
OASIS ID mmarchael-35562

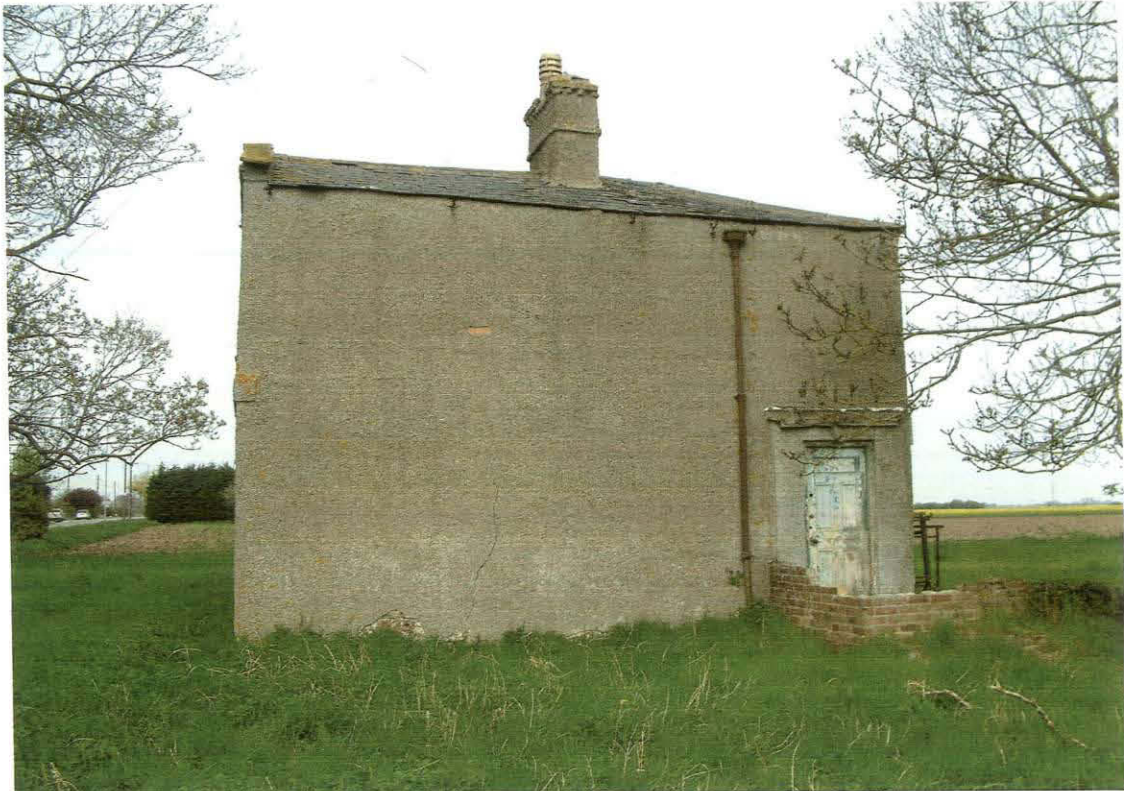
- 6.5 The eastern elevation of the building (Plate 1) shows a wooden entrance door at the northern end with the remnants of a porchway above and a brick surround of 20<sup>th</sup> century date. Note the iron downpipe. The roof is slate with a central chimney stack.

Plate 1. Eastern elevation of Moulton Farm House looking west.

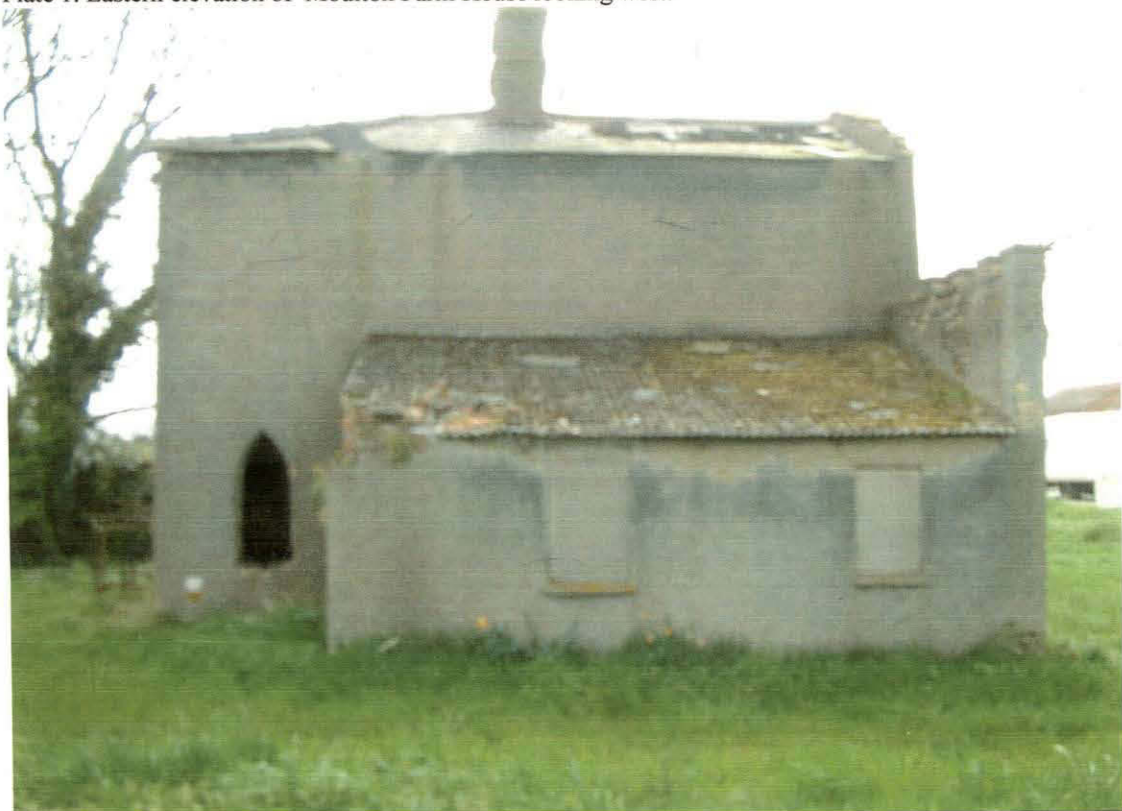
- 6.6 The western elevation (Plate 2) indicates the presence of a single storey lean-to, with a concrete corrugated roof which is considered to be an early 20th century addition. There is no access between the lean-to and the main building. To the northern end of this elevation is a pointed window, date uncertain but likely to be original (Plate 3). Structurally the extension is of poor condition (Plate 4). It contains a water boiler (Plate 5). The roof of the farmhouse is structurally unsound with slates missing at the southern and northern ends.

Plate 2. Western elevation of Moulton Farm

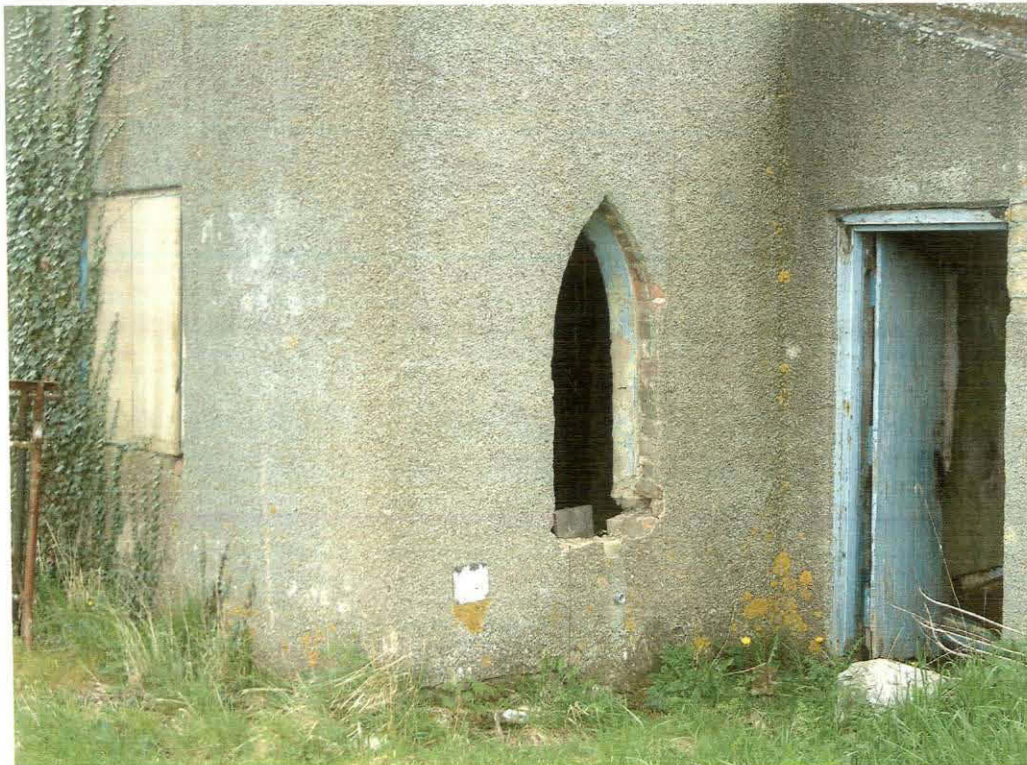
Plate 3. Window feature.

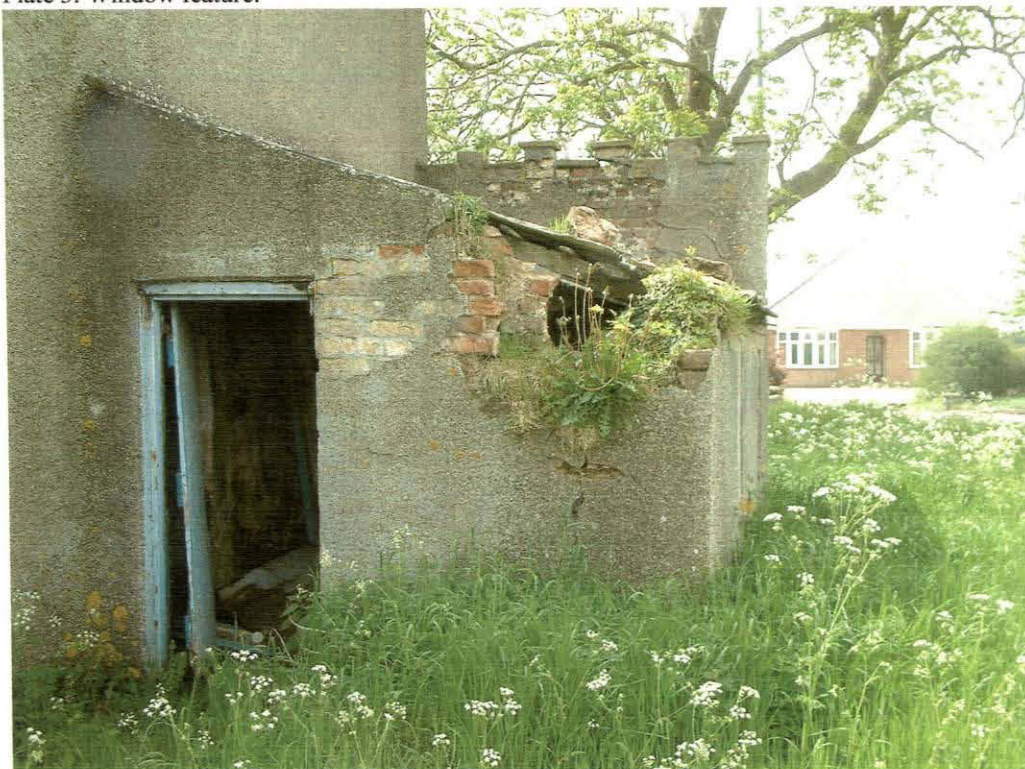
Plate 4. Showing poor condition of roof in extension.

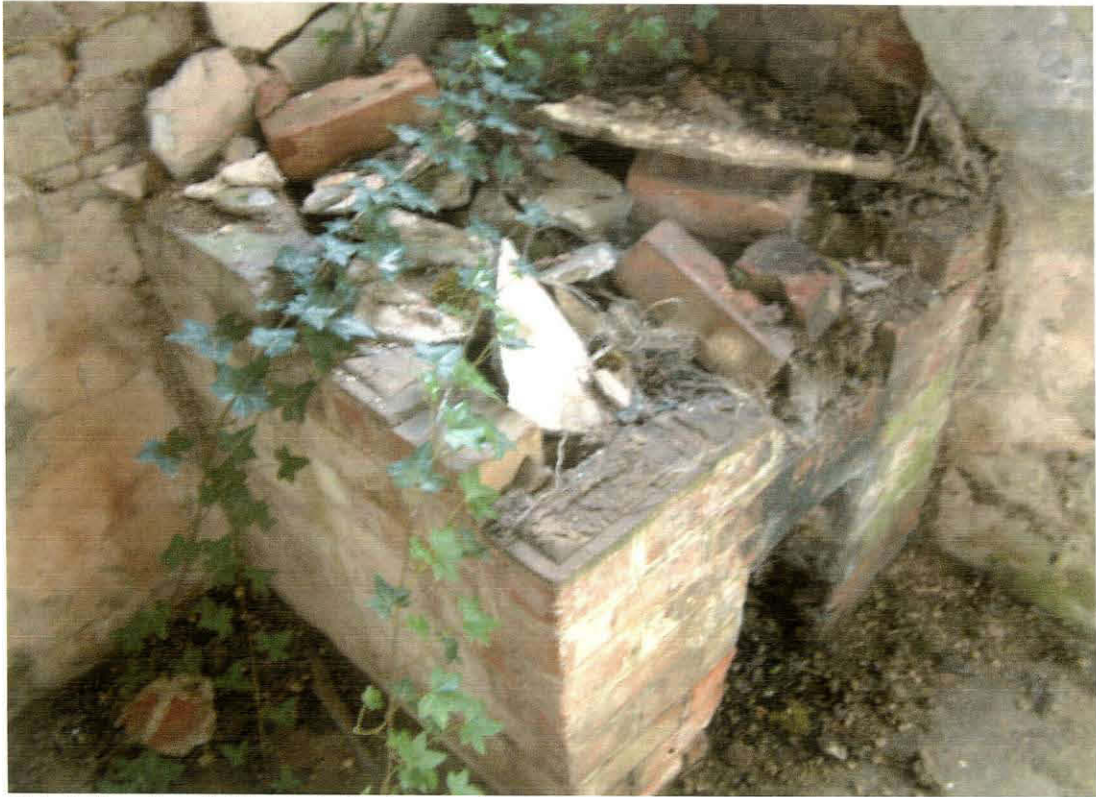
Plate 5. Remains of old water boiler in extension

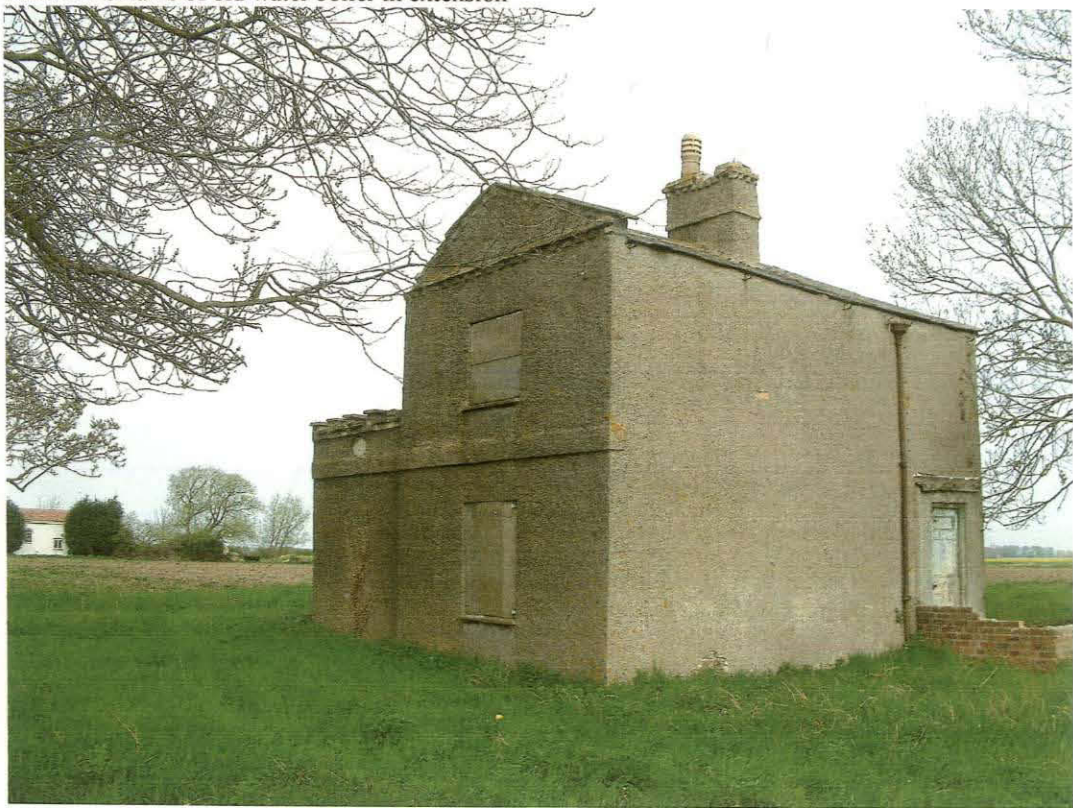
- 6.7 On the front (southern) elevation, the small extension is fronted by a castellated brick addition (Plates 6 & 7). The centre of this front shows a stone with the initials R.E.K. presumably the owner or builder at the time. The northern elevation (Plates 8 & 9) shows two boarded up windows.

Plate 6. View of the southern elevation.

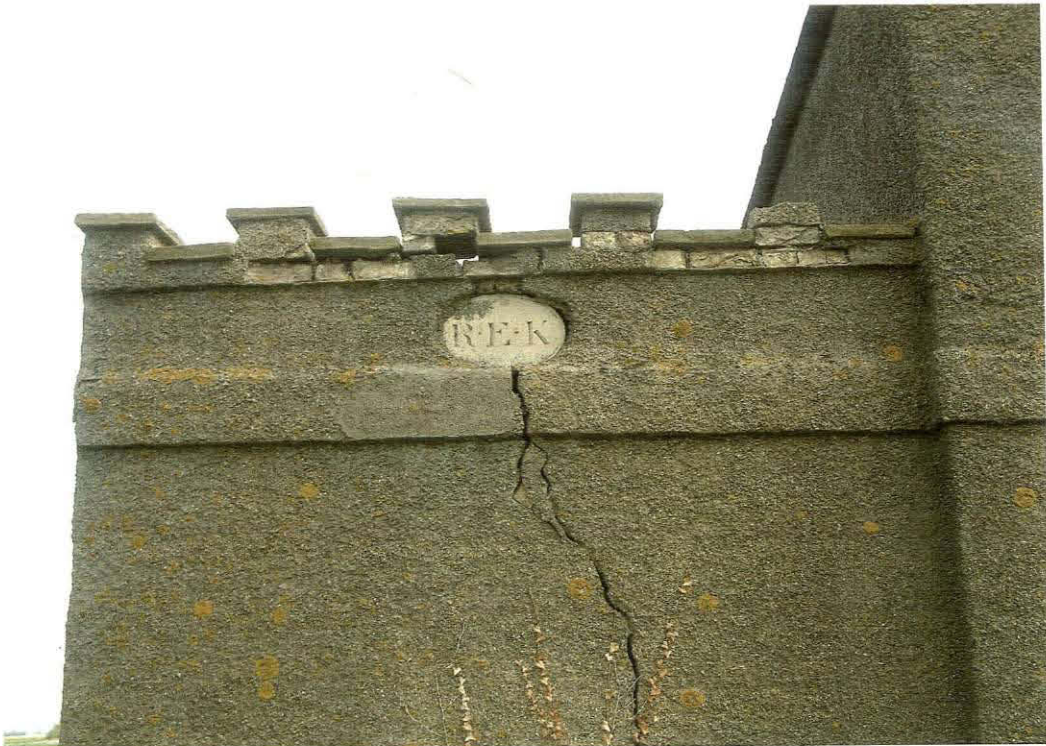
Plate 7. Name stone and castellations

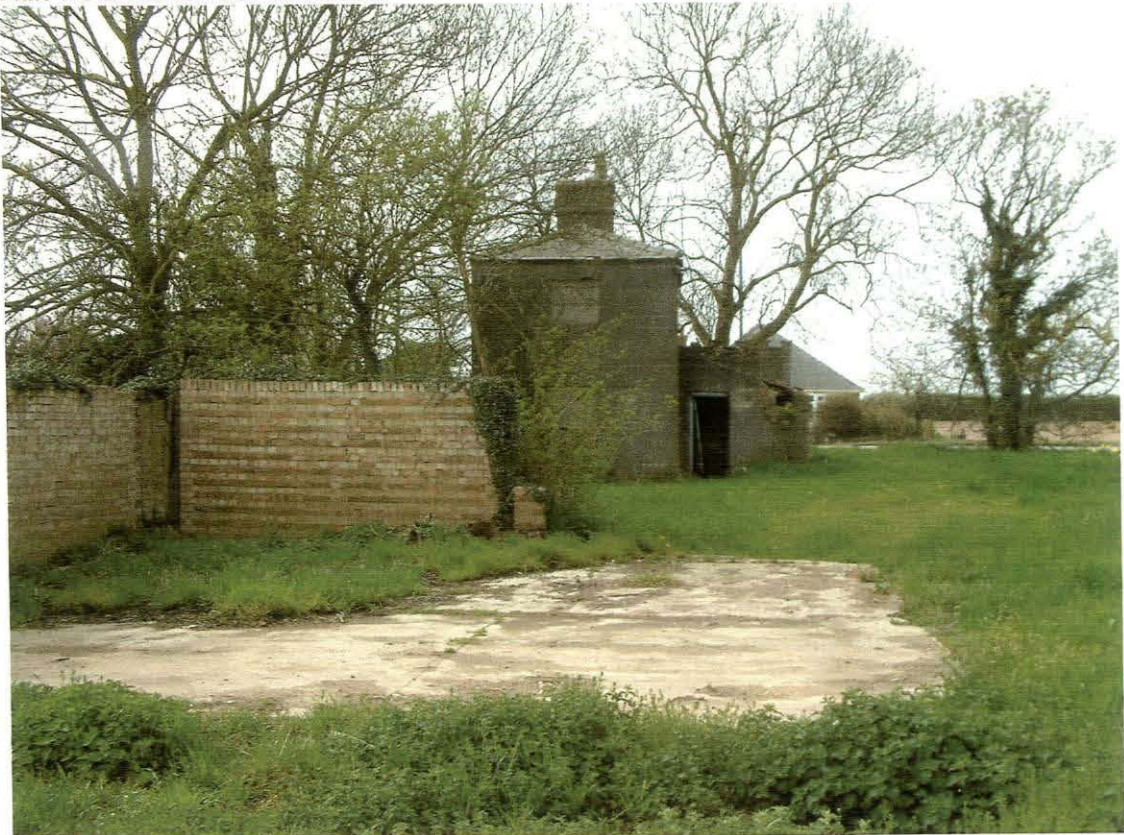
Plate 8. Northern elevation showing concrete floor of building demolished some years previously

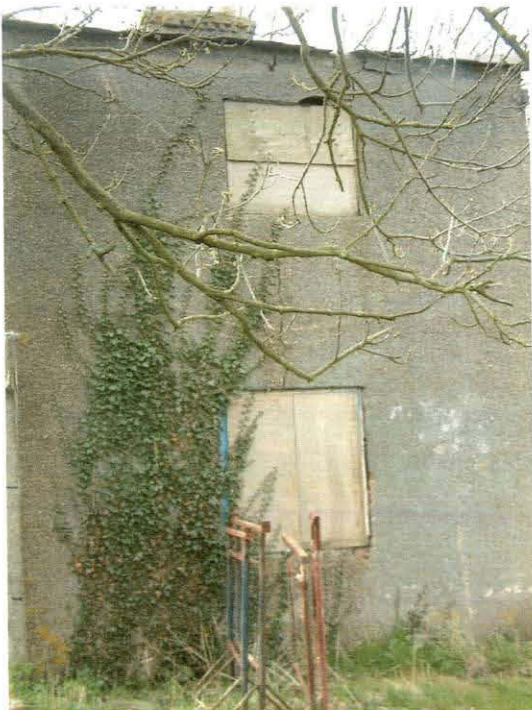
Plate 9. Close up shot of the northern elevation .

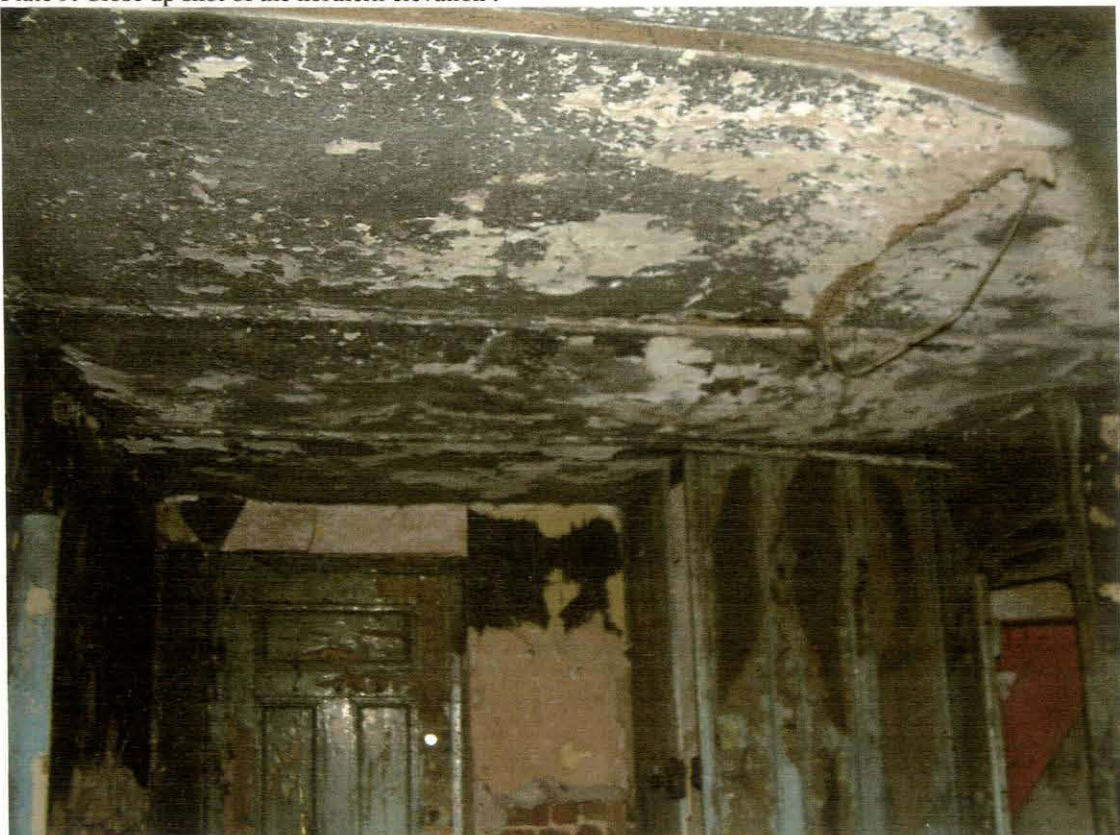
- 6.8 As indicated previously in the agreed specification, the structure was deemed to be too dangerous to enter safely for any great period of time for a full recording. The property had been damaged by fire (Plate 10) and the roof, upper floors (Plate 11) and staircase were unsound (Plate 12). Each room was assessed for its risk and whether it had any features of architectural interest. The southern end of the building was inaccessible because of the collapsed roof and upper floor.

Plate 10. Showing fire damaged ceiling.

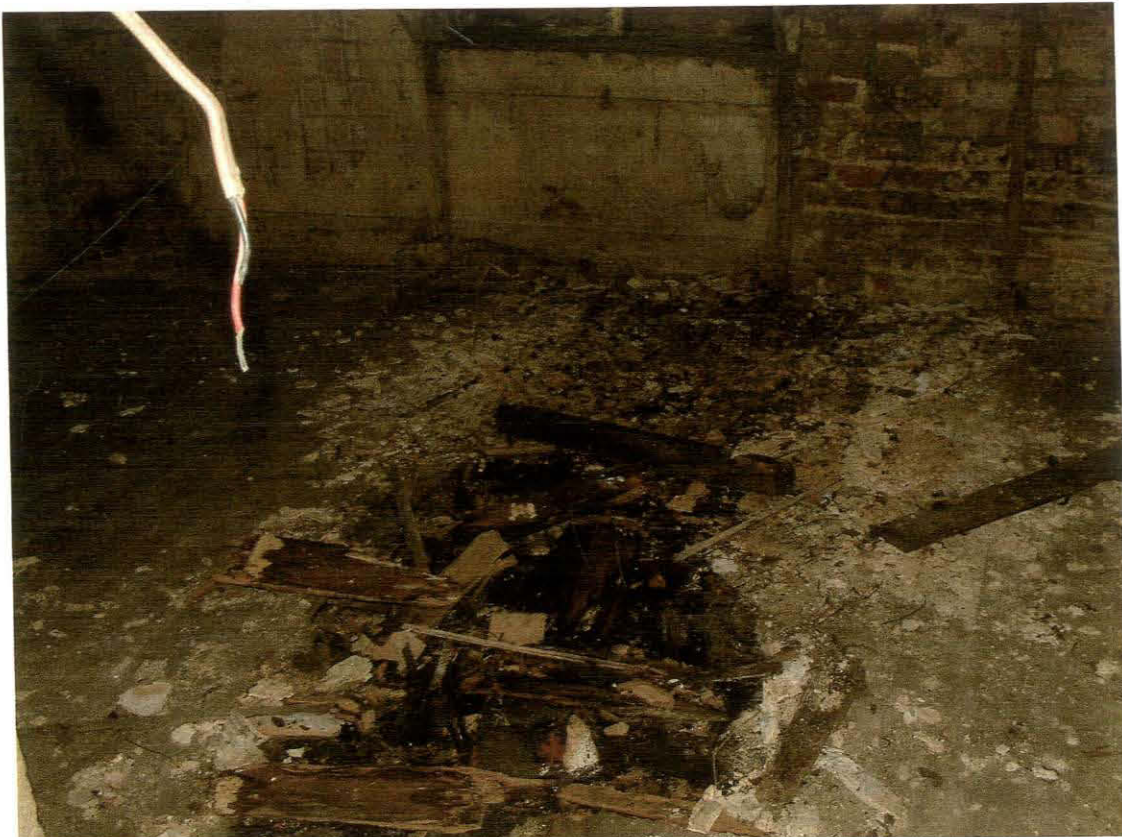
Plate 11. Showing the collapsed upper floor and rotten joists.

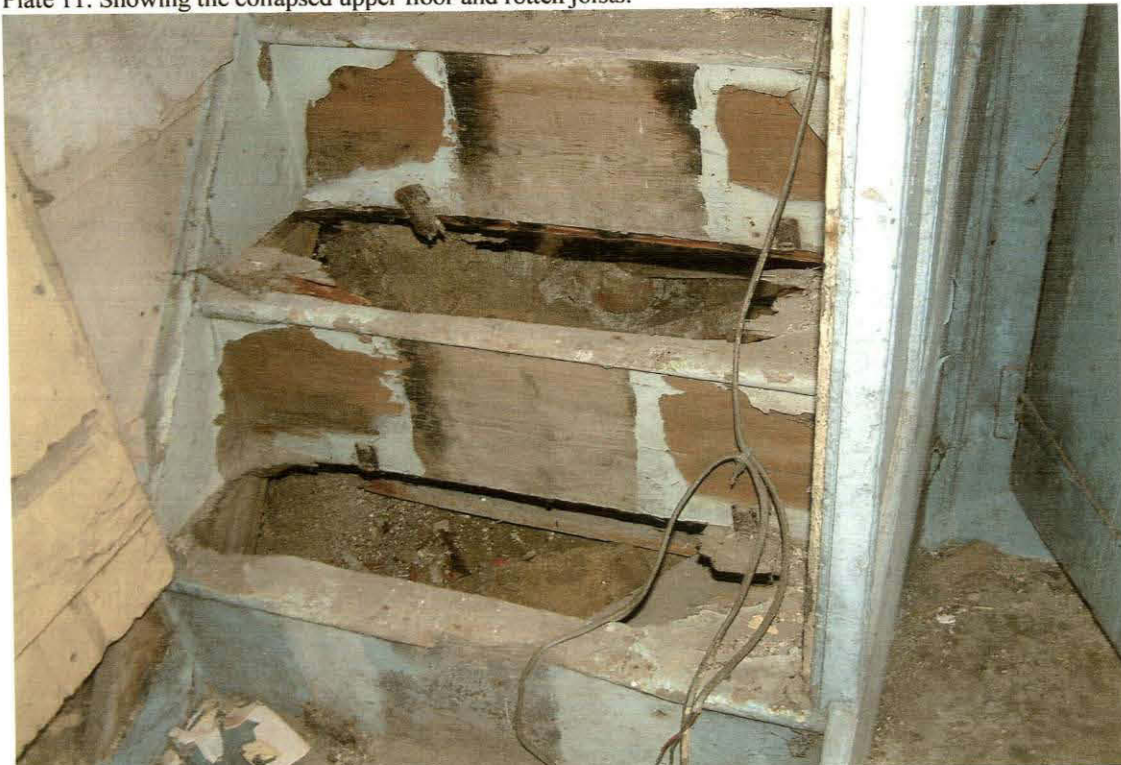
Plate 12. Showing collapsed stair treads apparent all the way to the top of the flight.

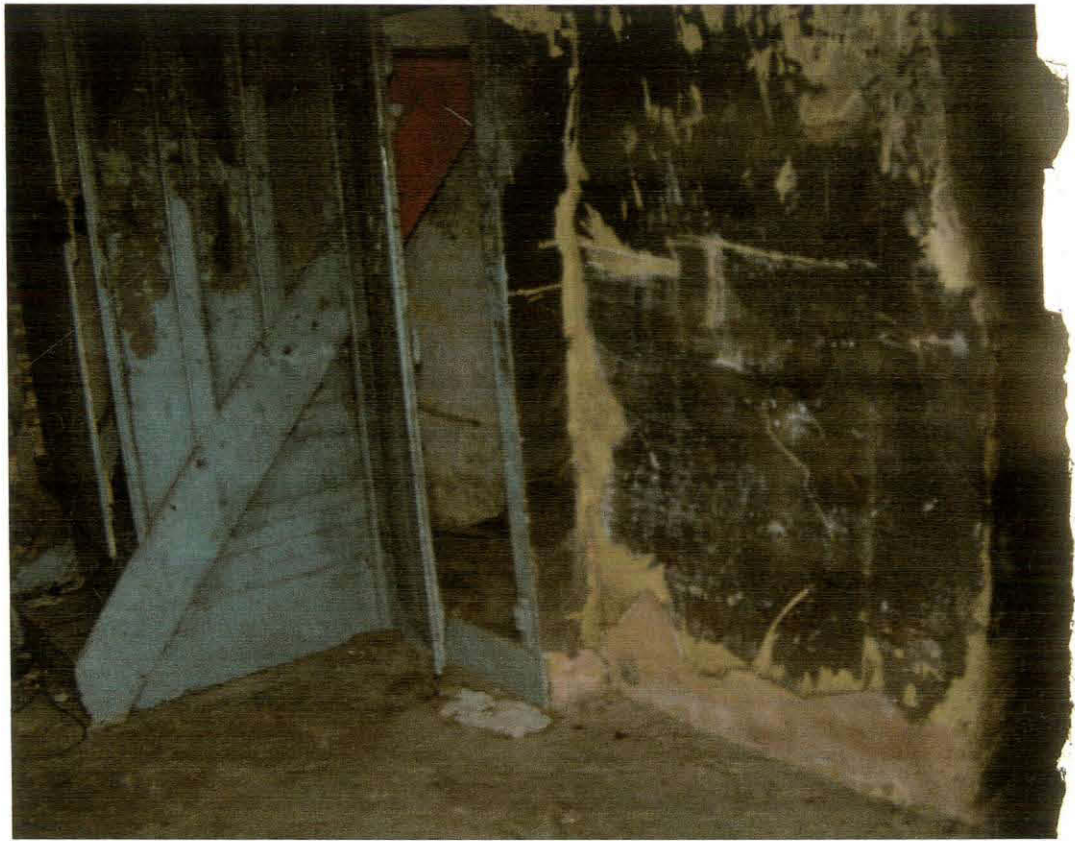
Plate 13. Showing bricked fireplace, staircase and cupboard understairs.

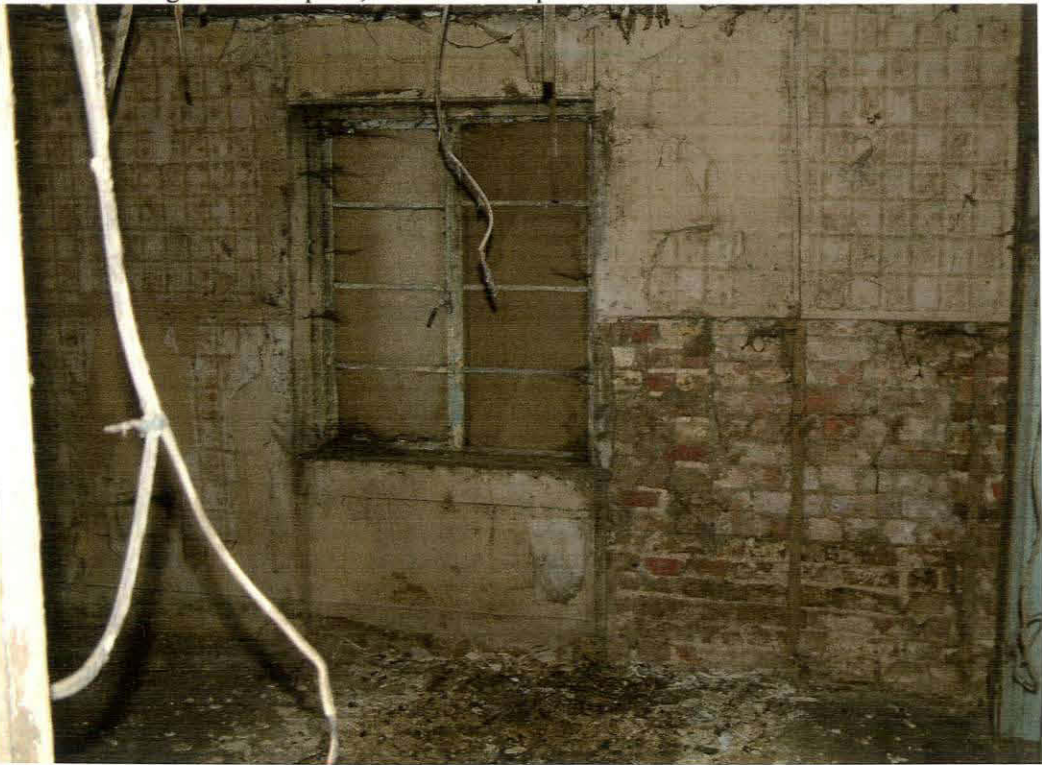
which had been ripped out. This room was photographed from the doorway as the lathe and plaster roof had caved in (Plate 14).

Plate 14. Shot of kitchen on the southern side of the property.

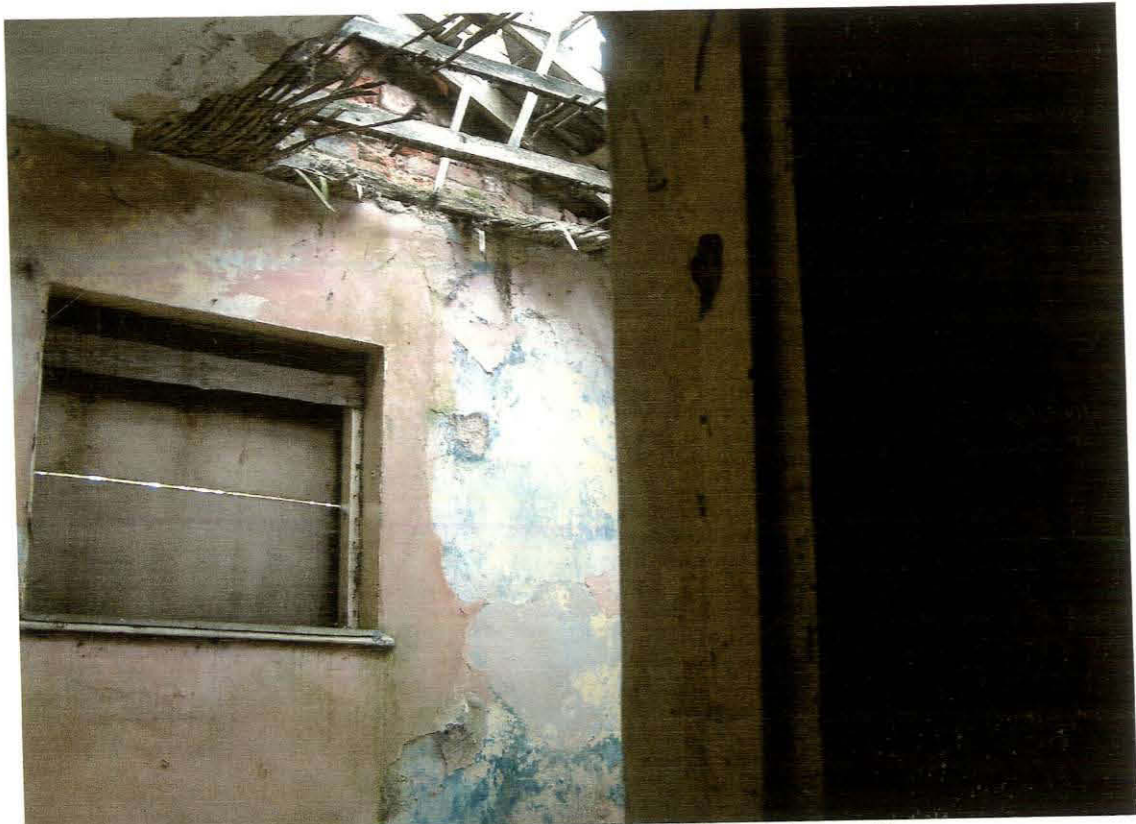
- 6.10 The upper floors were inaccessible and photographed from the third stair. They appear to have been used as bedrooms, given the décor of pink walls and pink and white patterned wallpaper. The roof had collapsed in, on the southern room (Plate 15) showing lathe and plaster ceiling. The door appeared original and floorboards appeared to be 20<sup>th</sup> century (Plate 16).

Plate 15. Southern bedroom showing the collapsed in roof and lathe and plaster ceiling

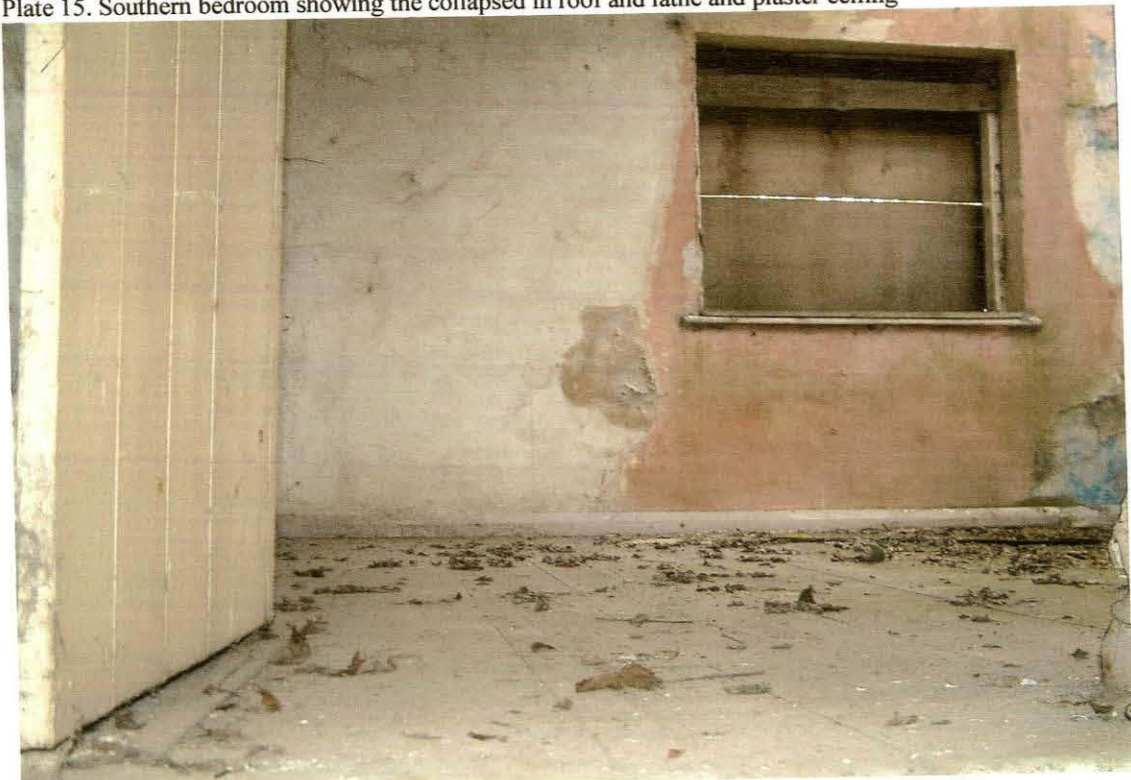
Plate 16. Showing original door.

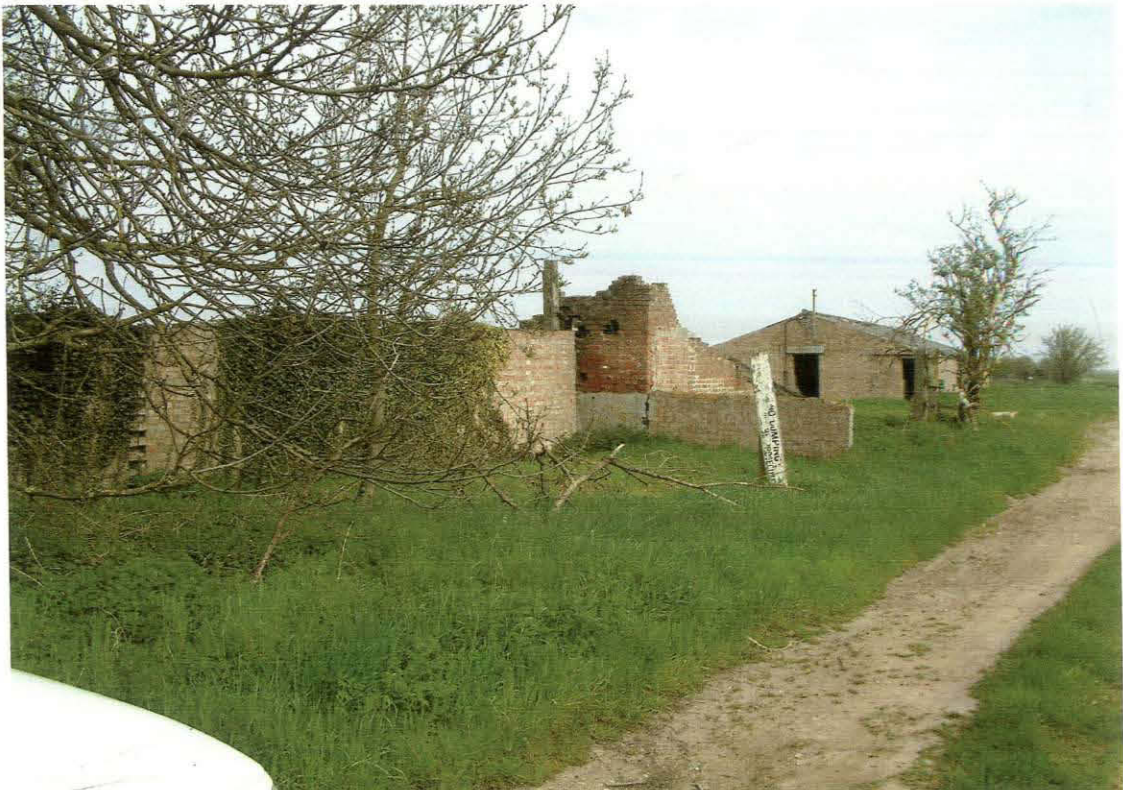
- 6.11 Outbuildings were present on the site which were to be demolished to make way for the new property. To the north of the farm house (Plates 8 & 17 & Figure 2), a brick built collapsed barn of 19<sup>th</sup> century date with 20<sup>th</sup> century repairs was present.

Plate 17. Out buildings to north of property, buildings in foreground to be demolished.

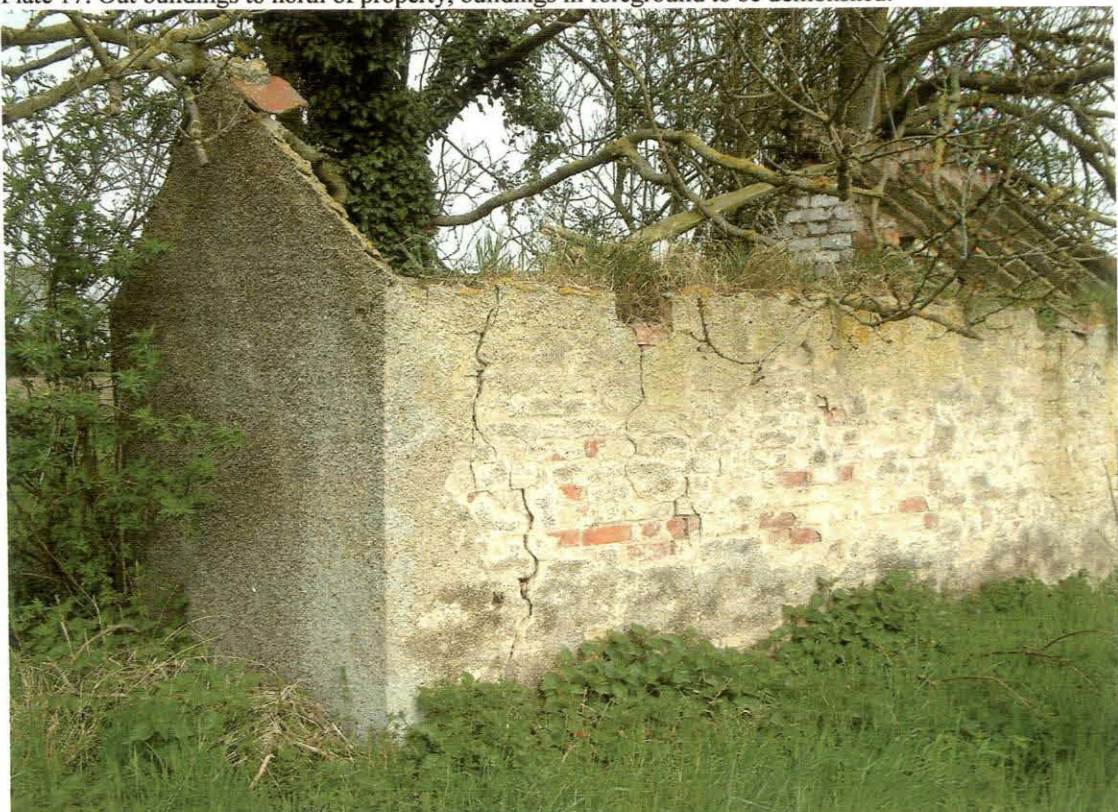
- 6.12 To the northeast of the farmhouse, a garage block (Plate 18 & Figure 2) of 19<sup>th</sup> century date was in bad decay with its roof missing and trees growing within it.

Plate 18. Old garage block to be demolished at north side of property.

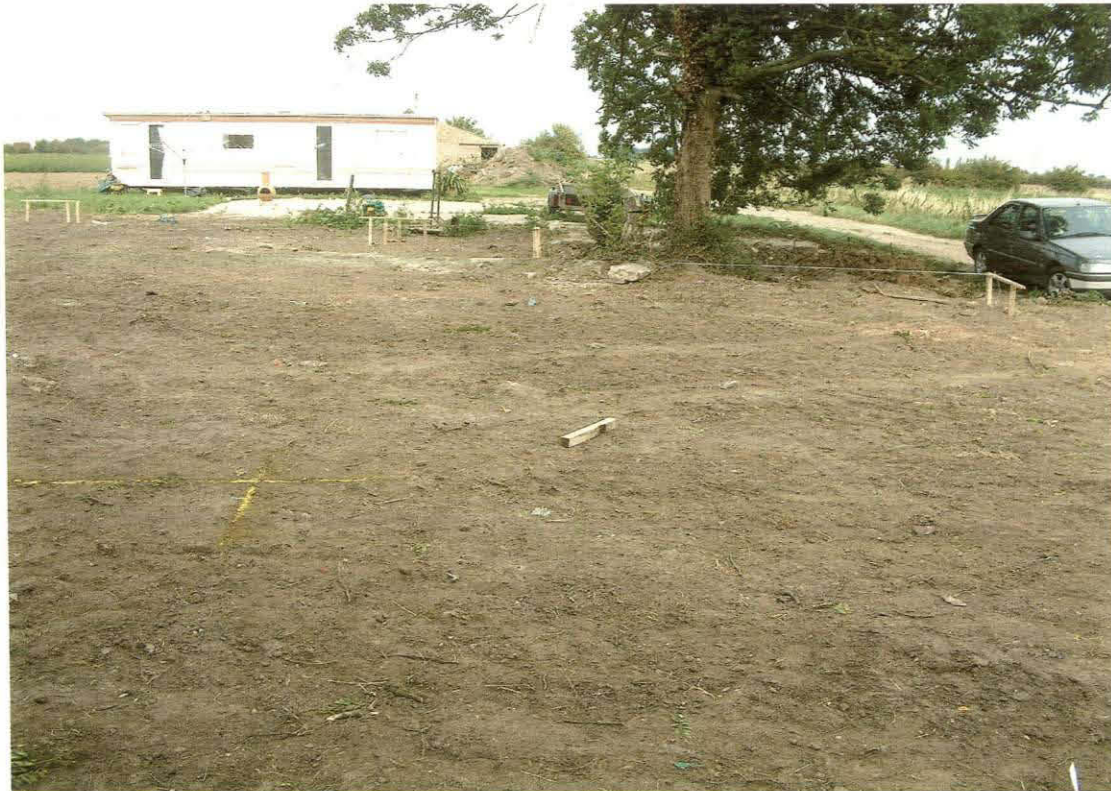
Plate 19. Site after demolition.

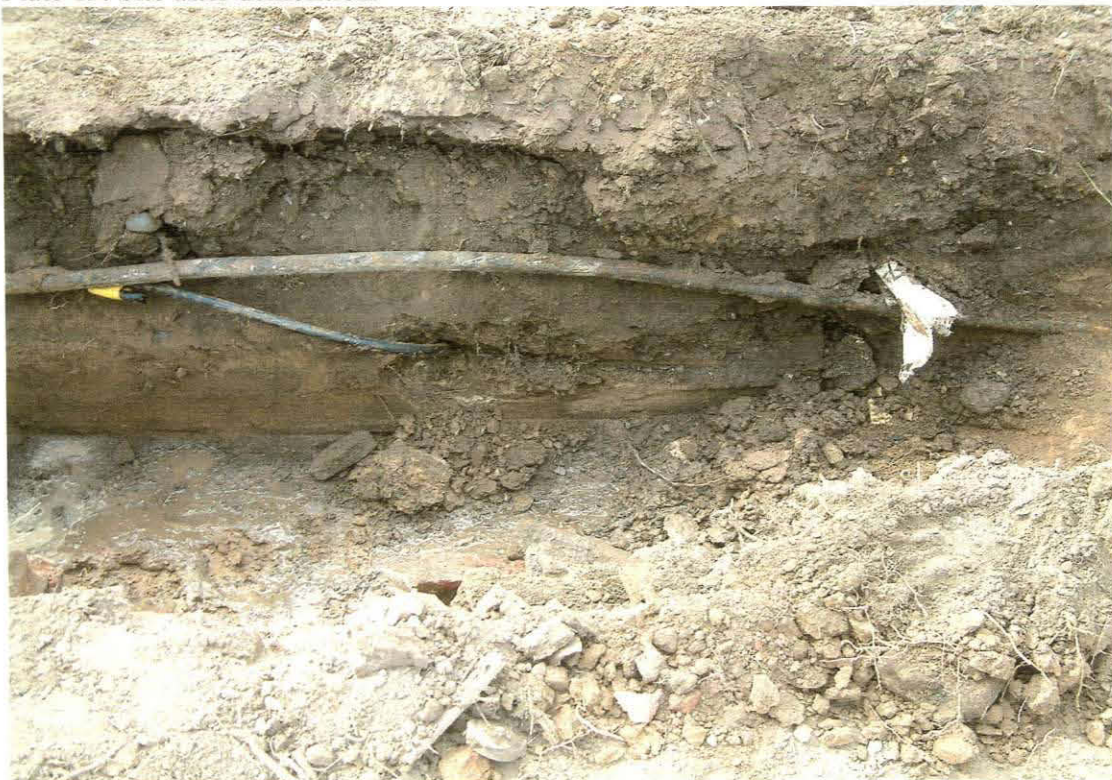
Plate 20. Showing old service pipes and cables.

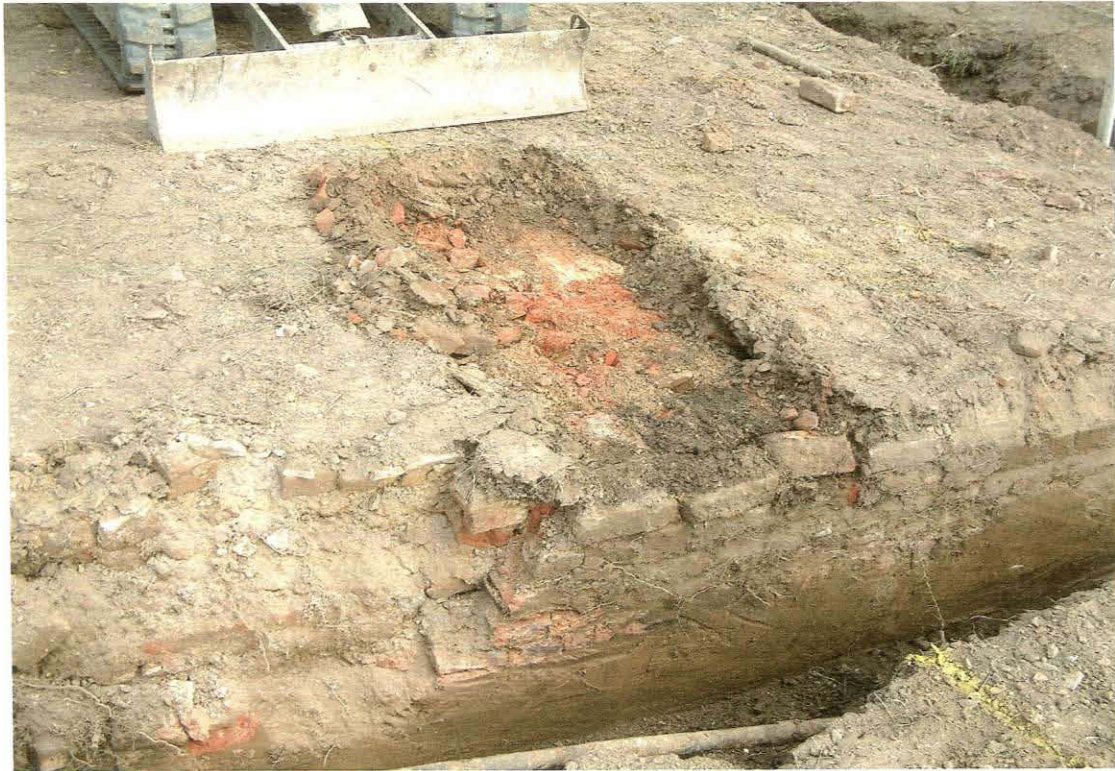
- 6.16 This sealed a brown silty sand (102) which was considered to be the natural geology and seen at a depth of 0.7m below the original ground surface (0.2m had already been removed during site clearance). In places, the original footings were still in situ and parts of these were left (see Plates 21 & 22).

Plate 21. Showing old footings of demolished building left in situ.

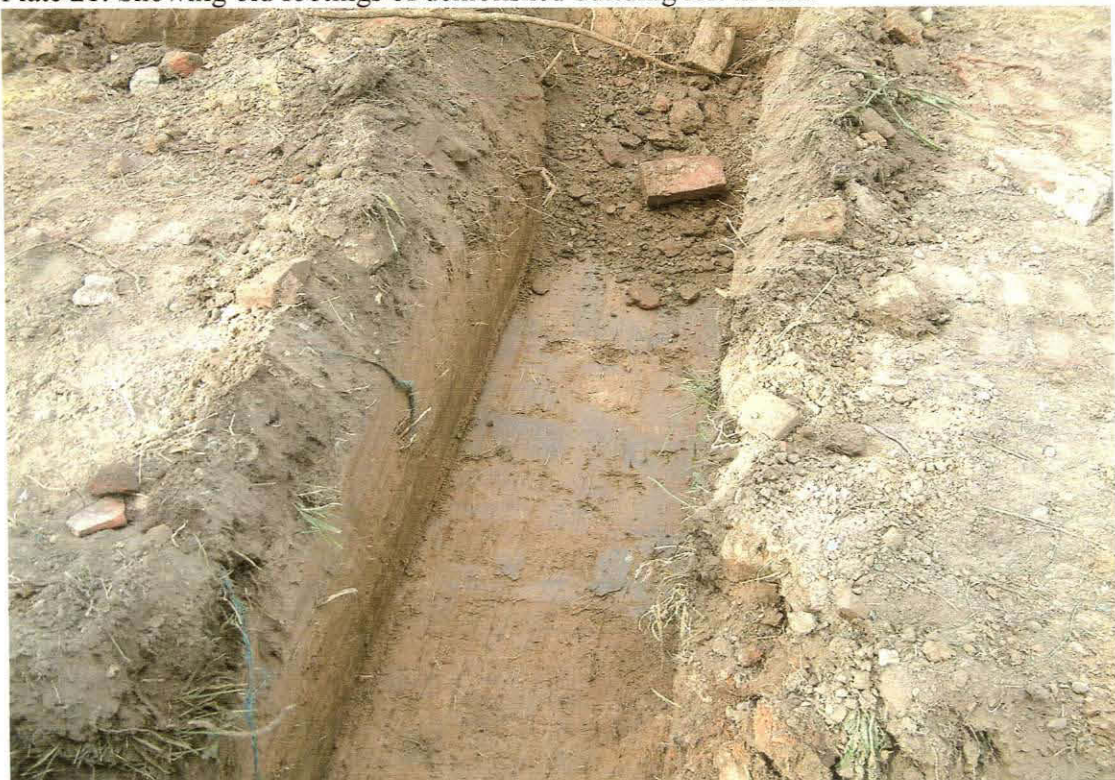
Plate 22. General shot of footings.
