ARCHAEOLOGICAL PHOTOGRAPHIC SURVEY
AND WATCHING BRIEF REPORT
LAUGHTON ENDOWED CE (A) PRIMARY SCHOOL
LAUGHTON, LINCOLNSHIRE.

NGR: SK 8488 9728
Site Code: LEPS 01
LCNCC Acc. No. 2001.171

Report Prepared for
Hyder Business Services.
by Mark Allen BSc AIFA

January 2002

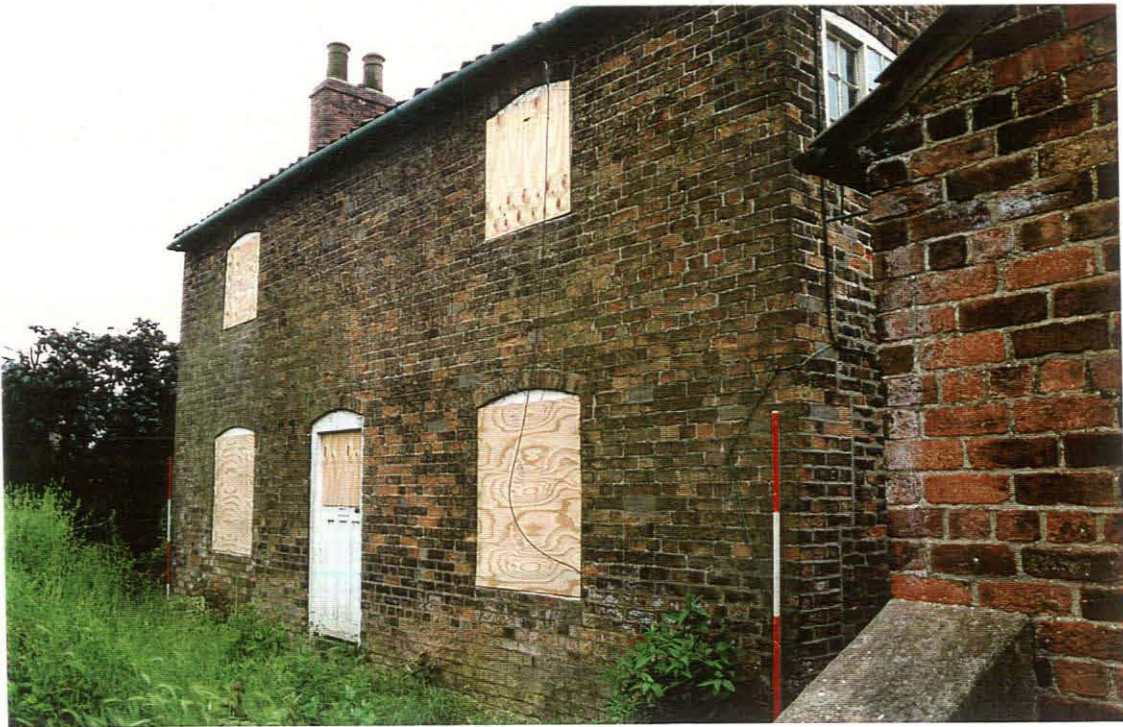
The east (frontage) elevation was constructed with imperial brick: typically 230 x 105 x 62mm. The front door is central, with two downstairs and two symmetrically arranged upstairs windows (plate 1).

Pl. 1 School House frontage, facing onto Church Road: Looking S.

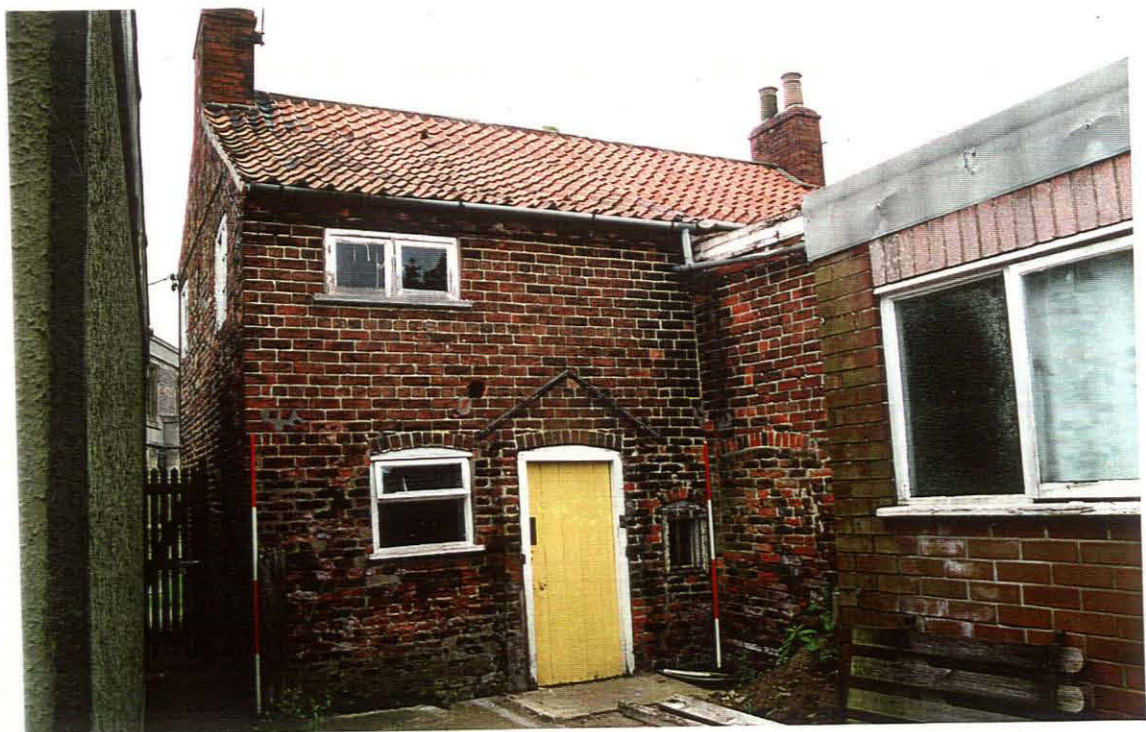
To the rear of the building (western elevation), several phases of construction were noted, reflecting repairs, rebuilds and additions (plate 2). The ground floor was built of possibly pre – 19th century handmade bricks. These were superseded on the upper floor by later imperial bricks (typically 220 x 107 x 72mm). A long, rectangular window (bathroom) on the upper floor is thought to be associated with documented 1939 works. The two windows on the ground floor are at different levels. The smaller, to the right of the door, is c. 0.8m above the modern ground surface. It seems likely this window is of a similar date to a floor surface found beneath the present one (see (015) in the watching brief results below). The larger window to the left of the door seems to be contemporary with the present ground surface. There was evidence of a possible former timber porch over the back door, probably dating to the 1939 extension.

Pl. 2 Rear entrance to School House, prior to demolition of reading room. Looking E.

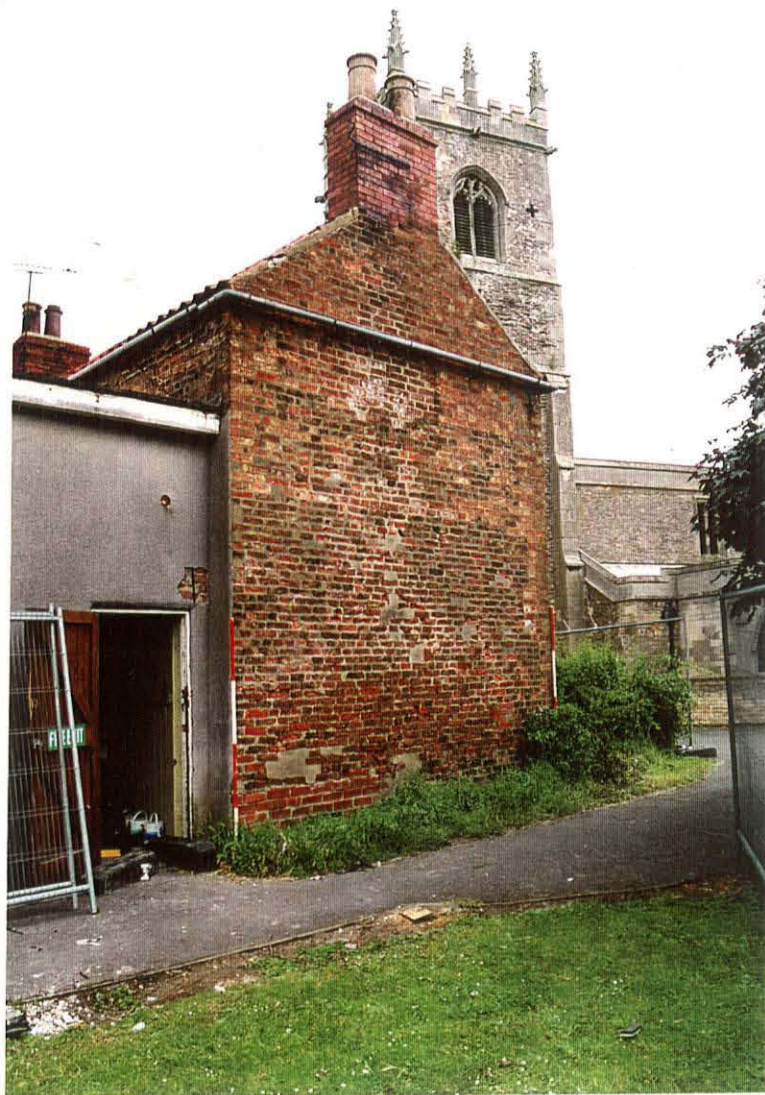
The south (gable) end contains no windows, and its chimney is of modern construction (commons bricks). The wall is made from handmade bricks, with a repair comprising modern commons towards the base (plate 3).

Pl. 3 Gable end of School House, prior to demolition of reading room. Looking N.

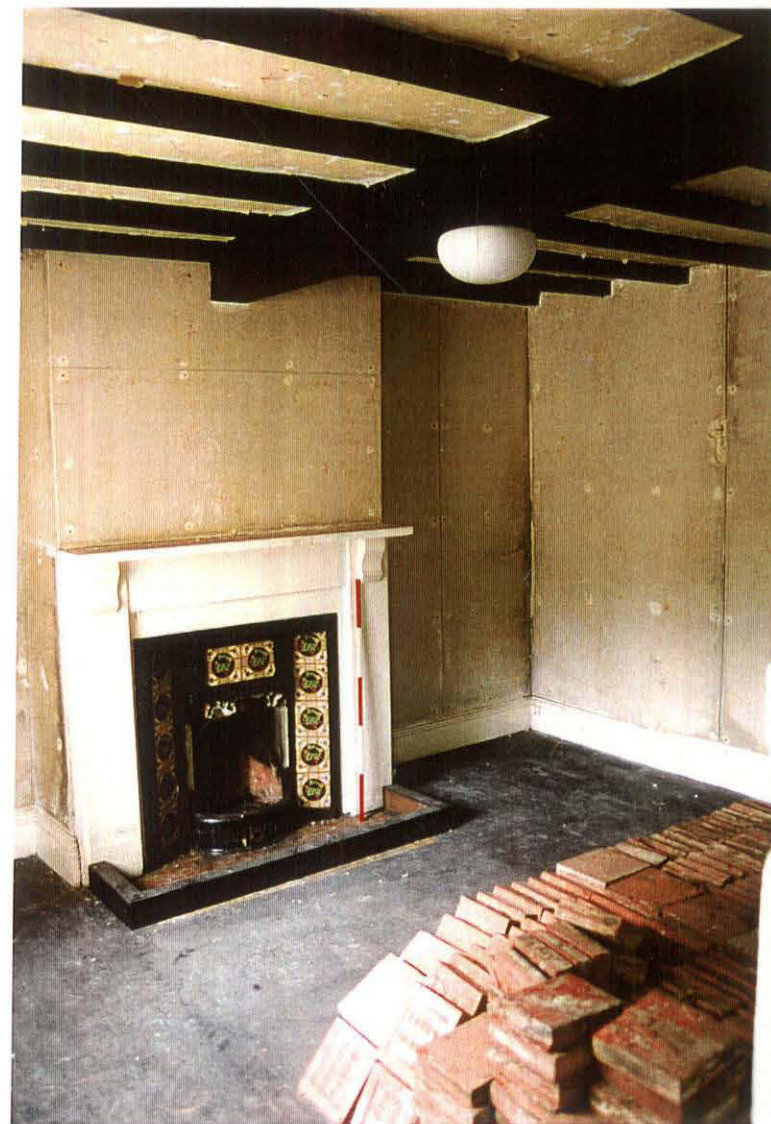
At ground level, the living room to the left measures 3.7m x 3.3m, with a fireplace along the south-east wall (plate 4). The fireplace, with original decorated tiles, seems to be of early 20th century date. The floor comprises tongue and groove boarding, and the walls, at the time of the brief, were covered with sheets of asbestos. The beam ceiling is not original, and comprises a number of small beams (0.065m wide and

Pl. 4 School House living room, looking S. Note floor tiles removed prior to photo survey.

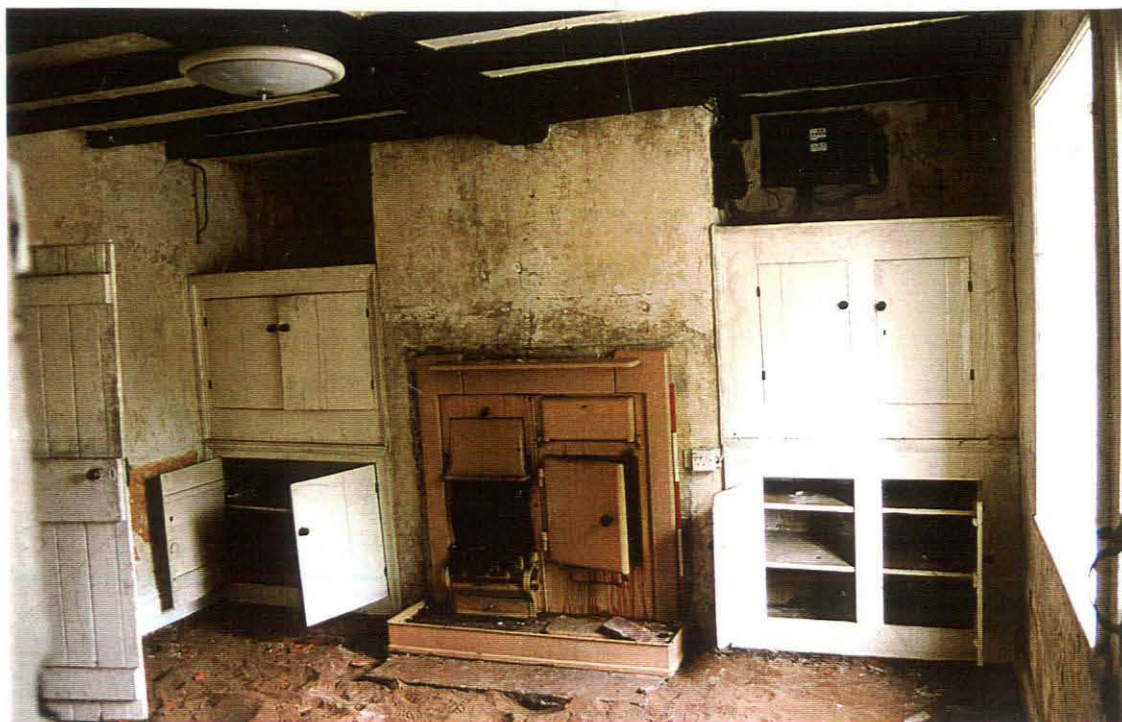
Opposite the living room was the kitchen (3.7m x 3.7m) (plate 5). A pattern of ceiling beams comparable to those in the living room was present, although this is where any similarities ended. The floor was of quarry tile construction, (each tile 0.185m x 0.185m x 0.045m) and the underside of each tile bore the makers name 'Cocking & Sons'. Removal of the floor exposed a sand-levelling layer. Wooden cupboards of 20th century date had been added to the recesses on either side of the chimney in the north-west wall. The original fireplace was removed in 1937 and replaced with a solid-fuel kitchen range, with built-in fireplace (for heating and cooking). An under-stairs cupboard in the south-east wall had plaster walls and identical quarry tiles.

Pl. 5 School House kitchen with 1937 solid-fuel aga, looking NW. Tile floor has been removed, leaving sand levelling visible.

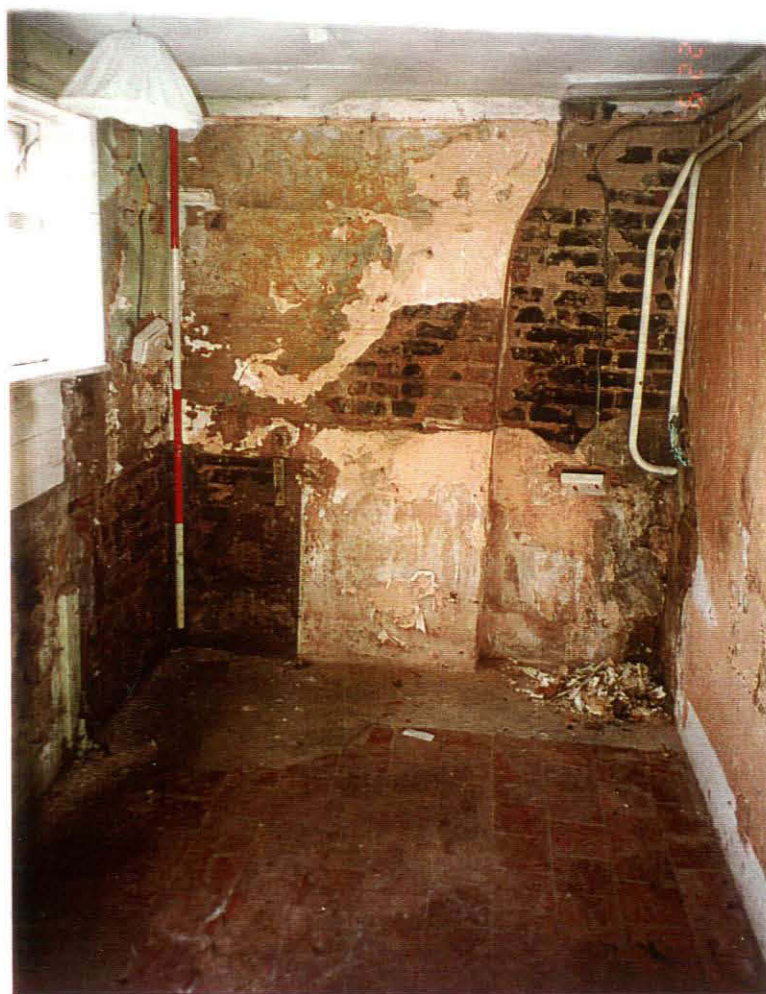
A doorway in the south-west wall led to the scullery (2.75m x 1.7m) (plate 6). The floor of the scullery was made of small quarry tiles (0.15m x 0.15m), at a level approximately 0.22m lower than the kitchen floor. A window looked out onto the playground. A doorway in the south-east wall led to a walk-in pantry.

Pl. 6 School House scullery, looking W.

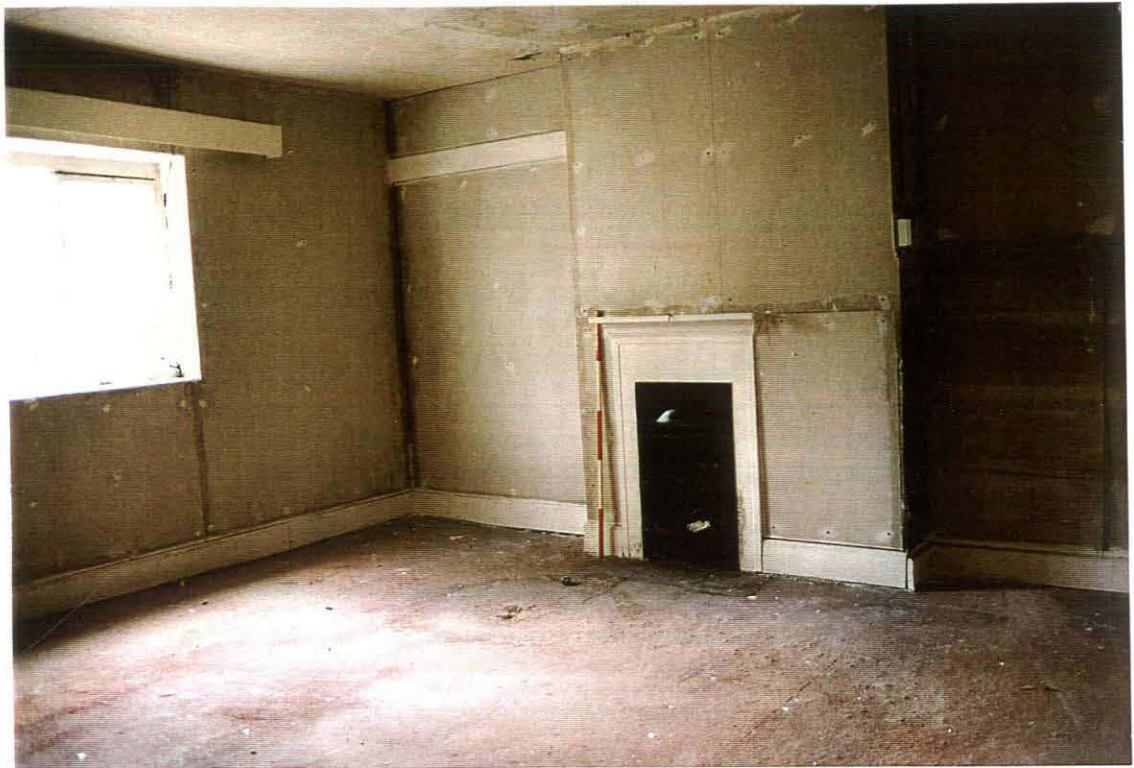
Bedroom 1 measures 3.7m by 3.3m, with asbestos sheets covering the walls (plate 7). The floor is concrete and the ceiling is plastered. A fireplace in the south-east wall may be early 20th century in date. The single window provided an unrestricted view of the parish church across the road.

Pl. 7 School House bedroom 1, looking SE.

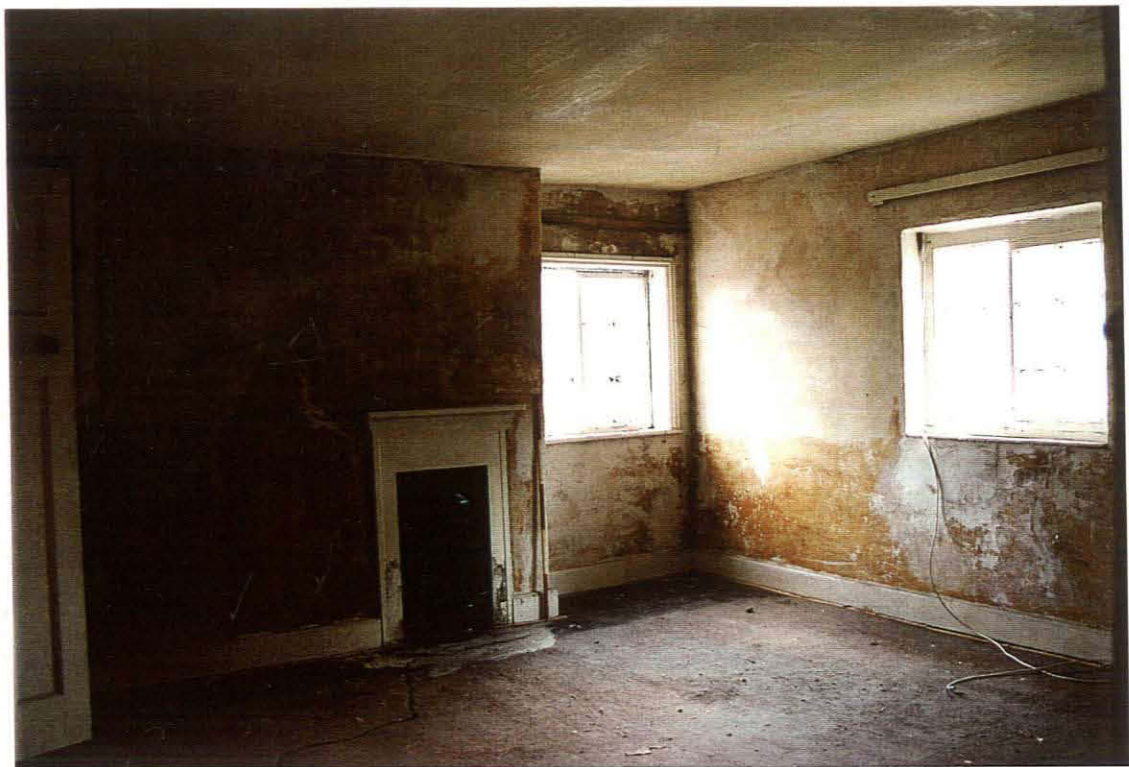
The second bedroom is 3.7m by 3.5m, again with concrete floor and plaster ceiling (plate 8). The cast iron fireplace seemed identical to that in bedroom 1, suggesting a similar date. One of the two windows falls within the recess formed by the chimneybreast. The other recess has been sealed to form a cupboard. A walk-in cupboard in the east corner of the room has plastered walls and ceiling, with a trapdoor leading to the roof space. A door in the south-west wall leads to the bathroom.

Pl. 8 School House bedroom 2, looking N.

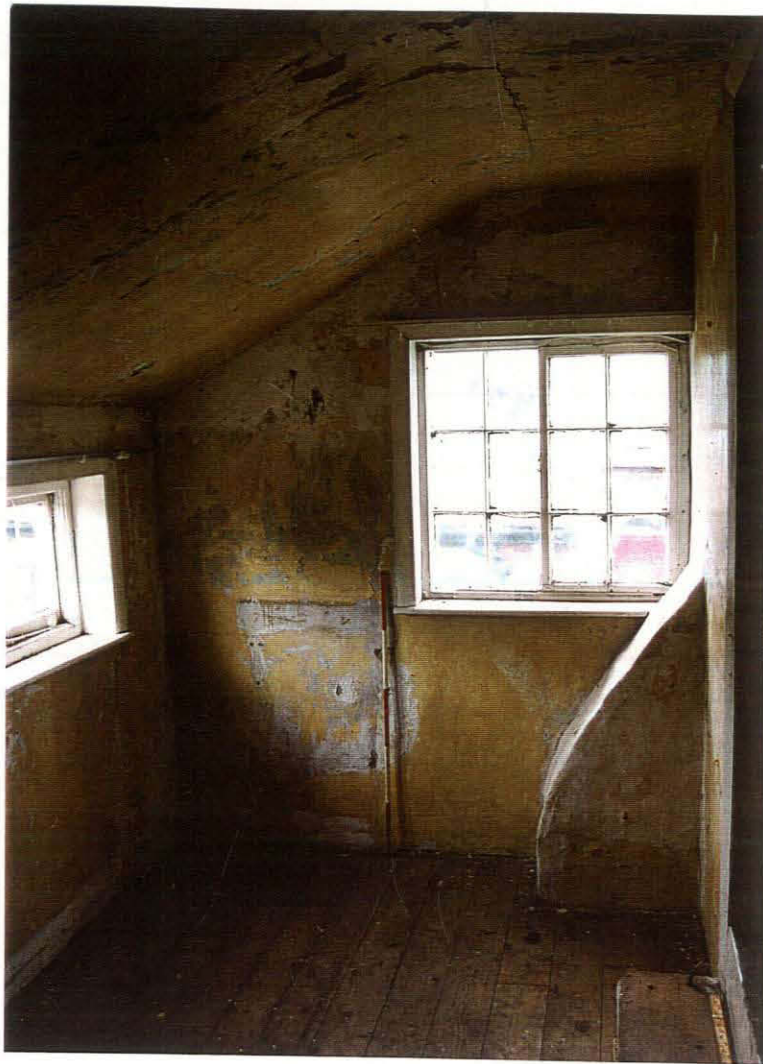
The bathroom floor is approximately 0.4m lower than the rest of the first floor level (access is via a single step) (plate 9). The wooden floor is of tongue and groove construction; the walls and ceiling plaster over brick. A small buttress slightly overlapping a window in the north-west wall may be an original feature, pre-dating this extension to the School House. Although the fixtures and fittings have been removed, copper piping in the east corner revealed the location of the boiler. This room was added as part of the 1939 extension.

Pl. 9 School House bathroom, looking NW.

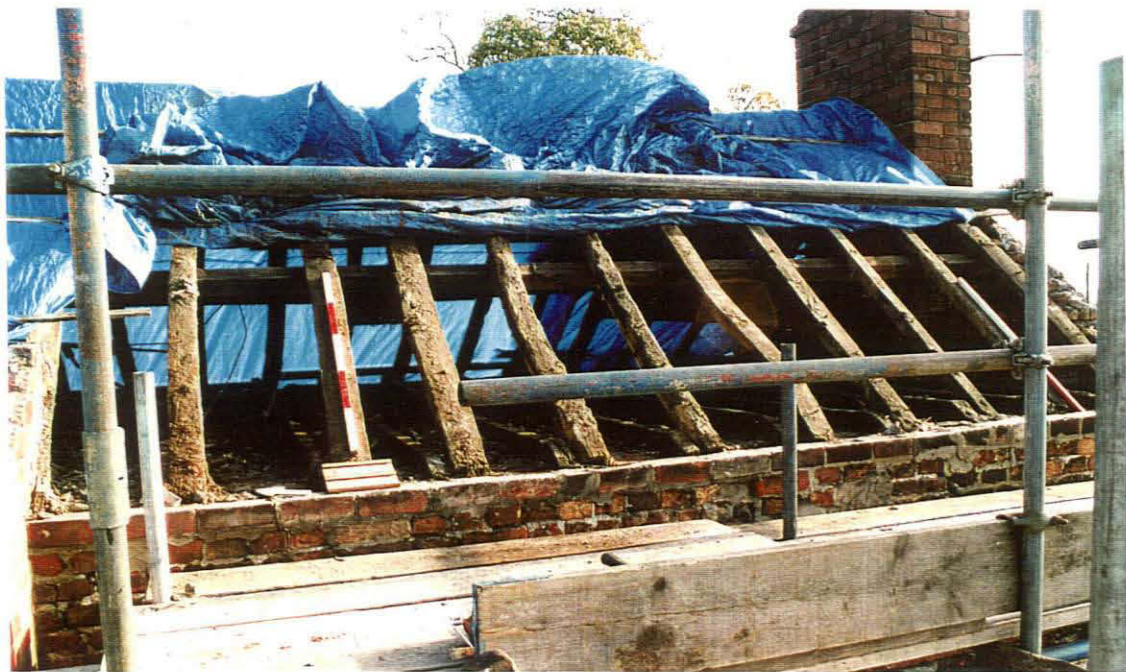
During the repair of the School House, the roof tiles were removed, allowing access to the timbers (Plate 10). The roof was of simple build, as befits a rural School House where only a limited span is required. It is a double pitch, single frame coupled rafter roof, with clasped purlins. There are no principal rafters.

The rafters were of 'common rafter' type, most of which appear to be part of the original roof build (reflected by accurate fittings into mortises cut into the wall plate). Replacements could be identified from the fact that the tennons on their lower ends were too small for the mortises. They also showed much less evidence of decay (which was principally dry-rot, although there were some wood-worm tunnels).

Pl. 10 Roof timbers exposed after removal of the School House roof tiles, looking E.

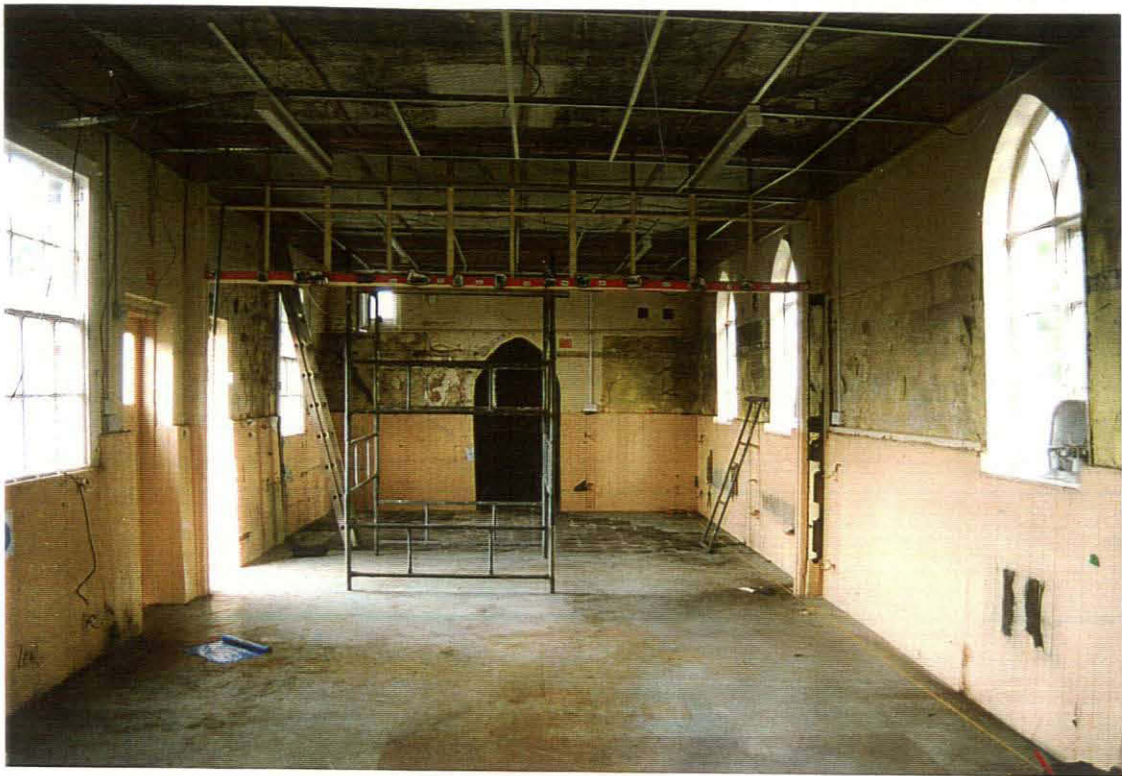
The classroom (probably dating to the 1821 phase of rebuilding) was 16m long (external) and 5.5m wide (plate 11). The main element of this Victorian building was a long rectangular room, partitioned into two by a wooden screen (removed before monitoring took place). The floor comprised modern linoleum tiles that had been glued onto a concrete surface. The walls had been plastered, with wooden slats added up to 1m from the ground.

Pl. 11 Internal view of Victorian classroom, looking NW.

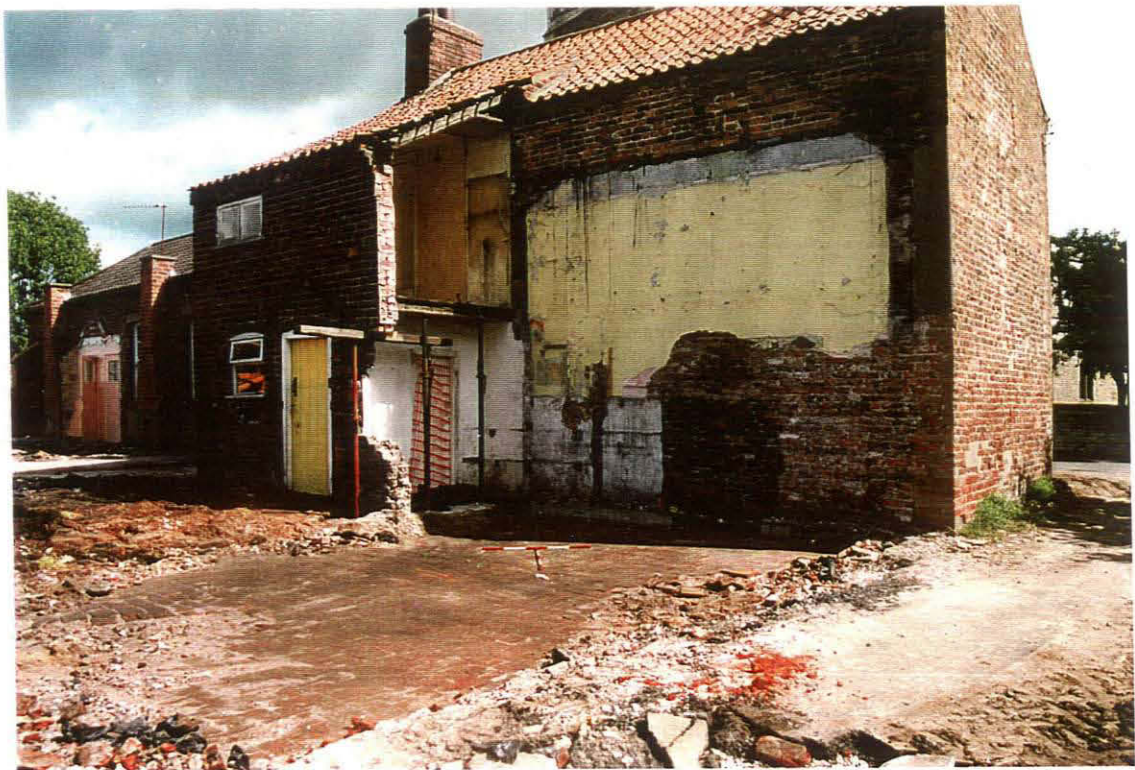
Adjacent to the School House, removal of the reading room floor revealed an earlier tiled floor (006) (figure 2; plate 14). The tiles were a uniform 160 x 155 x 50mm, with the company name 'Cowling' impressed into the underside of the tiles running around the edge of the room. These were similar to tiles found within the School House (similar date?). This surface was protected by a layer of plastic sheeting, beneath a layer of reclaimed bricks, and then more plastic sheeting prior to the reading room floor being constructed. This indicates a structure associated with the tiled floor was demolished immediately prior to the construction of the reading room. The early brick south-west wing ran perpendicular to the School House and measured some 8m long and 5m wide. The foundations for this structure comprised several limestone courses (005), with the 0.31m wide walls built using handmade bricks measuring 235 x 120 x 75mm (figure 9). This is probably an early (perhaps original) east – west 'wing' of the 1871 School House, and is depicted on the 1901 first edition OS map (Figure 10). The presence of an in-filled doorway on the first floor of the School House suggests the south-west wing comprised two storeys. The reading room was built using the foundations for the earlier structure.

Pl. 14 Tiled floor (006) after exposure and cleaning, looking NE. Reading room has now been demolished.

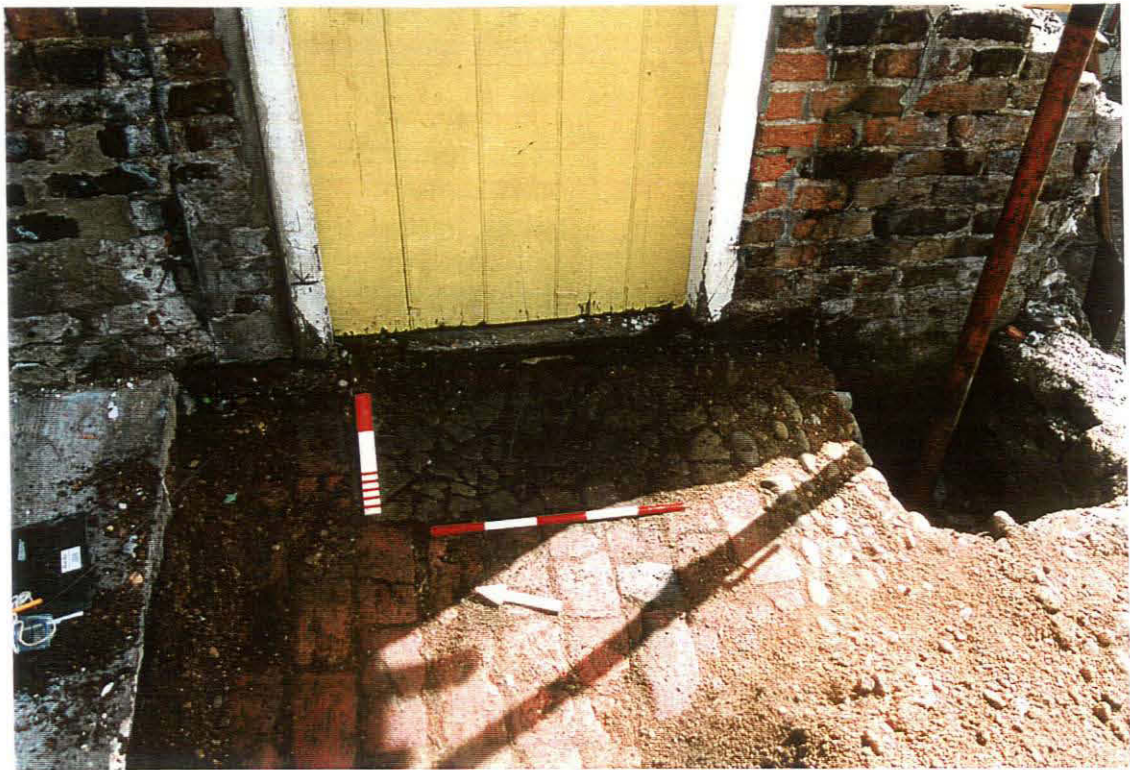
Removal of a concrete surface butting the rear entrance to the School House revealed an area of cobbles and a brick surface (003), with a shattered flag within the doorway (plate 15). This surface butts against the rear door, suggesting they were contemporary (part of extension built in 1939).

Pl. 15 Brick and cobble surface (003) adjacent to rear door of School House, looking ENE.

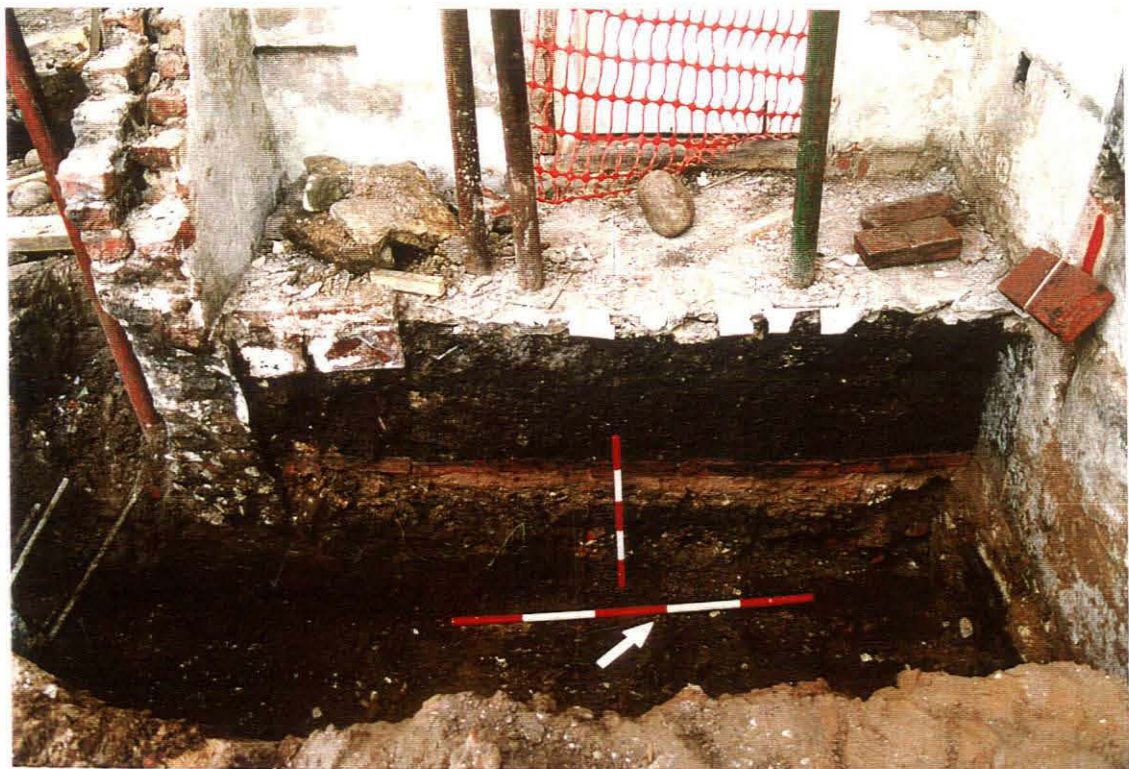
A side wall of the scullery/bathroom of the School House was removed, as it faced imminent collapse. This proved an opportune moment to examine deposits pre-dating the modern surface of the building (figure 11; plate 16). The scullery concrete floor (013) lay immediately above a modern industrial levelling layer, (014), comprising 0.4m thick black sand with large quantities of cinder, charcoal and coal. Willow pattern pottery was noted but not retained. This had been deposited over an earlier brick surface (015). The handmade bricks measured 235 x 1125 x 47.5mm and appeared to be within the scullery confines, suggesting an earlier surface for this building existed, perhaps a cellar? A yellow sand levelling layer (016) beneath the brick surface lay above brown clay sand with brick and limestone fragments (017), identified as a demolition layer pre-dating the 1871 School House. A layer of brown silty sand (018), identified as a possible former topsoil, pre-dated (017).

Pl. 16 SE-facing section through footings after removal of scullery wall, looking NW.
