**HISTORIC BUILDING RECORDING OF  
BARNs AT  
BOUGHTON HOUSE FARM,  
ASGARBY,  
SLEAFORD,  
LINCOLNSHIRE  
(ABH05)**

Work Undertaken For  
Steve Dunn Architects Ltd

March 2005

A.P.S. Report No. 41/05

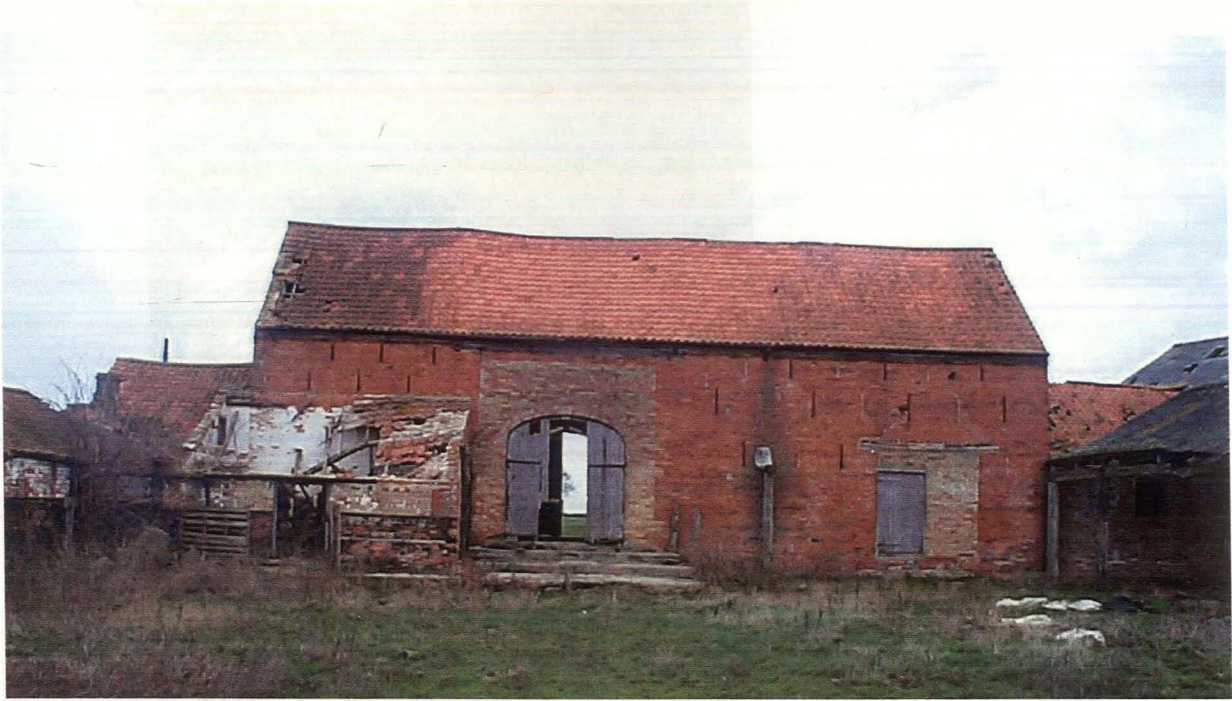
Plate 9 South elevation of main barn including lean-to stable with collapsed roof at left, looking north

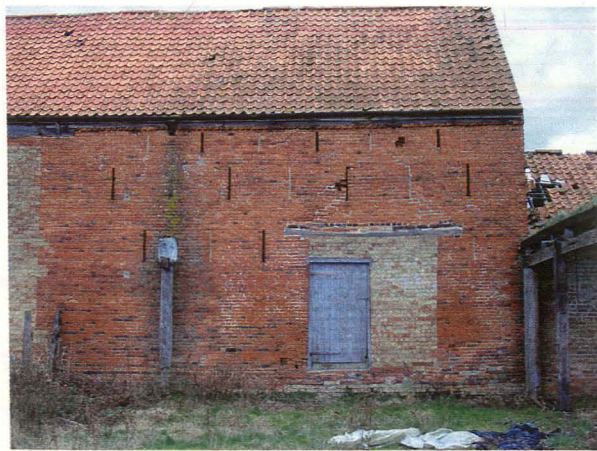
Plate 10 South elevation of main barn, east end, showing partially blocked doorway and breather slits (some blocked). Wood at left is probably part of former yard covering, looking north

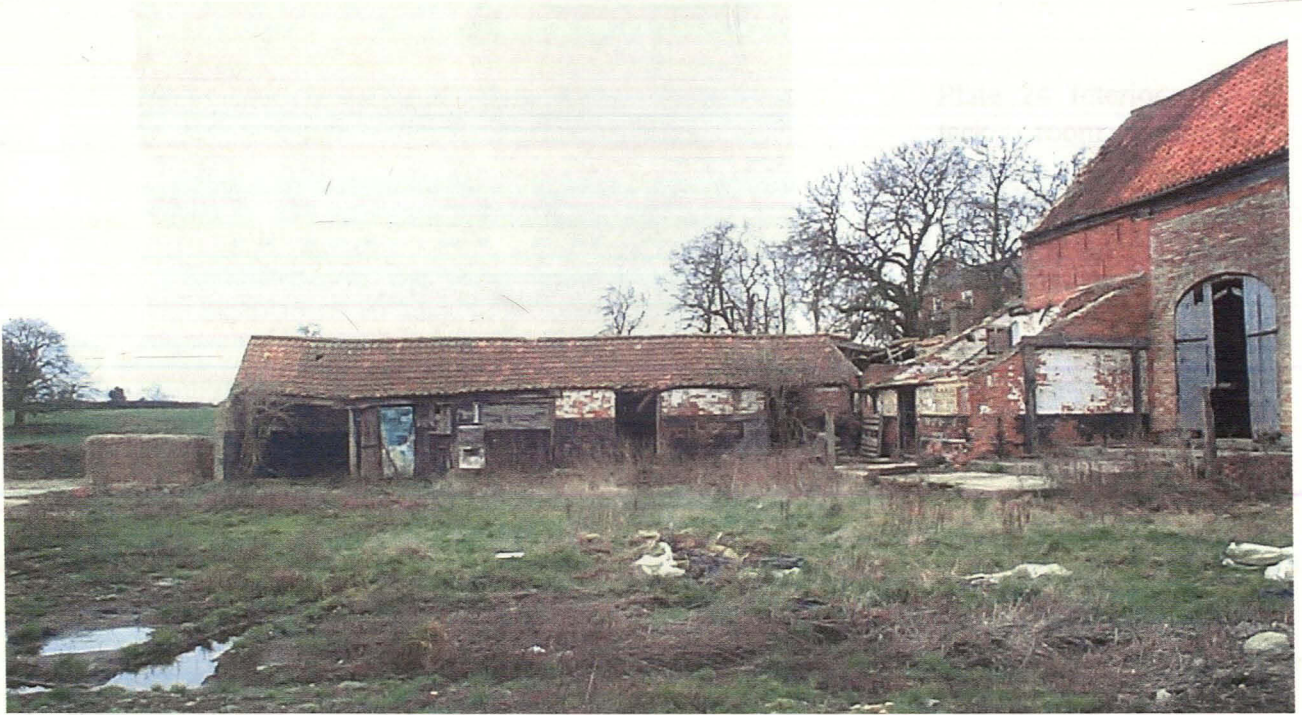
The northern half of the east elevation comprises handmade brick, the brick being of the same type as that used in the buttresses of the west elevation, but not the same as that used in the westerly north-south wall. A doorway near the centre of the range is that of a cobble-floored loose box, within which are a feed trough and tethering (Plate 23). Whilst access through the doorway to a second loosebox to the north is blocked by a tree (Plate 22), a cobble floor, feed trough and tethering can be seen inside.

Plate 22 East elevation of north-south range of loose boxes and shelter shed, including lean-to stable and main barn at right. Rectangular arrangement of timbers of east elevation of lean-to stable is probably part of former yard covering, looking west

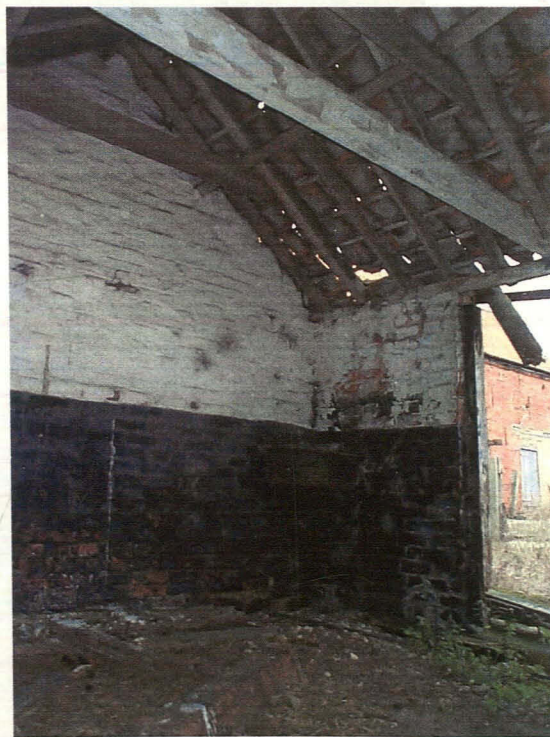
The internal plinths in the western wall of the shelter shed at the south of the range are also present in the loose boxes and the tackroom to the north. Although there is no further evidence to support this, the plinths might have originally supported tie beams. The current roof for this range is a simple one of tie beams and collars, with some of the collars not attached to the same rafters as the tie beams (Plate 23).

Plate 23 Interior of loose box at centre of western north-south range, showing roof construction, with feed trough just visible in corner of room, looking northeast

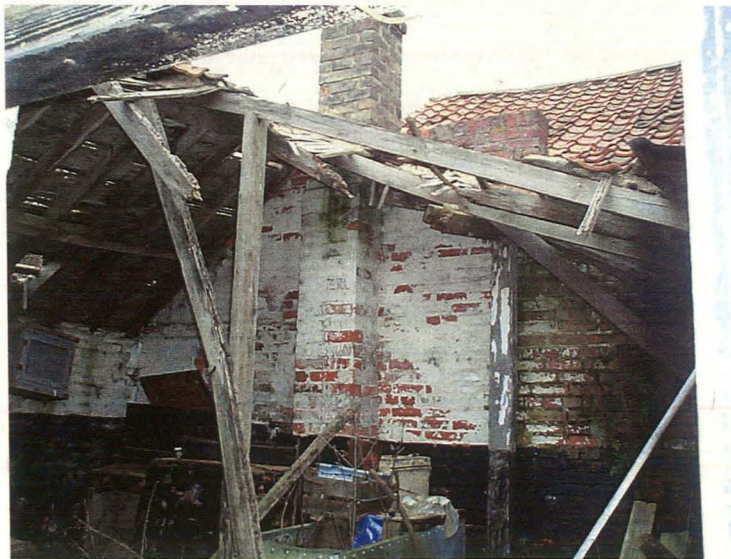
Plate 25 Interior of tack room from southern doorway, chimney and collapsing roof, looking north

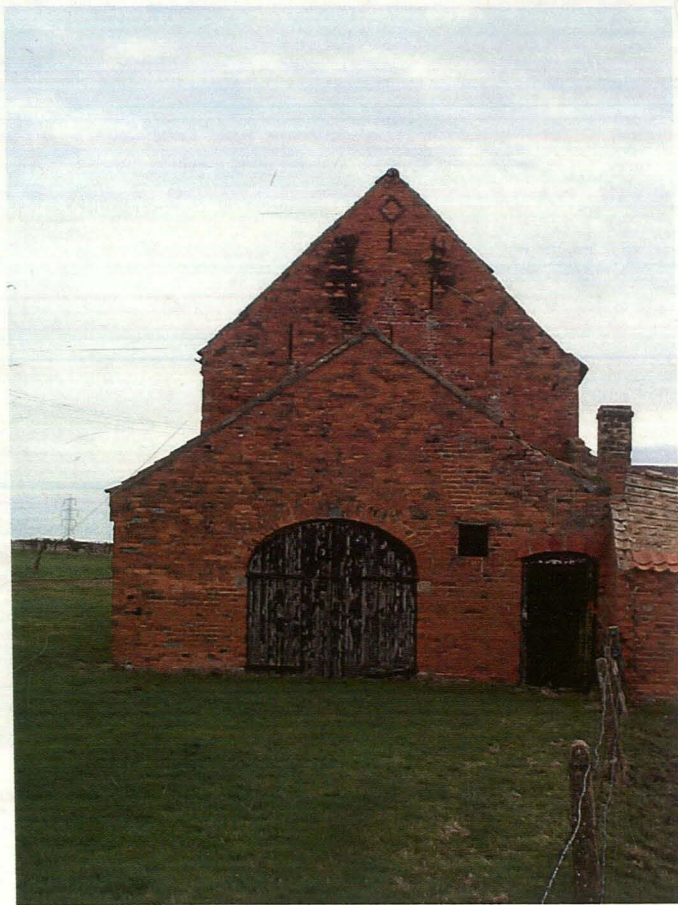
The west elevation (the gable) has a pair of double doors with a brick arch, similar to a four-centre arch but lacking a point. At the south end of the west elevation is a single door over which is a segmental brick arch (Plate 27). The bricks in this arch are larger than the rest of the building, and the mortar different, indicating that this is probably a replacement. The bricks in this arch are late handmade bricks, probably of the late 19<sup>th</sup> century. Between the two doors is a small ventilation opening with a timber lintel. Evidence of mortar, brick and tile used to edge this entry indicates that this is not original.

Plate 27 West elevation of main barn and western addition to main barn, comprising possible shed and loose box, looking east

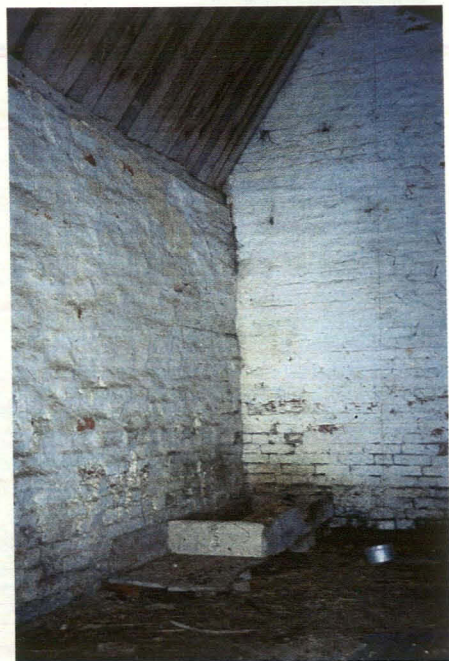
This building is split into two rooms by an east-west dividing wall, immediately south of the double doors. Whilst the room with the double doors was not accessible, the southern room was a loose box containing a feed or water trough and tether (Plate 28). Each of these rooms had a mixed cobble and brick floor.

Plate 28 Interior of loose box, part of addition to west end of main barn showing feed or water trough, looking northeast

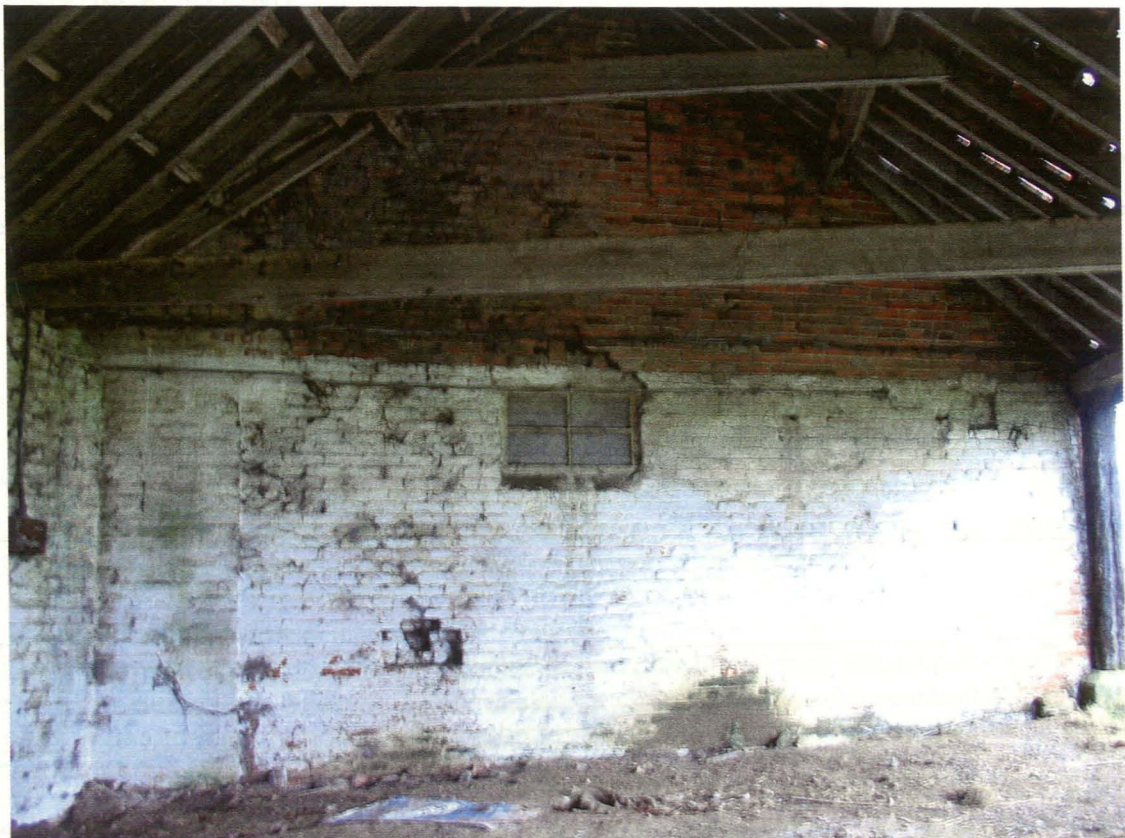
Plate 32 Shelter/cart shed at northeast corner of range, east facing internal elevation (and  
external elevation of northwest-southeast range), showing blocked window at top,  
window, blocked niche at right and rebuilt section of wall at left, looking west
