BAKERS LANE FARM BAKERS LANE, BASSINGHAM, LINCOLNSHIRE.

A DESCRIPTION AND RECORD OF THE DOMESTIC AND AGRICULTURAL BUILDINGS

A DESCRIPTION AND RECORD OF THE EXISTING BUILDINGS, BAKERS LANE FARM, BAKERS LANE, BASSINGHAM, LINCOLNSHIRE.

SURVEY CARRIED OUT: JUNE 2007

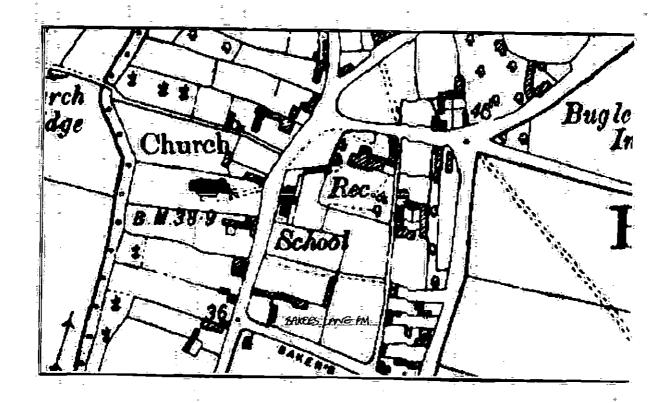
BAKERS LANE FARM, BASSINGHAM: EXTRACT FROM ORDNANCE SURVEY, 1901

The presumed original area of the farmstead is outlined in red

The House and outbuildings appear to be in the positions as surveyed for the report, including the cartlodge, which may have been reconstructed in the twentieth century on the site of an earlier agricultural building

It is noted that there was another range of buildings running to the north of the surviving buildings, on land now in residential use
