**BUILDING SURVEY OF BARNES AT THE GRANGE, YARBURGH ROAD,
ALVINGHAM, LINCOLNSHIRE**

NGR: TF 3596 9153
Planning ref: N/004/00173/07
Site Code: ATG07

Report prepared for
Christopher Press Architect
on behalf of Mr and Mrs Smith

by Chris Clay
May 2007

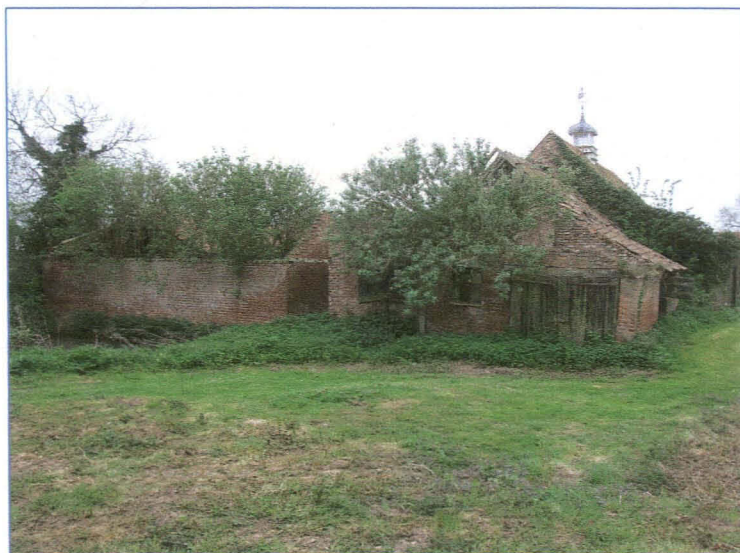
- 5.1.2 At the east end of the range there is a derelict outbuilding (Building 1), the roof of which has collapsed. Much of the brickwork above the wall plate on the south, east and west elevations has also collapsed. The east elevation has a set of double doors with a wooden lintel, and the north elevation bows out to the north with a large crack running top to bottom across the centre of the wall. The position of the double doors, pointing away from the crew yard, suggests that it served as a cart shed allowing access directly to the fields; a common architectural addition during the 19th century (Pickles and Lake 2006).

Plate 3: East elevation of the north range, showing the derelict stable and cartshed with the double wooden doors. Looking south-west.

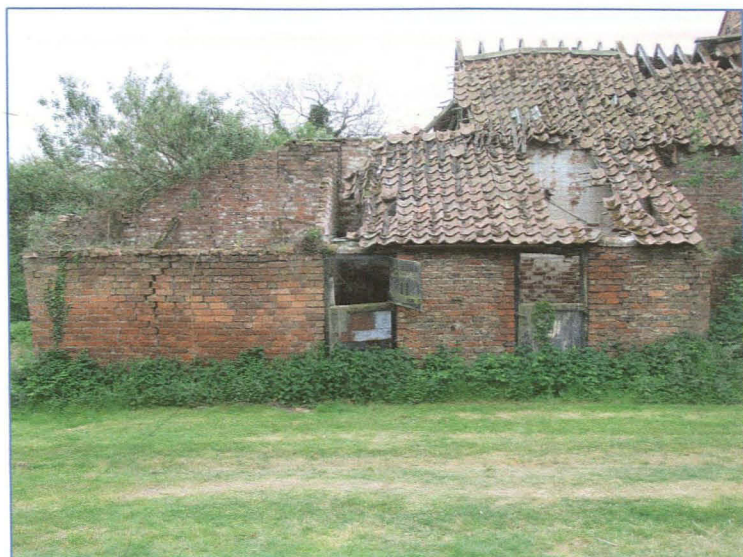
- 5.1.4 Attached to the east end of the outbuilding/cartshed is another range of three stable blocks (Building 3), with a mono pitched pantile roof. All three are in poor condition, but the two best preserved have a wooden door on their north elevations, while the north elevation of the western block has almost completely collapsed, and its west elevation has been built into the adjacent lean-to.

Plate 4: Stable block and cartshed at the east end of the north elevation of the north range. Looking south-south-east.

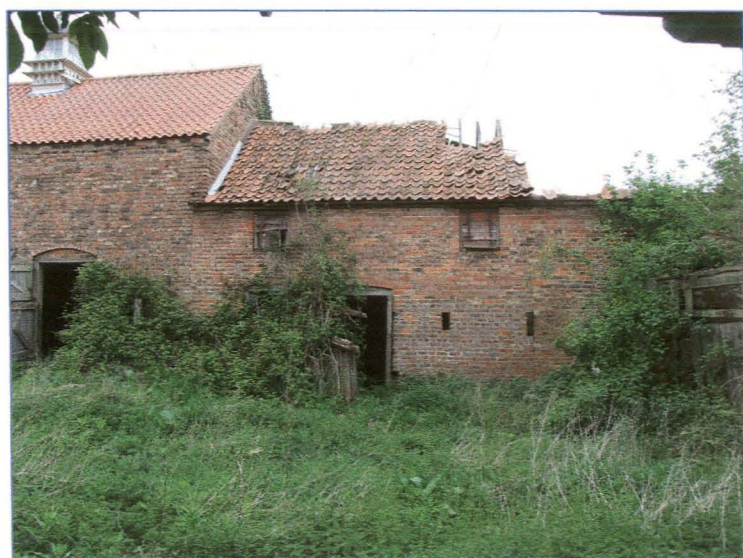
- 5.1.5 Another stable block with a hayloft in the upper storey is located to the south of the above (Building 4), with a wooden door with a segmental arch overlooking the crew yard. There is a small window to the west of the door, with two air vent holes and a possible blocked doorway to its east. Internally, the ground floor is divided into three bays by two timber partitions, with the ground sloping downwards to a timber gully which runs out into the pond to the east, to carry away animal waste. The upper floor is unsafe to enter, but is accessed by a timber ladder and a door in the west elevation. It is divided into bays by a series of low wooden partitions, which are attached to large timber verticals that support the roof purlins and tie beams. There are two shuttered pitching holes in the south elevation for the loading and unloading of animal feed or crops directly to/from the crew yard. The east end of the double pitched pantile roof has completely collapsed.

Plate 5: Stable block and hayloft in the south elevation of the north range. Looking north-north-west.

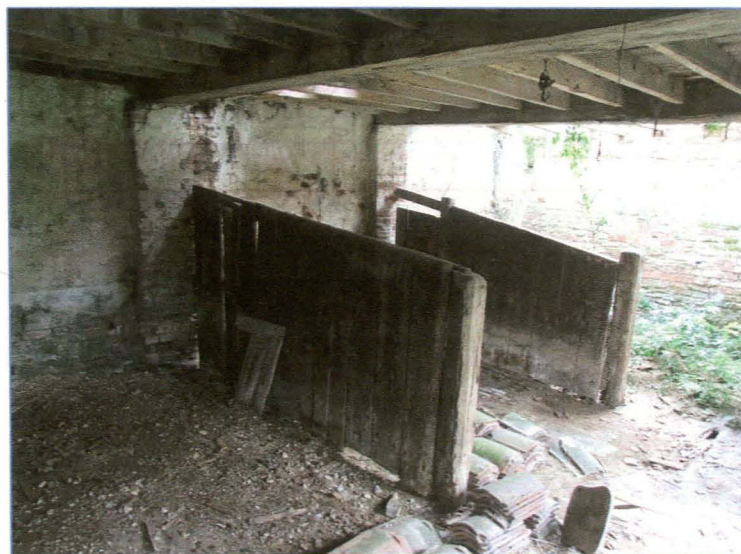
Plate 6: Interior of the stable block, showing the wooden partitions. Looking north-north-east.

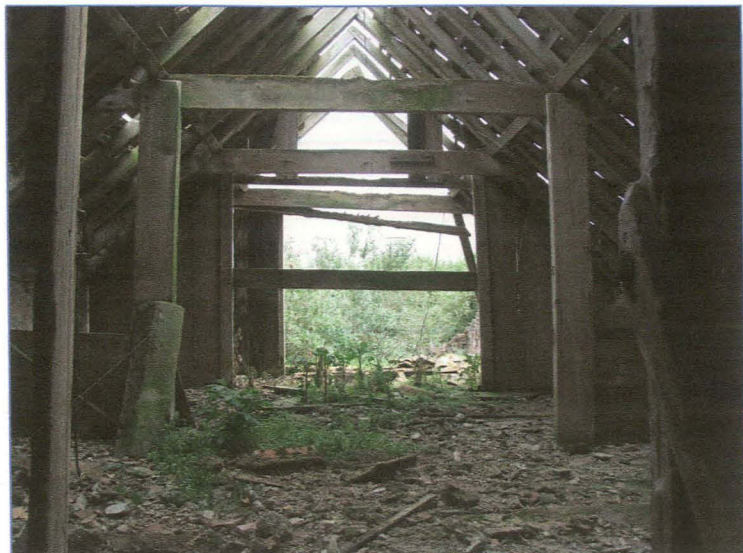
Plate 7: Hayloft above the stable block. Note the wooden partitions dividing the room into bays. Looking east-north-east.

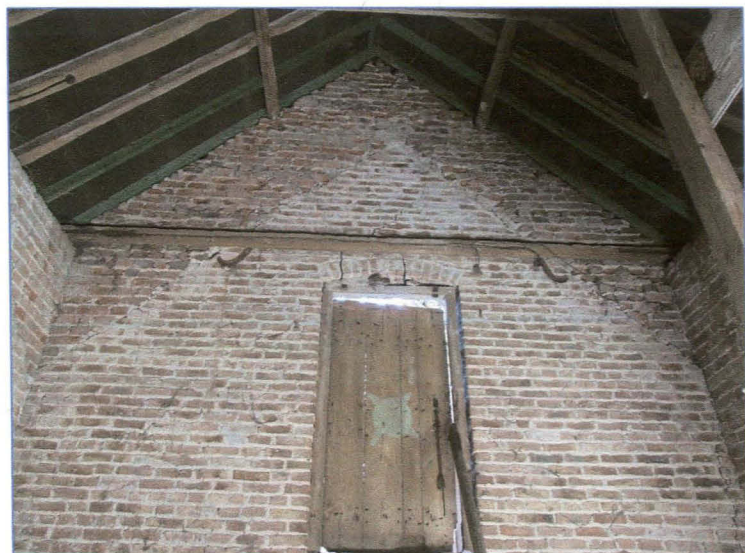
Plate 8: East internal elevation of the three storey threshing barn, showing the roof line of the adjacent stable/hayloft. Looking east-north-east.

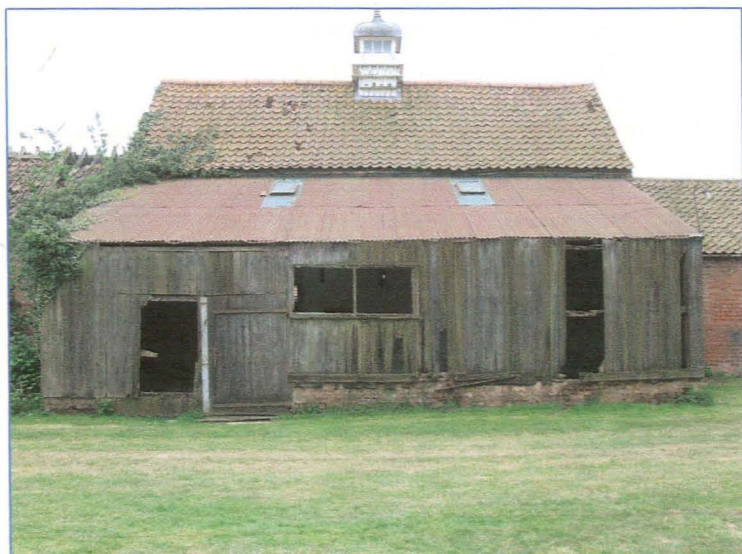
- 5.1.8 The barn has a large lean-to of probable 20th century date attached to its north elevation (Building 6), measuring 11m by 4.5m and constructed of a brick dwarf wall supporting vertical timber boarding and a mono pitched corrugated steel roof, with two skylights. The east elevation of the lean-to incorporates the west wall of the derelict stable block.

Plate 9: Lean-to on the north elevation of the north range. Looking south-south-east.

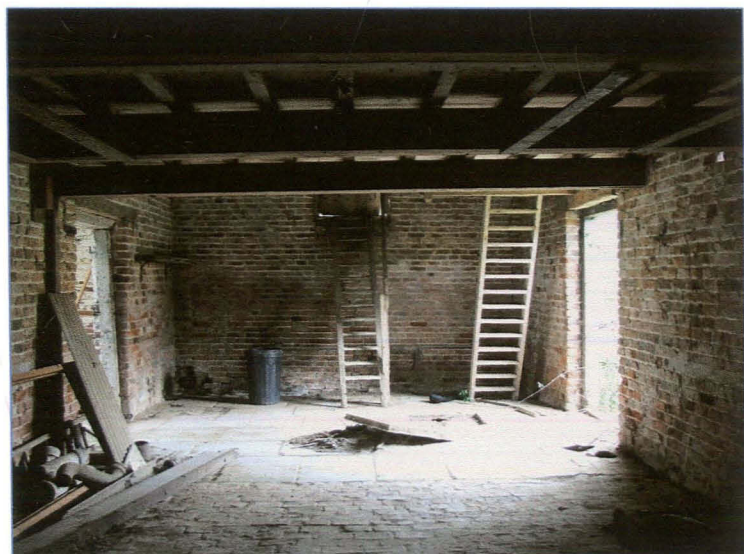
- 5.1.11 The ground floor of the barn comprises a single room, with a flagstone floor at its east end. This probably served as a threshing floor, with the opposing doors allowing a through flow of air to carry away the chaff. A loose flagstone exposed an earlier floor of compacted chalk gravel and soil beneath the probable threshing floor. The western portion of the room has a brick floor and was probably used to store the threshed crop.

Plate 11: Ground floor of the threshing barn, looking east-north-east towards the flagstone threshing floor, with the large doors at either side allowing the through-flow of air to carry away the chaff.

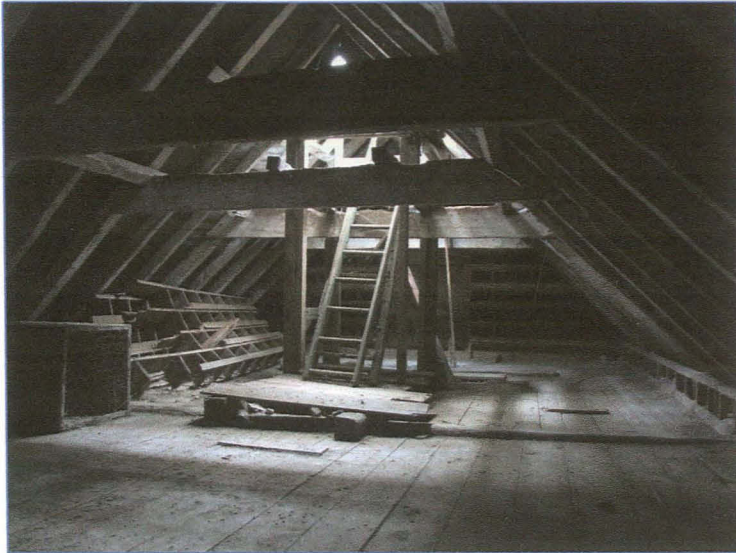
- 5.1.13 The second storey, which was used as a pigeon cote, is also accessed by a wooden ladder and a hatch in the north-west corner of the floor. It is slightly larger than the first storey, measuring 8.3m by 5m, and overhangs the lower storey at its east end. There was a curious feature attached to the floor rafters of this storey at its east end, comprising two steel supports holding a wooden timber with a small wooden box attached. A possible interpretation for this feature is as a roost and feed box for the pigeons. The room has a series of pigeon boxes around the walls, and a hatch in the centre of the roof allowing access to a glazed cupola. The cupola has a series of flight holes for the pigeons, glazed windows of six lights in each side, and a lead roof topped with a wind vane in the design of a Viking ship.

Plate 13: Pigeon cote in the second storey of the threshing barn. Note the pigeon holes at the far end of the room and along the right hand side of the shot, and the ladder allowing access to the cupola above. Looking west.

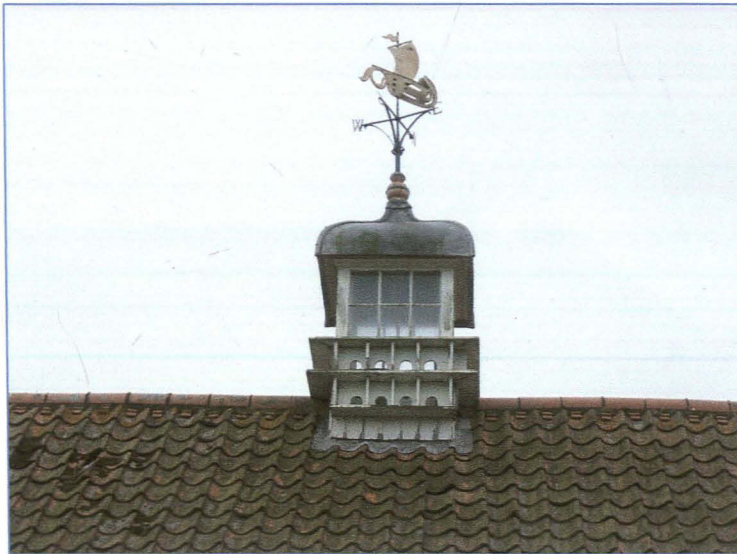
Plate 14: The glazed cupola on the roof of the three storey barn, with the wind vane and flight holes for pigeons. Looking south-south-east.

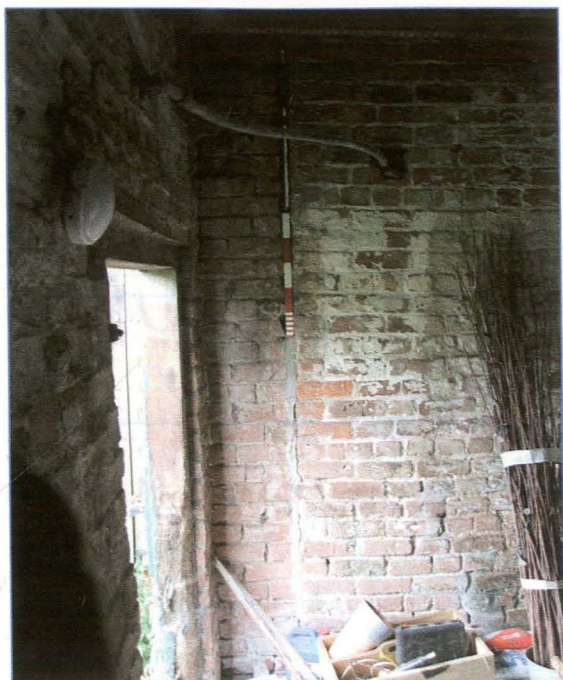
Plate 16: Internal east elevation of barn showing the relationship between the two phases of walls. Looking east-north-east.

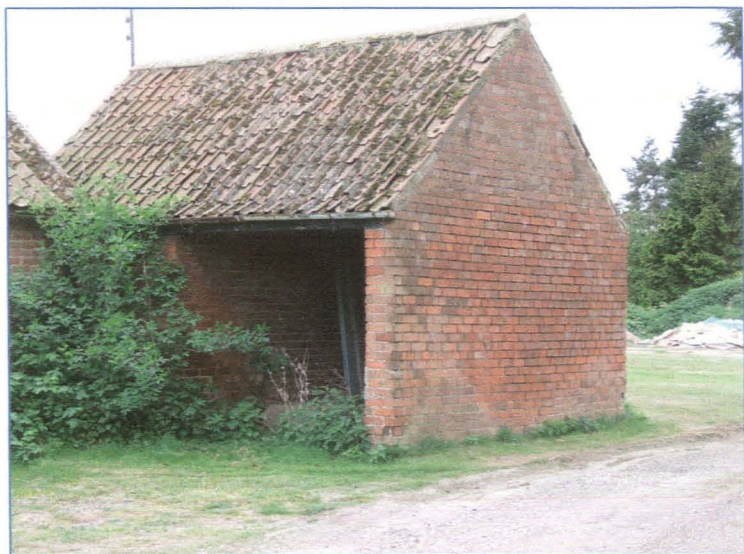
Plate 18: Outbuilding at the east end of the north range, showing the compartment probably used as a cartshed. Looking south-west.

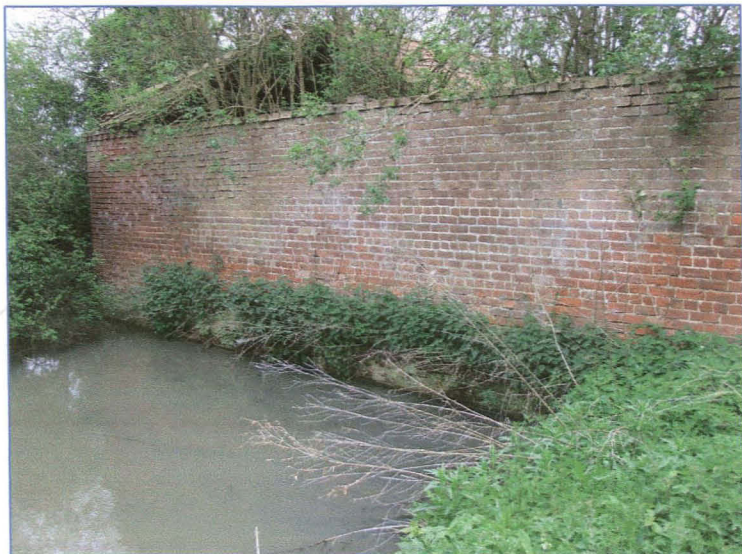
Plate 19: East elevation of the derelict barn at the east end of the south elevation. Looking south.

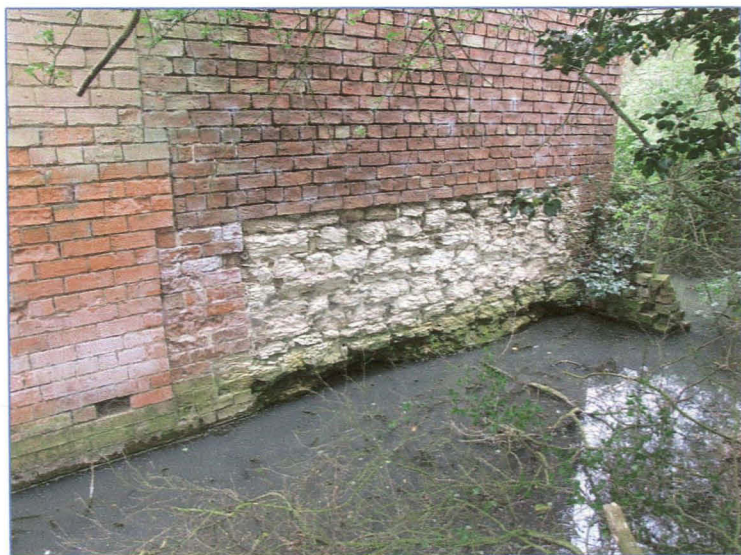
- 5.2.1 The south range comprises two buildings arranged in an L-shaped plan. The earliest building is at the east end of the range (Building 10), and extends northwards to within 1.5m of the north range. The gap between the two ranges appears to have had wooden doors at each end, of which only the western door survives. The building measures 11.5m by 4.2m and had a double pitched roof that has completely collapsed. The south end of the building extends into the adjacent pond, which runs along the south side of the south range. The east and south elevations are in English Garden Wall Bond (three stretchers to each header course), with a dentil course below the roofline. At the base of the east corner of the south elevation is a small area of dressed chalk blocks and a stub of a brick wall extending southwards. The chalk blocks may have been robbed from nearby earlier buildings. A second, less plausible possibility, is that they represent the in situ remains of an earlier stone wall.

Plate 21: Chalk blocks in the south-east corner of the south range. Looking north. Note also the difference in brickwork at the left of the shot.

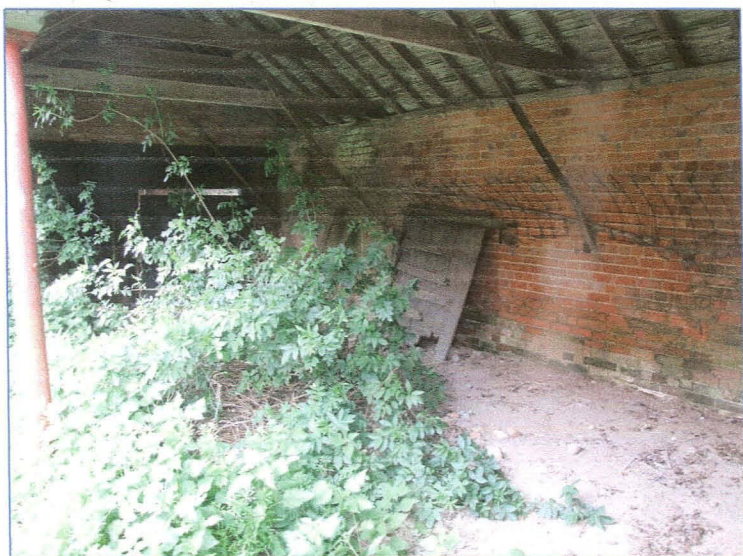
- 5.2.6 In the eastern bay, there is a steel mesh feeding tray along the south wall, similar to the wooden one in Building 10 to the east. The central bay has a door in the south elevation, with a row of brick feeding troughs and a water trough at its east end. To the west of the door the brick foundations for another row of feeding troughs are visible.

Plate 23: Interior of the eastern bay in the south range, with the feeding rack along the south wall. Looking east

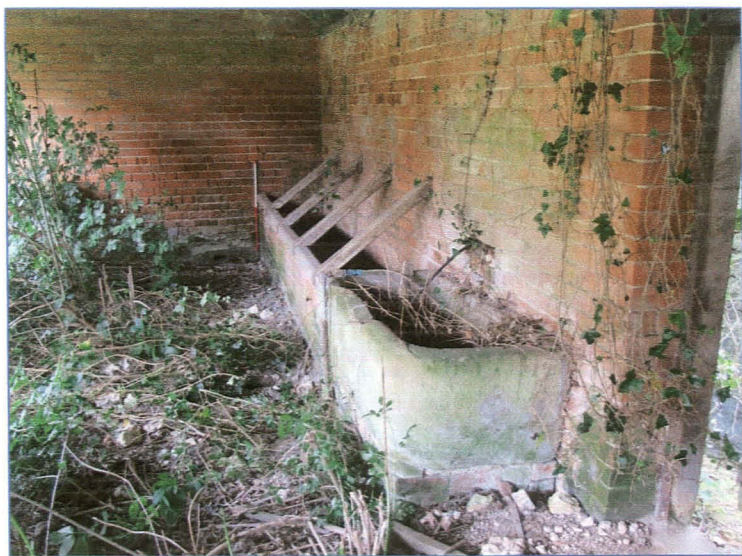
Plate 24: Feed trough and water trough at the east end of the south wall in the middle bay of the south range. Looking east.

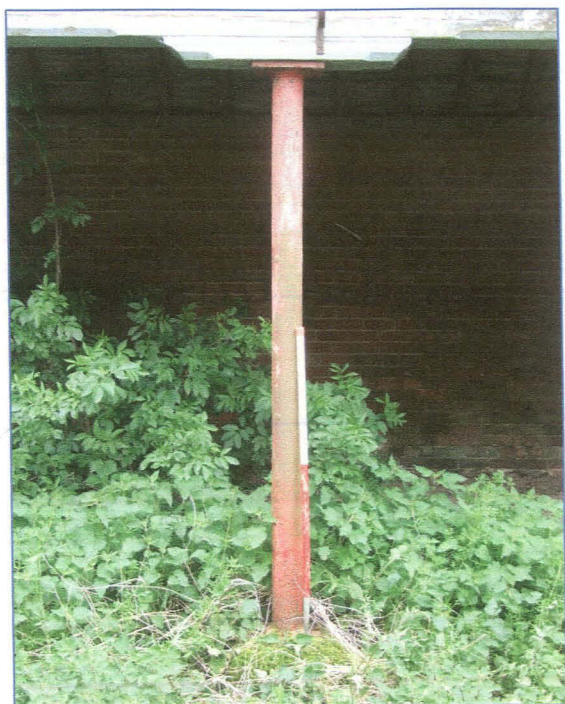
- 5.2.4 The second building in the south range (Building 11) is a single storey brick structure with a double pitched pantile roof, probably a cow shed. It measures 35m by 5m, and is divided into three uneven bays, open on their north elevation and facing into the crew yard. The three bays are divided by two brick walls, each fronted by a brick stanchion with bull nose bricks on the corners. The brick stanchions support a large wooden lintel, which is also supported by eight cast iron stanchions, each of which is set on a stone pad, with a timber pad below the lintel.

Plate 25: Detail of one of the cast iron stanchion on the north elevation of the south range.

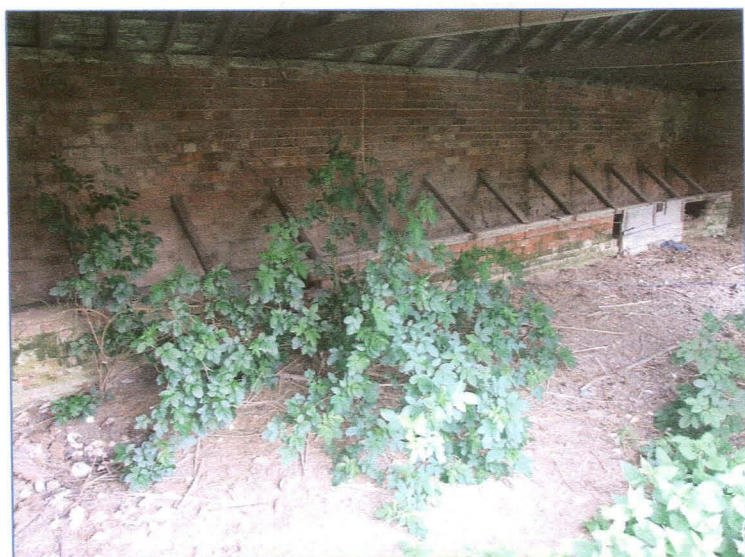
- 5.2.7 In the western bay, there is a similar arrangement of feeding troughs which run along the entire length of the south wall. Two stone troughs currently in the crew yard were probably originally located in the central and eastern bays of the cow shed.

Plate 26: Feed troughs along the south wall of the western bay of the south range. Looking south.
