**THE LANGTON ALMSHOUSES,
LANGTON, HORNCastle, LINCOLNSHIRE**

**STANDING BUILDING APPRAISAL
AND PHOTOGRAPHIC SURVEY**

November 2005

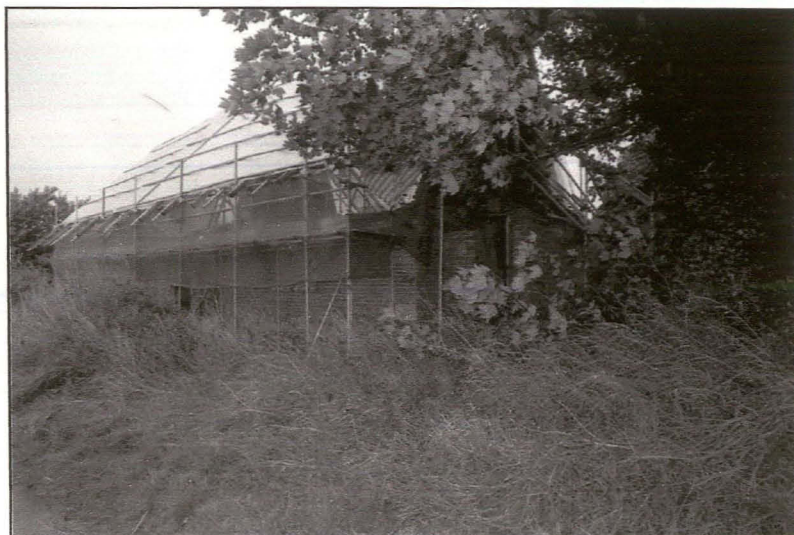
Plate 2: Closer view of the South Elevation.

The stone copings of the east extension are clearly visible as is the Lincolnshire limestone dedication stone towards the base of the main section.

Despite the problems of dating masonry purely on materials used, type of bricks and detailing suggest that the east elevation is likely to be one of the latest alterations surviving and fall within a time frame between the last quarter of the C19th and the first quarter of the C20th.

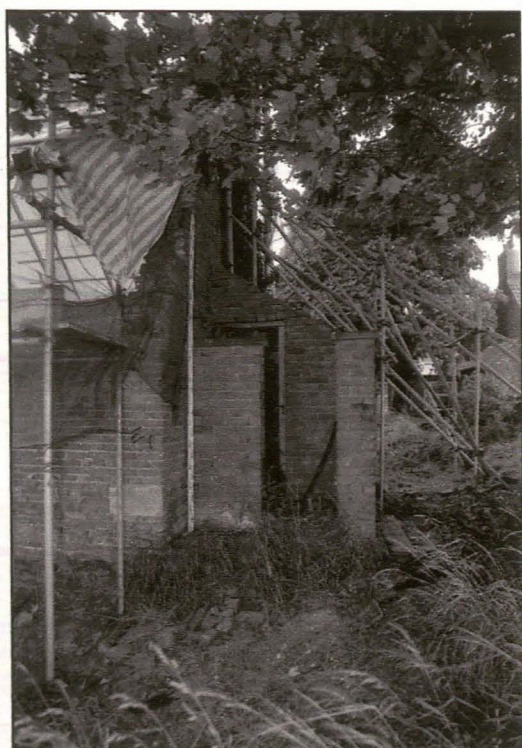
Plate 3: The East Elevation looking southwest. Again the temporary cover masks details; in this case of the gable and garret window. The east extension of a pair of privies is clearer, showing the simple lean-to rafter roof and York stone copings.

The extension was filled with rubble and it is unclear to what degree internal fittings survive, but the two openings in the east wall may be to remove nightsoil indicating a 'Thunder Box' or similar earth closet system.

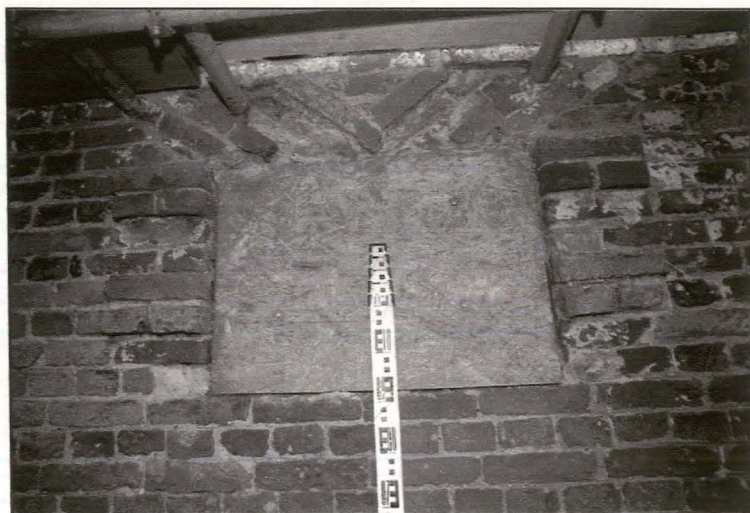
Plate 4: North Elevation, primary window of Unit A, showing the plain rustication to the jambs and the *Dutch* or *French* Arch that typifies the detailing of the original architectural design and characterises the building as belonging to the artisan mannerist tradition.

Dutch Arches are very weak and only used in small openings or where not much strength is required; in this case, the arch supports few courses of brickwork and the mass of the roof is carried primarily on the walls and heavy wall plate.

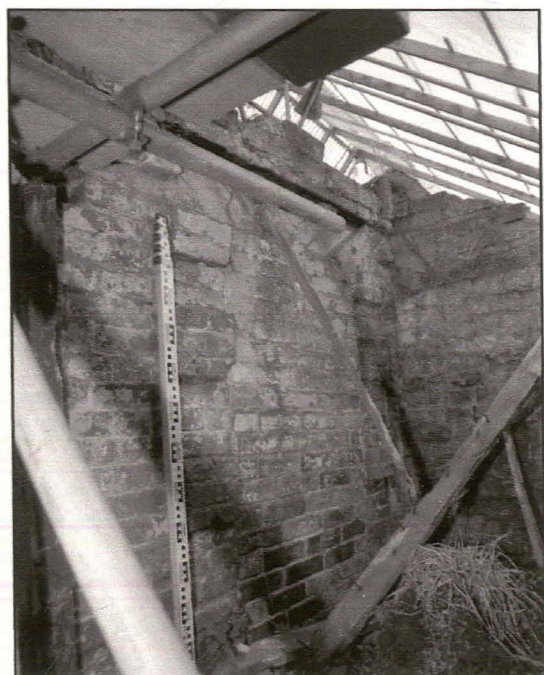
Plate 5: North Elevation of the primary phase taken inside the simple lean-to extension showing the blocked rear door of Unit B. As in the case of the original windows, the treatment of the jambs is plain rustication with a Dutch Arm above.

The bricks used in the blocking are unremarkable and do not point to even a broad date range. Photographs held in the Planning File by ELDC are more informative, however, showing the inserted staircase that that was the *raison d'être* for the blocking: of simple beaded plank construction similar to surviving internal joinery, it is likely to date from the mid/late C19th.

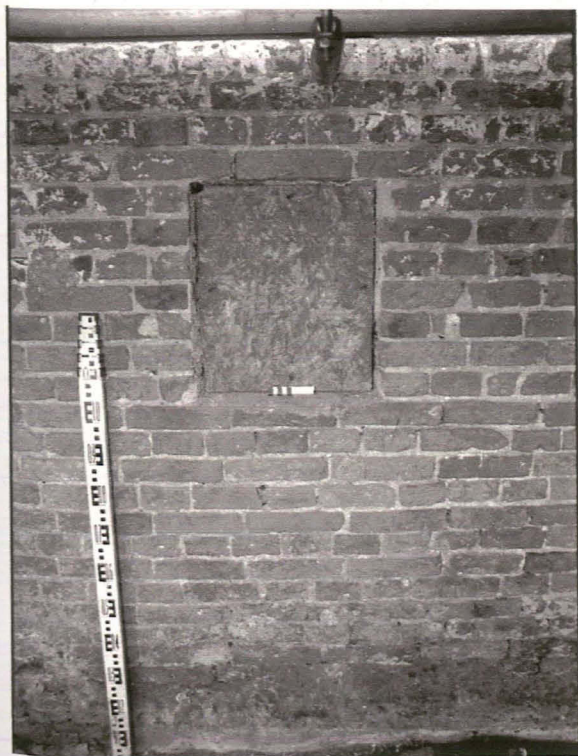
Plate 6: North Elevation, Unit B, showing inserted window opening of Phase II scullery or pantry. The opening is devoid of any detailing and as such cannot be mistaken for a primary opening.

This plate also shows the poor bonding characteristic of the primary phase: the lower ten courses or so are in English Bond, whilst above this it is in an irregular, though broadly English Garden, bond.

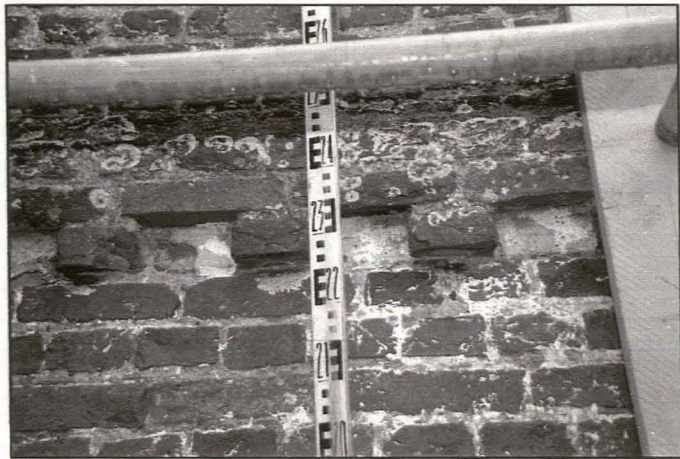
Plate 7: West Elevation showing denticulated stringcourse. Again, note the use of lime render infill between adjacent dentils complementing the treatment of the window detailing.

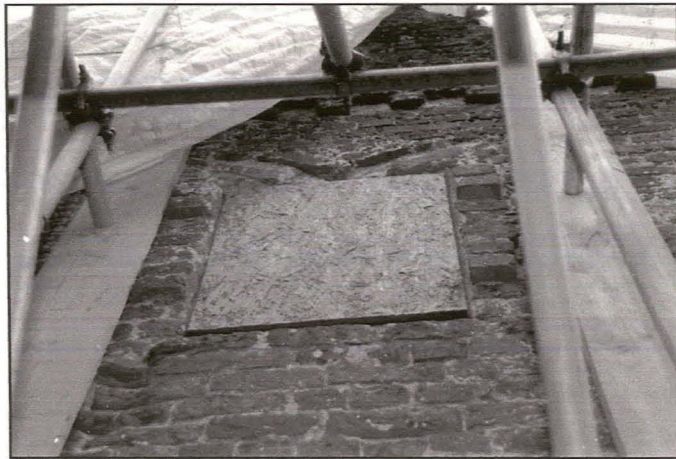
Plate 8: The garret window of the West Elevation showing the same architectural detailing as those of the ground floor. Note also, a second dentil string above the Dutch Arch.

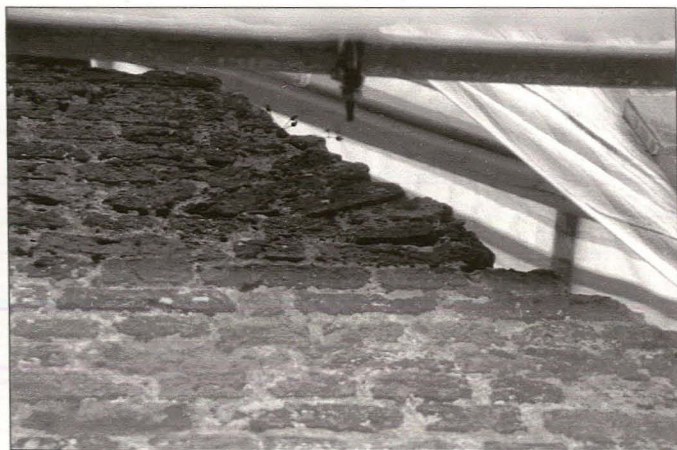
Plate 9: West Gable showing one of the fragments of 'Tumbling-in'. Sections also survive on the East Gable and indicate that the building originally had parapet gables.

Tumbling is a widespread detail but is particularly common within the region, occurring frequently in the hinterlands of the Humber, Trent and Ouse.

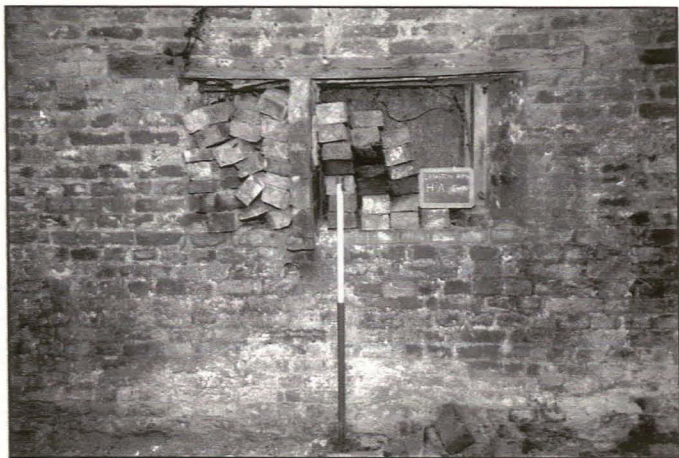
Plate 11: Interior view of the primary window in the front (South) Elevation.

This window was crudely divided during Phase II alterations by the insertion of a north-south wall.

Although the surviving evidence is a scar on the floor and the half-brick wall shown in this plate, photographs in the ELDC Planning File appear to suggest that this was largely a mud and stud construction.

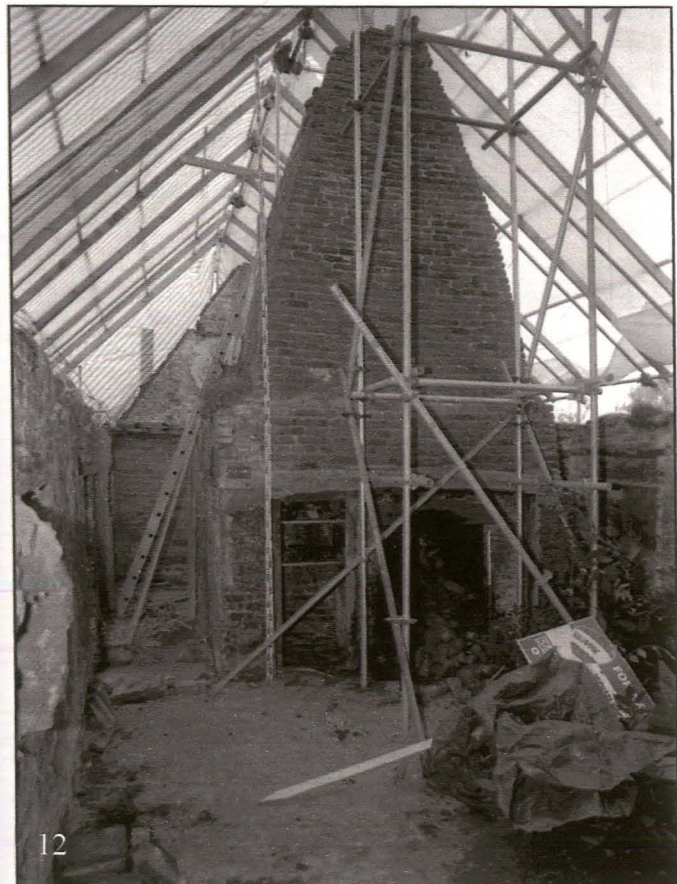
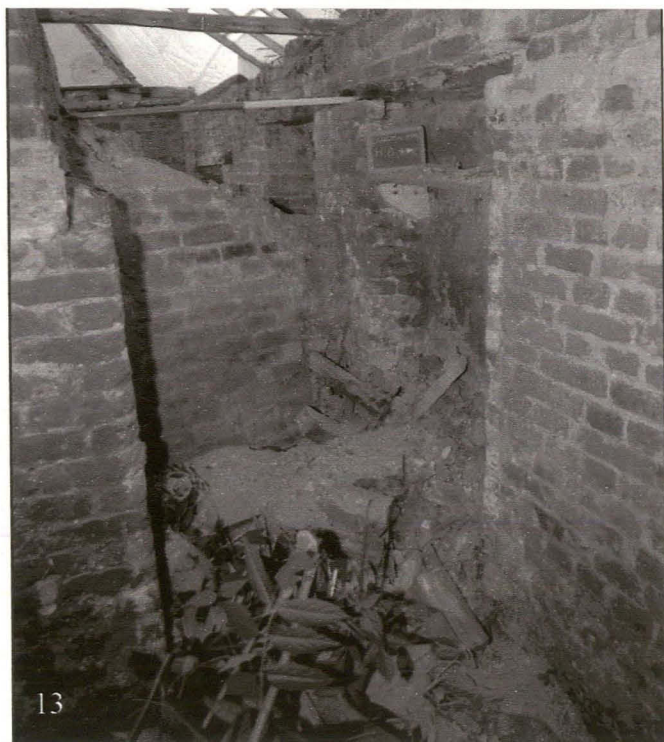
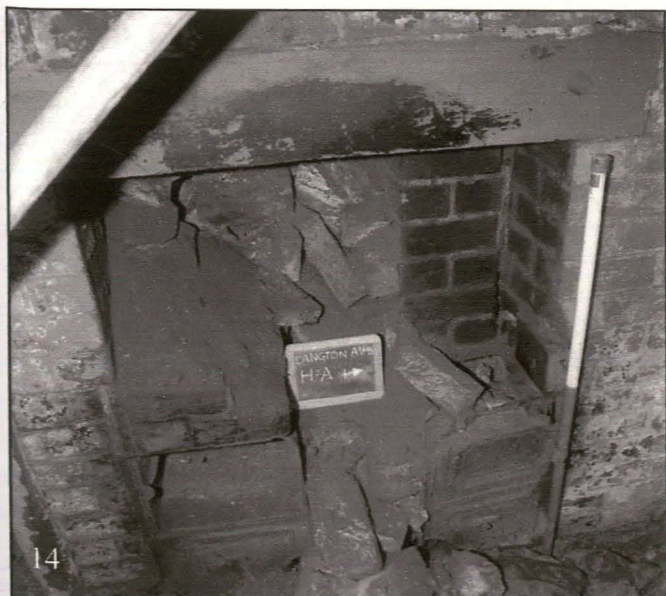
Plates 12-14: Detail of the central chimney, oven and fireplace of Unit A.

The original fireplace was an open inglenook with a reverse ogee-stopped chamfered beam. To the north, is a beehive oven, but there is no obvious access to the oven from Unit A.

During Phase II alterations, the inglenook was reduced by the use of brick and a stone lintel to house a cast iron range and cupboard to the south. The range has been badly damaged, has several missing components and is beyond economic repair

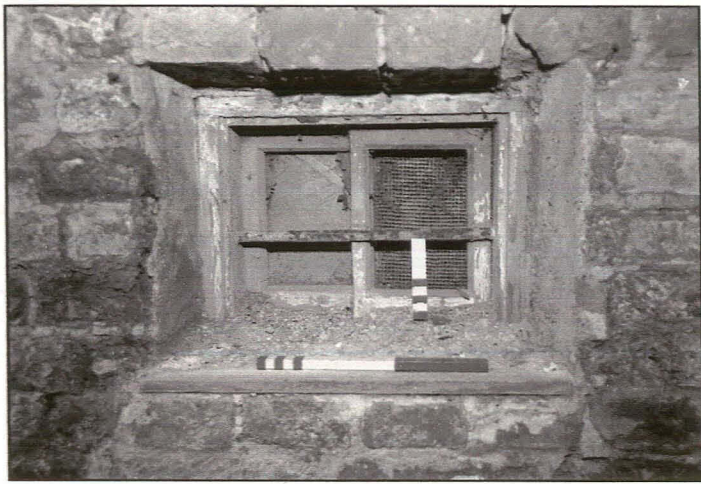
Plate 15: This shows a small Yorkshire sliding-sash window inserted into the north elevation and servicing Phase II pantry or scullery of Unit A.

The horizontal scale, at 25cm, indicates its diminutive size.

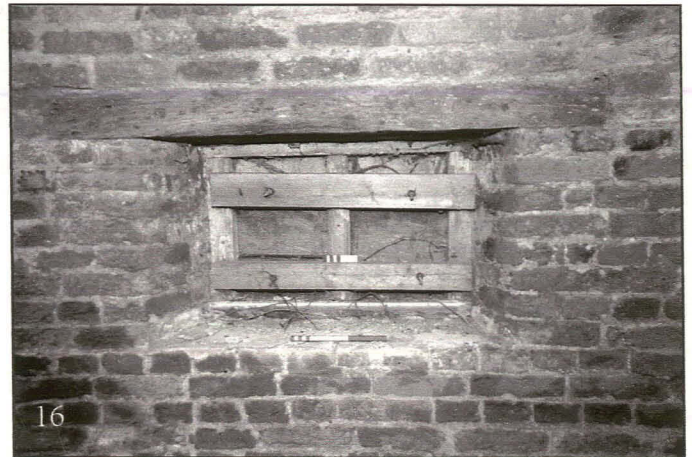
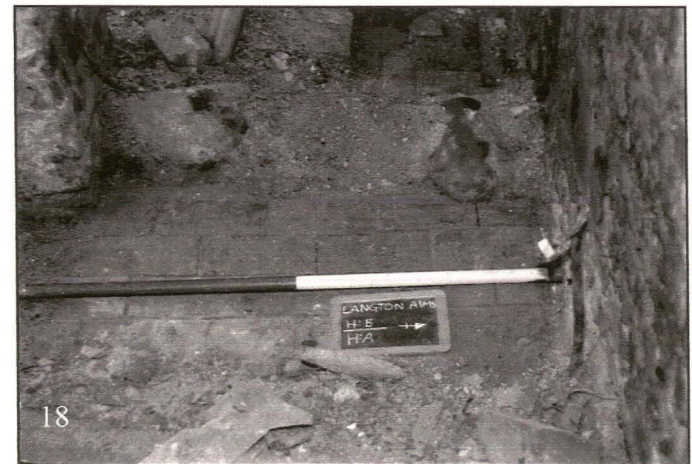
Plates 17 & 18: These plates record the remains of a mud and stud wall partitioning the two units. It ran between the central stack and pier of the two front entrances.

There are no surviving associated timbers, but the studwork can be inferred from a surviving transom on the north side of the chimney and socket in the South Elevation.

It appears to have had a foundation of large rounded waterborne cobbles and was butted by the existing floor coverings in each unit.

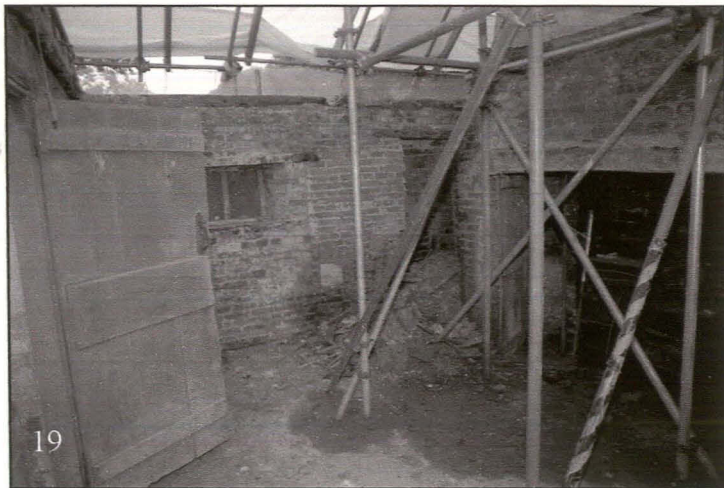
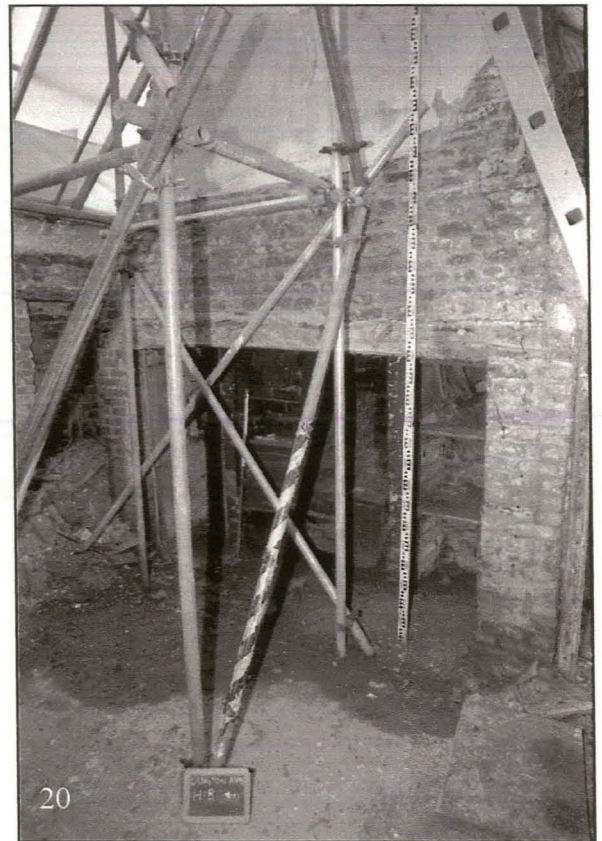
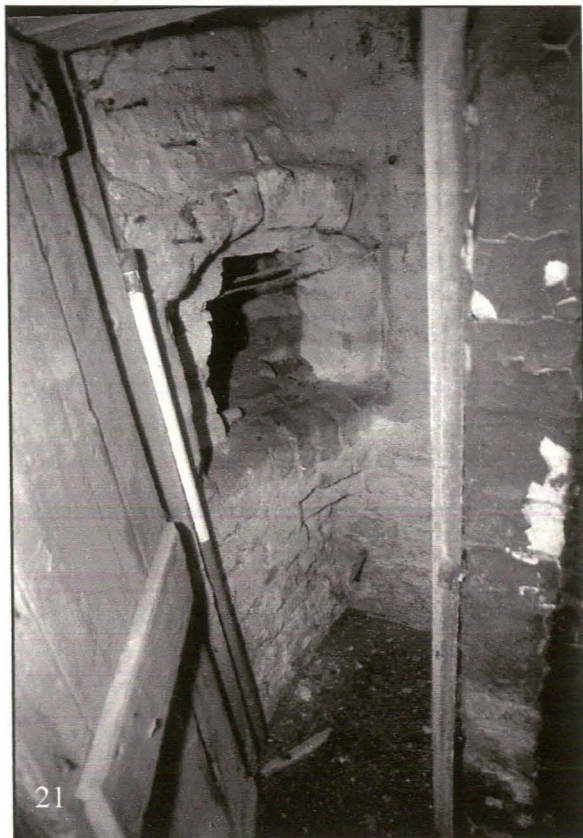
Plates 19-21: Interior of Unit B:

Plate 19 is a general view looking towards the north. The window in the background is primary and retains its original window frame, details as per Plates 16 & 22-23.

Plate 20 shows the reduced inglenook with cast iron range. Again, the fireplace beam is chamfered with reverse-ogee stops.

Plate 21 shows the beehive oven mouth accessed via a cupboard to the north of the range. It has a simple skew arch in headers and a sill of soldier course.

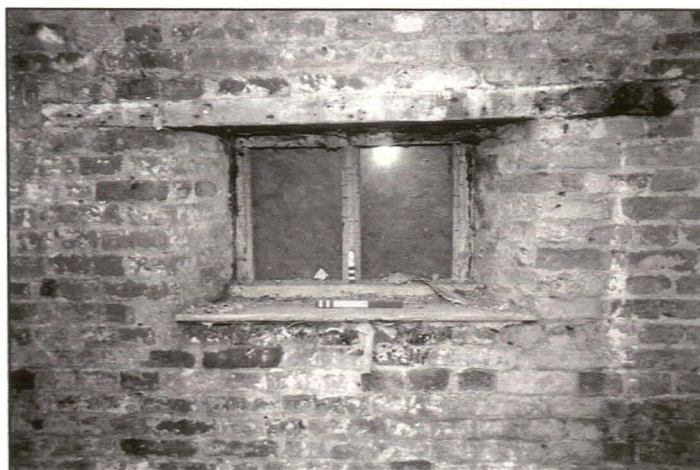
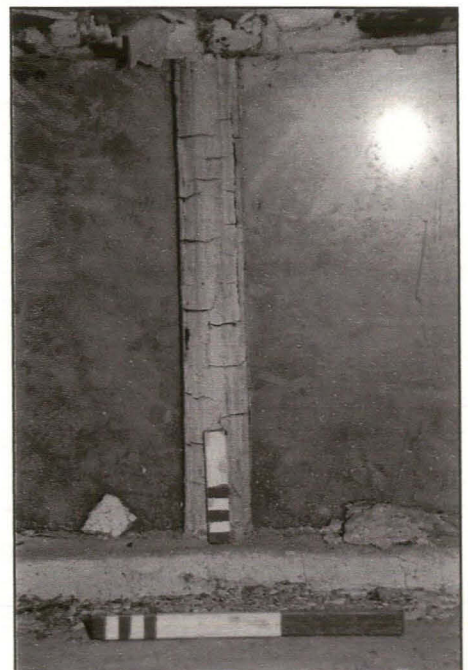
Plates 22 & 23: Original Phase I window and detail of mullion from the North Elevation of Unit B. Unlike the corresponding example in Unit A, this has been re-glazed, the oak lintel above the window is clearly evident.

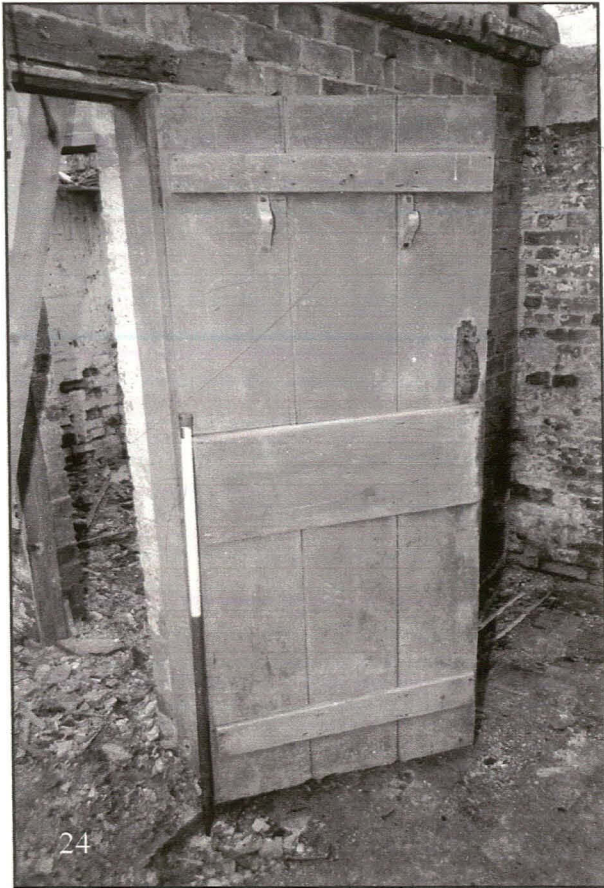
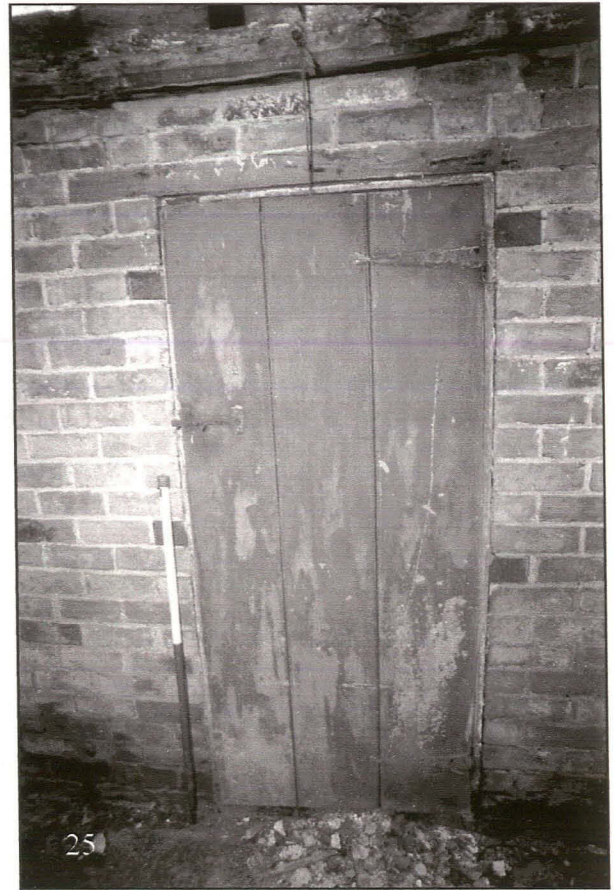
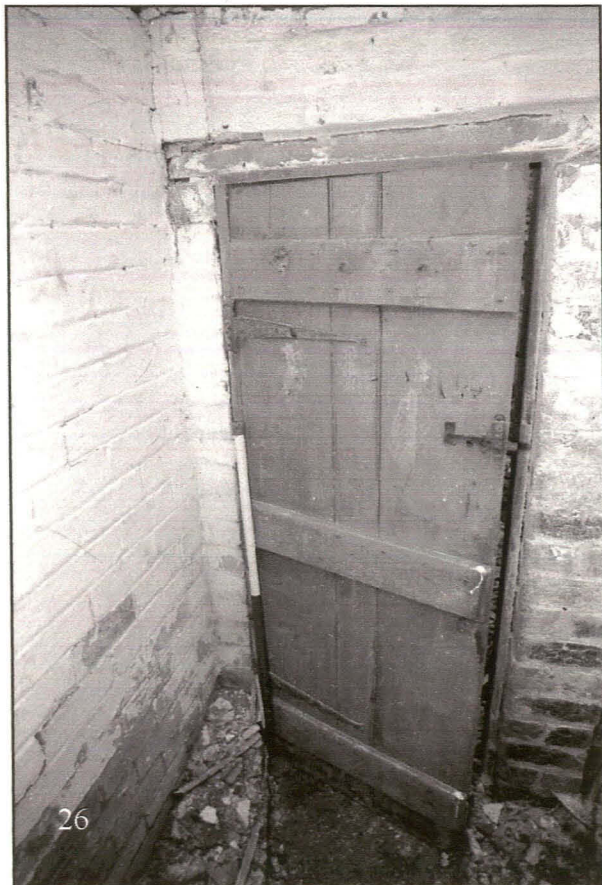
Plates 24 -26: Unit B retains more features than Unit A in the form of Phase II joinery as seen in these plates, recording two simple ledged plant doors with thumb latches. The planks are beaded on both doors and the are fixed by simple wrought T hinges.

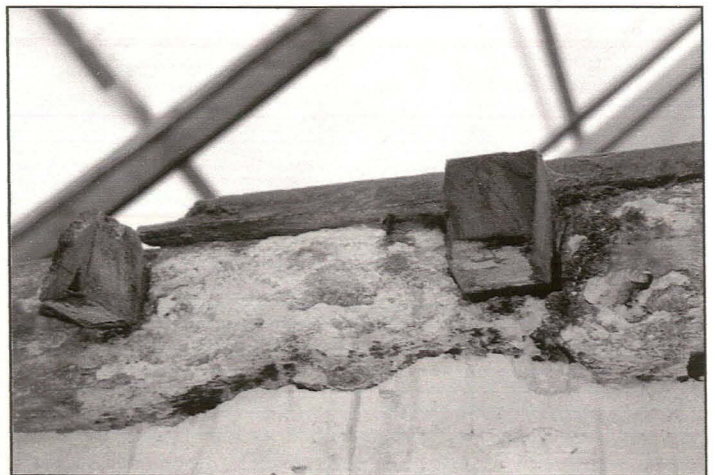
Plate 27: Unit B, this plate shows relict floor joists in oak still *in situ*. They are quartered and fit into sockets cut into the surviving tiebeam. The tiebeam is also in oak, boxed, and is finished with an ogee-stopped chamfer as per the fireplace beams.

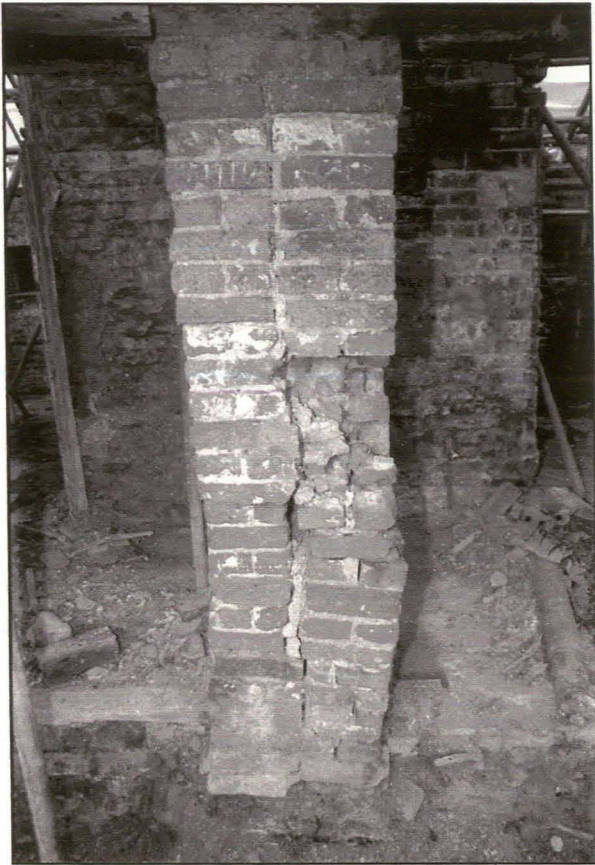
Plate 28: In contrast to the general quality of brickwork, which is generally fair to good, the central rusticated pier between the two front doors of the South Elevation is poor.

There is little cross-bed strength and this has partially contributed to its failure.

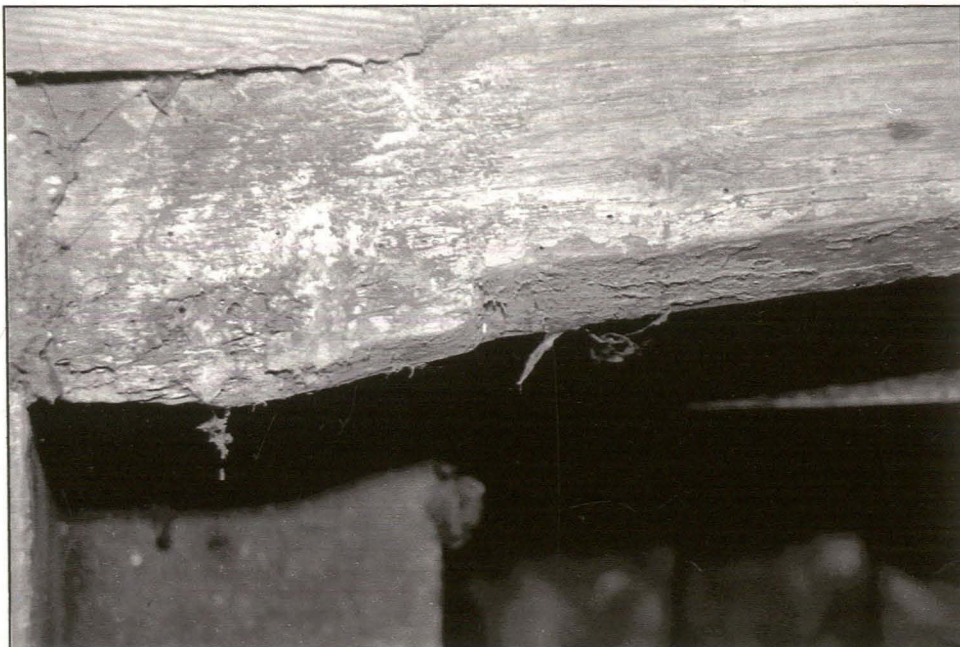
Plate 29: Detail of reverse ogee or cyma reversa, in this case from the east side, south end, of the surviving tiebeam.

This feature is a defining characteristic of Phase I detailing and is also present on both fireplace beams
