## THE OLD COTTAGE SOUTH ROAD NORTH SOMERCOTES

Site Code: NSC 94

### Archaeological Survey

# THE OLD COTTAGE SOUTH ROAD NORTH SOMERCOTES

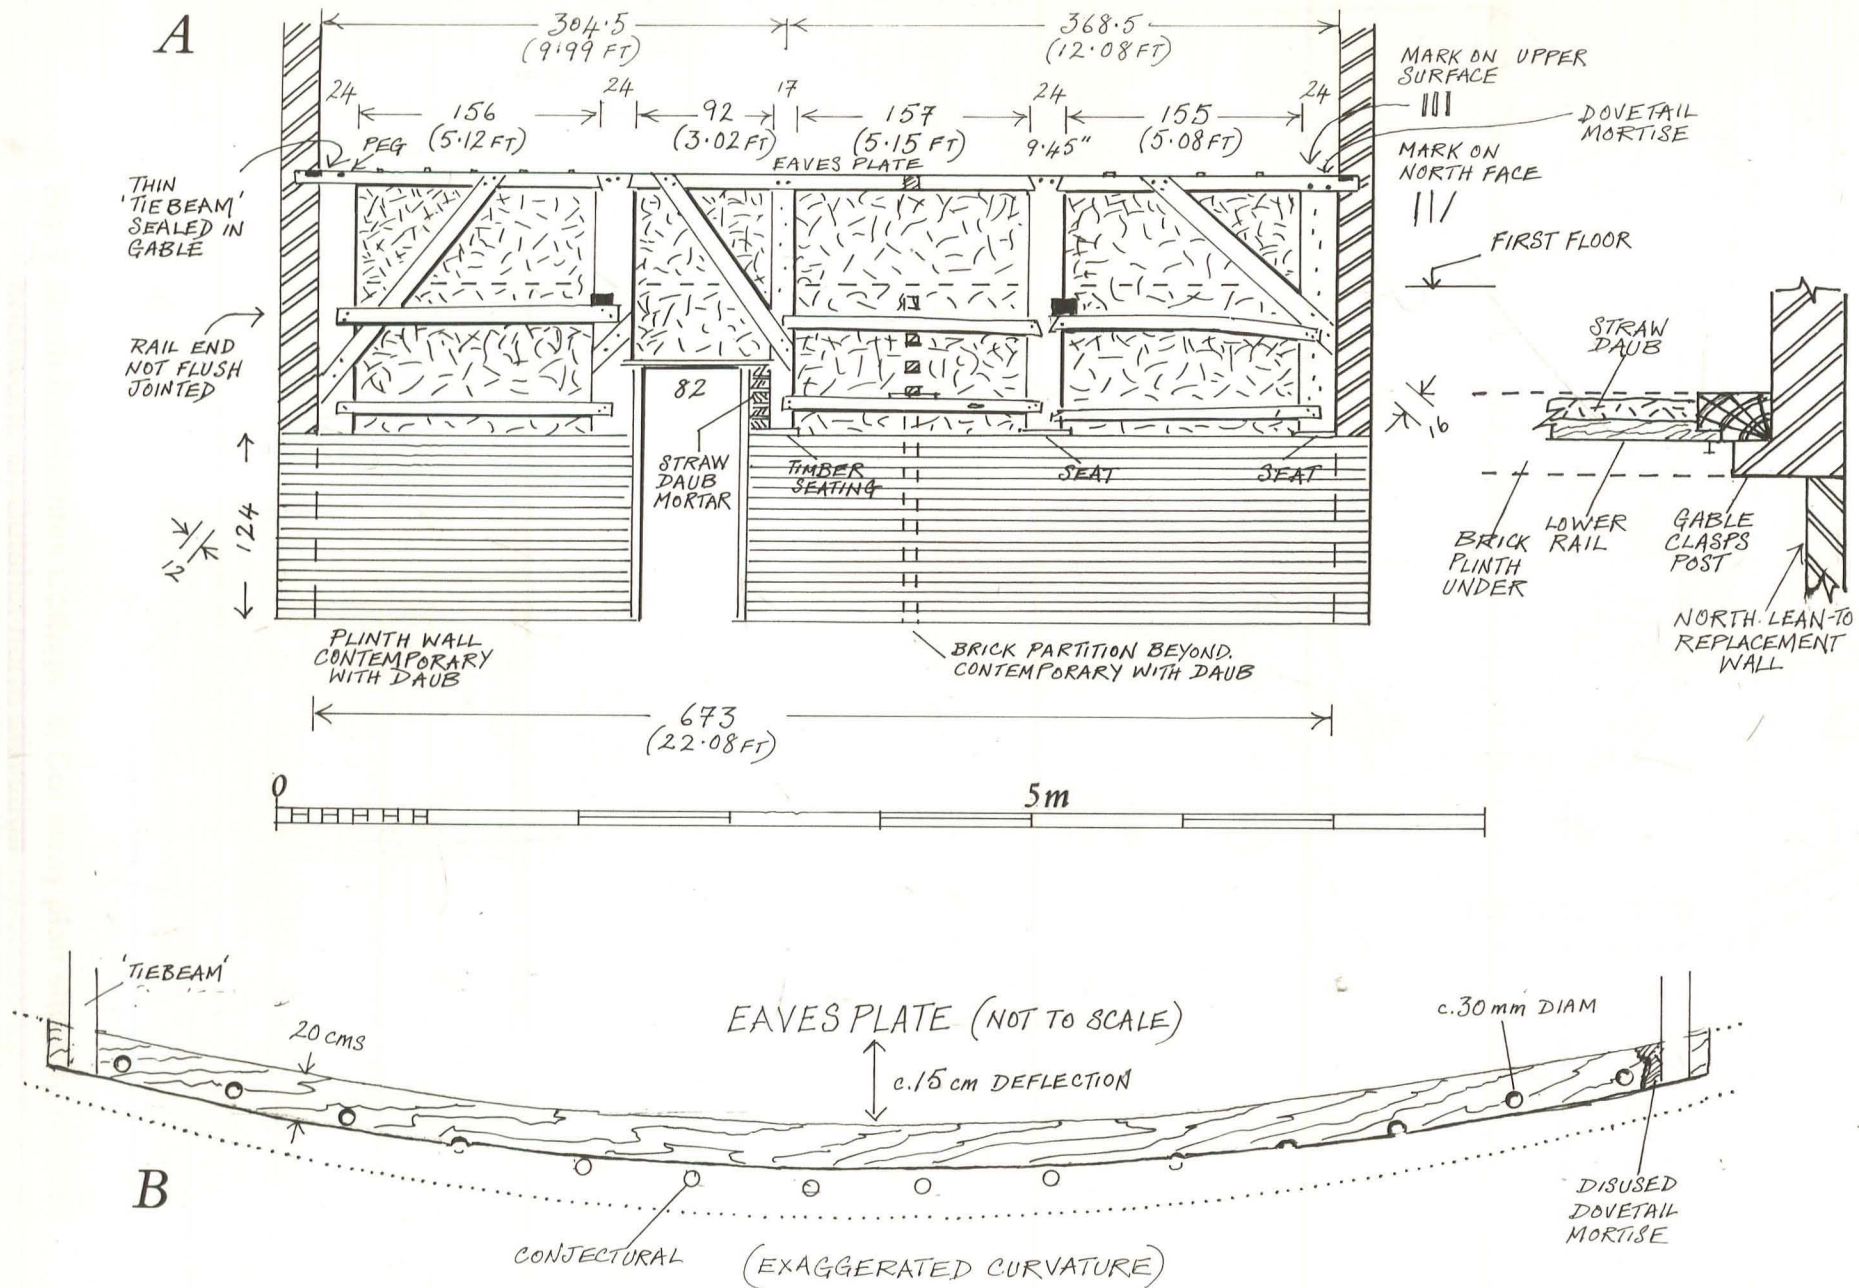
**Fig. 6 North Somercotes Cottage. a) Main north elevation  
b) Detail of eaves plate**

The braces in the main north wall were all straight and lapped into the north face of posts and eaves-plate (Fig. 6). There was no evidence for pegging or previous use. The only indication of braces rising from the lower part of the posts was to the east of the door-head, where a brace had been sawn off flush to the post, leaving behind the upper end, still lapped and nailed to the post (Pl. 31, 32). No trenching or stains could be seen on the eaves-plate or adjacent post to suggest it could have been an upward brace, which would, in any case, have crossed the brace which rose from the adjacent post. This, apart from thin timber packing pieces underneath some of the posts, is the only evidence for the frame having been underpinned, or at least trimmed and raised.

Fig. 6 illustrates the form of the main north eaves-plate. The pegs and peg-holes surviving were 25-30mm diameter, piercing the full height of the timber. No pronounced taper was evident and the peg upper projection was a few millimetres at most. Though the northward curvature of the plate was quite marked, the run-out of the pegs showed that it had been considerably more so originally; the original width may have been 300mm. It is suggested that this may have been a component of a vessel.

Fig. 6 shows the extent of surviving infill, except for small fragments adhering to joints on the outshot frame. Dense straw-daub was applied to roughly-hewn staves of varying thickness closely spaced and nailed to the main frame members (e.g. Pl. 37). The opposite side of the frame was devoid of staves or daub, i.e. the cavity was exposed, with only series of nails or nail-holes remaining to show that the north wall-skin had been removed. Below the level of the outshot ceiling the daub surface and timber frame had been white-washed over a long period. Above the outshot ceiling (in the roof-void) the daub and frame retained their natural surfaces (Pl. 31). The partition (part repaired, and with blocked door and underpinning) between the coal-house and larder also retained staves and daub, but the latter was of a different colour and mix, although a similar proportion of chopped straw was evident (Pl. 20). It is almost certain that the difference here is only a minor one of construction priorities.

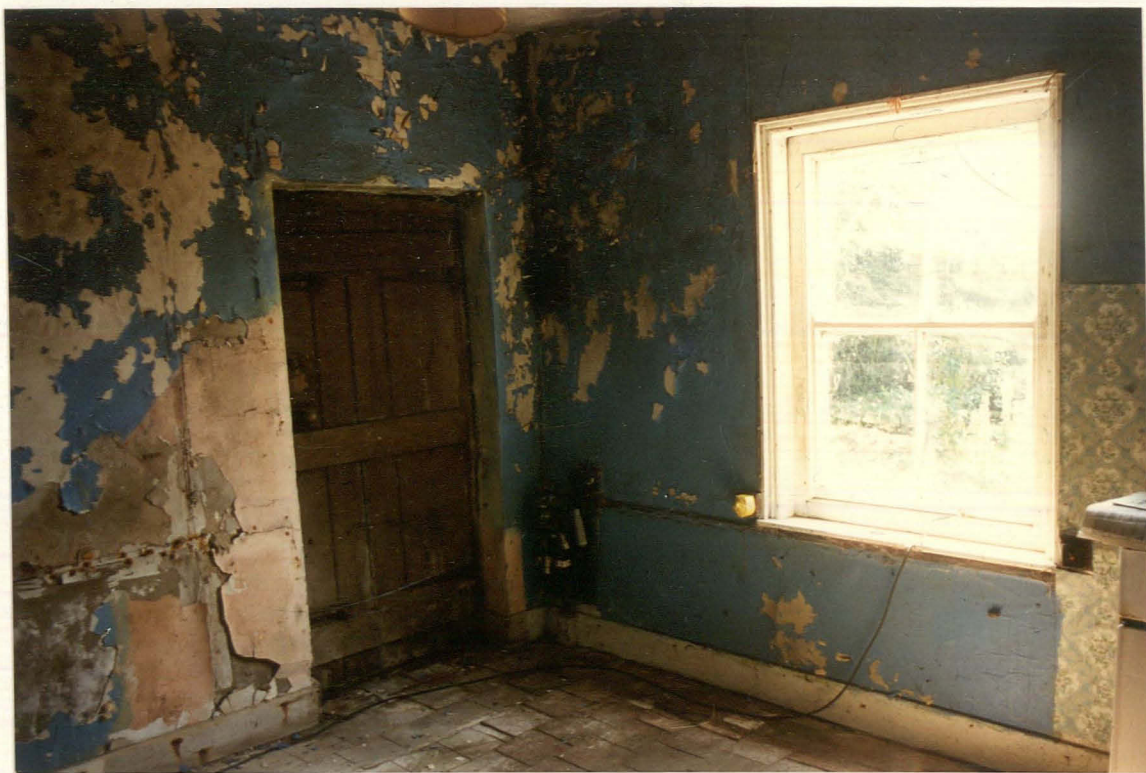
The east dividing wall was mud and stud with laths. It had been faced with brick on the coal house side, probably to prevent coal dust from contaminating food in the adjacent dairy/larder (Pl. 20).

Pl. 20. Coal house (east wall), from west.

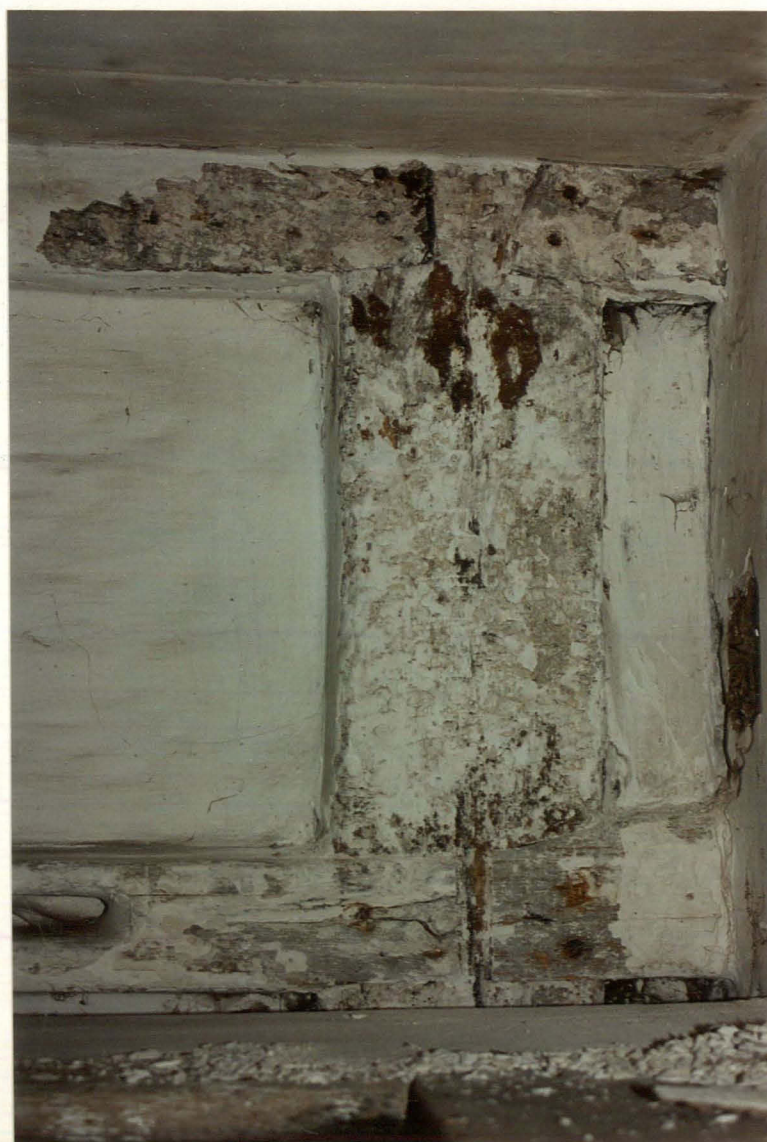
The NW (plain-tenoned?) post (Pl.36) was double-fixed near the eaves-plate soffit edge, again with large-headed nails, much eroded, but part of the peg was visible at the internal face (Pl. 54). The mark on the plate face was read as '3', being three carelessly-carved strokes.

Pl. 36. West gable clasp and north-west corner post (plinth below), from north.

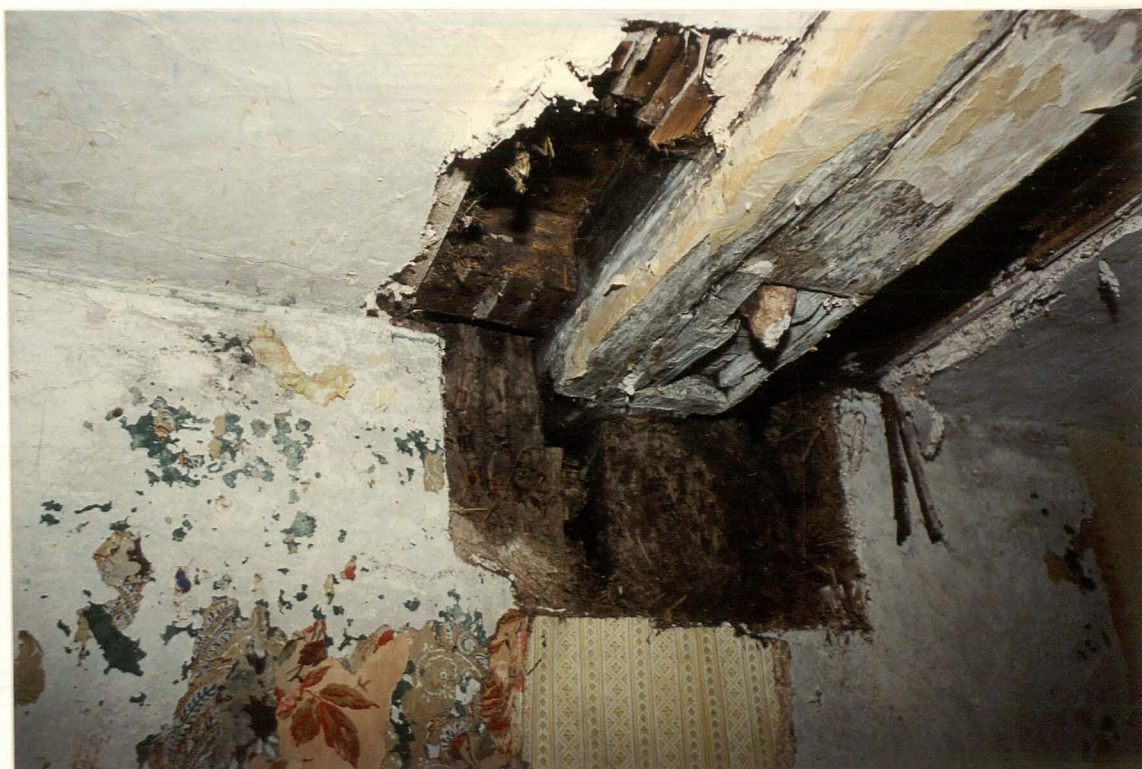
- the south lap-dovetail joint falls short of the present south wall (although the latter may have been built south of an earlier wall-line) and is disused, having simply been ledged on the present window lintel (Pl. 45,46).

Pl. 45. West binder, south dovetail cut for ledging (parlour).
