**St Mary Magdalene Church, Fleet
Detached Bell Tower
TF389 238**

Archaeological Building Survey

**LAS Report No. 373
November 1999**

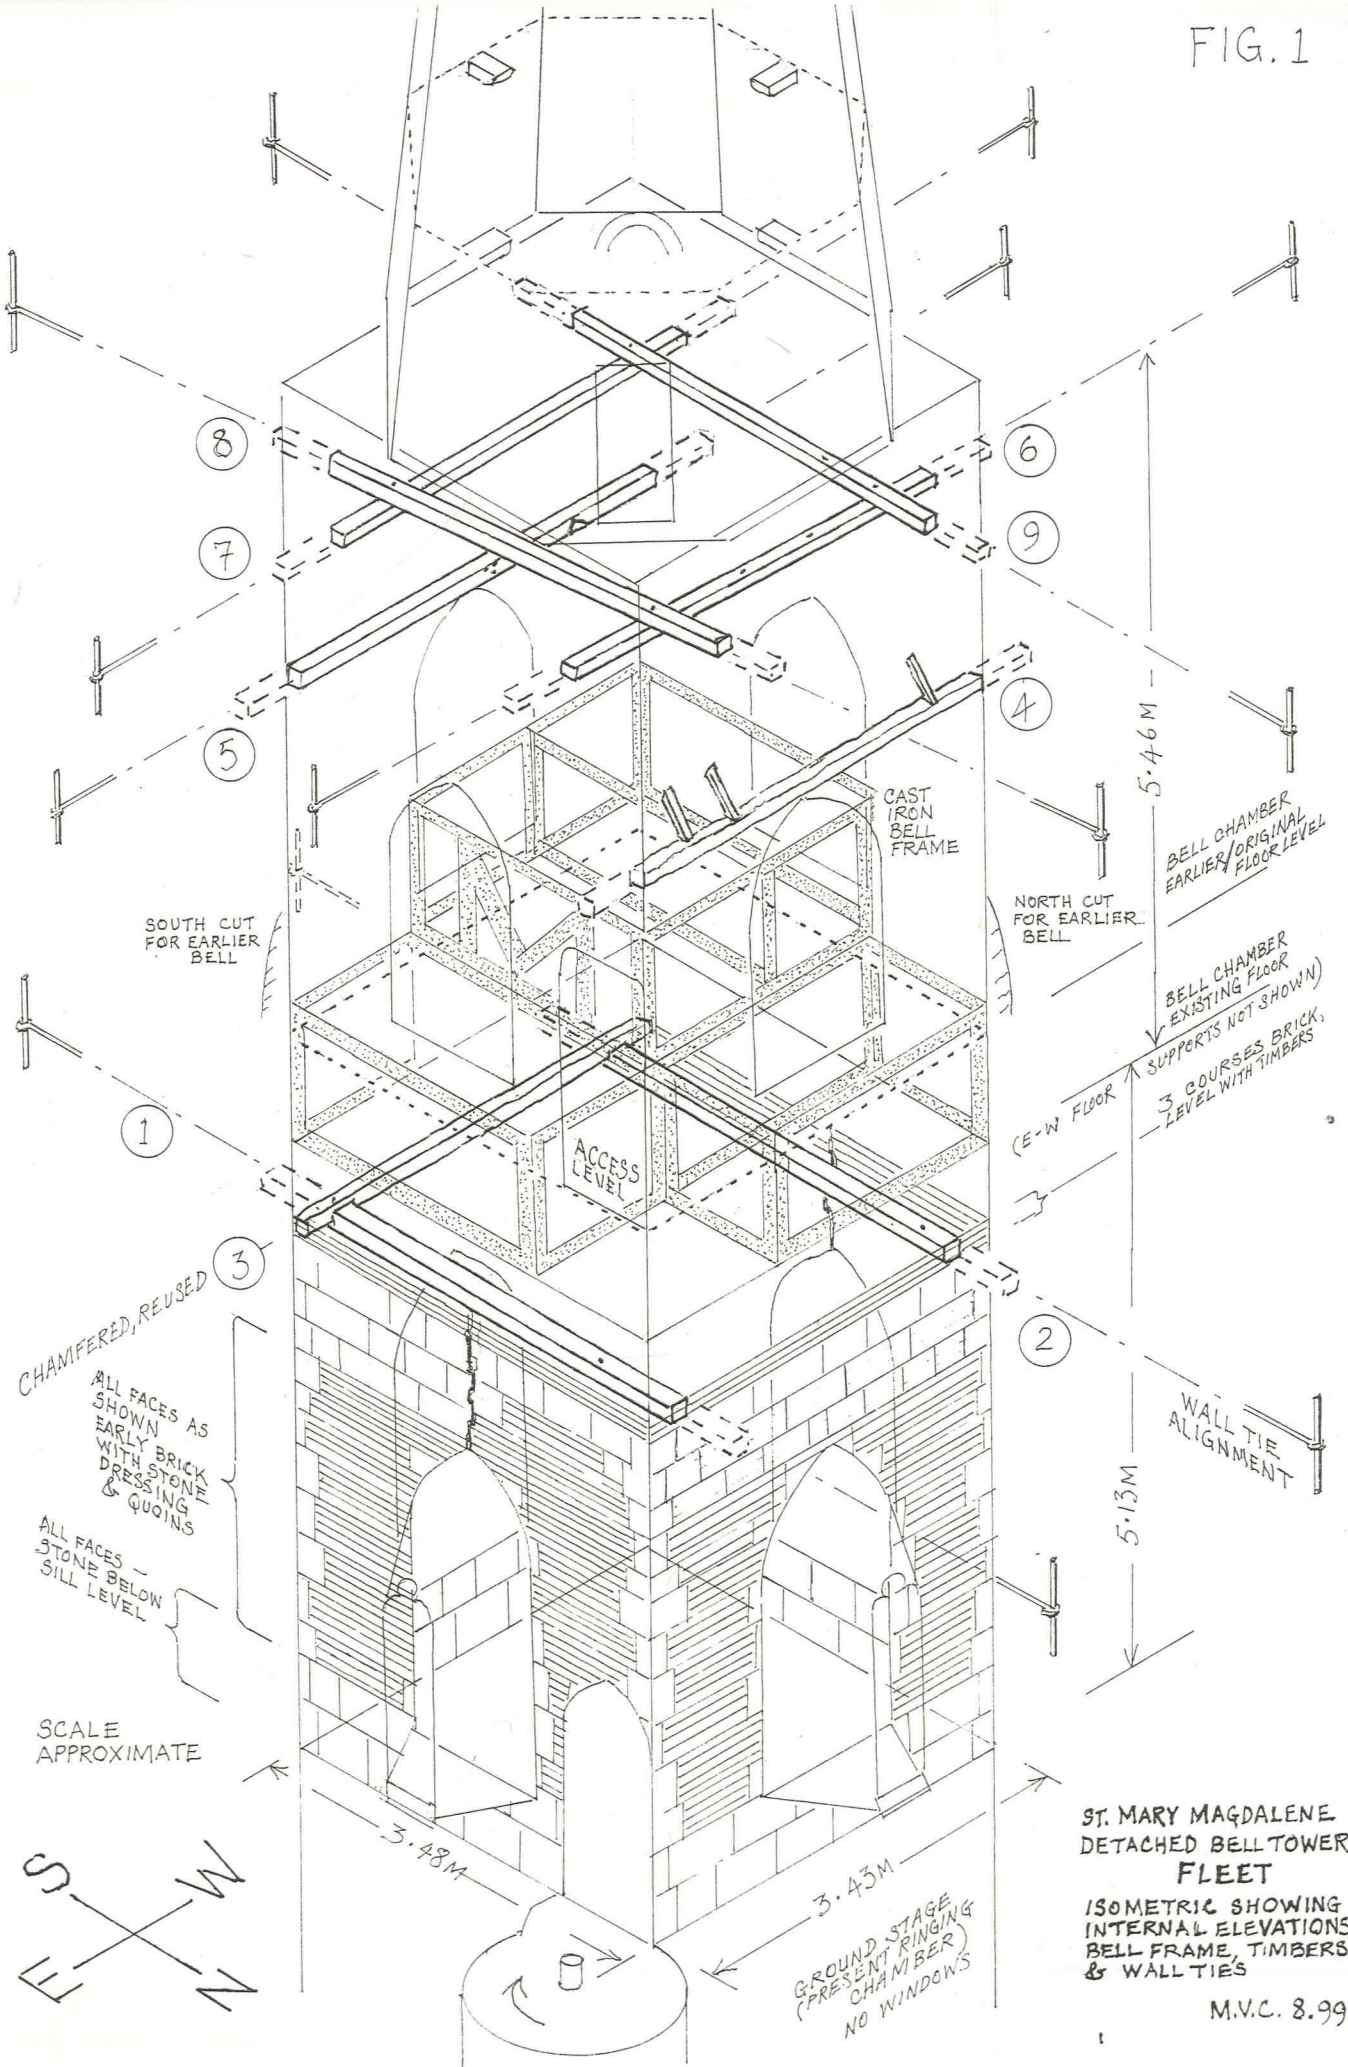
FIG. 1

The six bell cast-iron frame totally replaced any previous frame of timber and was installed a few feet lower, as evidenced by the height of the bell-chamber access threshold (Figs 1 and 4). At least two vertical radial scoops in the walls indicate earlier bell positions (Fig. 1) although the low height suggests they represent a secondary phase rather than the original. Investigations of previous wall-secured timber positions was prevented by the existing frame which occupies about four fifths of the floor area. The date of the lowered floor to which the existing frame is bolted is not known although it is certainly of no great age and could be 19th century. Frame and floor may be contemporary.

Fig. 3 shows the approximate location of external wall ties, based on proximity to windows and buttresses. Fig. 1 shows the obviously close correlation of seven of the timbers, including 1 and 2 to these ties. For this reason ties have been allotted numbers that correspond to approximate timbers (e.g. timber 5 has tie 5-east at one end and ties 5-west at the other). There are no ties which correspond to timbers 4 and 3 (the only one not set into the walls).

The decay in 6 may have been directly due to ingress of water from the damaged spire (restored 1994-5) since timber 4, immediately below, was apparently still in use as an internal angled gutter trough in the 1970s (from information by Rev. Edwards). Note the short angled timbers to 4 (Fig. 1), it is assumed that these are all that remains of an added gutter board.

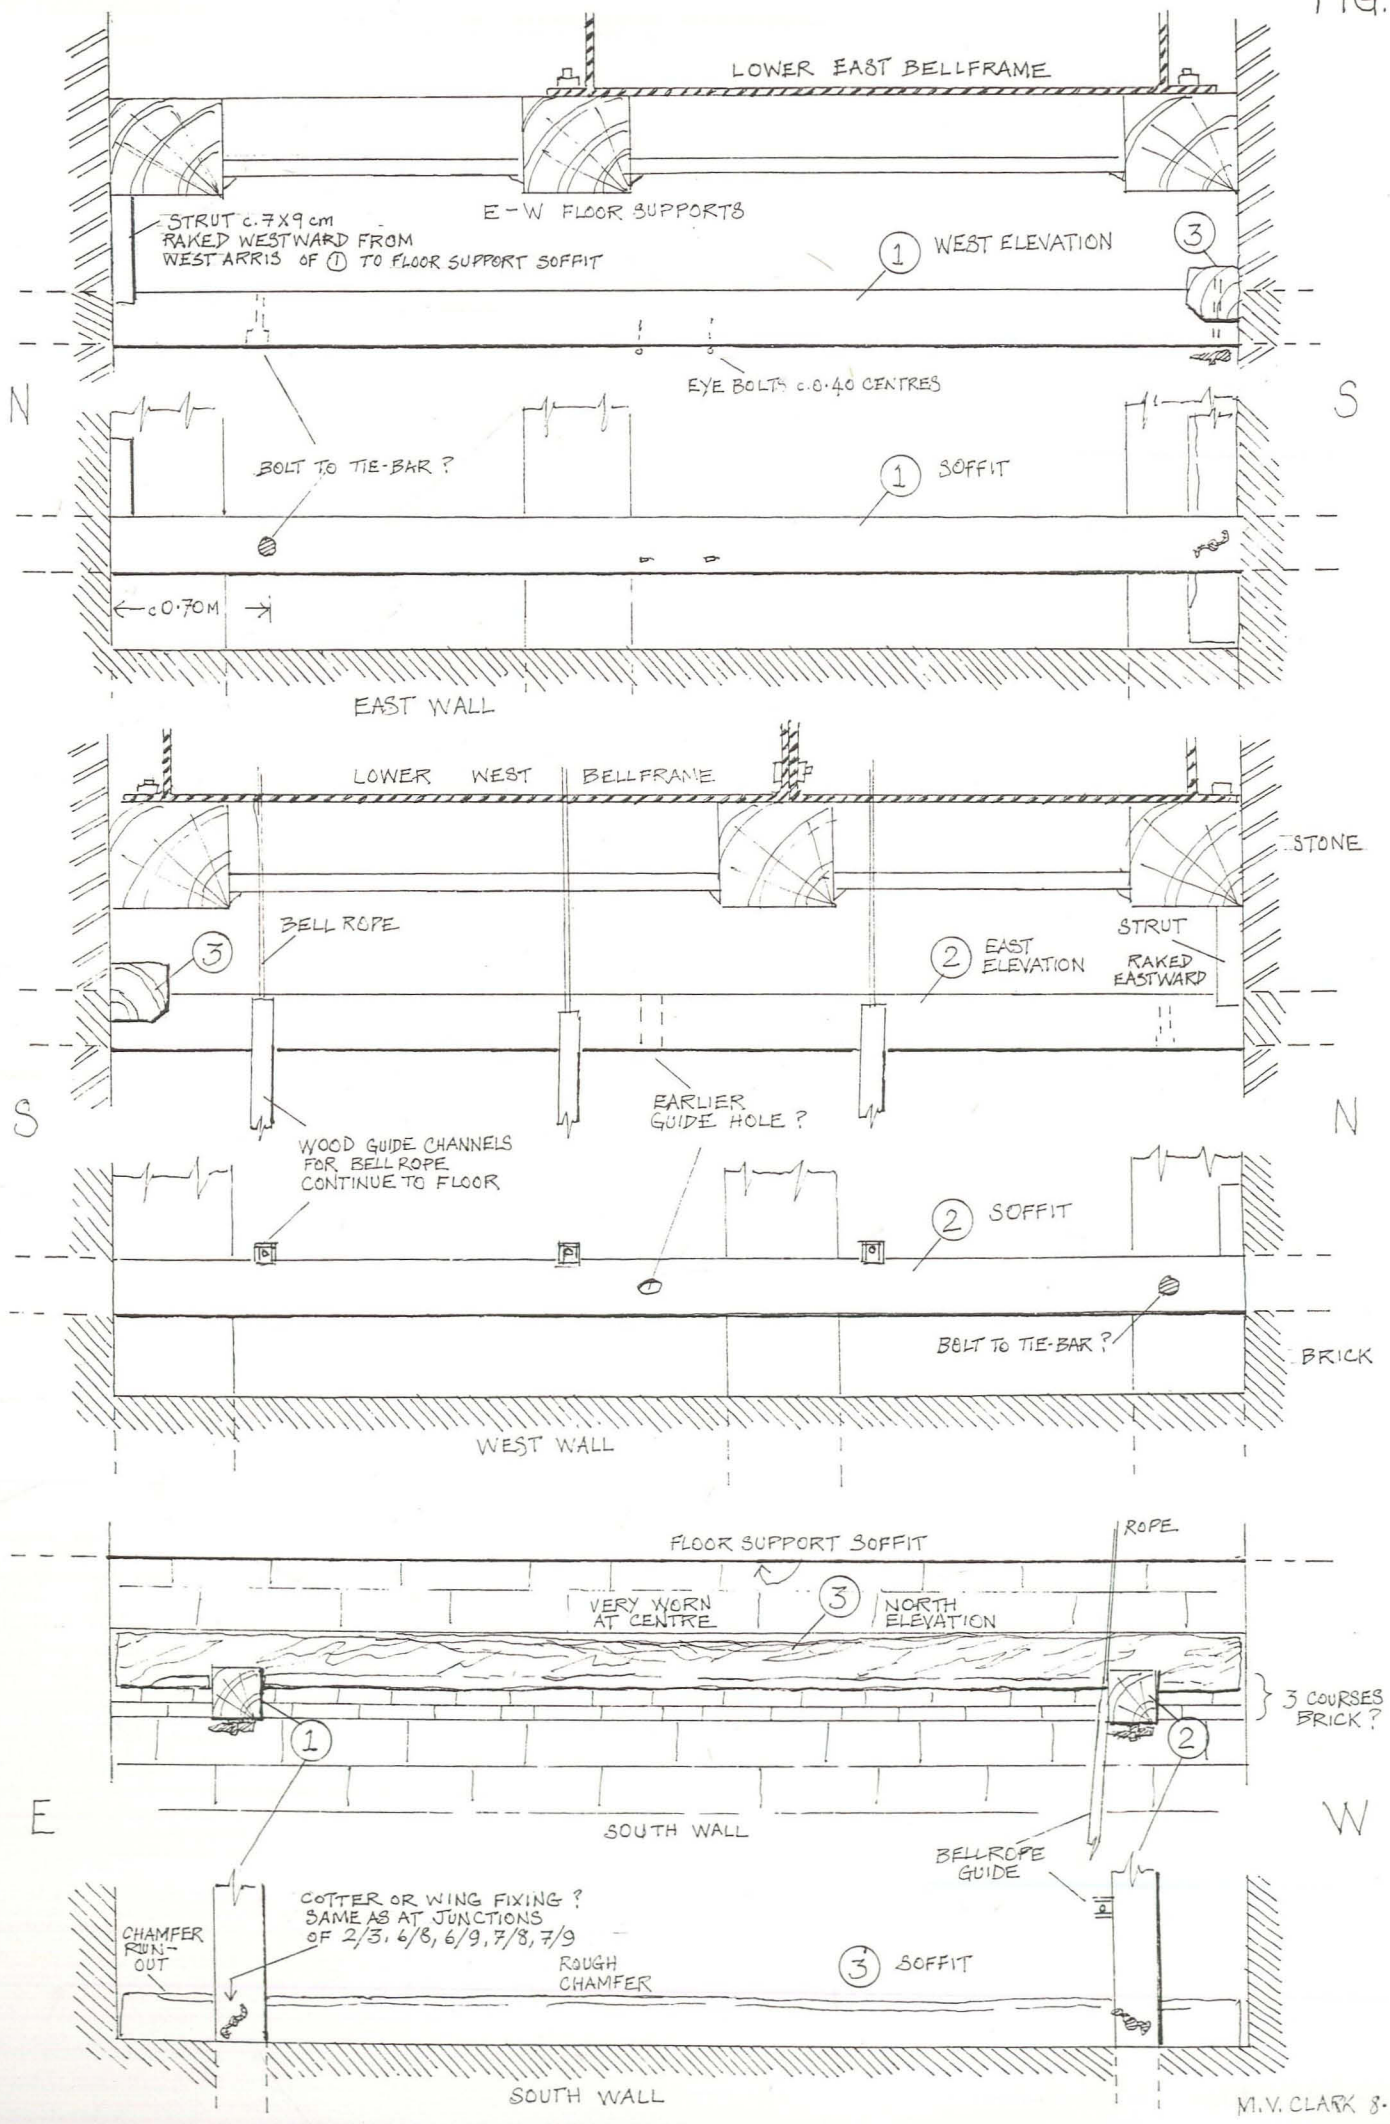
FIG. 2

These exhibit no signs of previous use other than an irregular vertical hole near the centre of 2 which appears to be a guide hole for an earlier bell rope. Existing ropes do not pass through the timbers, but are enclosed in raked timber box-channels which are let into 2 and fixed to the chamber floor. Two eye bolts in the soffit of 1 are believed to be for a stay or bracket for the clock drive (mechanism removed prior to survey). Neither 1 nor 2 have any appearance of antiquity or wear, or are located at any original floor level (but see "brick courses" below). These are the timbers which will be removed.

This is flush to the south wall and the only timber seen which does not have its ends set into the walls. Details of fitting are not known, but it appears to be trenched (as opposed to halved) over the uncut upper south surfaces of 1 and 2. The trenching abruptly cuts an inner soffit chamfer associated with previous use. Compared to the relatively straight, clean and unworn surfaces of timbers 1 and 2, timber 3 is slightly irregular, sagging, and worn, most noticeably over the centre upper and inner surfaces for a length of approximately 1m. Its present structural function appears to be to assist in locking 1 and 2 in the wall-fast positions, i.e. maintaining the distance between them as do the struts at the north ends.

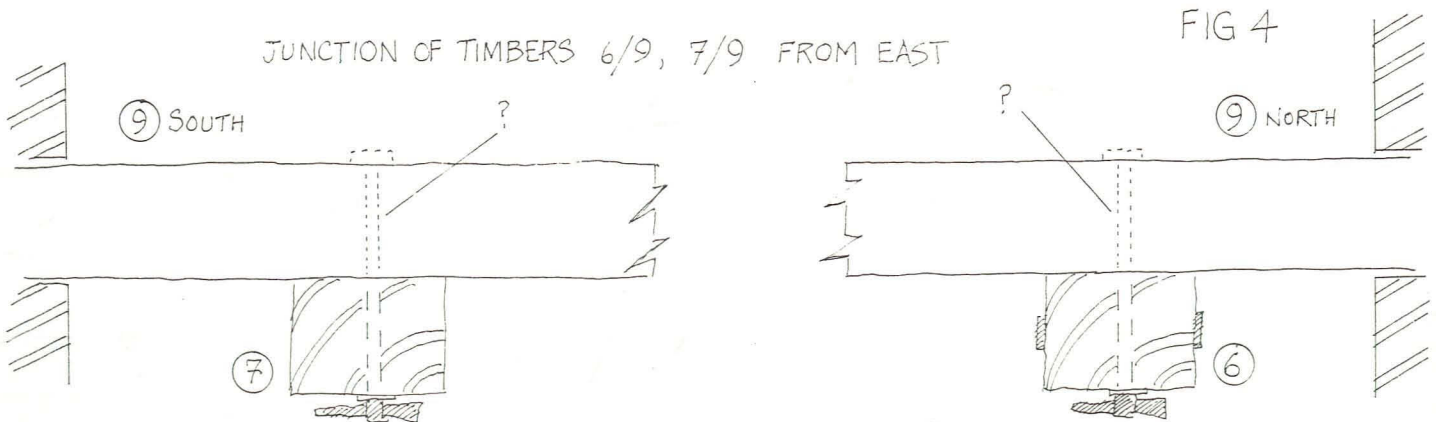
FIG 4

All timber connections are by bolts, i.e 1/3; 2/3; 6/8; 6/9 7/8; 7/9. Bolted timbers correlate to external wall ties. Timber 5 has wall ties but no visible bolts. All bolt fittings are of the same type, implying they are contemporary. Recessed bolt heads in the timber soffits may be fixtures for tie bars not visible from below.

JUNCTION OF TIMBERS 6/9, 7/9 FROM EAST
