LEVEL 1 BUILDING SURVEY REPORT
WELLWOOD FARM, DIGBY FEN, LINCOLNSHIRE

Planning Reference: N/22/1515/03
NGR: TF 1250 5452
AAA Site Code: DIWF 08
LCCM Accession Number: 2008.128
Oasis reference: Allenarc1_46329

Allen Archaeological Associates
Report Number 2008/045

July 2008

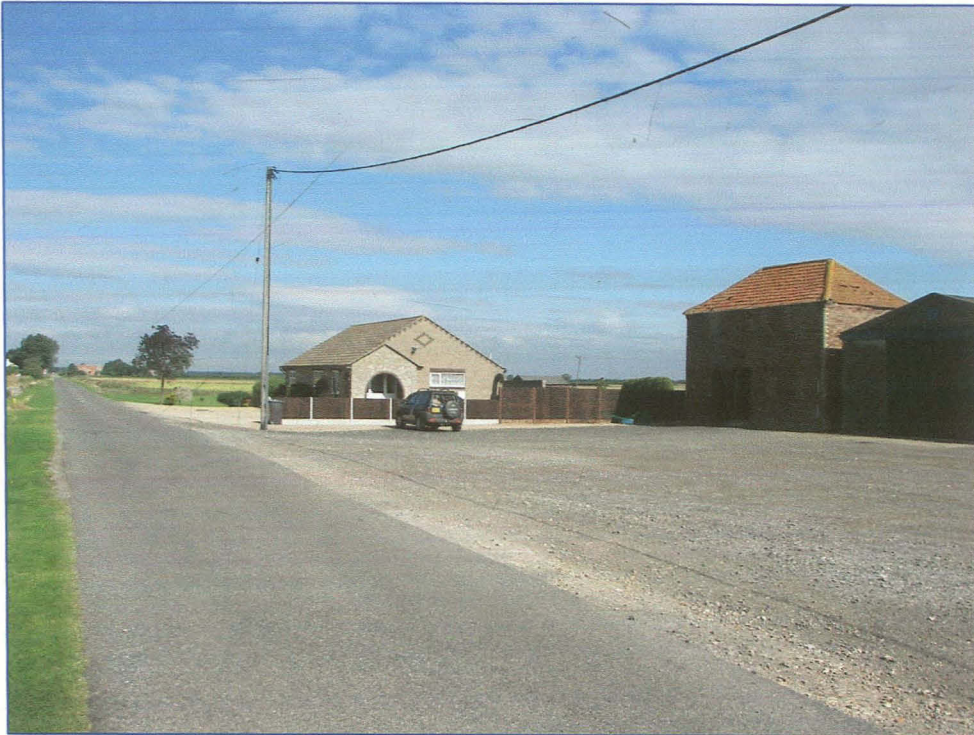
Plate 1 (Shot 2):
The setting of the barn, viewed looking north-west along the adjacent lane.

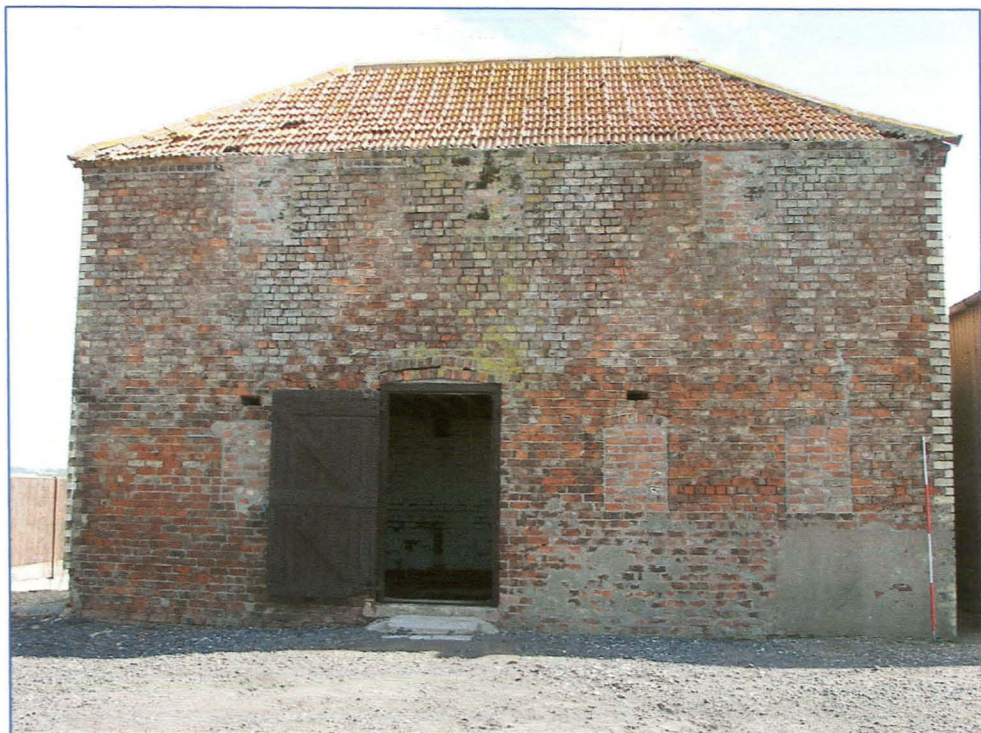
5.1.1 The south-west facing elevation has three blocked windows on the ground floor, arranged two to the left and one to the right of the main doorway. Each window aperture is headed by a rough segmental arch of brick headers. The doorway is topped by a double brick arch in the same style over a plain plank door in a timber frame that rests on a stone sill (Plates 2 and 3).

5.1.2 The first floor has three small blocked in windows at the eaves (Plate 2). The absence of brick arches over the window heads (as on the ground floor) indicates the lowering of the roof line at some point in the building's development.

Plate 2 (Shot 5): The south-west facing elevation showing the blocked in windows on the ground and first floors. Looking north-east.

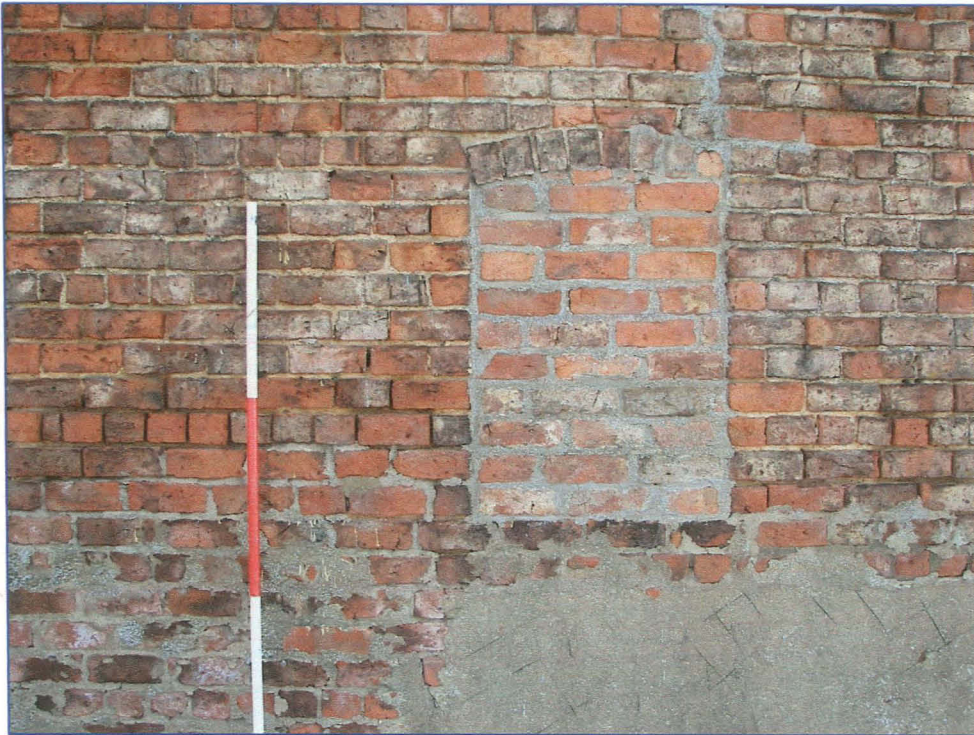
Plate 3 (Shot 6): Detail shot of a blocked in window on the ground floor of the south-west facing elevation, looking north-east.

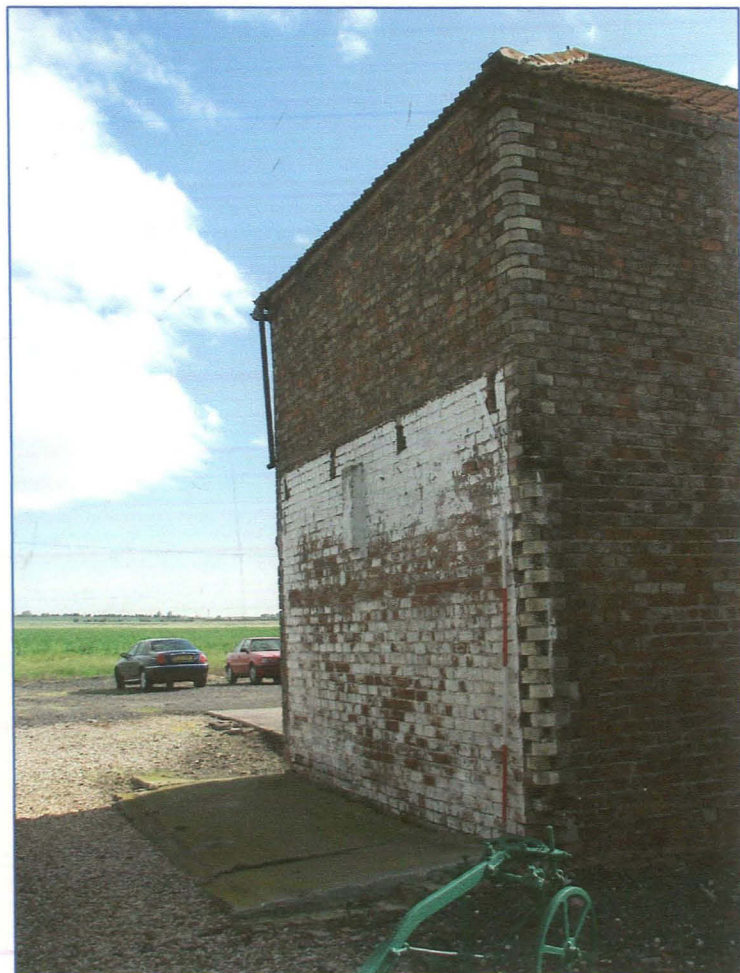
5.1.3 The north-west facing elevation (Plate 4) is of plain brick walling with holes at first floor joist level from the removal of roof timbers and projecting brickwork associated with the demolition of an adjoining single storey lean-to building. The concrete base from this building is still in situ, which is also evidenced by the remnants of whitewashing on the extant wall.

Plate 4 (Shot 9): The north-west facing elevation, looking north, showing the scarring from the recently demolished outbuilding and the surviving concrete floor.

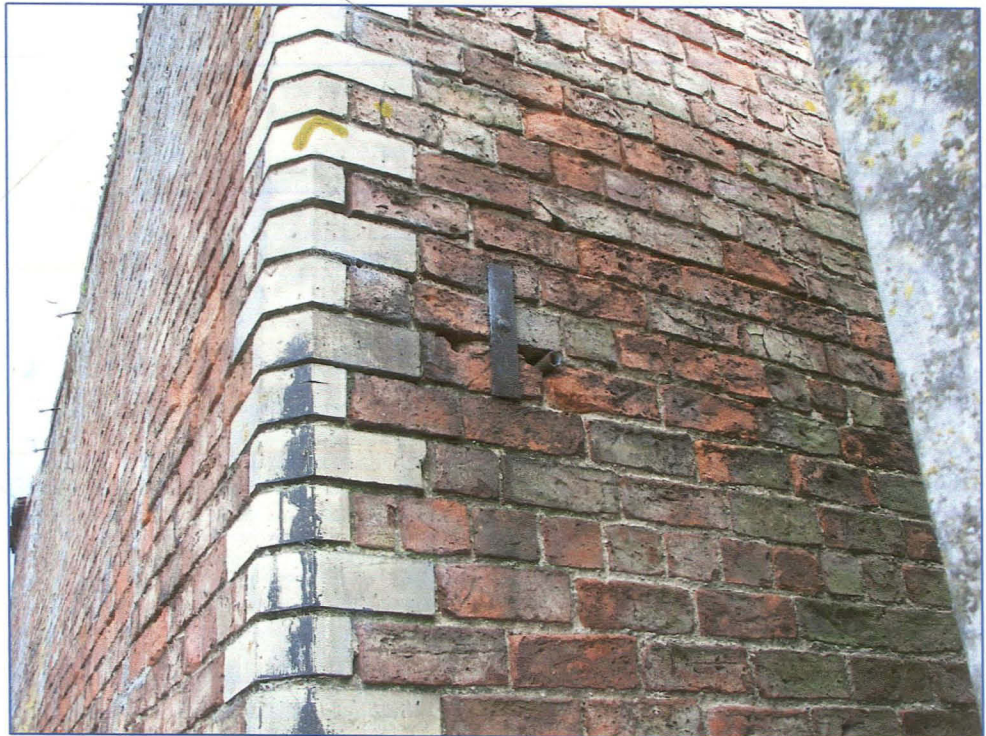
- 5.1.7 The south-east facing elevation is of plain brick walling with a single small blocked window on the first floor. There is a pair of plain strap iron tie plates at joist level at each corner with opposing tie plates located on the north-west elevation (Plate 5). This elevation could not be photographed due to the proximity of an adjacent building.

Plate 5 (Shot 24): Shot taken looking north-east of the south-west corner of the barn showing the polychrome detailing using single cant bricks in a gault fabric at the corners of the barn. To the right is a simple tie plate.

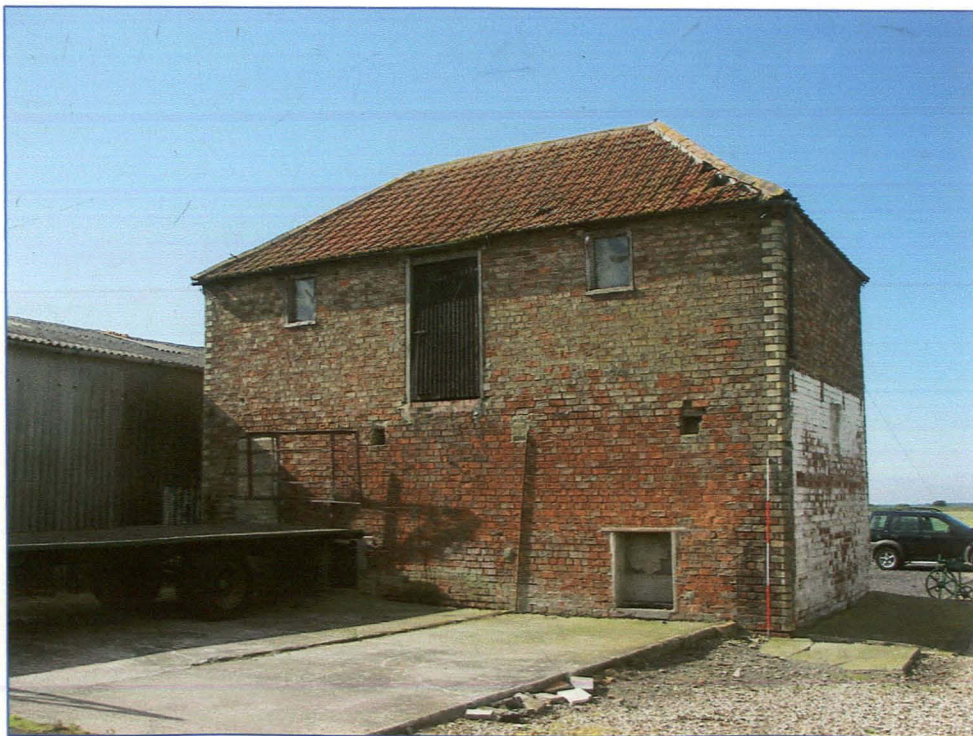
5.1.4 The north-east facing elevation (Plate 6) has three openings on the ground floor. Two small doorways set low in the wall (one partially obscured from view by a farm trailer) were associated with the buildings former use as pig sties. A blocked in single doorway at the left side of the façade (Plate 7) is topped by a single segmental arch of brick headers.

Plate 6 (Shot 11): The north-east facing elevation viewed looking south. Note the concrete apron for the pig sties formerly accessed through the small openings in the barn wall.

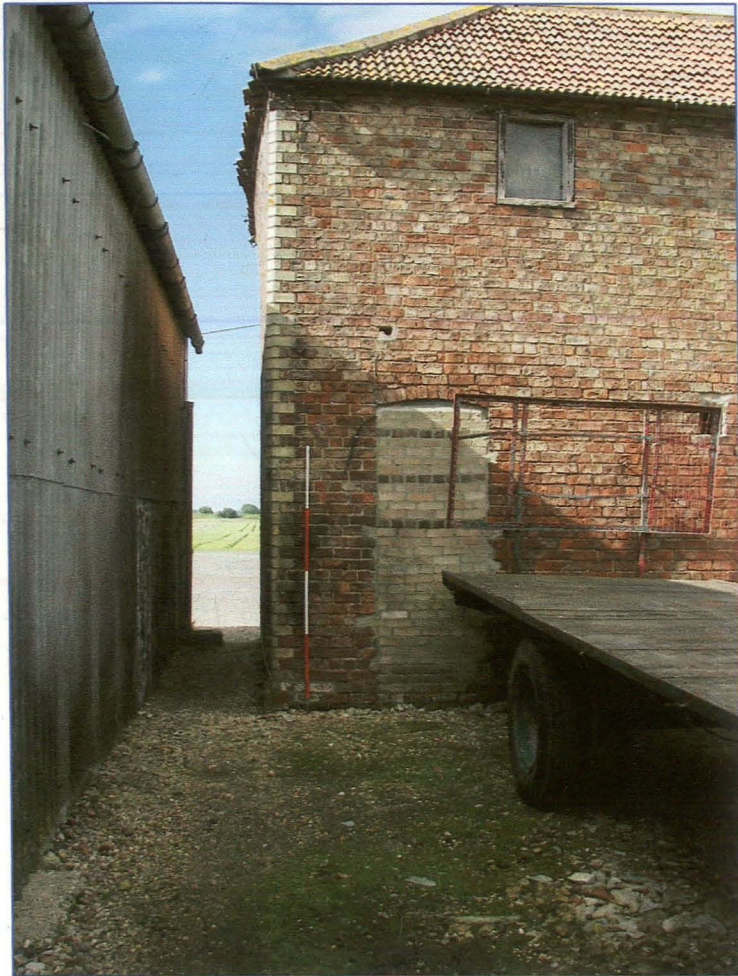
Plate 7 (Shot 15): A shot taken looking south-west showing the blocked doorway in the north-east elevation and the slight outward bow in the wall at eaves level in the south-east facing elevation.

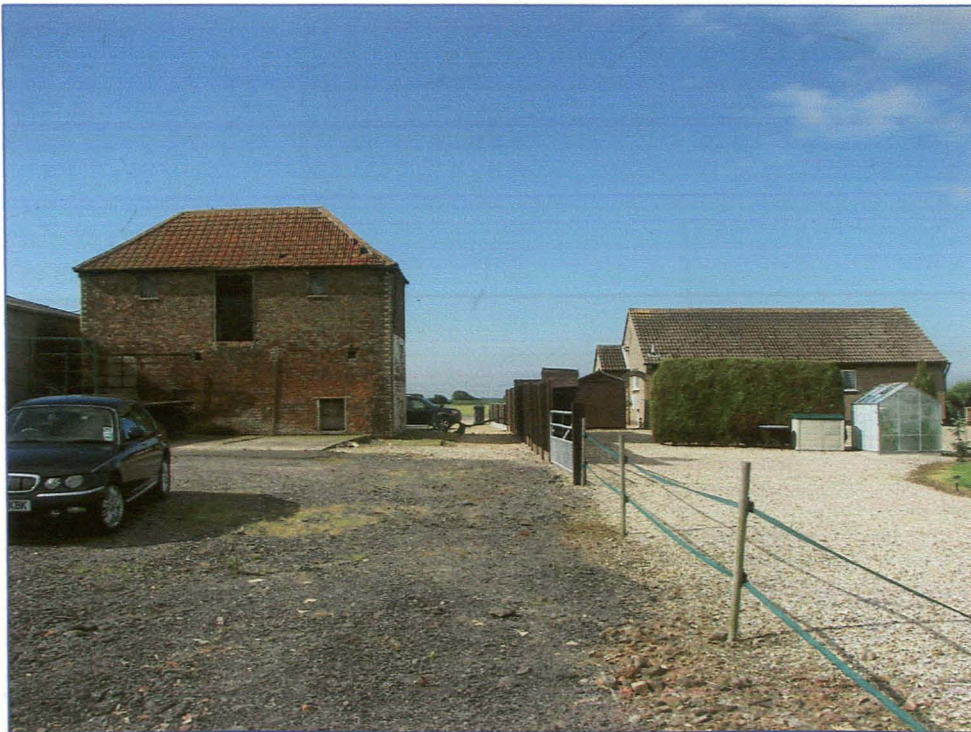
Plate 8 (Shot 13): The north-east facing elevation looking south-south-west and showing the rear aspect of the barn and surrounding buildings.

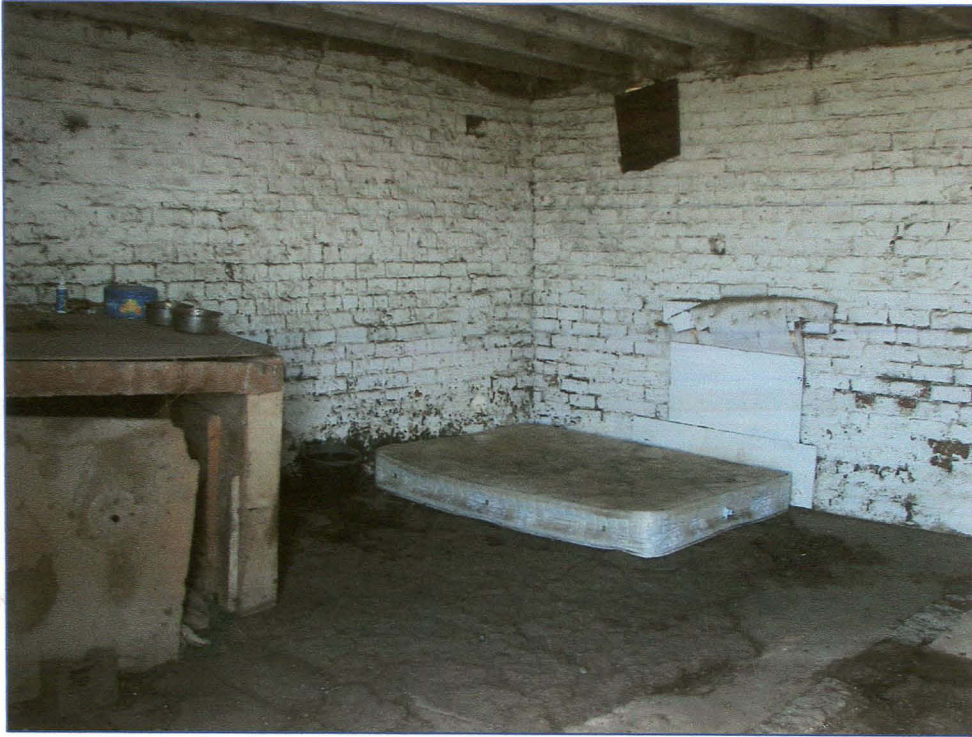
- 5.2 Internal:** Accessed via the main door in the south-western elevation, the ground floor currently consists of a single open space with a concrete floor inset with the remains of cinder block walling associated with its former use as pig sties (Plate 9).

Plate 9 (Shot 17):
The ground floor
interior of the barn,
looking north.

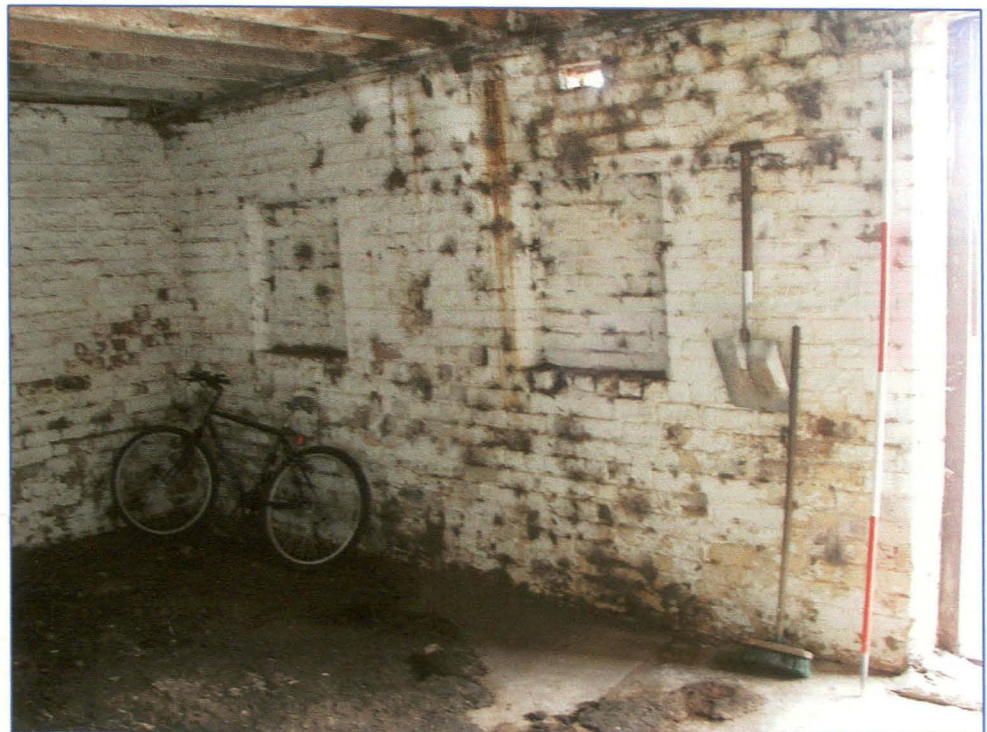
- 5.2.1 The blocked in windows in the south-west wall have cant brick detailing to their jambs and timber lintels above (Plate 10). The blocked in door at the north-west corner is similarly detailed (Plate 11).

Plate 10 (Shot 20):
The north-east facing
interior ground floor
elevation viewed
looking south.

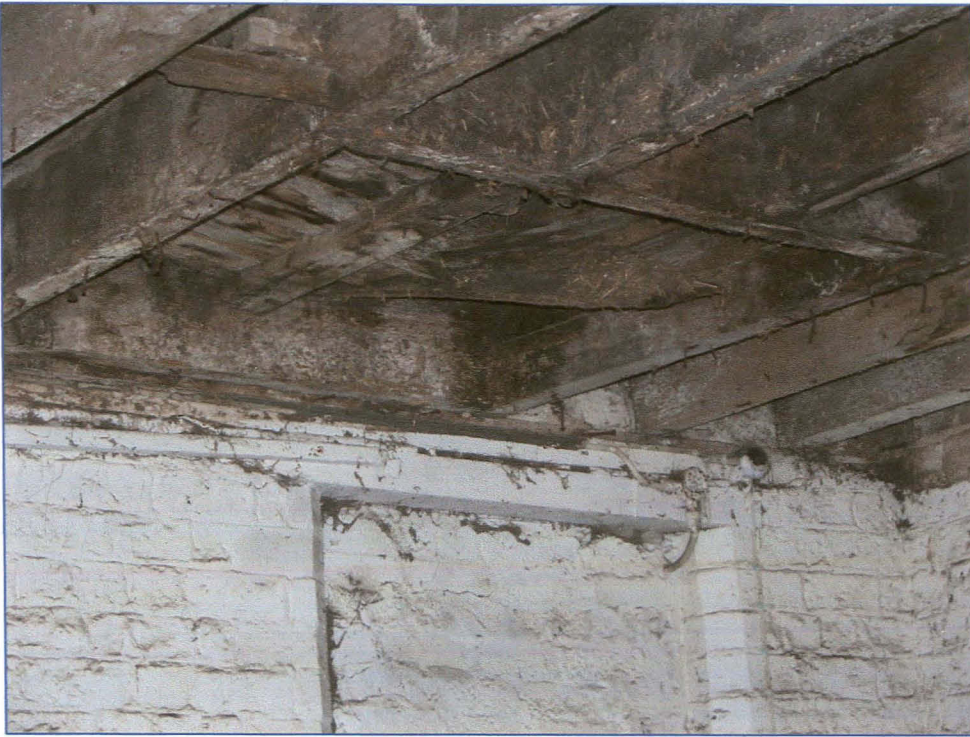
- 5.2.2 The ceiling is open to the joists that are supported by a wall plate set into the double thickness of the wall. A square opening in the joists at the north-east corner of the room (Plate 11) formerly provided access to the first floor via a fixed staircase (now removed).

Plate 11 (Shot 31): A blocked opening in the first floor joists that formerly housed an internal staircase. The opening is located in the north-east corner of the barn over the blocked external doorway, the shot was taken looking north-east.

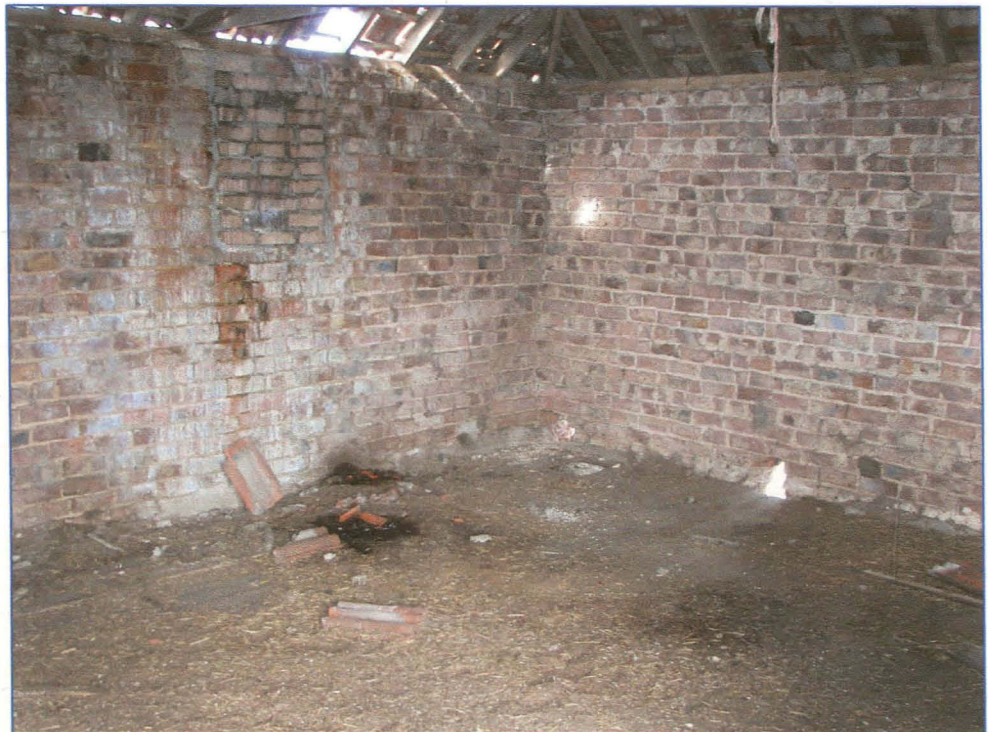
Plate 12 (Shot 28): Internal shot of the empty first floor looking south-west. Note the blocked window in the south-west wall

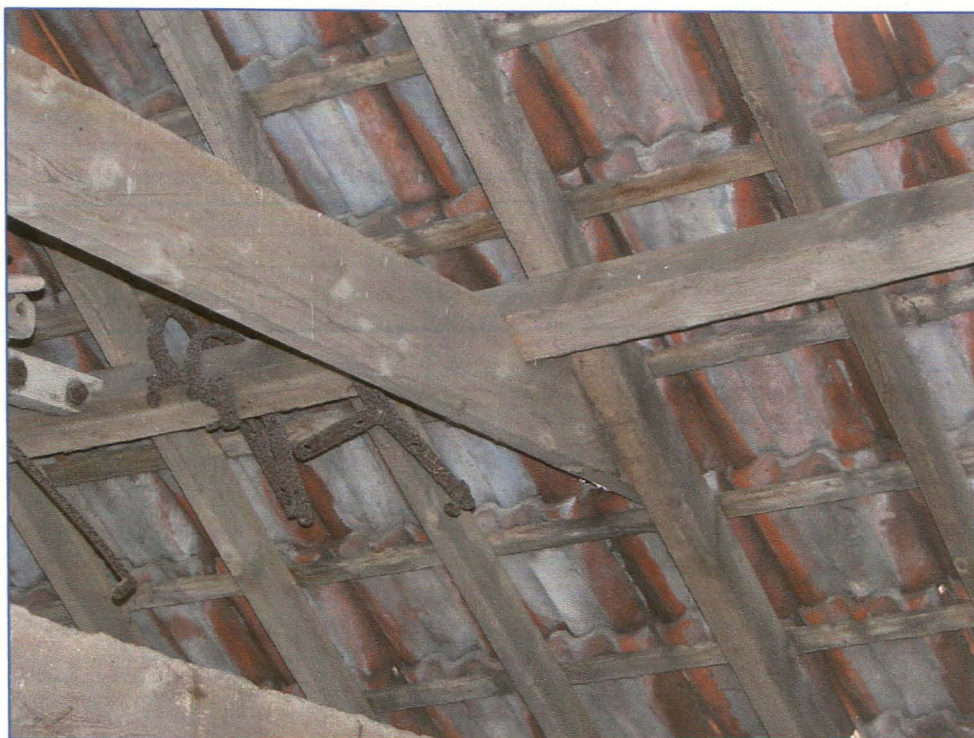
- 5.2.3 The first floor is also a single space that is open to the rafters (Plate 12). The hipped roof structure is of clasped purlin collar truss construction supporting common rafters (Plate 13). Additional cross beams connect to the truss base at the wall plate (Plate 14).

Plate 13 (Shot 30):
Detail of the clasped
purlin construction of
the roof timbers, viewed
looking south.

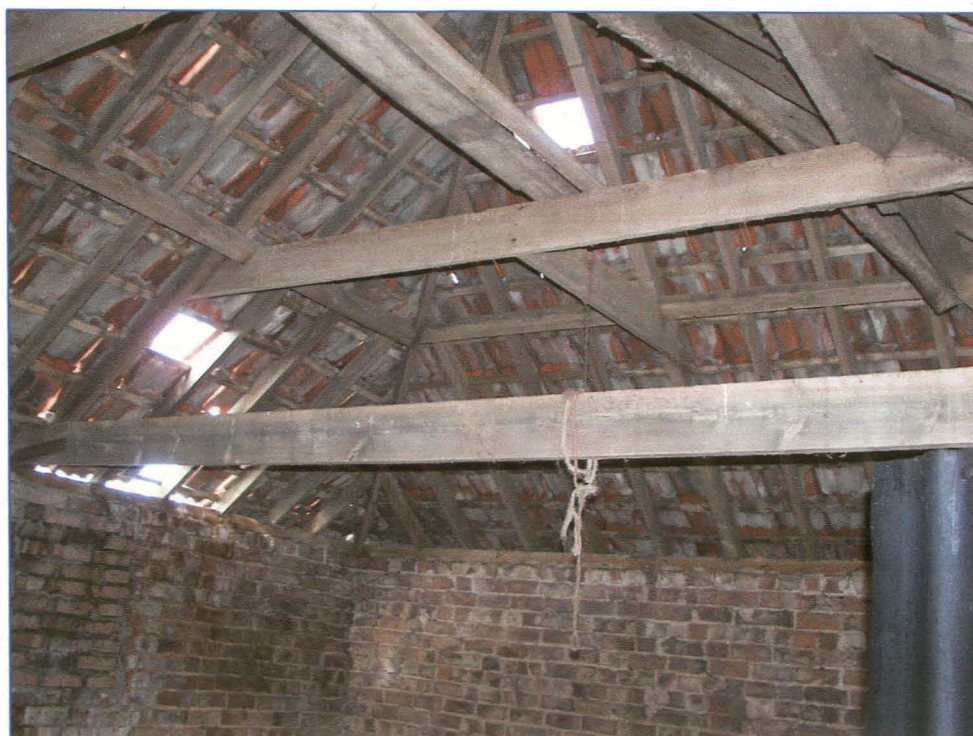
- 6.5 The present roof structure is constructed in light weight sawn timbers covered by 20th century triple ribbed tiles and has completely replaced the original roof structure. This is likely to be an addition which coincided with the lowering of the walls to the level of the first floor window heads.

Plate 14 (Shot 25):
General shot of the
hipped roof construction
looking south-west.
