**MEASURED SURVEY AND  
ARCHAEOLOGICAL BUILDINGS  
ASSESSMENT  
7-13 BRIDGE STREET  
HORNCastle**

SITE CODE: HBS01

**REPORT**

February 2003

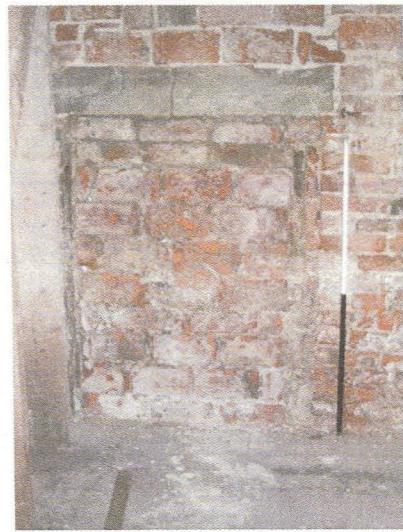
Room G2 can be accessed from street level and via G3. A third doorway provided access into G1, but has since been blocked in order to separate commercial and residential space. The north wall reveals a continuation of the straight joints identified in G3 and, once again, the east wall has been largely reconstructed in the 20th century. The south wall is dominated by a large fireplace which has been blocked in several stages (Plate 1). The first blocking can be seen high in the wall and employed a combination of tile and brick ( $0.23 \times 0.05 \times 0.13\text{m}$ ). The largest mass of blocking is distinguished by its use of quarry tiles set on edge, creating a void behind for the flue. Evidence for the head and jambs of a limestone fire surround, blocked with a second series of quarry tiles, is still visible.

Plate 1 Blocked fireplace in Room G2 (scale 1.0m)

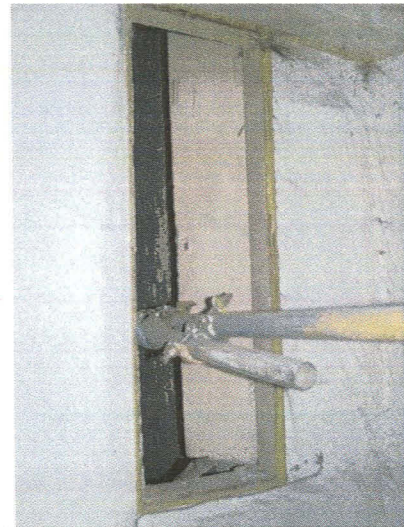
**Plate 2** Stairwell light in Room F1

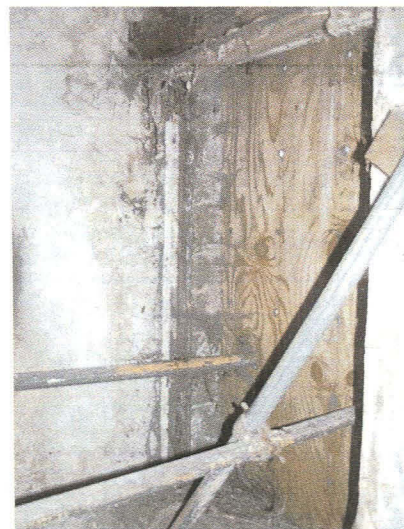
Access to Room F2 was restricted due to the poor condition of the floorboards. A large chimney breast is situated along the south wall, framing a small cupboard to the west. The chimney breast incorporates a small Victorian cast iron fireplace. The west wall forms a lath and reed partition which contains the stairwell window noted above. The east wall contains a single window opening. It is reasonable to assume a second to the south, however, the area has since been infilled with modern breeze blocks, probably due to the severe subsidence in the brickwork to the extreme south. The window to the north breaks the alignment of the north wall, suggesting an emphasis on symmetry across the entire external facade, rather than to the individual buildings (Plate 3). More importantly, it indicates a rebuilding of the eastern facade.

**Plate 3** Window cut by internal wall in Room F2

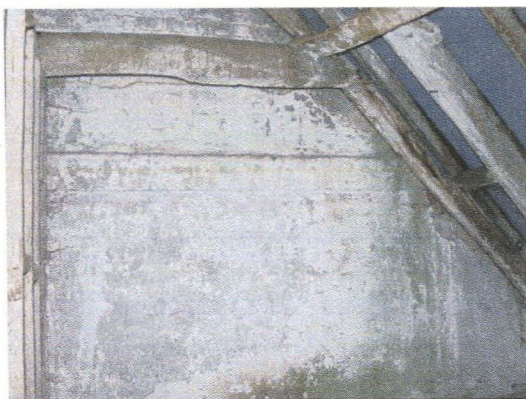
Plate 4 Stringcourse in internal wall of Room S2

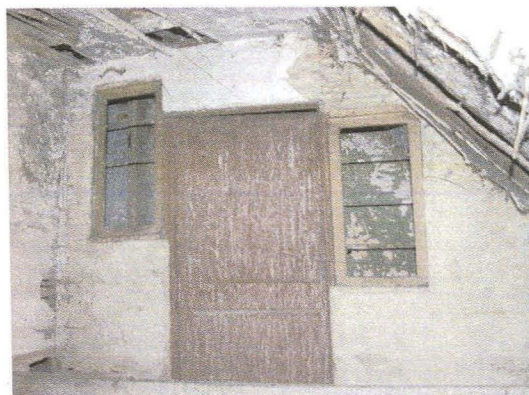
Plate 5 Stud partition between Rooms S1 and S2

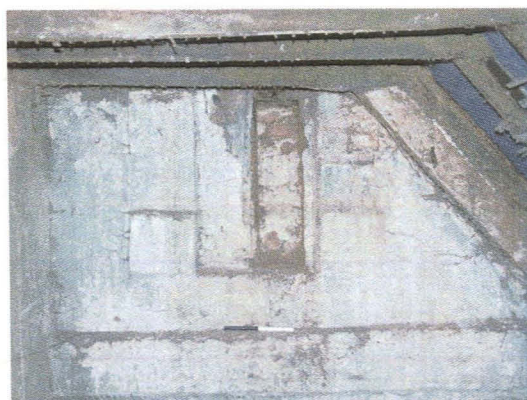
It is within the west wall that the most significant archaeological evidence is found. This takes the form of two blocked openings under segmental brick arches. At each corner are large squares of brickwork which protrude c.0.05m, each being formed by two headers sandwiched between two stretchers (Plate 6). Running beneath these is a continuous brick stringcourse (0.22m wide and 0.97m above floor level), similar to that seen on the external west gable of Number 11.

Plate 6 Blocked window in Room S3 (Scale 0.20m)

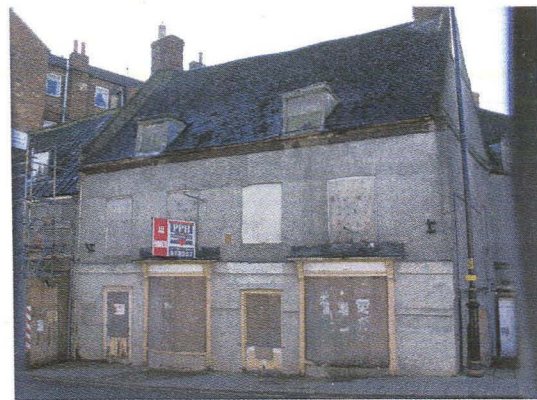
The street frontage has been much altered due to commercial activity on the site (Figure 6; Plate 7). At ground-floor level, the facade is divided into two rooms, each with a single bow window to the north and doorway to the south. The windows are of typical early 19th century type, being divided into small panels with thin glazing bars. Each has flanking pilaster decoration and bracketed entablature. The fielded panel door to the north, continues the pilaster ornamentation and also contains glass panes divided by thin glazing bars. That to the south was replaced in the late 20th century and the frame adjusted accordingly.

Plate 7 Shop frontage of Number 11

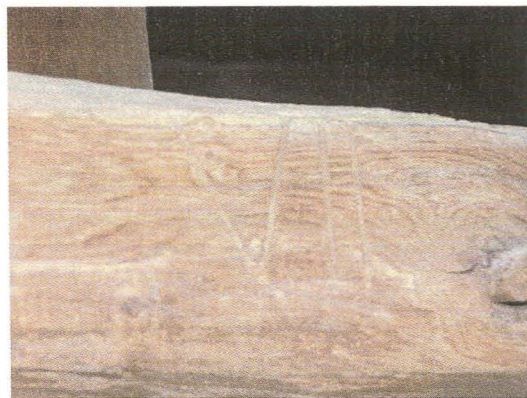
**Plate 8** Carpenters' mark in Room S4

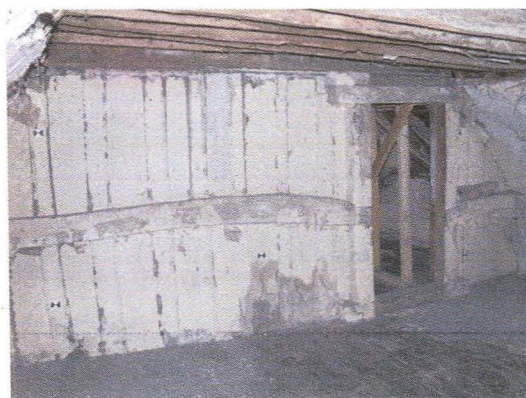
The doorway linking Rooms S4 and S5 cuts through the central tie-beam, but its contemporary date is suggested by the presence of tenoned lap joints composing the door frame itself (Plate 9; Figure 7). The jambs are formed by large uprights, tenoned into the sill and lintel. A similar arrangement is found between Rooms S5 and S6, but here, a doorway is cut through the wall plate, which is then housed in the door jambs. It is possible that this represents the position of a former dormer window.

**Plate 9** Tie-beam partition between Rooms S4 and S5

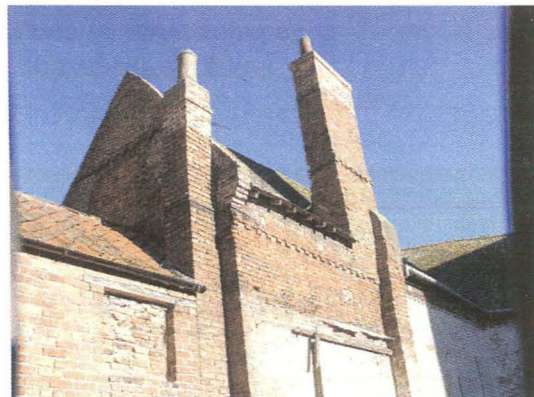
The south elevation is divided vertically by an external flue which runs into a larger chimney above (Plate 10). The chimney itself continues the dentilated brick band decoration, although its summit has been recently repaired. The external flue interrupts the second-floor stringcourse which continues across the wall. Across the main elevation, the building has been subject to a series of successive alterations, with numerous inserted or blocked features. To the east of the flue is a tall central window, half blocked, half boarded, which has been subsequently extended downwards in order to light the internal stairwell. At first-floor level, this is flanked by two openings, neither of which are apparent internally. At ground-floor level, a small central opening provides light to the below-stairs storage area. However, the two flanking openings perform unknown functions, with one opening into the chimney breast.

Plate 10 South elevation of No13

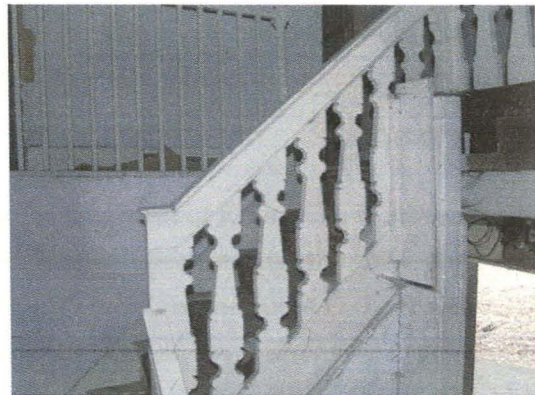
**Plate 11** Splat balusters in Room G6 with 19th addition above

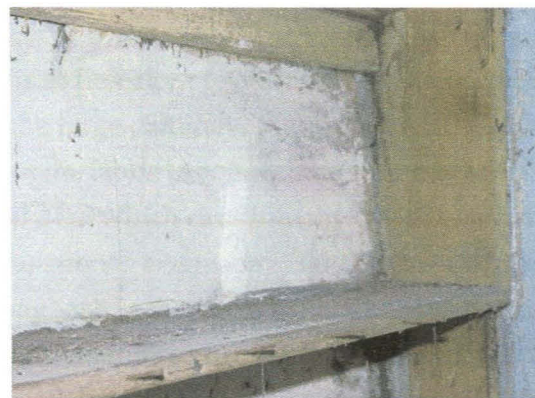
**Plate 12** Continuation of stringcourse in Room G6

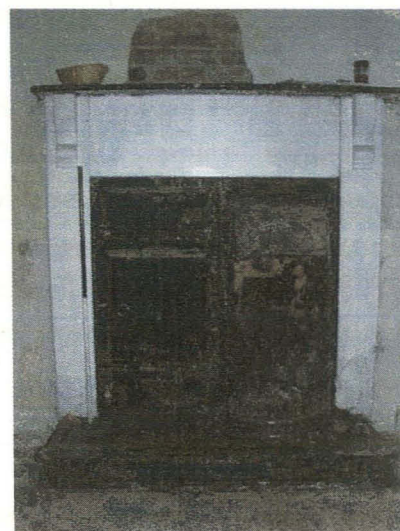
**Plate 13** Victorian range in Room G7
