**STANDING BUILDING SURVEY,
CORNHILLS FARM,
BROXHOLME, LINCOLNSHIRE**

NGR: SK 9168 7720
SITE CODE: CFB03

Report prepared for NGH Construction Ltd.,

January 2004

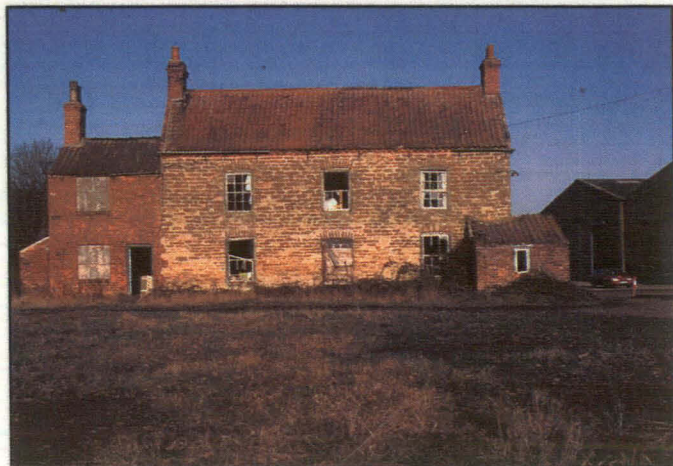
The house was laid out on a two bay plan, typical of the Lincolnshire vernacular, (Roberts, 1974). Thus, there are two rooms on each floor opening from a central entrance hall or stairway. The windows in the first 2 storeys were all set into the south wall, presumably to take advantage of the light and view, while the attic rooms each

Pl. 1 : South elevation of farmhouse. The brick buildings to either side are later additions. Note 2 bay layout with rooms either side of a central stairwell.

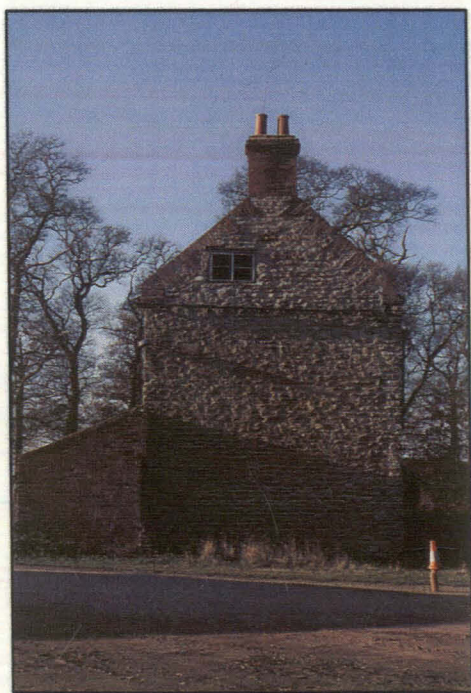
The gable ends exhibited a feature known as tumbling-in, where brickwork is laid at right angles to the slope of a gable forming triangles by tapering into horizontal courses, (Pevsner & Harris, 1989). This feature is typical of Lincolnshire architecture. The top of the two longer walls were also brick built, three courses in dentition bond serving as a kneeler on which the lower roof timbers rest.

Pl. 2 : Eastern elevation of farmhouse. The upper window provides light to one of the attic rooms, the brickwork at the top of the gable is known as tumbling-in and is typical of Lincolnshire architecture.

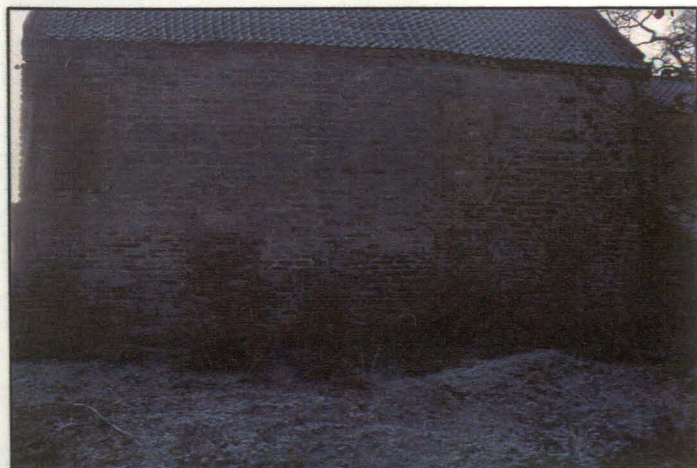
had a window in the gable end, (see plates 1 & 2). Although the internal walls could not be inspected, a number of alterations and features in the north wall were visible externally, (plate 3). There were a number of blocked openings, comprising four doorways, 2 each at ground and first floor level and a smaller hatch, which may have opened onto an under-stair storage area. Examination of these openings revealed that they had been inserted into the original fabric, the jambs being partly brick-built. This tends to suggest that a second row of rooms had been added, converting the house to a double pile layout. These openings were presumably blocked when this additional structure was demolished. One of these blockages was partly ruinous, and examination of the bricks used demonstrated that they were un-frogged and of probable early 19th century date.

Pl. 3 : Northern elevation of farmhouse. The blocked openings were inserted after the house was built, presumably to give access to a further range of rooms. They were then blocked when this range was demolished.

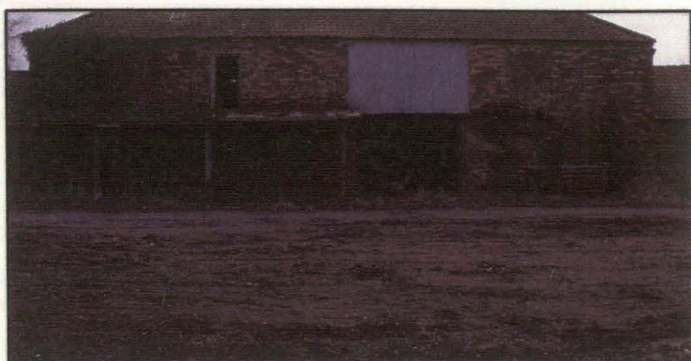
Pl. 4 : North elevation of barn. The large wagon door has been partially blocked with corrugated iron, to the bottom left a lean-to marks the area where a steam engine would have stood.

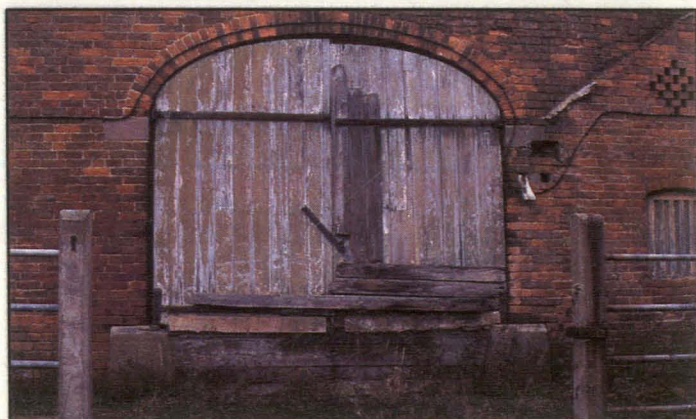
Pl. 5 : Southern barn door. This is lower as it was only designed for unloaded wagon. Note the threshold at the base of the door and the stone hinge blocks common to many buildings in the complex.

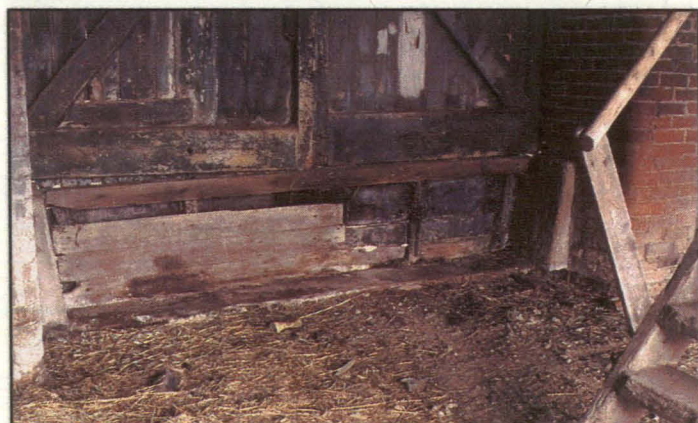
Pl. 6 : Southern barn door, internal view. Note threshold mounted in stone blocks integral to the building wall. The earth floor in the foreground may have originally been covered with oak planks.

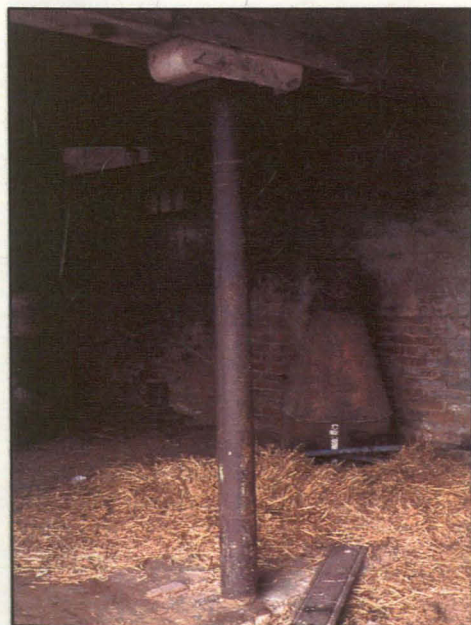
To the west and east of this floor were storage areas originally for the un-threshed crop and the waste that periodic threshing would produce; the easternmost supported by a cast iron pillar, (plate 7).

Pl. 7 : Interior of barn showing cast iron pillar supporting storage loft above. Behind it is a metal hopper, which would have been used to channel processed grain.

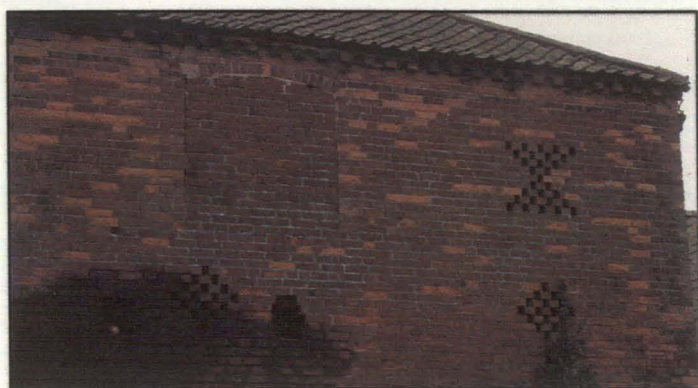
The upper storey of the western side of the barn was ventilated by a series of gaps in the brickwork arranged in ornamental diamond patterns, (plates 8 & 9). There was also a blocked pitching door in the northern wall, which also gave onto this upper storey.

Pl. 8 : North elevation of barn. Note blocked pitching door and ornamental brickwork providing ventilation to upper storage area.

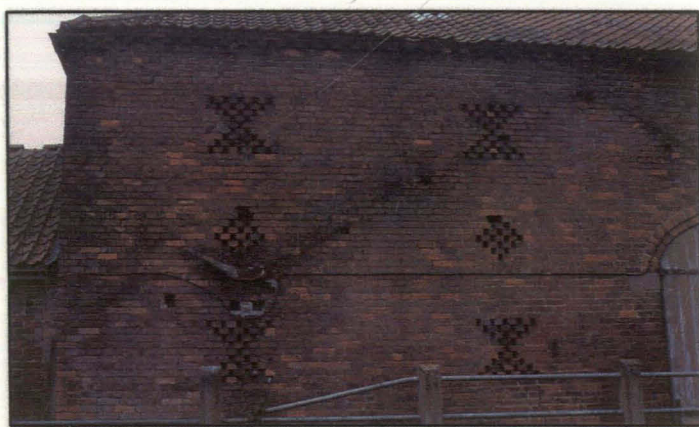
Pl. 9 : South elevation of barn. The ornamental ventilation holes on this side give onto both storeys. Note the scar of a later roofline, later demolished.

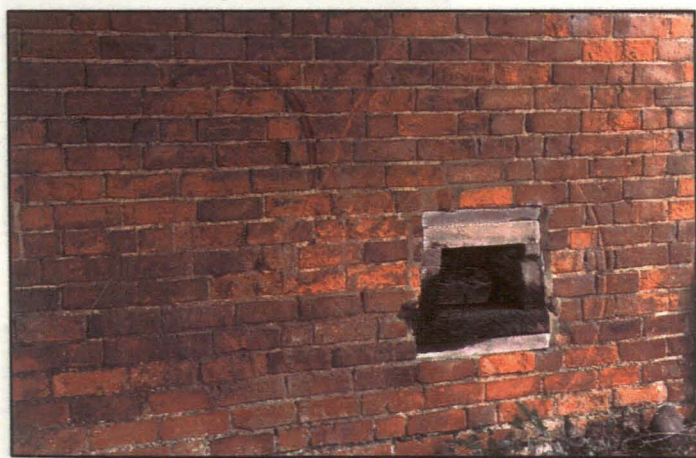
shaft holes had been let into the northern wall and re-enforced with timber, (plates 10 & 11). These would have transferred power from an external steam engine to a series of internal shafts and belts, which could in turn transmit it to threshing or other machines. The easternmost of these shafts survived, (plate 11), and connected with an internal arrangement of belts, pulleys and drive shafts which distributed the power, (plate 12). As part of this re-design an internal brick wall was added, dividing the easternmost lower space into two smaller rooms. These additions were clearly contemporary with or later than the conversion to steam threshing, as a slot for a drive belt was part of its original form, (plate 13). The presence of the engine outside the barn is demonstrated by grooves in the brickwork made by the flywheel, (plate 10). When this wall was added a doorway and window were inserted into the north wall to give access and light to the room created. At the same time, an original ground floor doorway had been blocked, as it would have been obstructed by the engine and its drive belts.

Pl. 10 : Drive shaft hole let into northern wall of barn. Note circular grooves in brickwork caused by the wheels of an external steam engine.

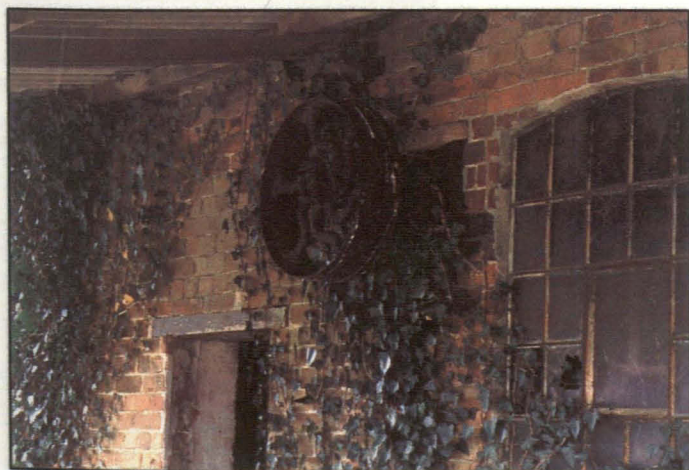
Pl. 11 : A further drive shaft hole, positioned higher and to the east. In this case the drive shaft and pulley survive, see also plates 12 and 13.

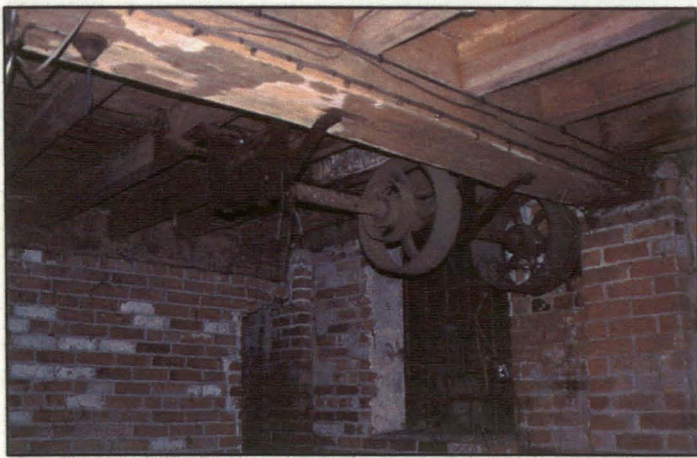
Pl. 12 : Internal shot from east end of barn showing drive shaft and power take-off pulleys. One of the drive belts fed through an internal wall to the room to the west, see below.

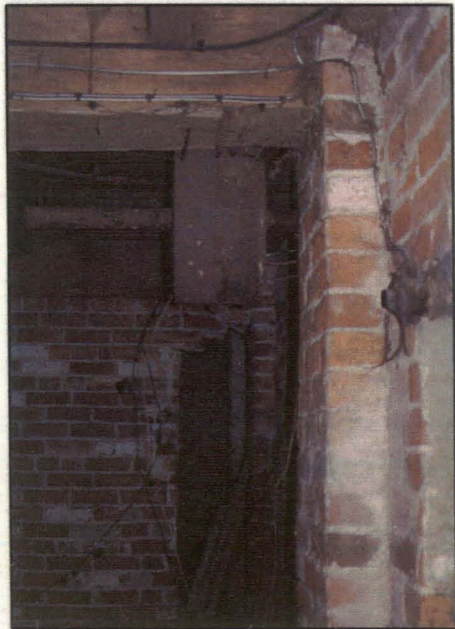
Pl. 13 : Shot looking along the line of drive belt. The pulley at the top of the frame would have fitted a belt that passed through the hole in the wall below into the room beyond.

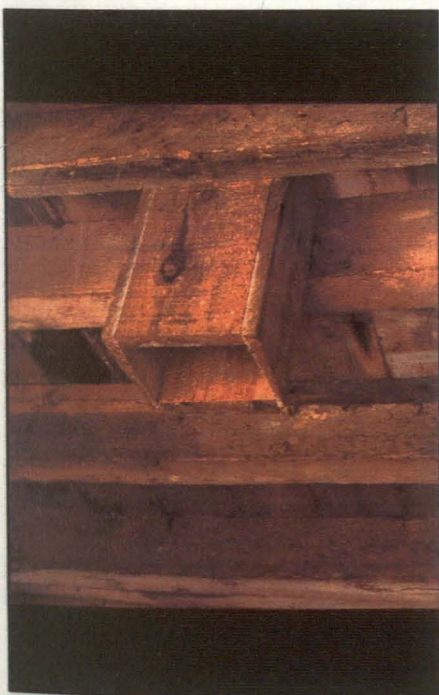
With the conversion to steam power, the function of a barn such as this underwent fundamental changes. It was no longer necessary to store large quantities of un-threshed grain for gradual processing throughout the winter as machines could process the entire harvest in a matter of days. The threshing floor too became obsolete and would now only serve as a loading bay where a wagon could be placed to transfer its cargo to the barn. As mentioned above, the lower part of the barn was converted to a machine room while the upper stories took on the function of a granary. This is demonstrated by the presence of a chute set in the floor and metal hoppers, both of which would have served to dispense grain stored in the upper area, (plates 14 & 7).

Pl. 14 : Grain chute leading from the upper to lower storeys of the barn. This would have served to pass processed grain from storage above to be distributed or used below.

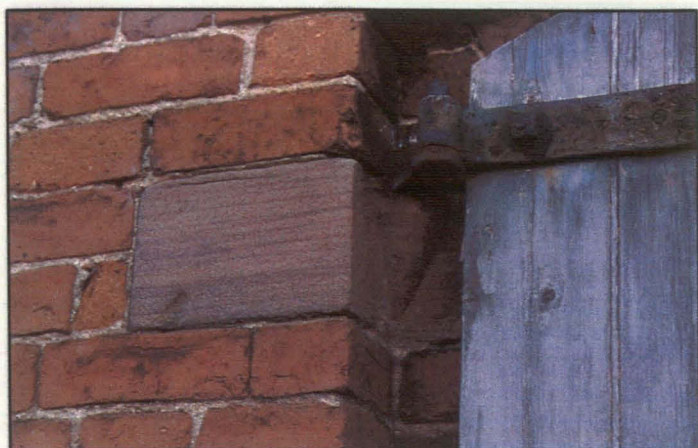
The south side of the shed was later blocked with a doorway to the west and a wooden slatted window to the east. The door jambs were partially constructed of large worked limestone hinge blocks; like those seen on the long range of buildings to the west, and suggesting that they are contemporary, (plate 15).

Pl. 15 : Stone hinge block from eastern side of the stable building. This is similar to other hinge blocks in this range as well as to the doors blocking the south side of the barn extension.

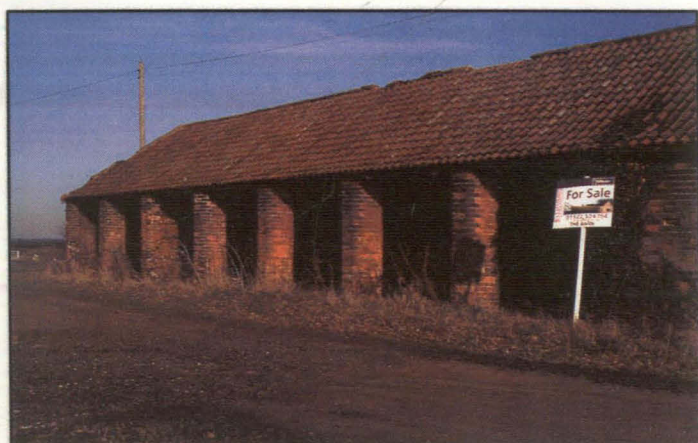
Pl. 16 : Western side of wagon shed, open with the roof supported on pillars. Sheds of this type usually faced away from the yard so that wagons would have more room to manoeuvre.

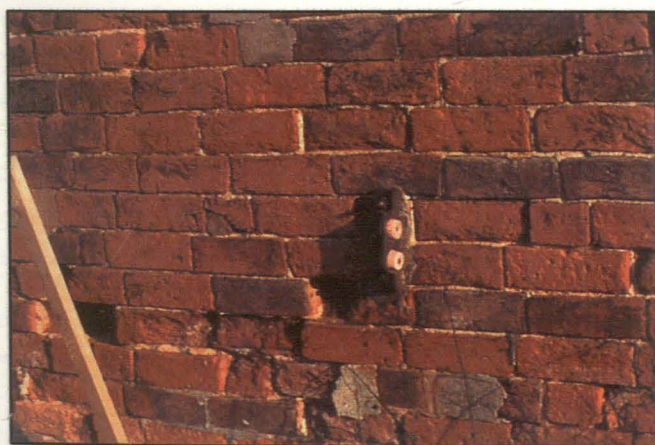
Pl. 17 : Door stop from collapsed portion of north-south range. This demonstrates that this room was originally entered via a sliding door.

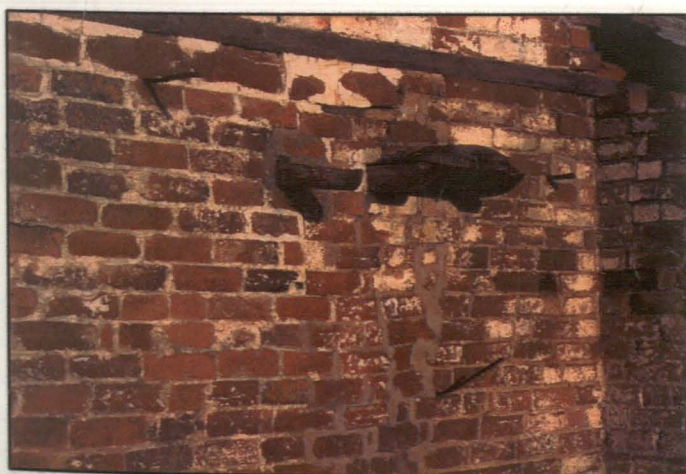
Pl. 18 : Harness or tack hook from the interior of the ruinous room. This space seems to have been designed for the storage of harnesses as well as other bulky gear (hence the sliding doors).

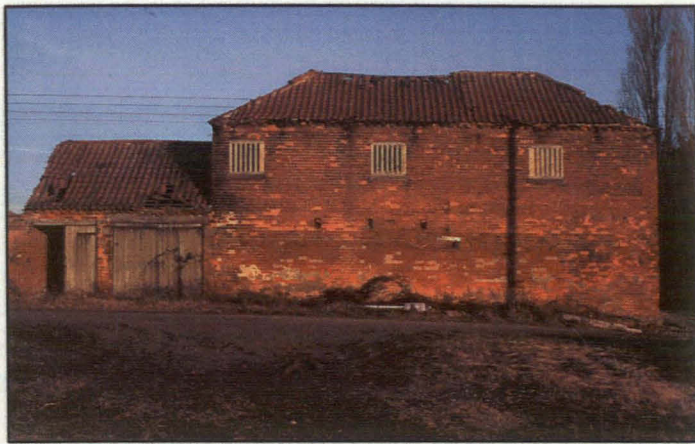
Pl. 19: West elevation of Stable building. This housed three stalls on the ground floor with a granary above. The slatted windows provided ventilation for the grain stored therein.

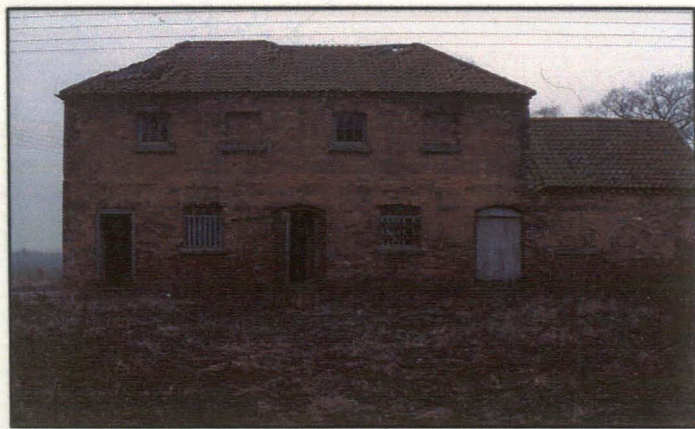
Pl. 20 : East elevation of Stable building. The windows to the ground floor stables face east to make the best of the early morning light.

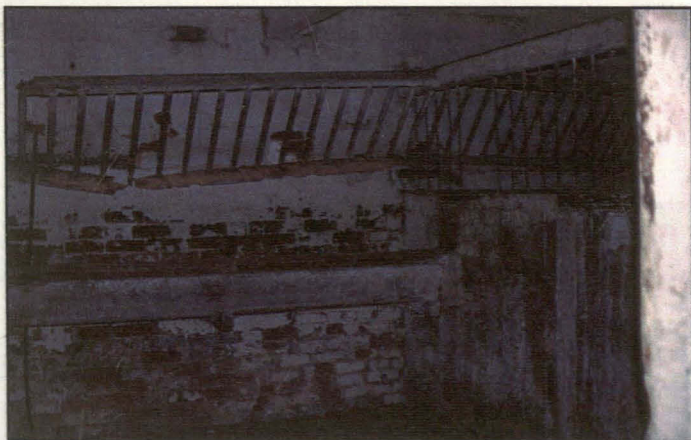
Pl. 21 : Central stall of the stable block with a hay rack above and manger below. The floor of this building sloped towards the door to aid mucking out.

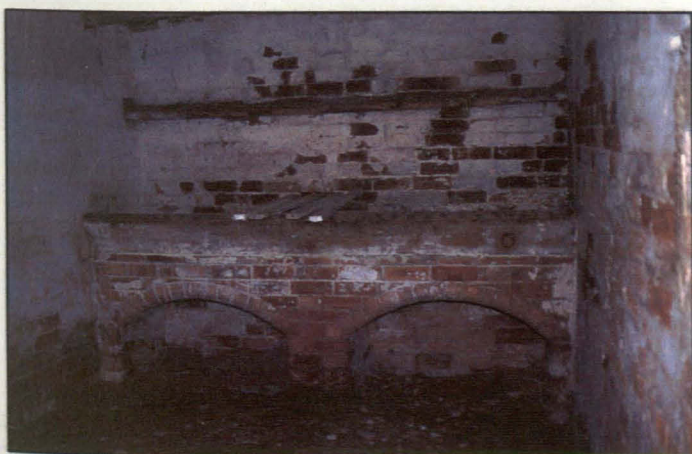
Pl. 22 : Southern stall of stables. The arched openings below the manger are to accommodate the litter that would build up.

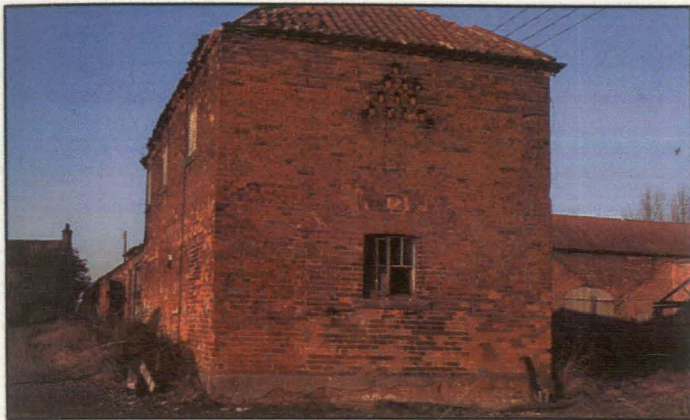
The southern part of the ground floor comprised a small room, which housed a workbench against its southern wall. In its original form, this room had a large arched opening in the southern wall, the function of which is unclear (plates 23 & 24).

Pl. 23 : Southern gable-end of stable block. Note further ventilation provided by gaps in brickwork. The window is inserted into a later block, see close-up below.

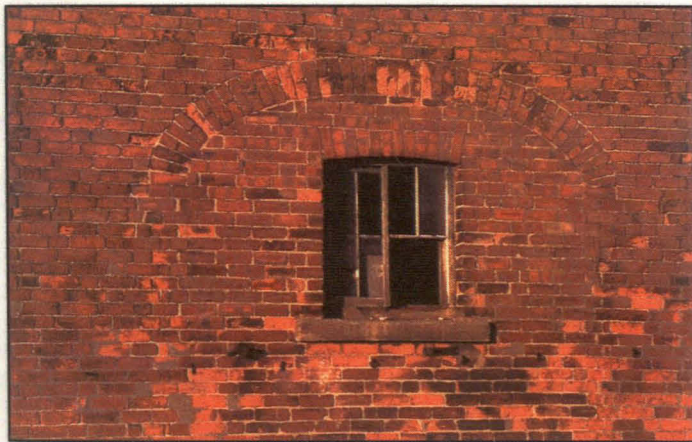
Pl. 24 : Blocked opening in southern wall of stable building. The purpose of this redesign could not be determined.

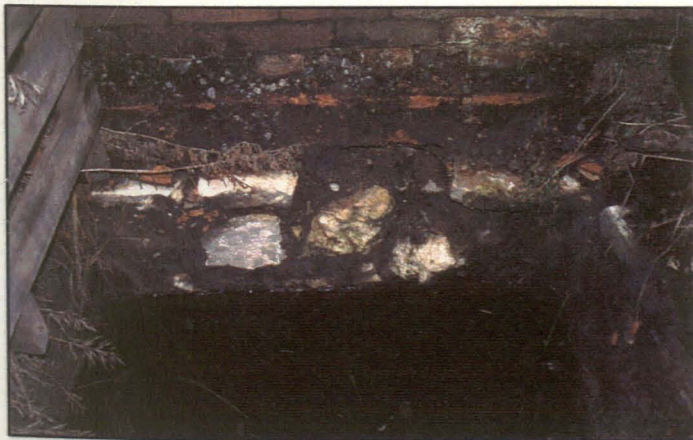
nationwide through the middle of the 19th century but with some local peculiarities. It seems to have been based around an earlier barn and a farmhouse that may be earlier still. Examination of a trial hole excavated against the north wall of the barn demonstrated that it was set on stone foundations, (plate 25), and may be a successor to an earlier stone structure.

Pl. 25 : Trial excavated against northern wall of barn showing stone foundation. It is possible that this is a re-used foundation from an earlier barn contemporary with the farmhouse.
