**BUILDING SURVEY OF
FARM BUILDINGS AT
BRIDGE FARM,
SWINESHEAD BRIDGE,
LINCOLNSHIRE
(SWBF07)**

January 2008

Report Compiled by
Neil Parker MA

A.P.S. Report No. **158/07**

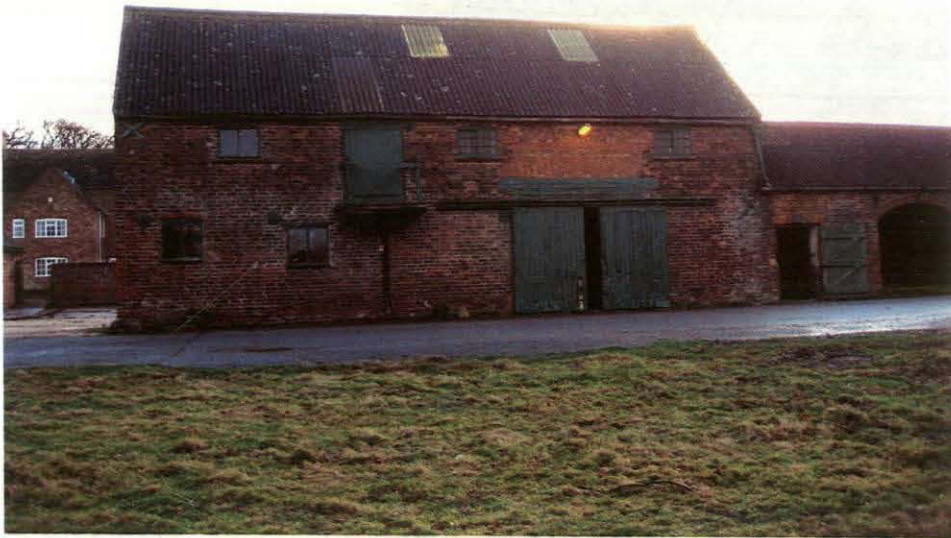
Plate 1.

On the northwest elevation are external round wall tie plates that correspond to the internal beams supporting the first floor. There is also a large crosstie corresponding to an internal beam at the base of the roof and its opposite tie on the southeast elevation. At the southerly end of the northwest elevation is another large crosstie at the base of the first floor level (Figure 5, Plate 1).

The main barn doors on the northwestern elevation are upright wooden slatted sliding doors with a wooden lintel and a brick over-arch. Adjacent to the door on the northern side is a single blocked breather slit (Figures 4 & 5, Plate 1).

On the ground floor the windows differ from one another in that the northerly window has a segmented arch and is similar to those on the first floor whereas the southerly window is lower, flat topped and shaped differently. This appears to be a later insertion (Figure 5, Plate 1).

At first floor level is a hinged doorway and outer platform to the north of the main barn doors for the loading and unloading of grain (Figures 4 & 5, Plates 1 & 2).

Main barn and
Cartshed

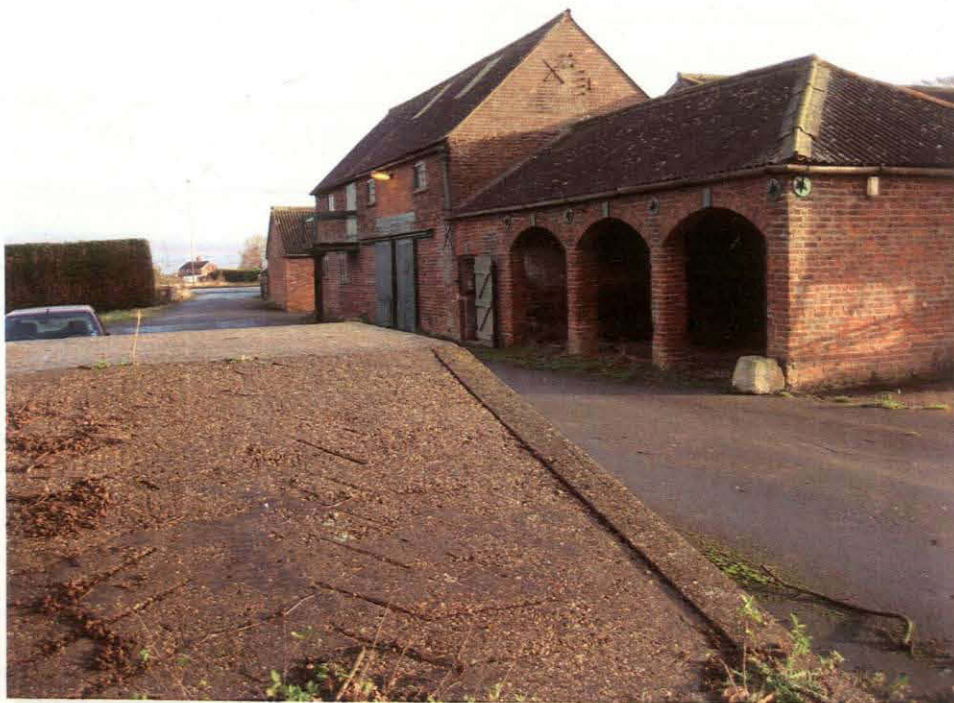
Plate 2

Above these at each gable end are more recent machine-made red bricks, laid in stretcher bond and held in place with large crossties suggestive of a roof repair (Figure 5, Plates 2 & 4).

The northeast elevation to which the cartshed is attached shows a single large crosstie slightly offset from the centre (Figure 5, plate 2).

Small round wall ties correspond to the internal beams inside the cartshed and the central point of each arch is reinforced with a small metal plate (Figure 5, Plate 2).

At the southwest end of the cartshed is a large mounting block corresponding to the one at the northeast end of the main barn (Figure 5, Plate 2).

Cartshed and
main barn

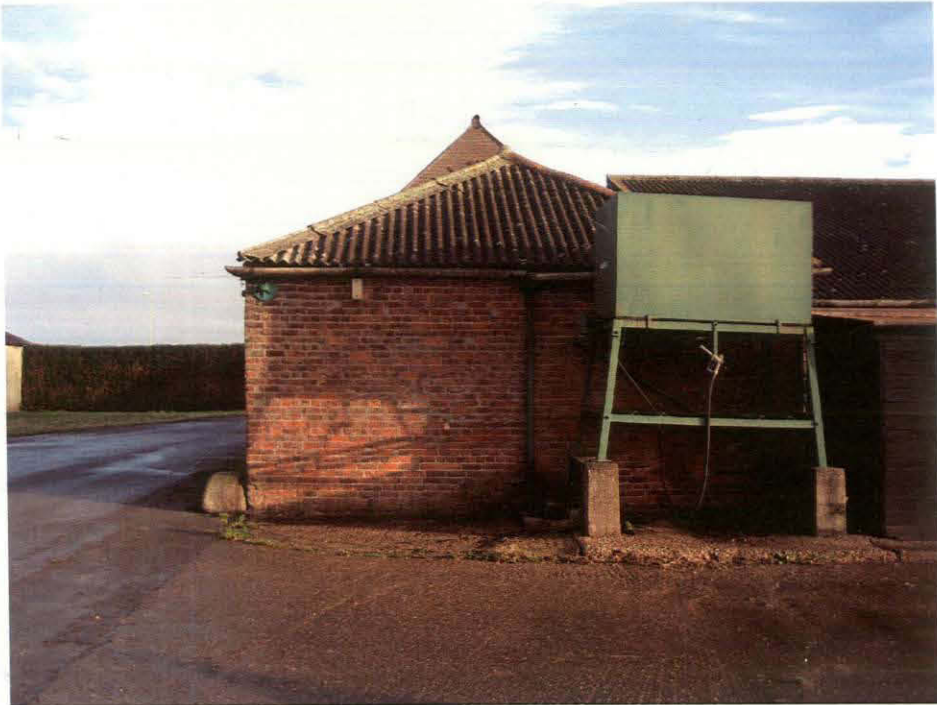
Plate 3

The northeast elevation of the cartshed is partially obscured by a raised metal tank. There is a single visible wall tie on the upper left corner below the roof level (Figure 5, Plate 3).

Cartshed. End elevation.

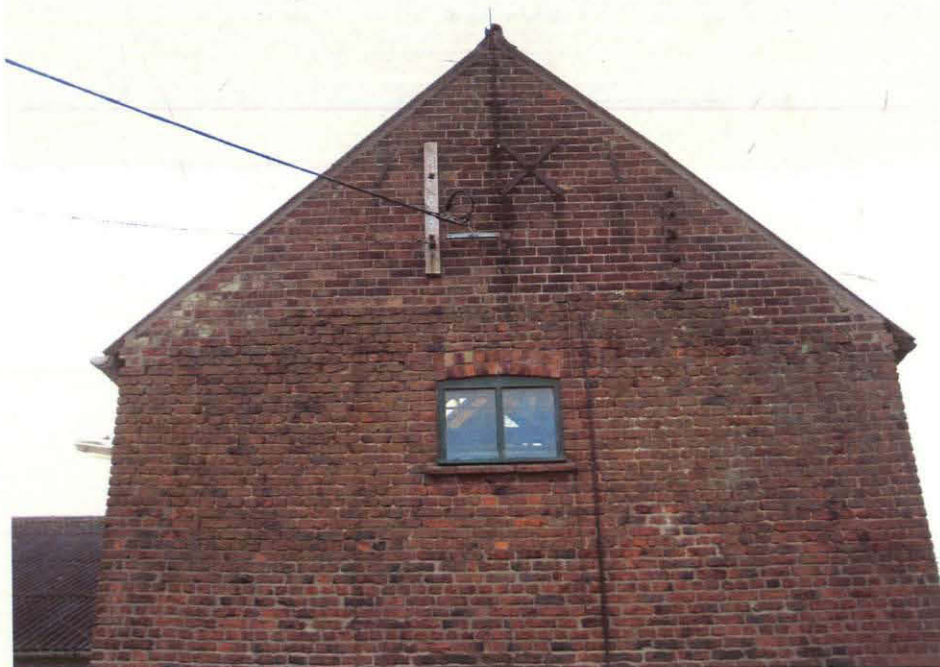
Plate 4

Unlike the northeast elevation, the southwest elevation has a single window at first floor level (Figure 5, Plate 4).

Main barn.
End elevation.

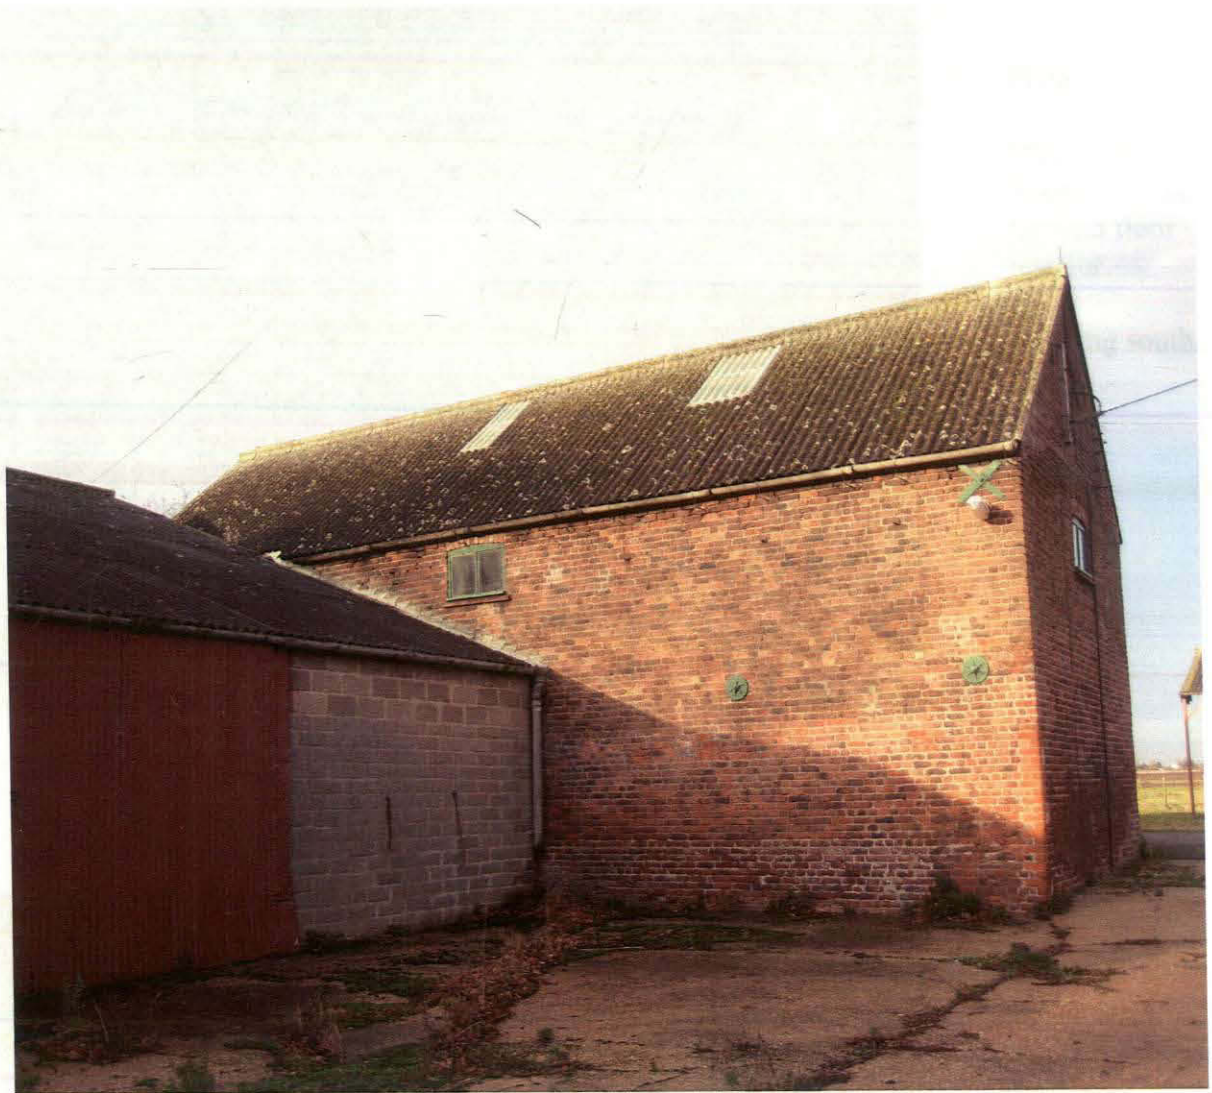
Traces of two blocked breather slits are visible to the north of the vehicle shed and also, at first floor level, one window

similar to the one on the northwest elevation. The round crosstie plates holding the internal beams correspond to those on the opposite, northwest, elevation (Figures 4 & 5, Plate 5).

Plate 5
Main barn.
Looking northwest.

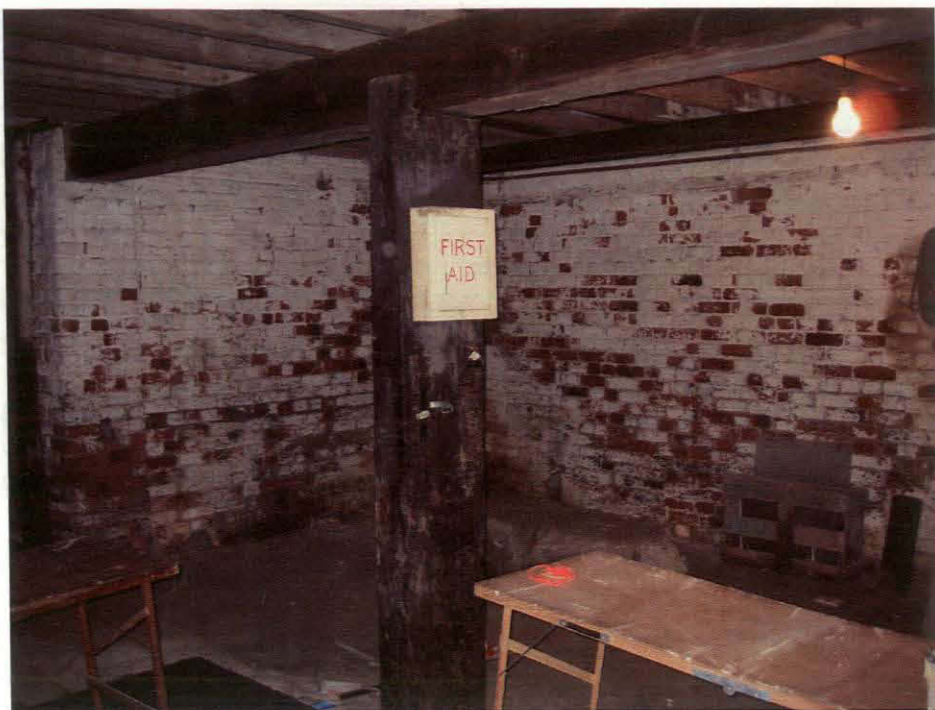
Plate 6

The southerly section of the barn has a concrete floor into which is set a modern post supporting the southernmost tie beam (Figure 4, Plates 6 & 7).

Adjacent to this is a large concrete block underneath an iron girder across the ceiling that is possibly related to the previous instalment of what may have been a threshing machine, now removed (Figure

Main barn.
Southwest end.
Ground floor
interior.

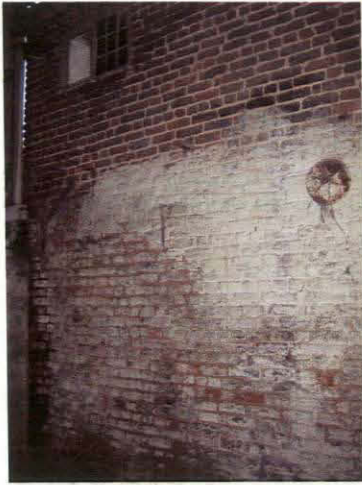
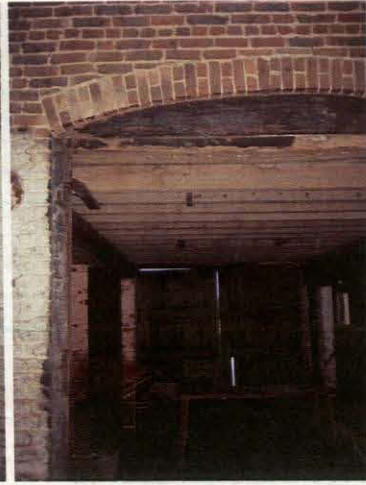
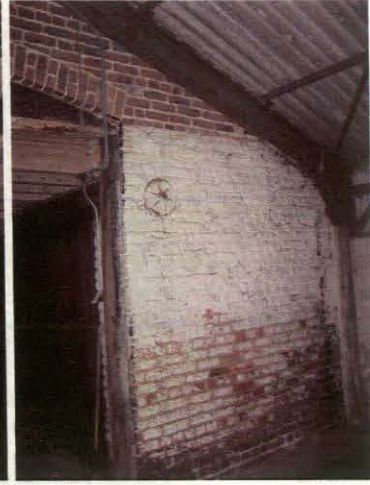
Although no longer retaining its doors, the barn door on this elevation is comparable to the one on the northwest elevation. In addition the single first floor window is set further to the south than its corresponding window on the northwest elevation (Figures 4 & 5, Plates 8-10).

Main barn door. South side of the barn. Looking west, northwest and north.

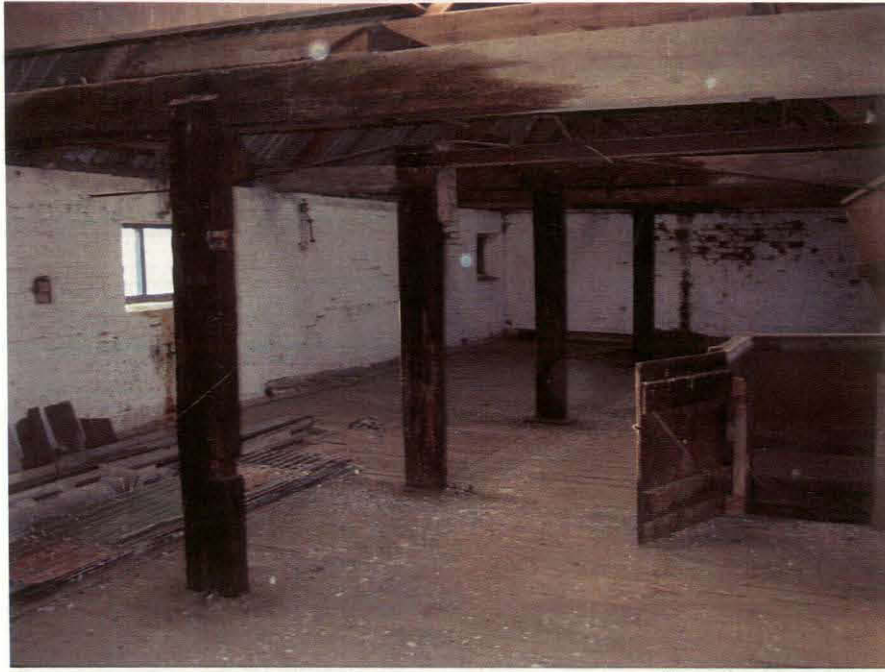
Plate 13

Toward the centre of the floor is a blocked opening, possibly a trapdoor through which grain was shovelled to the ground floor (Figure 4, Plates 13 & 14).

On the southeastern wall of the barn the wooden lintel of the main barn door is visible slightly above the level of the floor (Figure 4, Plate 13).

Main barn.
First floor.

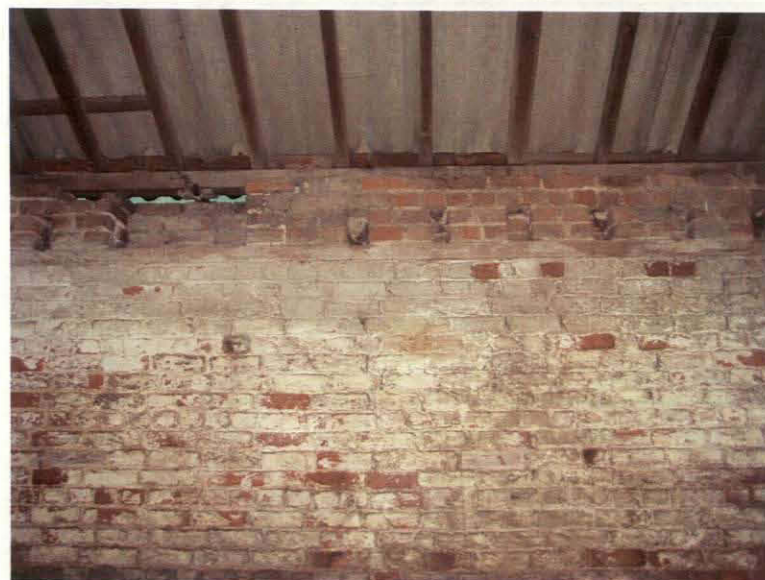
Plate 19

On the southwestern internal face of the wall is a series of fourteen joist recesses that suggest an upper floor that has since been removed. If this is the case it did not span the entire shed as there are no corresponding recesses on the northeast wall (Figure 4, Plates 18 & 19).

Cartshed interior detailing
joist recesses.

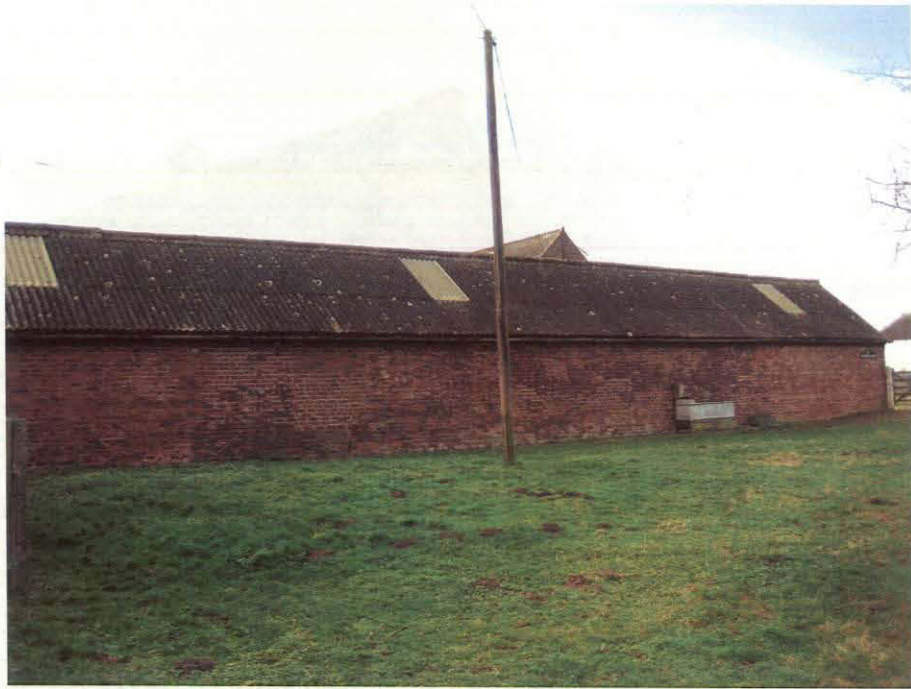
Plate 29

Also a much repaired wall, the north elevation has various different types of brick and no external features save a water trough toward the western end (Figure 7, Plate 29).

Stable range
exterior.

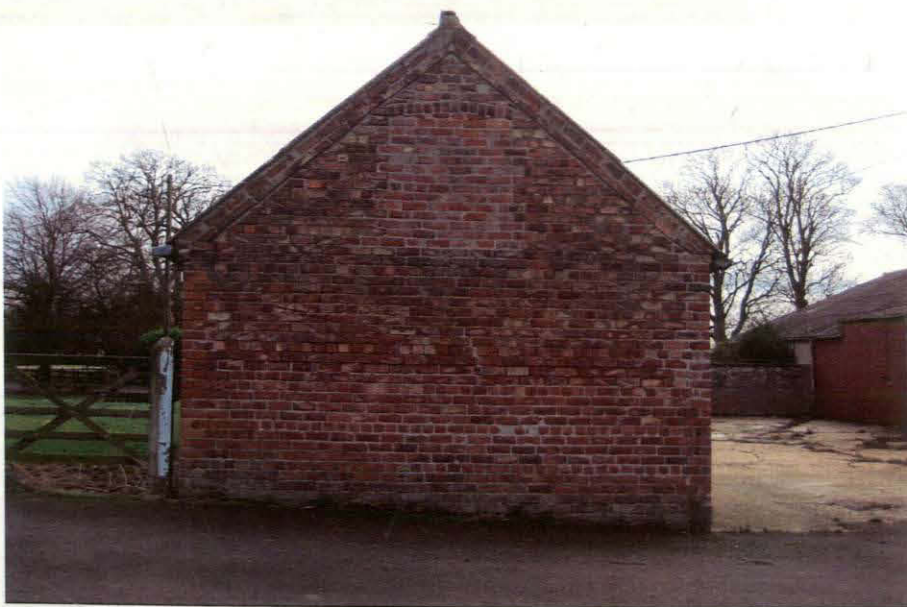
Plate 30

Similar to the south elevation, the west elevation also has various brick types suggesting repair work. Another bricked up opening is visible below the apex of the roof (Figure 7, Plate 30).

Stable range,
exterior.

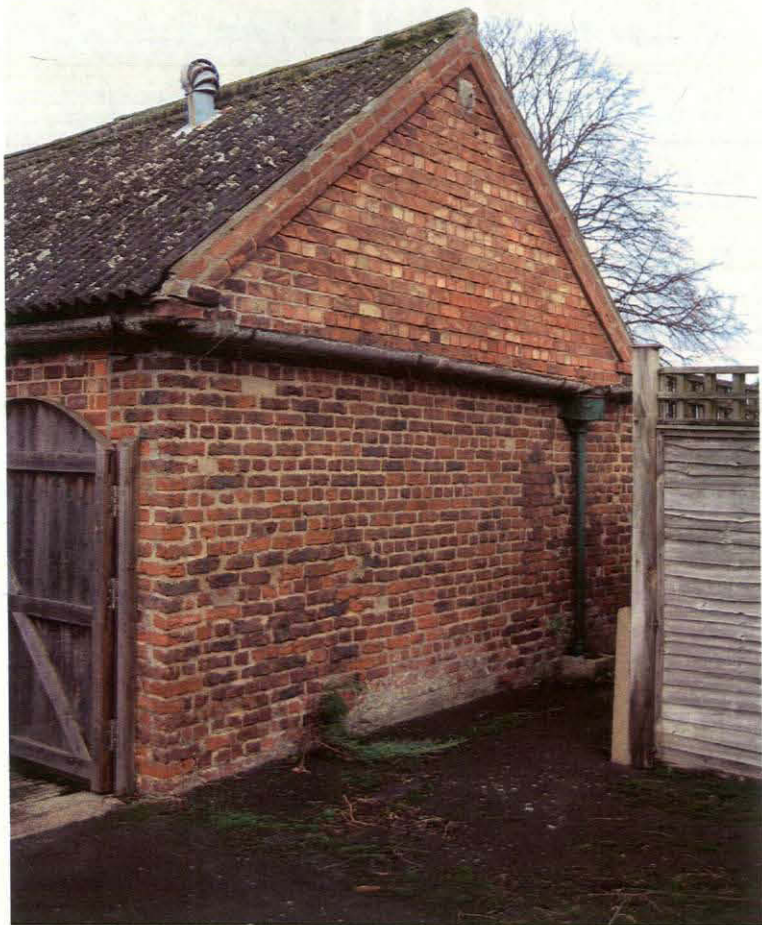
Plate 31

The east elevation of the stable is featureless but has newer brick forming the gable end (Figure 7, Plate 31).

Stable range, exterior.

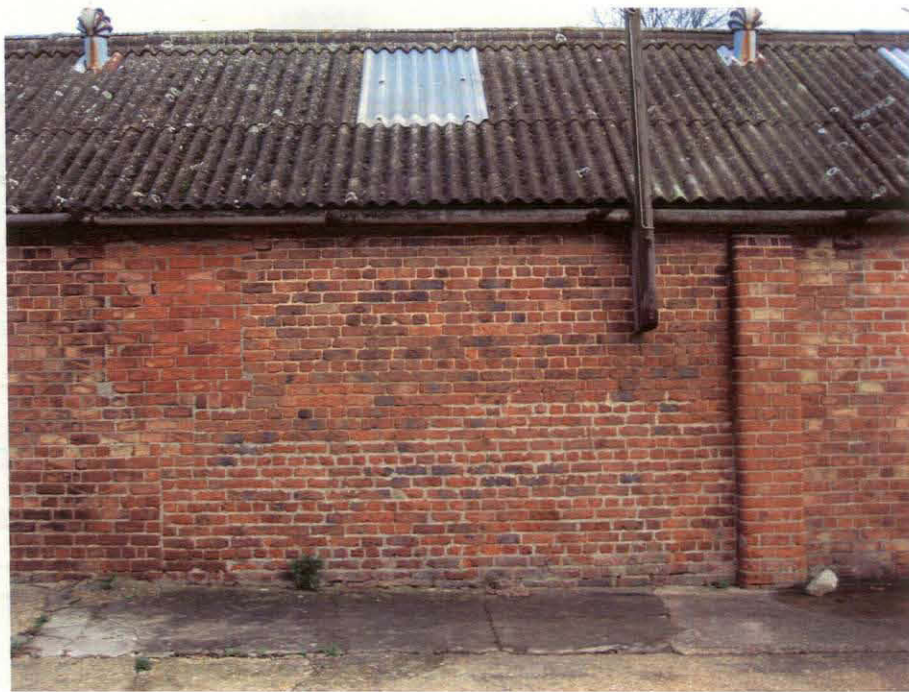
Plate 33

Varying in age and quality, the brickwork over the entire stable has been altered and repaired many times.

On the south elevation are four blocked openings; one at ground level. There are also two surviving windows (Figure 7, Plates 33-36).

Stable range,
exterior detailing
brickwork
repairs.

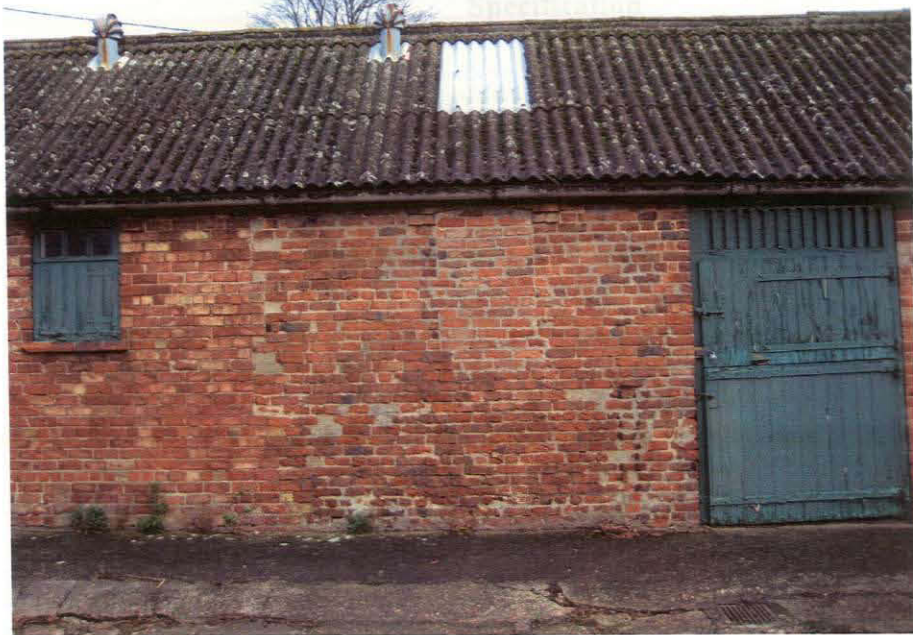
Plate 35

Stable range,
exterior detailing
brick repairs and
stable doors.
