**BUILDING SURVEY OF
FARM BUILDINGS AT
IVY HOUSE FARM
SKELDYKE ROAD
KIRTON
LINCOLNSHIRE
(KSI03)**

March 2004

A.P.S. Report No. 19/04

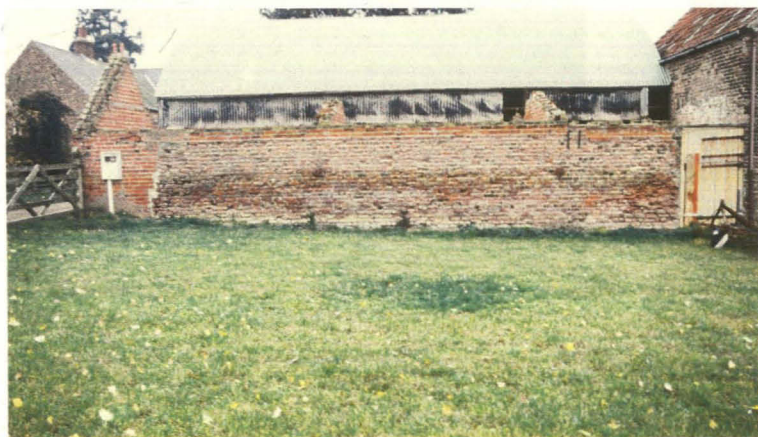
The southeastern range shows considerable evidence of restructuring and rebuilding. The southeastern elevation has been extensively patched, and two internal brick partitions have been inserted. The partitions are tied into the external walls by steel bracings and ties. The considerable rebuilding of this range and its present derelict state make the interpretation of its original function difficult.

Plate 4 Southeast wing,
looking northwest

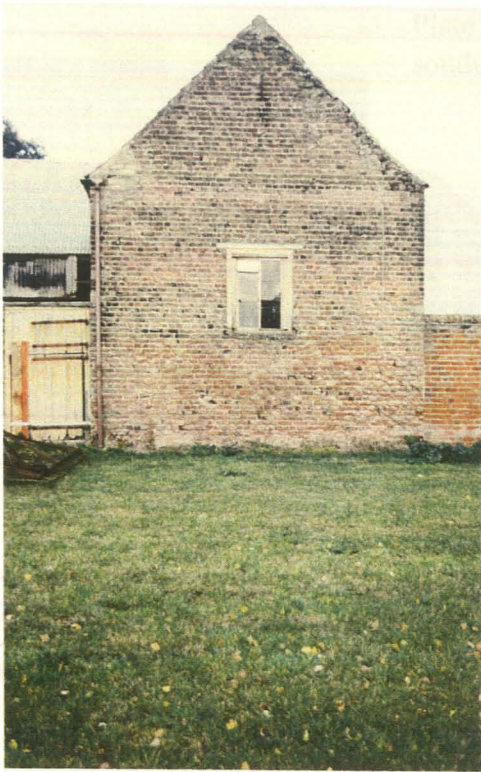
The northeastern range comprises the main barn, which adjoins a later two-celled extension. The main barn is constructed of handmade red brick again in English Garden bond. The structure is opened to its pitched roof. Timber trusses support a red pantiled roof, which has the occasional clear tile to allow additional light into the barn. Current access to the barn is

Plate 5 Northeast wing-main barn,
looking northwest

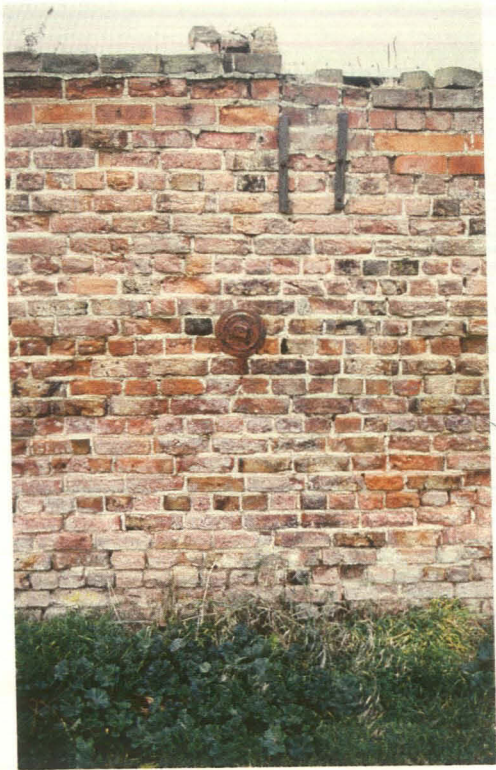
The range has been divided into three cells by the insertion of later internal brick walls, which have been pinned by RSJs and iron tiebars. The floors are concreted throughout the range, and are considerably overgrown with vegetation. The only visible signs of internal fixtures and fittings was in the southwestern cell where recesses in the brick wall indicate the removal of a feeding trough. An external wooden dutch door at the northeasternmost end of the building range provides access to the adjacent paddock and creates a straight joint between the range and the main barn. Scarring of a pitched roof that would have adjoined the range to the main barn was evident on the southwest elevation of the main barn. The range is in a very poor state of preservation, with the bricks showing signs of efflorescence (the leaching of salt from the bricks).

Plate 9 RSJ in
southeastern wing

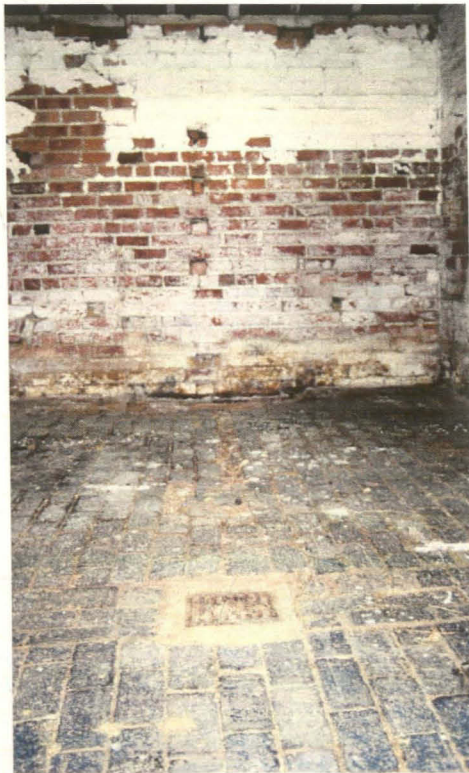
The stable block, detached from the main farm buildings, appears to form the third structural phase. The styles of the doors, windows, brickwork and floors suggest the block is probably late 19th century. However, the stable block appears on the 1890 OS map, indicating its existence by that date. The block is in a good state of preservation suggesting that it maintained its function until relatively recently. The stable is divided into four stalls with the southwesternmost stall probably functioning as a tack room. The two middle cells may be loose boxes (Barnwell and Giles, 1997). The block is well lit by the provision of windows and dutch doors, features typical of farm yard stable blocks where the horse is considered higher in status than other farmyard animals (Brunskill, 2000). Complete remains of brick flooring were present in each stall, with the type of brick and bonding pattern differing between each stall. The brick flooring would have facilitated the removal/cleaning out of manure.

Plate 16 Brick flooring in northeastern stable compartment

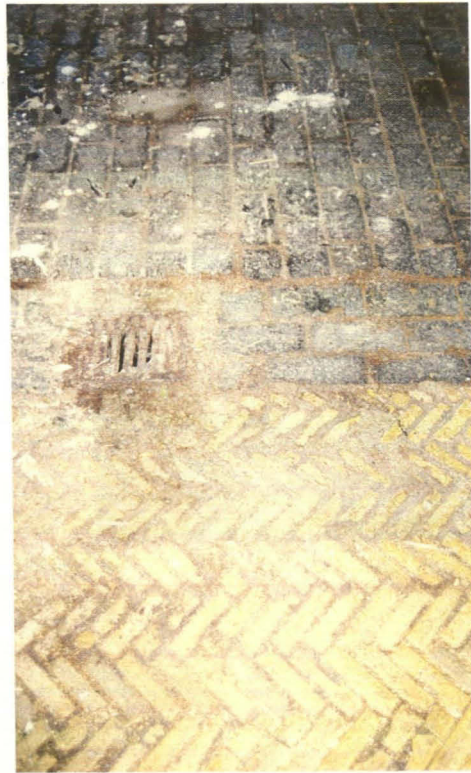
Plate 17 Brick flooring in central stable compartment

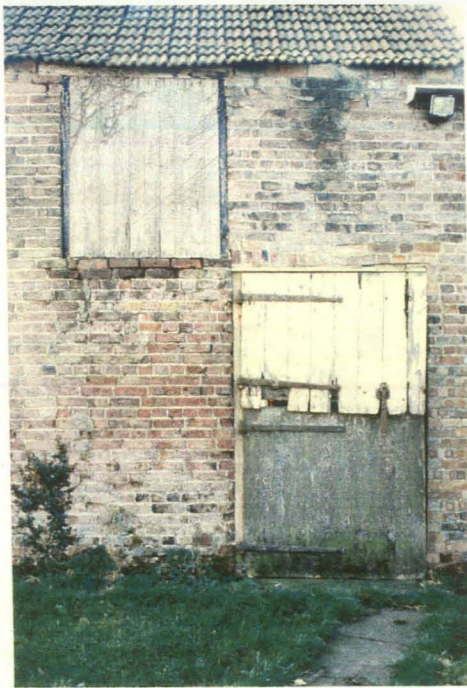
provided by two wooden dutch doors directly opposite each other at the northwestern end of the barn. Two opposing large brick blocked arches were present at the southeastern end of the main barn, both of which had the later insertion of wooden framed windows that are presently boarded up. Additional wooden framed windows were present in the southeast gable and adjacent to the door in the northeastern elevation. Brick patching at the northwestern end of the barn suggests the removal of an internal partition wall.

Plate 19 Dutch door and boarded window- main barn, looking southwest

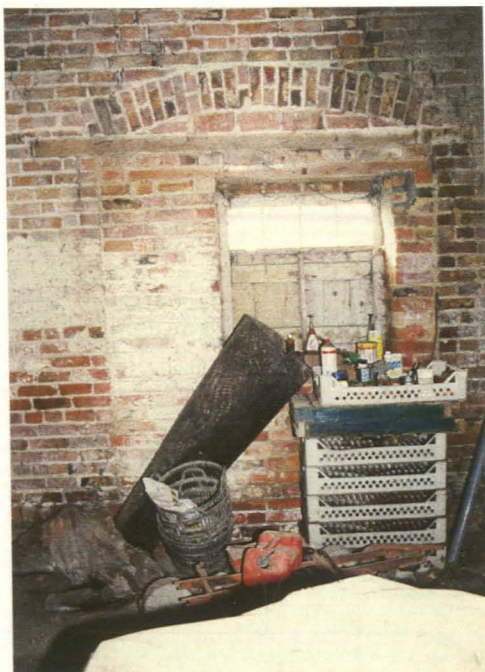
Plate 21 Blocked arch and boarded window-main barn-southwestern elevation, looking southwest

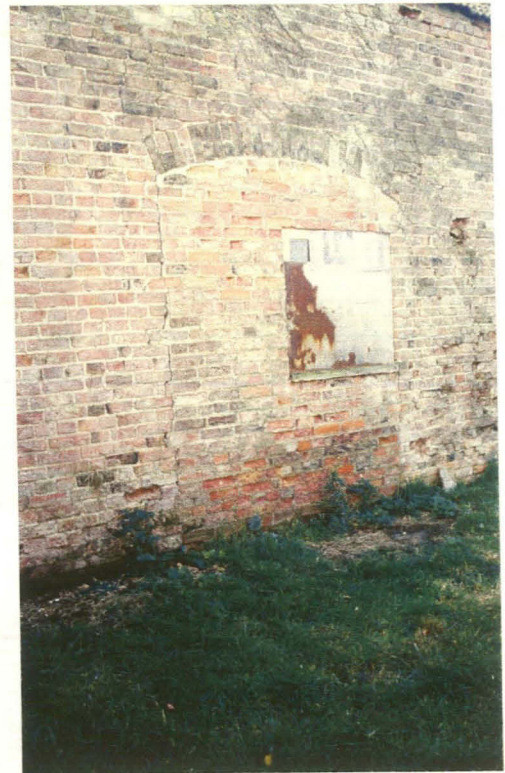
Plate 20 Blocked arch and boarded window-main barn-northeastern elevation, looking southwest

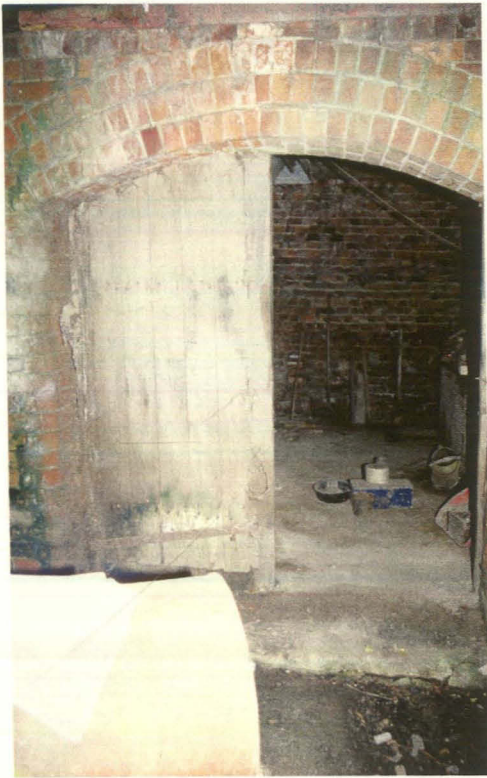
A double door set in a chamfered brick arch provides access to the smaller of the cells. The northwestern gable is in poor condition with the wall bowing out. Again a reused timber with peg holes is present in the gable wall. Fragments of the walls have been rendered with concrete. A timber framed window overlooks the courtyard.

Plate 22 Arched doorway
into smaller barn cell,
looking northeast

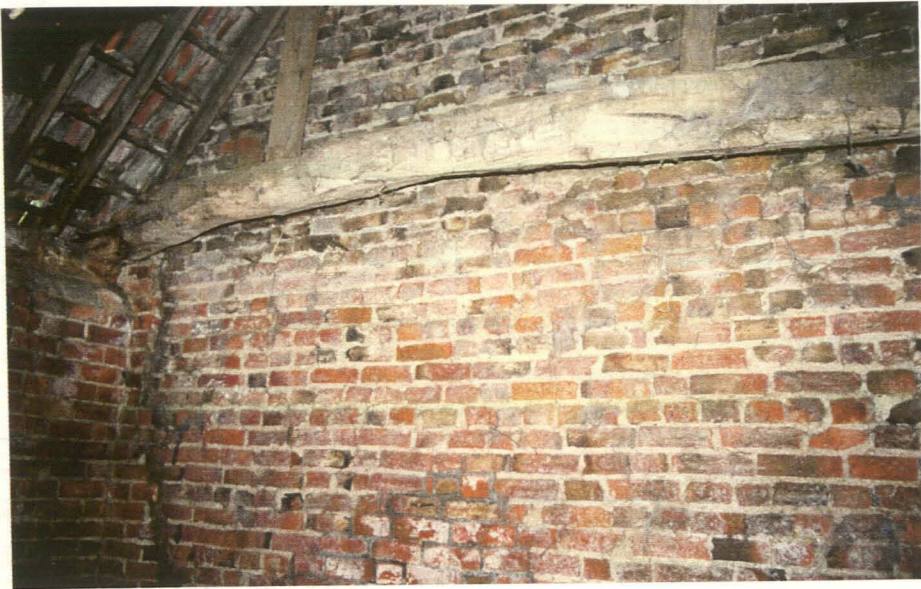
The second construction phase is the addition of a smaller barn to the main barn. This structure was later divided into two cells, with the divide containing a large reused timber beam. An additional timber beam was also identified in the northwestern gable. Both of these beams have peg holes, demonstrating that they have been reused from elsewhere. It is

Plate 29 Reused timber beam in smaller barn, looking northwest

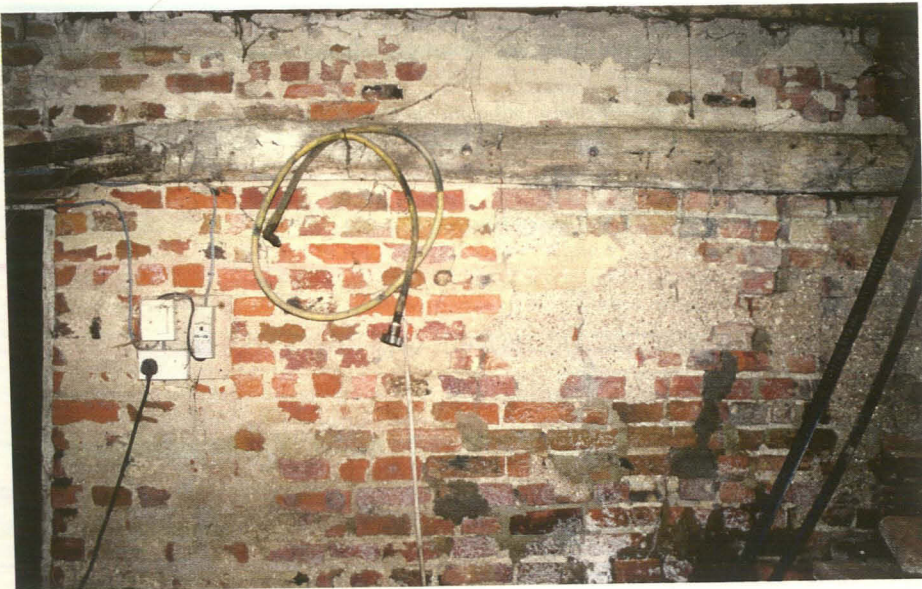
Plate 30 Reused timber beam, looking northwest

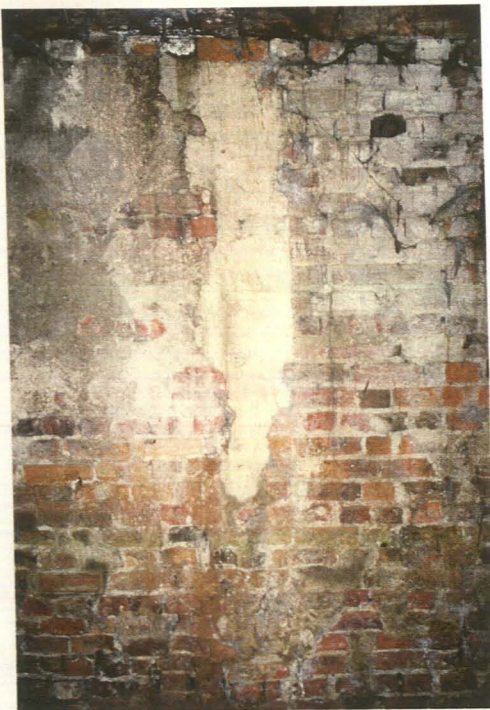
Evidence of a further internal divide was identified in the larger cell with the concrete scarring of two vertical narrow linear marks centrally located within the barn.

Plate 31 Scaring of internal divide, looking southwest

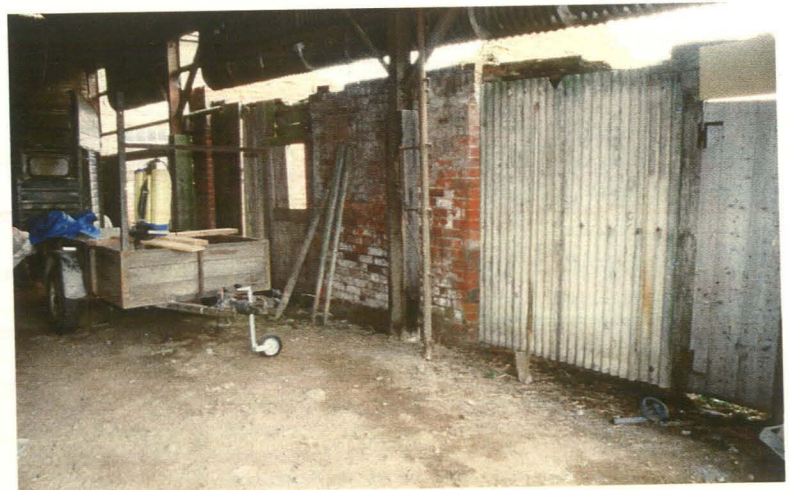
Linking the southeastern, northeastern and northwestern building ranges is a corrugated dutch barn. The barn is roofed by an arched corrugated steel roof, which is supported by a steel frame that is attached by brackets to the earlier building ranges. Filling any open spaces between the earlier buildings and the corrugated roofs is wooden shuttering supported by a wooden frame. The front/southwestern elevation differs, as corrugated steel forms a large wall up to roof height. The corrugated steel is set on a short wall capped by bullnose bricks contemporary with the northwestern range. The wall would have enclosed the original courtyard. Vehicle access from Skeldyke Road to the barn was by large double steel

Plate 32 Covered courtyard, looking east
