**HISTORIC BUILDING SURVEY REPORT:
HARDINGS FARM, LISSINGTON,
LINCOLNSHIRE**

Planning Reference: 125521
NGR: TF 0994 8485
Site Code: LIHF 10
LCCM Accession Number: 2010.110
OASIS Reference Number: allenarc1-80430

By
Allen Archaeology Limited
Report Number 2010043

August 2010

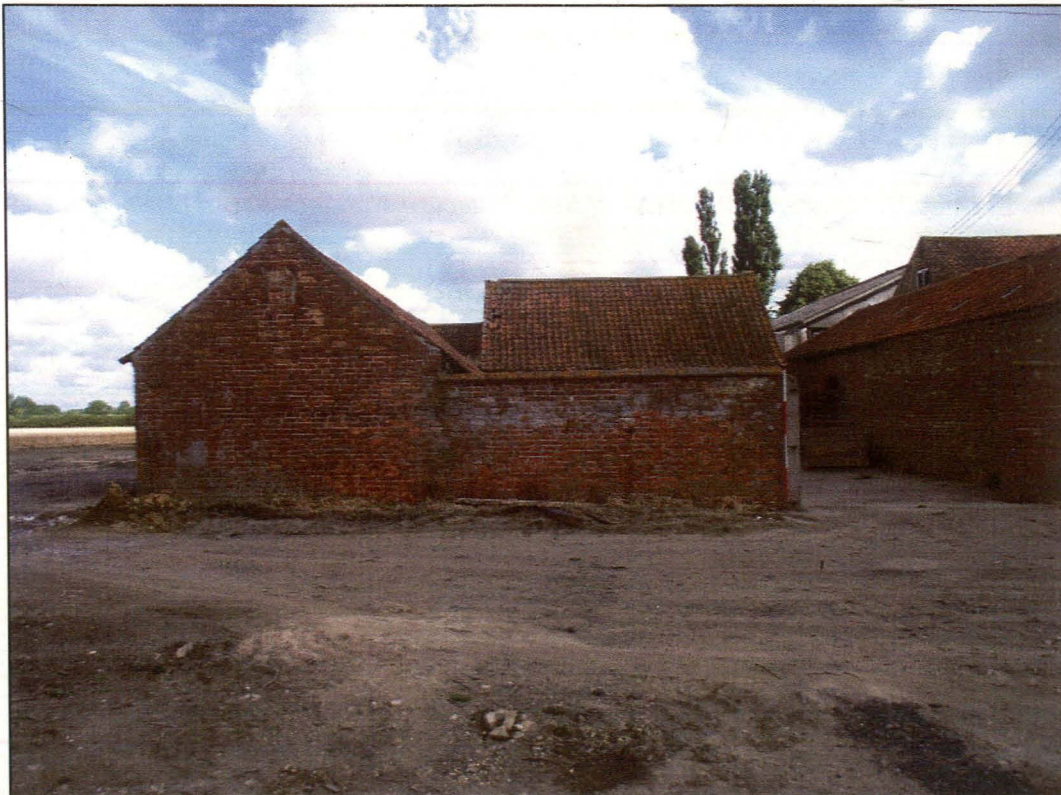
- 6.1.2 A1 is a three bay structure open on its east elevation, divided by three wooden columns, with the northern and southern examples on a concrete pad (Plate 1). The south gable show signs of later brickwork near the apex of the roof. This is likely to be a repair rather than a blocked up opening since there is no sign of any previous arch or a wooden lintel. A brick boundary wall extends eastwards from the south-east corner of the building (Plate 2). The west-south-west elevation has brick dentilation beneath under the eaves and two wooden double barn door openings accessing A2 and A3. (Plate 3).

Plate 2 (Shot 8): South-south-east elevation of Block A with brick repair on the gable of A1, looking north-north-west

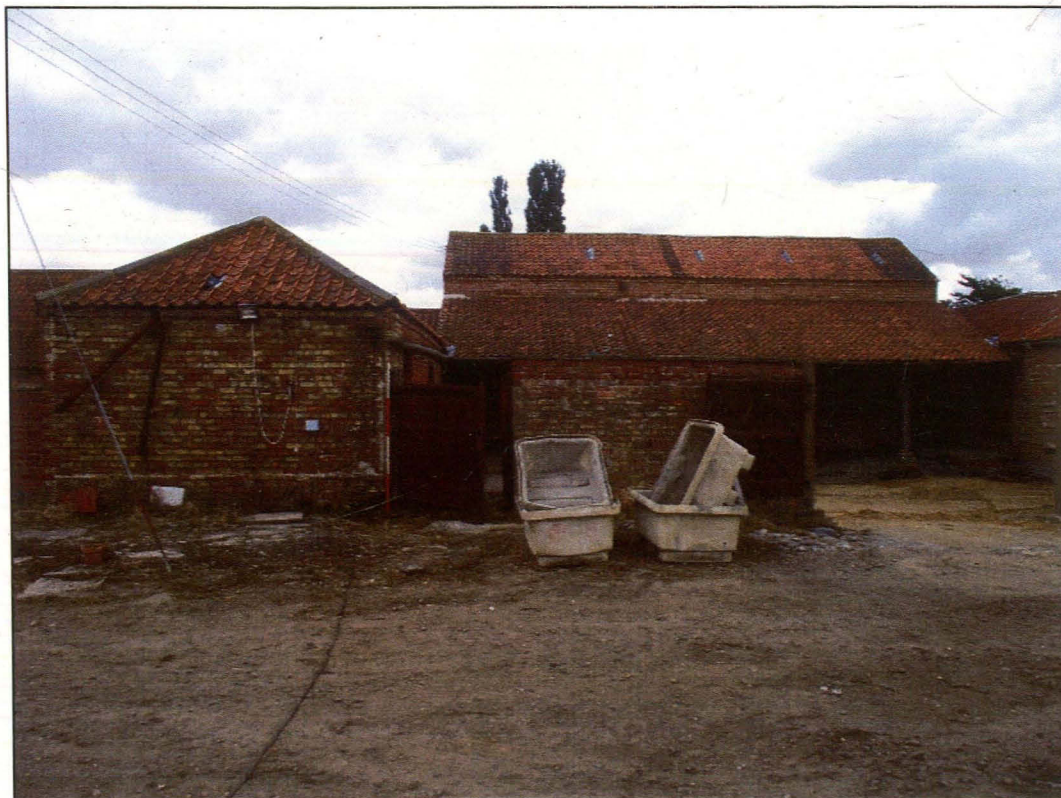
Plate 14 (Shot 21): General shot of south-south-east elevation of the western range. A clear glass pantile has been used to repair the roof. Looking north-north-west

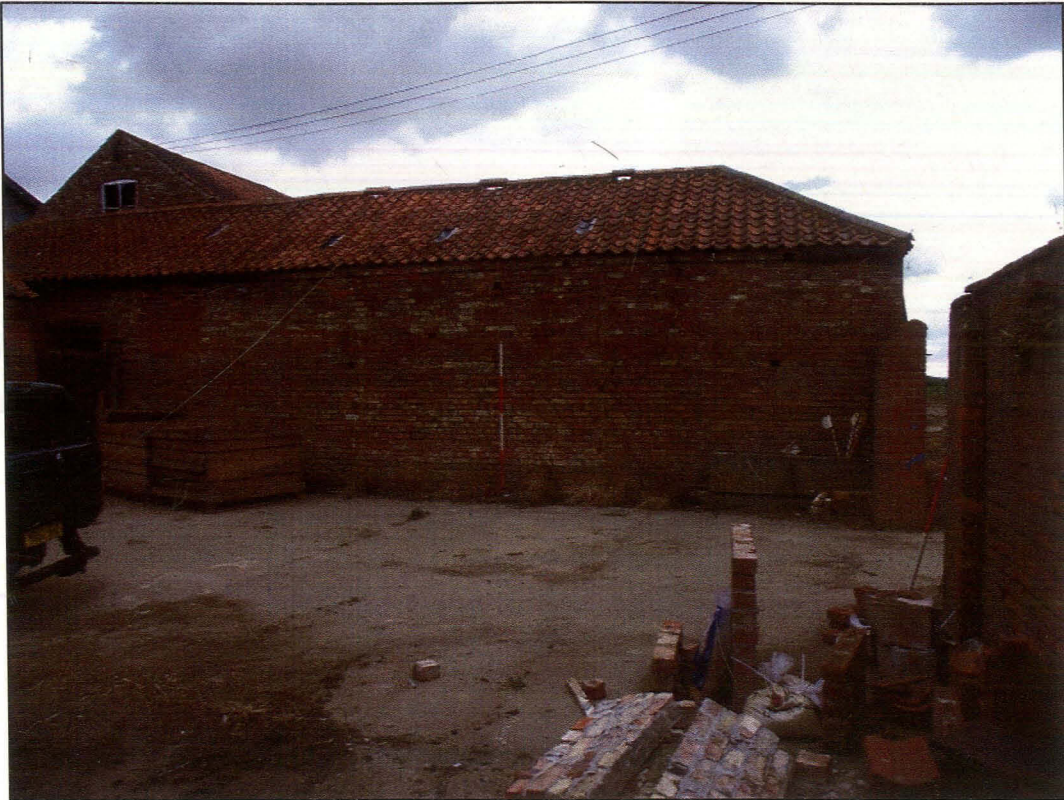
- 6.2.2 The east elevation of the west range, facing the crew yard, has three openings into B1, B2 and B3, each with wooden stable doors (Plate 13). The west elevation of B1 to B3 has few features of note, other than a bricked-up opening in B3, a number of small ventilation holes, and occasional small brickwork and concrete repairs (Plate 15).

Plate 15 (Shot 20): West-south-west facing elevation of the western range of Block B showing recent brickwork repair adjacent to door, looking north-east

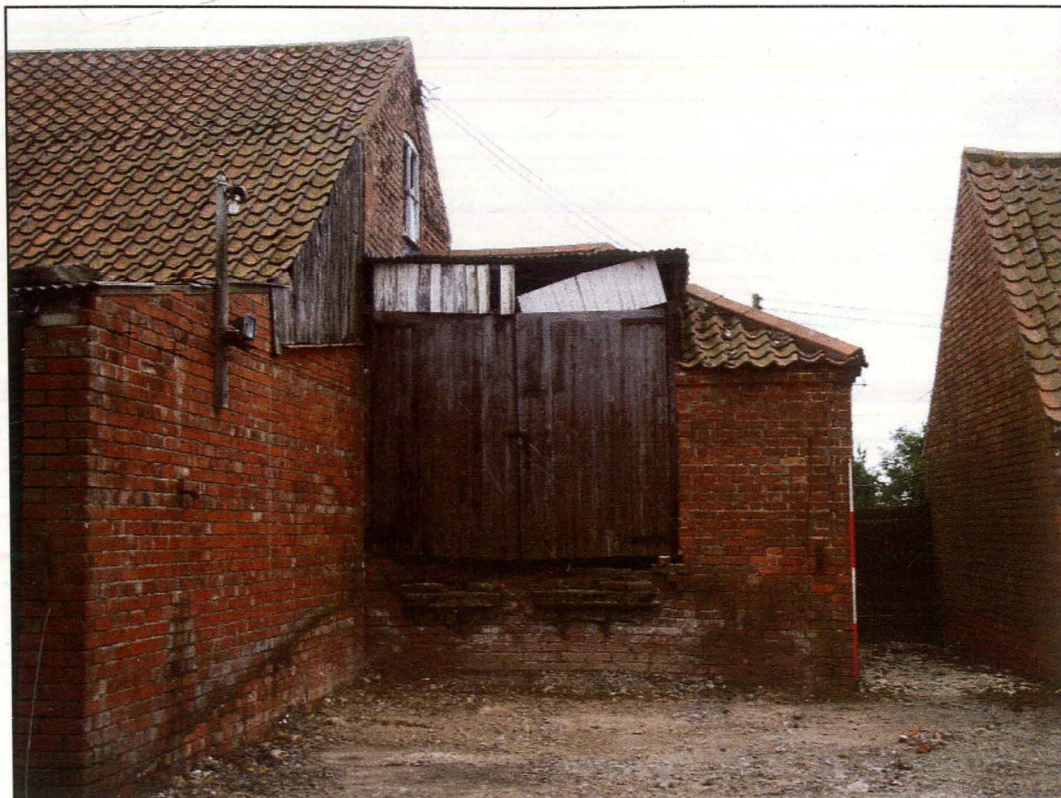
Plate 17 (Shot 27): North-north-west elevation of western range of Block B. The adjacent elevation of the lean-to shows scarring of a modern ramp that was recently removed. This shot also shows the recently raised roof above the double barn door. Looking south-south-east

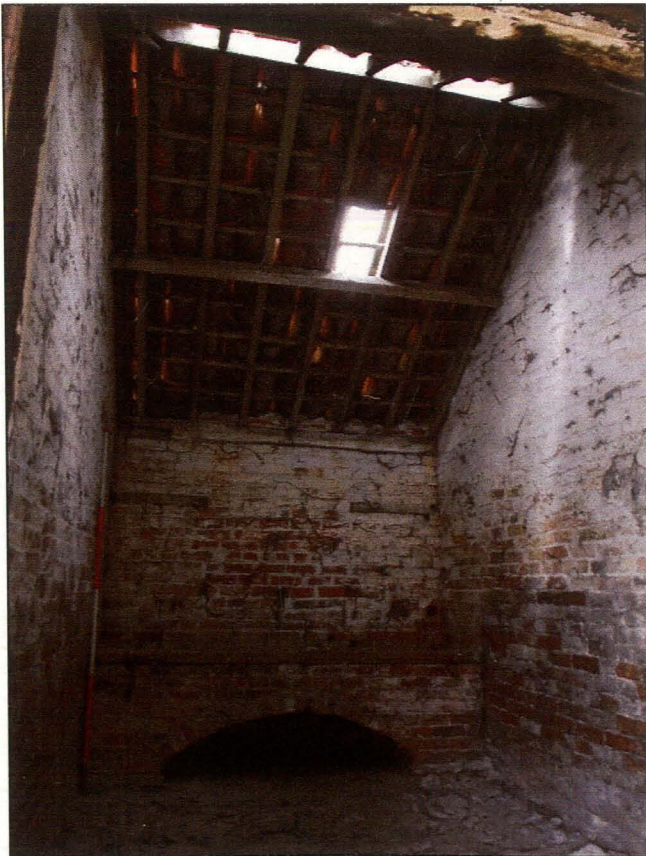
Plate 20 (Shot 46): Interior of barn B3 showing roof structure, broken cement floor and feeding trough. Looking west-south-west

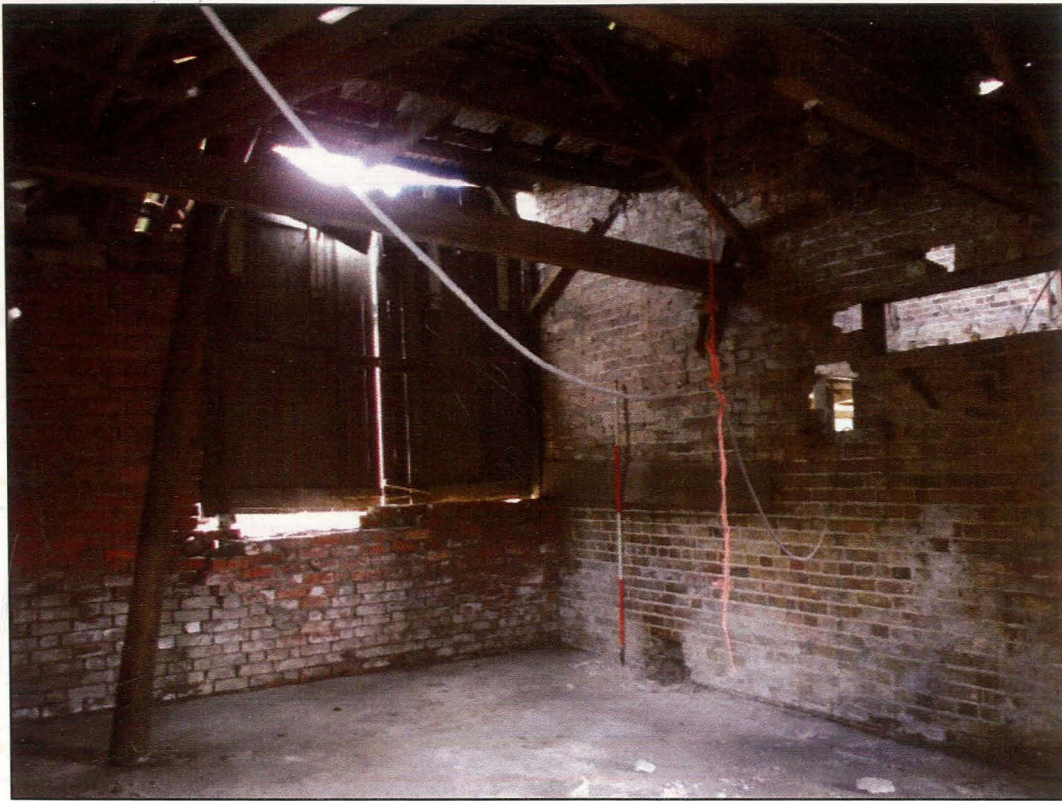
- 6.2.6 Elements of barn or store B4 were in a poor state of repair, with the eastern wooden door hanging off its hinges and an unstable roof structure, possibly a result of the raised roof above the double door opening in the north elevation (Plates 21 and 22). A probable machinery opening supported by a wooden lintel had been made through the adjoining wall with B6. The coupled rafter roof consisted of through purlins and two collar beams with a ridge piece and several ad hoc modifications (Plate 23).

Plate 21 (Shot 48): Interior of barn B4 showing collapsing roof and machinery opening on the west-south-west facing elevation. Looking north-north-east

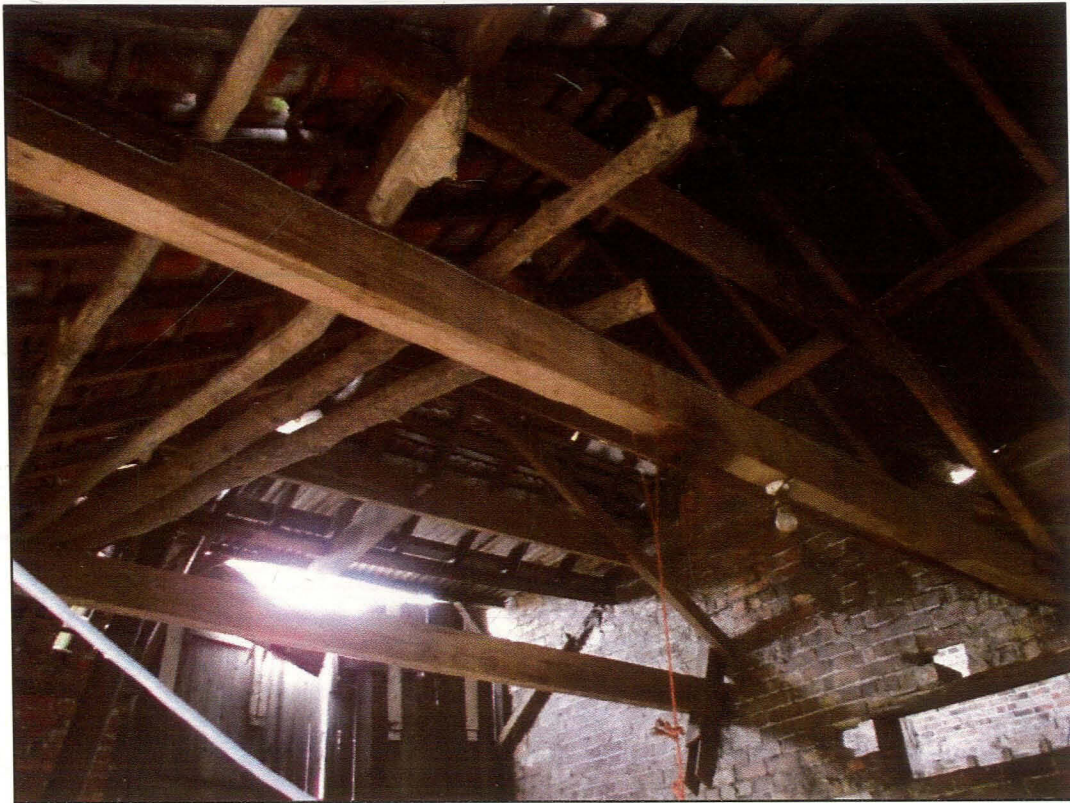
Plate 23 (Shot 52): Roof structure of barn B4, looking north

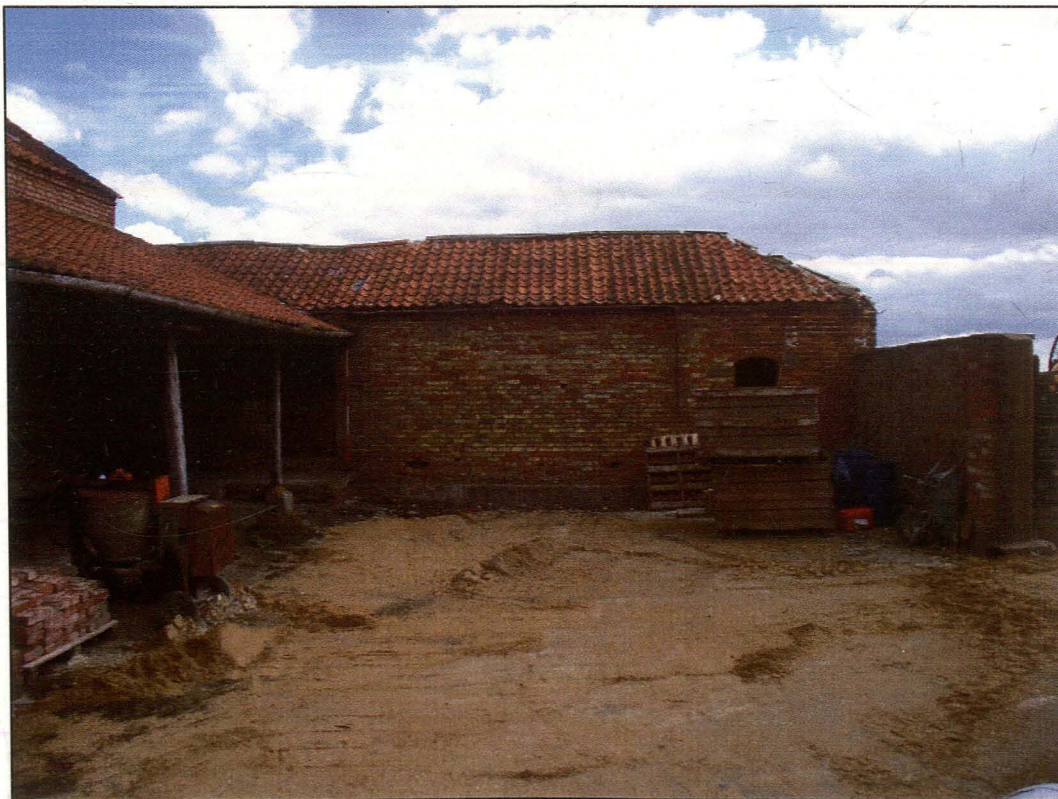
- 6.2.12 On the eastern range, barn B8 and store B9 can be accessed from the west-south-west facing elevation. The polychrome brickwork shows evidence for repairs to the exterior of store B9 at the southern end of the range (Plate 34). The southern elevation of B9 has a wooden door and adjacent bricked up opening to its right with a rounded brick arch (Plate 34). Barn B10 and store B11 are both accessible from doors in the east-north-east facing elevation (Plate 36).

Plate 34 (Shot 40): West-south-west facing elevation of the eastern range of Block B showing access to barn B8 to the left and store B9 to the right. Looking east-south-east

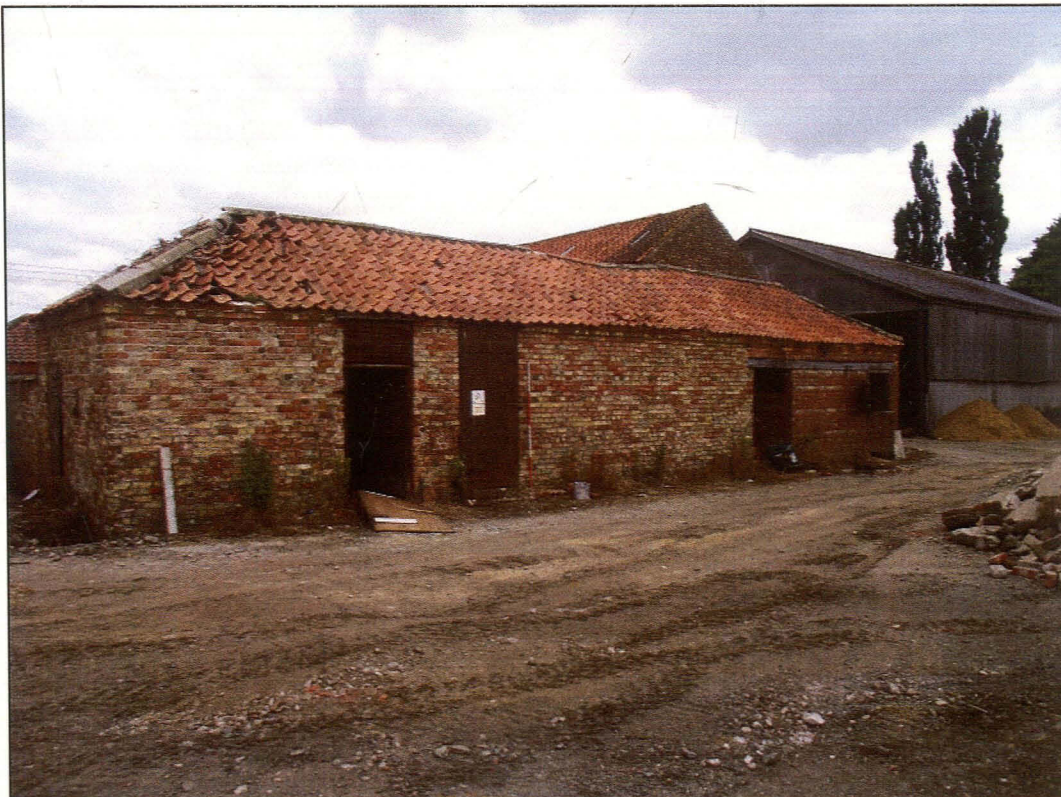
- 6.2.13 The northern end of the eastern range consists of a grain-dryer B7 with a coupled rafter roof, representing the latest addition to this block with modern brickwork repairs (Plate 36). A brick partition wall separates the grain-dryer from an aisle leading into the crew yard. Internally, there is a modern metal funnel against the west elevation, connected to an opening running under the floor surface and exiting the building outside the eastern elevation. This is likely to be part of the grain-drying process (Plate 37 and 38).

Plate 36 (Shot 23): East-north-east facing elevation of the eastern range of Block B showing openings to barn B10, store B11, access to crew yard and an opening to the grain dryer B7. Looking north-west

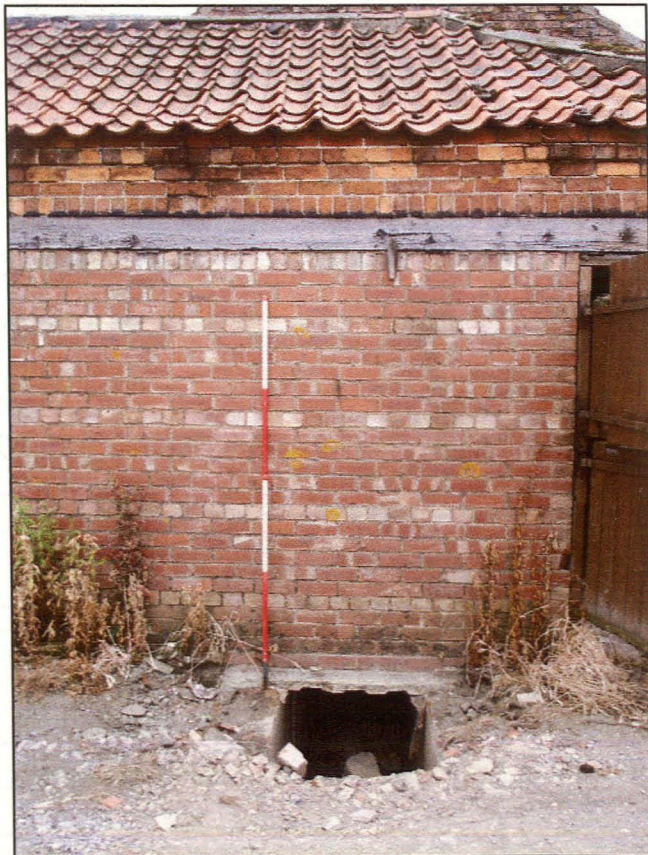
Plate 38 (Shot 72): Exterior shot of the grain-dryer B7 with modern brick work with an English Garden Wall Bond below the wooden beam. Looking west-south-west

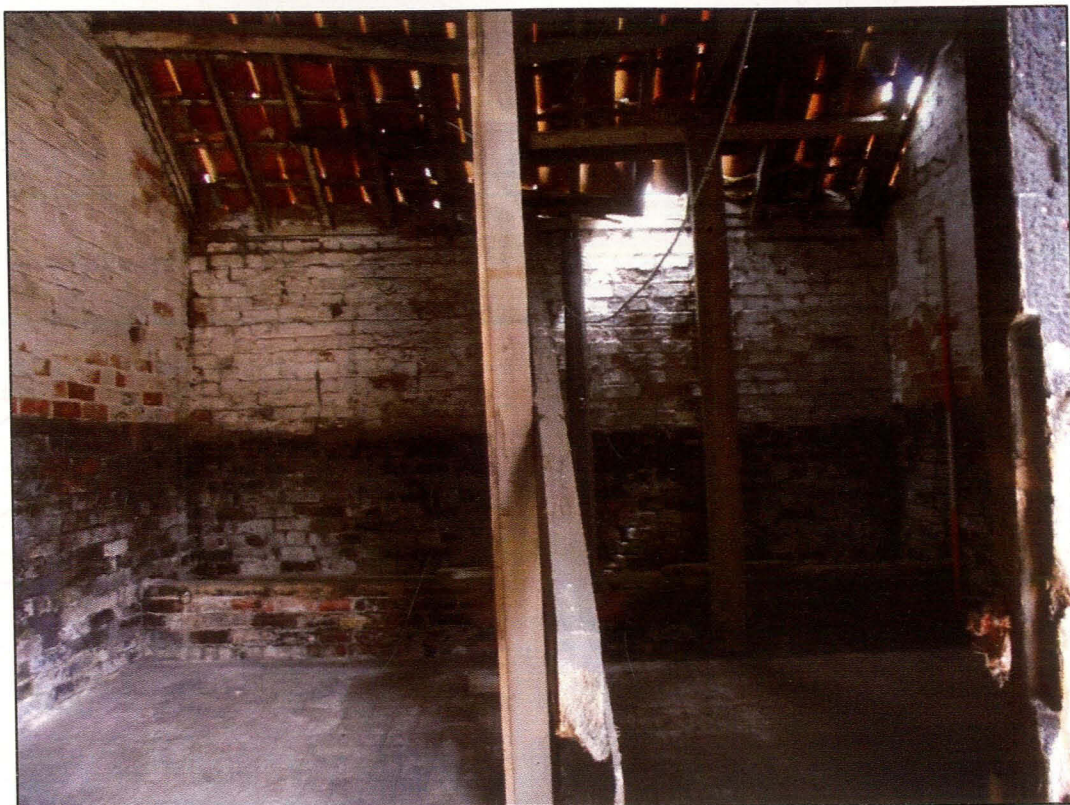
- 6.2.14 Barn B8 is located on the opposite side of the aisle, to the south of B7. Modern repairs have been made to the roof which is still slightly slumping, and it is held up by wooden support

Plate 39 (Shot 75): Interior shot of barn B8 with broken roof structure and raised floor with a feeding trough at the far end. Looking east-north-east

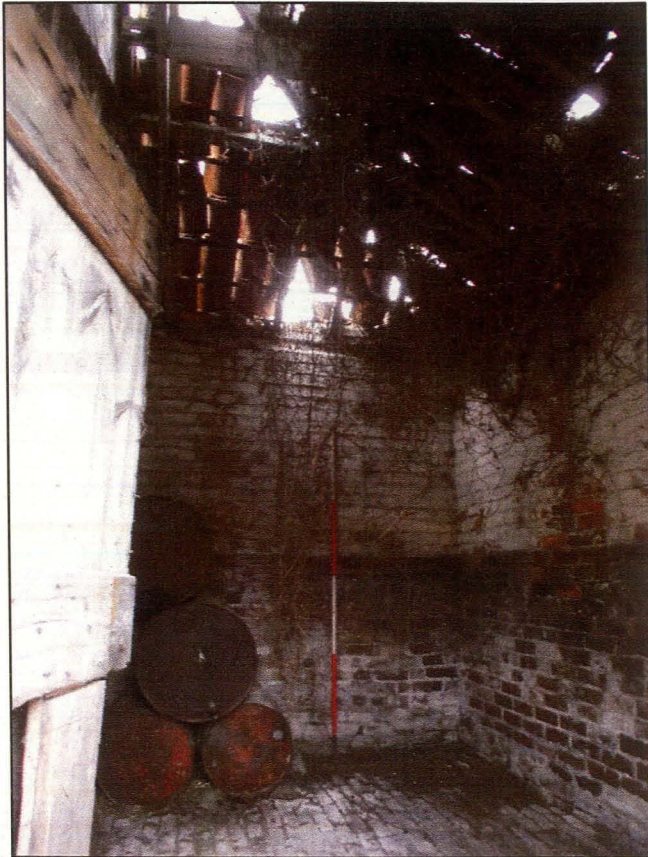
Plate 41 (Shot 77): General view of store B9 showing intruding vegetation from the roof. Looking east-south-east

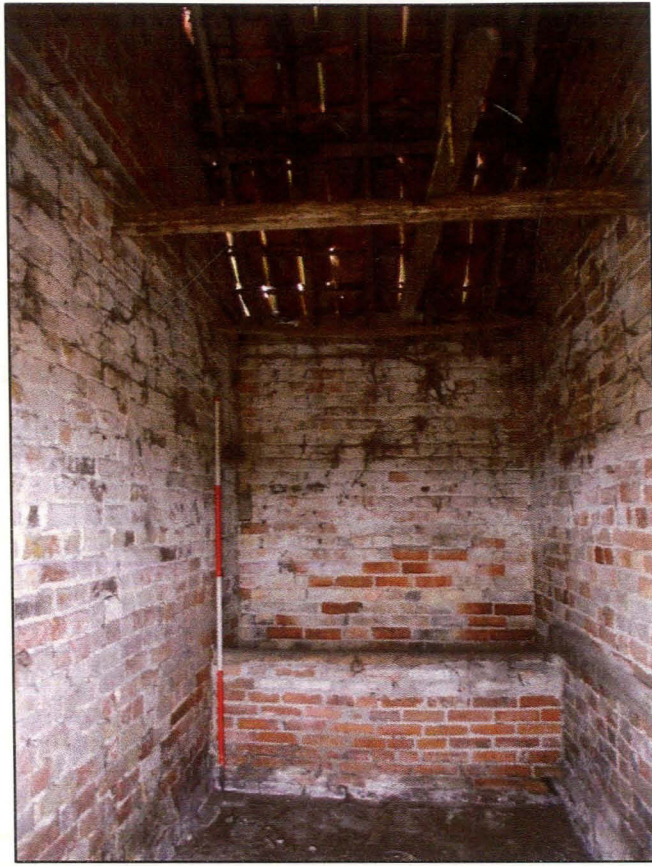
Plate 43 (Shot 81): Barn B10 showing feeding trough. Wooden beams have been installed to perhaps offer wall support. Looking west-south-west
