BUILDING SURVEY OF FARM BUILDINGS AT MAIN ROAD, HOLLAND FEN, LINCOLNSHIRE (HFM02)

Work Undertaken For Mrs J. ENGLAND

January 2003

APS Report No. 231/02

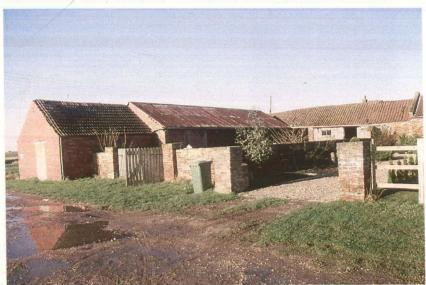
> The third phase of building is the addition of a room at the southeasternmost end of the wing constructed of machine made brick and pantiles supported by machine produced trusses (Plates 2 and 6). This

Plate 2 Section of barn, looking northwest

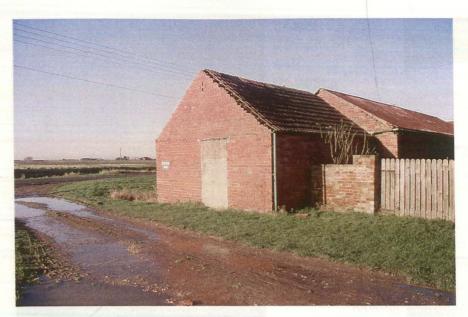
room has a raised concrete floor creating a step up from the central open plan area, and is entered by wooden dutch doors. An external door in the eastern gable is presently blocked and has been rendered with concrete (Plate 5).

The third and final construction phase is predominantly represented by the addition a room at the southeasternmost end of the southeast-northwest wing. This room, unlike any other section of the barn, is constructed entirely of machine made brick with the concrete floor being raised from the main open cow shed area. A former entrance in the eastern gable has recently been blocked.

Plate 5 Southern elevation, showing blocked doorway, looking northwest

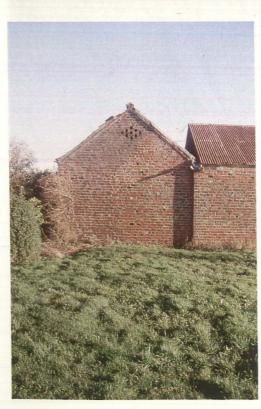
Plate 7
Western
elevation of
east-west block
showing diaper
pattern
ventilation,
looking east

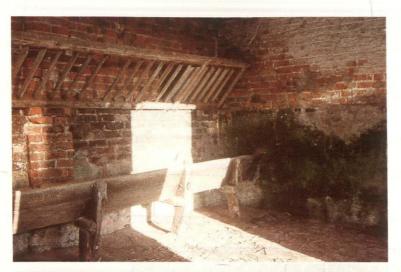
The central room had the remains of a wooden cattle trough and, above it, a feeding rack inserted along northwestern wall (Plates 14 and 16). Five wooden posts, all with metal rings for the securing of cattle, supported the cattle trough. In the wall immediately behind and above the trough were several further iron tether rings. A central plinth supporting two upright reused wooden beams supported the wooden doors located on the wall was a chamfered brick plinth extending the height of the wall (Plate 14). A third reused cross beam was chamfered and centrally overhung across the width of the room (Plates 15, 16). This reused beam had several square notches cut into it, which bore no purpose for its present function. The room still has the original hand-made brick floor, which presently forms a rough and uneven surface.

Plate 14 Cattle trough and overhead hay rack in cattle stall, looking northwest

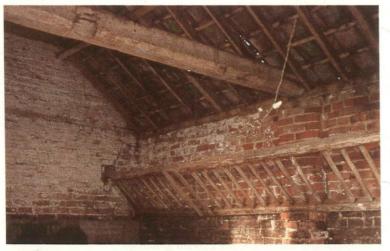
Plate 16 Hay rack and overhead beam, also showing roof detail
