**Barn adjacent to 8 Church Road,
Laughton, Lincs
Archaeological Building and Photographic Survey
NGR: SK 8501 9720
Planning Application No.: M04/P/0301
Site Code: LACR 07
LCNCC Accn No.: 2007.226**

**Report
for
Mr E. Walker
By
Naomi Field**

**LAS Report No. 1024
December 2007**

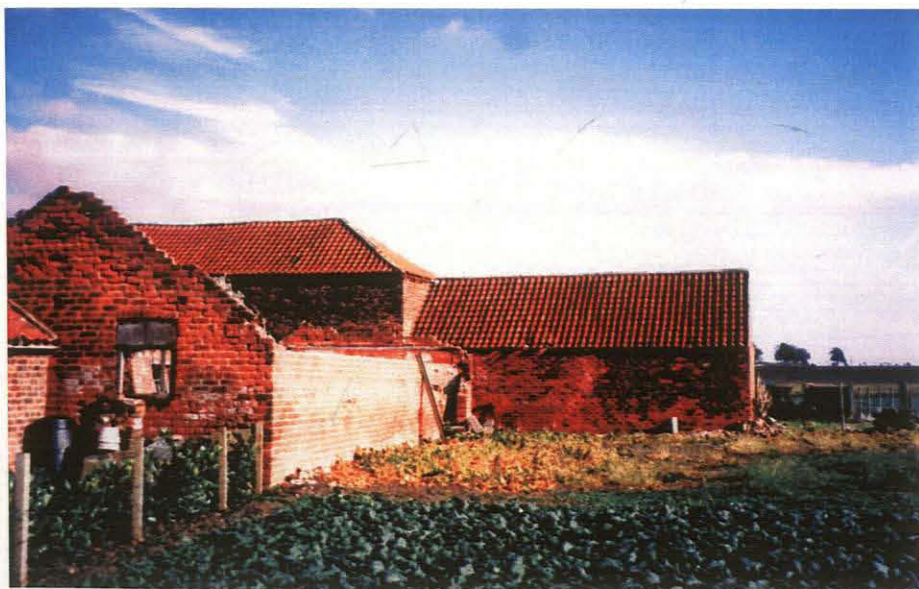
Pl. 6 Derelict stable block on south side of crew yard, looking east to cart shed (Photo, Mr Walker)

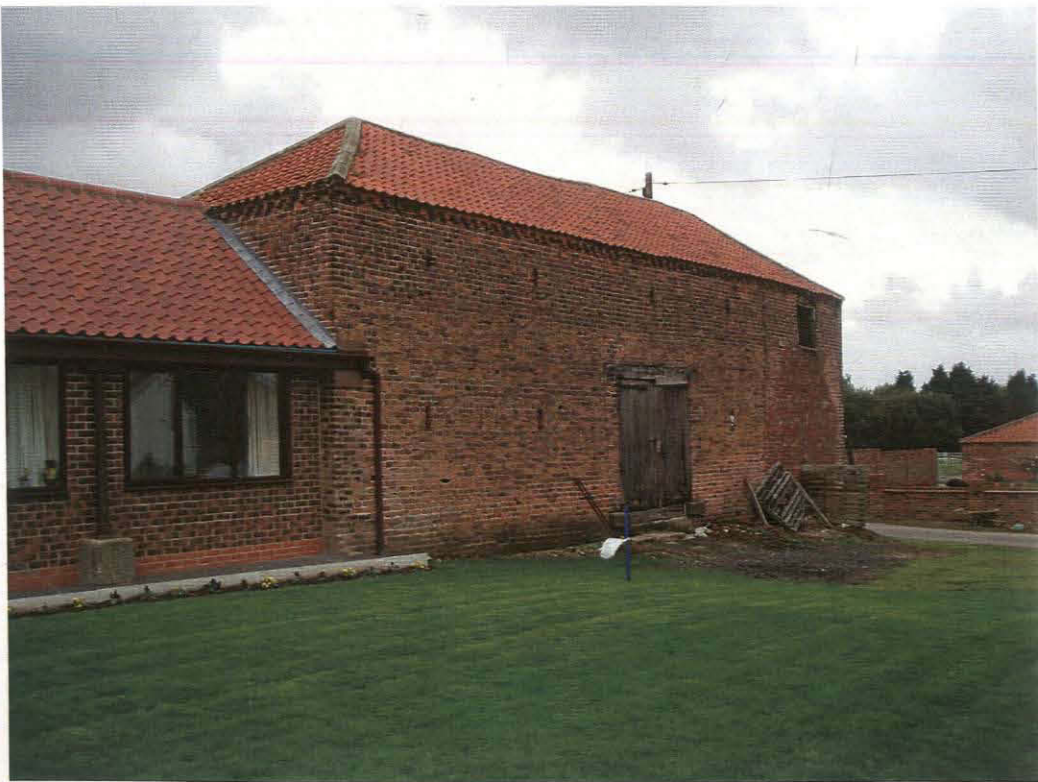
The barn is contemporary with the farmhouse and probably of early 19th century date (Pl. 8). It is of three bays and is constructed in hand-made brick measuring 210 x 102-110 x 63-65mm. The buff lime mortar beds are 15mm thick and the walls are 1 ½ bricks thick (0.34m). The pantile roof is hipped at both ends. There is a dentil course below the eaves of alternate headers that protrude from the face, with a header course above (Pl. 9). This is present on all four elevations. The south and east elevations are obscured by later buildings.

Pl. 8 The barn, east elevation, looking NW

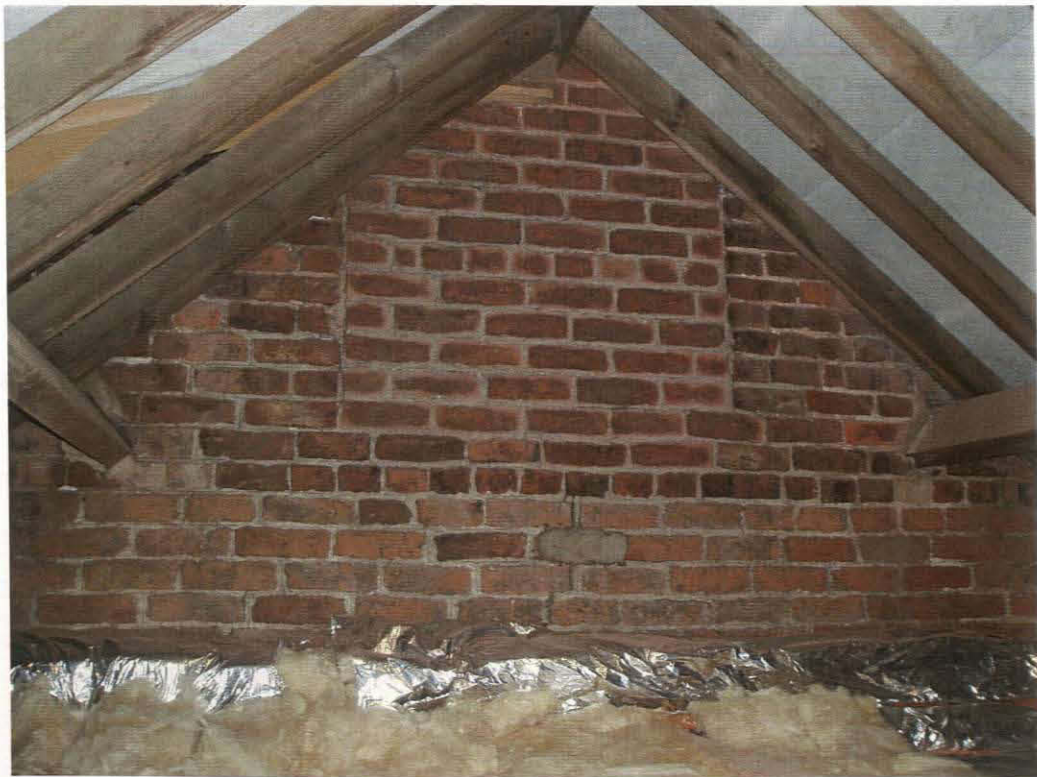
This is mainly obscured by the cart shed. There is a blocked window at first floor level, visible in the roof space of the cart shed (Pl. 10).

Pl. 10 Barn south gable (inside cart shed roof) showing blocked window

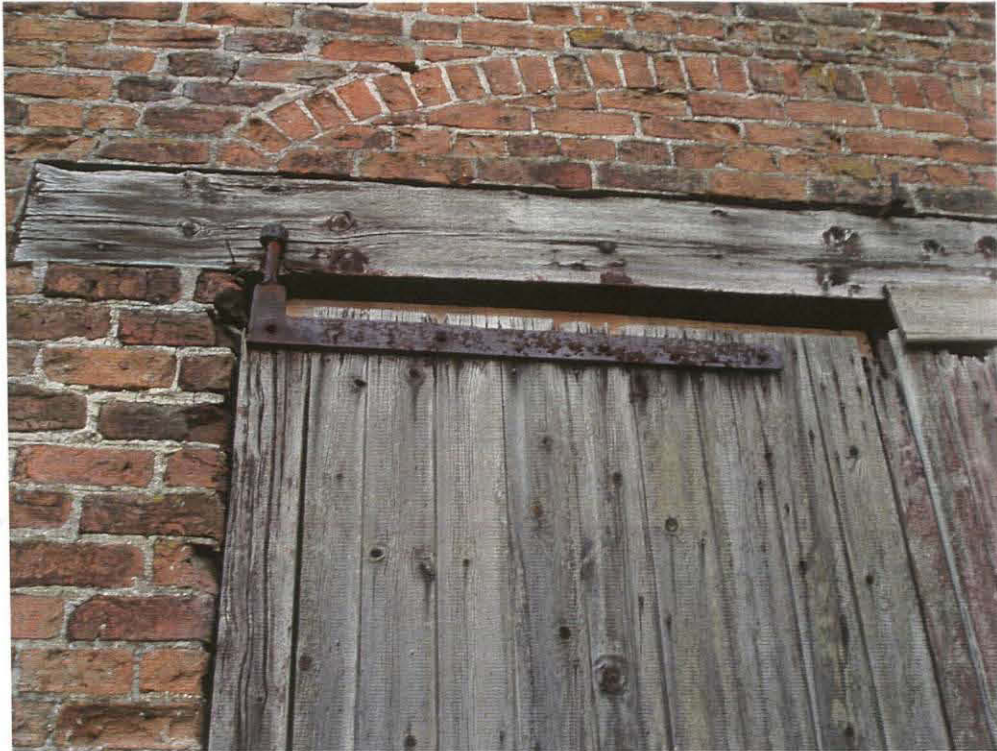
The door opening has a wood lintel beneath a brick relieving arch. The upper hinge pintles are attached to the lintel (Pl. 11). Granite slabs on either side of the double doors provide a pivot for the lower pintles which are integral with the lower door hinges (Pl. 12). There are two rows of vents on this elevation, one just below the eaves and one at c.1.80m above ground level (Pl. 13). North of the doors is a large crack in the brickwork which extends the full height of the building, at the point where the interior cross-wall is located (Pl. 13). The whole north end of the barn is slowly falling towards the road. There is a window at the north end of the elevation providing light to the upper floor of the north

Pl. 11 Barn, east elevation. Detail of double door showing lintel with relieving arch over, and upper hinge and pintle

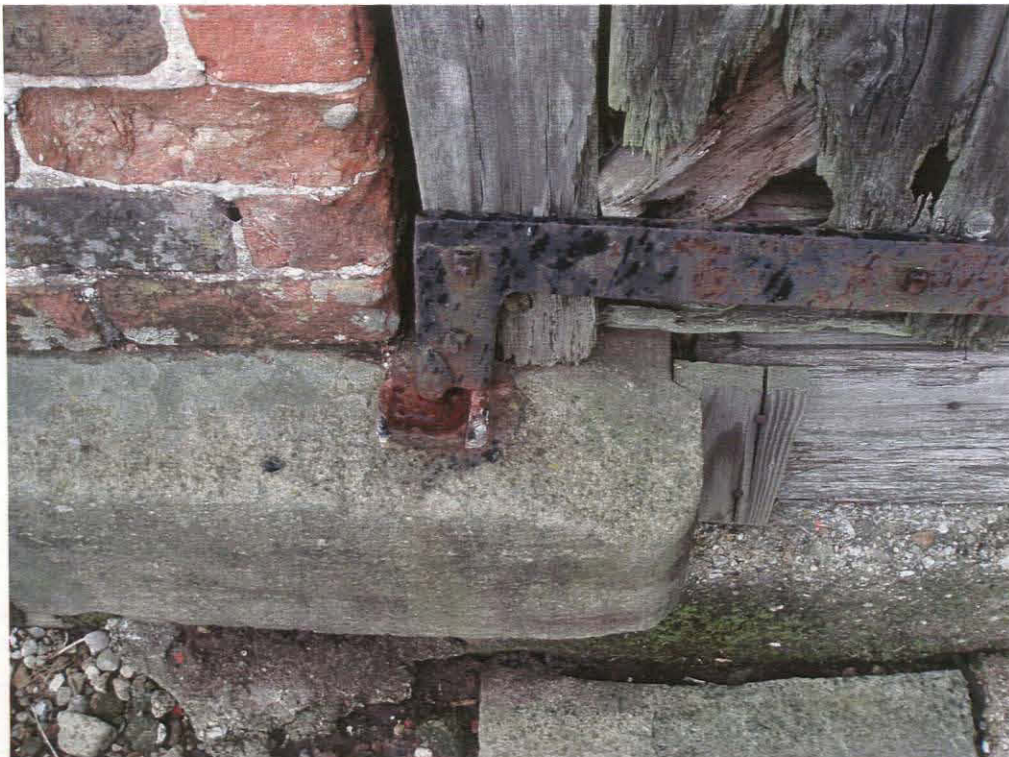
Pl. 12 Barn, east elevation. Detail of double door showing lower hinge and pintle inserted into granite block

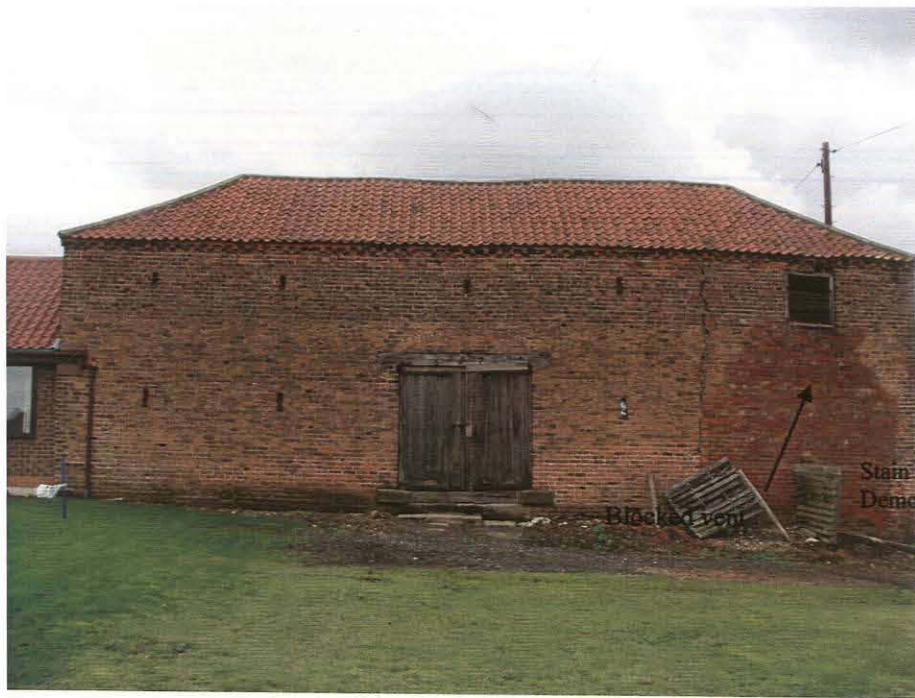
bay and a stain on the wall below the window marks the former position of a building which must have abutted the barn (the vent in the lower row has been blocked) (Pl. 13)

Pl. 13 Barn, east elevation showing two rows of vents, vertical crack, upper window at north end of building and stain marking position of demolished building

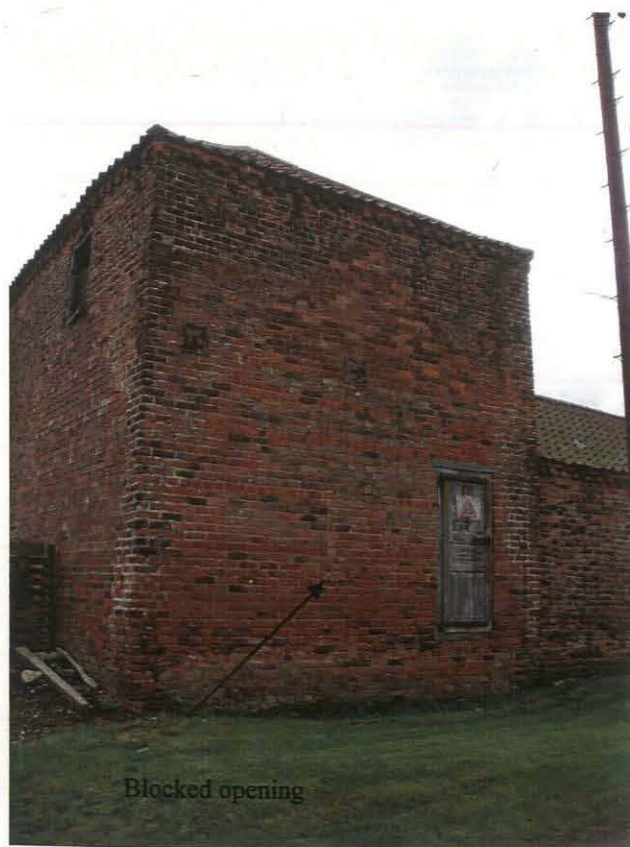
This elevation has been much repaired. There is a blocked opening 0.77m wide x 0.60m high at 1.70m above existing ground level and 2.12m west of the north-east angle of the building (Pl. 14). There is also an inserted door with a concrete threshold 1.9m high x 0.90m wide and 0.85m from the north-west angle of the building (Pl. 15). It is 0.89m above existing ground level. It has a wood lintel and there is a patch of modern brickwork above

Pl. 14 Barn, north elevation showing blocked opening and inserted door.

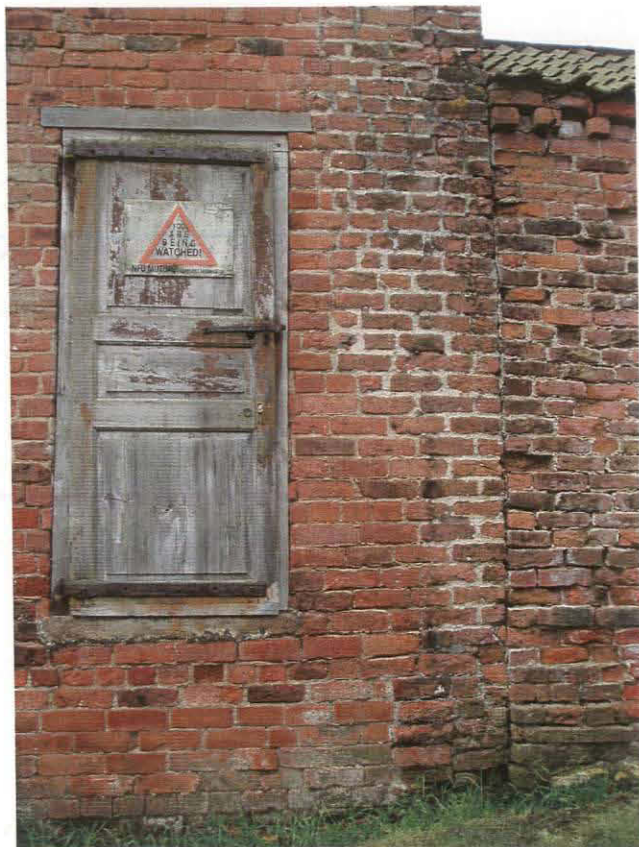
Pl. 15 Barn, north elevation showing detail of inserted door.

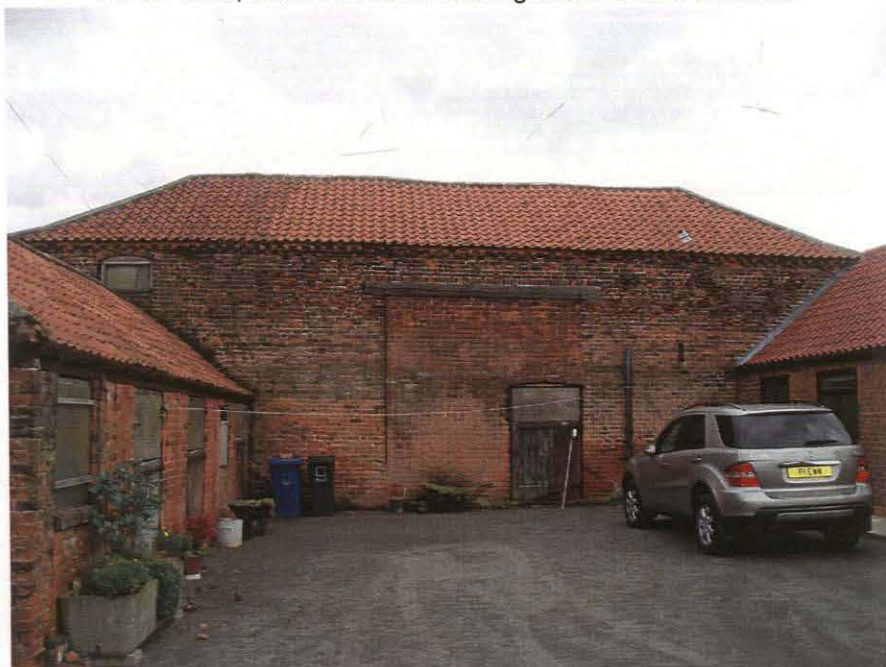
This is partially obscured at the north and south ends by the stable block (see below) and the new extension which replaced the derelict stable block (Pl. 16).

There is a window at the north end of the elevation providing light to the first floor of the north bay (as on the east elevation). The vents on this elevation have mostly been blocked. The double entrance which is opposite to that on the east elevation, has been blocked and filled with a smaller entrance. It was originally much taller than that on the east elevation and the wood lintel lies beneath the eaves with a course of soldier headers above.

Pl. 16 Barn, west elevation showing blocked double entrance and window at north end of the building.

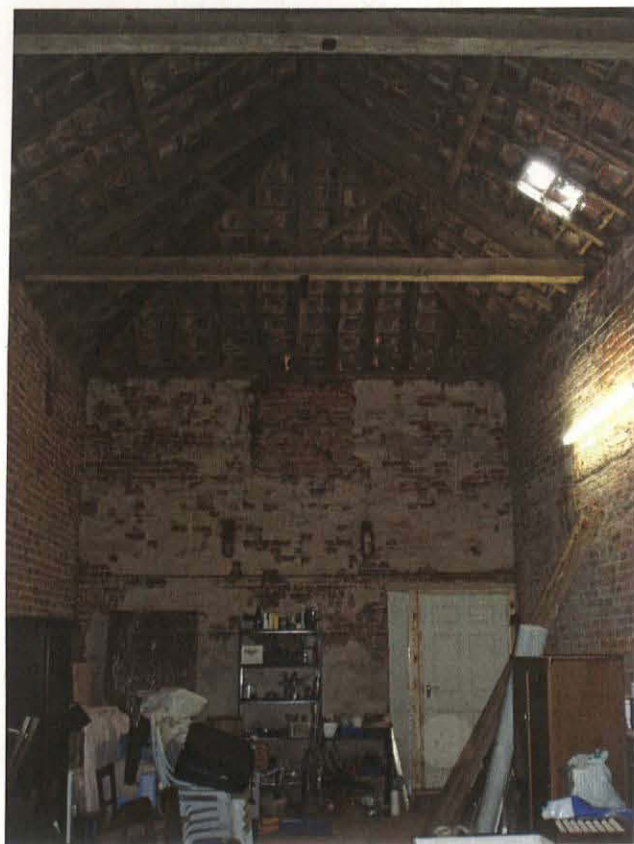
The barn originally comprised 3 bays, open internally at ground level, with central opposing entrances. There were stores above the north and south bays but the southernmost first floor has been removed (Pl. 17). The north bay has been partitioned off with a brick wall with 11 steps leading up to a door providing access but the floor inside this area has collapsed (Pls 18 and 19). As this area lies outside the proposed development area it was not viewed. The rafters and the king post trusses do not appear to be original; there are no visible carpenters' marks on the trusses (Pl. 20).

Pl. 17 Barn interior, south end showing blocked window in gable and inserted door into the house (formerly the cart shed).

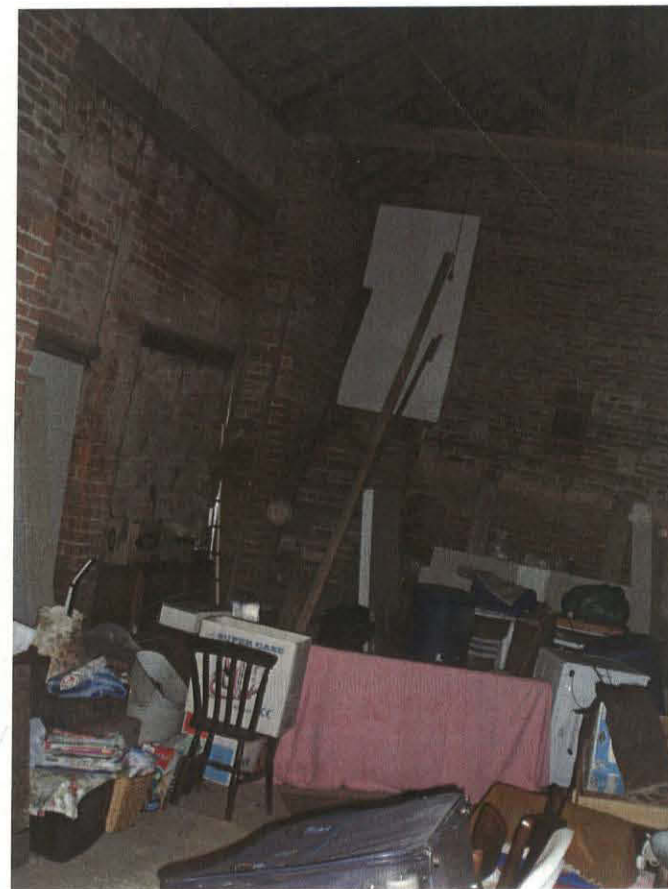
Pl. 18 Barn interior. Middle section showing blocked west door and cross wall with access to the north bay, looking north

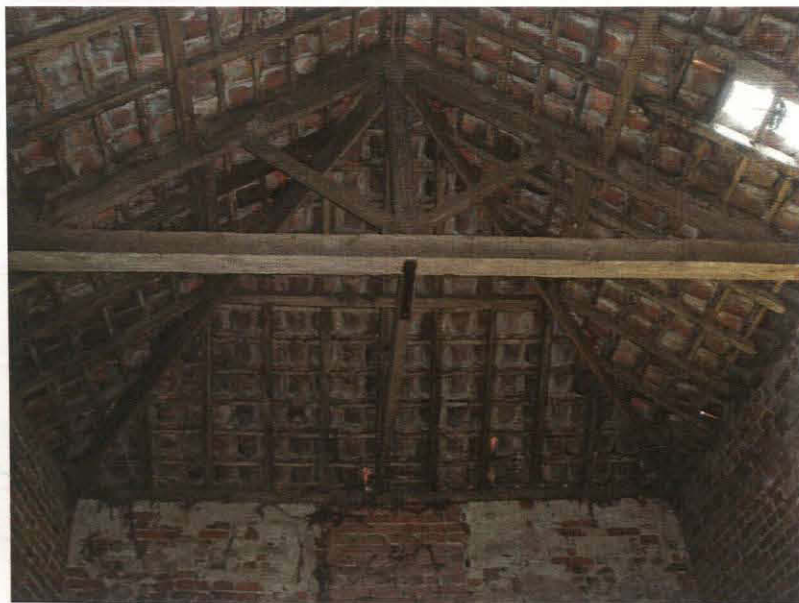
Pl. 20 Barn roof, south end, showing roof truss and hip.

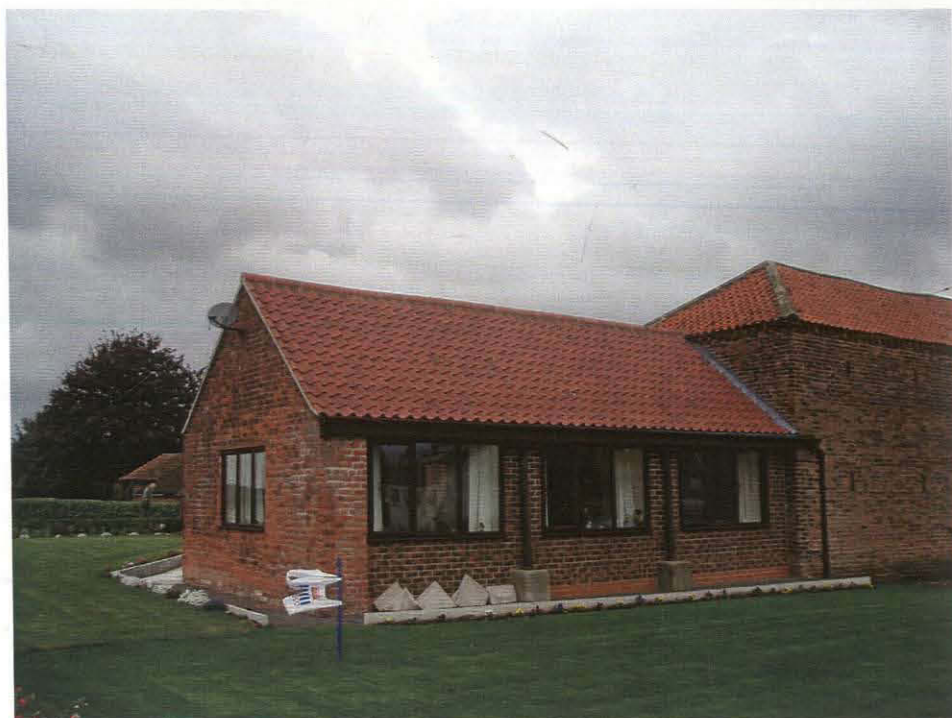
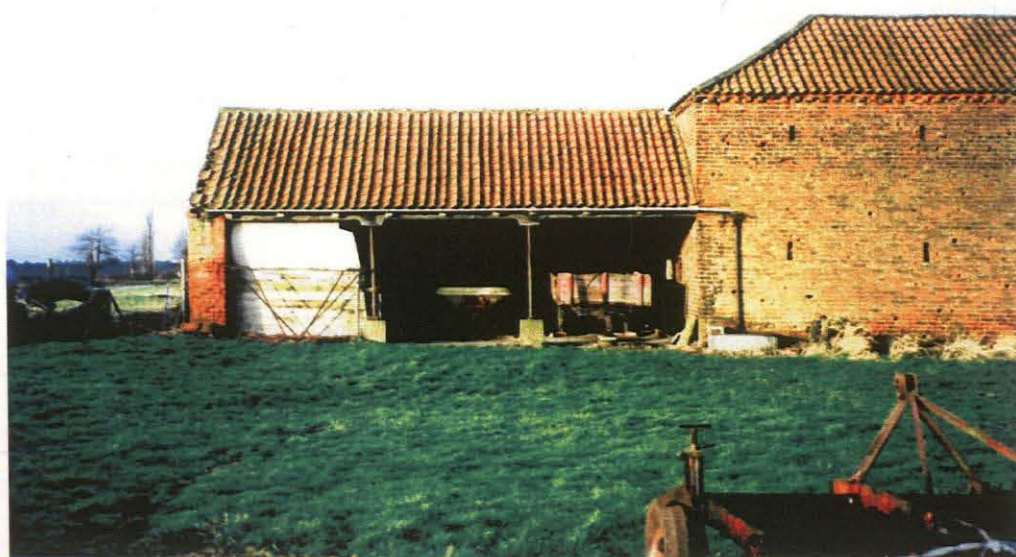
The cart shed had been converted to domestic use at the time of the site inspection (Pls 21 and 22). It abuts the south gable of the barn and is later clearly later in construction. Its red bricks are larger than those of the barn (220x100x70mm) and are machine-cut. The pantile roof is new. The east elevation was originally open, with the return of the gable wall at the south-east angle extending only 0.69m along the east elevation. This side of the cart shed was originally open and has been infilled as part of the conversion, with a window in each of the bays, separated by original cast-iron columns (5" diameter) sitting on granite stone bases, 0.23m square (Pl. 23). The bays are of unequal width (2.70m, 2.95m and 3.15m centre to centre from south to north). A window has been inserted on the south gable and a door and 2 windows on the west elevation.

Pl. 21 The cart shed south of the barn, after conversion, looking west

Pl. 22 The cart shed prior to conversion (Photo Mr Walker)

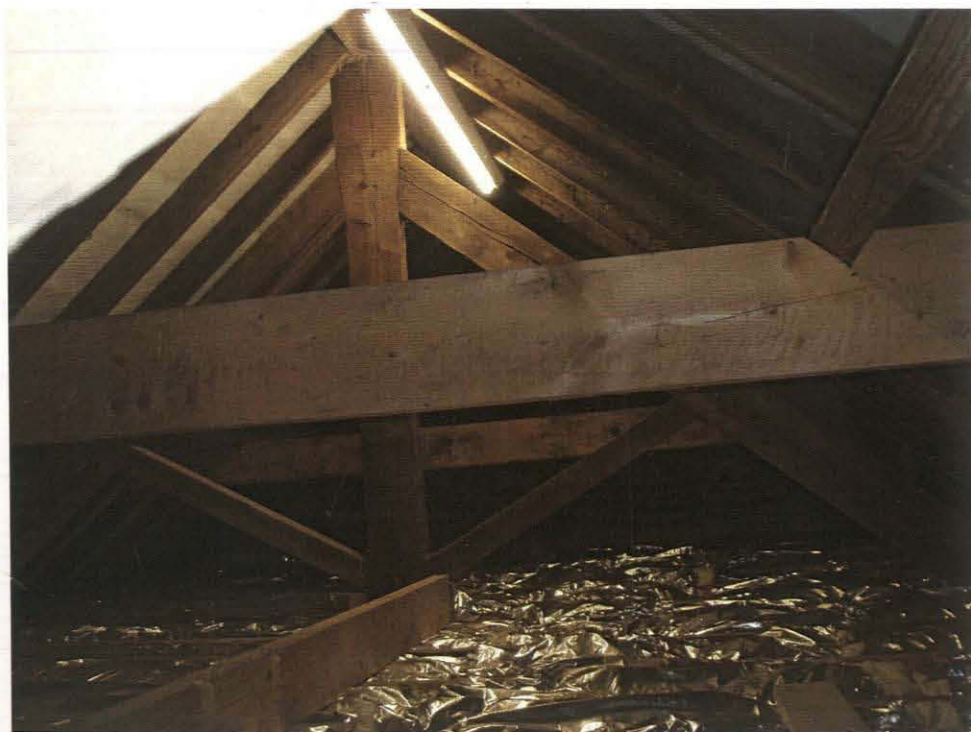
The ground floor has been converted into a lounge and bedroom with access to the roof space through a trap door in the bedroom. There are two king-post trusses with bolted braces (PI. 24). Truss 1, to the south is stamped with a I (PI. 25) but there are no visible marks on Truss 2.

Pl. 24 The cart shed roof trusses, looking south

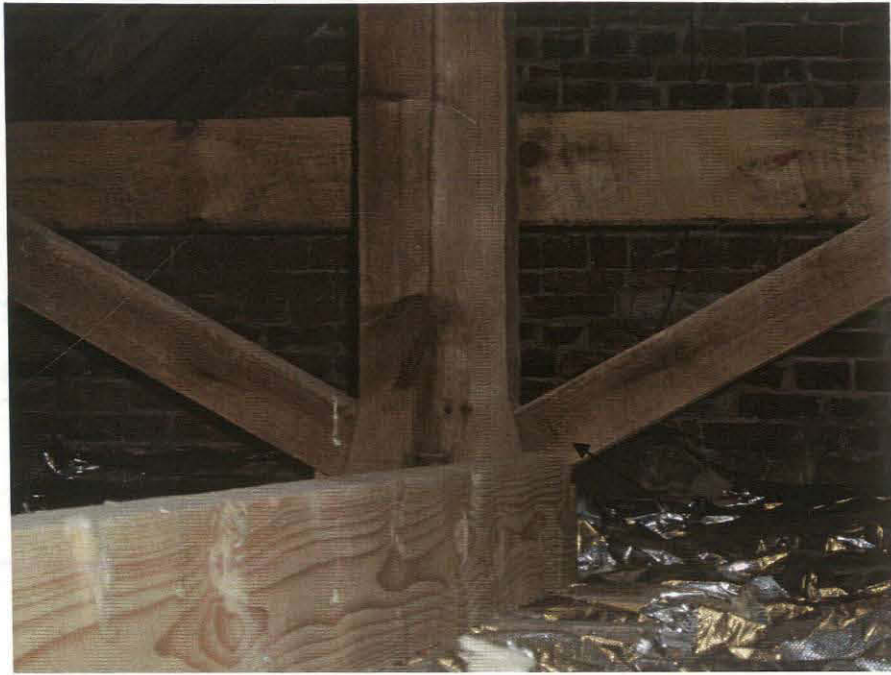
Pl. 25 The cart shed. Detail of Truss 1, showing truss number

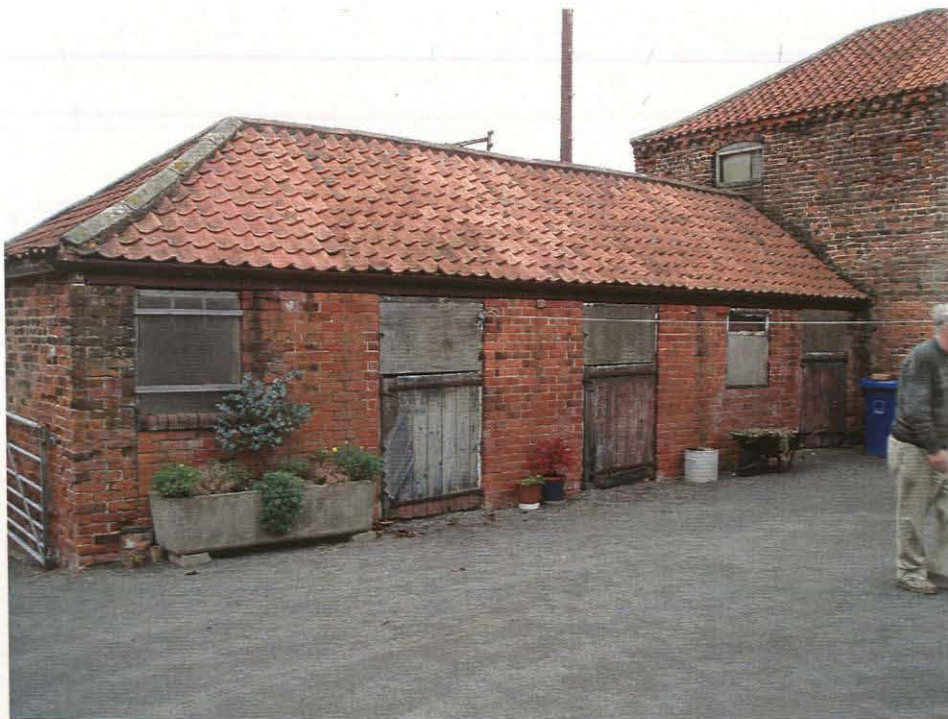
This is a single storey structure abutting the north boundary wall of the crewyard (PI. 26). It has a pantile roof and is constructed in machine-cut red bricks, probably of late 19th or early 20th century date, very similar to those of the cart shed. It was originally a covered shed but partition walls were inserted to create two stables and a central store. Each cell has split stable doors and a window to the west of the west and east stables. There is no window in the centre store (PI. 27). A feeding trough survives along the north wall of the west stable (PI. 28). The east stable was locked and not inspected internally. The roof timbers are all nailed (PI. 29).

Pl. 26 The stable, south elevation, looking north

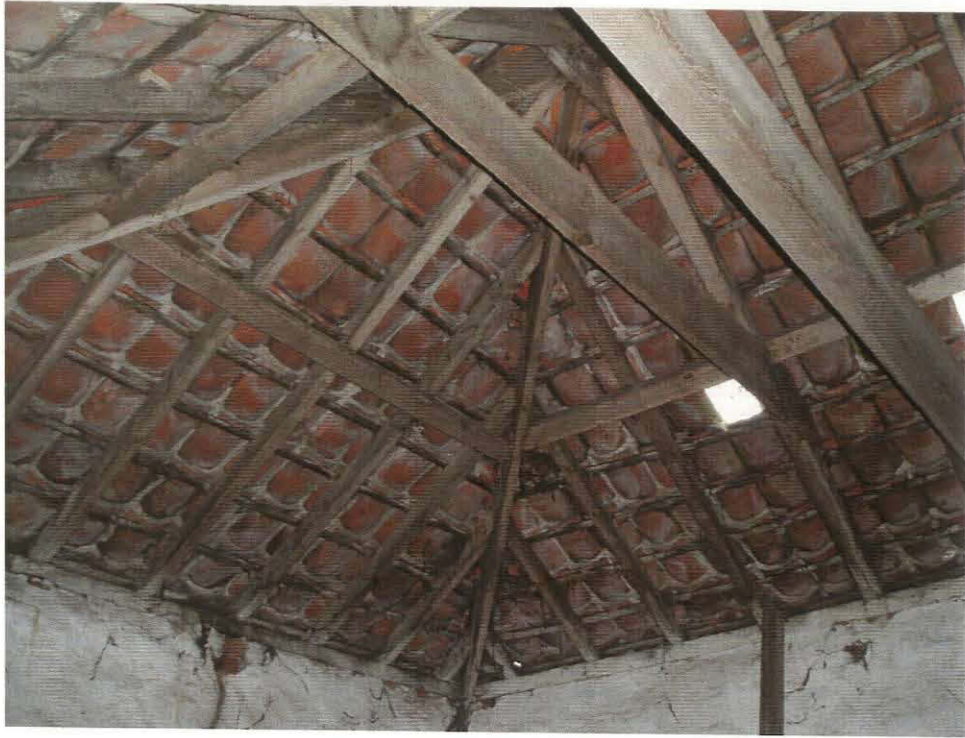
Pl. 29 The stable roof, hip at west end.
