LINDSEY ARCHAEOLOGICAL SERVICES

**Blacksmith's Yard, Station Rd,
Timberland, Lincs.
Archaeological Recording
Planning Application No.: N/67/16666/03
NGR: TF120 584
Site Code: TABY 04
LCNCC Accn No.: 2004.110**

**LAS Report No. 758
June 2004**

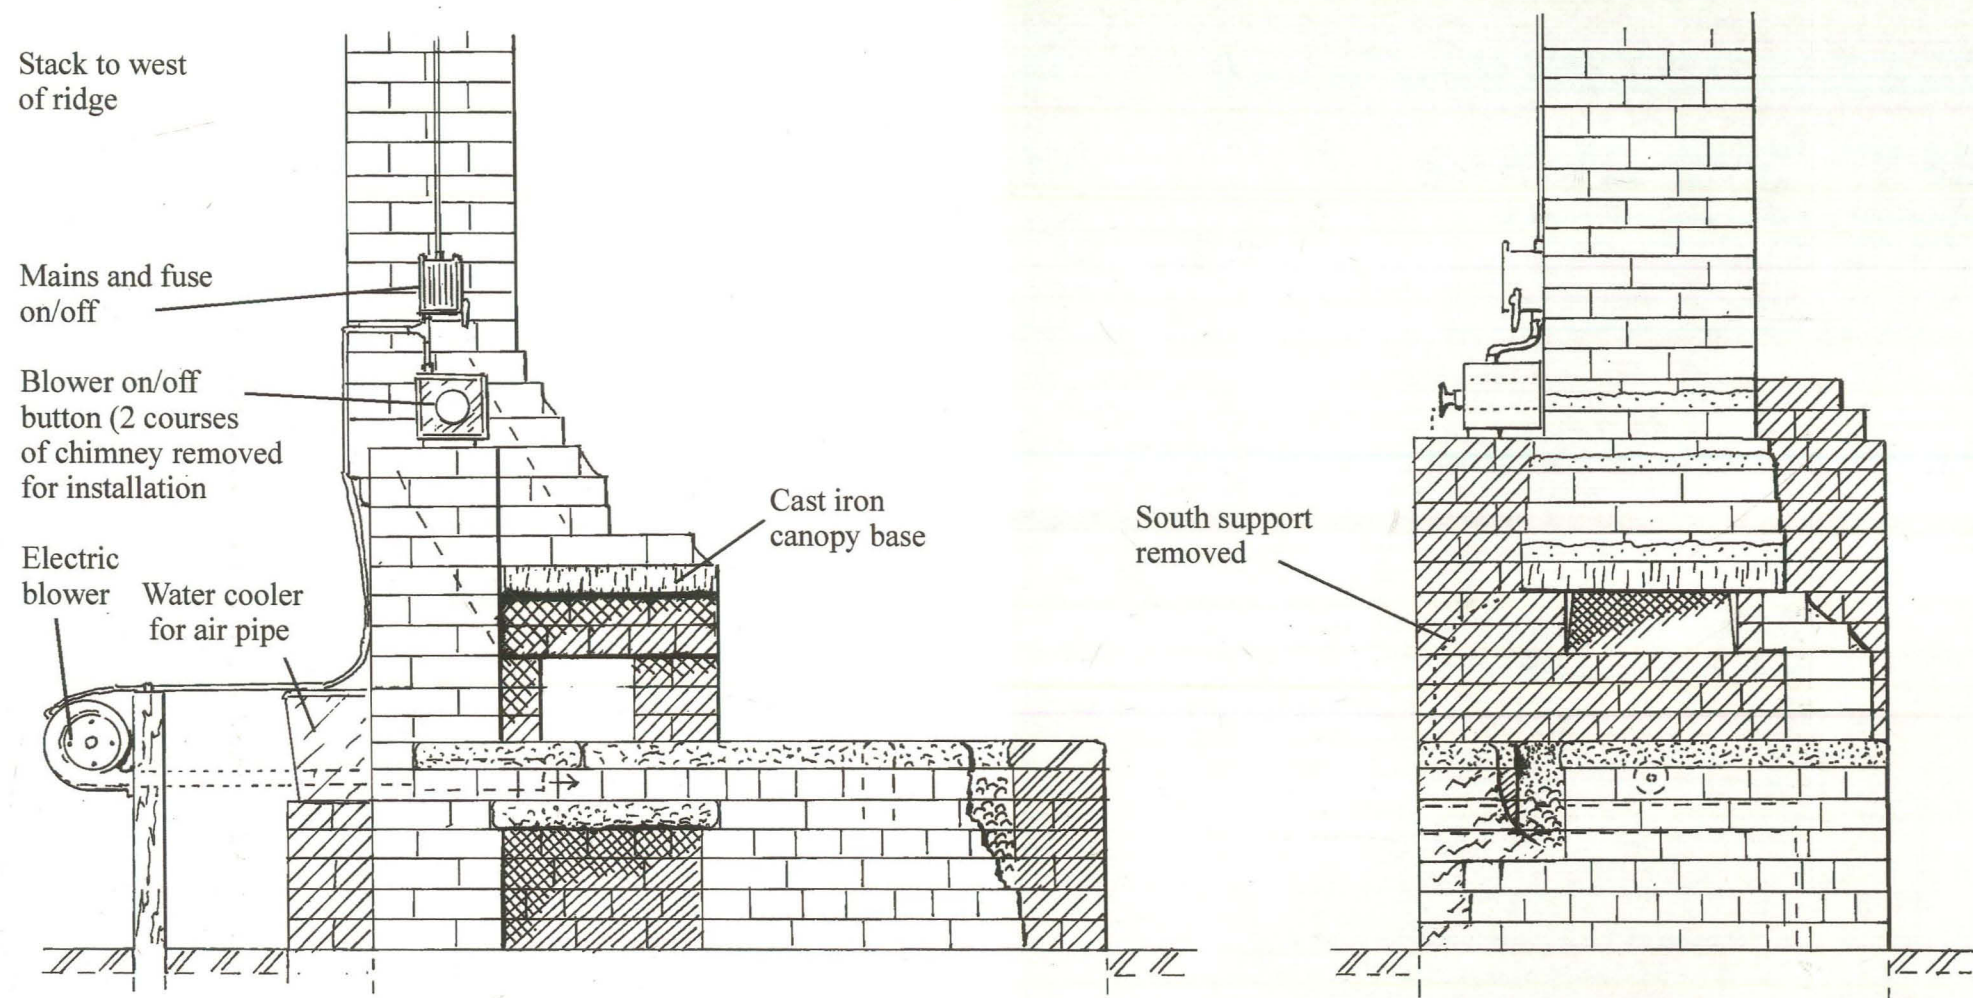
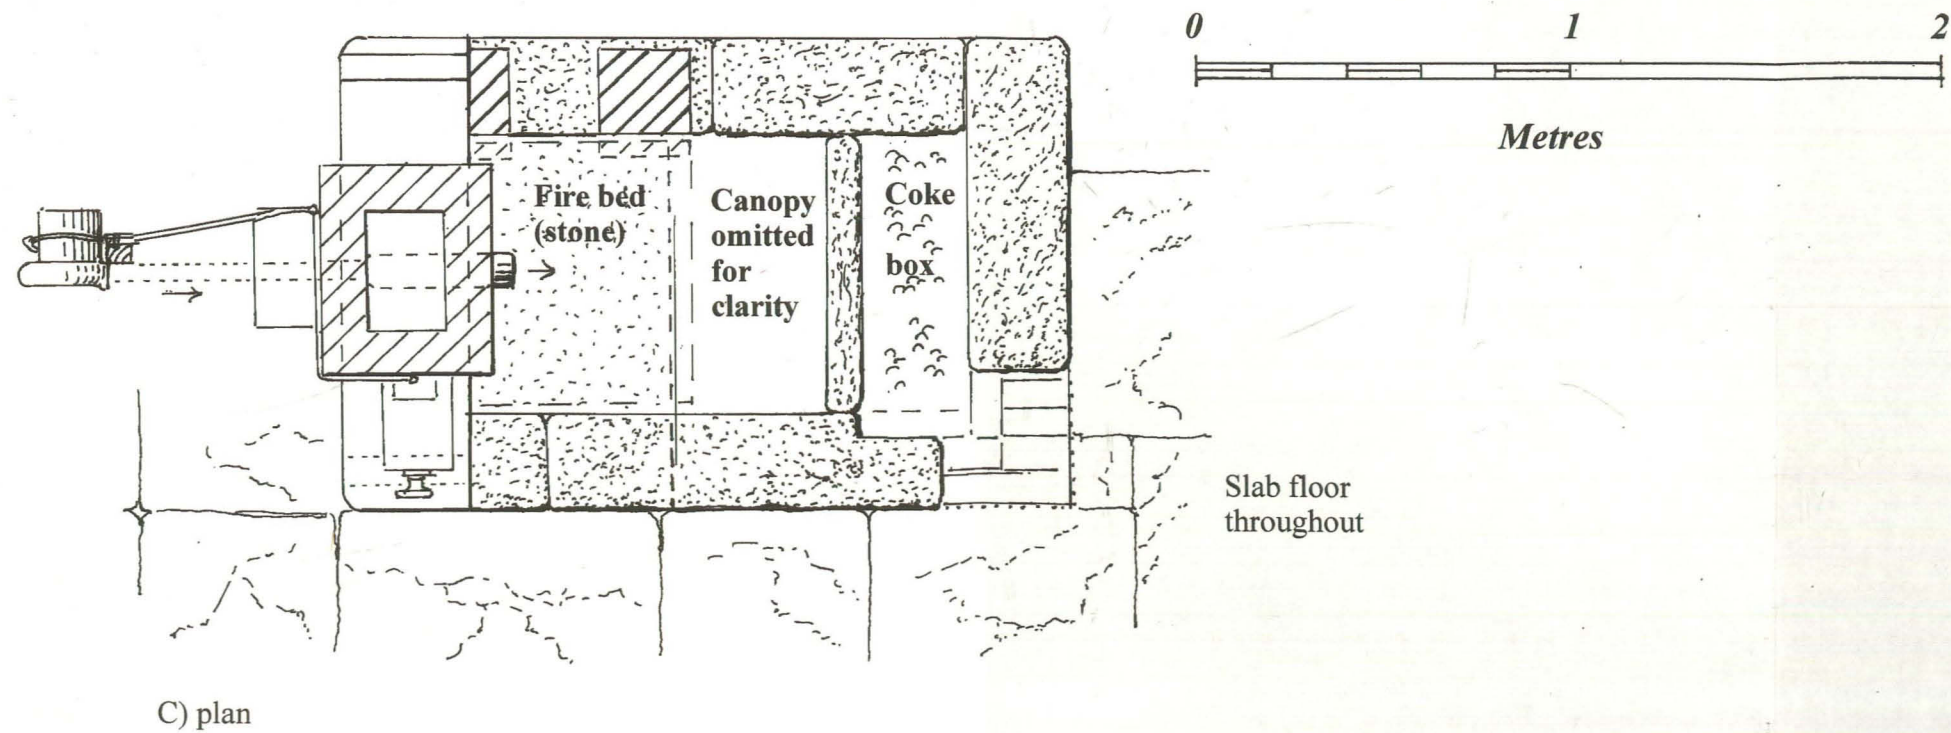
Fig. 3 Blacksmith's Yard, Timberland, The Forge . Scale 1:20. M. Clark

Building 3 Blacksmith's shop (Fig. 3)

This is infill between Buildings 4 and 2. The rear wall is brick (Pl. 11) and the front of the building is timber infill (Pl. 12). The south gable is built on top of the end of Building 4 and the north gable butts Building 1. The pantiled roof is constructed in the same style as Building 1 with nailed, lapped joints. Rafters are 0.38m (15") apart and measure 50 x 110mm in cross-section.

The three-bayed structure contains a work bench and forge (Pl. 13) in the northernmost bay which is constructed in bricks with a shallow frog which measure 230x 110 x 75mm. There is an electric blower at the rear of the furnace inscribed 'The Mota Fan', manufactured by Alldays & Onions Ltd, Birmingham (Pl. 14). A pipe runs from the hopper and protrudes 0.20m into the firebed beneath the oversailed chimney which originally would have had a cowl on it (Pl. 15). The rake out beneath the firebed contains several broken tools and iron rods and a shovel used in the forge was found outside in the yard (Pl.16).

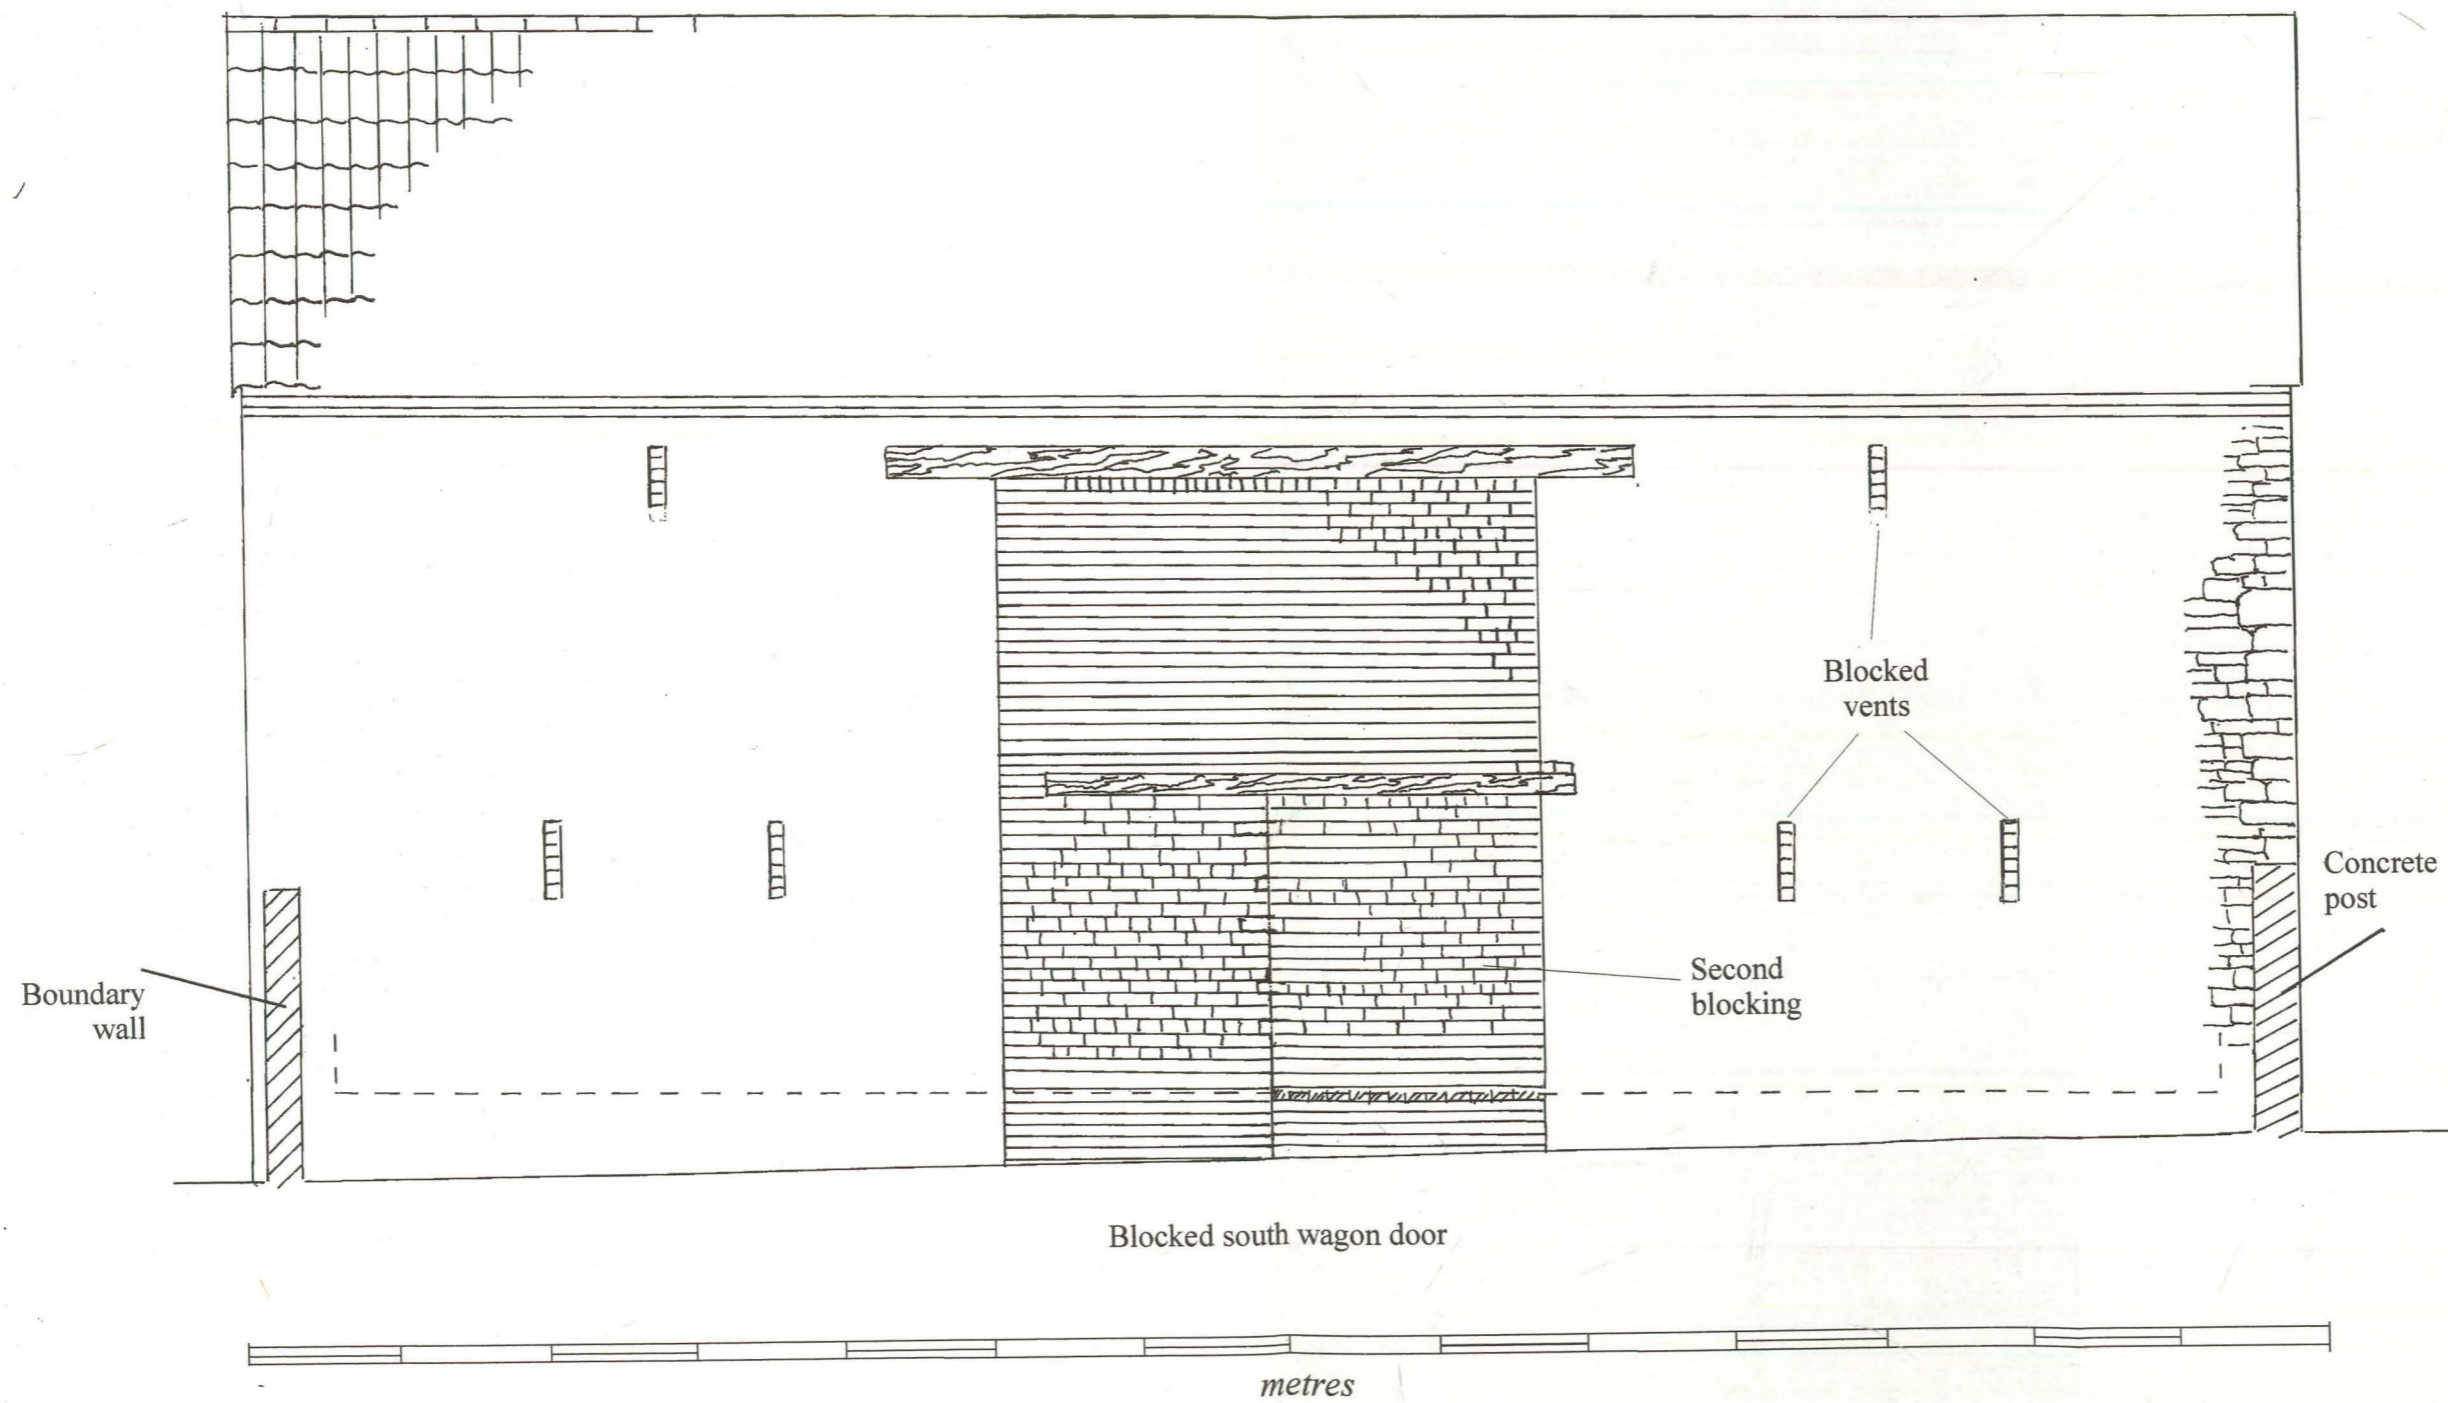
Fig. 4 Building 7. Stone barn south elevation (M. Clark).

The rectangular stone barn is orientated west-east and lies to the north of Building 6 and east of the remaining buildings in the complex (Pl. 39). Originally it had central opposing entrances on the long axes, which were open to eaves height, below wooden lintels (Fig. 4; Pls 40 and 42). The entrance on the south wall has been blocked with brick in two stages, firstly with brick similar to that used in Building 6, leaving a smaller entrance in the corner. This has subsequently been blocked with the same type of bricks used on the east walls of Buildings 4 and 5 (Pl. 40). A lean-to outbuilding formerly rested against the east gable but has been removed , a stone horse trough is still in the corner (Pl. 41).

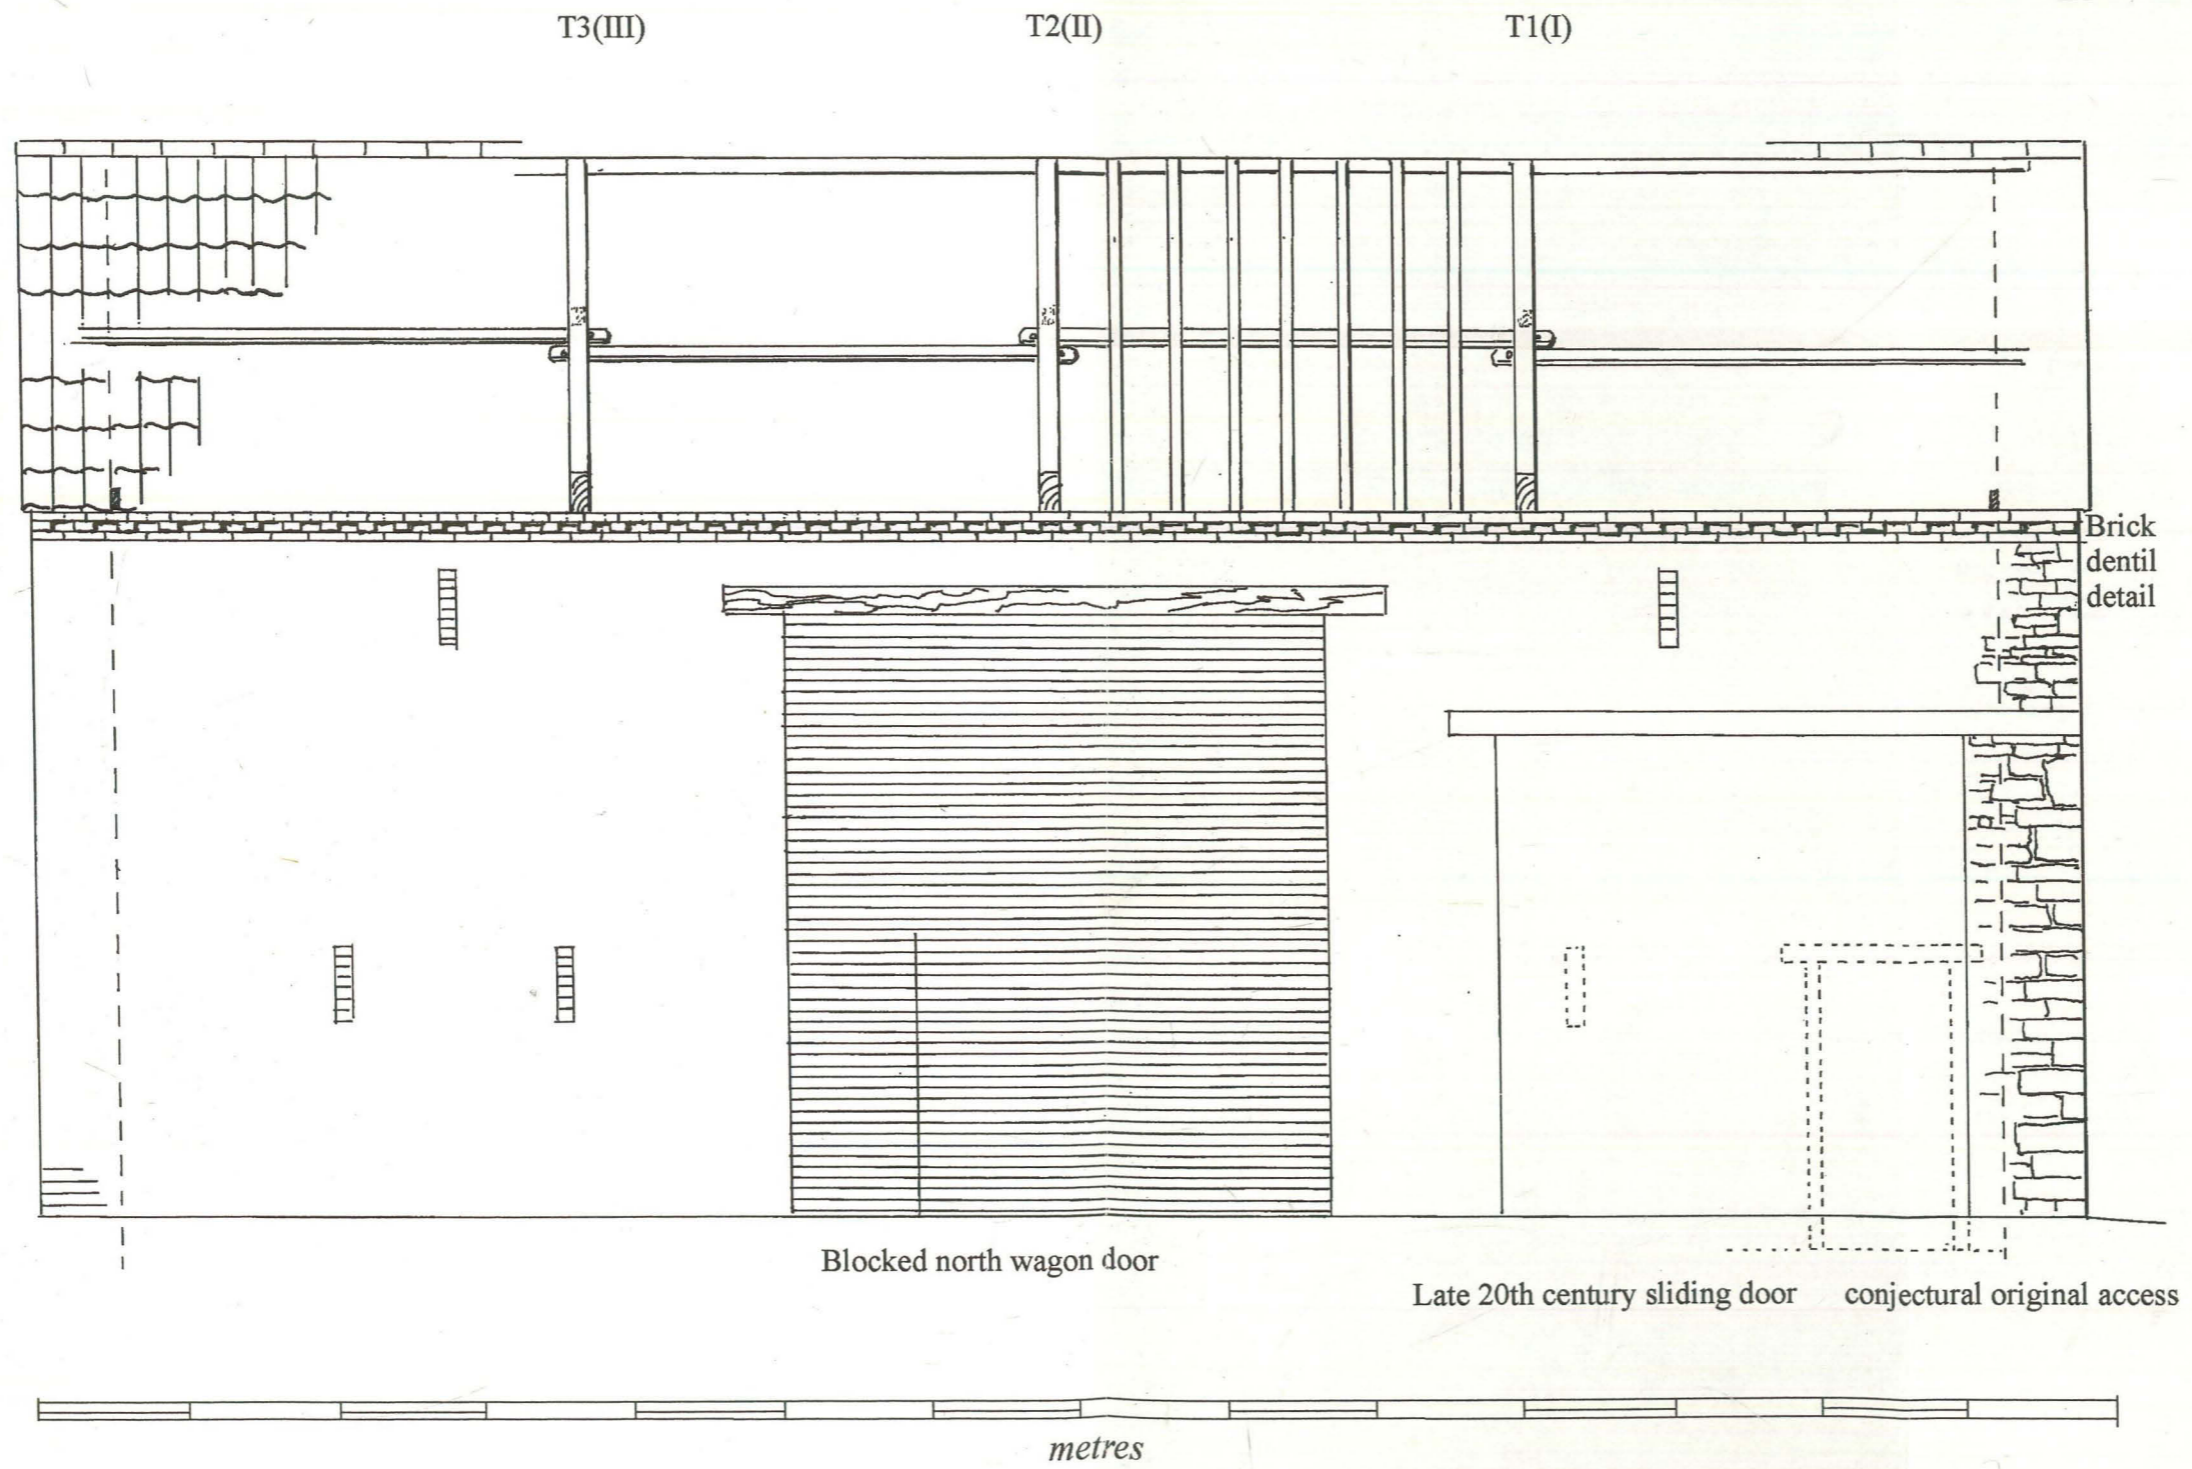
Fig. 5 Stone Barn. North elevation(M. Clark)

The original north wall entrance has a single blocking using a mixture of bricks from various sources (Fig. 5). There is an internal chamfered base, presumably to strengthen the blocking. A new metal sliding door has been inserted to the west of the blocked entrance (Pl. 42).

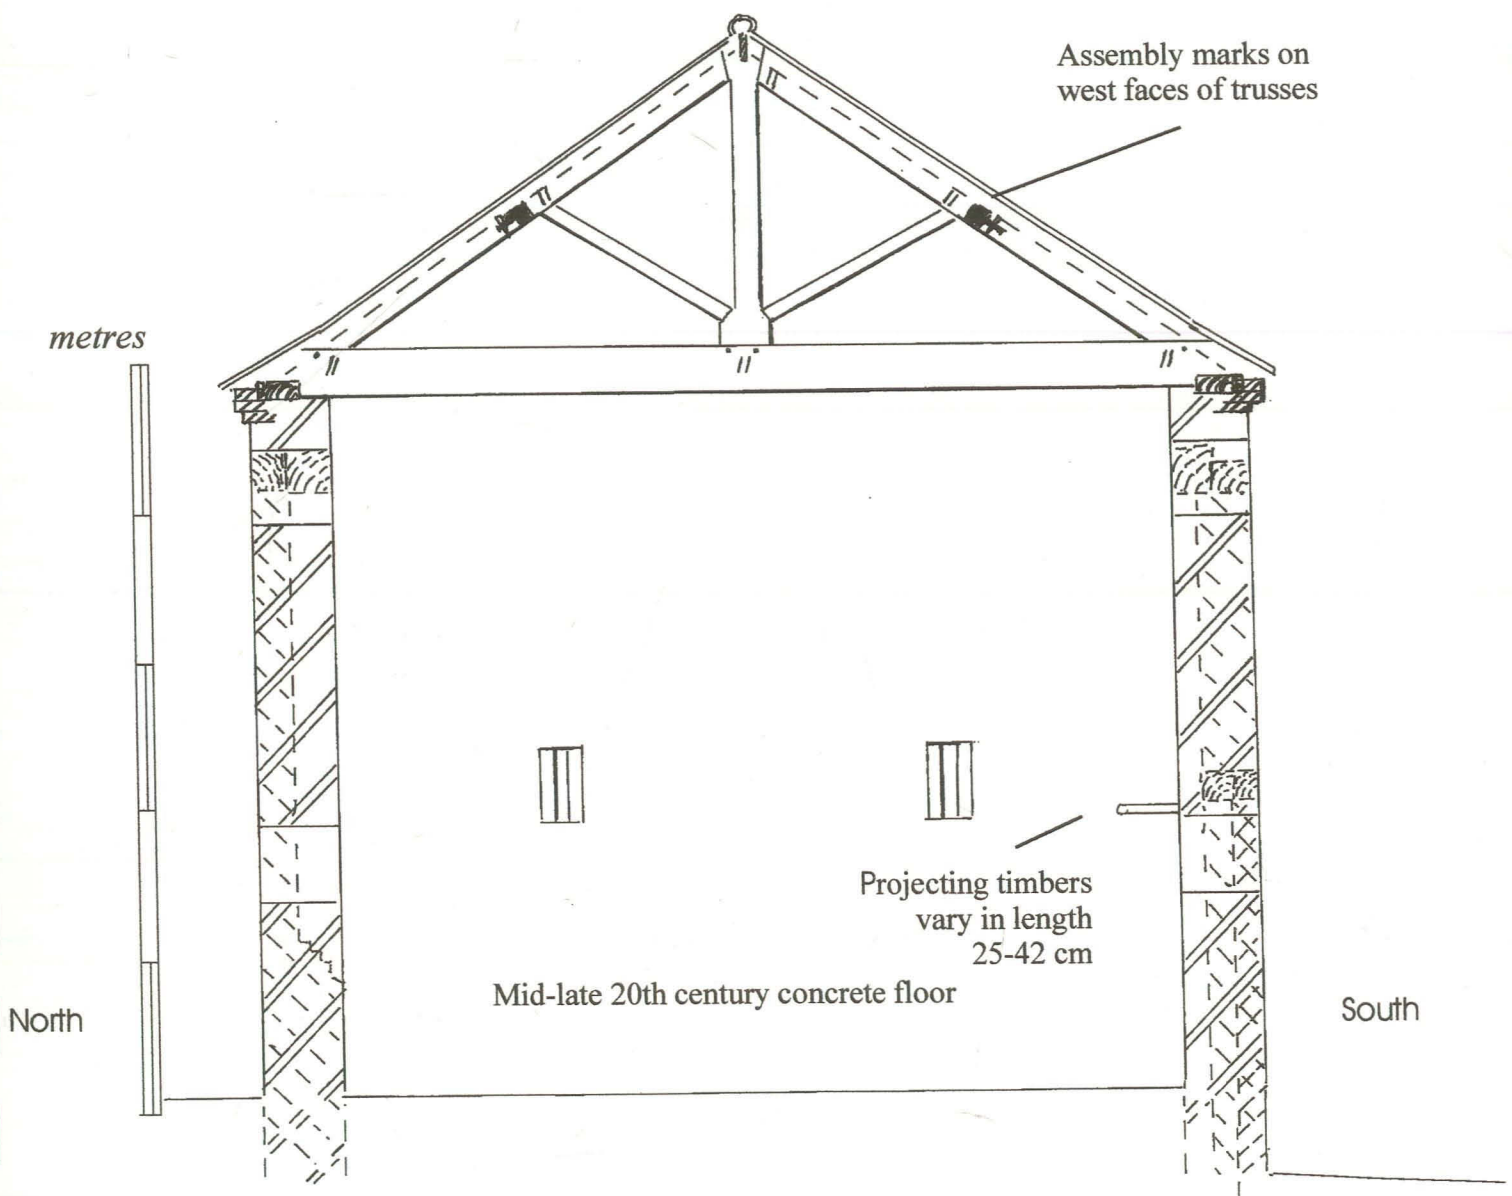
Fig. 7 Threshing barn cross-section

Vents at eaves level are present on the north and south wall, on the north and south side one on each side of the central entrance (2 on each wall). There is a row of lower vents, 2 to either side of the entrance (4 on each wall). There are 2 vents on each gable end, a little higher than on the long walls. There is an opening in the west gable above the vents (which is an inserted window, later blocked) (Fig. 7).

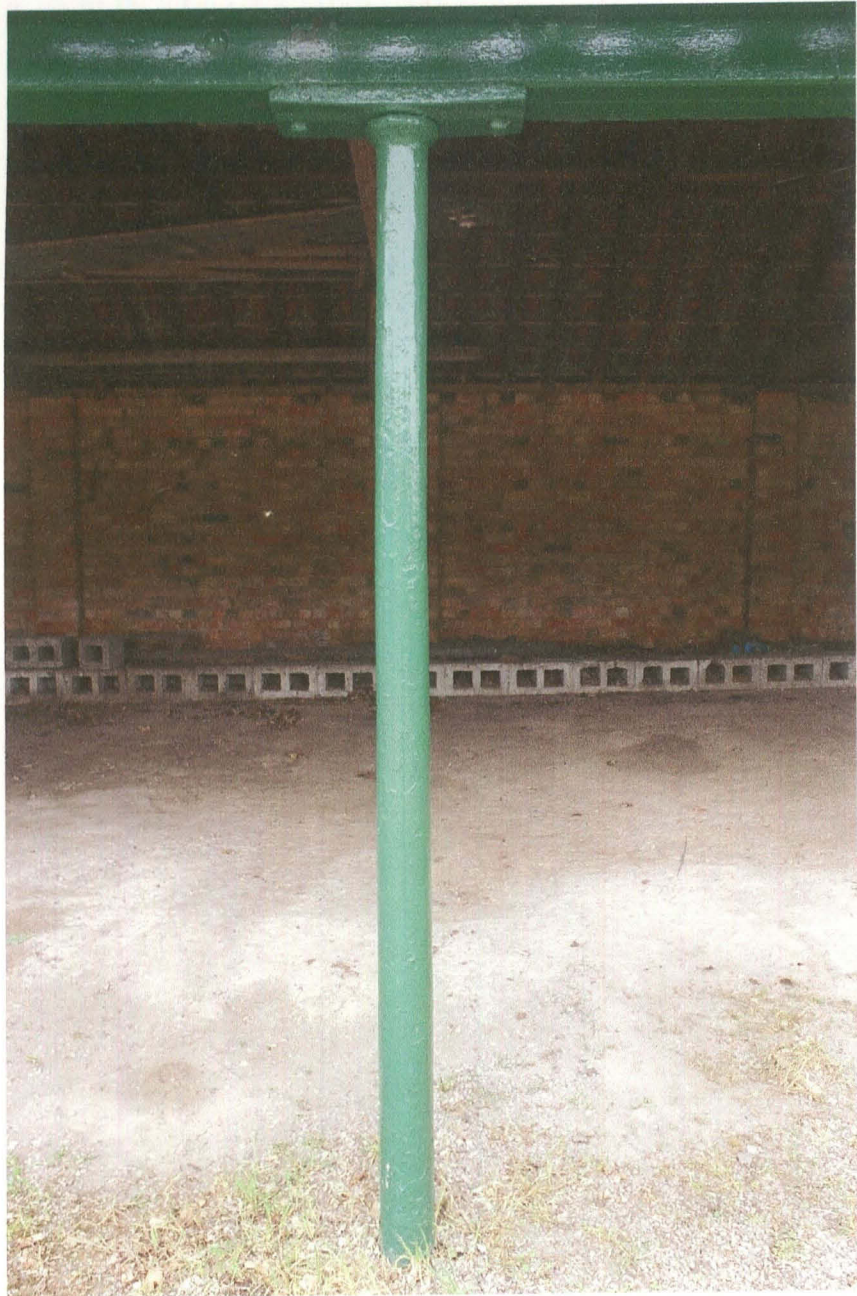
This is actually a single 7-bayed structure comprising a 19th century cart shed constructed in brick with a pantiled roof and hipped gables. It is orientated N-S with an open east side facing the farm yard (Pl. 4) supported by plain cast-iron columns (Pl. 5).

Pl. 5 Detail of cast iron column, Building 1.

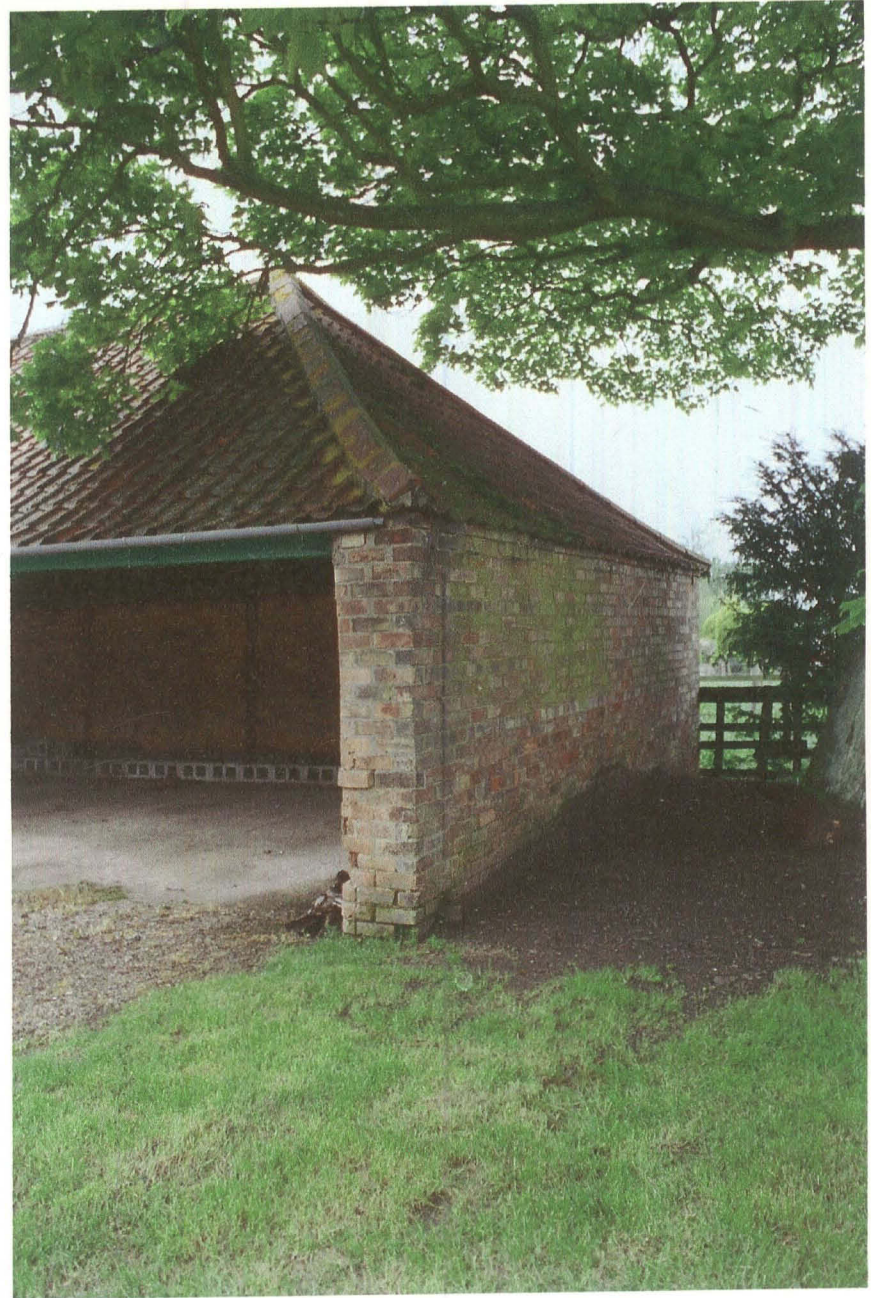
There are header courses every 3-4 courses with mixed headers and stretchers in the remaining courses. The bricks measure 225 x 110 x 75mm and are yellow-pink in colour with no frog and sharp edges. They are bonded in a sandy,gritty light beige mortar. Bullnose bricks have been used to finish the open northeast corner of the structure (Pl. 6). There are

Pl. 6 North east corner of Building 1.

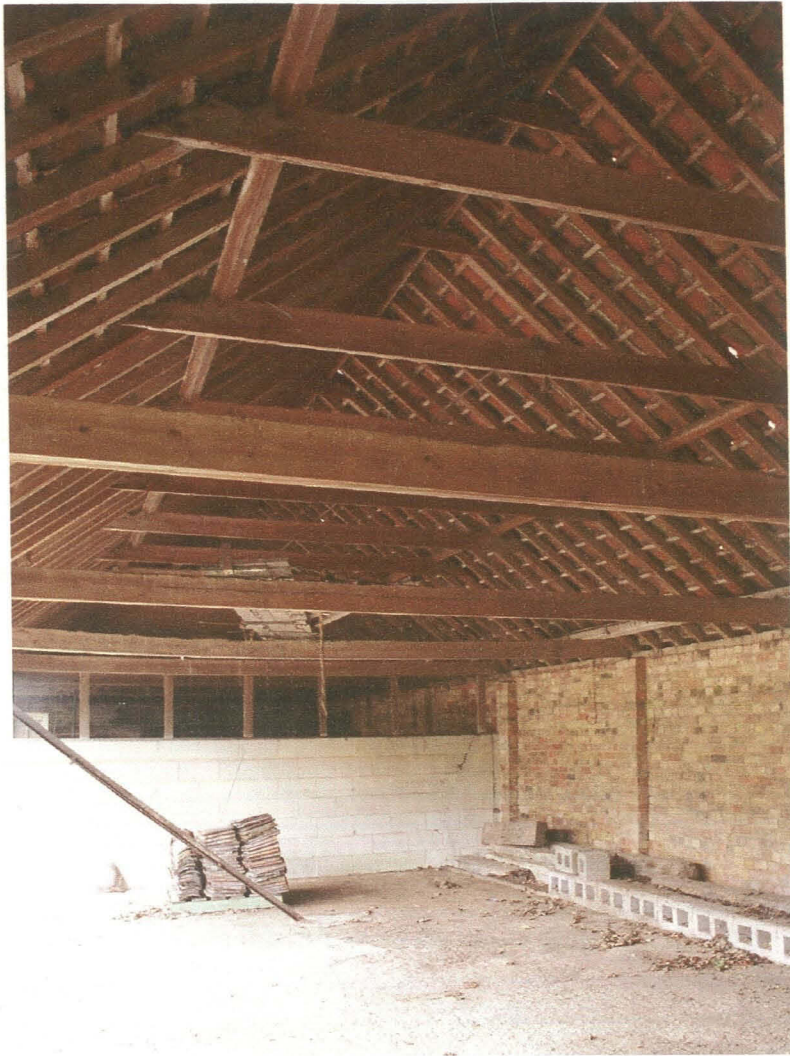
internal brick pilasters, rectangular in cross-section, measuring 120mm x 345mm, along the west wall, which mark the bay divisions (Pl. 7). The floor is crushed chalk.

Pl. 7 Building 1 interior, showing internal pilasters on west wall, and roof structure, looking south.

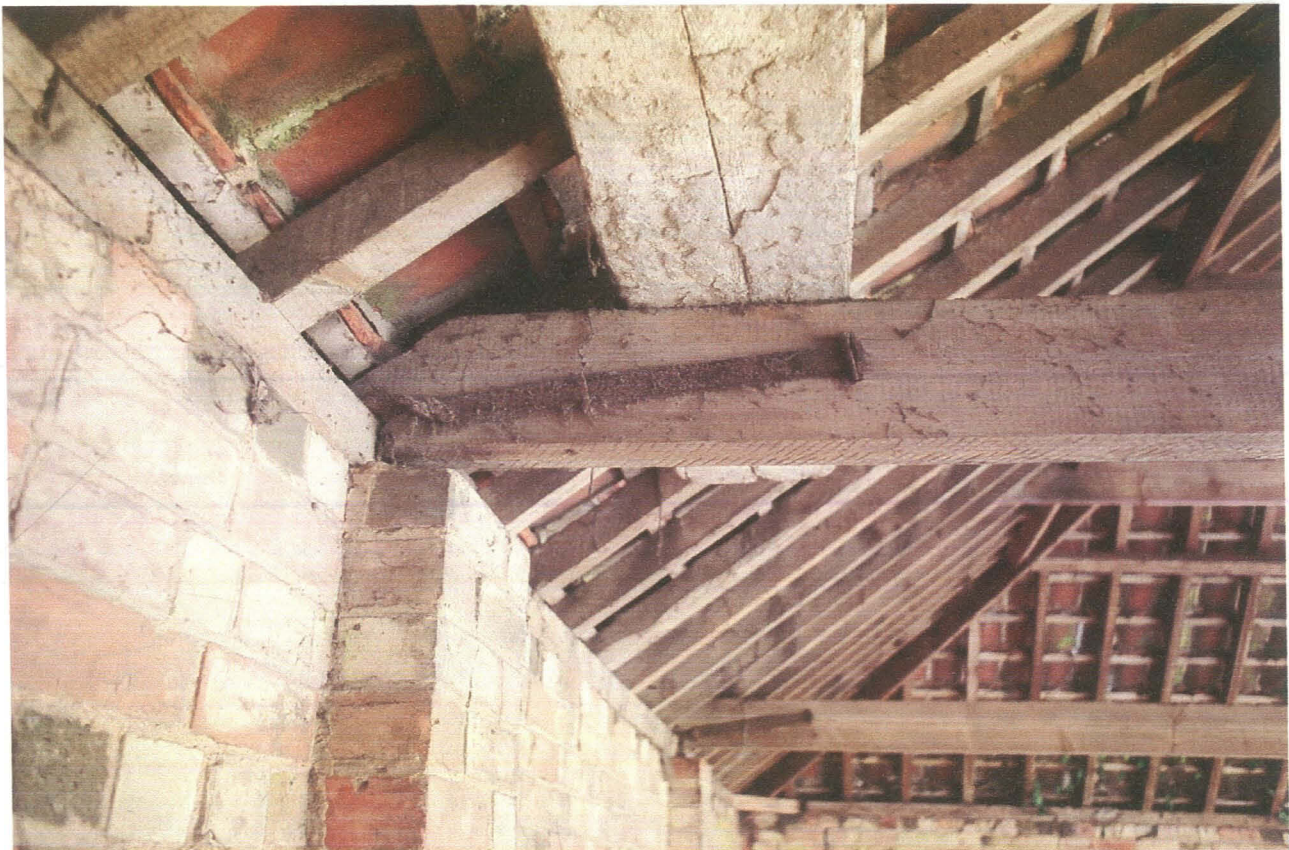
The roof timbers are machine-sawn, and of single clasped purlin construction, with lapped, nailed joints (Pls 7 and 8). The purlin is 1.93m from the eaves. There is a collar nailed at the apex and a narrow ridge plate. The rafters are 0.30m (1ft) apart and are 55-60mm x 80mm in cross-section. The principals of slightly larger scantling being 80 x 95mm in cross-section. Iron ties are strapped to the wall plate (Pl. 9).

Pl. 9 Building 1 Iron straps secure the trusses to the eaves plate.

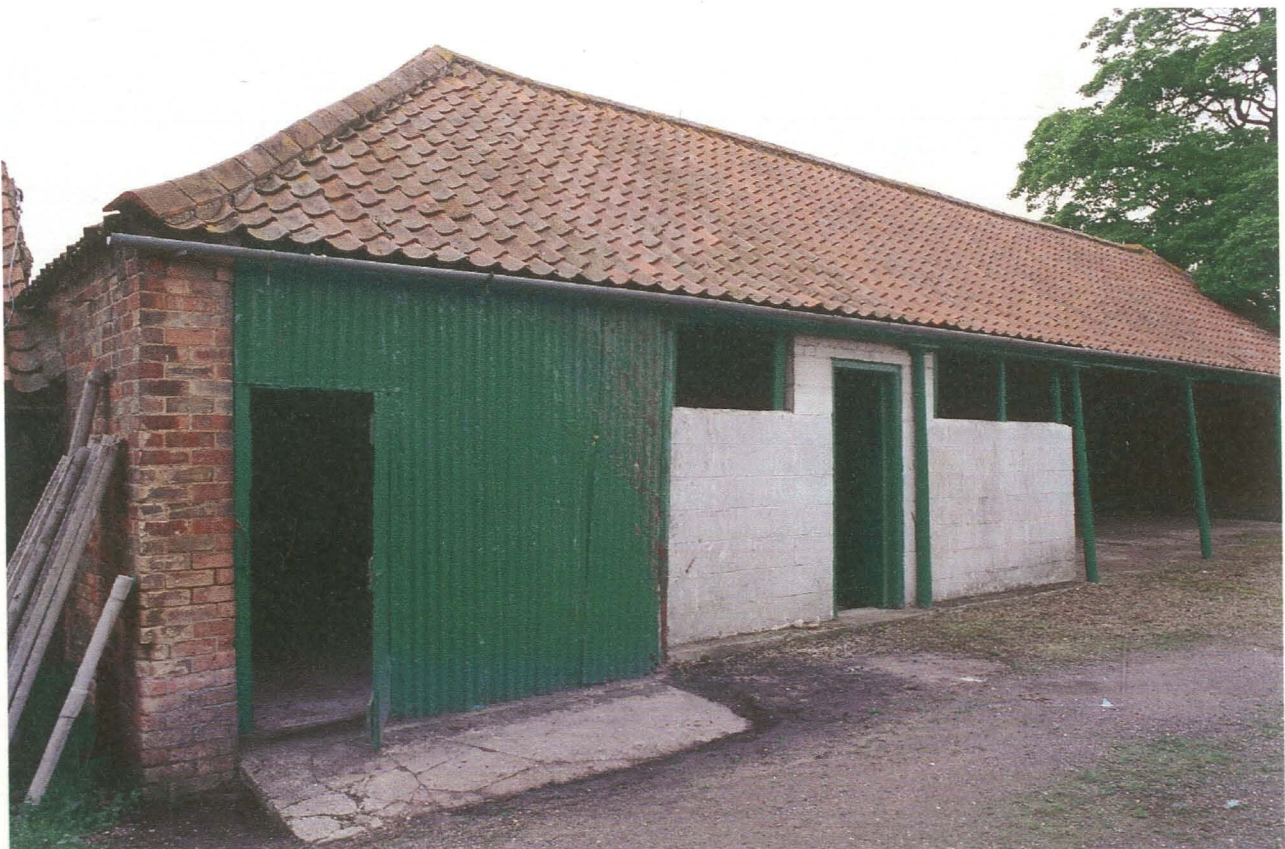
'Building 2' comprises the southern 3 bays which have been partitioned off with breeze blocks to provide a secure store. The door is reused and probably of 1930s date. The southernmost bay is clad in corrugated iron and the floors in these bays are of concrete (Pl. 10).

Pl. 10 Building 2 east elevation showing infill of corrugated iron and breeze blocks between the cast iron pillars.

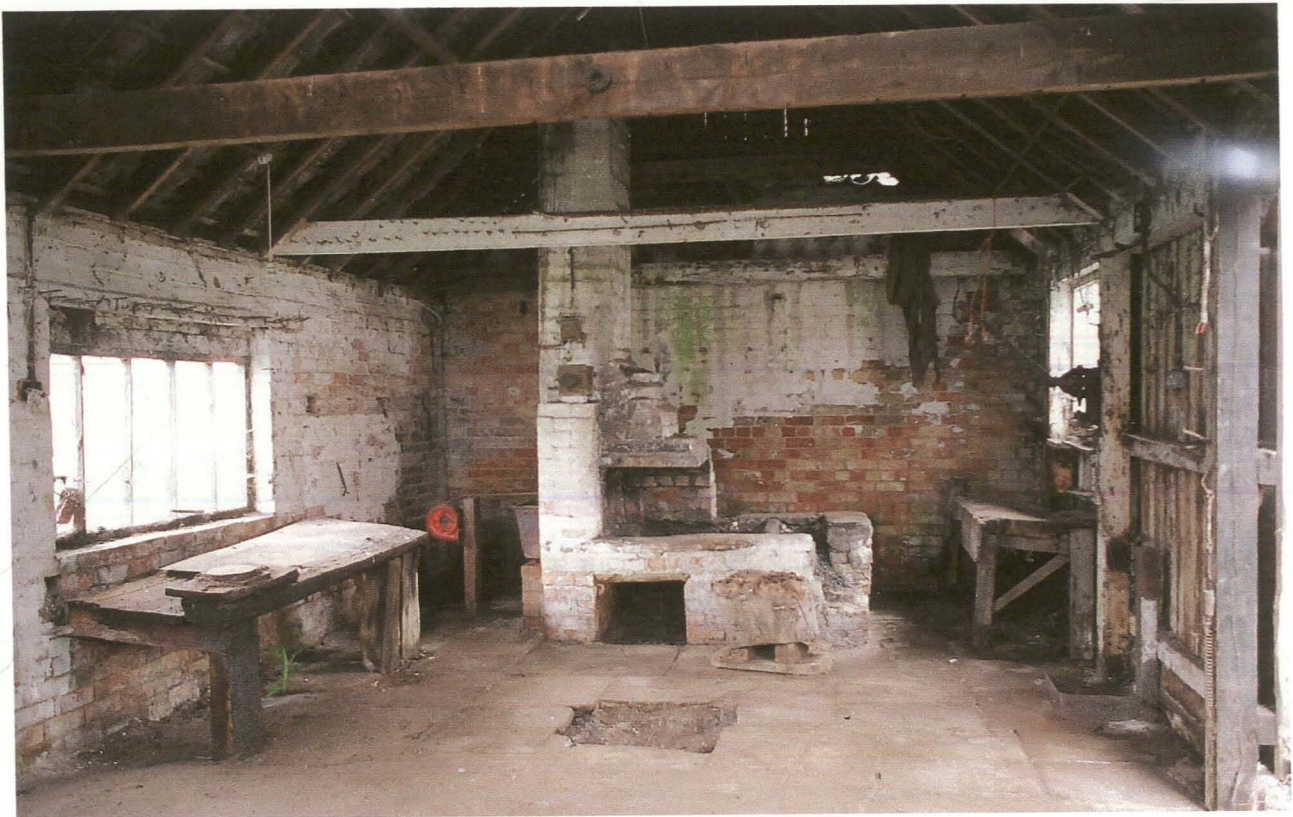
Pl. 13, Building 3, blacksmith's workshop interior looking north showing forge and work benches. Hole in flagged floor marks original position of anvil base which sits in front of forge.

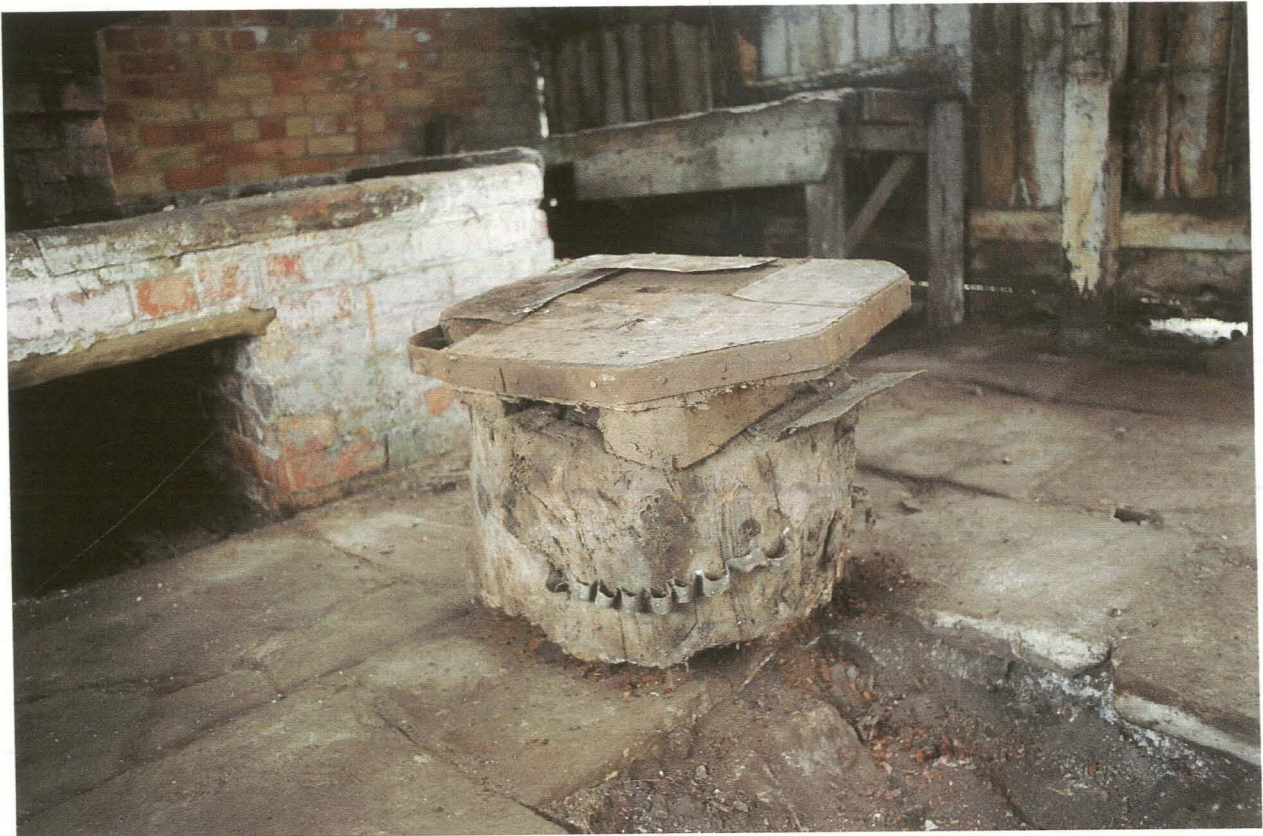
A hole in the ground to the south of the furnace marks the former position of the anvil, which was set on a large tree stump. A zinc metal strip nailed around the tree stump formed a crude tool holder (Pl. 17). There is a third bench at the south end of the shed (Pl.18).

Pl. 17 Anvil base, next to original location marked by hole in ground . Note zinc metal strip nailed around the tree stump formed a crude tool holder.

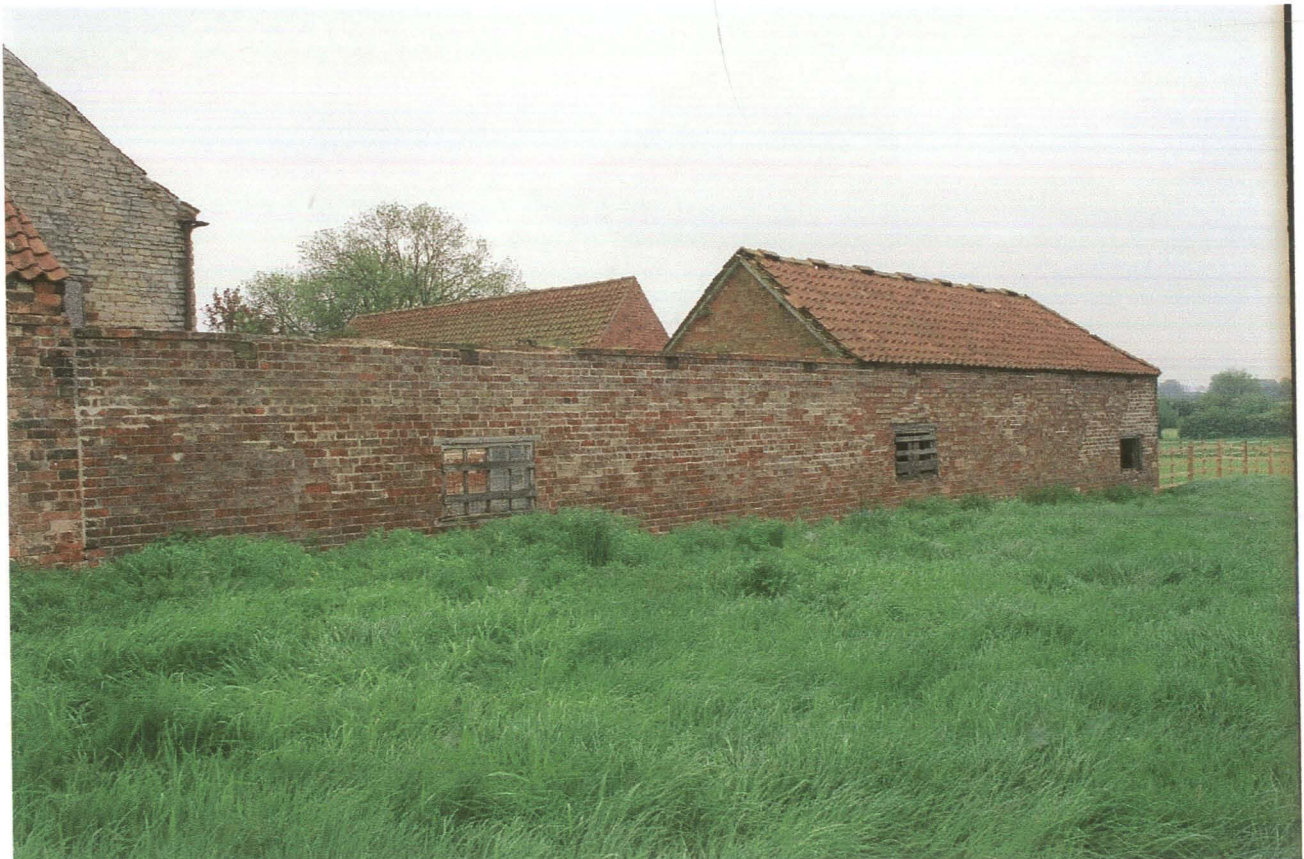
This was originally a single eight-bayed single storey structure which was divided into two almost equal parts of four bays each. This is most clearly seen on the rear elevation which is continuous brickwork (Pl. 19). Coursing is 3-4 header courses to 1 footer course. The red bricks measure 225-230 x 110 x 70mm. A square ventilation hole with a metal grille is present at eaves height on the west side, in the centre of each of the eight bays. Originally used for cattle the building appears to have been converted to use for pigs in the 20th century.

Pl. 19 Buildings 4 and 5. former cow shed Rear (west) elevation, showing ventilation holes at eaves height and three window openings.
