LINDSEY ARCHAEOLOGICAL SERVICES

**Blacksmith's Yard, Station Rd,
Timberland, Lincs.
Archaeological Recording
Planning Application No.: N/67/16666/03
NGR: TF120 584
Site Code: TABY 04
LCNCC Accn No.: 2004.110**

**LAS Report No. 758
June 2004**

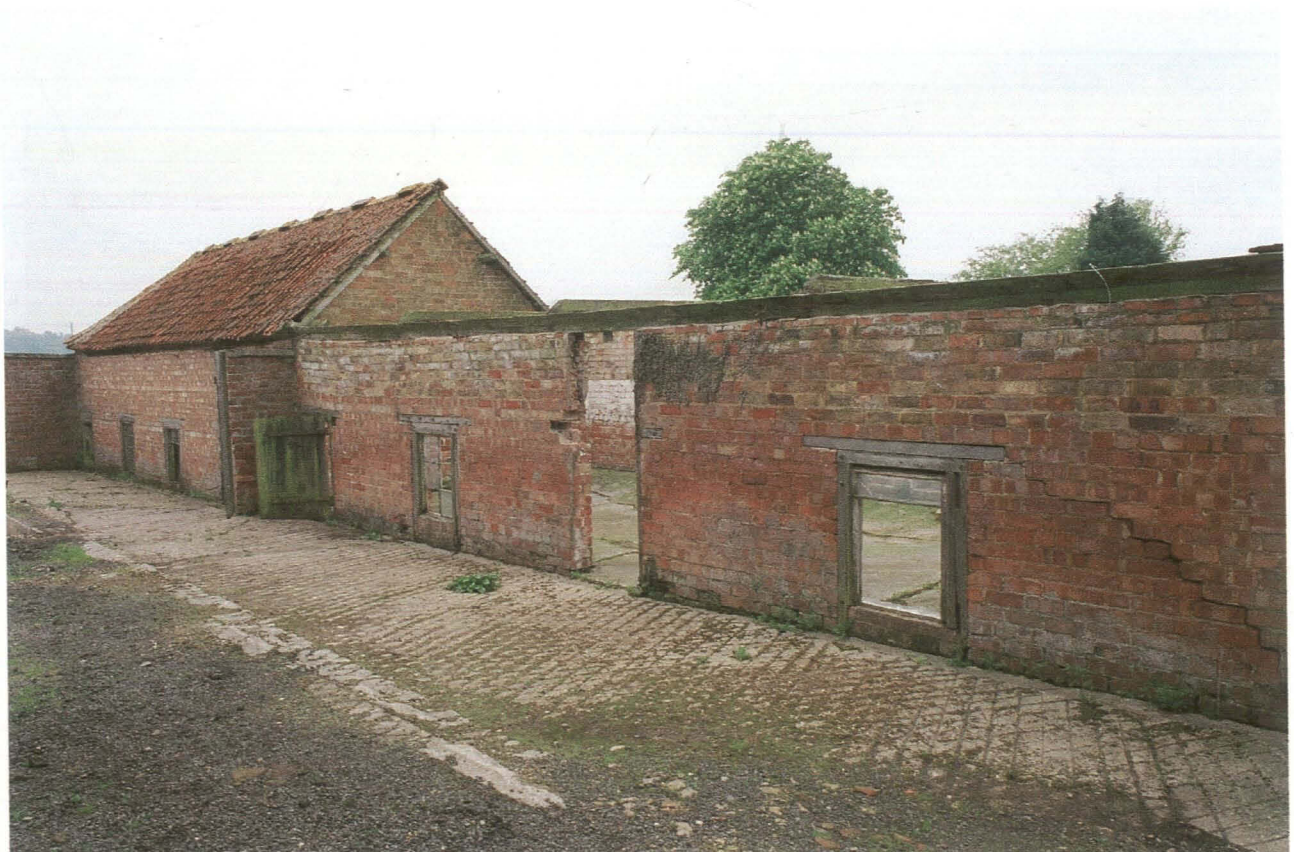
There is an opening in the south bay west wall and the north bay west wall. There is a vent in the north gable at eaves plate level. The roof is clasped purlin construction the same as Building 1 with machine sawn timbers, nailed, lapped joints. The rafters are 0.35m apart. There is a roof collar and ridge plates (Pls 27 and 28). The covering is pantile with vents along the ridge, every third ridge tile being raised (Pls 19 and 20).

Pl. 20 Buildings 5 and 4. Front (east) elevation showing converted feeding hatches with door in Building 4. Not raised ridge tiles, providing ventilation to the building and concrete surfaces in front of the building.

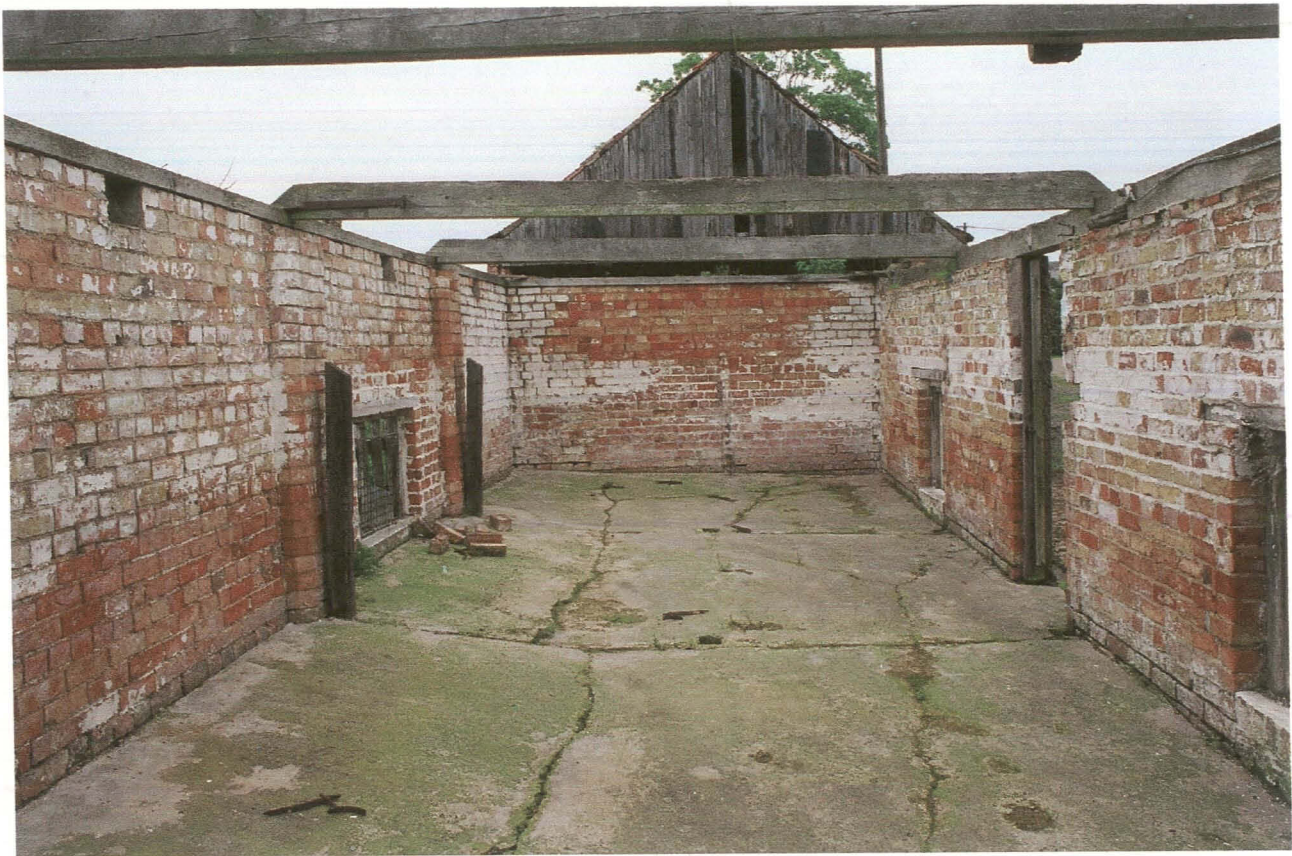
Pl. 21 Building 4 interior looking north, showing concrete floor and base of trusses strapped to eaves plate.

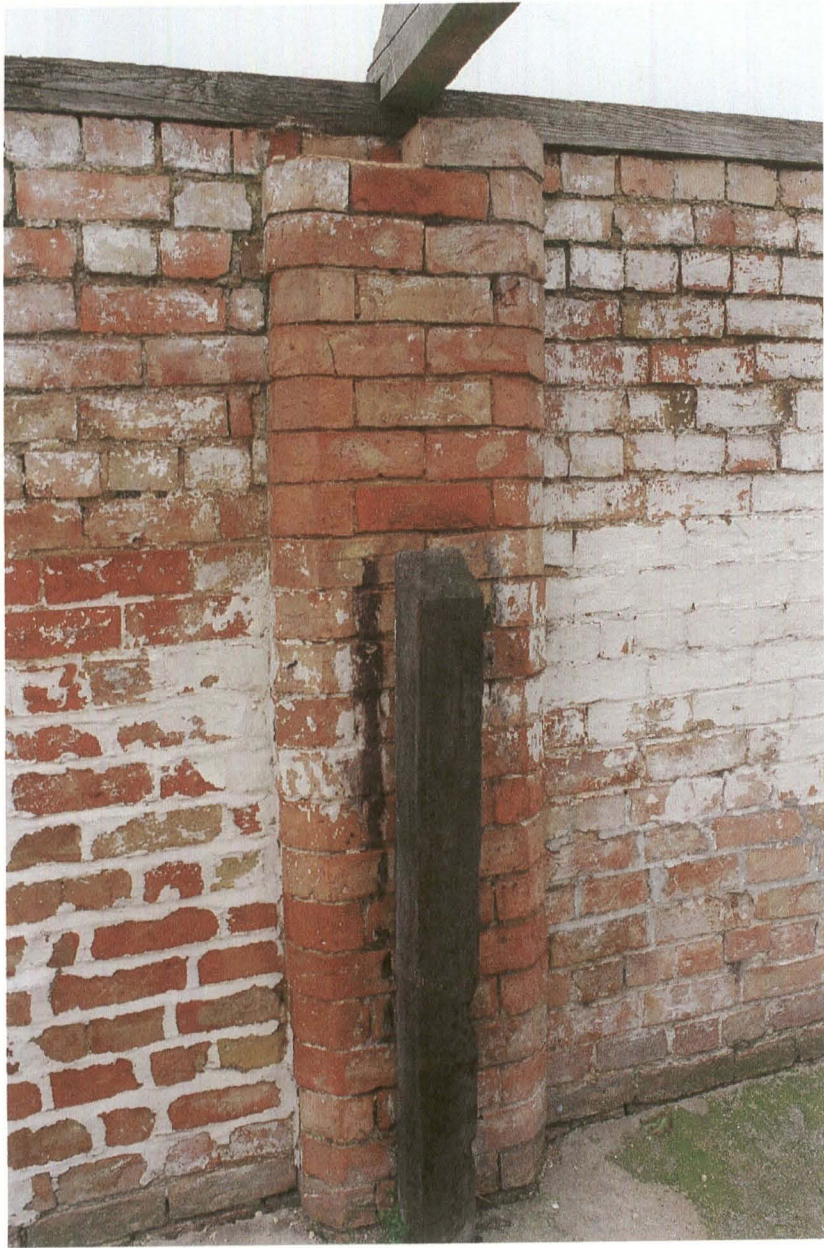
The east wall was probably originally open and has been infilled with brick beneath the eaves plate, possibly in the early 20th century. These measure 220 x 105 x 75mm. Four low openings, measuring 1.30 x 0.95m, were incorporated into this wall, probably hatches for feeding pigs. These were subsequently converted to windows, except in the second bay where an entrance was inserted to eaves height (Pl. 20). The roof has gone but trusses and eaves plates with cast iron ties are still in situ (Pls 21 and 22). The central bay divisions have been removed but their positions are marked by post holes in the concrete floor. On the west side of the building the bay divisions are marked by three brick pilasters with chamfered edges (Pl. 23). The NE and SE corners, are also chamfered to match the pilasters on the west wall (Pls 24 and 25).

Pl. 23 Building 4. Example of chamfered pilaster supporting west wall.

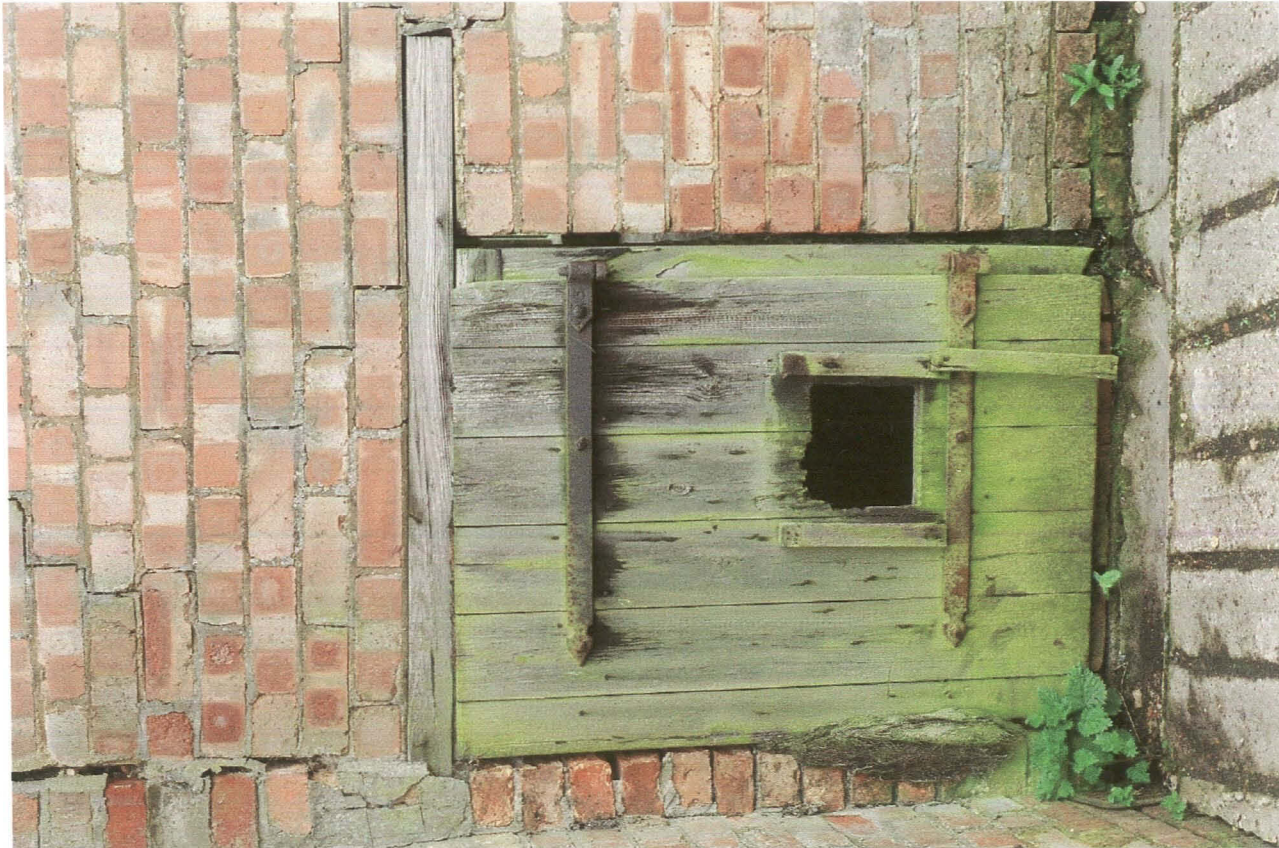
The east wall is later infill, as Building 4, with four more feeding hatches for pigs. These have been converted to windows, which have been blocked in the two central bays, with the original door surviving in the southernmost bay (Pl.26). Two of the internal wood partition posts remain in situ. There is a modern concrete floor.

Pl. 26 Building 5 . Feeding hatch at south end, with original door.

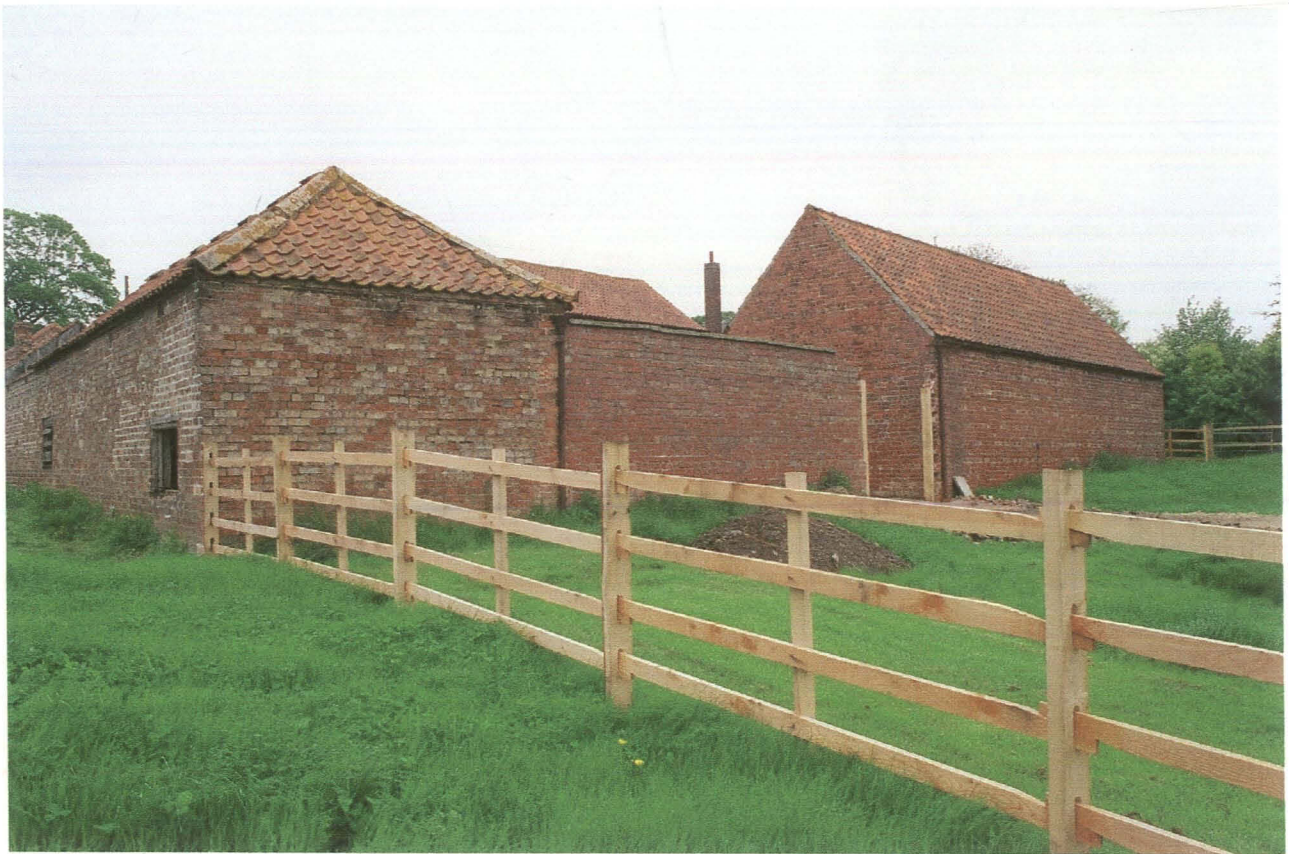
This building is constructed in red brick which is the same as the southern boundary wall that abuts Building 5 to the west (Pl. 29). This confirms that building 6 is later than both Buildings 4 and 5. The shed is a three-bay construction, open on the north side in a newly created yard which lies between it and the stone barn (Building 7) to the north. The walls to the west and east are all in the same brick with concrete posts and cast iron pintles for single gates, which have been removed (Pls 30 and 31). The bricks measure 230 x 105 75mm with a dished frog. Coursing is 3,4 and 5 rows of stretchers to 1 header row (Pl. 32).

Pl. 29 General view looking north east with Building 5 to left, yard wall with inserted entrance attached to Building 6 to right.

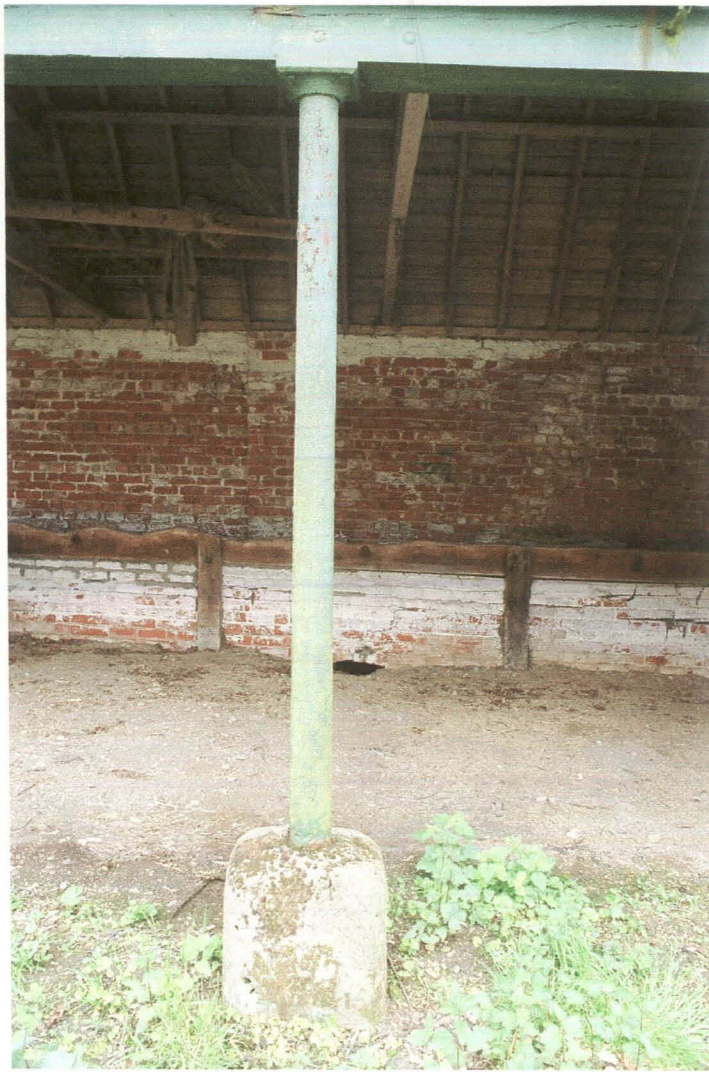
The open side is supported on cast iron stanchions similar, but not the same as those in Building 1 (Pl. 33). Their bases are clad in concrete. Internal brick pilasters, rectangular in

Pl. 33 Building 6, cast iron column with concrete base.

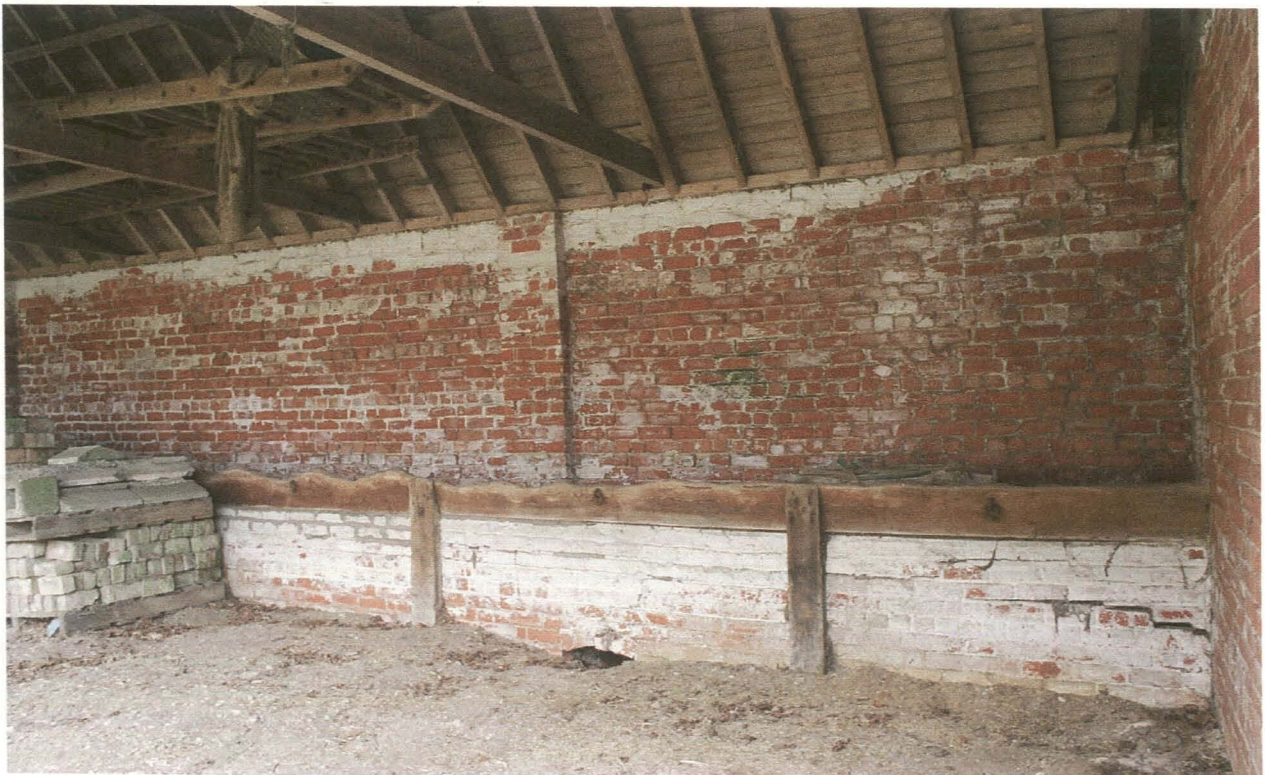
cross-section, measuring 460mm x 120mm mark the bay divisions. There is a brick plinth, 0.75m high, along the full length of the back wall of the shed, with a wooden feeding trough above. There are 6 iron rings attached to the trough (2 to each bay) for tethering animals (Pl. 34). In the westernmost bay is a brick arch at the base of the plinth (Pl. 35), probably a drain running into the ditch at the back (Pl. 36) .

Pl. 34 Building 6. Feeding trough along south wall, with tethering rings attached to the board. Note brick pilaster marking the bay division.

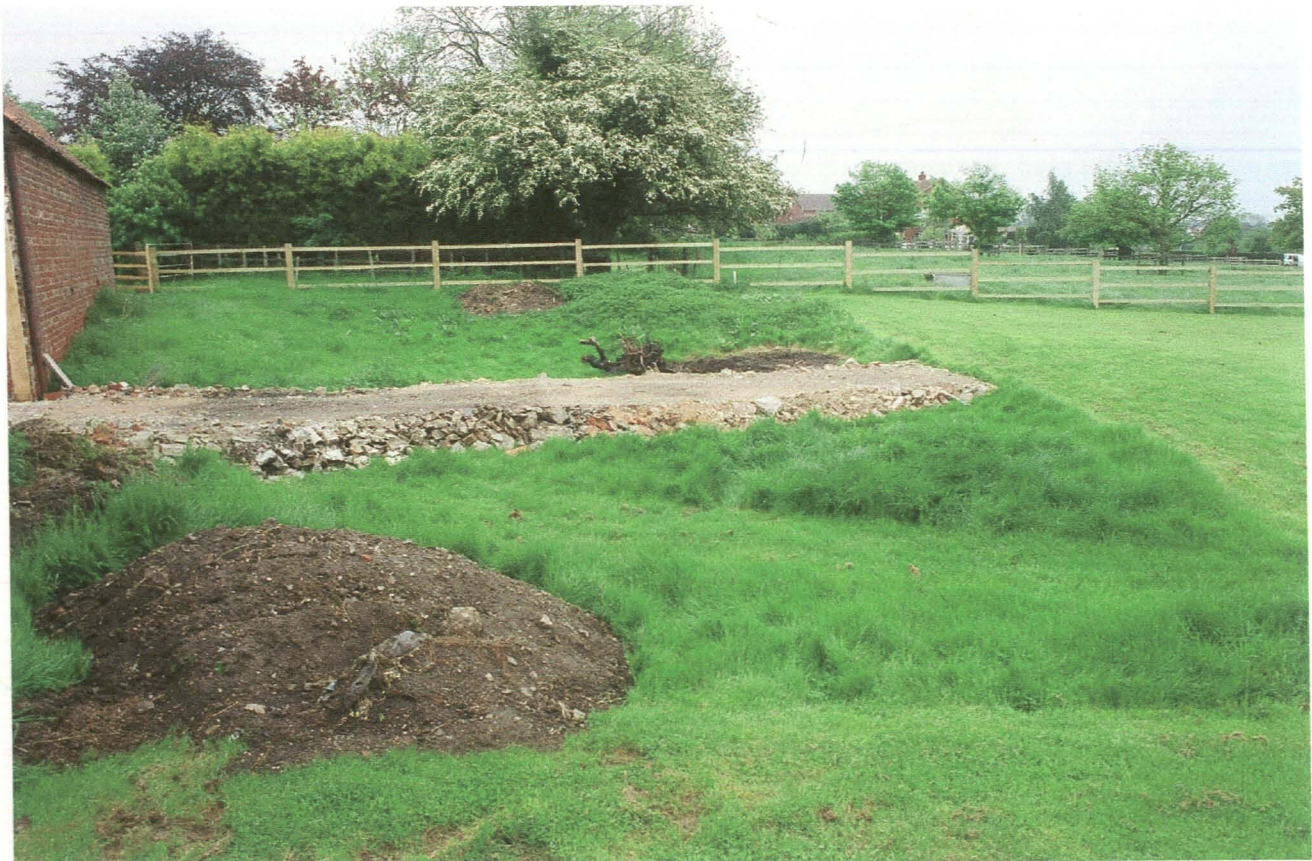
The southern boundary to the plot is a large ditch which has been partially filled in and extends eastwards towards the walled garden probably an old kitchen garden belonging to Anwick House. There are a number of large drains in this village so it is not immediately clear if the ditch was of any great antiquity.

Pl. 36 Partially filled-in ditch behind Building 6, which runs east into adjacent property. View east.

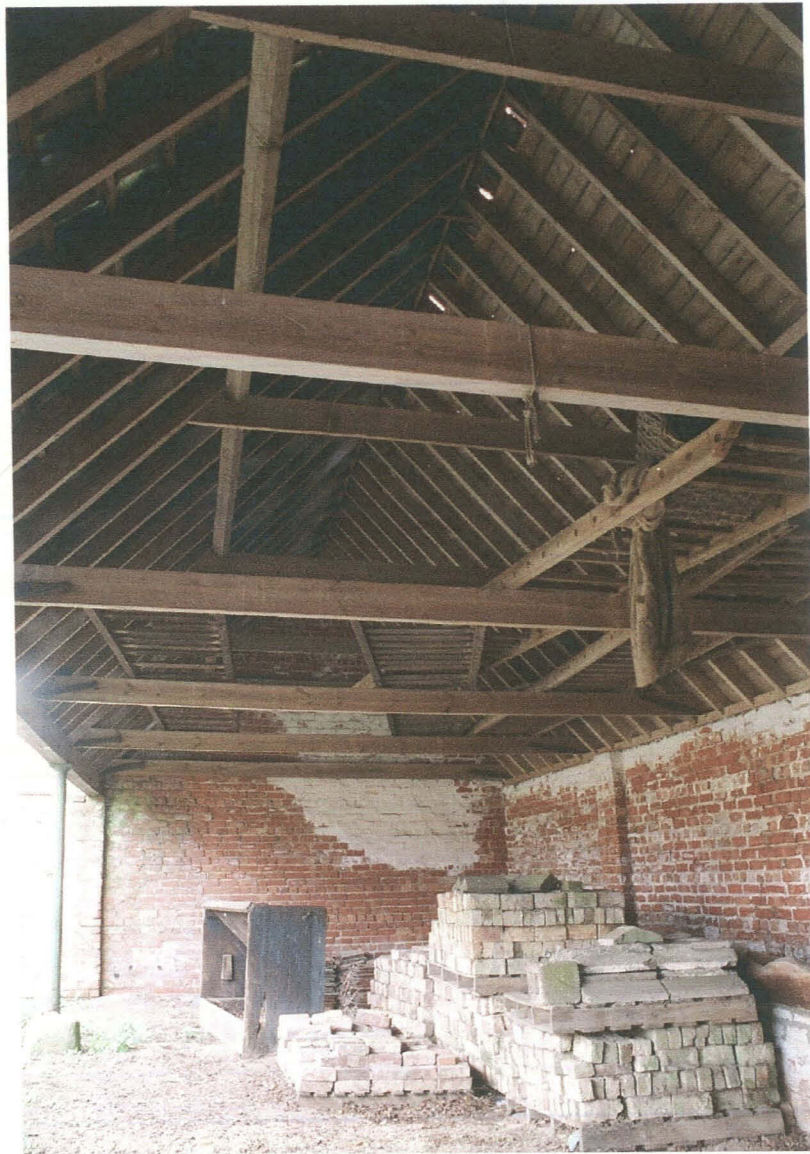
The clasped purlin, pantiled roof is of similar construction to that in Building 1, with machine sawn timbers and nailed, lapped joints (Pl. 37). There is a collar and roof collar. Horizontal boarding underlies the pantiles on the south side of the roof. The trusses are joined to the eaves plates with cast iron ties (Pl. 38). The roof has 5 bays which do not coincide with the brick bay divisions, nor indeed the 4 bays as defined by the 3 cast iron stanchions.

Pl. 37 Building 6. general view looking east showing roof construction, note internal boarding on south (right) side of roof only.

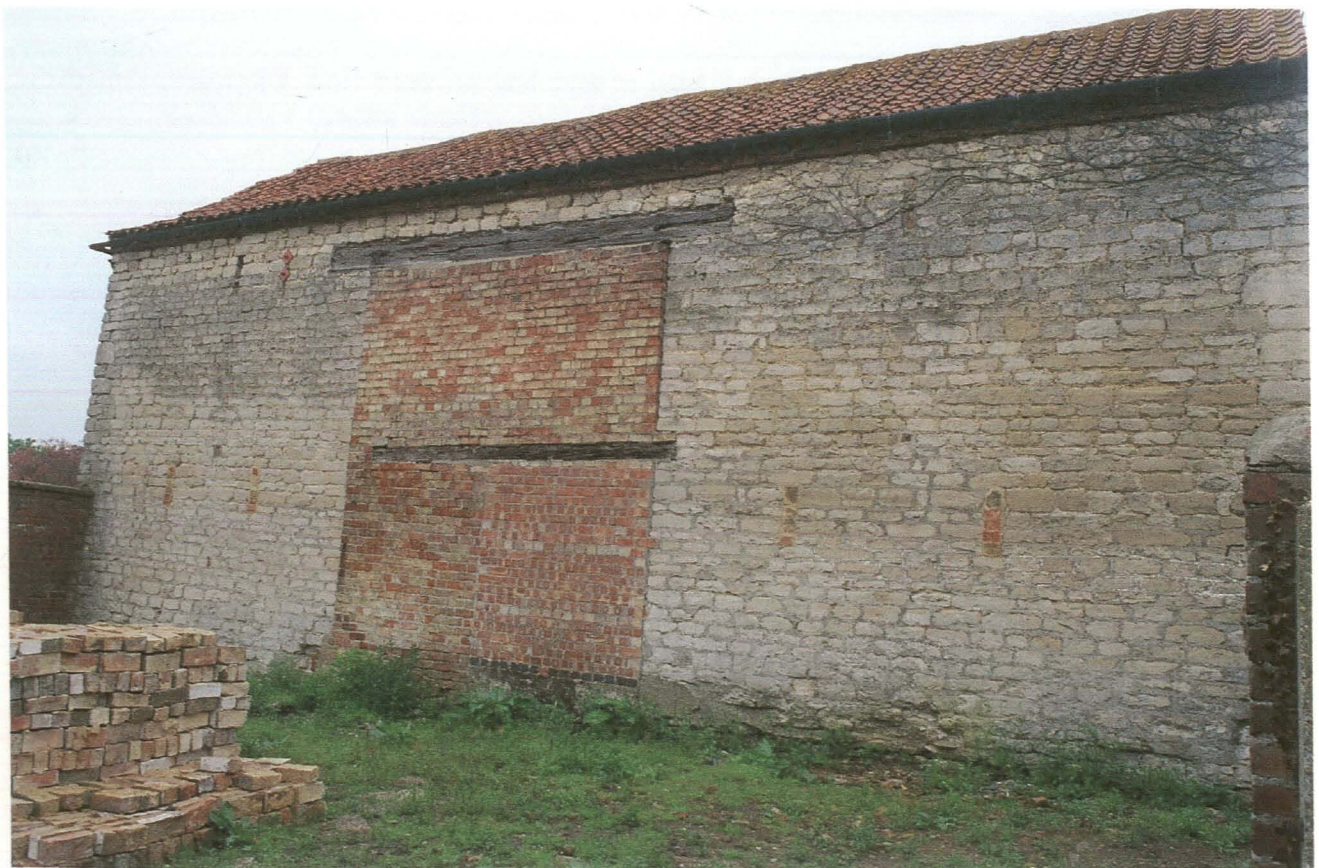
Pl. 40 Building 7. South elevation showing two phases of blocking of the main entrance, and two rows of bricked up ventilation holes.

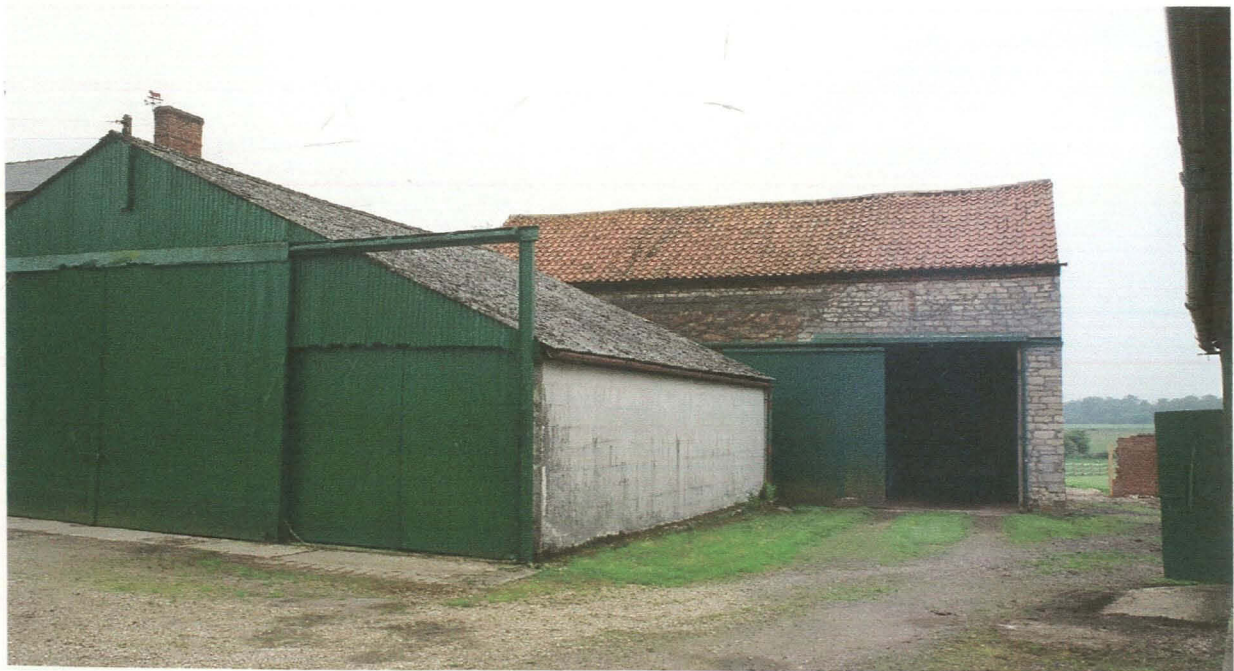
The original north wall entrance has a single blocking using a mixture of bricks from various sources (Fig. 5). There is an internal chamfered base, presumably to strengthen the blocking. A new metal sliding door has been inserted to the west of the blocked entrance (Pl. 42).

Pl. 42 Building 7, north elevation showing blocked original entrance with inserted sliding door to right (west) with Building 8 in foreground.

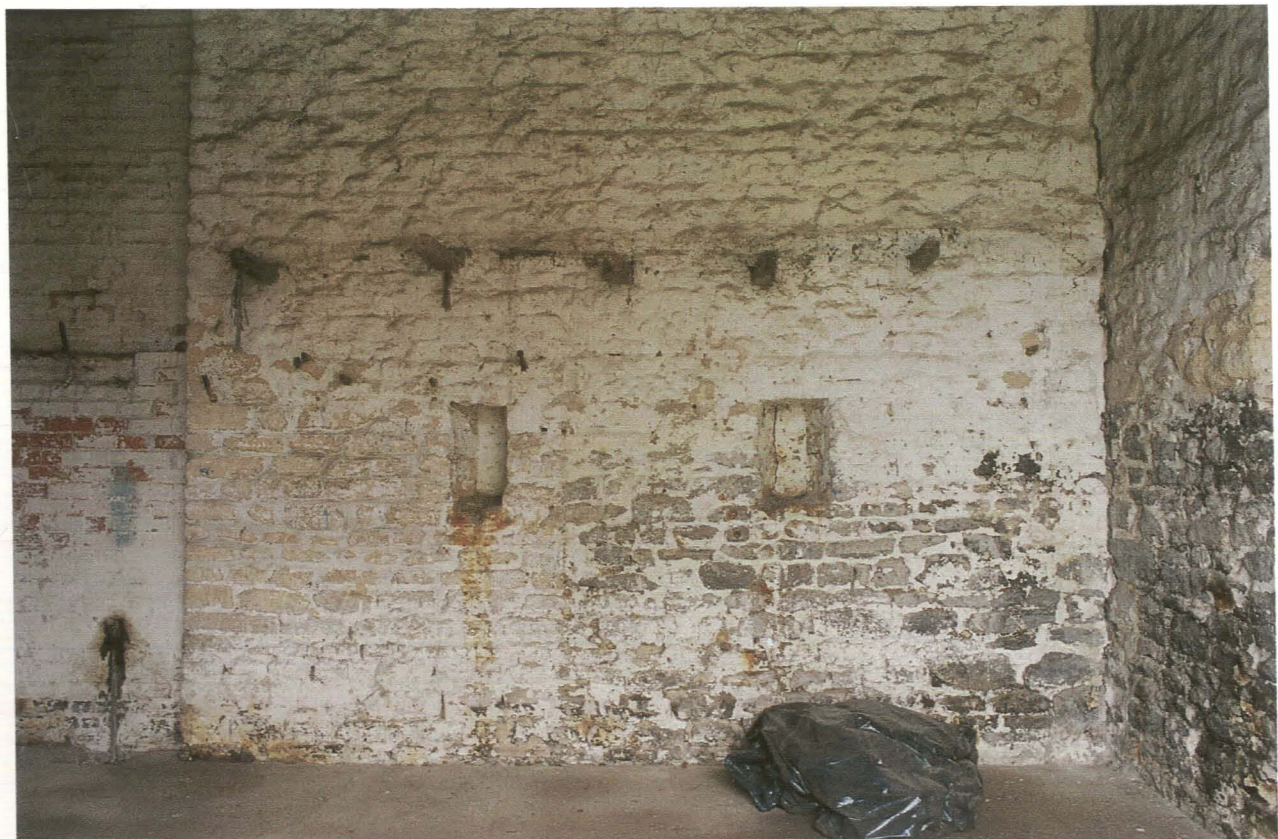
Pl. 44 Building 7. Internal elevation of south wall showing blocked ventilation holes with row of protruding timbers above.

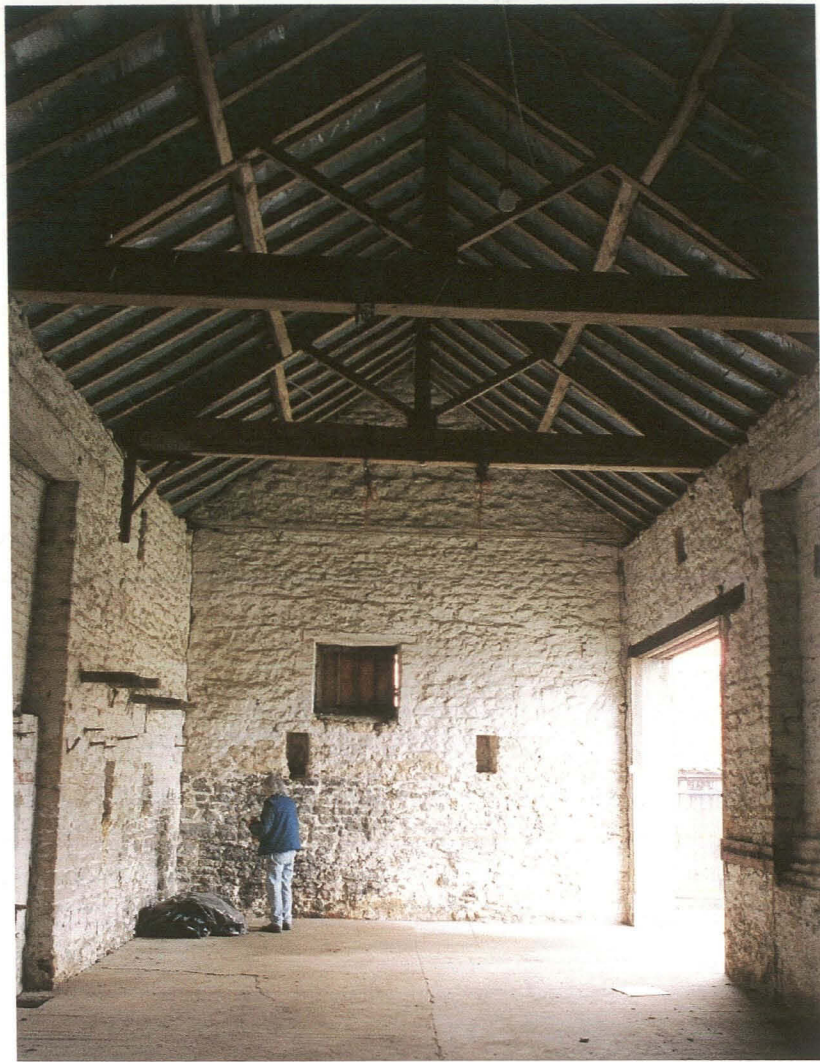
clasped purlin is pantiled. The king post trusses, with diagonal struts are pegged and properly jointed (Pl. 45).

Pl. 45 Building 7 internal view looking west, showing blocked ventilation holes and window, inserted sliding door with blocked opposing doors.

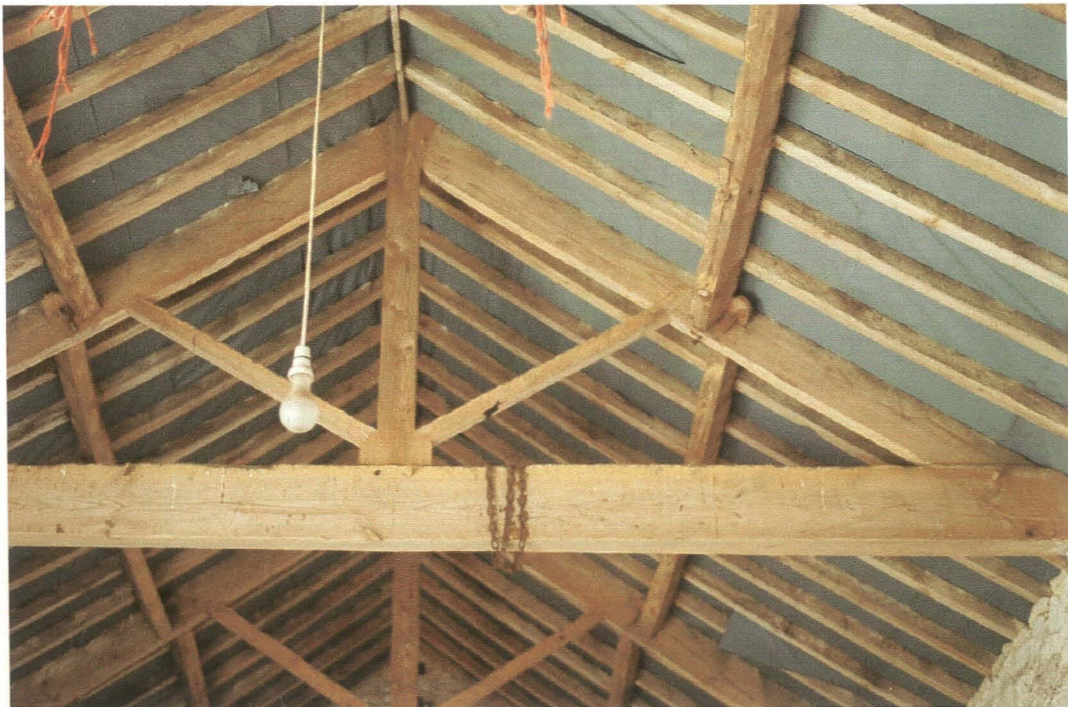
It is assumed that there would have been a loft on either side of the entrance for the storage of grain. Chains are still wrapped round all the roof trusses which are number I II and III from west to east (Pl. 46).

Pl. 46 Building 7. Truss II, showing numbered timbers (II) and pegged staggered purlins. Note chain round the cross timber
