COGGLESFORD MILL, EASTGATE, SLEAFORD

PHOTOGRAPHIC BUILDING SURVEY (LEVEL 3)

S. A. Savage

July 2007

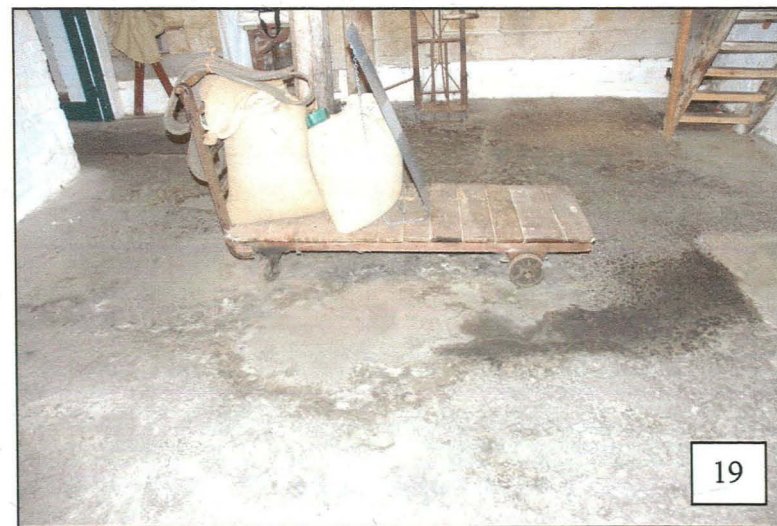
Plate 19: general view of the floor in Room 1, looking south. A patch of modern tarmac is in the foreground.

The majority of the floor area in Room 1 is of asphalt or tarmacadam. It was originally laid in east-west strips 4 ft in width – the jointing is clearly visible in the northern (less worn) area of the floor. The asphalt is heavily worn and has been frequently repaired, in a mixture of concrete and more modern asphalt.

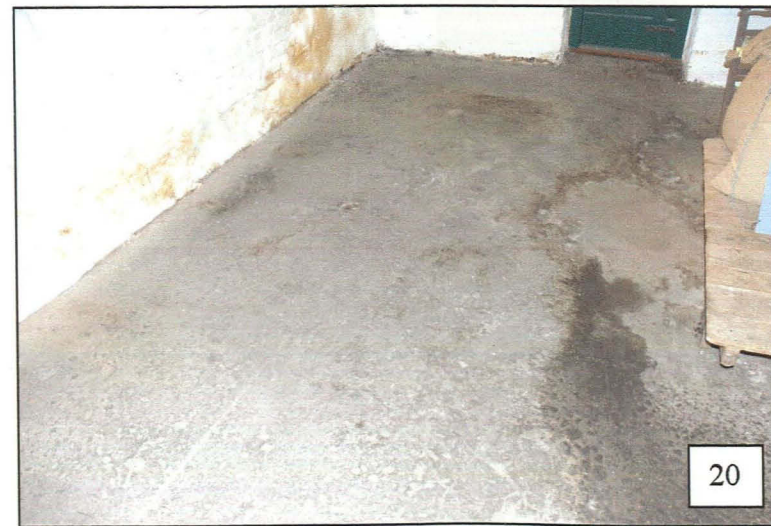
Plate 20: The floor on the north side of Room 1, looking northeast. The jointing between the strips of tarmac is visible in the lower left of the picture.

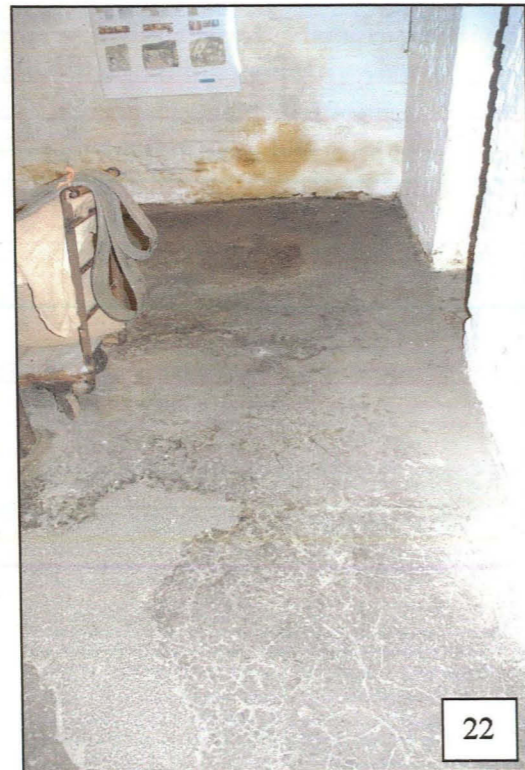
Plate 22: The floor on the east side of Room 1, looking north. Another patch of modern tarmac is in the lower left of the picture.

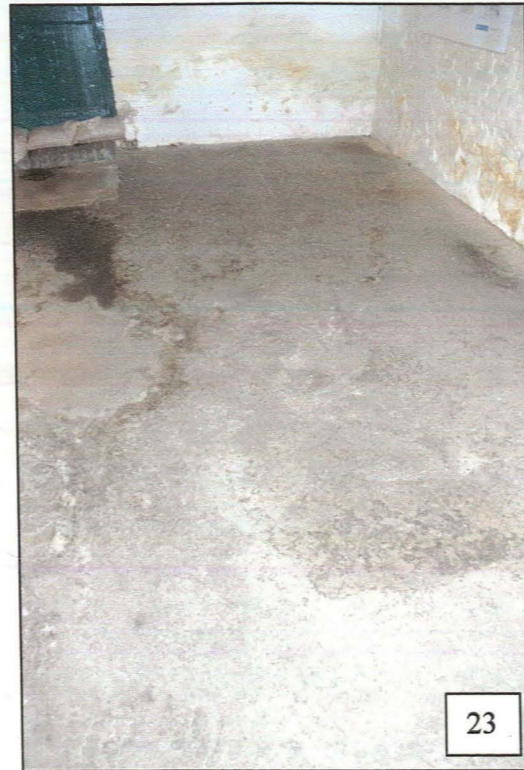
Plate 23: The floor on the north side of Room 1, looking northwest. This is the best preserved area of the original tarmac floor.

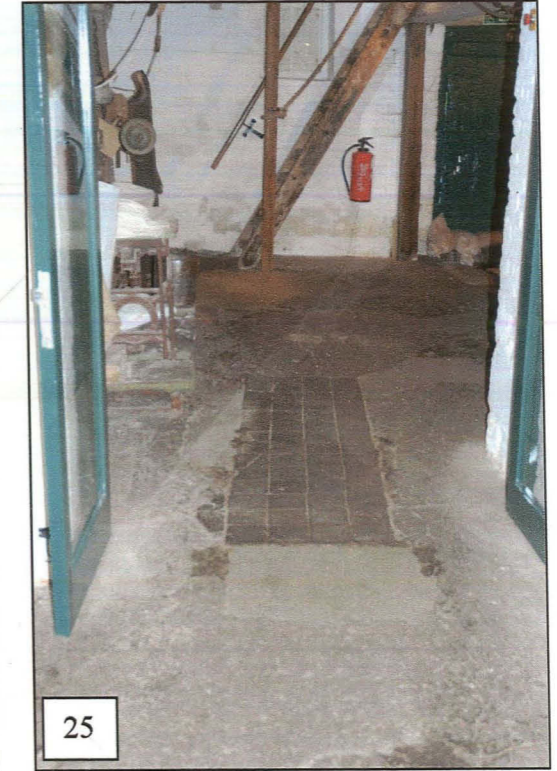
Plate 25: Area of quarry tiles between Rooms 1 and 2, looking west. A rectangular patch of modern tarmac is in front of the tiles.

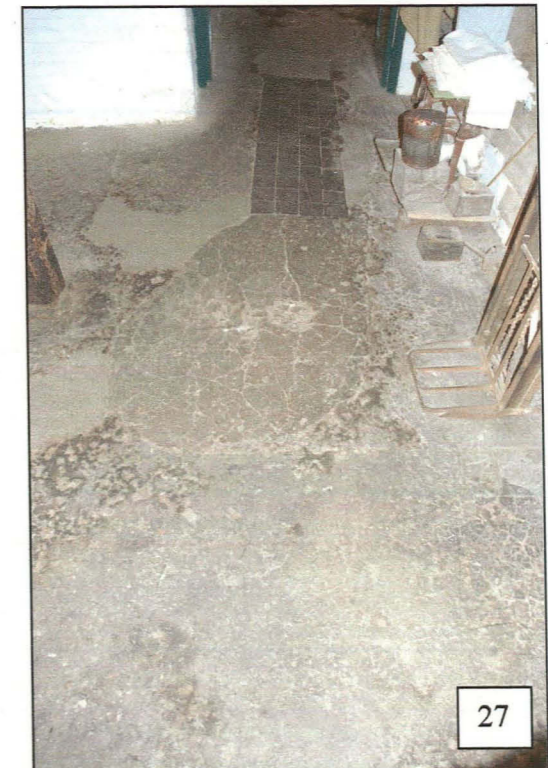
Plate 27: The patch of concrete in Room 1 below the grain hoist trapdoor, at the west side of the quarry tile area, looking east.

Immediately below the first floor trapdoor (through which the sacks of grain are lifted to the bins on the second floor) is a large patch of concrete. This does not appear modern, and has been worn smooth. Leading away from this in the direction of Room 2 is an area of quarry tiles, four tiles (or 2ft) in width and 14 tiles (or 7ft) in length.

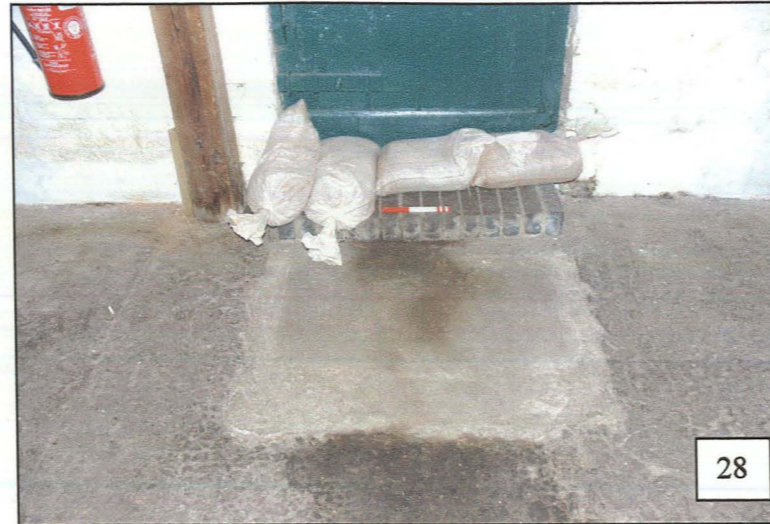
The main door has a step of modern 2 ½" blue engineering bricks, in front of which is a rectangular patch of modern concrete.

Plate 28: The concreted area inside the west door of Room 1, with the recent engineering brick step, looking west.

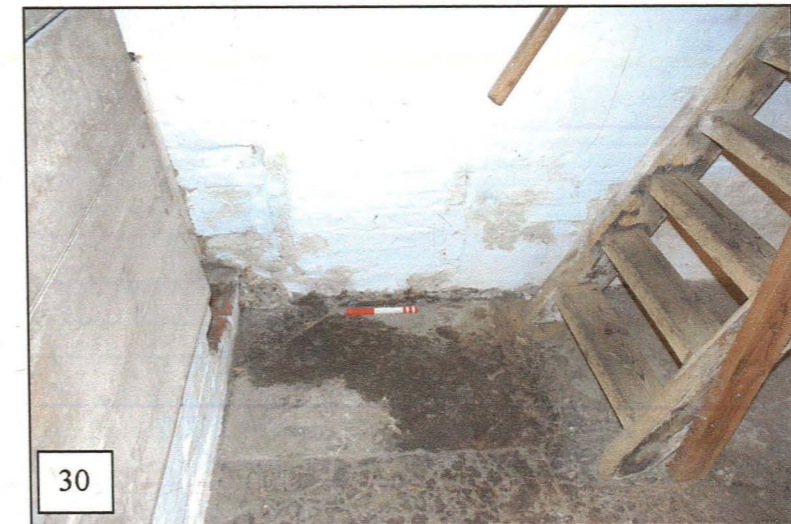
In the southwest corner of the room a fireplace has been bricked up, but the hearthstone is still present in the floor, now missing its southwest corner.

Plate 30: The hearth stone at the foot of the steps to the first floor.

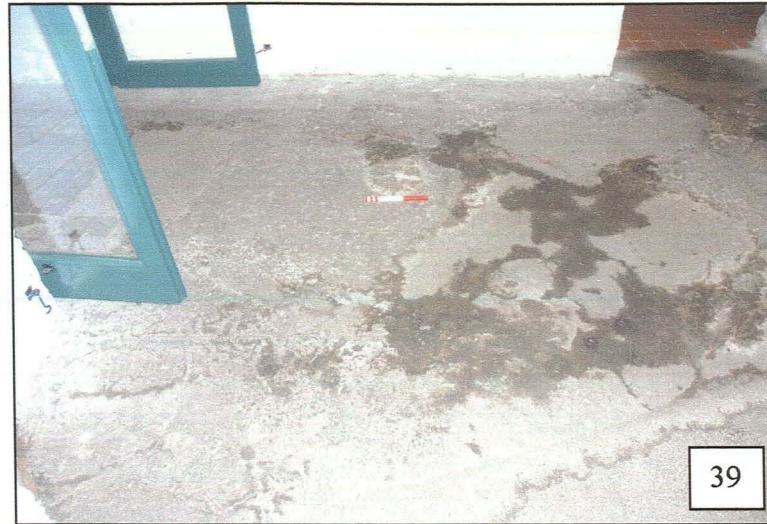
In two places the asphalt floor has worn through and in these locations a small area of underlying stone has been exposed; a further stone protrudes through the floor and is probably a padstone for a supporting post (no longer evident). The stones are discoloured and heavily fragmented making identification impossible.

Plate 39: The western part of the tarmac floor in Room 2. The scale is in front of the padstone.

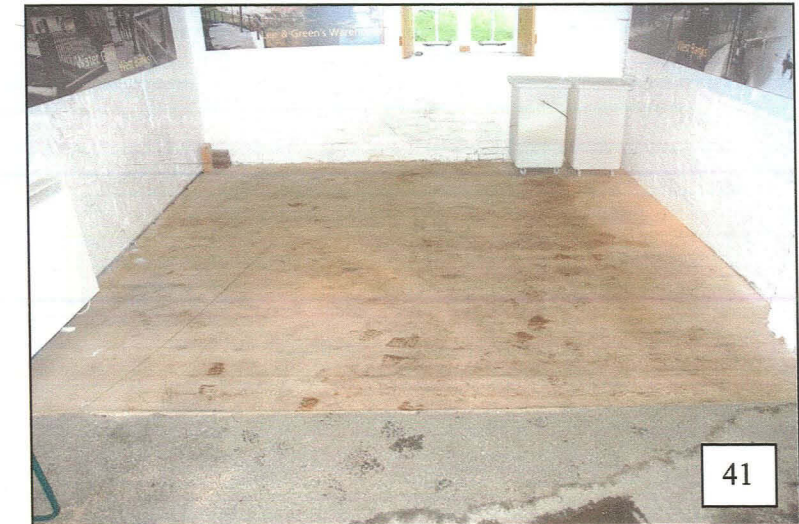
The southern two thirds of this room is floored in wood: 8 ¼" tongued and grooved floorboards laid east-west. This is a modern replacement of an earlier floor, the original having been constructed over the disused secondary wheel pit.

Plate 41: The modern timber floor over the secondary wheelpit in the southern part of Room 2, looking south.

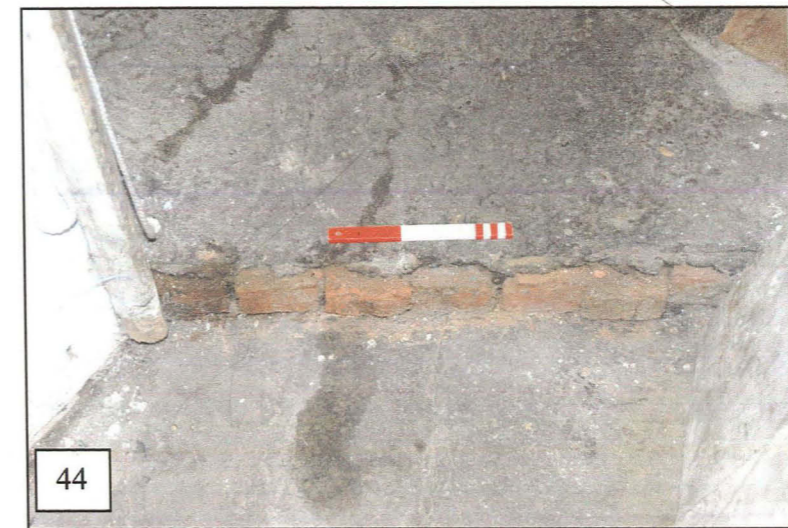
The nature of the floor below the asphalt also remains enigmatic. Although a row of 2 ¾" bricks is seen below the asphalt in the doorway of Room 3, this may only represent a threshold. Elsewhere, heavily fractured stone can be seen where the asphalt has worn through. Only partial or complete removal of the asphalt surface would fully answer these questions.

Plate 44: The edge of the tarmac exposed in the doorway of Room 3.

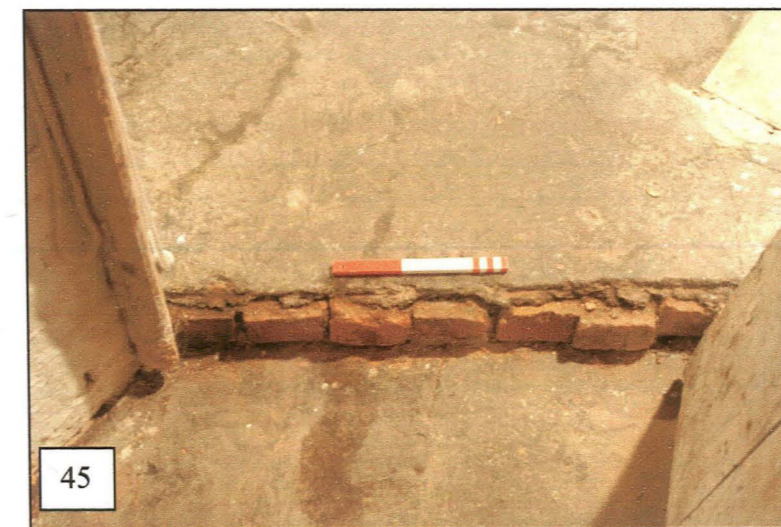
Plate 45: same shot as 44, but taken without flash to emphasise the exposed bricks below the tarmac floor.

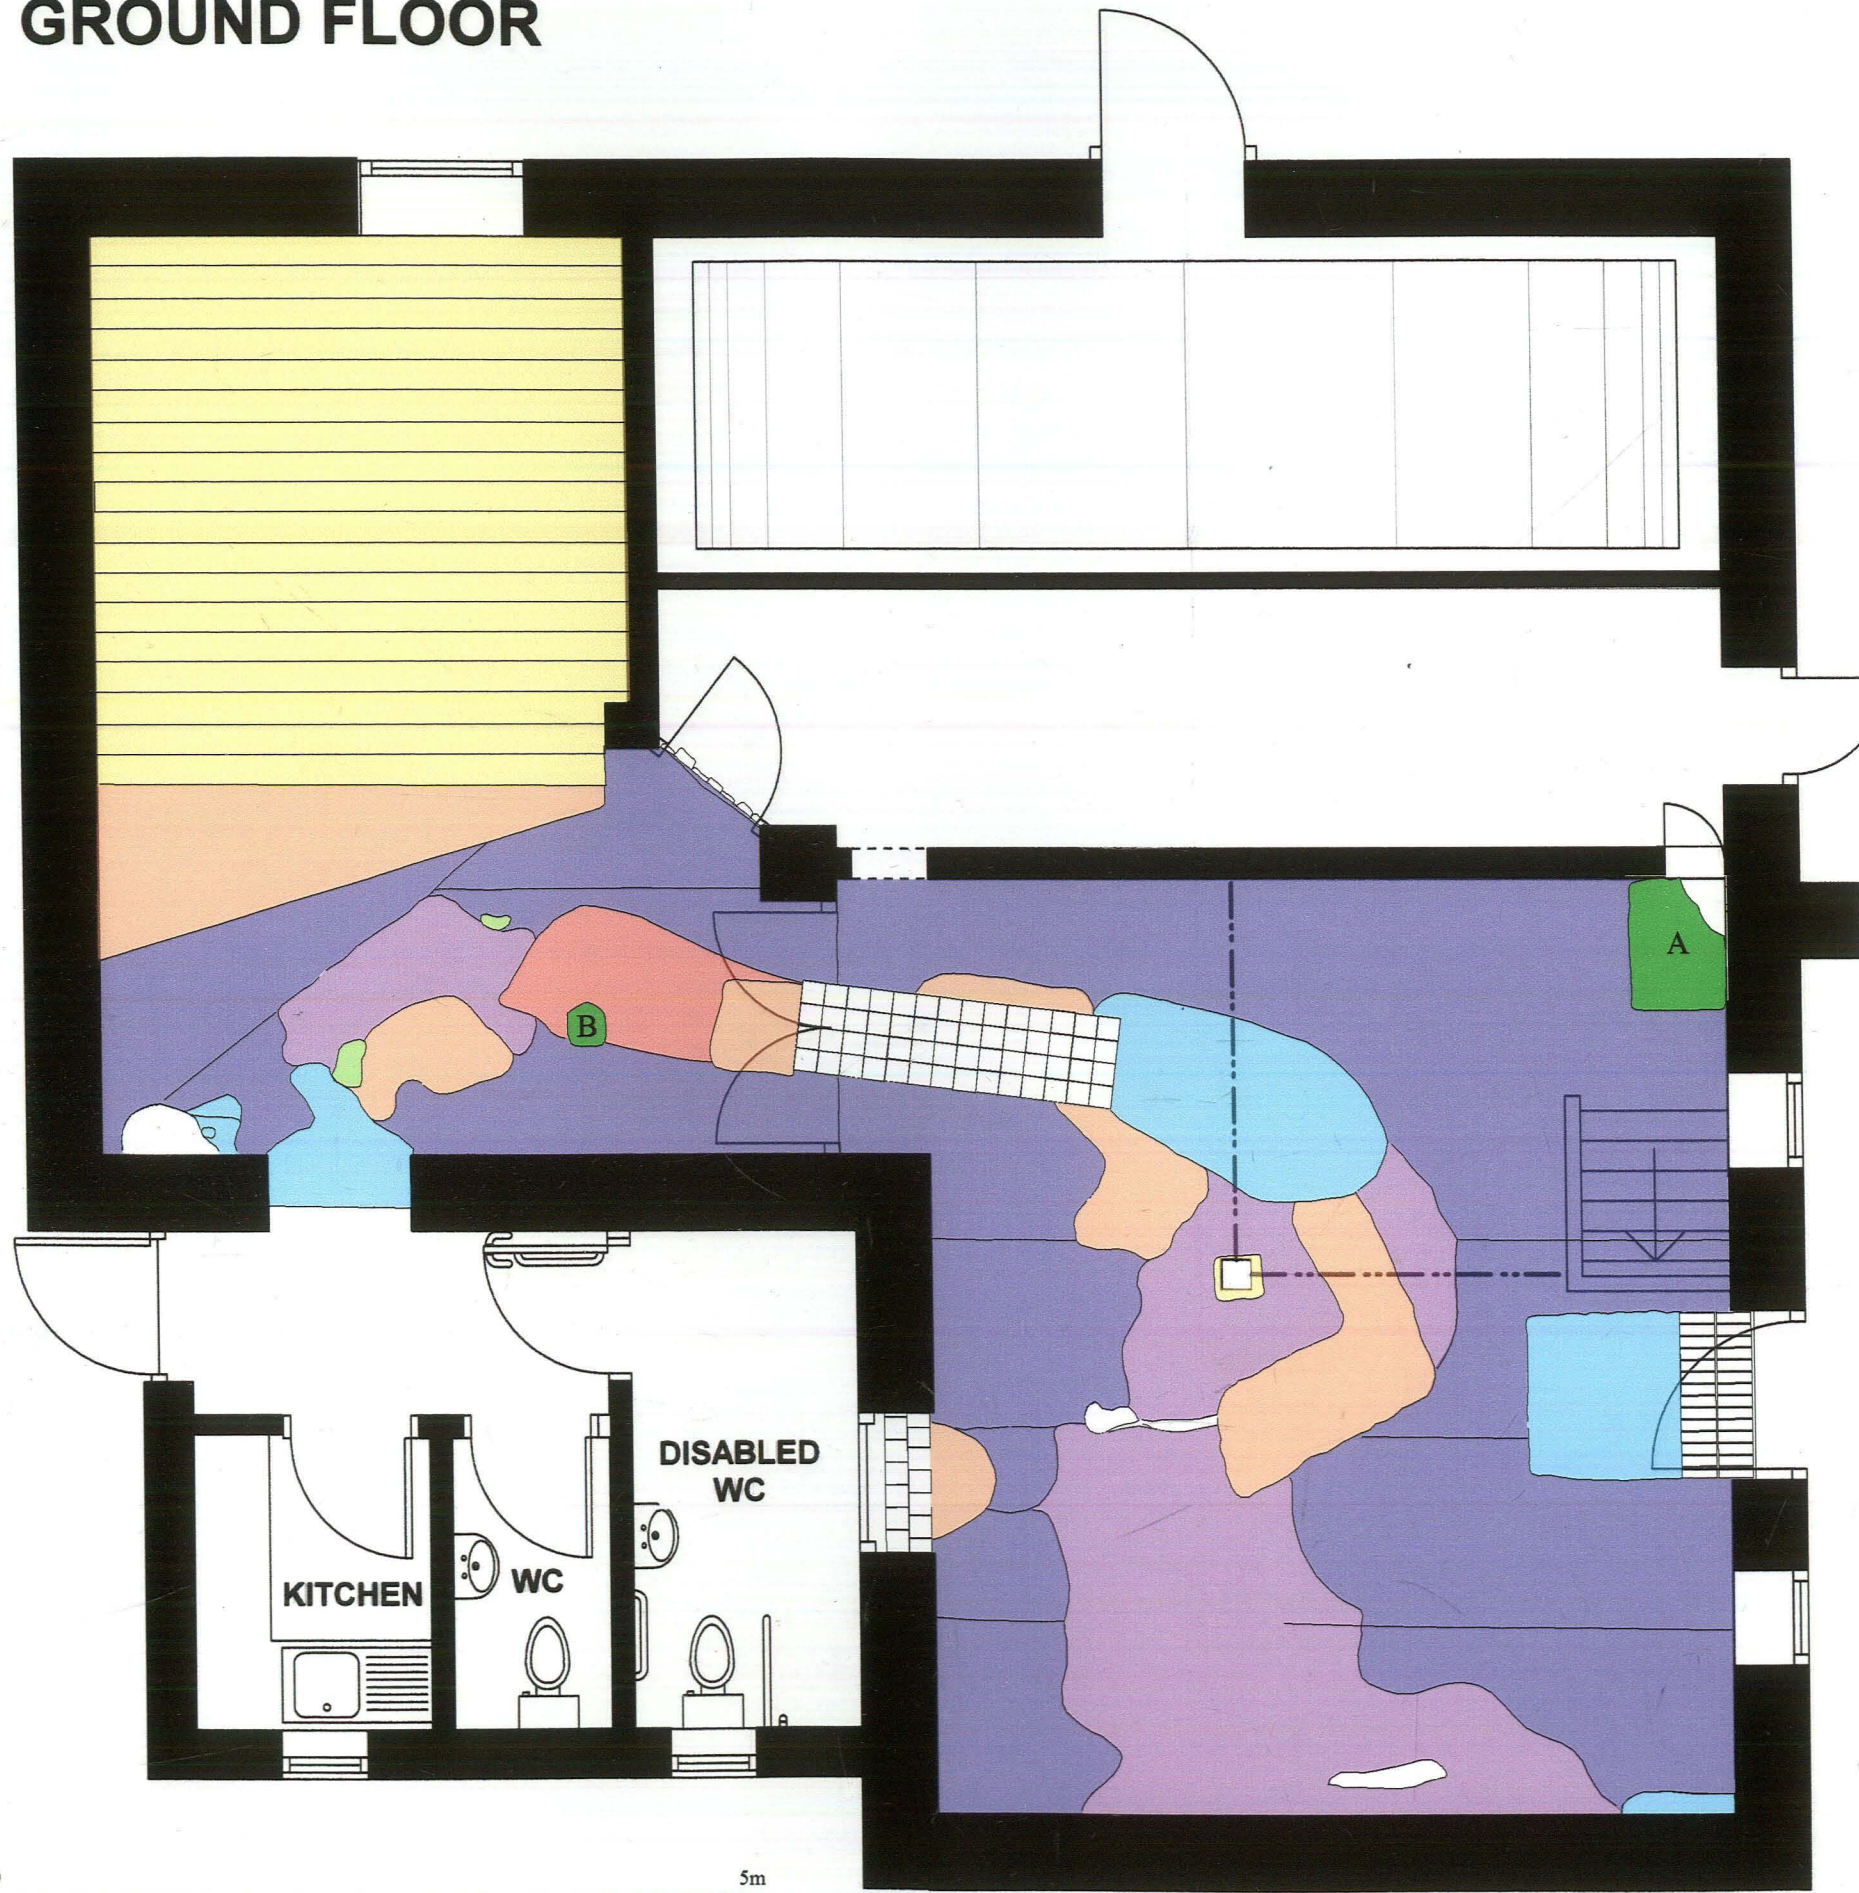
Fig. 2: Plan showing the floor surface of the ground floor of Coggesford Mill. Scale 1:50

The jointing in the original asphalt surface indicates that the floor was laid in 4ft wide east-west strips. The pattern of wear and repairs suggests that the floor is contemporary with the use of the building for milling rather than storage. The heaviest wear is present in the area below the grain hoist, and in the area between Rooms 1 and 2. Here, the floor has been repaired both with modern asphalt and concrete and appears to have been supplemented by quarry tiles in areas where asphalt would have been or proved to be insufficiently hard-wearing. Interestingly, the width of the patch of tiles between Rooms 1 and 2 is only 2-3" wider than the axle widths of the sack carrier and trolley on display in this room. This appears more consistent with the building's use as a mill (transportation of sacks of grain to the grain hoist and sacks of flour from the flour chutes).
