Cow Pasture Barns, Hainton, Lincs.

Archaeological Recording

LAS Report No. 640

August 2003

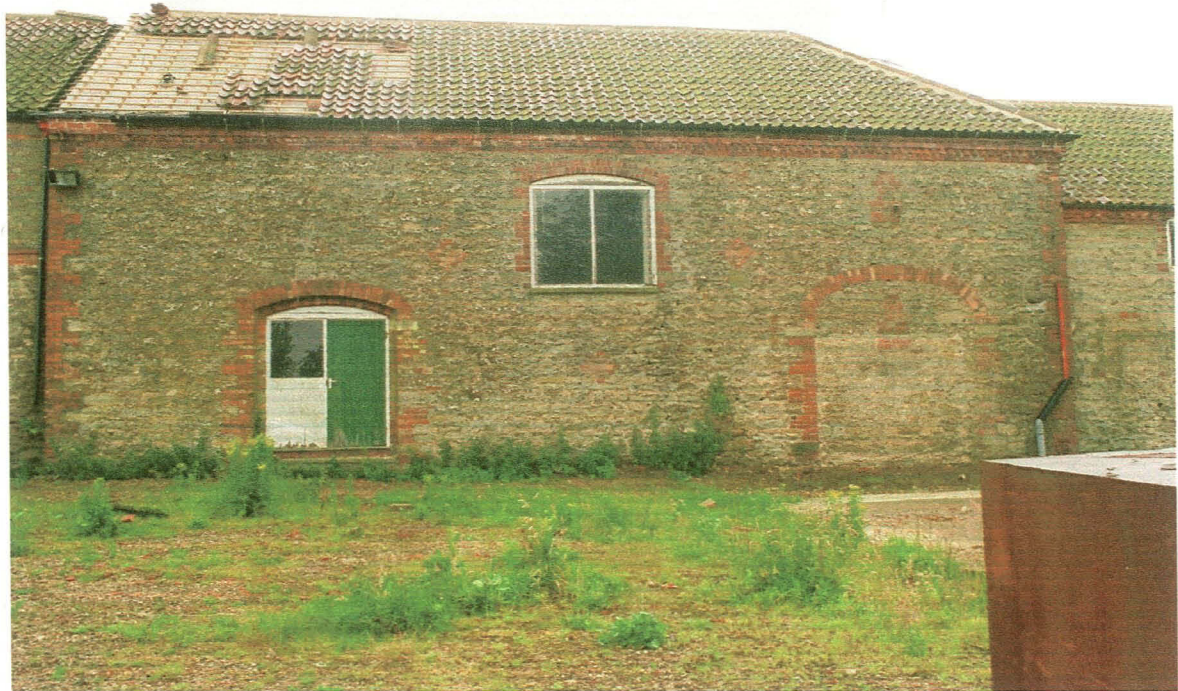
The barn is constructed in stone with red brick detailing around the openings, with a dog-tooth eaves cornice of later brick (Pls 3 and 4). There are two pairs of opposed entrances on the north and south elevations. The north west entrance has been blocked in stone (Pl. 3). This opening and its opposite entrance on the south elevation are identical in style: wide openings with brick jambs are of a distinctive 'long and short' design. They are topped by an ashlar block from which an elliptical arch of orange-red brick springs. The two entrances opening onto the crewyard have outward-opening, wooden double-doors with strap hinges (Pls 8 and 32).

Plate 4: Exterior north elevation of Barn (1).

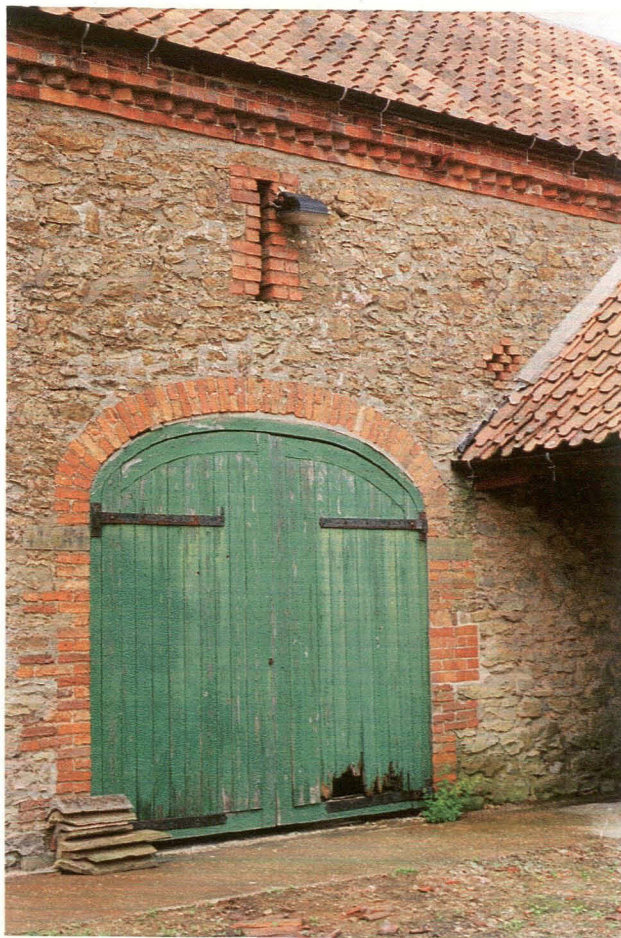
There are three diaper-shaped ventilation holes in honeycomb brickwork on both the north and south elevations (Pl. 8); those on the north elevation are now blocked with one to either side of the window and one below (Pl. 4). There are narrow ventilation slits above both the north west (Pl. 4) and south west entrances (Pl. 8); the former is blocked. Internally, the ventilation is channelled through two vertical slits positioned either side of the external slit, to prevent a direct cross-draught through the barn (Pl. 9).

Plate 8: Barn (1) exterior detail of south elevation, showing entrance, ventilation slit above and diaper-shaped ventilation holes, partially obscured by later roof of Cattle shed (5).

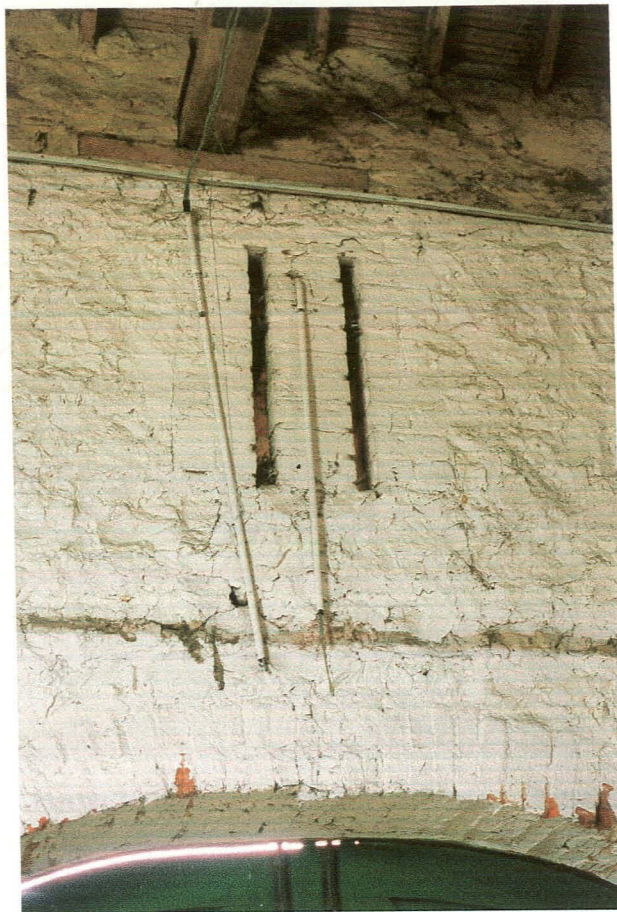
Plate 9: Barn (1) - detail of double ventilation slits on interior wall.

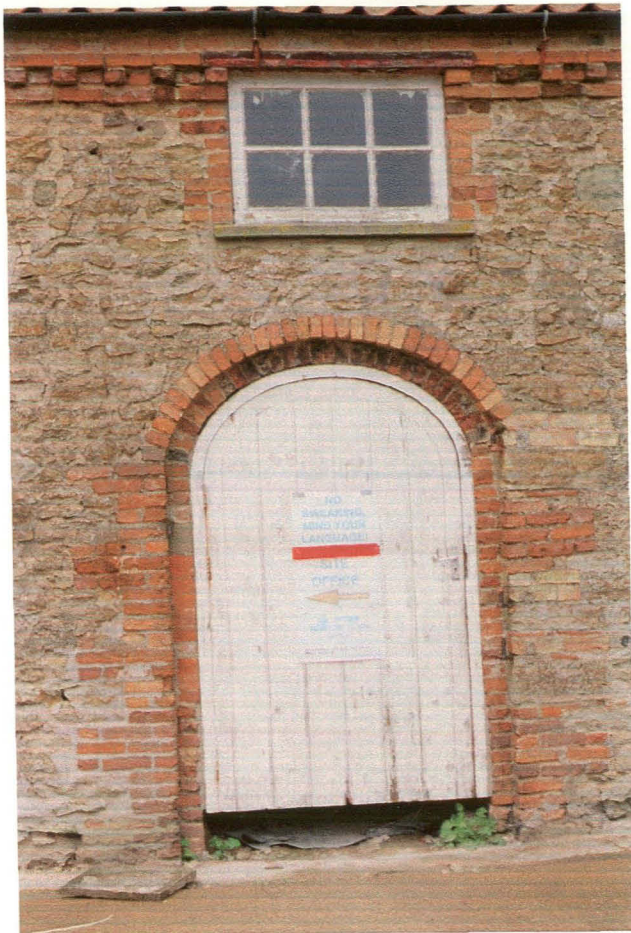
Access to the barn from the crewyard is provided via a single doorway on the south elevation (Pl. 11). The double pintles indicate that the original door was a traditional split stable door. The two entrances at the west end of the south elevation are modern insertions. The west gable end contains a wide, high opening with a shallow segmental arch over. Its brick jambs have been removed and the opening cut back to the surrounding rubble walling, probably to receive a recent blocking of breezeblock and rubblestone cladding.

Plate 11: Barn (2), detail of exterior south elevation, showing original entrance and window above. Note the double pintle on the jamb, indicating that opening originally had a split stable door.

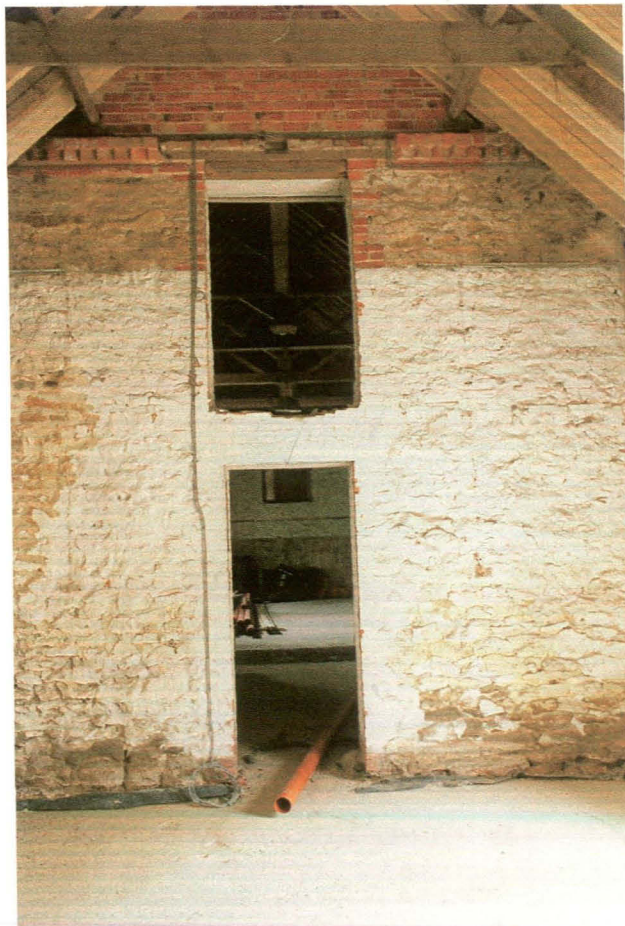
Plate 12: Interior of Barn (2), looking east, showing east wall. Note eaves course treatment and inserted openings.

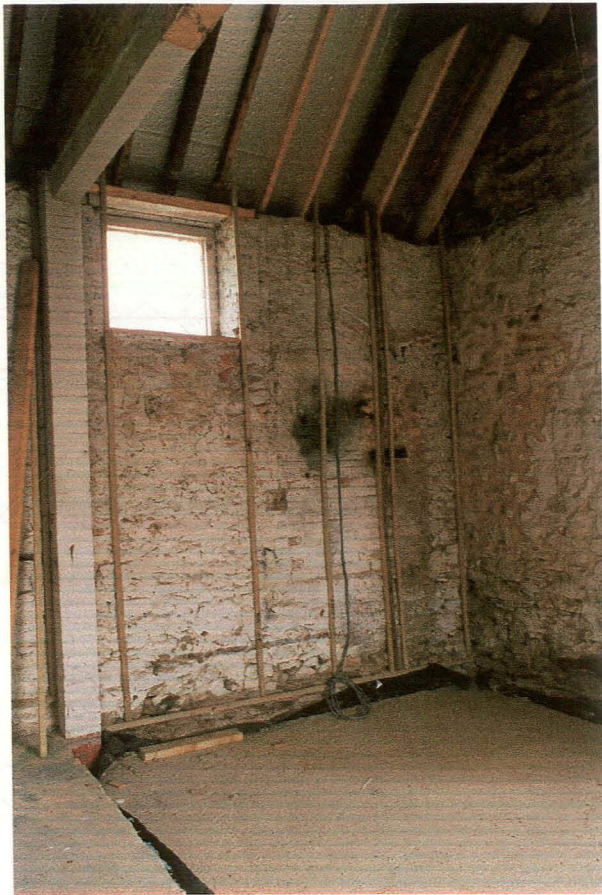
It is likely that the two ground floor windows are primary features (Pls 3 and 10); a third ground floor window at the west end of the north elevation has been brick-blocked (Pl. 13). Also original are the two small, rectangular upper windows placed high up on the south elevation, their stone lintels built into the eaves cornice. On the north elevation, the three upper windows are later enlargements of the original eaves height windows; the lintels and red brick jambs of these replaced windows remains. On the large central window, the enlarged area is marked by nineteenth century yellow brick jambs. The glazing is modern throughout. The upper windows probably lit a first floor level open to the roof, now removed.

Plate 13: Interior north wall of Barn (2), showing inserted window (left) and blocked window behind pipes (right).

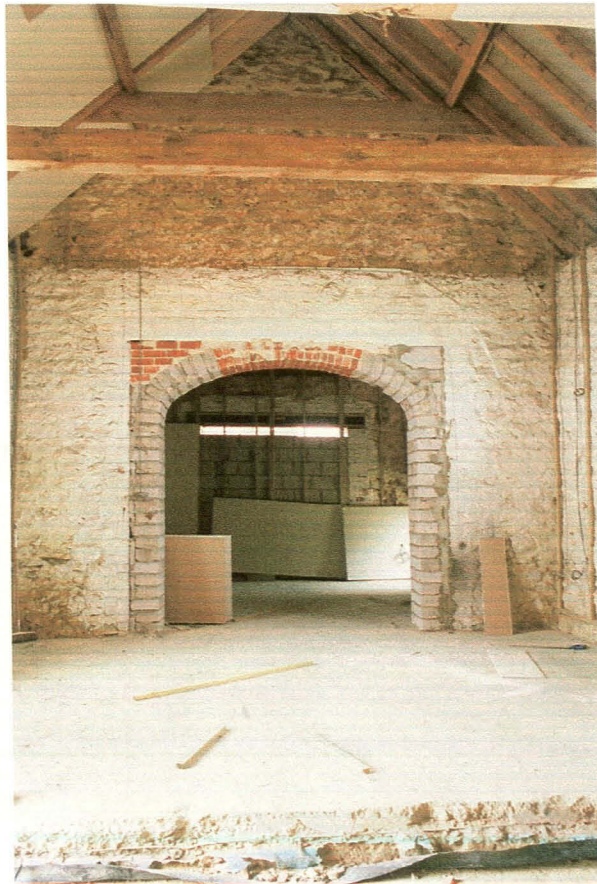
Internally, Barn (2) currently comprises two rooms. The roof has been almost entirely replaced at the west end, and is hipped with a transverse collar joining the central collar from the hip, all clad with plasterboard. The central partition wall has had its access altered and has recently been reduced in height with a low elliptical arch copying original arches in the central barn (1) (Pl. 14). The western barn (2) is present on the 1814 Heneage estate map (Fig. 6).

Plate 14: Interior of Barn (1) looking west. Note inserted breezeblock and brick archway inside larger rectangular opening.

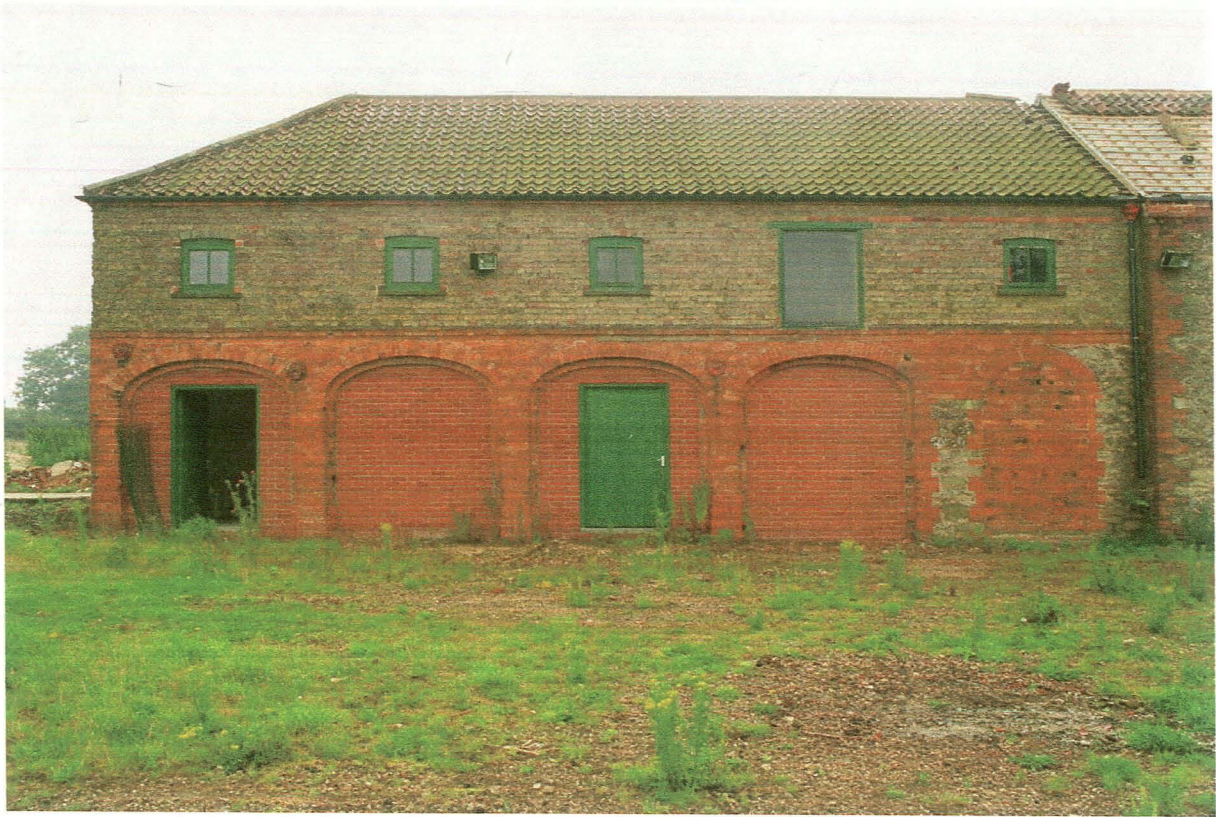
and 'long and short' jambs of red brick. Fragments of the west jamb of the adjacent arch also survive (Pl. 15). Above the arches, the first floor is yellow brickwork with five windows (one has been enlarged within the last fifty years). Internally, the window jambs have bullnose bricks.

Plate 15: Exterior north elevation of Barn (3).

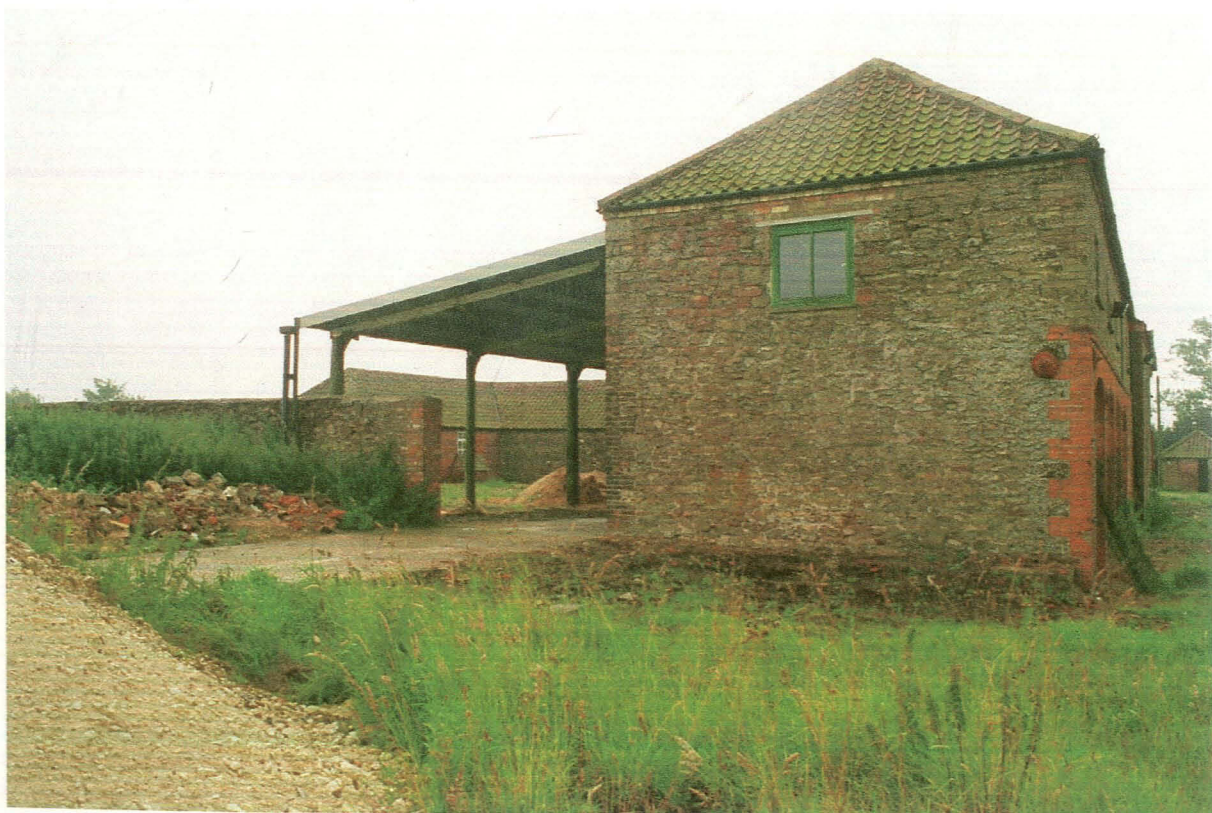
The east and south elevations are stone built (Pl. 16 and Pl. 32). The south elevation has been partially rebuilt and original features at ground floor level, such as opposed entrances, may have been concealed or removed (Pl. 32). The three upper windows have stone surrounds, replacement stone sills and modern fenestration.

Plate 16: Exterior east elevation of Barn (3).

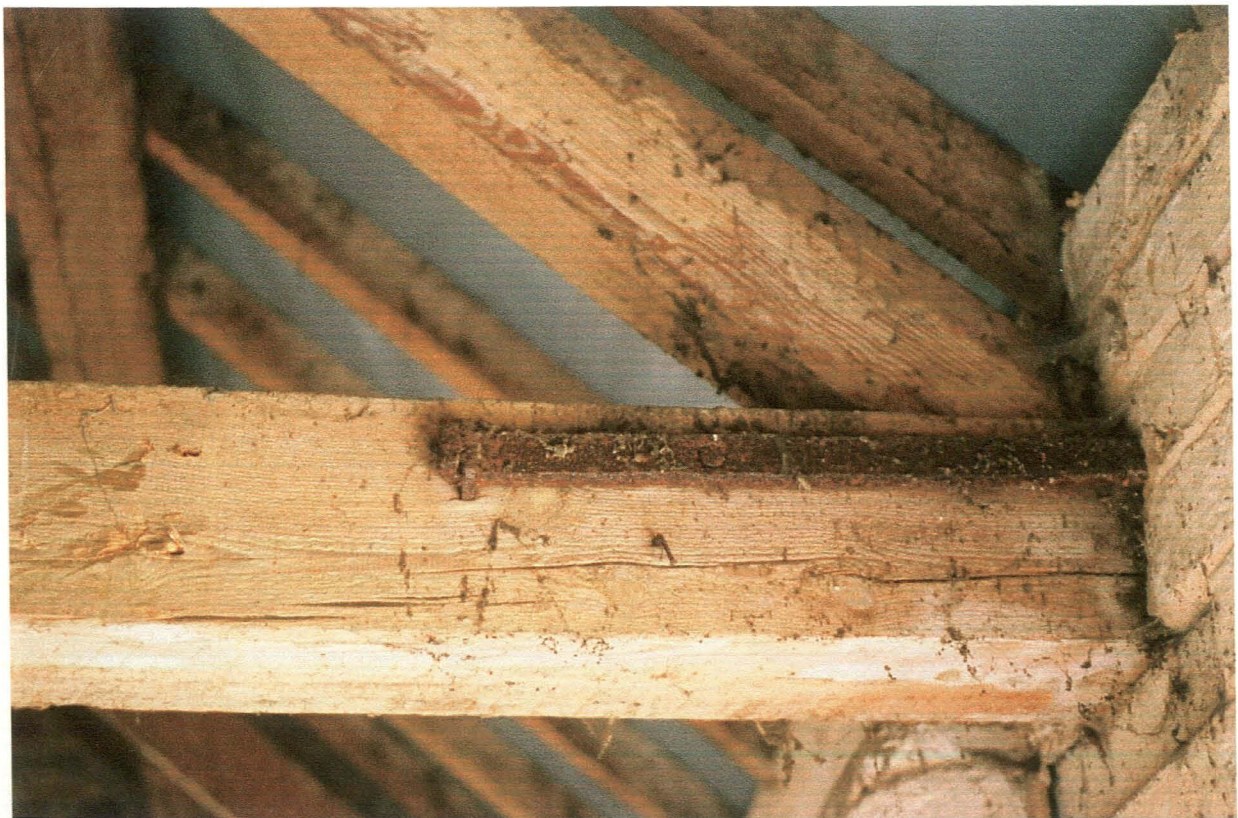
Plate 18: Barn (3): detail of iron strap used to secure tiebeam to wall.

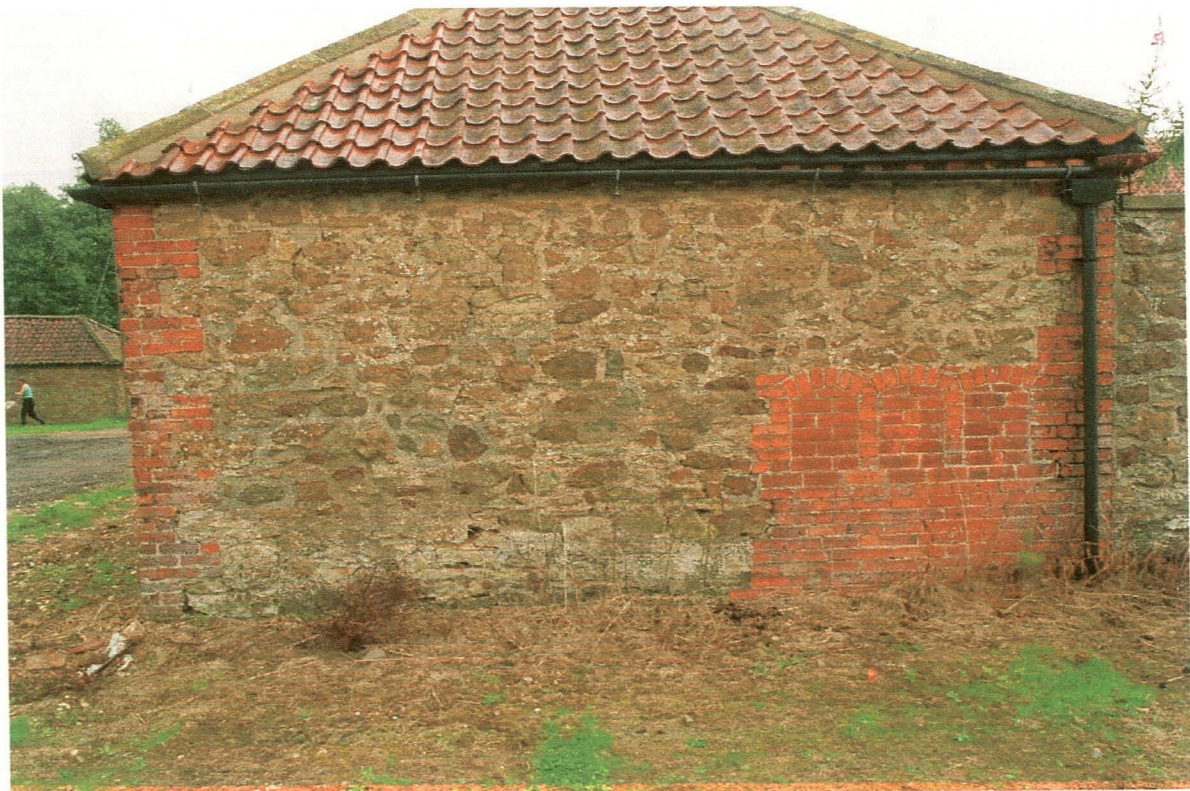
Plate 20: South elevation of Stable block (4). Note blocked niches.

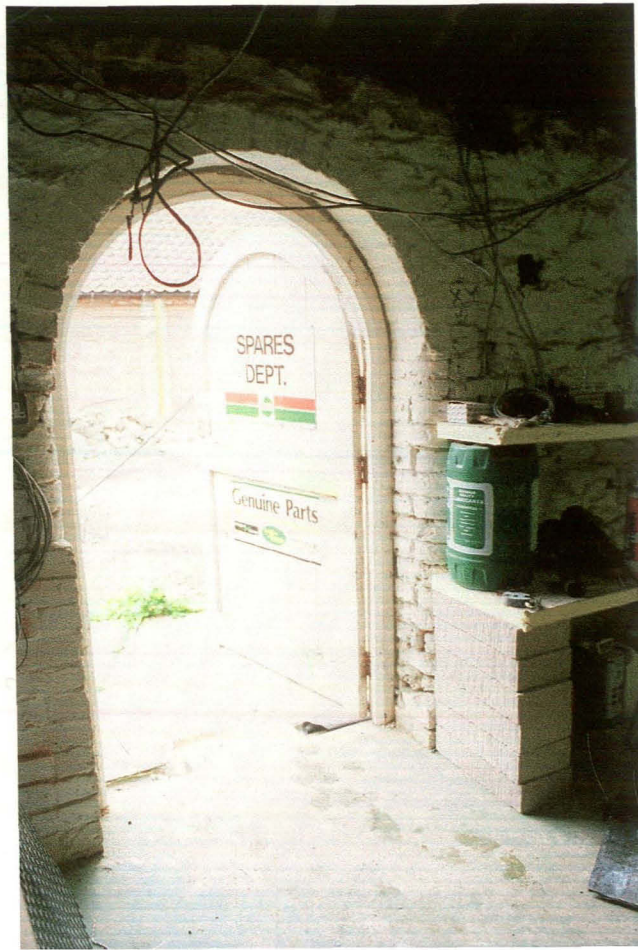
Plate 21: Stable block (4) - entrance in east elevation, showing bullnose brick detail on jambs.

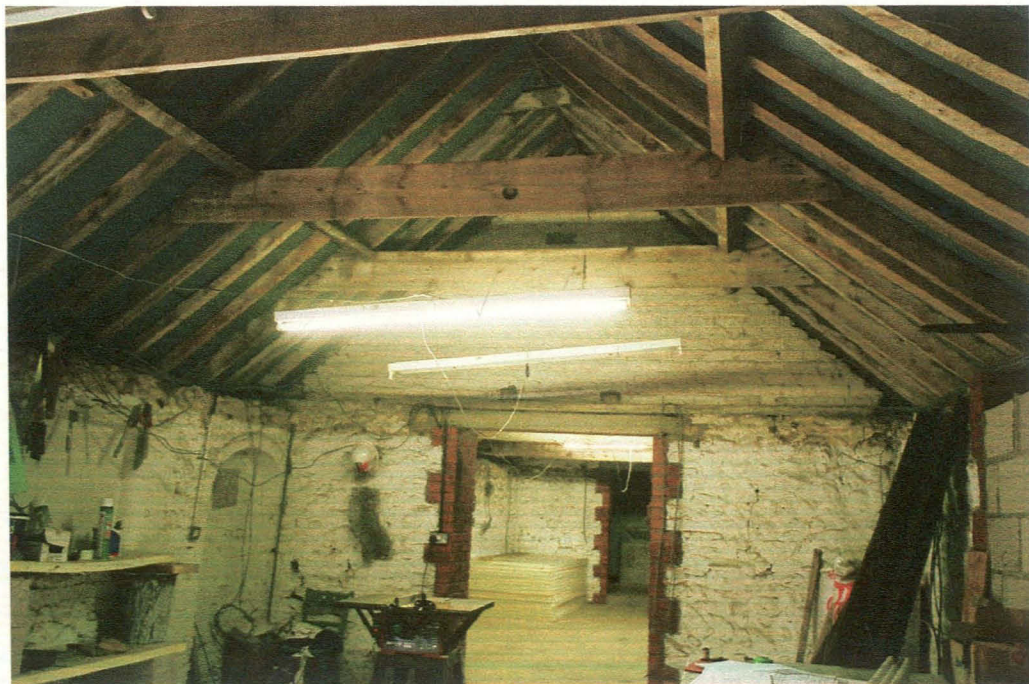
Plate 22: interior of Stable block (4), looking south. Note blocked door in front of cross-wall.

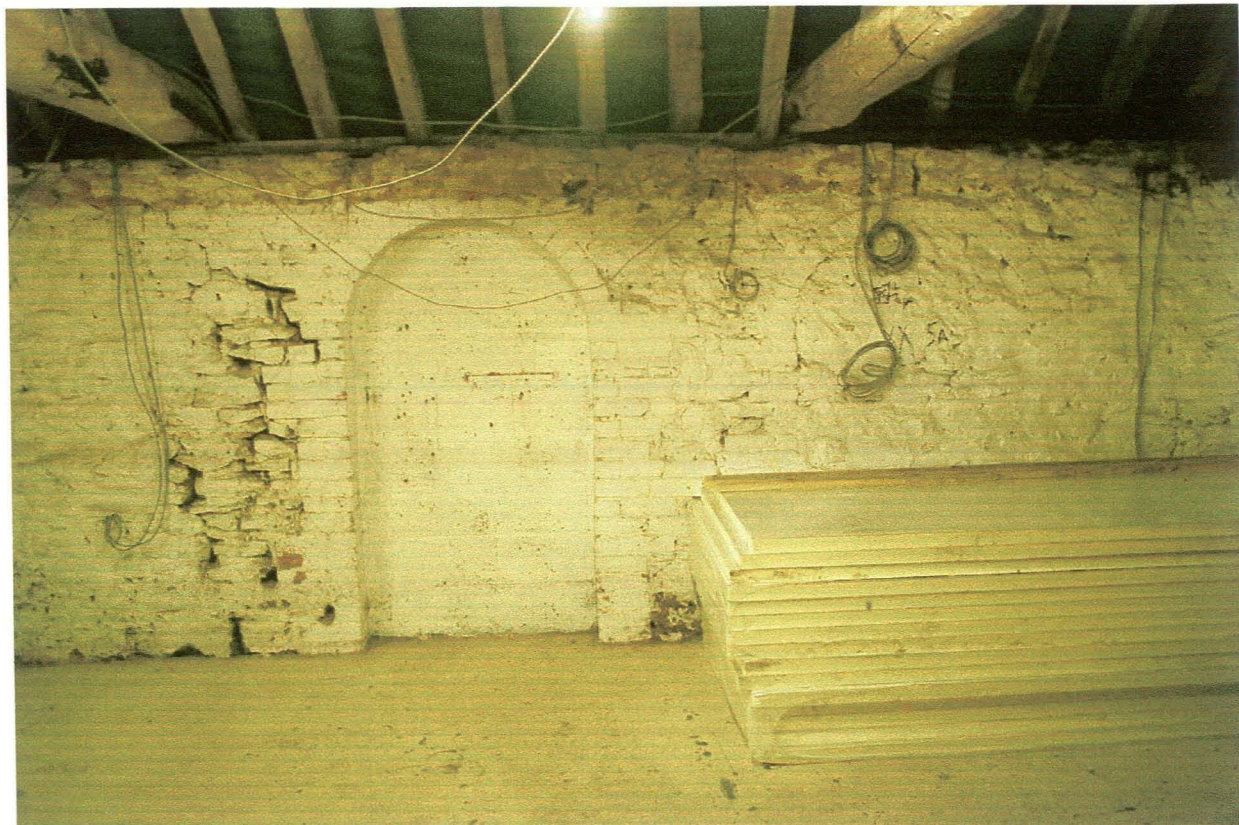
Plate 23: Internal east elevation of Stable block (4), showing blocked door.

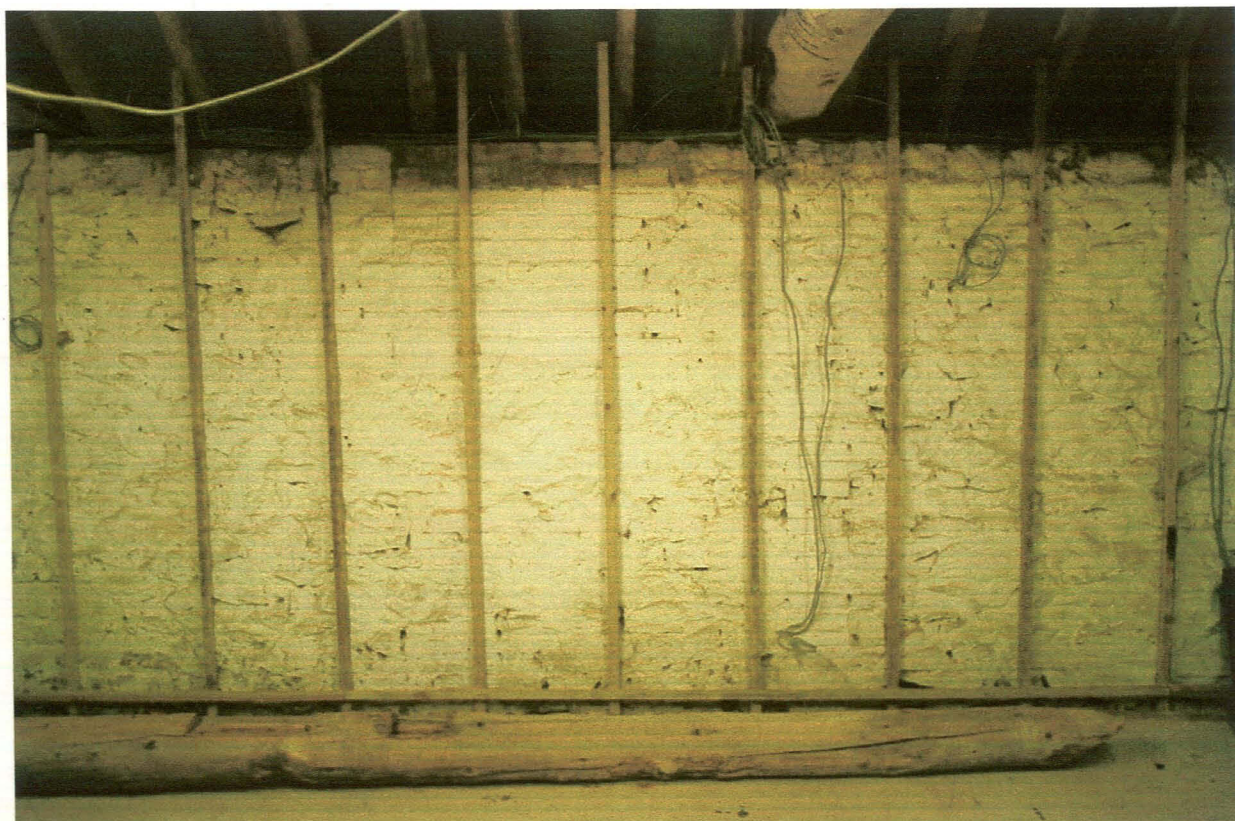
Plate 24: Internal west elevation of Stable block (4), showing blocked door.

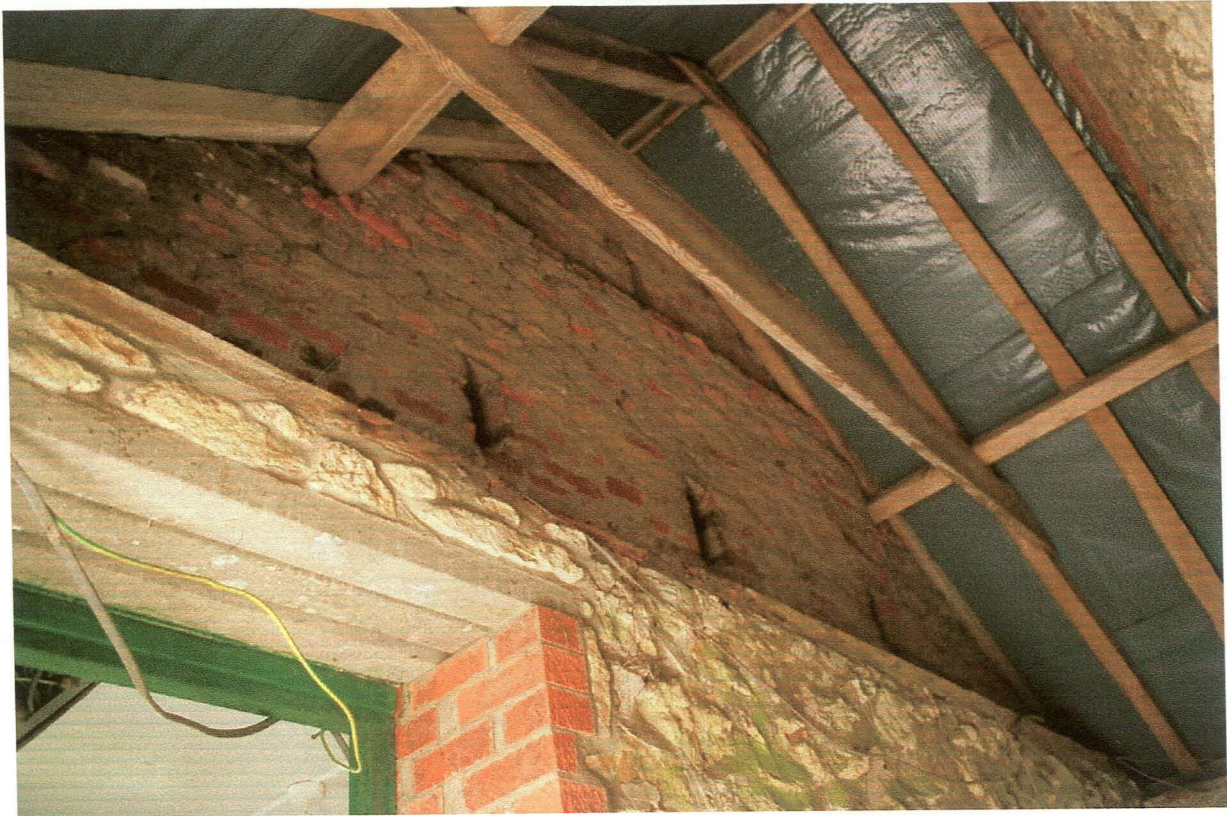
Plate 25: Stable block (4): detail of north gable wall, showing ventilation slits.

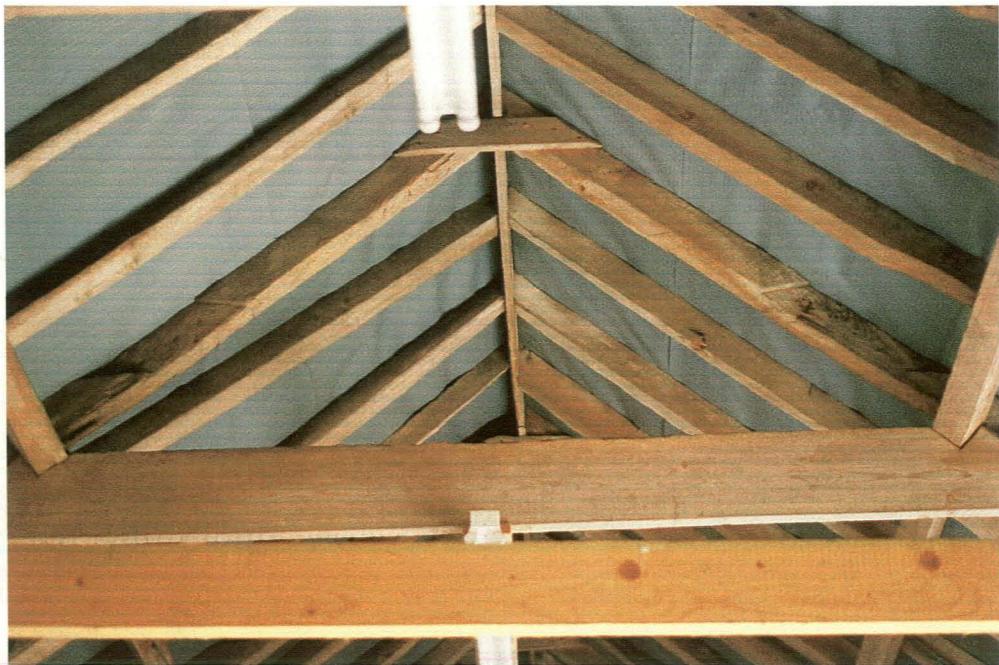
The internal length of the shed is 19.4m. Resting on top of each brick pier is an unsquared log forming a tiebeam, secured with metal braces (Pl. s 27 and 29). The intermediate machine sawn tie beams, rafters, ridge piece and ridge collars are modern (Pl. 28). There are eight rafters per bay and a collar every four rafters, i.e. two per bay. There is evidence that there was a second collar position above the purlins in eight of the twelve collar rafters (Pl. 28).

Plate 28: Interior of Cattle shed (5) - detail showing sawn rafters, ridge piece and collar.

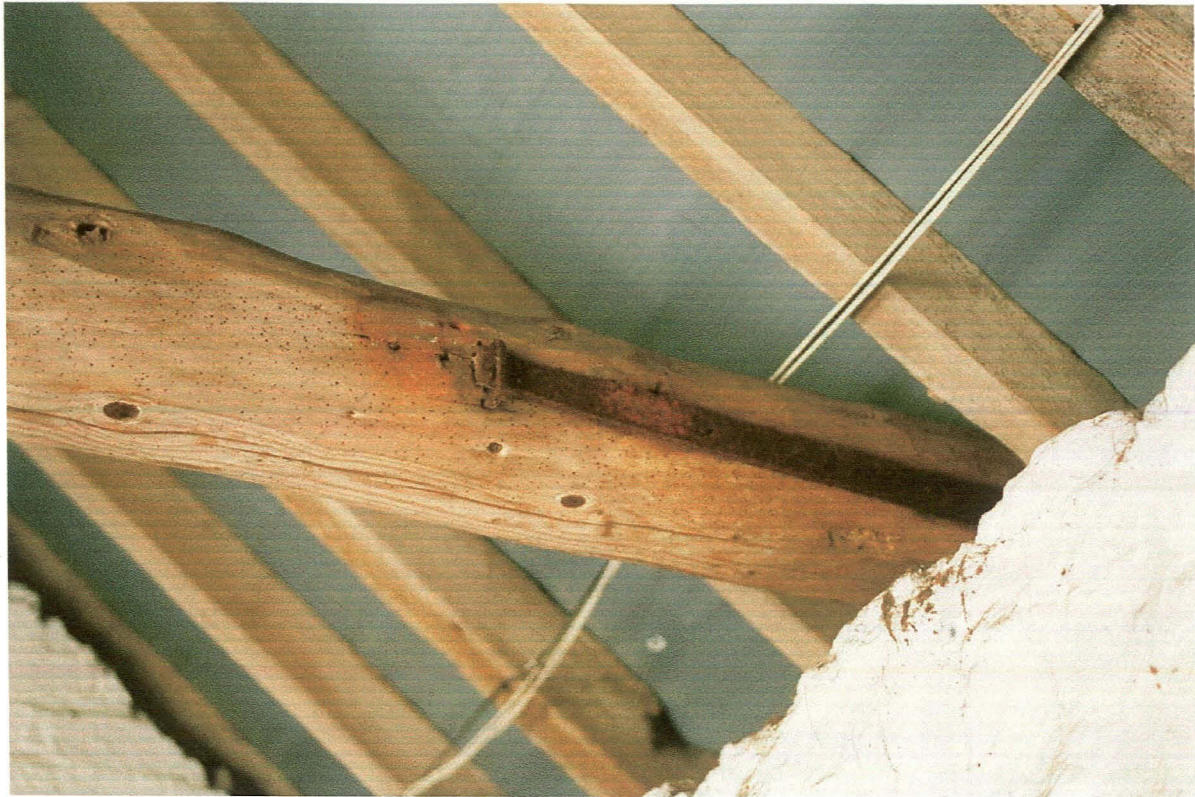
Plate 29: Cattle shed (5) - detail of iron strap used to secure tiebeam to wall.

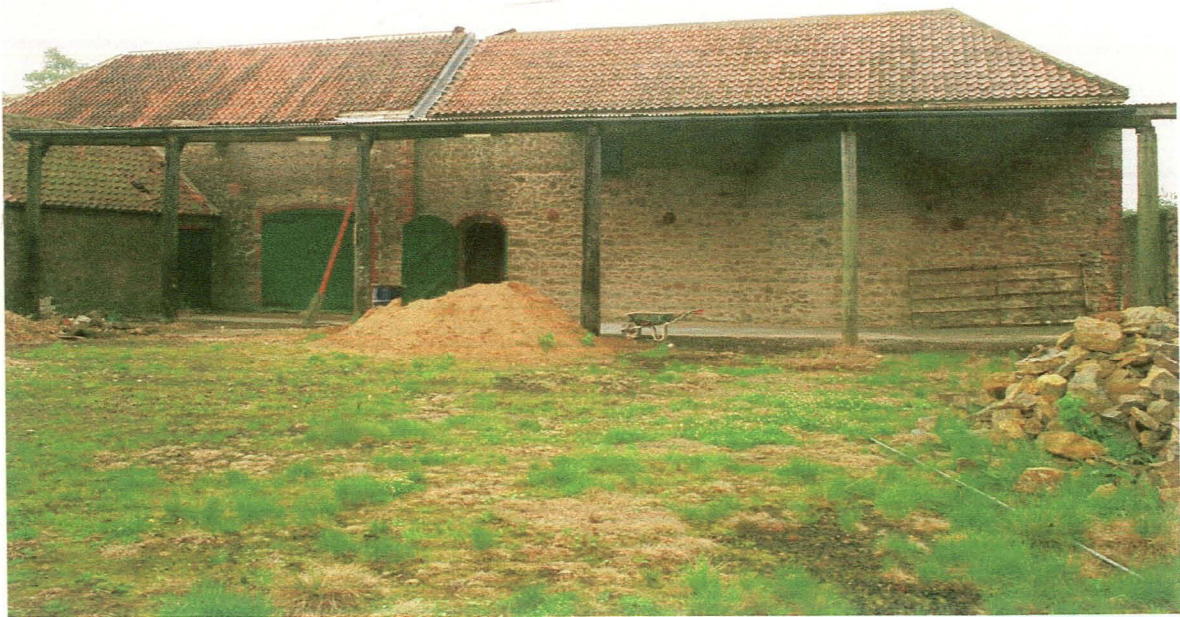
Plate 32: Exterior south elevation of Barn (3), with Dutch barn (7) adjoining.
