FARM BUILDINGS AT 65, HIGH STREET, HEIGHINGTON, LINCOLNSHIRE

PHOTOGRAPHIC BUILDING SURVEY

Report prepared for J. H. Walter LLP (Agent)

March 2010

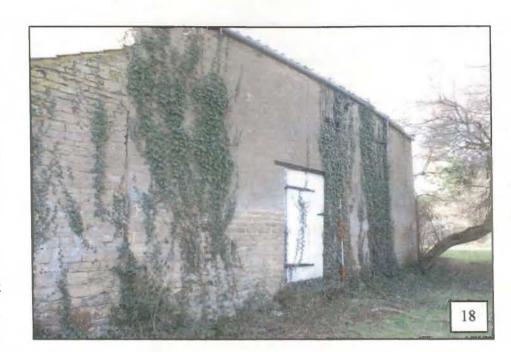
North Elevation

The north elevation of the building had a large conventional door opening located to the east of the midpoint of the elevation. This opening had a simple timber lintel and a concrete step, while the door itself had long strap hinges and was secured with a thumb latch.

The elevation was locally obscured by ivy. At high level, the western part of the elevation had two slit vents and the corresponding tie-rod endplates to those seen on the south side, here both were of cruciform type. The original cast-iron downpipe survived here, but the guttering had been replaced in plastic.

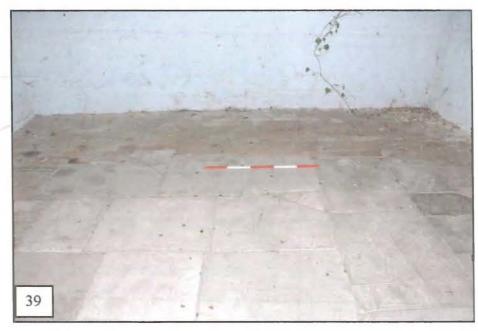
Floor detail

The main part of the floor was of York paving stones, (average 25" x 24", largest 36" x 30") generally laid in north-south rows. This was surrounded by brick (9" x $4\frac{1}{2}$ " in size), 44" wide on the south side, 32" wide on the north side, 4ft in width elsewhere.

The floor had been raised by some 0.25m at some time in the past. This was suggested by the concrete settings for the hinges of the southern doors, while the floor itself did not display the wear which threshing would have generated. It is possible that the floor was raised to prevent flooding from the nearby millstream.

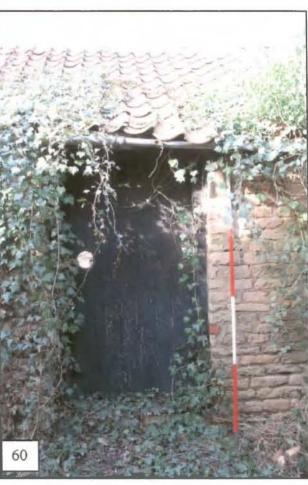
The east wall of the structure was of stone and a single door opening was present in the northern part of this wall, utilising the wall plate as a lintel, with a concrete step on the exterior. Like Building F to the south, the southern part of the east wall of the structure leaned markedly to the east.

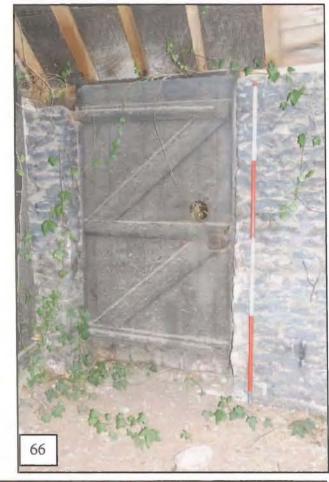
East Elevation

The deflection in the east wall observed on the exterior was more noticeable on the interior, where the timbers of the partition walls had been cut to allow for the shape of the wall.

The second bay from the north contained the exterior door, of ledged and diagonally braced plank construction. It was constructed of $5\frac{1}{2}$ " wide tongue and grooved planks, in a 4" x 3" frame.

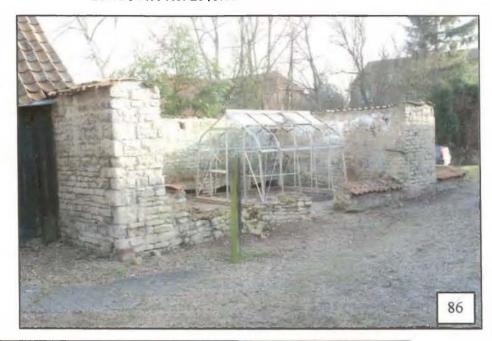
East Elevation

The east wall of the structure showed evidence for the failure of its roof, as it leaned markedly to the east. This appears to have occurred over an extended period, as two large limestone buttresses had been constructed against it.

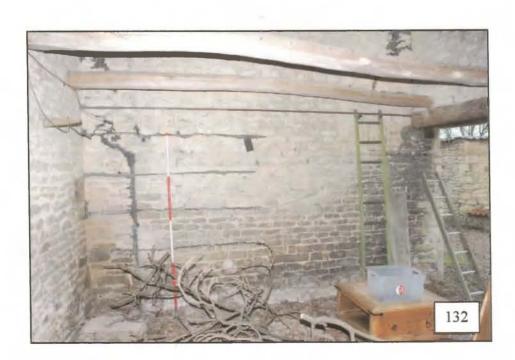
A blocked opening was present on the west side of the north wall, across which a series of modern tie bars had been inserted using a dark-coloured cement mortar.
