**FORMER CHAPEL, ST. JOHN'S HOSPITAL,  
BRACEBRIDGE HEATH, LINCOLN  
STANDING BUILDING  
PHOTOGRAPHIC SURVEY**

SITE CODE: SJBH05  
NGR: SK 9813 6779  
ACC. NO. 2005.139

Report prepared for KB (Midlands) Ltd.

June 2005

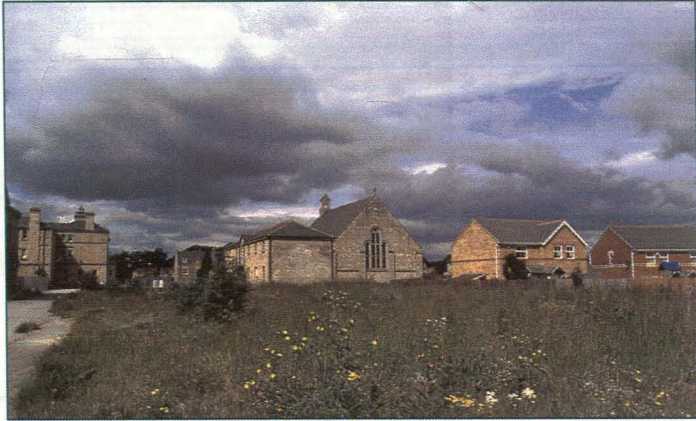
**Pl. 1:** General view of the chapel in the context of its surrounding landscape. Looking west.

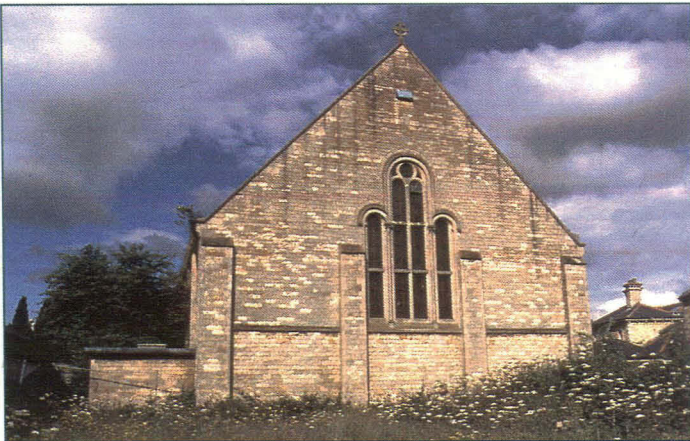
The windows are framed by two buttresses, with clasping buttresses on the corners of the elevation. A simple stone cross marks the apex of the roof, with a copper vent cover below.

**Pl. 2:** General view of eastern elevation of chapel, looking west.

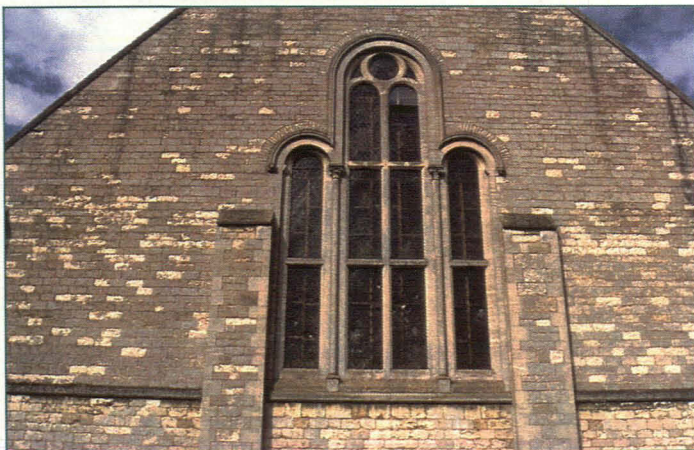
*Eastern elevation (pls.1-4):* The east elevation has a single tripartite window in Neo-Romanesque style with semi-circular arches and large mullions and transoms, with simple tracery in the upper portion of the middle light. The windows are plain diamond pattern leaded windows, broken in places. The large central window is divided from the two side windows by decorative mullions in the form of plain Doric columns with Corinthian or stiff-leaf capitals.

**Pl. 3:** Plate showing Neo-Romanesque tripartite window in eastern elevation. Looking west-south-west.

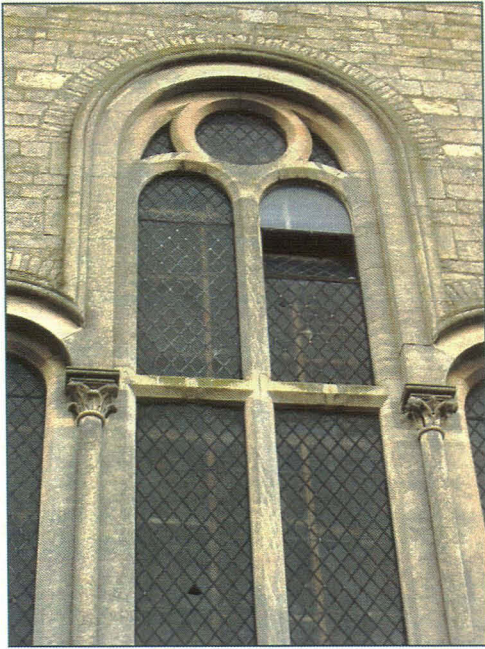
**Pl. 4:** Detail of central portion of window in eastern elevation, showing tracery in middle window and Corinthian capitals. Looking west-south-west.

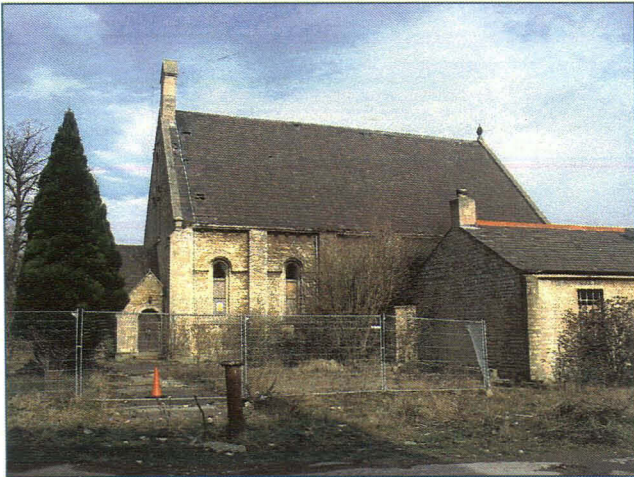
*Southern elevation (pls.5-8):* Again, much of the south elevation was obscured by vegetation, although some detailed inspection was possible. This elevation has seven buttresses, dividing the wall into six bays, each of which has a window consisting of a single light with a rounded arch, again in Neo-Romanesque style. The glass in these windows is modern frosted, mostly broken, although the second window from the east end of the wall has its original stained glass intact (see *Interior*, below).

**Pl. 5:** View of southern elevation of chapel, with the probable former nurses' quarters to the fore. The south porch is also visible. Looking north.

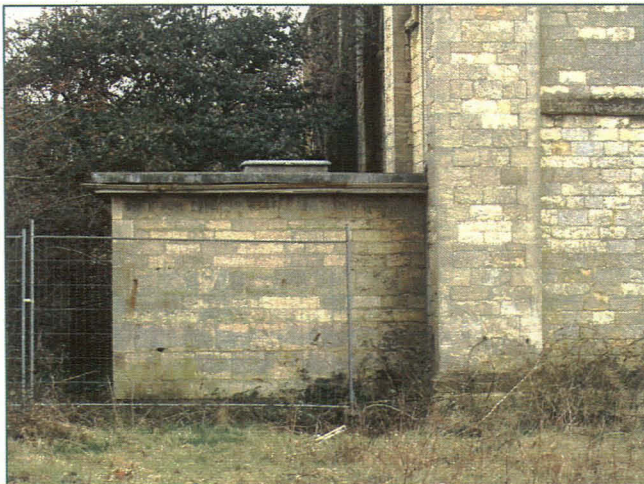
At the very east end of the wall, a small flat roofed annexe has been added, built in the same stone as the rest of the chapel. There is a wooden door in its south face. The window above this extension has been shortened to accommodate the annexe.

The photographic survey suggests that the chapel is largely of one build, representing the original form of the structure. The only structural alteration apparent is the addition of a small annexe on the south-east corner of the building, and the concomitant reduction in size of the window above. It was not possible to access the annexe, and its function is unclear, as is the date of its construction.

**Pl. 6:** View of small annexe at the east end of the south elevation. Looking west-south-west

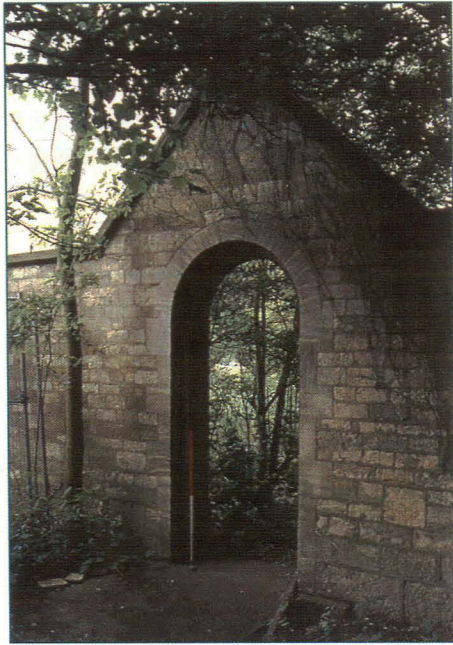
A boundary wall extends south from the south wall of the chapel, being attached to the third buttress from the west end of the elevation. An arched doorway has been inserted into the wall. The wall adjoins the north-west corner of the row of probable former nurses' houses to the south of the chapel.

**Pl. 7:** Arched doorway through the wall which connects the south elevation of the chapel with the nurses' quarters to the south.

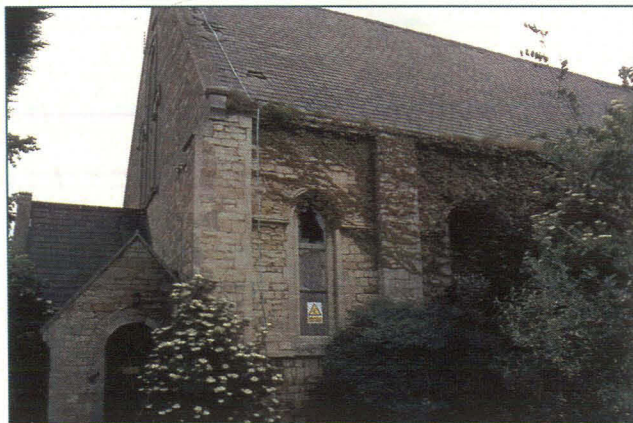
**Pl. 8:** Detail of south-east corner of chapel, showing the extent of overgrown vegetation at the time of the survey. Looking north.

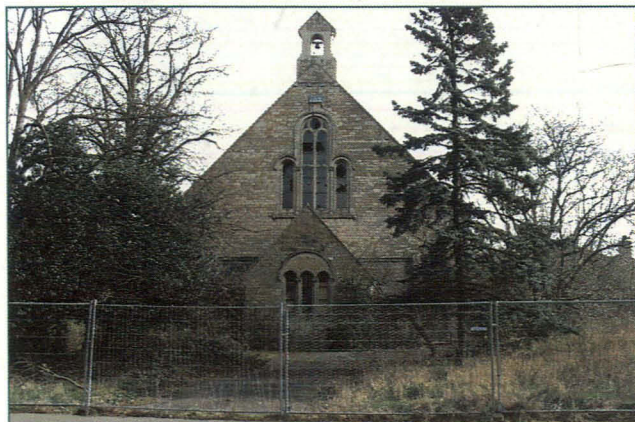
**Pl. 9:** West elevation of chapel, looking east-north-east.

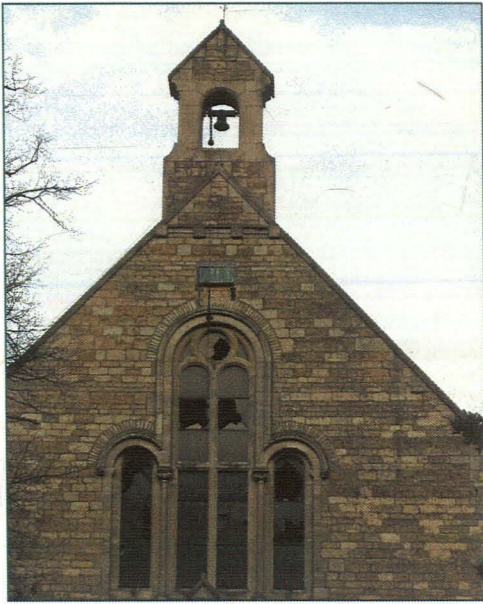
*Western elevation (pls. 9-16):* The upper portion of the western elevation was largely similar to the eastern elevation, with a copper vent cover near the roofline, and an identical tripartite window. At the apex of the roof is a bellcote containing a single bell.

**Pl. 10:** West elevation of chapel, showing tripartite window identical to that in the east elevation. Note also the copper vent cover, again replicated in the east elevation. Looking east-north-east.

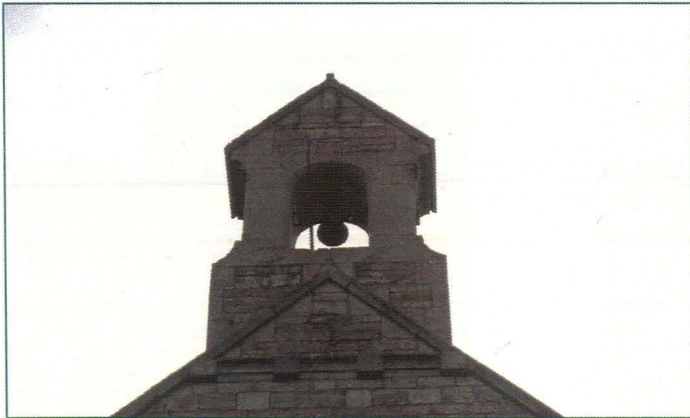
**Pl. 11:** Close up of bellcote on west elevation. Looking east-north-east.

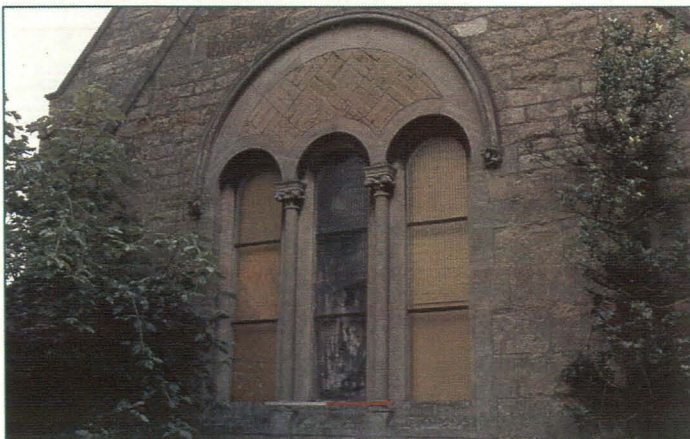
Below the window is a vestibule with a double-pitched roof and porches on the north and south sides. The west face of the vestibule also has a tripartite window, each light being divided by a plain Doric column with a Corinthian or stiff-leaf capital and a zig-zag decorated abacus. Over the window is a semi-circular relieving arch, infilled with parquet masonry.

**Pl. 12:** View of window in west face of vestibule. Looking north-east.

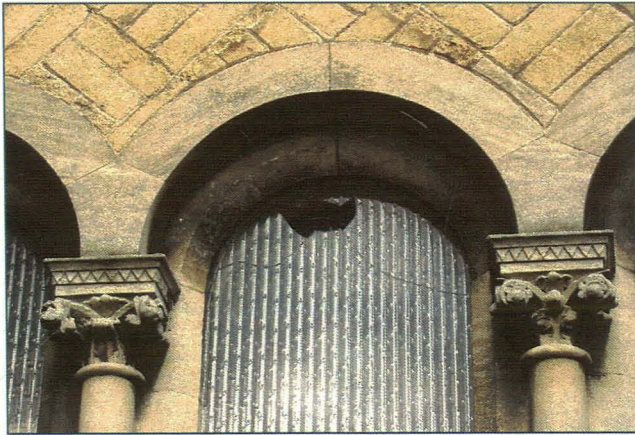
**Pl. 13:** Detail of Corinthian capitals in vestibule window. Looking east-north-east.

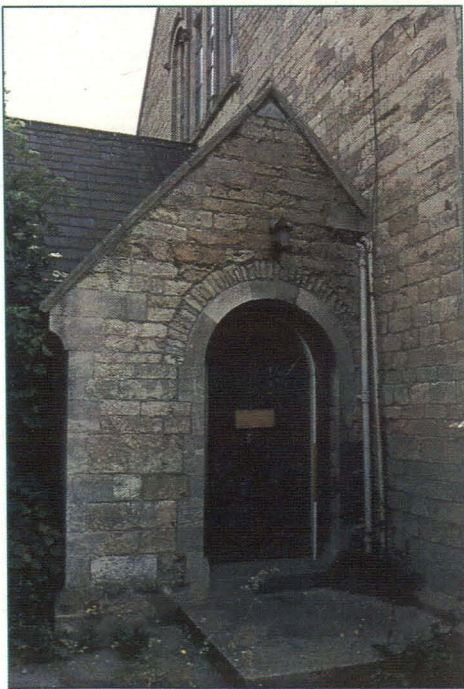
**Pl. 14:** East porch of vestibule. Looking north

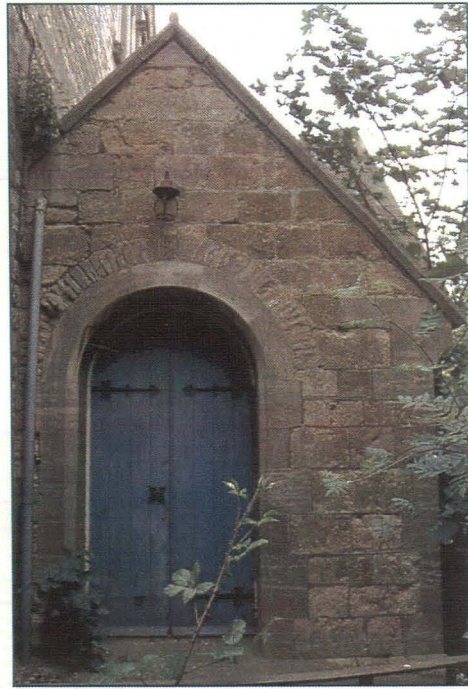
**Pl. 15:** West porch of vestibule. Looking south-south-east.

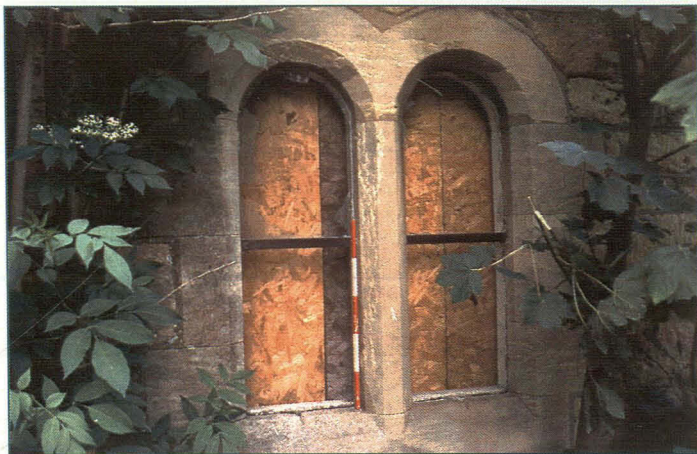
The two porches each have two small windows with rounded arches on their southern elevations. Both doorways are capped with Neo-Romanesque arches in keeping with the rest of the chapel.

**Pl. 16:** Windows in west wall of east porch. Looking north-east.

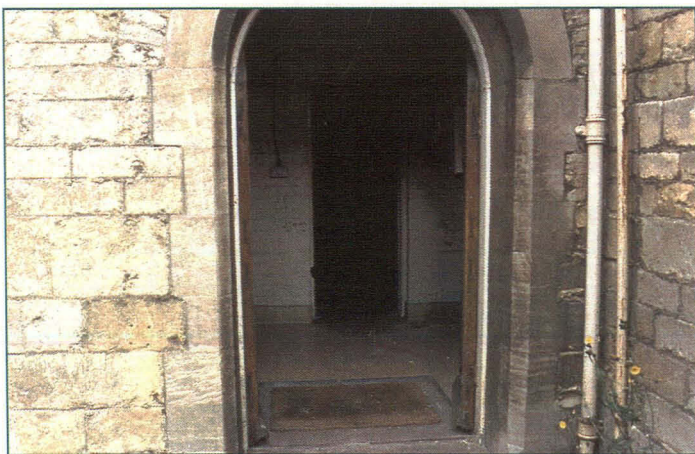
*Interior (pls. 17-24):* The chapel was accessed by the door in the south porch. The interior of this porch had a recent tiled floor, and a wooden door allowing access to the main hall of the chapel. The walls were painted white. The north door of the north porch was locked and its access to the vestibule was also blocked.

**Pl. 17:** Interior of east porch with vestibule beyond. Looking north-north-west

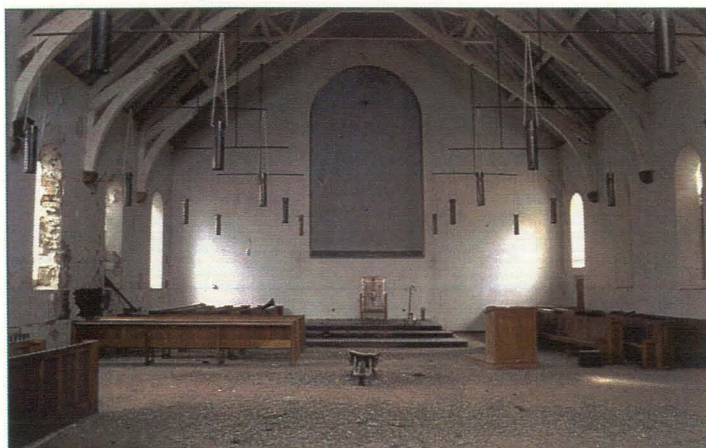
**Pl. 18:** Interior of chapel. Looking east-north-east towards altar. The reduced window in the far corner is also visible over the door to the annexe (shown in pl. 6).

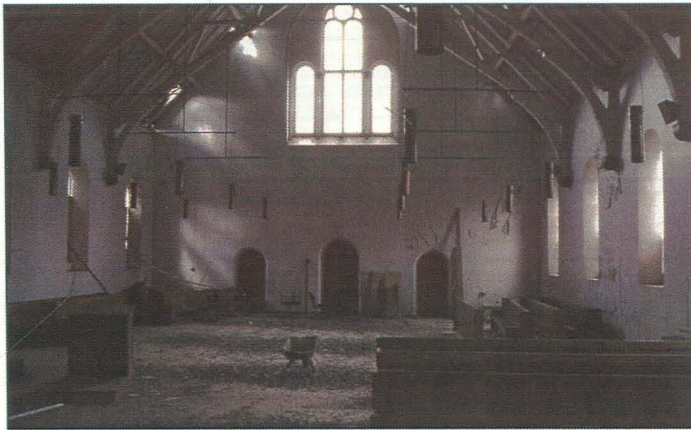
**Pl. 19:** Interior of chapel. Looking west-south-west. The three doors all exit to the vestibule.

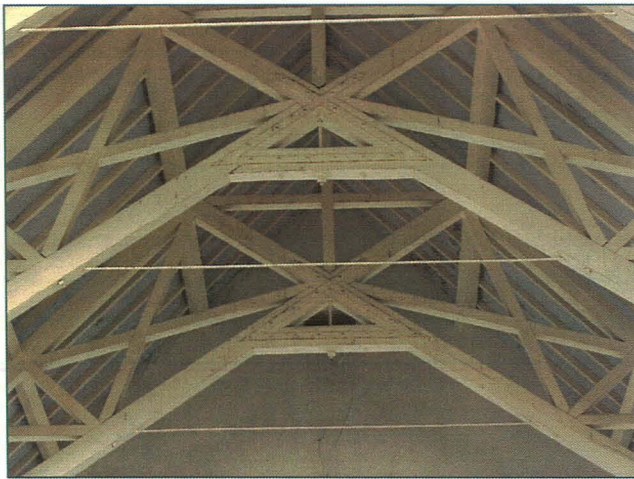
The interior of the chapel consisted of a large open hall, with a roof supported by five scissor braced trusses, supported by plain corbels at the level of the window arches. At the east end of the hall was a raised marble altar. At the east end of the south wall, a wooden door allowed access to the small annexe observed on the external south elevation, with the reduced size window above. The next window to the south of this was the only one with complete stained glass panes surviving *in situ*. Two inscriptions were incorporated into the lower panel, reading;

**Pl. 20:** View of scissor bracing of roof trusses. Looking east-north-east

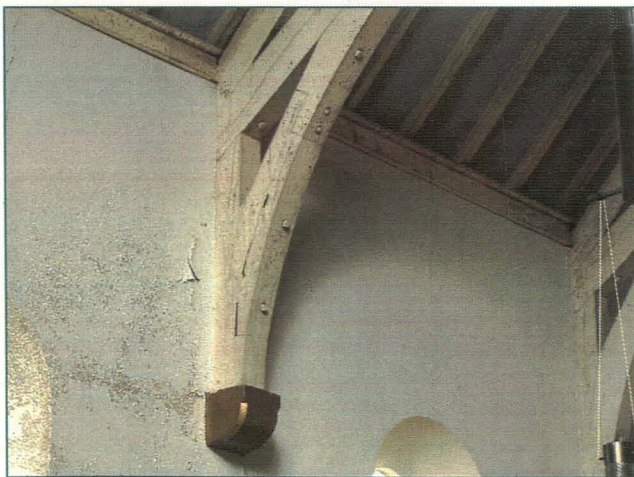
**Pl. 21:** Corbel on north wall supporting roof truss. Looking north-east.

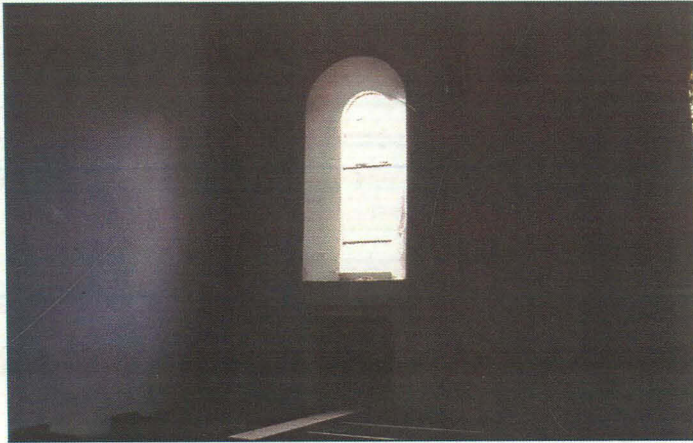
**Pl. 22:** Reduced size window, over door to annexe on south-east corner of chapel. Looking east-south-east

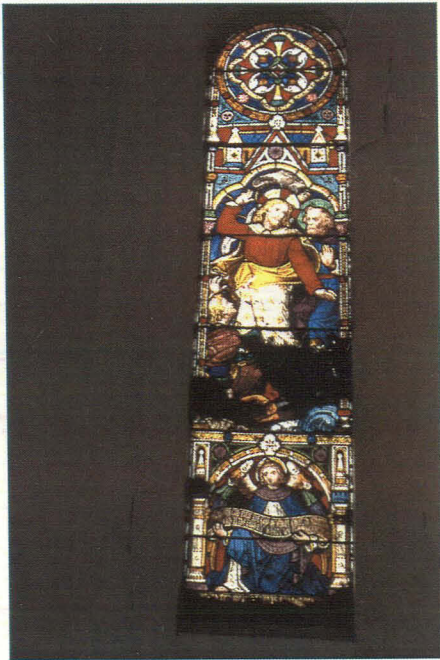
A single stained glass window has survived intact, in the south wall of the chapel. The dedication along the bottom panel of the window lists it as a dedication by a G.K. Jarvis of Doddington. The Jarvis family acquired Doddington Hall in 1830 as an inheritance to George Jarvis from Sarah Gunman. This probably refers to a Colonel G.R.P Jarvis who served in the army in India in 1794-9 and in Portugal under Wellington in 1808-10. His son was a G.K. Jarvis, who was schooled at Eton in 1818-20, and died in 1873-4. It is most probable that the dedication of the window is associated with this man, strongly suggesting that the window belongs to the original construction of the chapel in 1869.

**Pl. 23:** Stained glass window in south wall of chapel (second window from east end). Looking south-south-east.

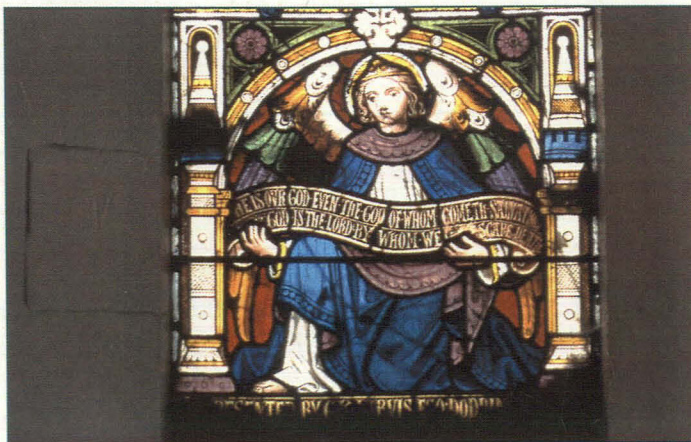
**Pl. 24:** Lower panel of stained glass window. The upper portion of text reads, "He is our God even the God of whom cometh salvation. God is the Lord by whom we escape death." The lower text is a dedication, reading, "Presented by G.K. Jarvis Esq., Doddington"
