GAINSBOROUGH OLD HALL

Dais Window Survey 1995

ENGLISH HERITAGE

March 1995

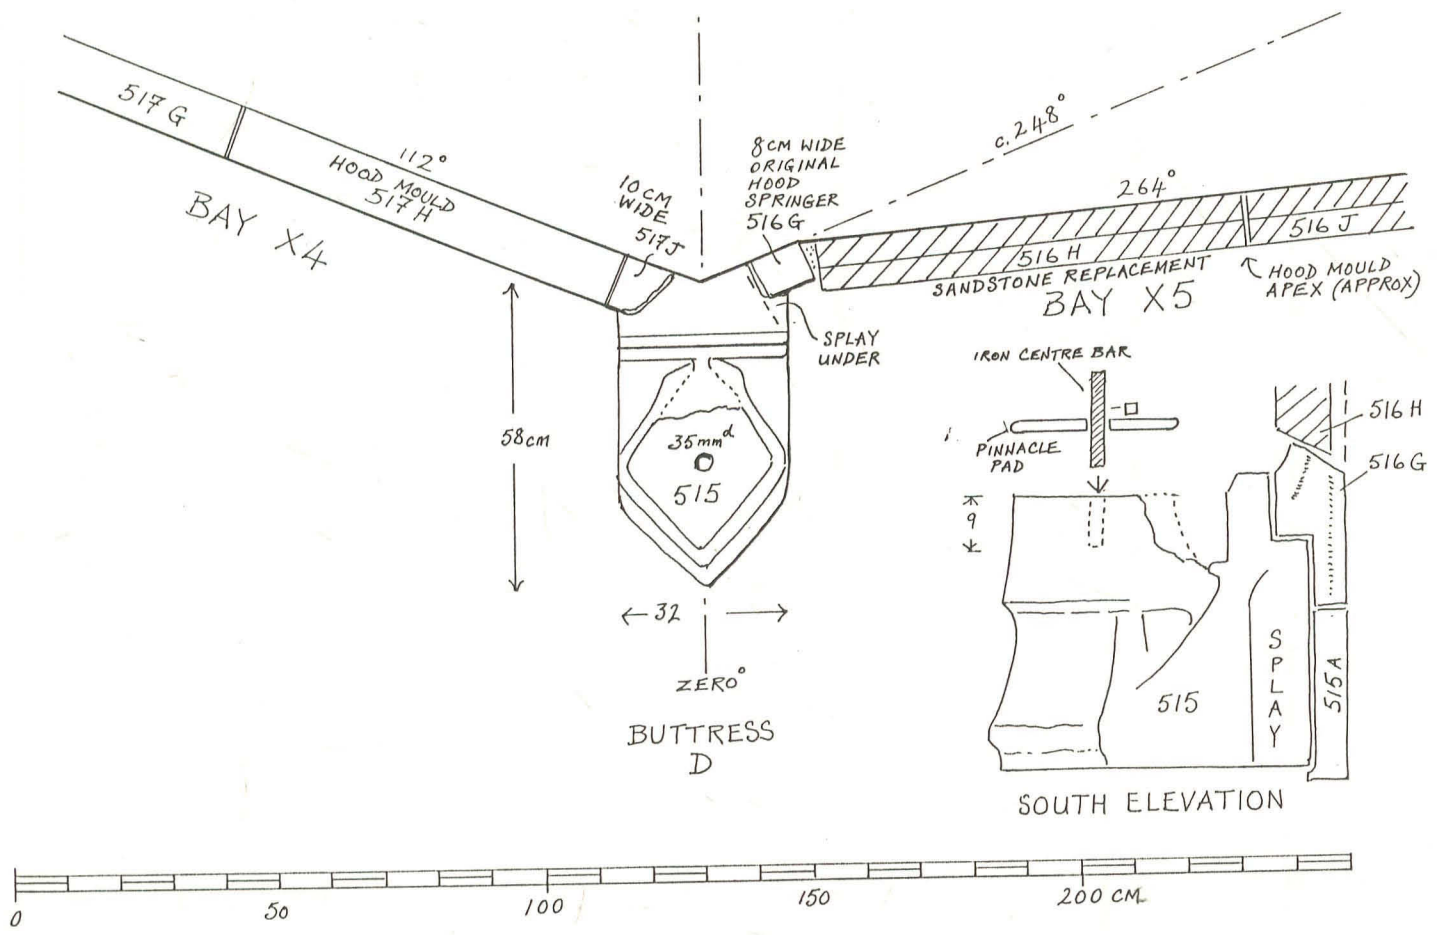
Fig. 3 Buttress D capping block and hood springers

A revised version of the 1991 elevation drawings is given in Fig. 2. Alterations mostly entailed additional joint definition. Fig. 3 shows Buttress D capping block in plan and side elevation (see also Pls. 1-3).

The massive capping blocks of the buttresses each incorporated an outer seat of lozenge section for the separate pinnacles and an inner block, the upper rear surface of which is roughly diagonally cut away on each side to house the springers of the hood mould to the adjacent windows. The front upper edge of the inner block is flat chamfered; the rear angle of the pinnacle seat slopes down to merge with the lower centre of the inner block. The front flanks of the inner block slope downwards and forwards to merge with the lower stage of the pinnacle seat; a shallow groin serving as a water run-off. The eroded portion of this capping block was reconstructed from the intact profile of Buttress C (Pls. 4,5).

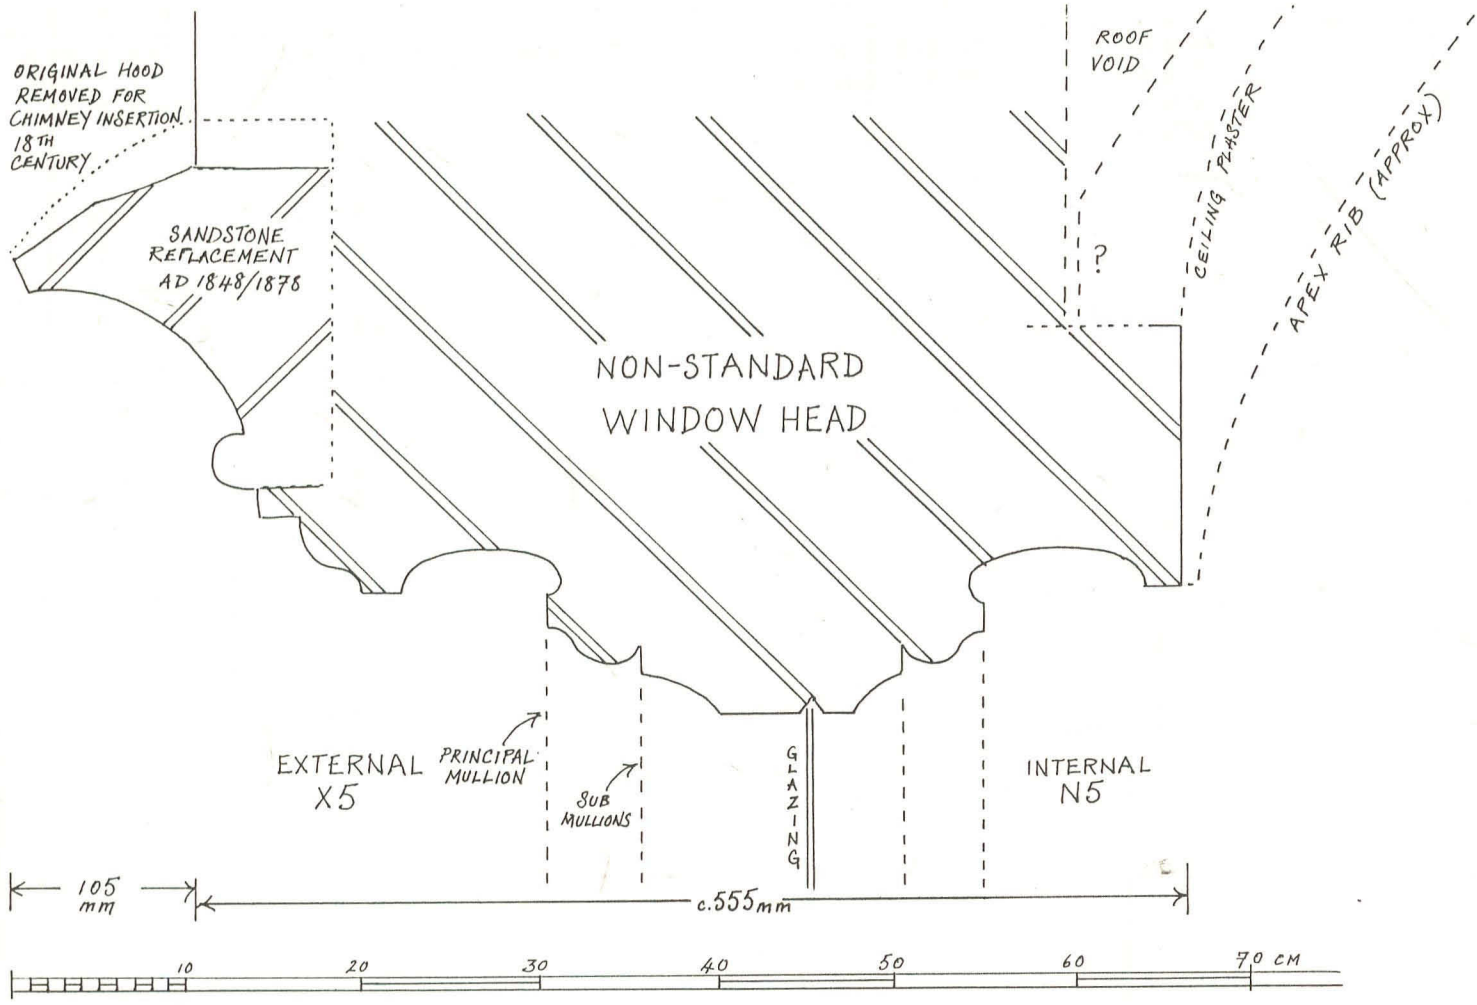
Fig. 5 Non-standard window-head section (X5)

The window head section shown in Fig. 4 is the standard for X1-X4 (see also Pl. 12). The non-standard head of X5 is shown in Fig. 5. The tracery head appears to be the only one which is not in one piece, being divided down the centre of the mullion, 516 to the left and 516A to the right (Pl.11). It differs largely in the angle of the external mouldings but is contemporary with the other windows. It may have been chosen due to the overall narrower width of the jamb mouldings (the lights are the same width as in the other bays), to fit the smaller bay, but even so, it was necessary to cut away part of the buttress so that the jamb mouldings were exposed by a splay (Fig. 3). The distribution of internal masons' marks (Fig. 6) proves that this window is from the same source as the other parts of the structure.

Most of the constructional discrepancies of the Dais window are disposed of at the angle of Buttress D and Bay X5. The slightly expanded X5 was given a non-standard window of the same apparent width as the others, but with very shallow jamb mouldings at nearly 90 degrees to the glazing line. Even with the extra length gained by these two adjustments it was still necessary to cut a splay in Buttress D to expose the cramped jamb mouldings. Both X4 and X5 jamb mouldings were cut by the same mason, as evidenced by the marks.

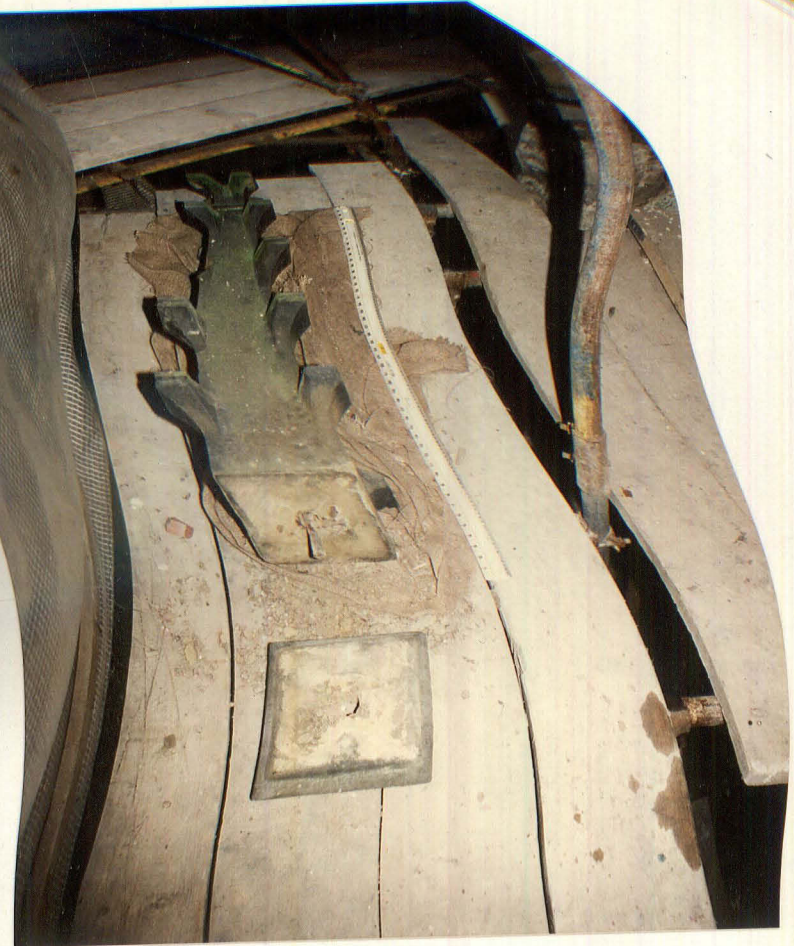
8. Pinnacle, pad and fixing rod (scale 1.20m).

Buttress pinnacles are in the form of a much-debased and simplified *columna rostrata*. They are made of sandstone and have very thin base pads with rolled edges and of the same lozenge section as the pinnacle bases and buttress tops, with piercing for central iron bars which hold the three elements together. Only one pad was actually observed after dismantling. The sharpness of the carving and the good overall condition suggests that the pinnacles are replacements of the originals (Pl. 8).

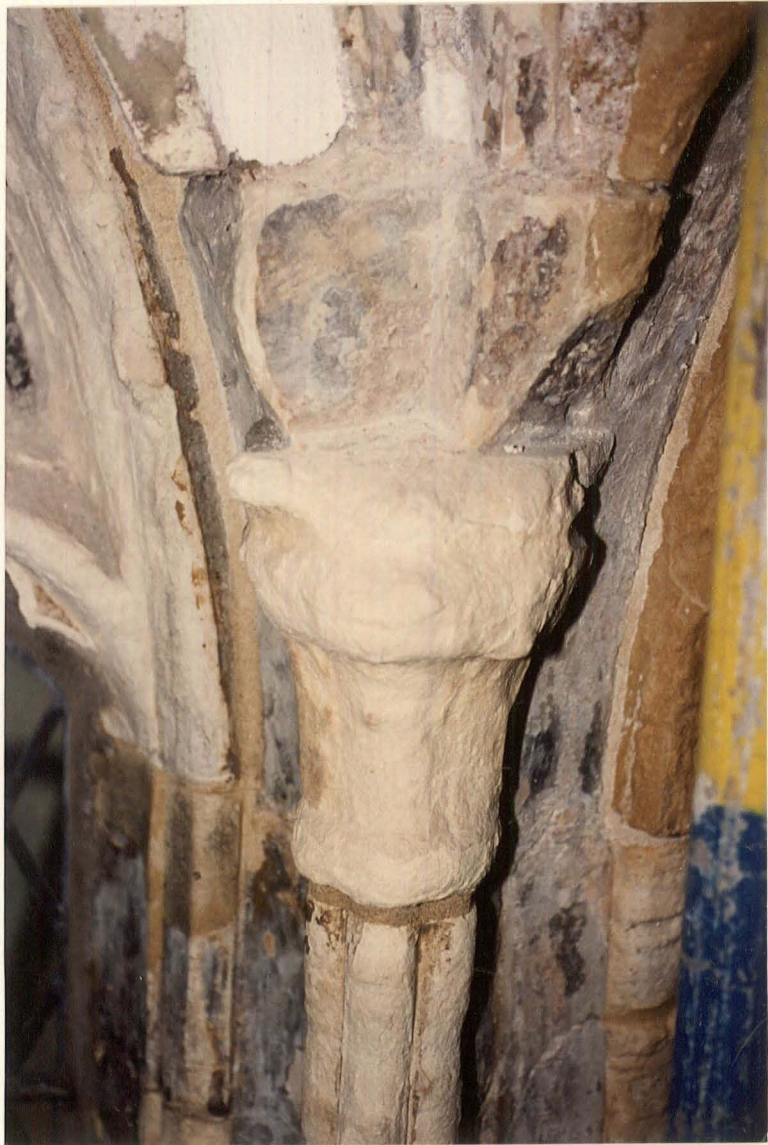
15. C3 capital and springer.

springing position and/or a new profile to match a new vault. C3 and C4 have no rib profile at this level, being simply rough-hacked surfaces with a vestigial centre-notch (Pls. 15,16). Trimming back the profile would suggest either difficulty in installing an over-sized or off-centred vault, or an adaptation to accommodate a replacement whose ribs spring from a point farther from the centre, i.e. from a point almost flush with the internal wall face. This would not occur in the case of a repair of a collapsed vault resulting from outward-moving walls unless the same vaulting could be re-fitted only with a change in overall span profile, thus meeting the walls at a different angle. It is further possible that a total rebuild of the whole structure would result in minor errors that necessitated individual alterations at each springing point.

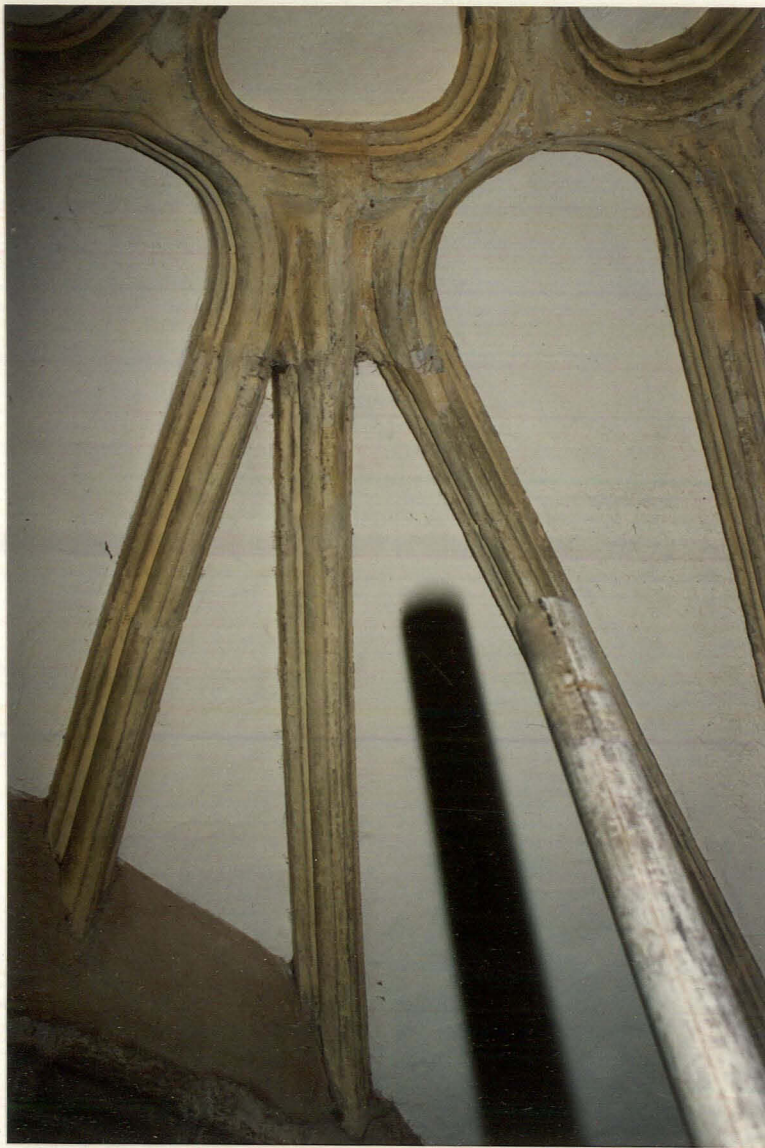
It should also be noted that the original position of each window apex which carried an interval rib was crucial to the vault symmetry. The existing vault is so displaced and irregular that it is not possible to single out any part which may have been installed in an unconventional manner.

19. Vault, showing 'junction blocks' between inner and outer cells.

20. Vault, showing distortion at outer junctions.

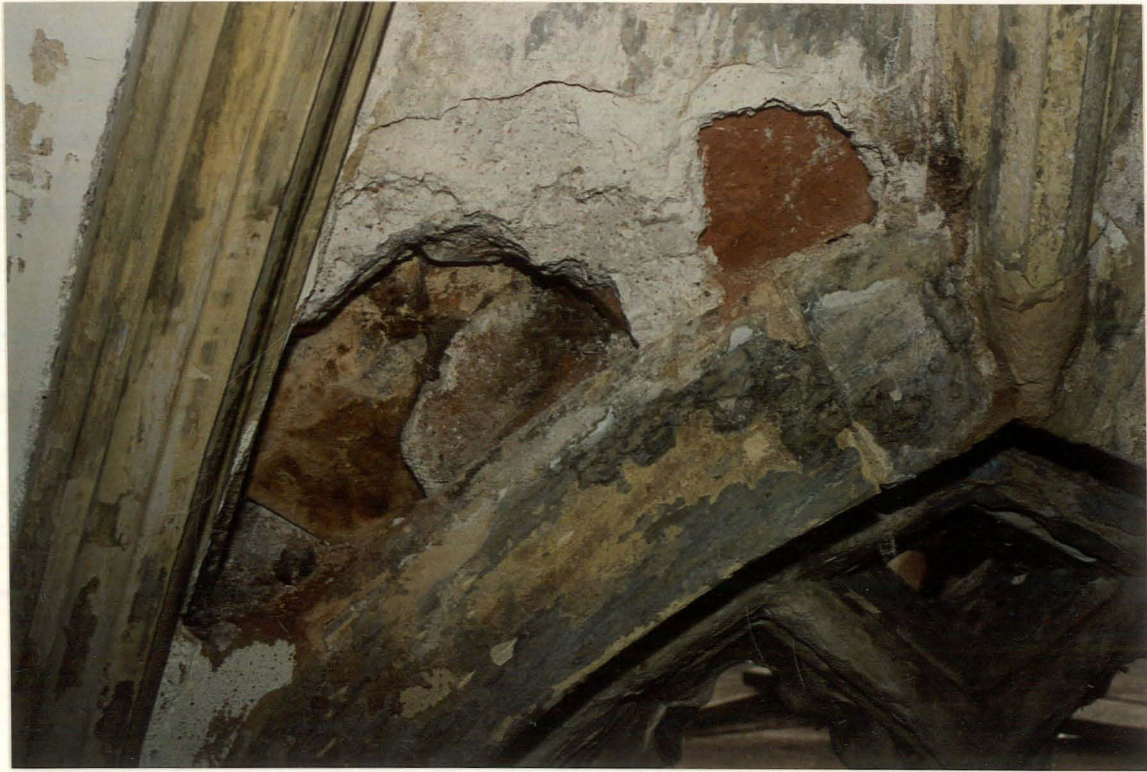
A brick was removed from the internal edge of the vault ceiling over the northern window bay by the conservators. Its precise position was not recorded but it seemed to have been used as infill immediately over, and to the left of, the window head at Bay N3 (Pls. 12, 23). Except for a thin rendering over the ceiling in this area it is possible that the fabric beyond had not been disturbed by the 1972 repairs. Beneath the render was a pinkish plaster of unknown date.

23. Brick infill and plaster over window head at N3.

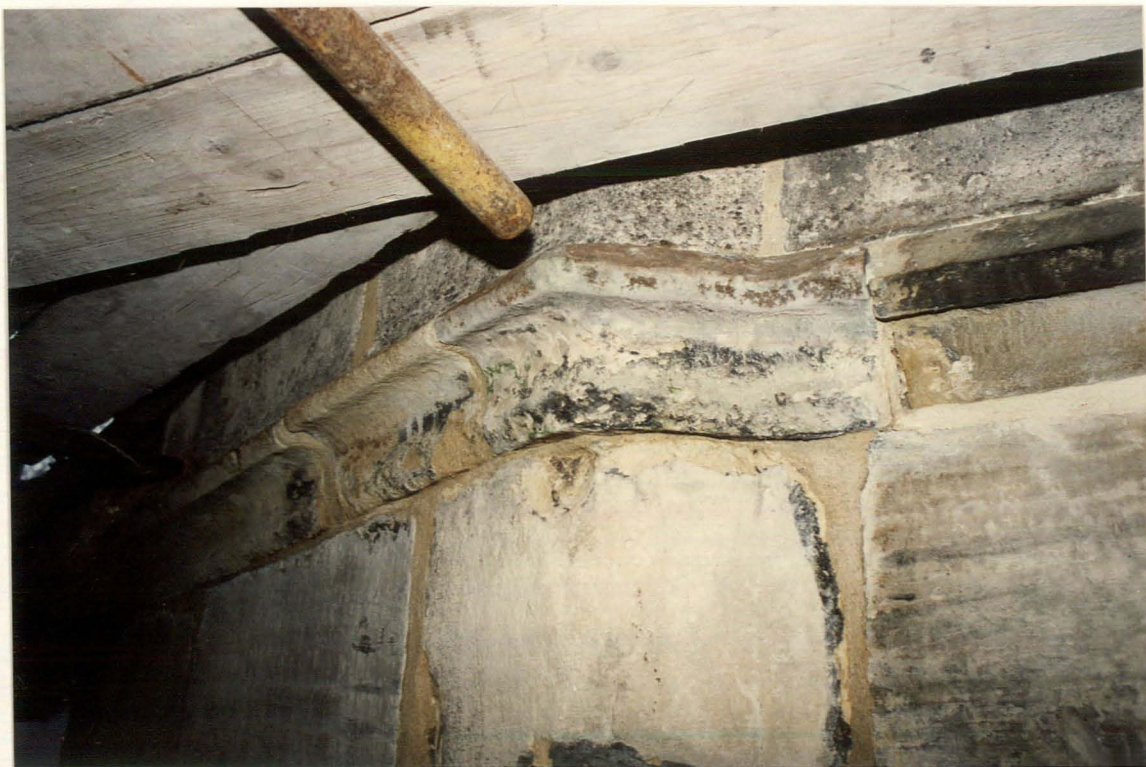
Blocks 632, 583, 567 and 548 represent the normal and the deviating angle on single stones and are proof of an original intention to deviate rather than a later clumsy alteration (Pls. 24-27).

24. X5 wall deviation at string course 583 and block 567 (below).

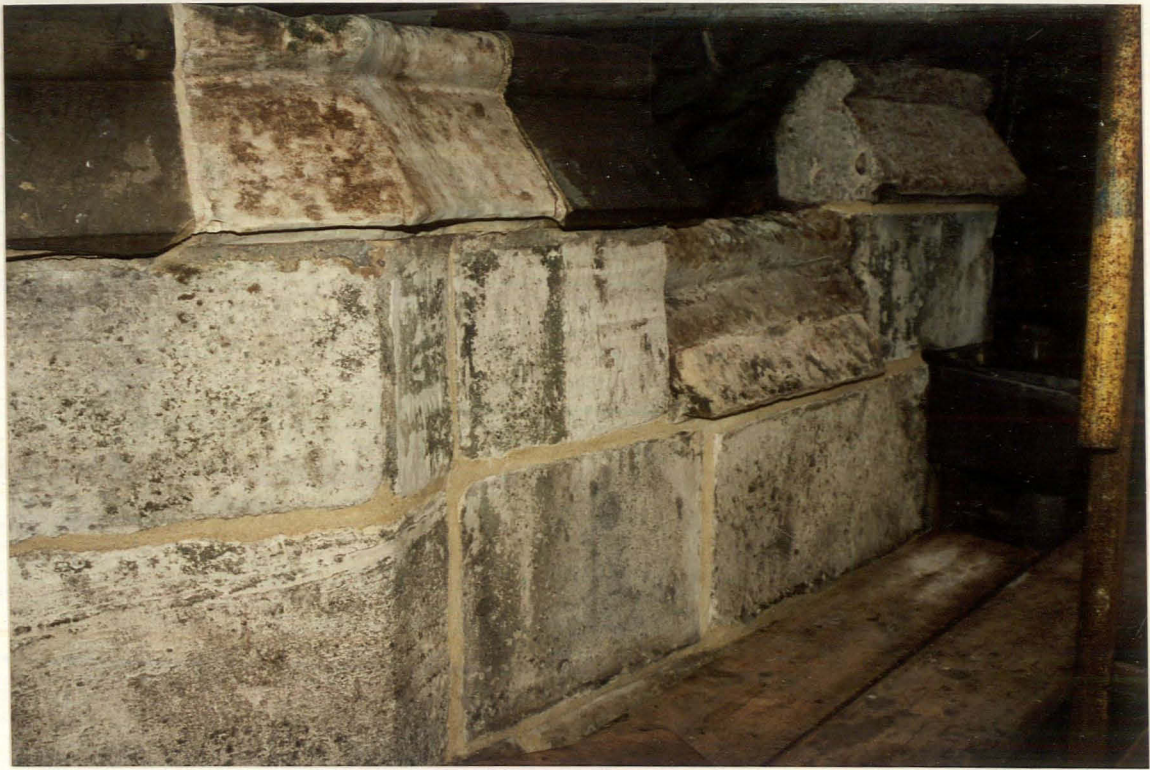
25. X5 wall deviation at parapet, from north-west.

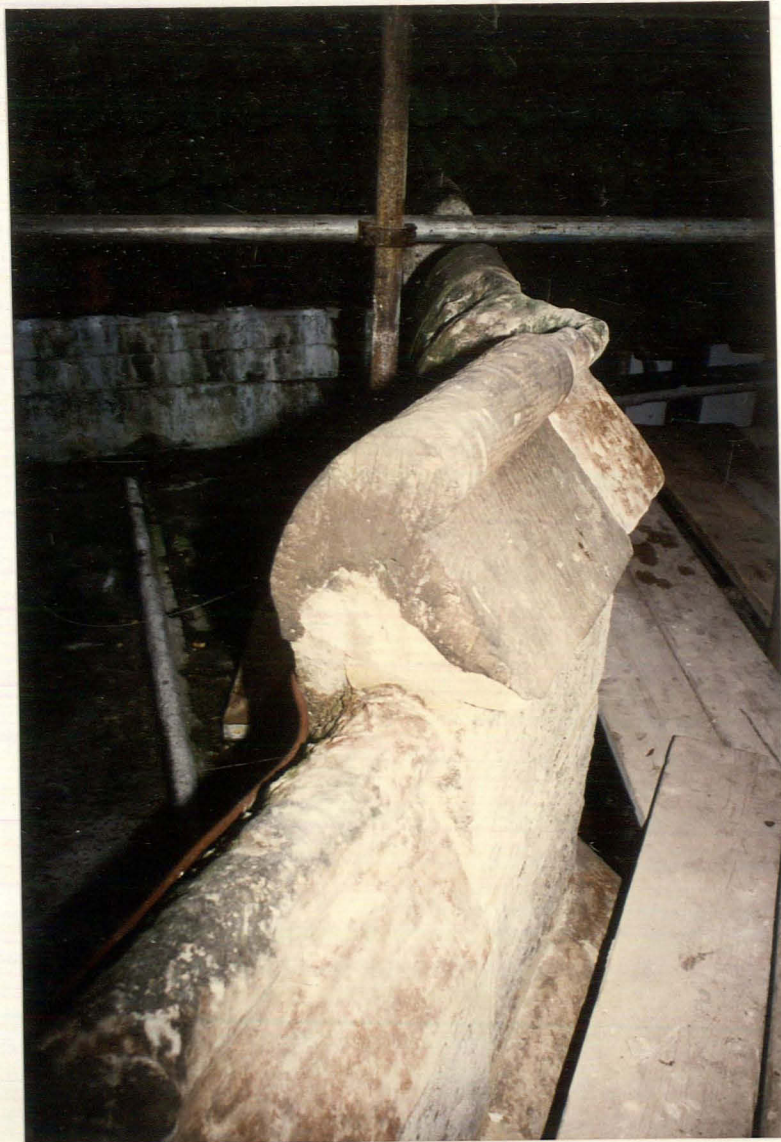
26. X5 wall deviation at parapet coping, from north.

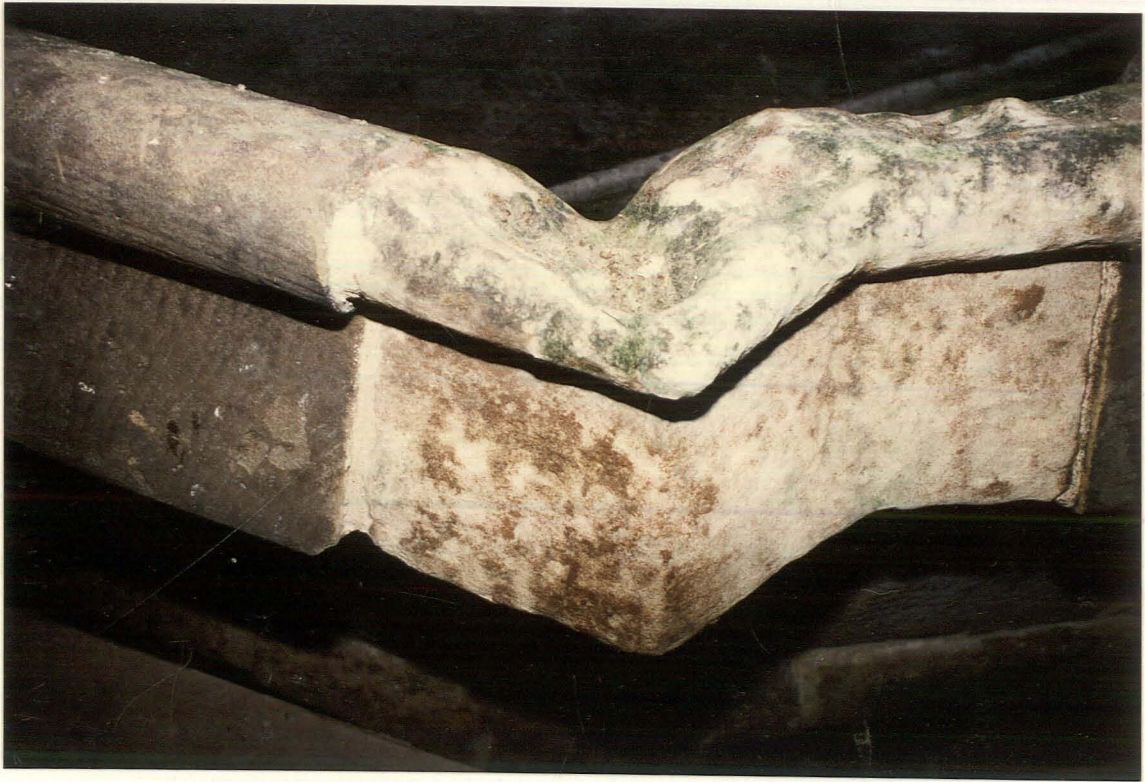
27. X5 wall deviation: parapet cope 632; replacement 632 to left.

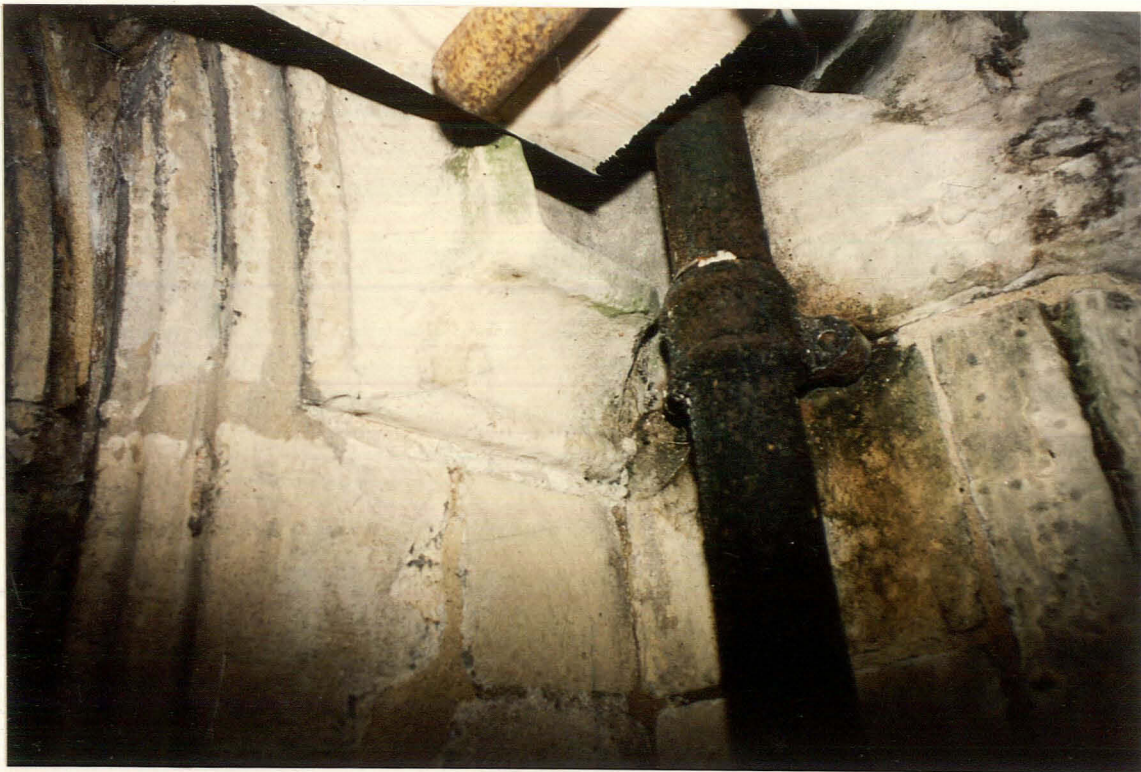
The hood-mould terminal 527, to the south, is cramped by Buttress E capping 529 and may even have been trimmed to fit; this area is obscured by a rainwater pipe (Compare hood mould 465 in Bay X1, Pl. 29, with 527, Pl. 30).

30. X5: Hood-mould terminal 527.
