Brayford Quays

Level 1 Photographic and Materials Record & Watching Brief Report

Brayford Quays, Lincoln

Supplementary Report to Cultural Heritage Assessment

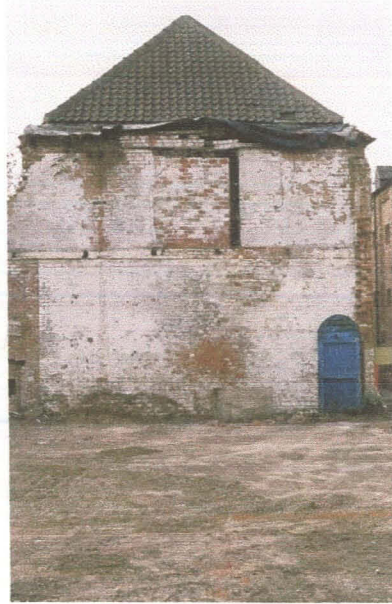
Building 1, West Elevation

The reveal of a first floor window and a ground floor doorway of the demolished northern range can be seen on the right hand side of the plate. Also of note, on the left, is the butting of the lower wall contemporary with Building 3 and the toothing of the upper extension. This may be the result of the northern range being contemporary with Building 1, but there is too little surviving fabric to be definitive

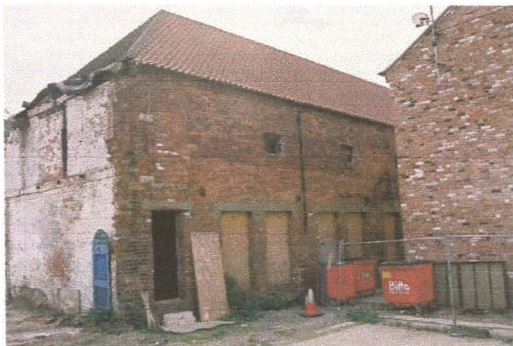
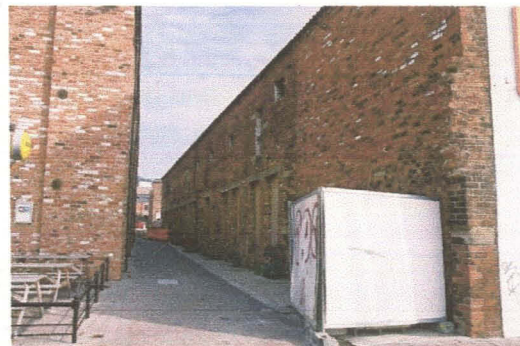
Building 1: North and South ends of the West Elevation

5.3.6 At the north and south ends of the west elevation, there was surviving fabric indicative of arched openings. At the north, a stone abutment and part of the haunch of a semi-circular scheme arch with a half-brick face survived, the geometry being evidenced by a surviving framed and ledged boarded door. Similarly, at the south end, part of a haunch also survived. In this case, however, the arch was a three ringed arch and sprang from a 60° skewback. This naturally leads to a wide arch with a low rise and it is thus considered likely that this arch originally bridged over a side passage and was most likely set out with three centres.

Note Springs for segmental arches, C20th alterations to window openings, and the extensive rebuilding at the south end

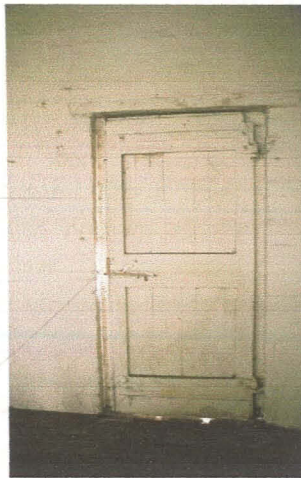
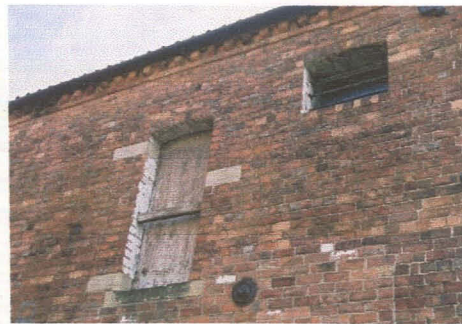
Building 1, West Elevation

Framed and boarded door and first floor showing original detailing of doors and windows. Note stone bonders, segmented arches and cornice.

5.3.10 Two of the west elevation first floor doors survived and were constructed as framed and ledged boarded doors; the top, middle and bottom rails being of equal scantling. The door was carried on simple strap hinges and gudgeon pins led into fine grained sandstone bonders. The original catch/locks were absent having been replaced by through-bolts.

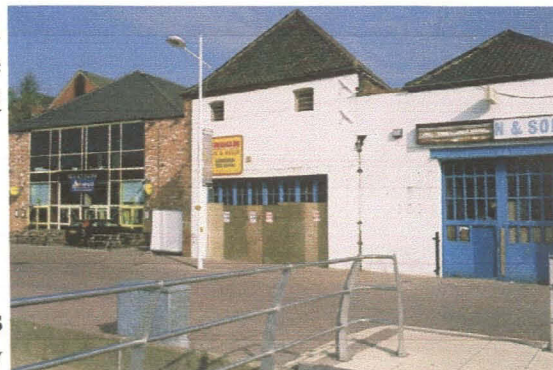
The South elevation - original window openings are evident on the first floor, but the original arrangement of the ground floor has been lost by the insertion of large framed and boarded doors

original detailing appeared unchanged at first floor level with two windows identical to those previously described at first floor level on the west elevation. At ground floor level a large opening had been inserted with glazed frame and ledged boarded doors.

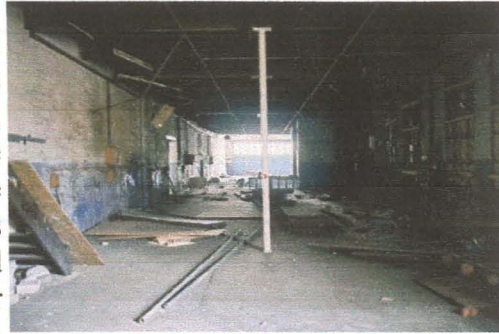
Building 1, ground floor looking south

5.3.15 The east elevation formed the party wall with Building 2. There were numerous blocked openings at ground floor level, both towards the top and bottom of the wall. Although some of these were primary features of the building, such as the bottom openings being blocked ventilation holes, the function of the upper openings could not be discerned owing to later modification and truncation.

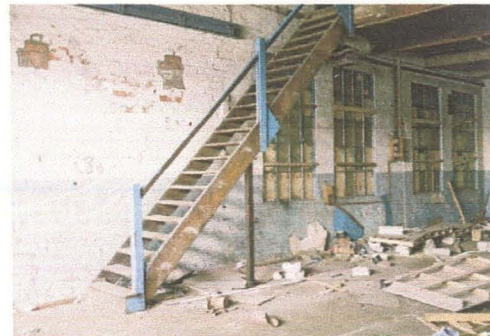
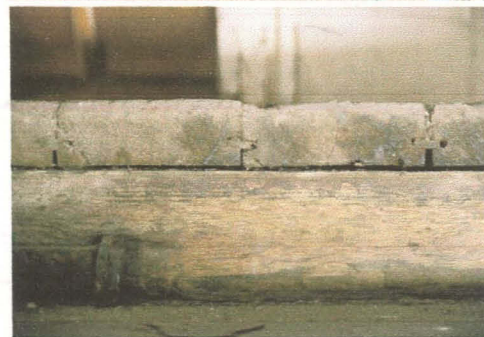
Building 1 -the south-east stair and detail of first floor boarding

5.3.18 The first floor was accessed by an inserted open-tread stair in the northeast corner and by an original example in the south east corner. The latter was of single riser construction with plain newels and a bull-nosed handrail.

5.3.19 The floor was boarded by slabbed and grooved softwood of 7" by 2 1/2" scantling with loose tongues over parallel beams aligned east-west.

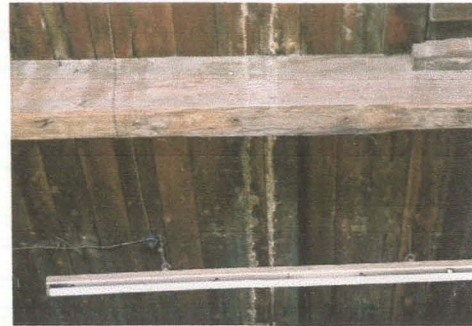
5.3.20 The beams totalled 22 in number, at 7' 6" centres, but two had been replaced by Rolled Steel Joists. Each beam consisted of a single timber with a section of 12" x 24", with the underside finished with chamfers to both edges. These were stopped at either end, but towards the

Building 1 Beam with simple stopped chamfer either side of spine beam (removed). Owing to the length of the building, the spine beam must have been composite and supported at intervals by verticals

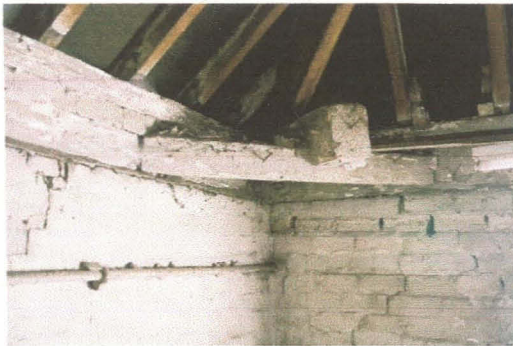
Dragon bracing at the north-east corner

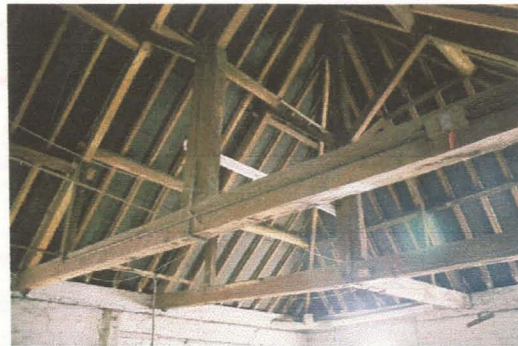
King Post roof trusses at the south end

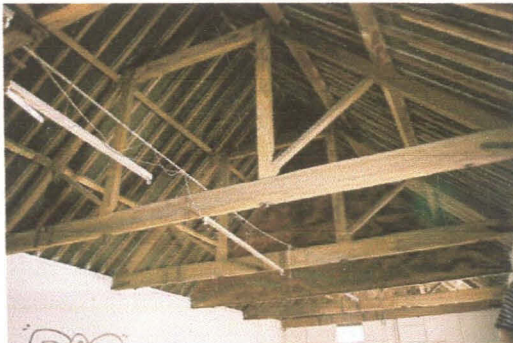
Queen Post Roof Trusses

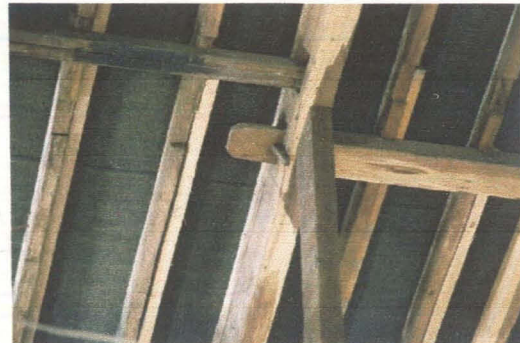
Detail of butt purlins

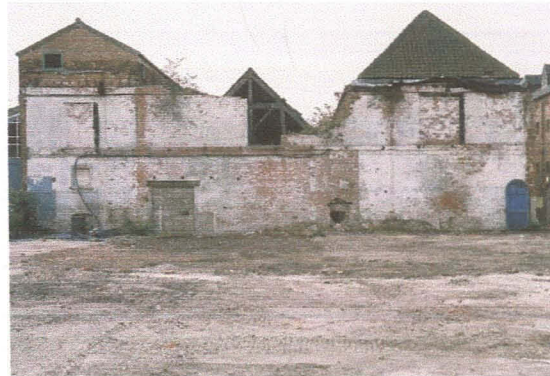
- 5.4.3 The North elevation was essentially of two builds. The lower portion, to below a line of slots indicative of floor joists of the demolished North range, was contiguous with Building 3, but butted Building 1. It was constructed in the local stock bricks of 9 x 2³/₄", laid with a hot-mixed lime mortar, and it is interesting to note that the end butting Building 1 was detailed with closers rather than being laid to a half-brick. It is likely that this formed a wall enclosing a paved yard between the two earlier buildings.

The central section is complex: the lower portion of the wall is contemporary with Building 3 and is stopped at the west end with closers. Building 1 was partially built off this wall and the height extended at a later date, with the extended portion of the wall mainly butting Building 3, but with the upper three courses keyed in. This suggests that at least some components of the demolished north range post-date Building 3 but are contemporary with Building 1

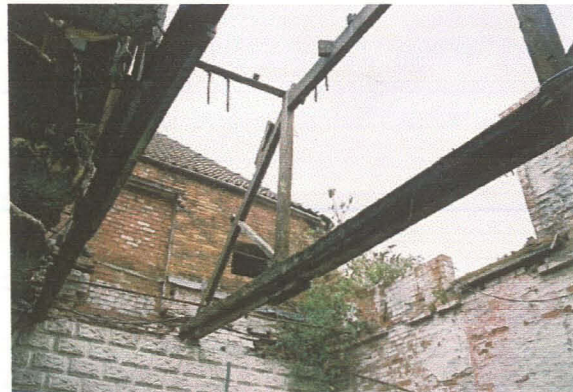
Building 2 -North Truss

5.4.9 The northern truss, though incomplete owing to the partial loss of the roof, retained sufficient timbers to indicate that it not only formed part of the Queen Post roof Truss type, but that it had *kerb principals* or principal rafters which only run from the Tie beam to a collar (or in this case, the straining beam) and an upper King Post or King Strut extending from the straining beam to the apex of the roof. This truss was therefore unique within the building complex. It supported through purlins on cleats which were tenoned in to a King Post truss to the south.

Though incomplete, enough of this frame survived to show that it was not only unique in terms of Building 2, but within the whole building complex.

The reasons for the change in frame design in Buildings 1 & 2 were not established, but Queen Post roof trusses are generally considered more appropriate for spanning wide buildings than King Post trusses, and it may be that the change is due to the redesign and repair of either a failed or fire damaged section

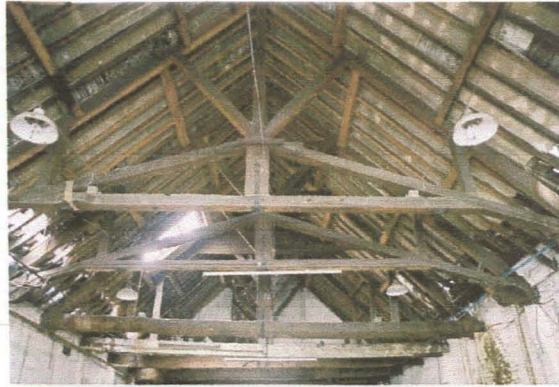
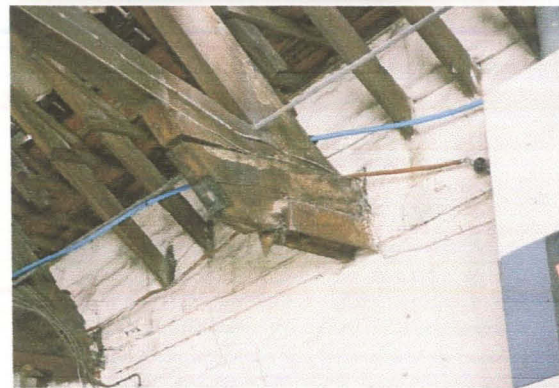
Building 2

General shot and detail of modified King Post roof trusses at the south end of the Building. The tiebeam has been reduced to corbels at either end of the truss, the King Post reduced and a new tiebeam added with additional inclined braces.

- 5.4.11 The modifications included cutting the Tie beam, reducing it in effect to corbels at either end, and trimming the King Post and side struts. The truss was then triangulated by the addition of braces extending from the King Post to the Principal Rafter/Tiebeam interface which picked up the struts. The base of the King Post was picked up by the addition of a strutting beam to the underside of the braces, the whole construction being cobbled together by the use of metal stirrups and straps.

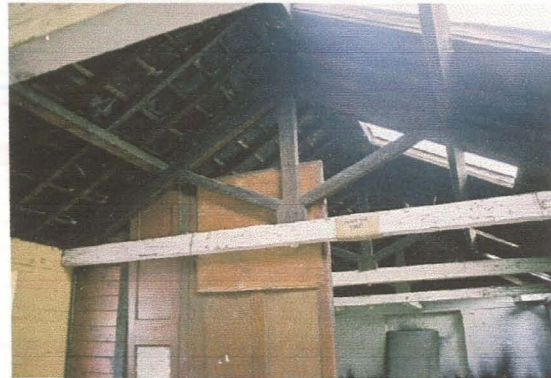
Short King Post roof trusses at the south end of the building

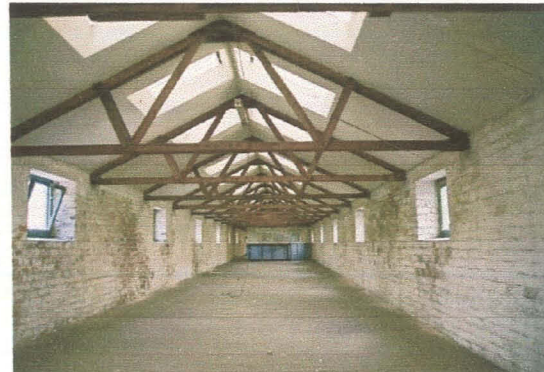
TDA or TRADA roof trusses replacing the original short King Post trusses. Made of uniform scantling, they are formed by connectors rather than by traditional jointing and strapping techniques

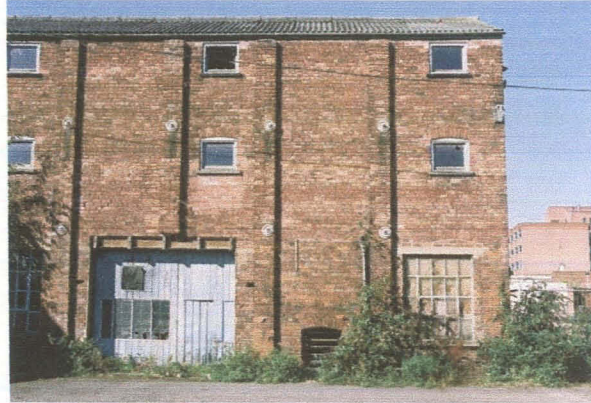
Building 3

The north end of the east elevation had sufficient surviving details to enable the original arrangement to be known with certainty.

Simple segmented windows, centrally aligned, for each floor with similar weepers just above ground floor level

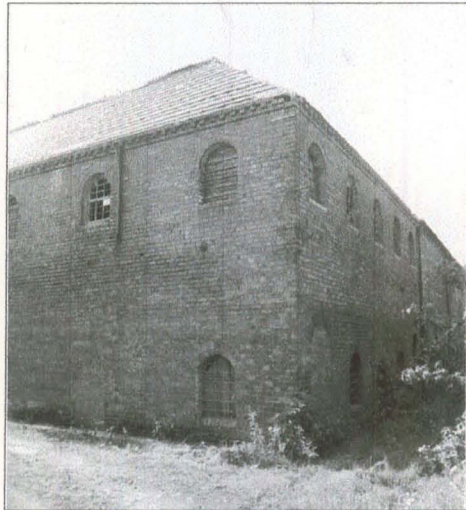
The demolished north range, which comprised the kiln, looking from the north-west. The extreme top right hand opening is the reveal recorded on Figure 3

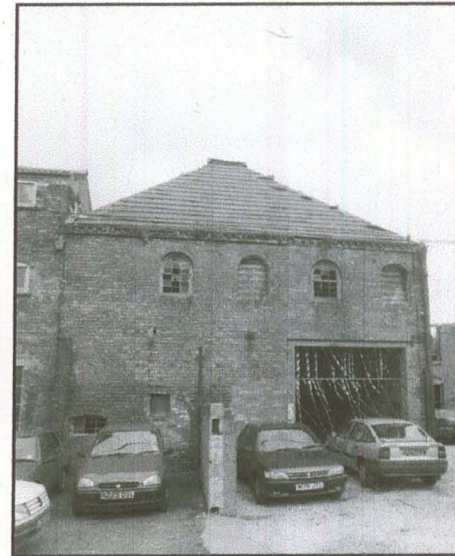
The Kiln, East Elevation, Building 3 can be seen on the left hand side of the picture

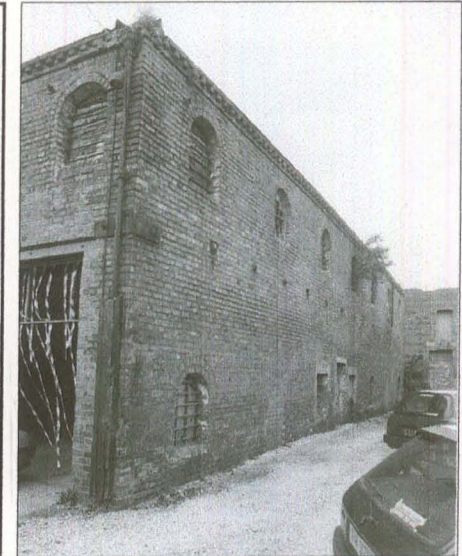
The kiln looking south-west

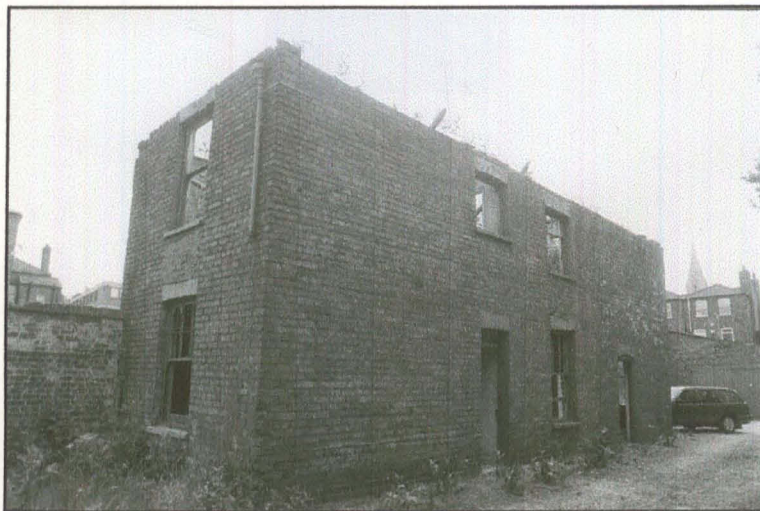
The Foreman's House looking north-east
