King's Head, Mercer Row, Louth, Lincs.
Archaeological Recording (*Building*)
NGR: TF 3278 8730
Planning Application No.: N/0105/01582/01
LCNCC Accn No.: 2002.452
Site Code: LKH 02

Report

Unique Pub Properties Ltd

LAS Report No. 635
January 2003

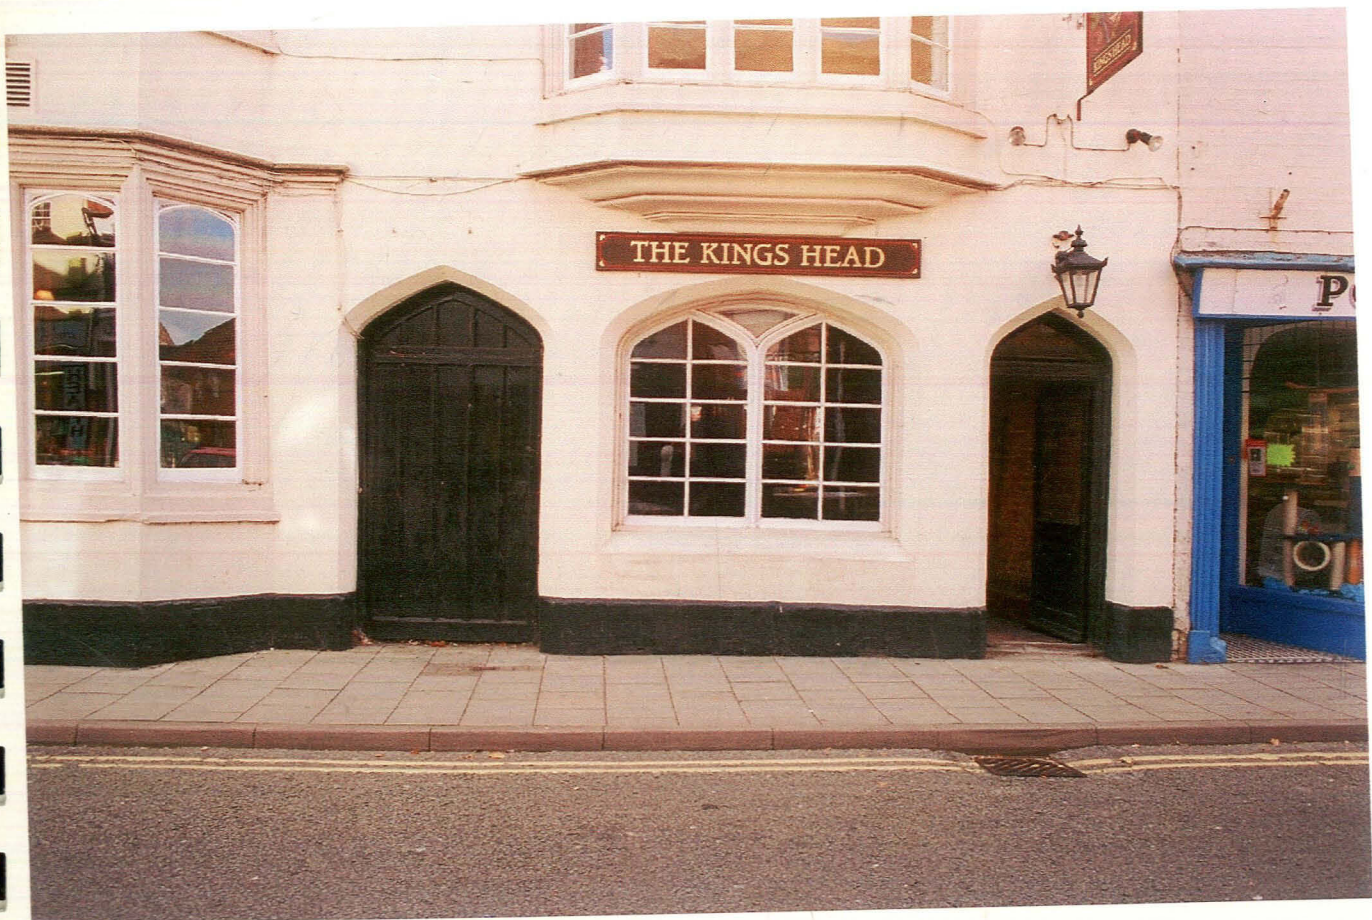
Access from the street is in the north-west corner of the room to the west of the passageway (Pl. 2 and 8). There is a four-centred arched window to the east of the door, which may originally have run to base of wall as there is a vertical joint below the window. Voussoirs above the door and window are identical in style and brick size and are presumably original.

Pl. 2 Blocked entrance (left) and entrance to the bar (right).

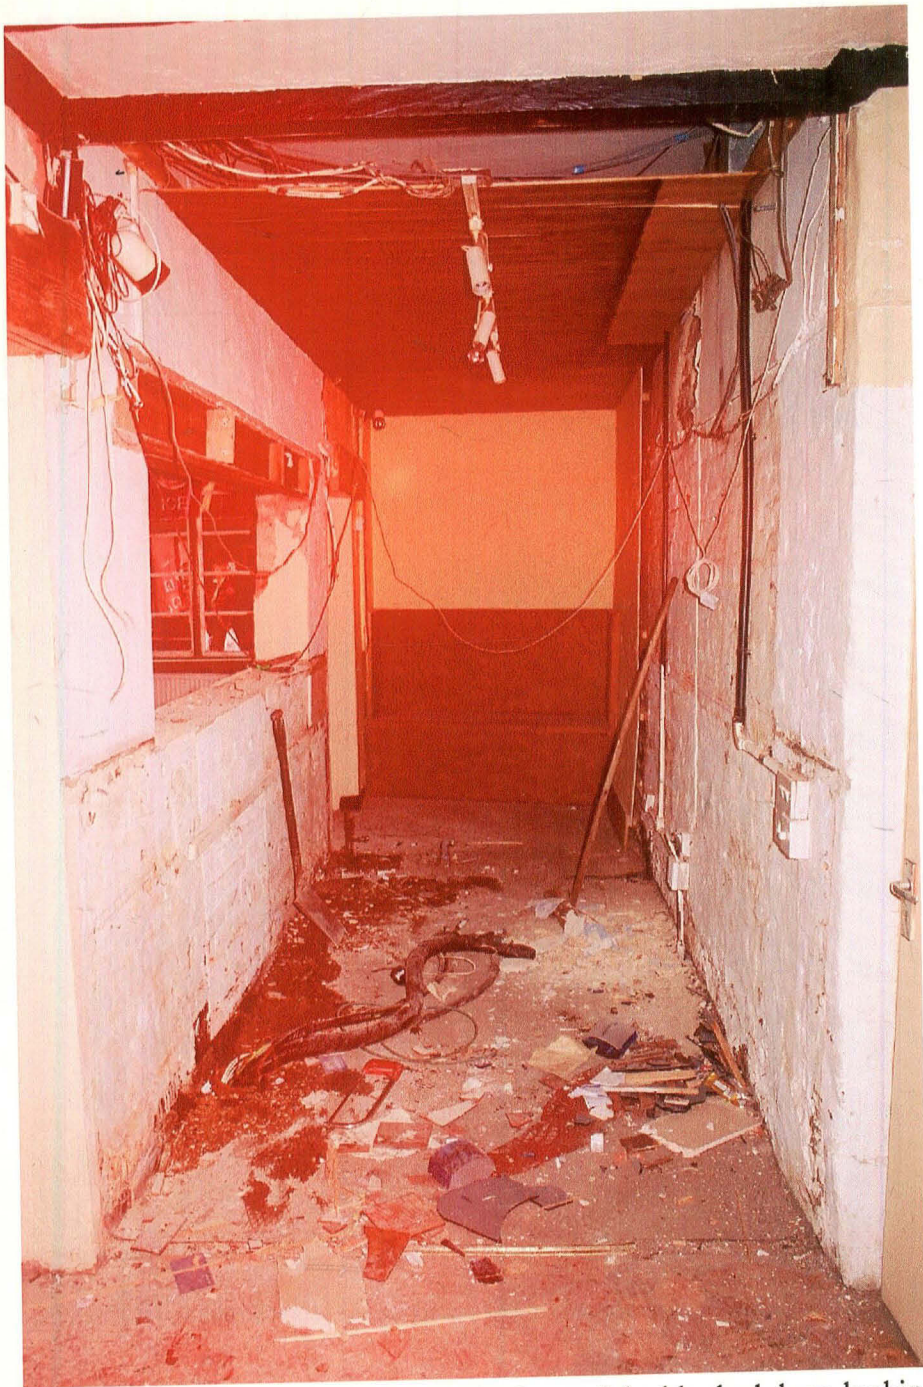
The area recorded was the ground floor room on the west side of the building fronting Mercer Row. Originally this comprised a room and access passage through to rear of building but the door to the passage was blocked (Pl. 2 and 3) to create a bar area with a seat built across the door at the north end. The intermediate passageway wall is present at ground floor level only

The east wall of the passageway, which is the load-bearing wall, was partially clad in plasterboard at its north end and the remainder was covered in several coats of paint making the brickwork difficult to distinguish. There were no visible blockings or features (Pls 3 and 4). On the west wall of the passageway a blocked doorway, 0.93m wide, was visible beneath the inserted hatch opening (Pl. 5). It is assumed that this would have been blocked when the hatch and the two flanking openings were created. This was not seen on the opposite side of the wall because the area beneath the bar hatch was not stripped of its plasterwork. (Pl. 6). However, removal of plasterwork above the hatch revealed an RSJ (supporting the bar opening) with two wood lintels above (Pl. 7). The lower of the two wood lintels, which rests on the RSJ, probably relates to the door opening, but at 1.75m long there may have been a window to one side of the door.

Pl. 3 Passageway showing new seat in front of the blocked door, looking north

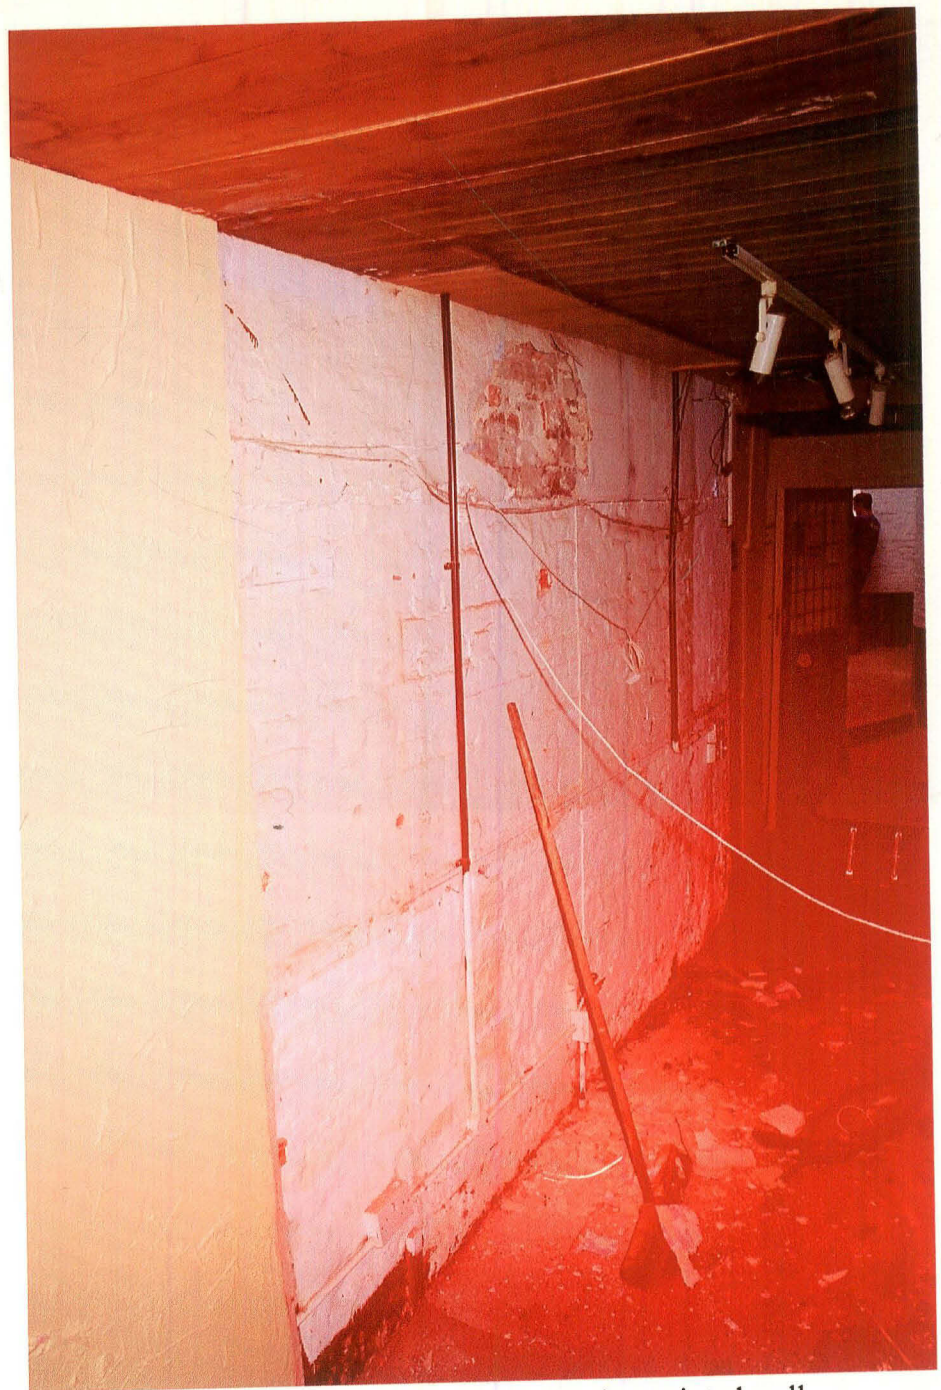
Pl. 4 Passageway, looking south showing painted wall

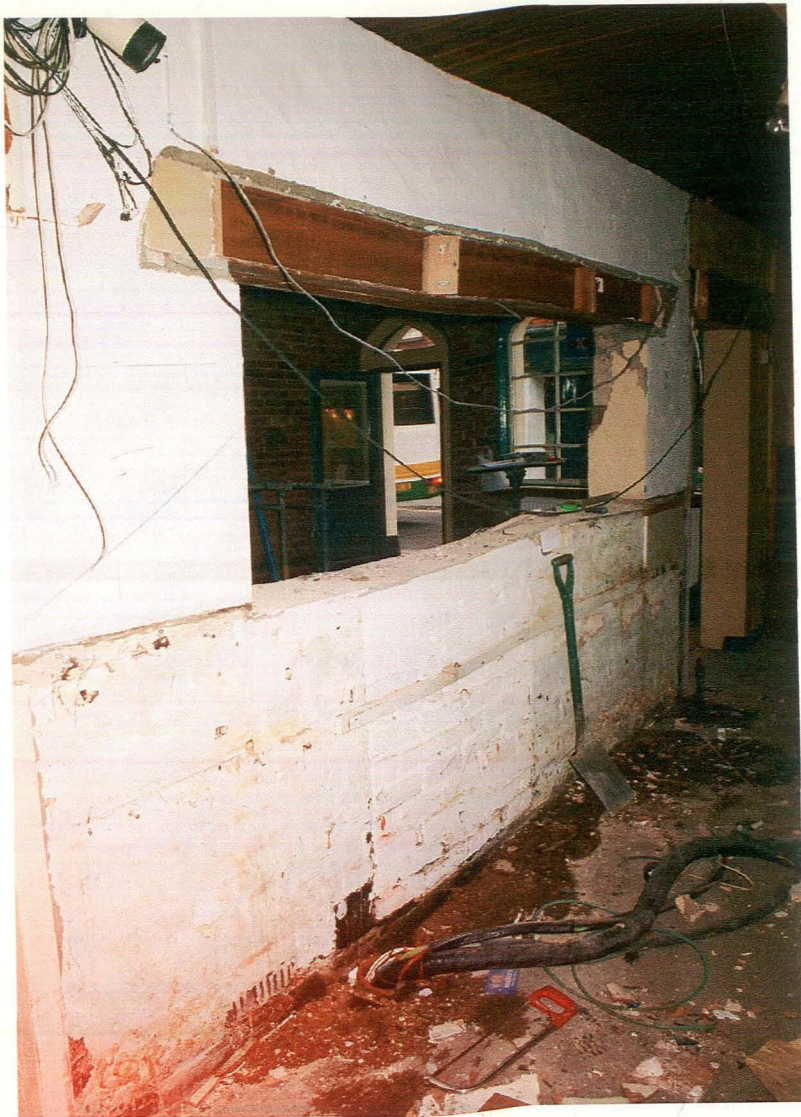
Pl. 5 Passageway, showing inserted bar opening in east wall with blocking beneath (to the left of shovel).

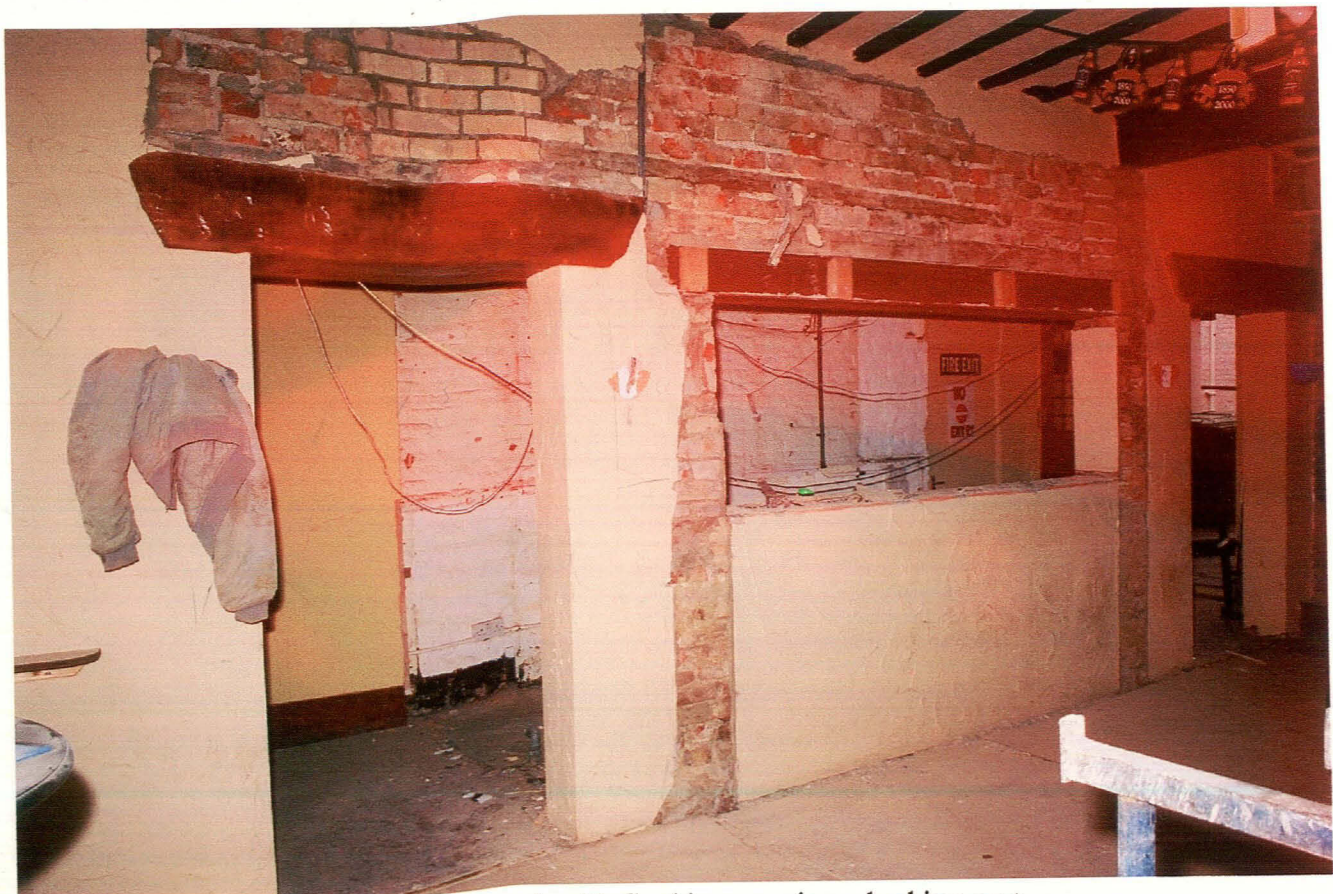
Pl. 6 Bar hatch with flanking openings, looking east.

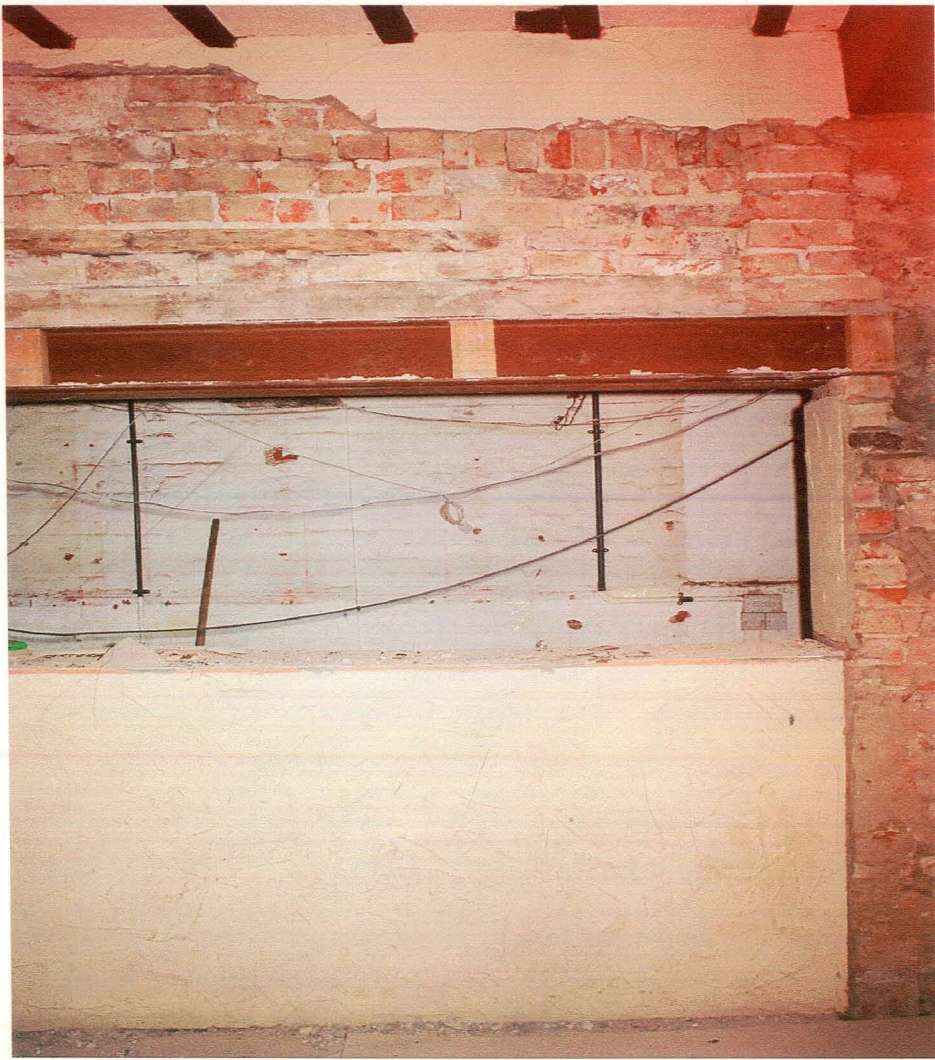
Pl. 7 Detail of vertical joint in brickwork above RSJ.

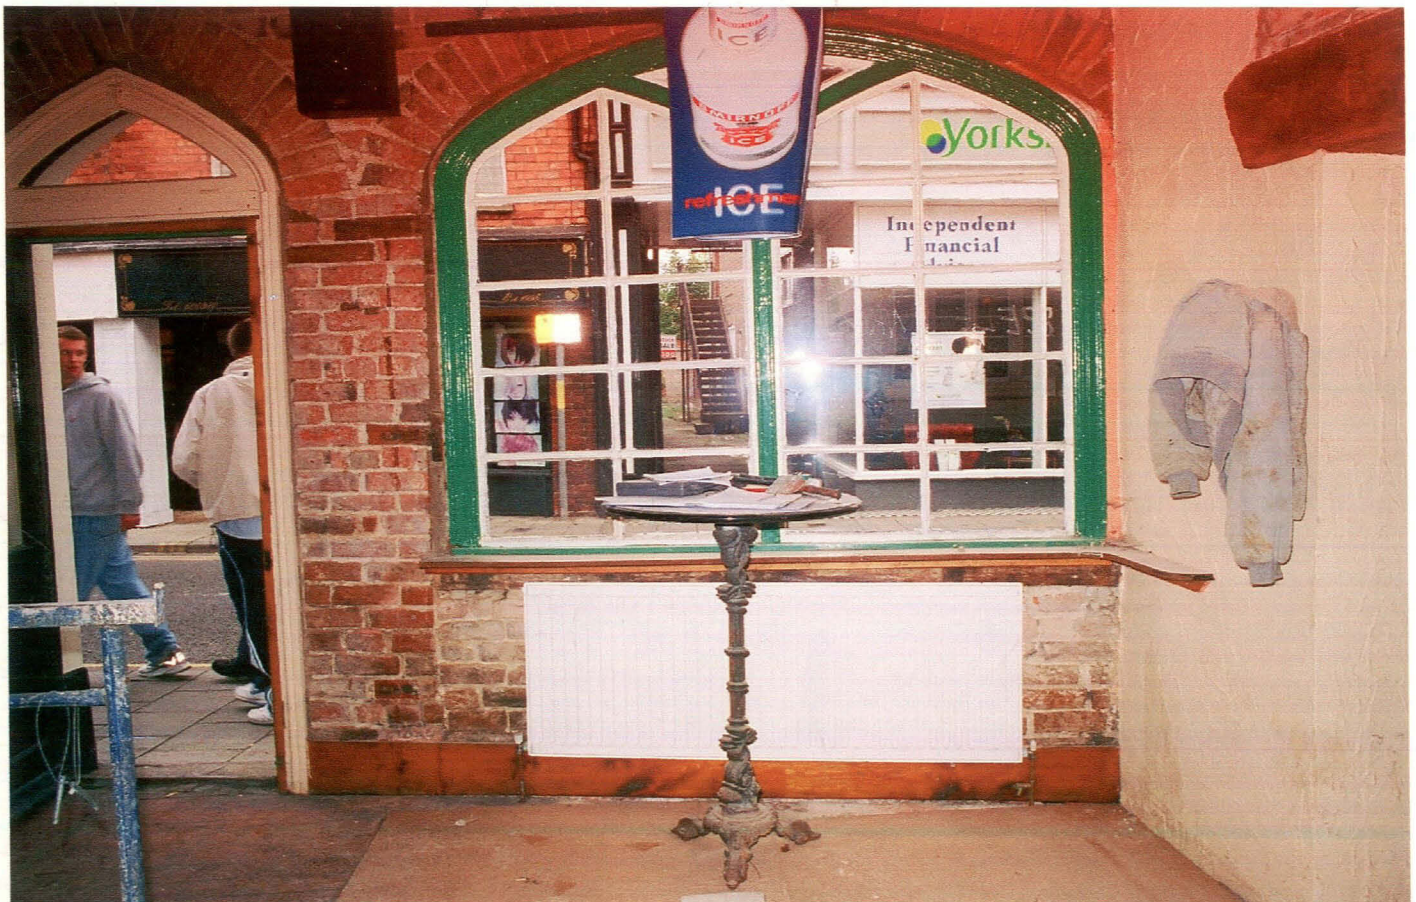
Pl. 8 North wall of bar, showing entrance onto Mercer Row and window with blocking beneath.

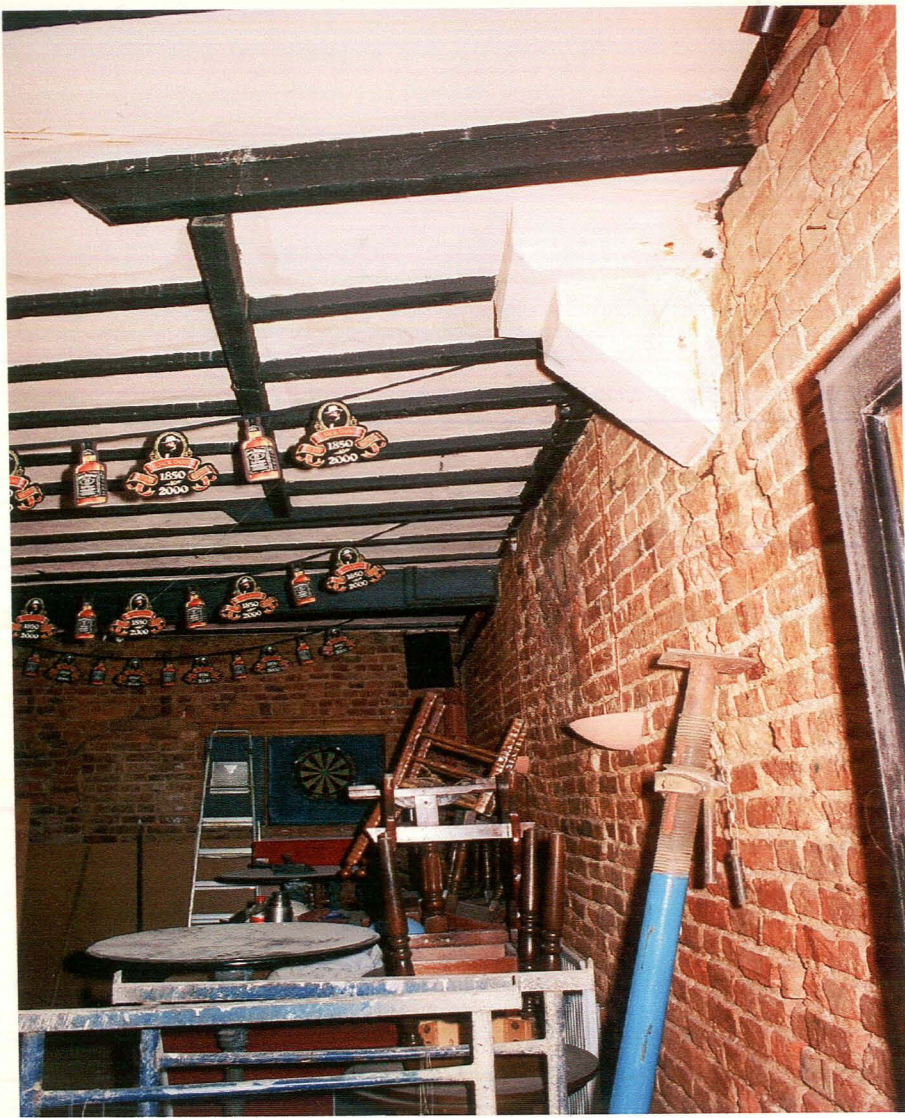
The west wall has been cleaned of plasterwork and the brickwork bonding is five stretcher courses to one header course, the hand-made bricks are 225 x 109 x 72mm. One stone corbel probably supports the first floor fireplace/hearth (Pls 9 and 10). An area of disturbance in the brickwork marks a second corbel position (Pl. 10). A scorchmark, which runs at an angle across the wall up to first floor level, shows the flue position for the ground floor fireplace which would have projected into the room.

On the east side of the south wall, adjacent to the existing access to the rear yard, is evidence for an inserted access in the brickwork with a flat lintel of brick headers above, which has been blocked with brick (Pl. 9). There was no access to other face to corroborate the information.

Pl. 9 West wall of bar, looking south showing corbel supporting hearth above. Note blocked door in south wall at far end of room.

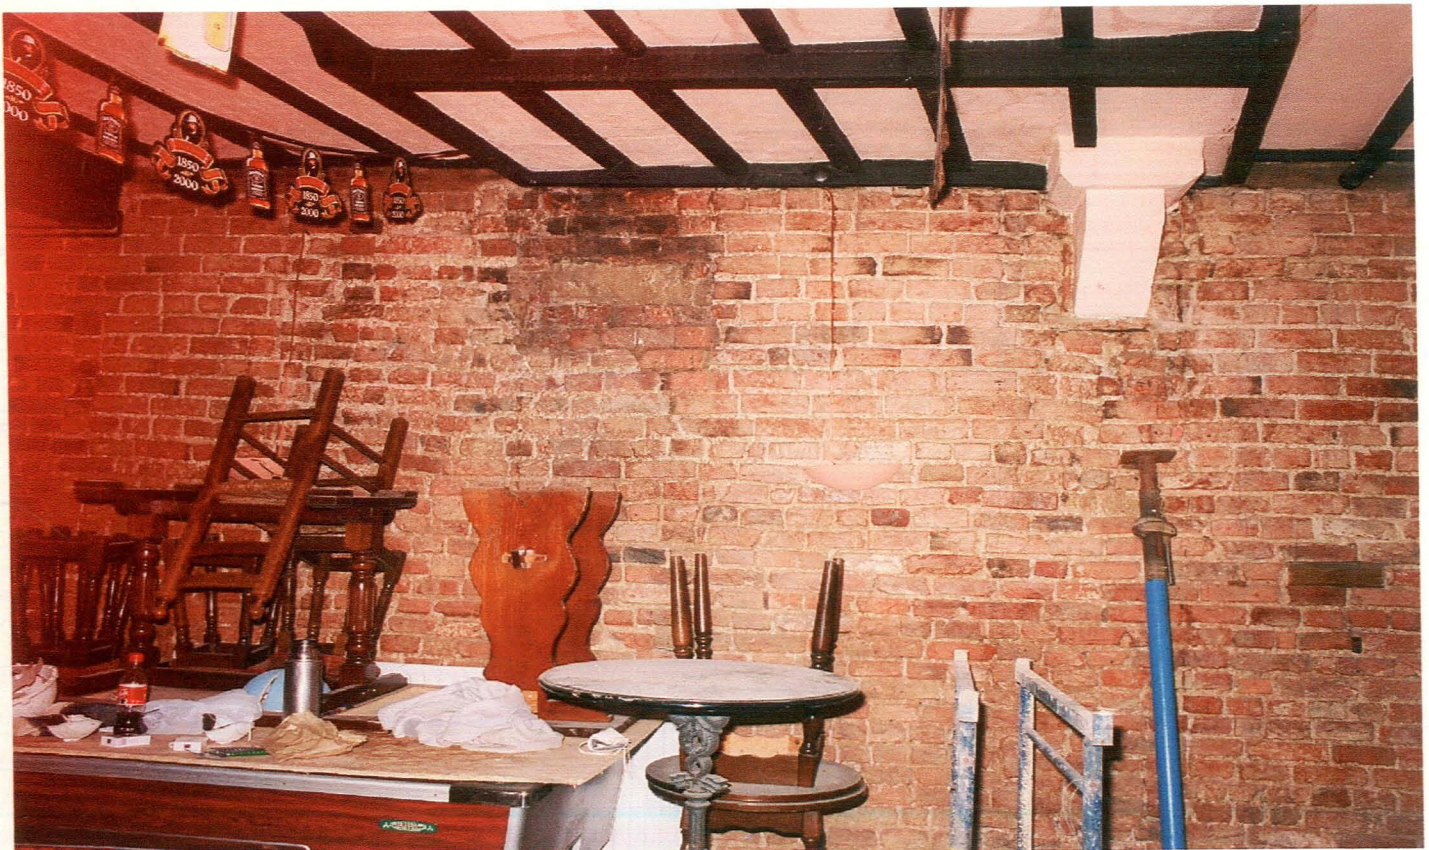
Pl. 10 West wall of bar, looking west showing corbel supporting hearth (right) and disturbed Brickwork (left) marking position of second corbel.
