LITTLE GRIMSBY HALL. ARCHAEOLOGICAL WATCHING BRIEF AND STANDING BUILDING REPORT

Site Code: LGH02
NGR: TF 3267 9137.
Planning Ref. N/019/0702/01
Accession No. 2002.134

Report prepared for Mr and Mrs Mountain .
by
Alex Brett

July 2002

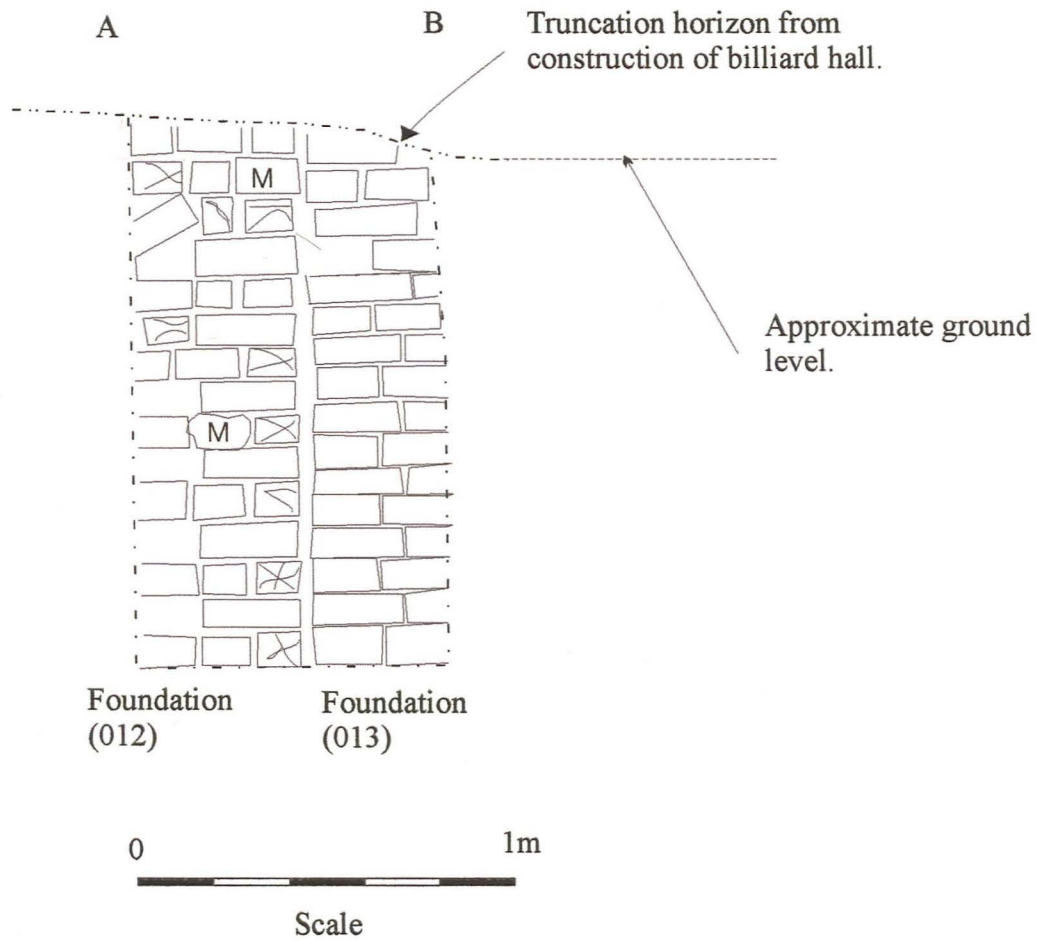
Fig. 4: North facing section. Shows re-used foundation (012) on which building (001) was constructed. Location shown on Fig. 2.
Scale 1:20

The earliest phase of building associated with the range was the western foundation (012), which was observed during the watching brief when a deep foundation trench was cut for the new swimming pool complex (see fig. 4). This was brick built, 1.4m high and 0.35m thick, running under the existing building for part of its course. The great depth of this foundation suggests that it may have been originally designed for a significantly more substantial building than a single story lean-to (see plate 2). Therefore, this foundation was probably re-used for the western part of the building surveyed for this project. It butted a similar north-south footing to the west, (013), which was not disturbed by this project. The eastern part of the range was supported on a comparatively shallow foundation, recorded during the watching brief using context numbers (001) and [112] – see fig. 5.

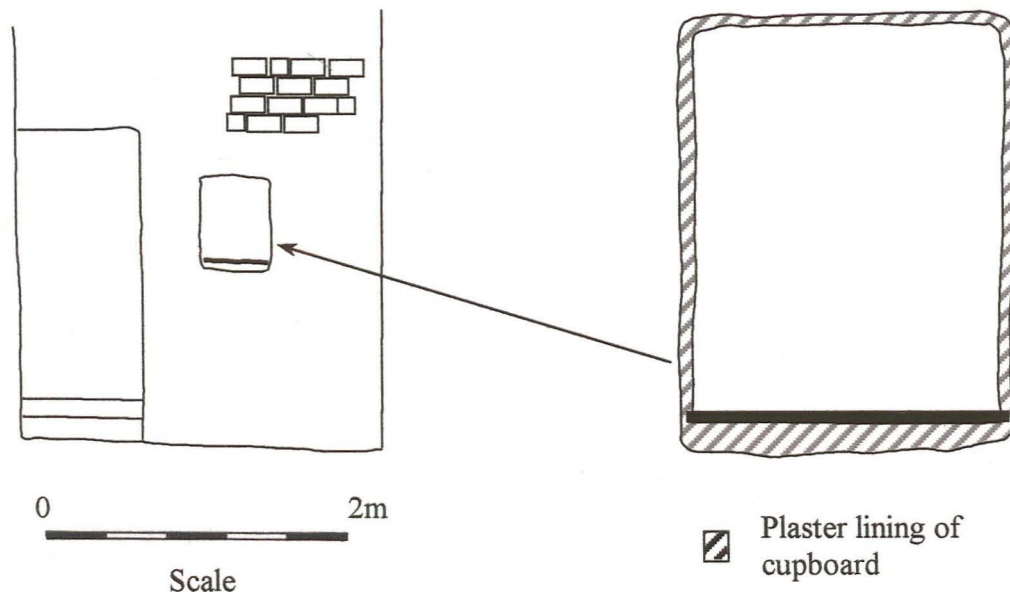
The building represented by context (001) incorporated a number of features that are noteworthy. In the centre of the south wall, to the west of the doorway, was a small recessed cupboard, formed within the body of the wall itself (fig. 6, plate 3). This was 570mm high, 440mm wide and 290mm deep, lined with a lime render that was still visible on parts of the internal face of the wall.

Fig. 6: North facing elevation showing cupboard in wall (001).
Main drawing at 1:50, close-up at 1:20.

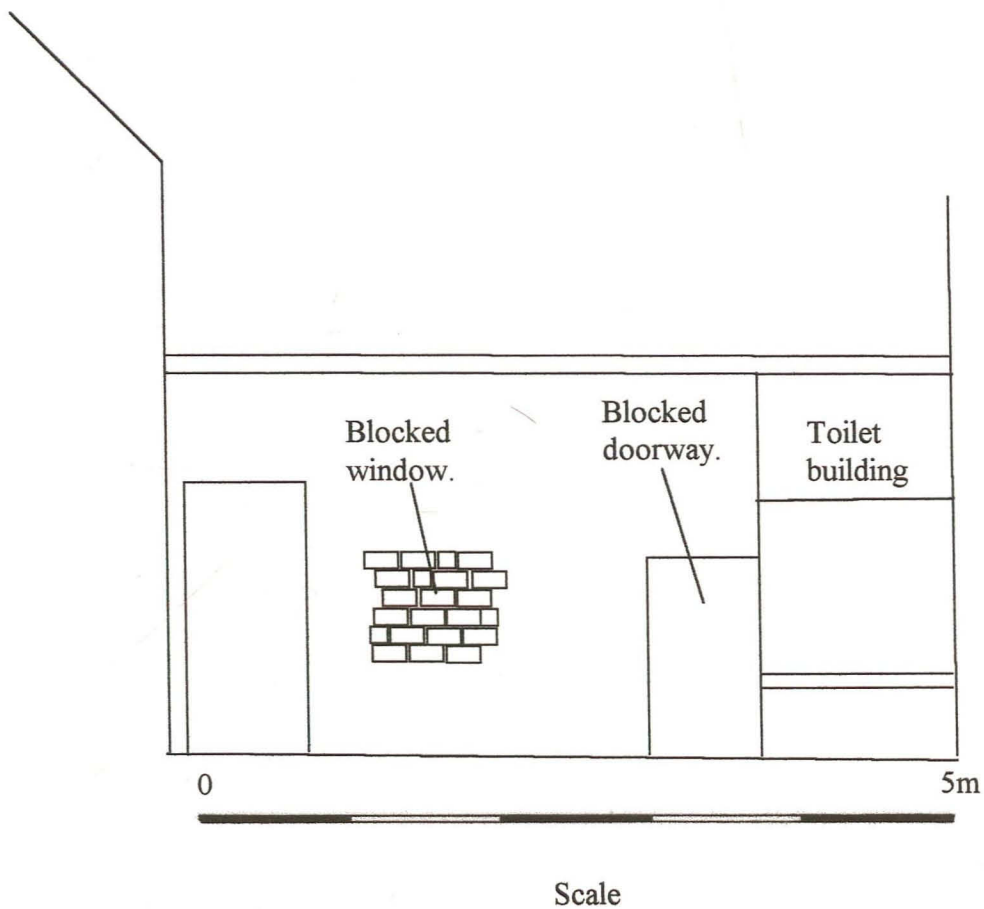
Also in the south wall, but to the east of the original doorway, the remains of a former window were observed. This was blocked, but appears to have been square, approximately 700mm to a side. The wall around this window was rendered internally with lime plaster 10mm thick, and a number of large iron nails were driven into the inside wall for use as hooks. See Fig. 7 and plate 4.

Fig. 7: South facing elevation. Shows blocked window in first phase of building and later blocked doorway. Interface between phases (001) and (006) not visible externally. 1:50

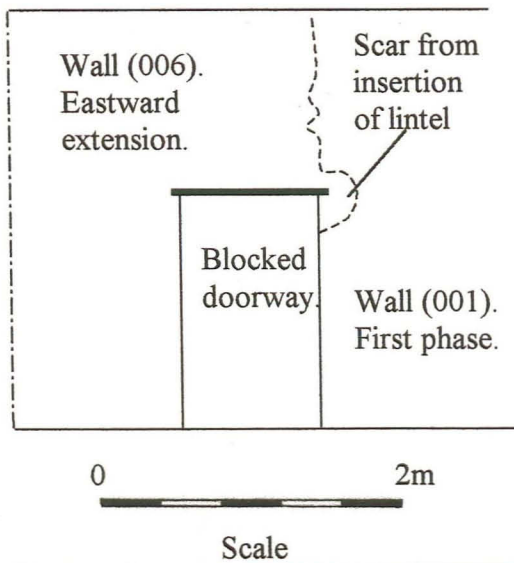
Fig. 8: North facing elevation showing two phases of wall building and doorway between, later blocked. 1:50

The southern part (006) was commenced some 0.90m from the broken end of the former wall, leaving a doorway opening to the south. The top of this doorway was marked by a wooden lintel; built into the new structure, but inserted into the existing wall, leaving a considerable scar that had to be repaired (see fig. 8). This doorway was later blocked, see below.

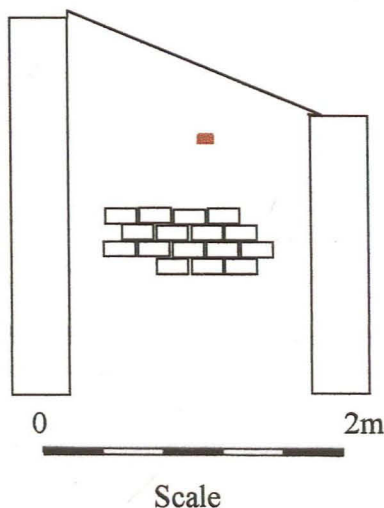
Fig. 9: Wall (011), east facing elevation. Sample of brickwork illustrated to show bond. 1:50

An unusual feature of the westernmost dividing wall (011) was a wooden beam incorporated into it and protruding at right angles to each side, shown brown in Fig. 9. It was 540mm in length, protruding almost equally to each side, 95mm wide and 60 mm deep. The eastern end was chamfered with a vertical hole 20mm in diameter bored through

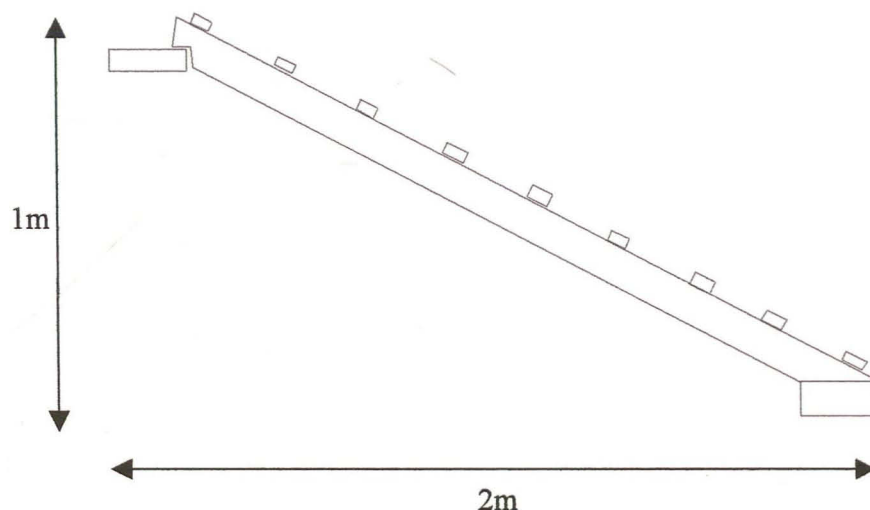
The roof structure on the recorded building was reasonably modern; the timber was all softwood and the nails used were not corroded. It was of lean-to construction, made up of 18 rafters, about a third of which were more robust principle rafters. These supported 8 purlins from which hung 8 rows of ribbed pan tiles. The rafters rested on wall plates, the lower of which was made up of some hardwood timbers, presumably re-used from an earlier roof (see plate 6).

Fig. 10: Sketch section of roof.
Not to scale.

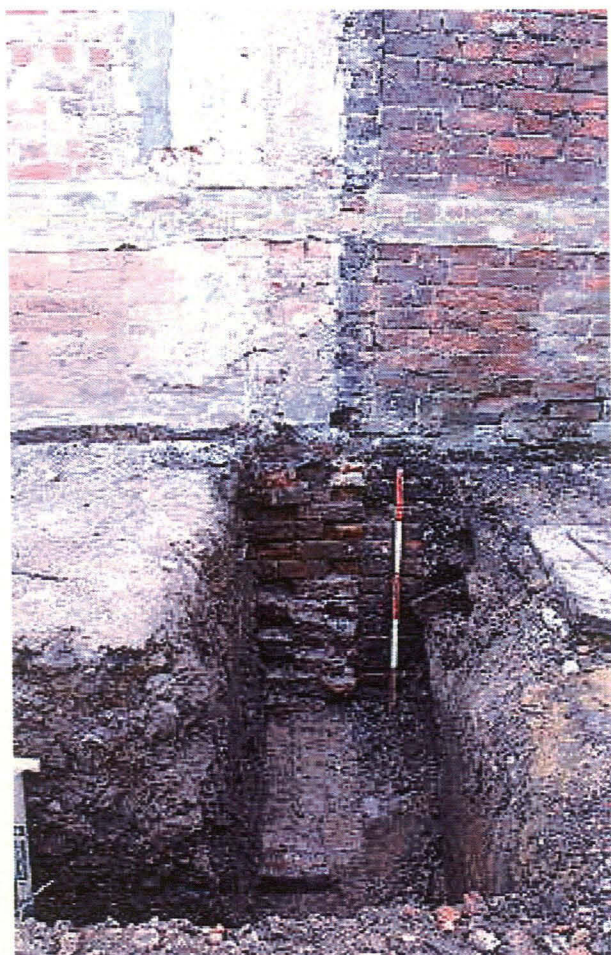
Pl. 2 Re-used foundation (012). The other re-used foundation (013) is visible behind the scale. Looking south.

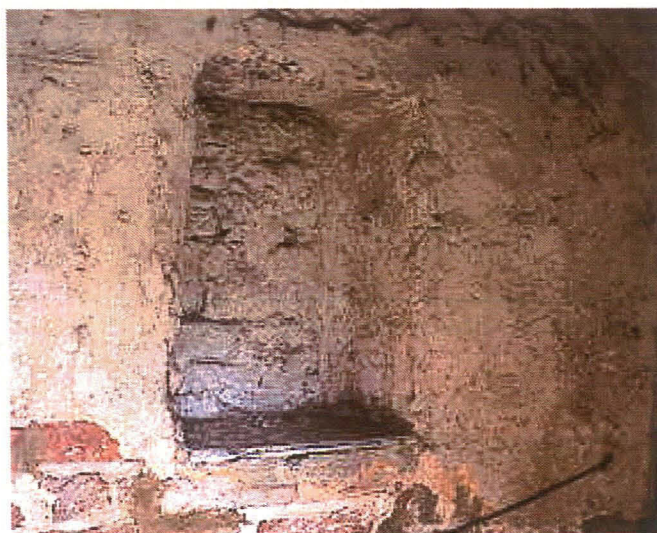
Pl. 3 Cupboard in south wall of building. Looking south.

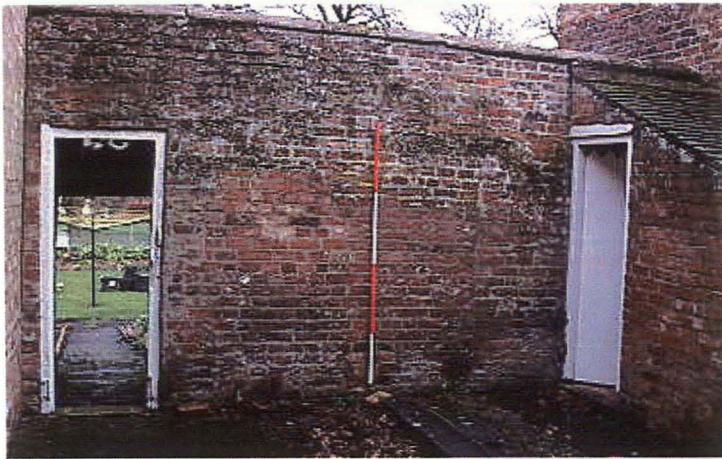
Pl. 4 South wall of building, blocked window is visible to the left, blocked doorway to the right. Looking north.

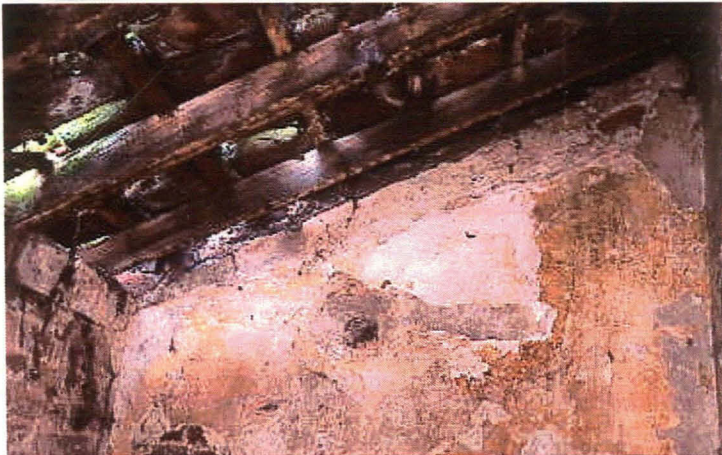
Pl. 5 Scar indicating raising of roof in wall (011). Wooden protrusion is visible towards the centre of the frame. Looking east.

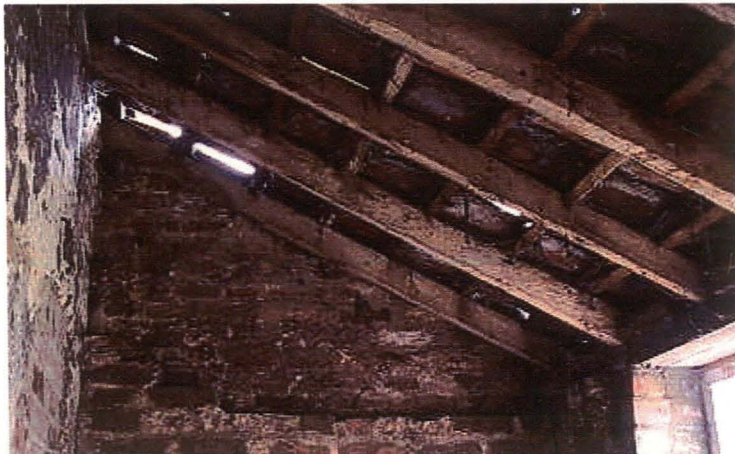
Pl. 6 Structure of roof, rafter in fore-ground is a principle. Looking west.

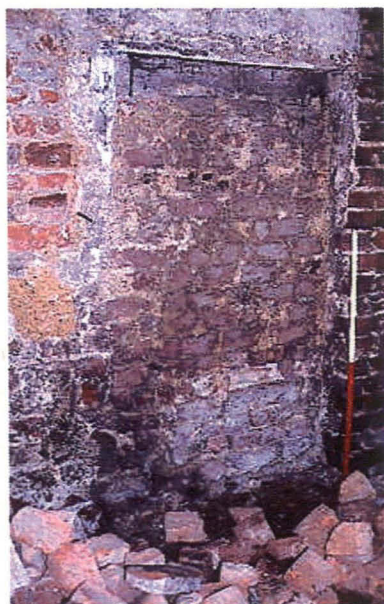
Pl. 7 Blocked doorway between (006) and (001). Looking south-west.
