**Manvers Arms 204-206 Monks Road Lincoln  
Photographic and Archaeological Recording**

**Report**

**LAS Report No. 1025  
January 2008**

*A photographic record and description of the Manvers Arms was undertaken prior to its demolition to make way for a housing development. The pub was built in 1934, to serve the growing population at the east end of the city. It also provided overnight accommodation. Its plain brick construction, with decorative brick and tile quoins, with hipped, tiled roof was typical of the period. There were coloured glass panels over two external doors but otherwise the style was functional rather than decorative. The first-floor bedrooms retained original washbasins but the lounge and saloon bars had been remodelled in the 1970s, with conversion of the snug at the rear to a pool room. Original doors and fittings were present but the décor was mainly of 1970s vintage. There was a garden at the rear, on a higher terrace, and provision for parking on the forecourt.*

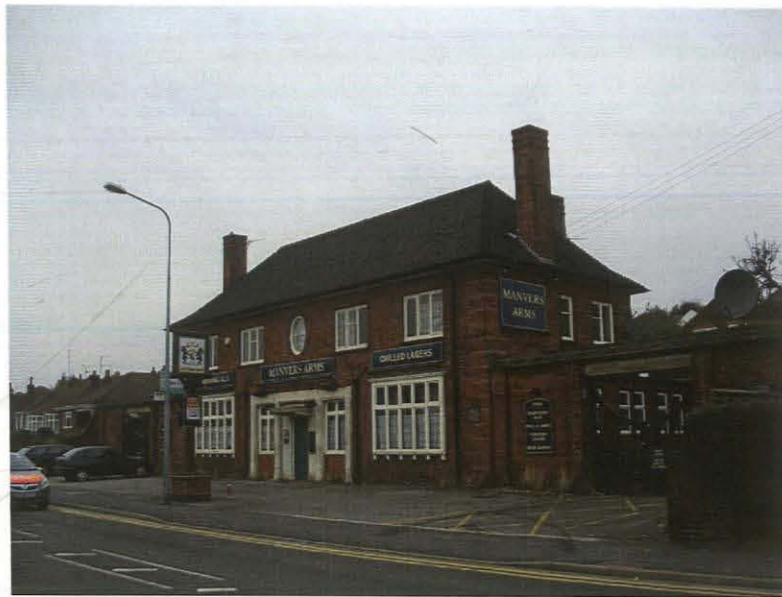
This brick building (in Flemish bond) was constructed in 1934 and is substantially as originally built with only minor alterations to the external fabric (Pl. 1). The tiled roof is hipped at both ends with two-flued chimneys serving the bars and first-floor bedrooms. Chimneys on the rear elevation served ground floor fireplaces in the pool room and landlord's living room. A plinth, two stretchers high is formed by vertical stretchers projecting 15mm from the face and at all four corners a faux quoin effect has been created by using three tile courses with the equivalent thickness of one brick every fifth course (Pl. 2).

Pl. 1 Manvers Arms, view looking north-west

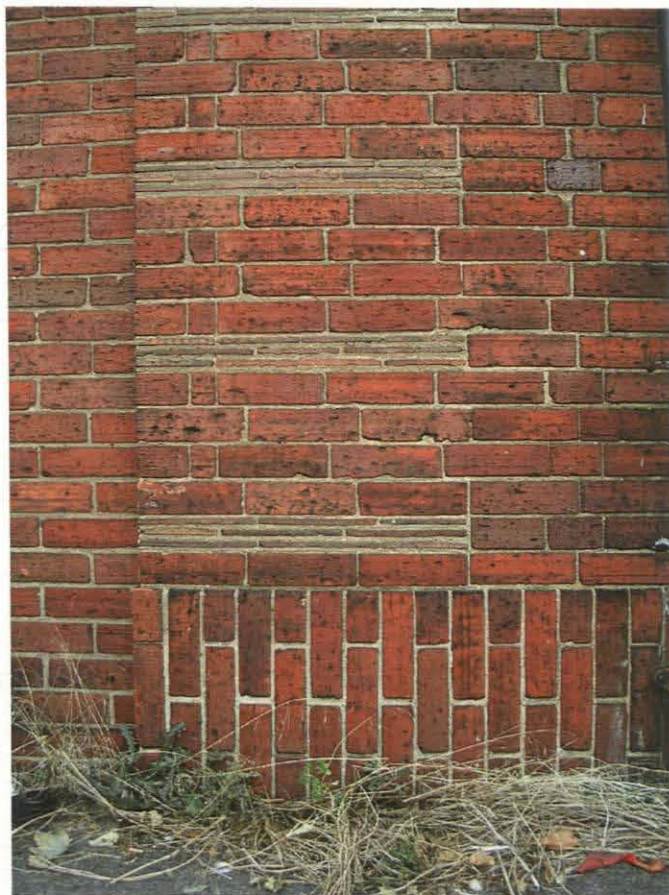
Pl. 2 Detail of plinth and quoin construction

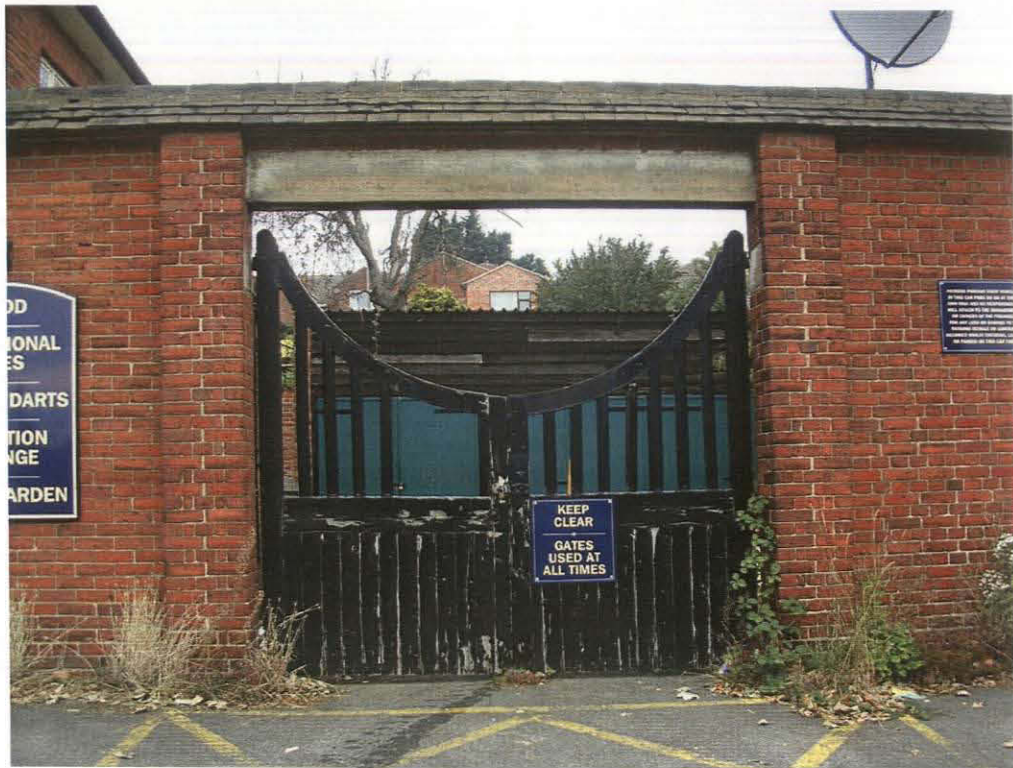
The building was set back c.6m from the pavement creating a forecourt which runs the full length of the property. To either side of the building is a brick wall, 3.20m high, capped with tiles and ridge tiles (0.30m wide). Double gates, 3m wide, are located in this wall and give access to courtyards. Garages have been inserted in eastern one (Pl. 3). The boundary walls

Pl. 3 Gates to the east yard, with garages visible inside

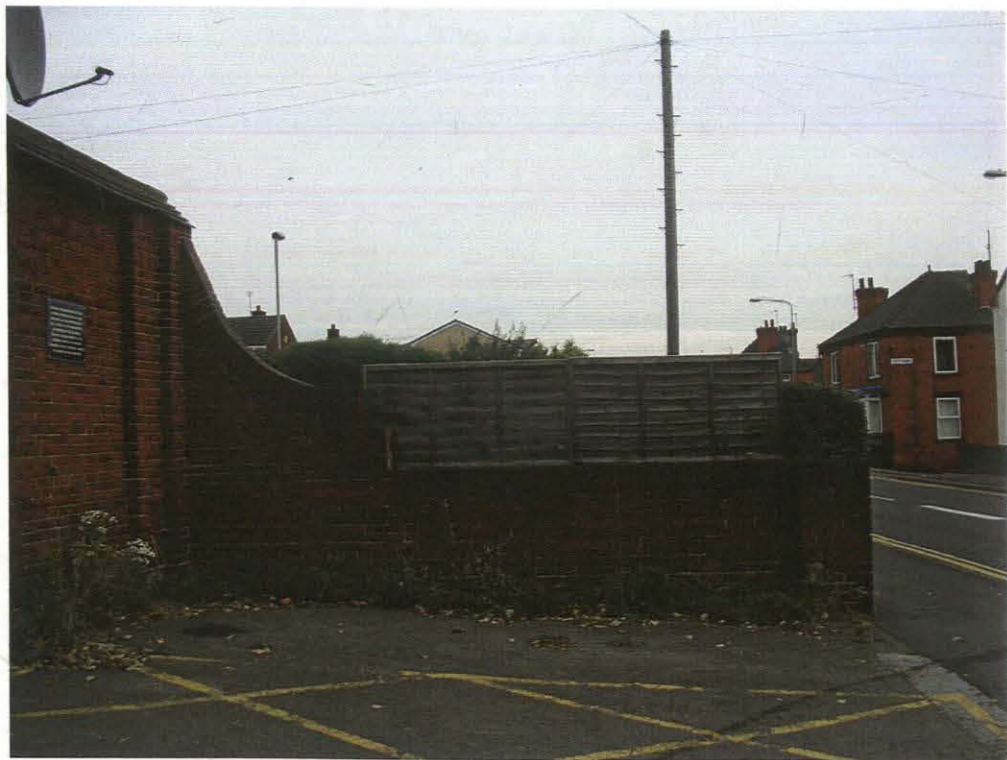
return to the front of the property, reducing to c.1.30m, where they reach the street (Pl. 4). The walls are of one build with the pub. The forecourt is currently tarmac and in front of the entrance is a lamp post and a modern pub sign on a wooden post, set in a brick plinth all constructed after 1934 (Pl. 5).

Pl. 4 East boundary wall

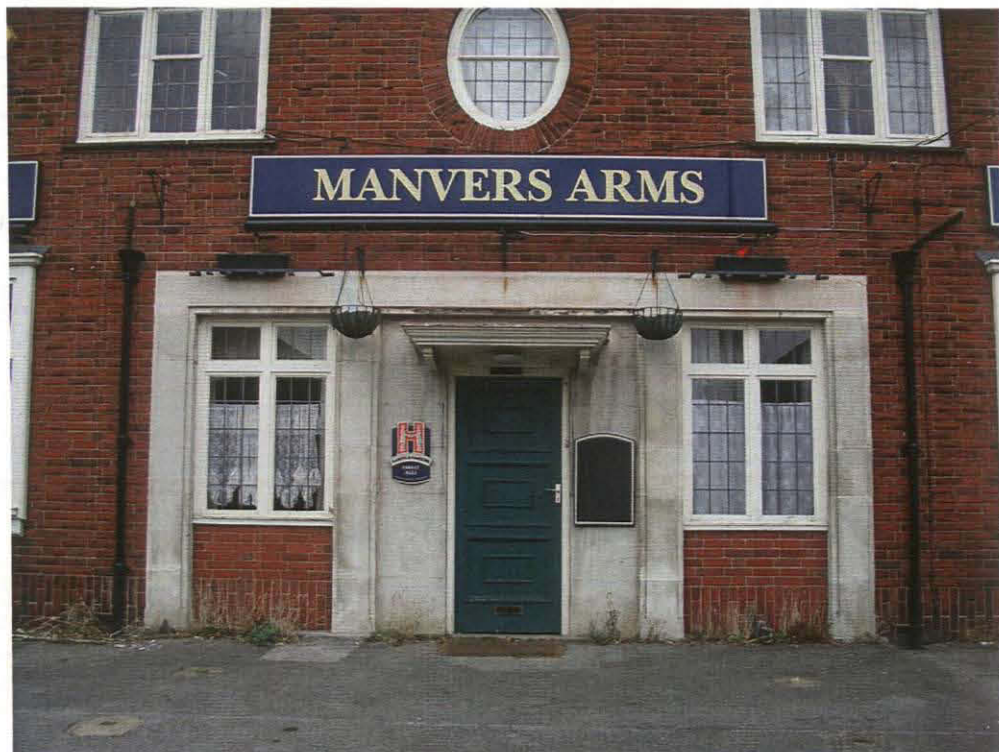
The front elevation has a central entrance, with projecting portico, incorporating flanking windows all contained within a limestone surround (c. 6m wide) (Pl. 6). The area surrounding the three-panelled door has been rendered to look like limestone. The canopy over the door is not present on photograph in the newspaper article of July 12th 1934 and must be an addition. The quality of the photo is too poor to be sure but it looks as if there was a central double door with flanking entrances into the bars (Lincolnshire Echo 12/7/34). Ground floor bay windows project from the wall face by 55mm and rest on six wooden corbels (Pl. 7).

Pl. 6 Entrance to the Manvers Arms, with oval window above

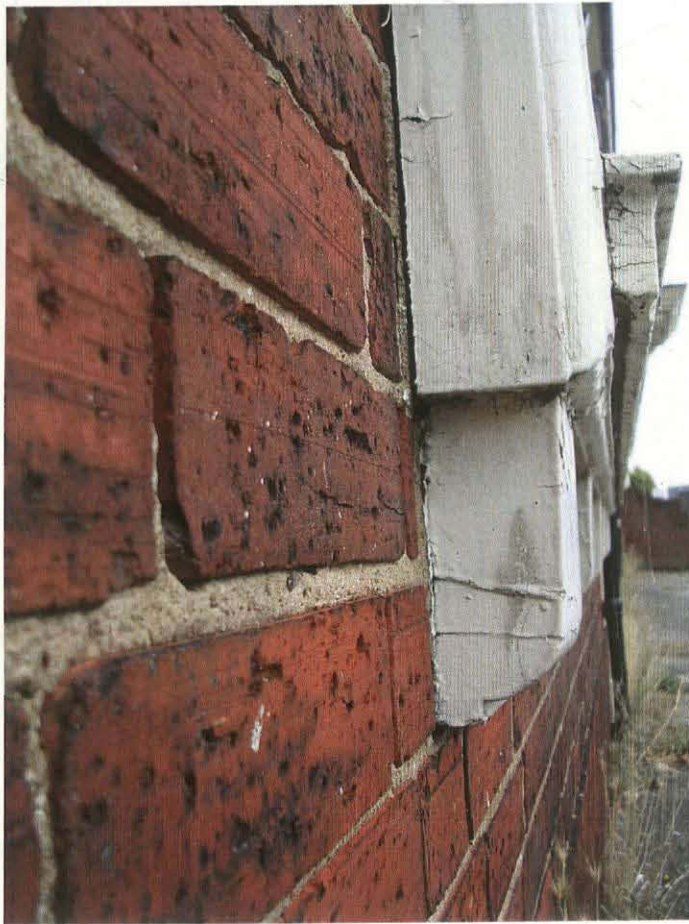
PL. 7 Detail of ground floor window corbels

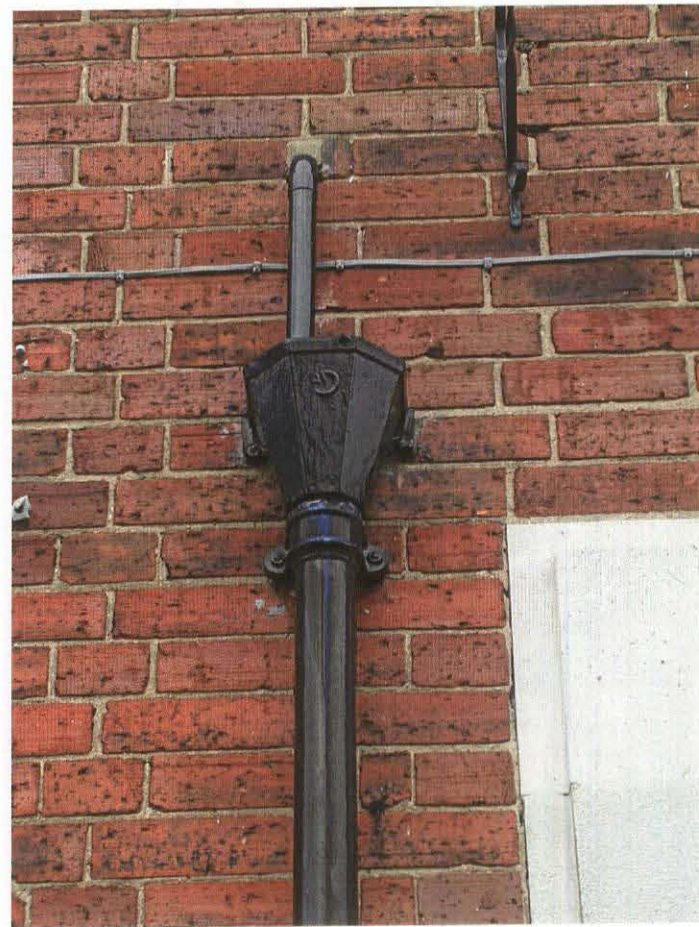
There are cast-iron rain water pipes at each end of the elevation that take water from the guttering. In addition, two shorter pipes with fluted hoppers, take water from the basins in the first floor bedrooms (Pl. 8).

PI. 8 Hopper and down pipe serving first-floor wash basin

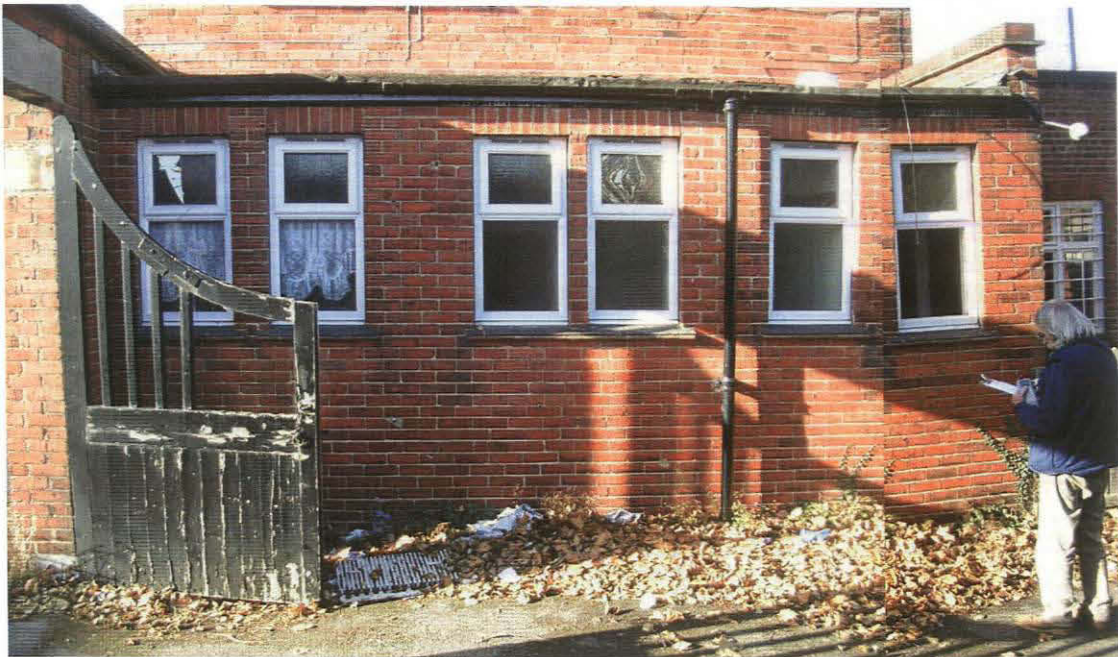
There is a single-storey ground floor projection containing the ladies and gent's toilets (with modern UPVC windows (Pl. 9). At first floor level there is a central single window (Bedroom 6) and northern double window (Bedroom 7), leaded, as on the front elevation. There is no window to the south as this is where the fireplace in Bedroom 6 is located. There is pub sign board attached to the blank wall.

Pl. 9 East toilet block

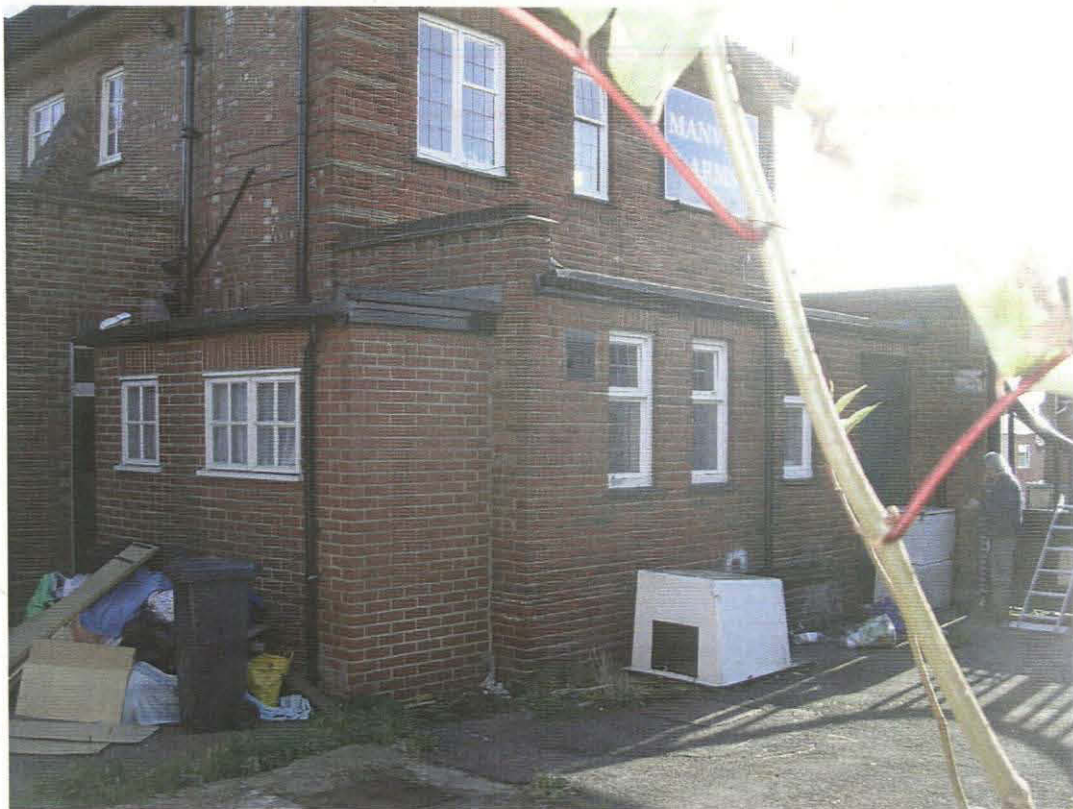
This is almost identical to the east elevation except that the ground floor toilet windows are original and not UPVC (Pls 10 and 11). A double door with a leaded light window over is situated adjacent to the gate and is the entrance to the barrel chute, into the cellar (Pl. 12). This takes up the area occupied by the ladies' toilets at the east end of the pub. The ladies' at this end are in an extension to the north elevation, probably 1950s-60s in date (Pl. 10).

Pl. 10 West toilet block

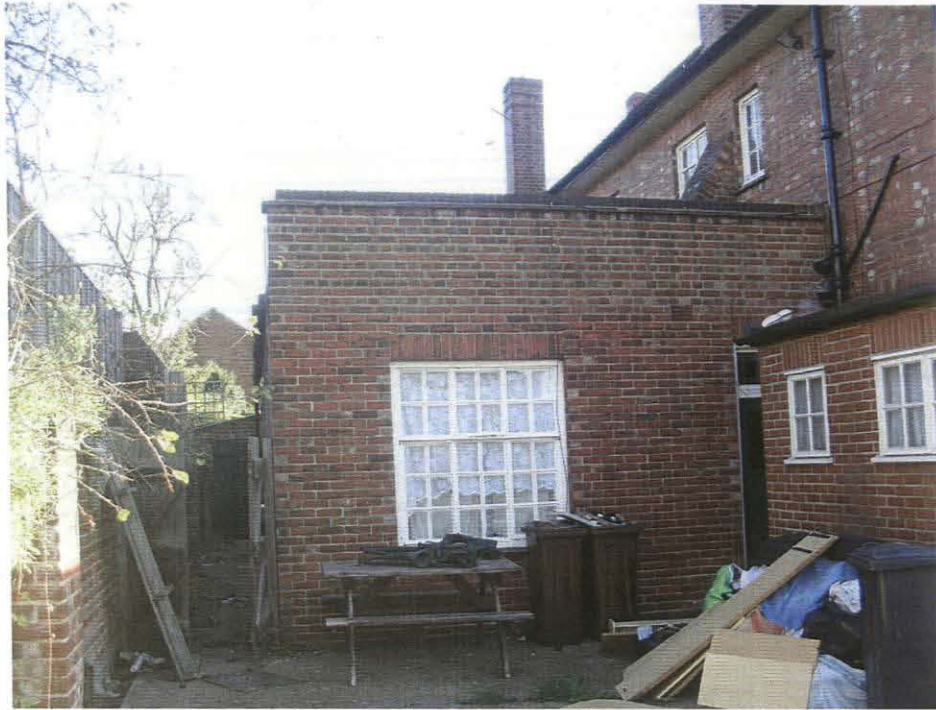
Pl. 13 West elevation of single storey block on north side of pub.  
Note added parapet marked by change in mortar colour.

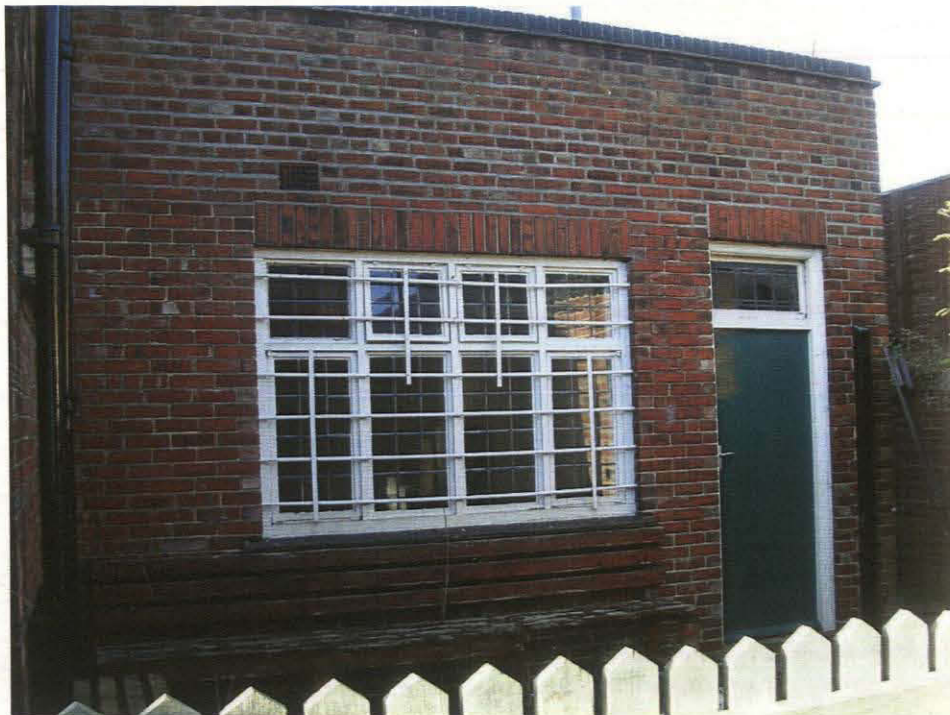
The rear elevation has a single storey block with flat roof containing the pool room, with stores along the rear, the kitchen and landlord's living room. It has a raised parapet on the east and west sides, presumably contemporary with the first floor door which was inserted to give access to the flat roof at an unknown date. At ground floor level there is a door to an outside store which contains the gas and other meters, a window for the walk-in larder off the kitchen, a kitchen door and window, and window for the landlord's living room. There is access to the single-storey range on both the west and east elevations (Pl. 13). The east door has a coloured glass window over. The door is a replacement. There is also a window for the living room on this elevation. The west door is identical with a window over, with the same coloured glass- it gives access to a lobby leading to the pool room (Pl. 14).

Pl. 14 West elevation of single storey block showing access to the pool room  
Note added parapet marked by change in mortar colour.

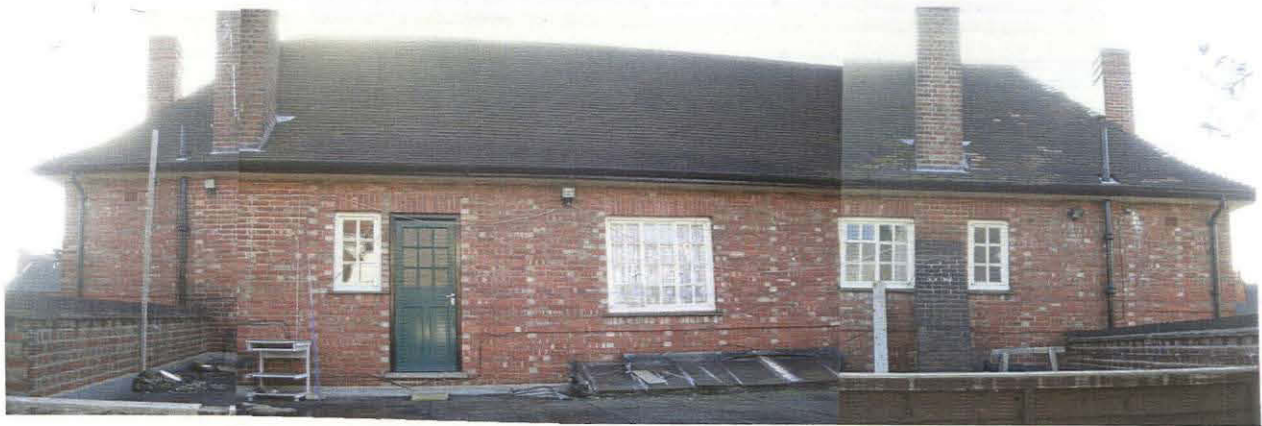
Pl. 15 North elevation showing inserted access to flat roof and chimney between the bathroom and toilet windows that serves the landlord's living room .

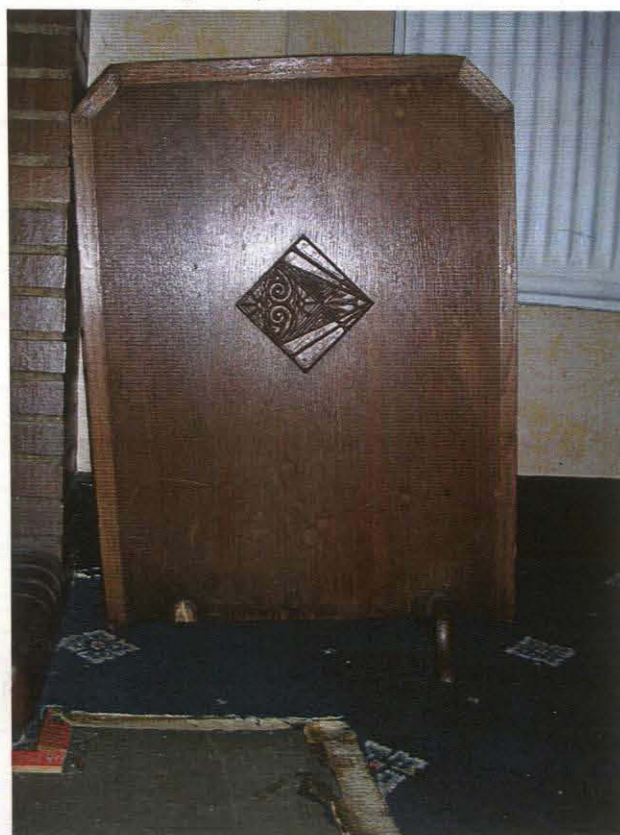
The door from the lobby into the lounge is modern. The 'beamed' ceiling is probably original (Pl. 18) as is the brick surround of the fireplace on the west wall (Pl. 19). A damaged wooden fire-screen could also be original (Pl. 20). A built-in velour bench seat is situated along the northern wall and looks recent in date. The carpeted floor overlies tiles of genuine linoleum which might be 1960's or 1970's in date. The bar appears to be of 1970's vintage and the light fittings consist of gold-effect chandlers and could be any date from the 1980's onwards (Pl. 21).

Pl. 20 Firescreen in the lounge

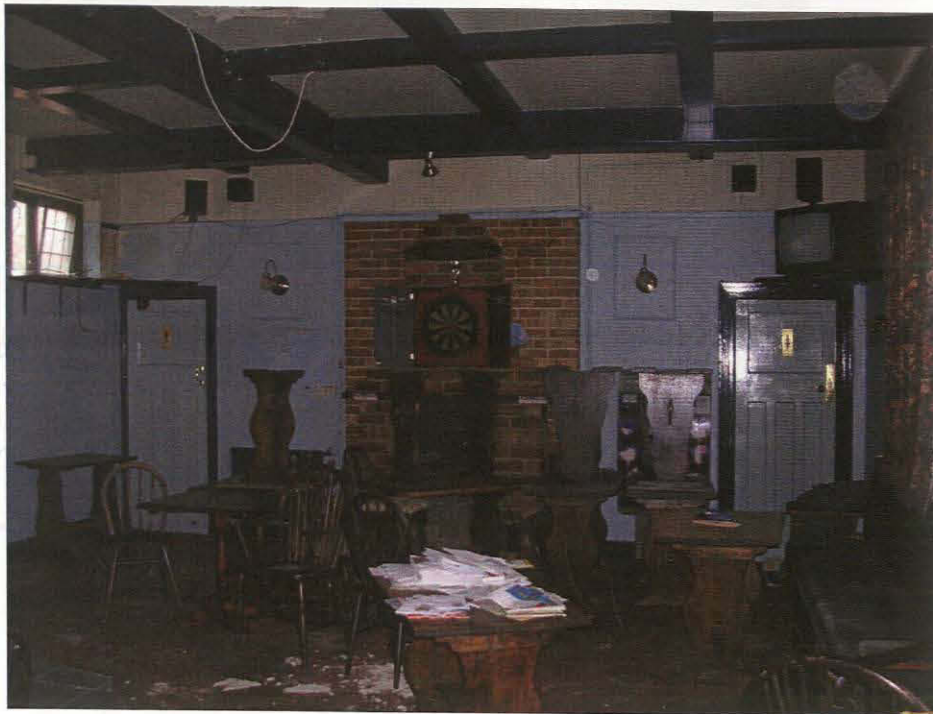
The beamed ceiling is the same as found in the lounge bar. The brick fireplace and mantel are of larger bricks and look more recent (Pl. 27). A dartboard is incorporated into a later brick alcove above the mantelpiece. The doors to either side of the fireplace lead into the toilets and look original (there was no access into these toilets during the survey). A bench seat along the south wall has an oak frame with fluted legs and armrests which would be consistent with a date of 1934, but has been re-upholstered in light green velour with added thin plywood panels between the legs (Pl. 28). The floor covering is partially carpeted with a ceramic tiled floor adjacent to the bar.

Pl. 27 The saloon looking east

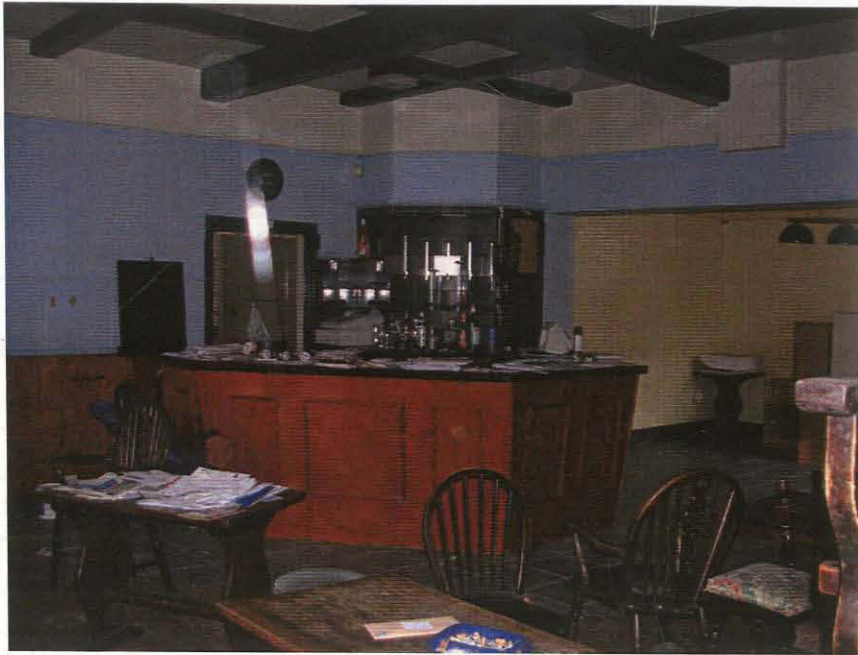
The angled bar is the same style and date as the lounge (1970's) (Pl. 29). The northern wall has been cut through giving access into the 'pool room' with a rear lobby beyond that provided access from the east yard. The door has a coloured glass window above which is probably original (Pl. 30). There is a blocked fireplace in the south-east angle of the pool room and it may originally have been a snug, with its own rear entrance.

Pl. 29 The saloon bar with pool room to rear

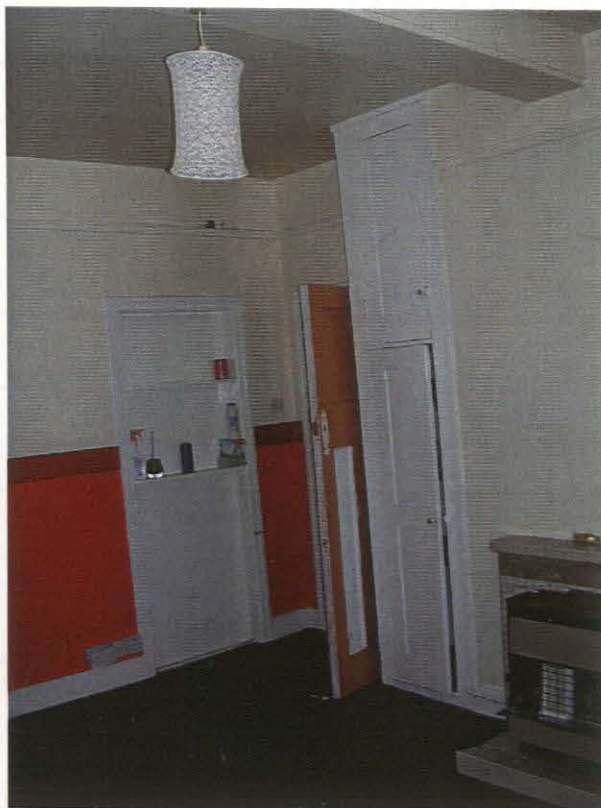
There is a modern gas fire in front of a 1950's tiled fireplace, with fitted cupboards to either side that look original (Pl. 35). The windows on the north and west walls are original. A blocked door on the west wall originally provided access to the kitchen (Pl. 36).

Pl. 36 Blocked door to kitchen (shelved) in west wall of landlord's living room

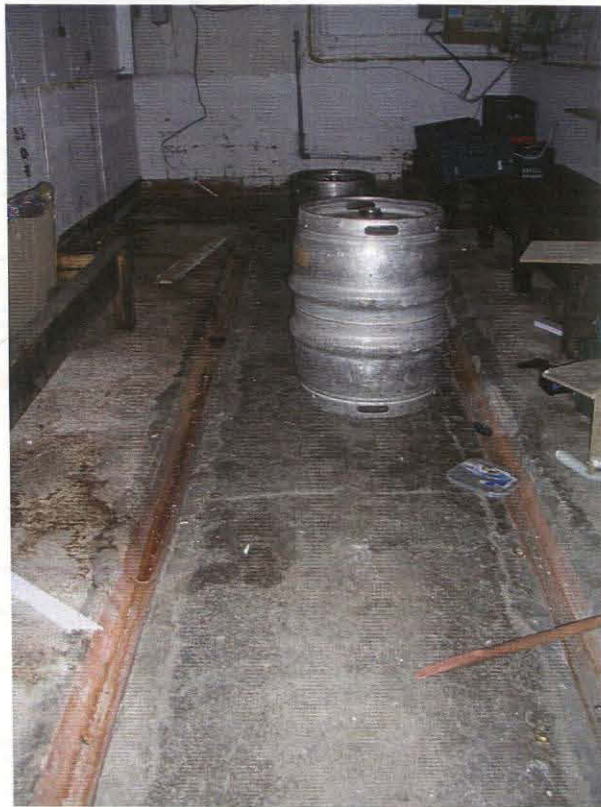
floor is embedded with ceramic pipes forming open channels leading to a drain situated in the south-west corner of the cellar (PIs 39 and 40). The walls are painted brick and the ceiling is plastered. The dumb waiter extended into the basement beneath the stairs (PI. 41).

Pl. 39 The cellar south half, looking east.. Note drainage gullies in floor
