**Market House, 11-13 Market Street,
Long Sutton, Lincs.**

Archaeological Building Survey and Watching Brief

LAS Report No. 773

October 2004

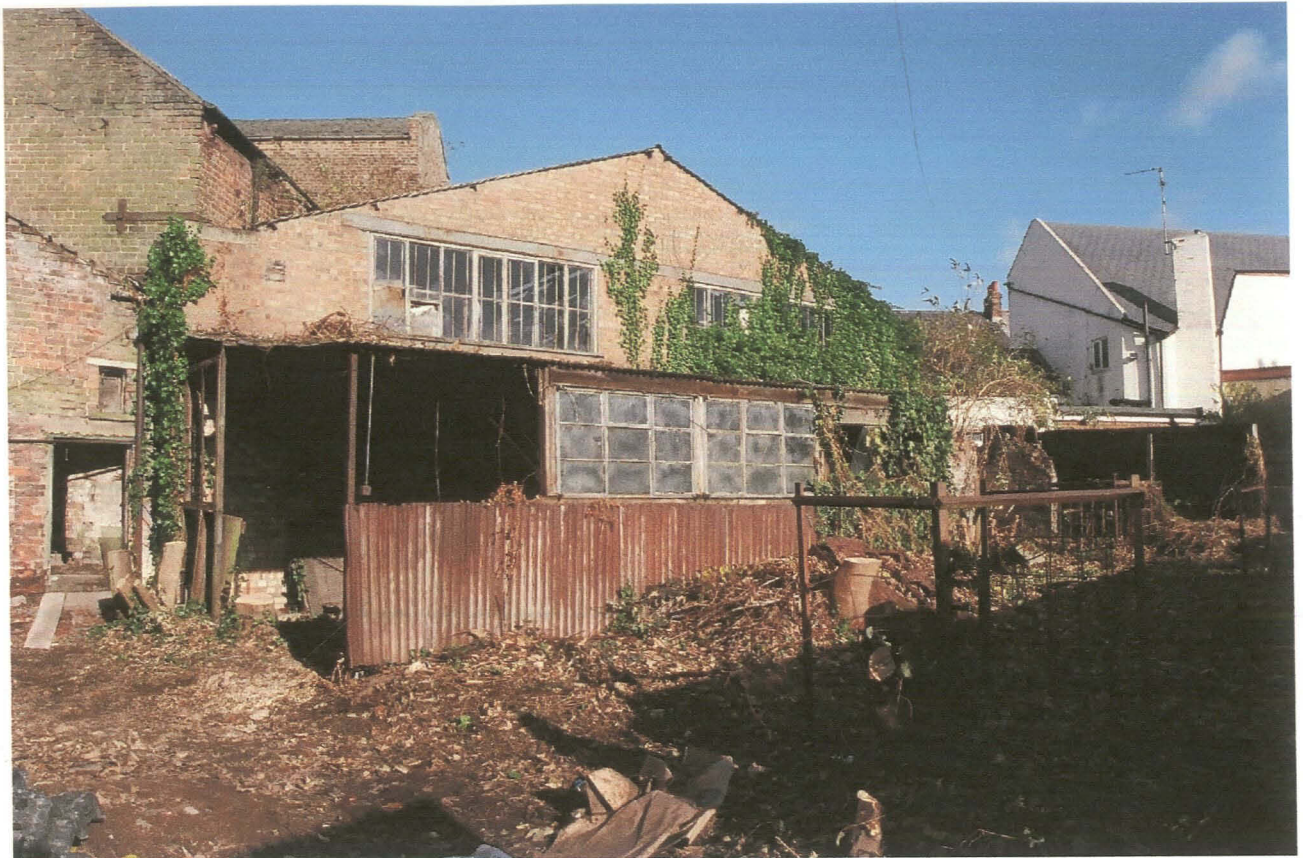
century brick pier surviving. A corrugated iron lean-to shed butted the north boundary of the yard (Pl. 1). Along the western boundary of the yard was a row of two outbuildings (Pls. 2 and 3).

PI. 1 General view showing corrugated iron lean-to in yard, looking north.

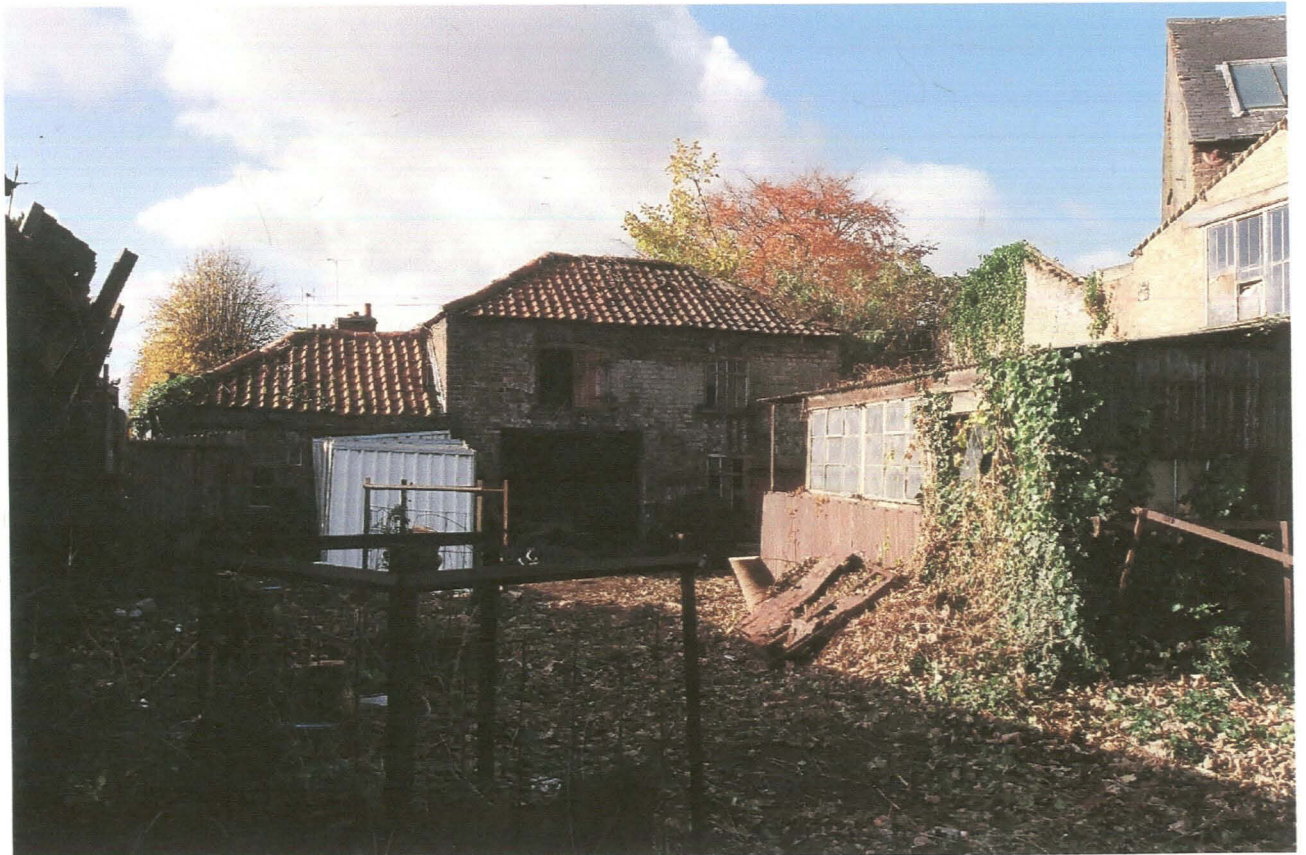
PI. 2 General view of Buildings 3 and 2, looking west.

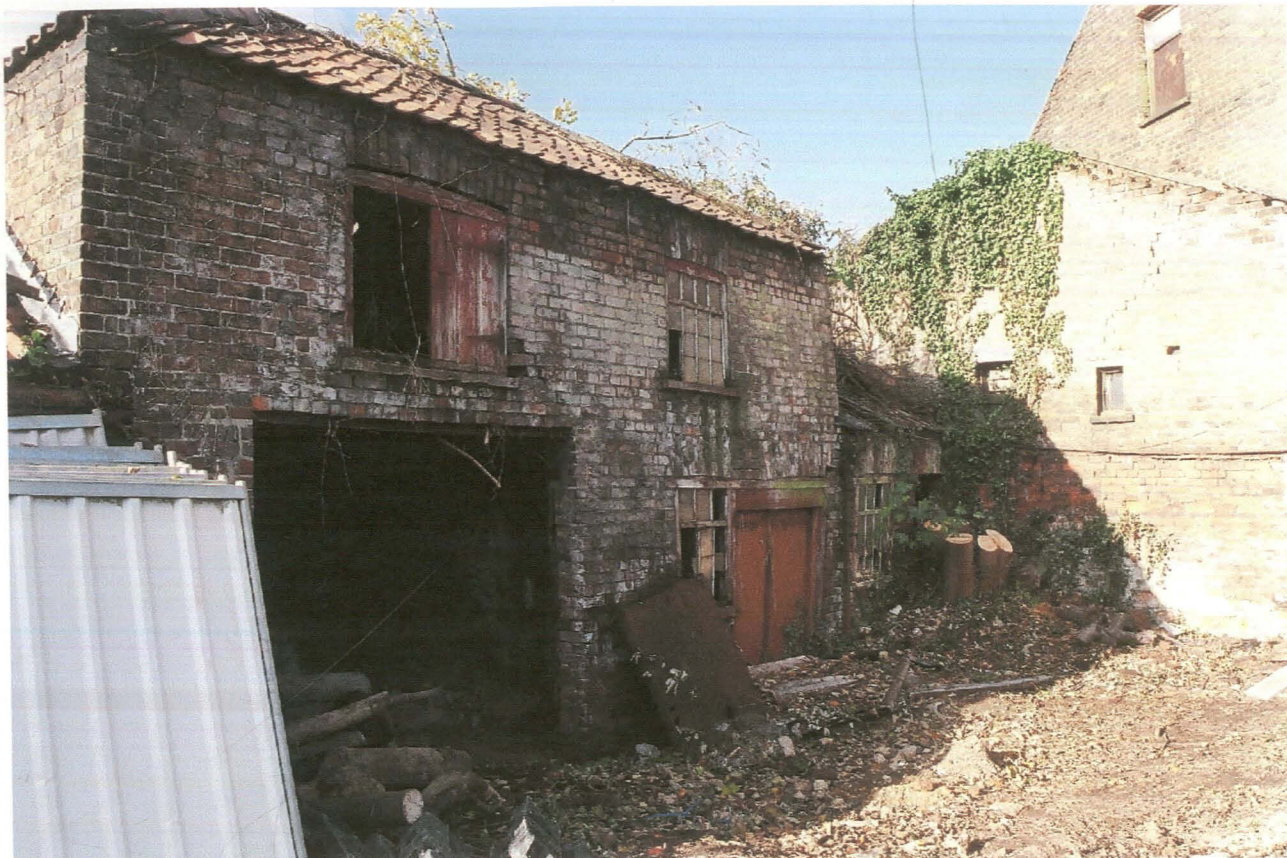
PI. 3 East elevation of Buildings 2 (left) and 1, with gable end of Building 4.

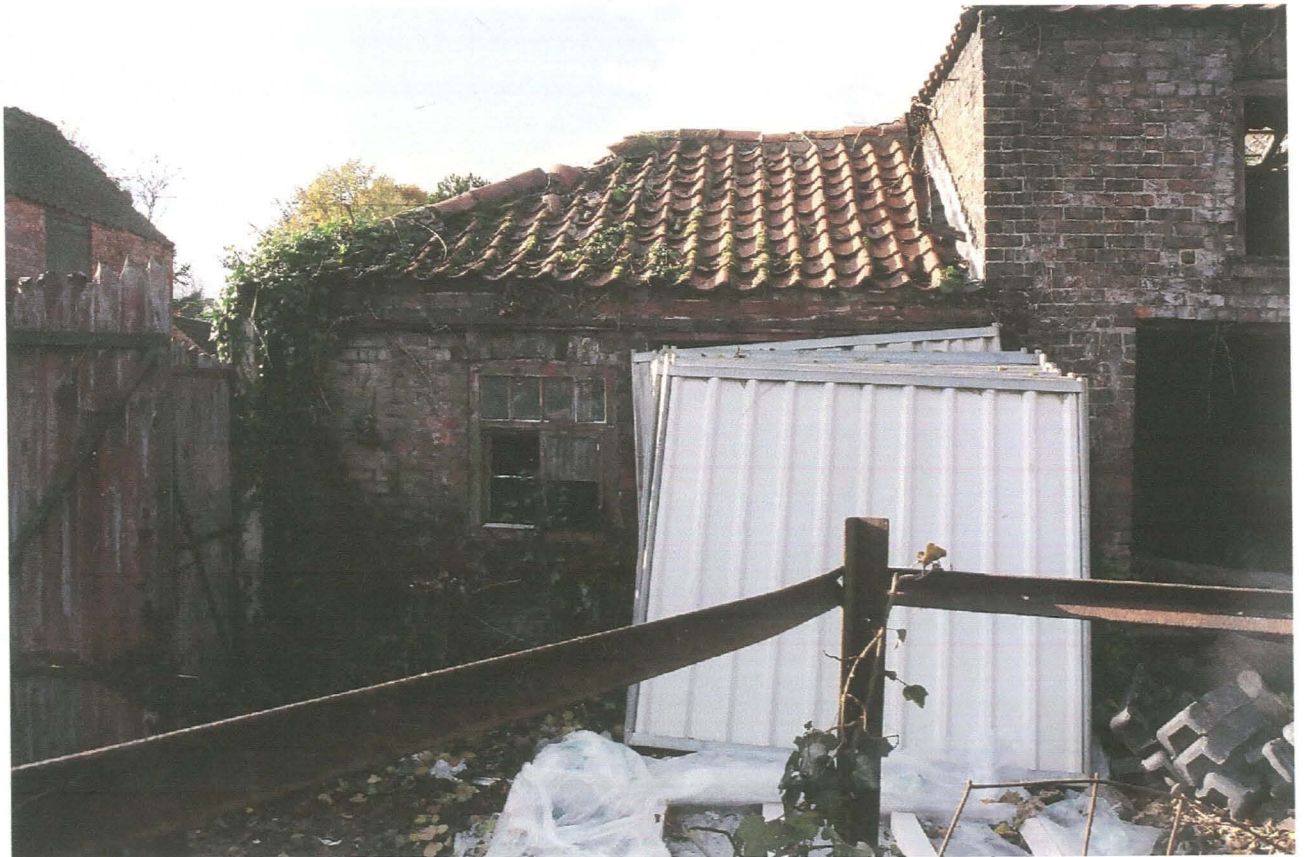
3. A single-storey brick building with a hipped roof was built onto the south gable of Building 2 (Pl. 6). It was constructed with three courses of stretchers and one course of headers, with large red bricks (221mm x 105mm x 70mm) of 19th century date. The large bricks were identified as of nineteenth century date. The external door lintel had been inserted into the south-east corner of Building 2, with a window to the south. There were four lights above in a horizontal-sliding sash window; there was a brick lintel but no true sill. A window on the south gable end, overlooking Bull Lane, survived as a twelve-light window internally, but had been blocked on the external face (Pls. 7 and 8). The building was sub-divided into two rooms, the southern room clad in tongue-and-groove panelling (Pl. 8). It may have provided accommodation for stable boys.

PI. 6 Building 3, east elevation.

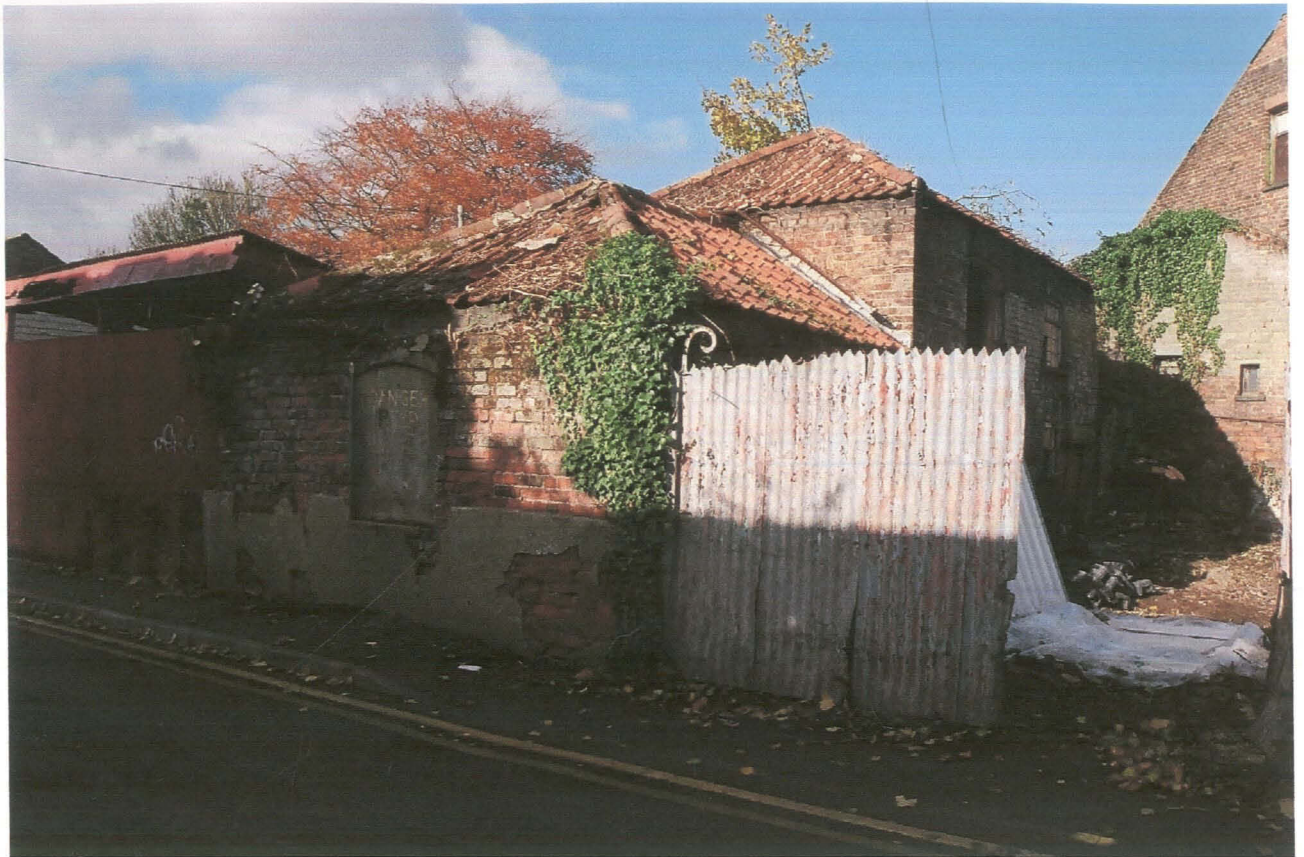
PI. 7 Building 3, south elevation, showing blocked window.

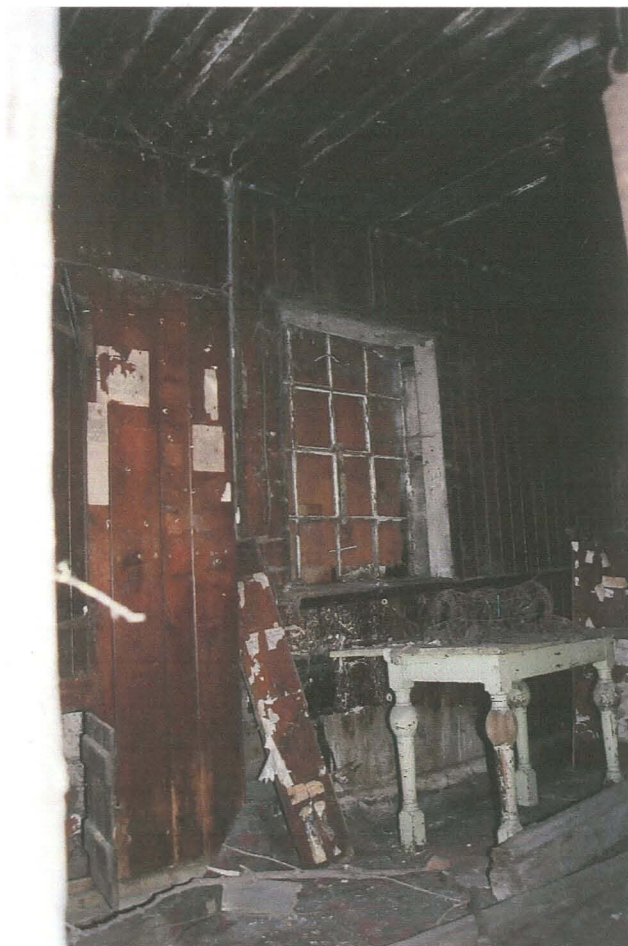
PI. 8 Building 3, interior view looking south showing blocked window and tongue and groove panelling.

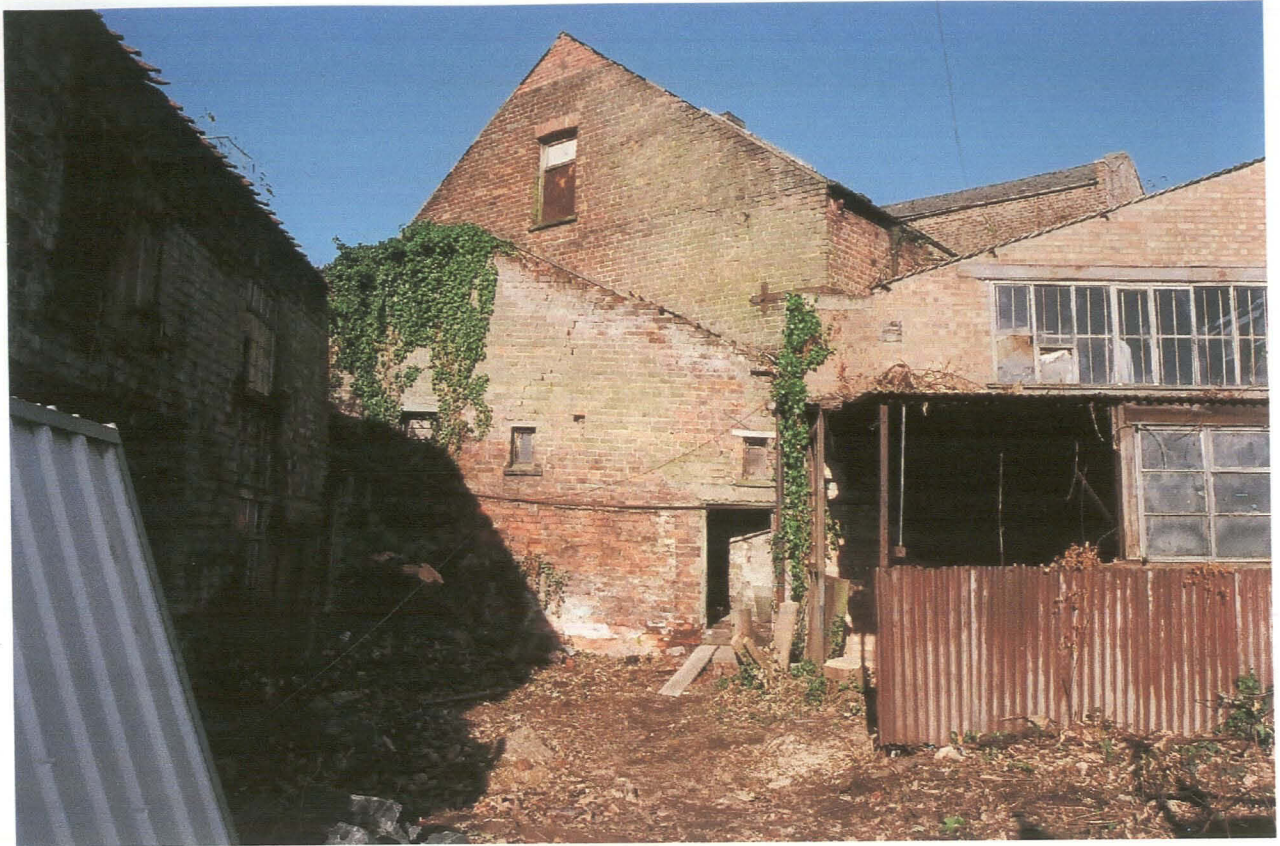
4. This was the gable end of a building superseded by the Corn Exchange (Pl. 9). Part of the west wall of the earlier building had been incorporated into the construction of the Corn Exchange building with no join in the brickwork, which is continuous (Pl. 10). It was butted by Building 1, which was a completely separate structure. The gable end had a low pitched roof, and was presumed to have been a single-storeyed building judging by the roof scar in the southern gable end of the Corn Exchange. However, it may have been lowered when the Corn Exchange was built. No roofing survives *in situ*, but Welsh slate on wood laths attached to collapsed rafters were evidence of its construction. All that remained of this building was a triangular piece at the rear of the later Corn Exchange, comprising two small rooms. There was an inserted door at the south-east angle, with

three small slit windows, one above the door, and two centrally placed below the apex (Pl. 9). If there had been a fourth window, to the west, it had been masked by the internal gable wall of 1 on the external elevation, and by plasterwork internally. The coursing was three stretchers and one header. The large bricks (240mm x 116mm x 74mm) are 19th century in date.

PI. 9. Building 4, with gable end of Corn Exchange to rear, looking north.

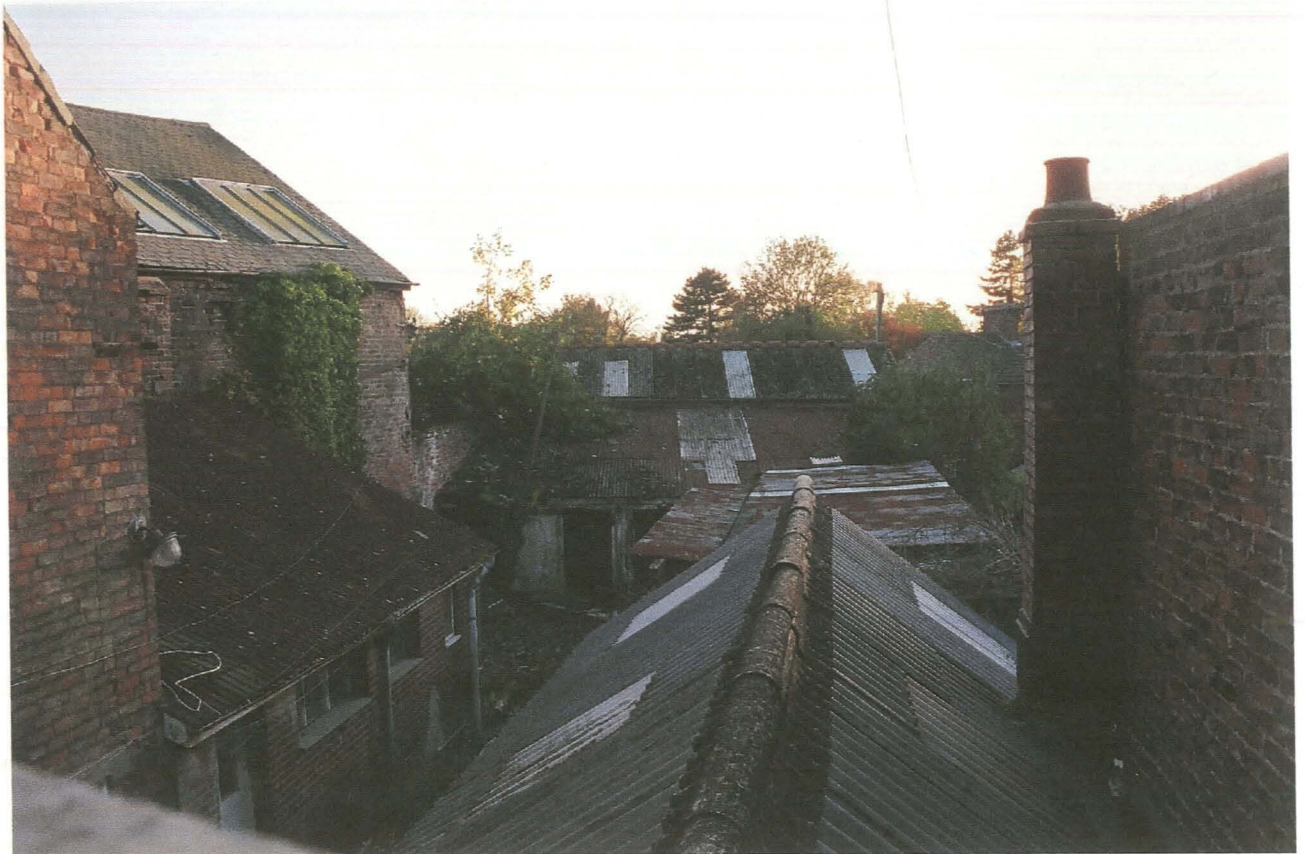
To the west of the buildings described above was a separate yard accessed from Market Street, through Building 11 (see below). The yard contained a series of derelict outbuildings, most recently used as a stonemason's workshop (Pl. 13).

PI. 13 General view of west courtyard looking south towards workshops (Buildings 5 and 6).

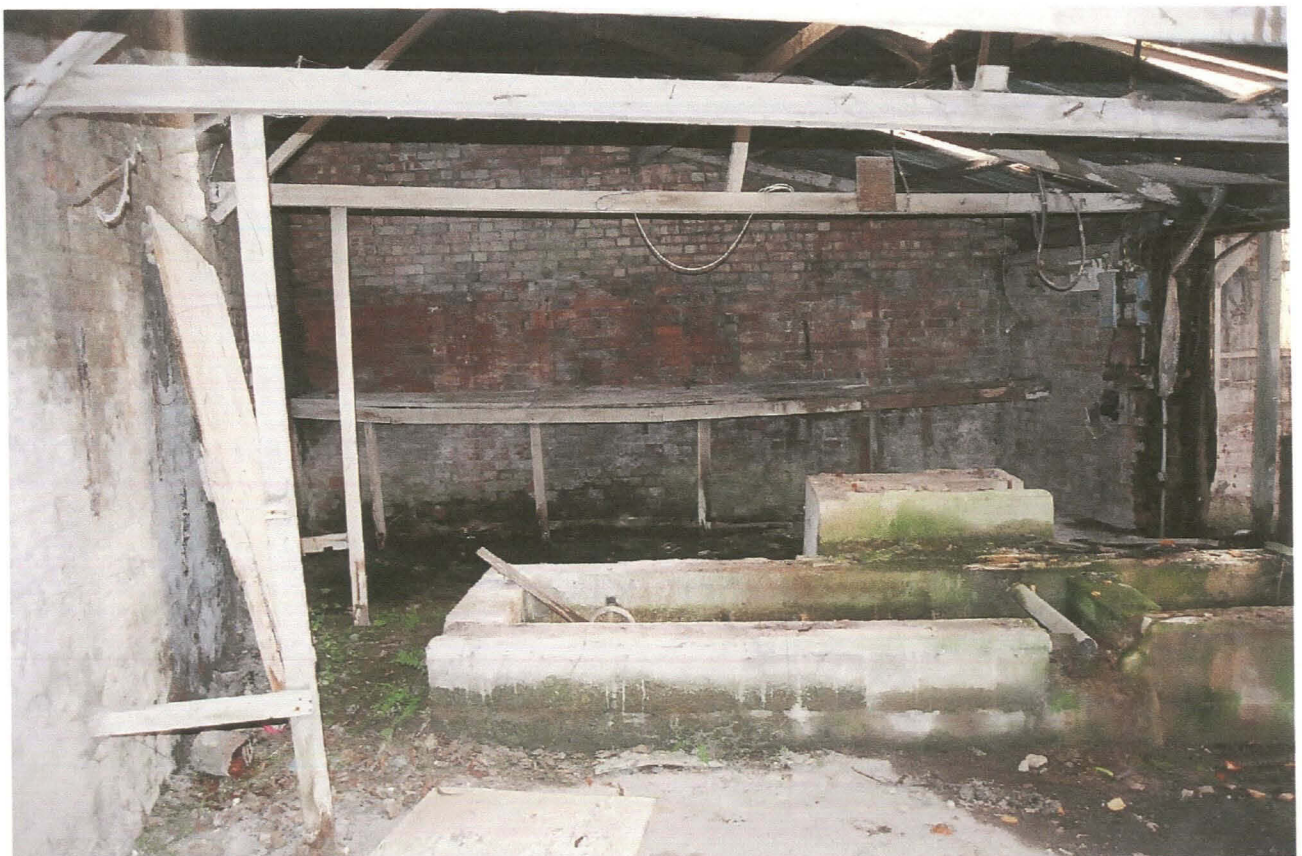
The floor was concreted in two areas, which stepped down 0.08m from the East bay into the central area or bay in which the sawmill was sited (Pl. 14). The sawmill had been constructed from breeze blocks, with a drain leading out of the rear of the building. A work table was positioned along the eastern wall of the lean-to (Pl. 14).

PI. 14 Interior view of Building 5 showing breeze block saw mill, with bench along east wall.

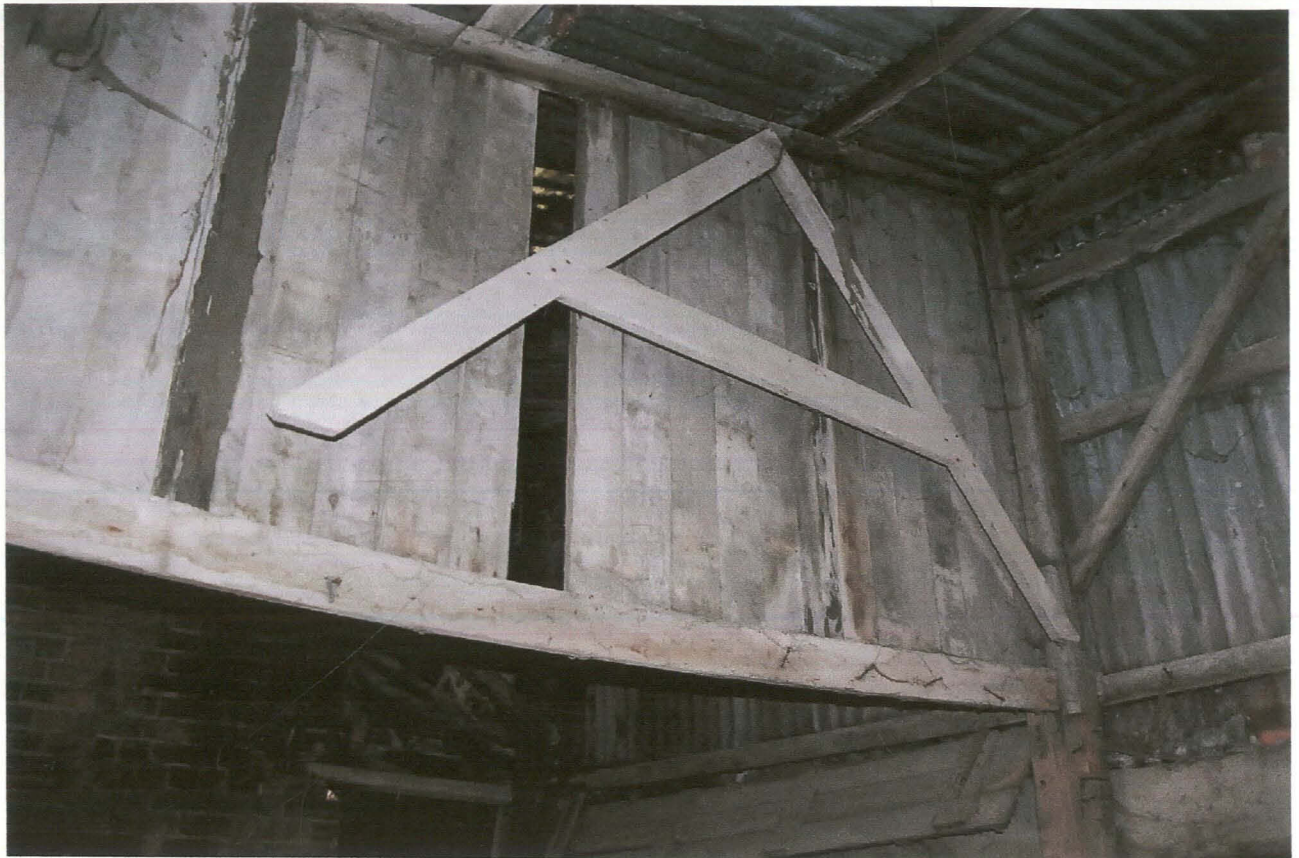
The remains of a timber partition between the East bay and the sawmill area were propped up on a re-used timber, braced at its base. An 'A' square template was hanging on a nail attached to the partition (Pl. 15).

PI. 15 Interior partition wall of Building 5, with A-square template hanging on the wall.

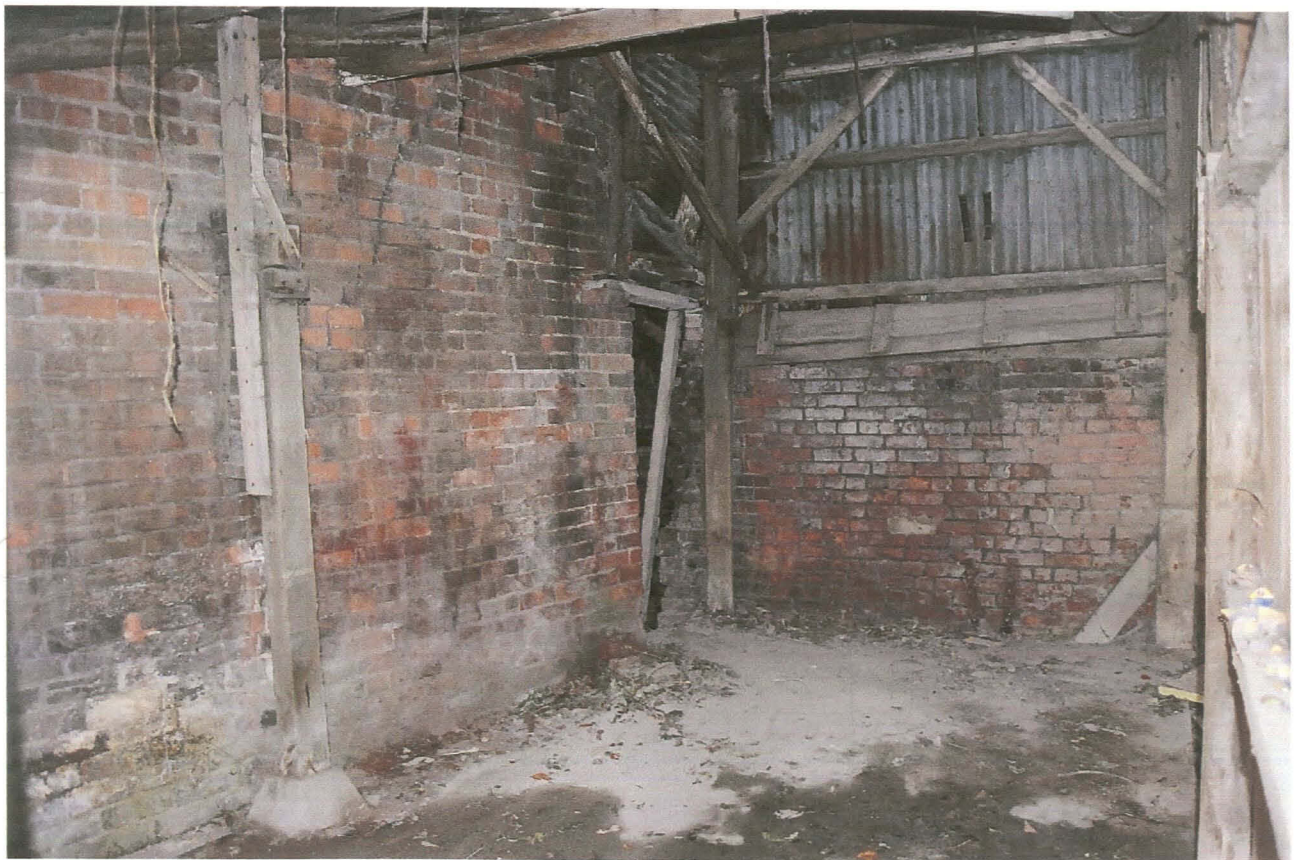
The only access from the yard into the eastern part of the site was through an inserted door in the south-east angle of the workshop, leading into Building 1 (Pl. 16).

PI. 16 Inserted entrance in south-east corner of Building 5 giving access to Building 1.

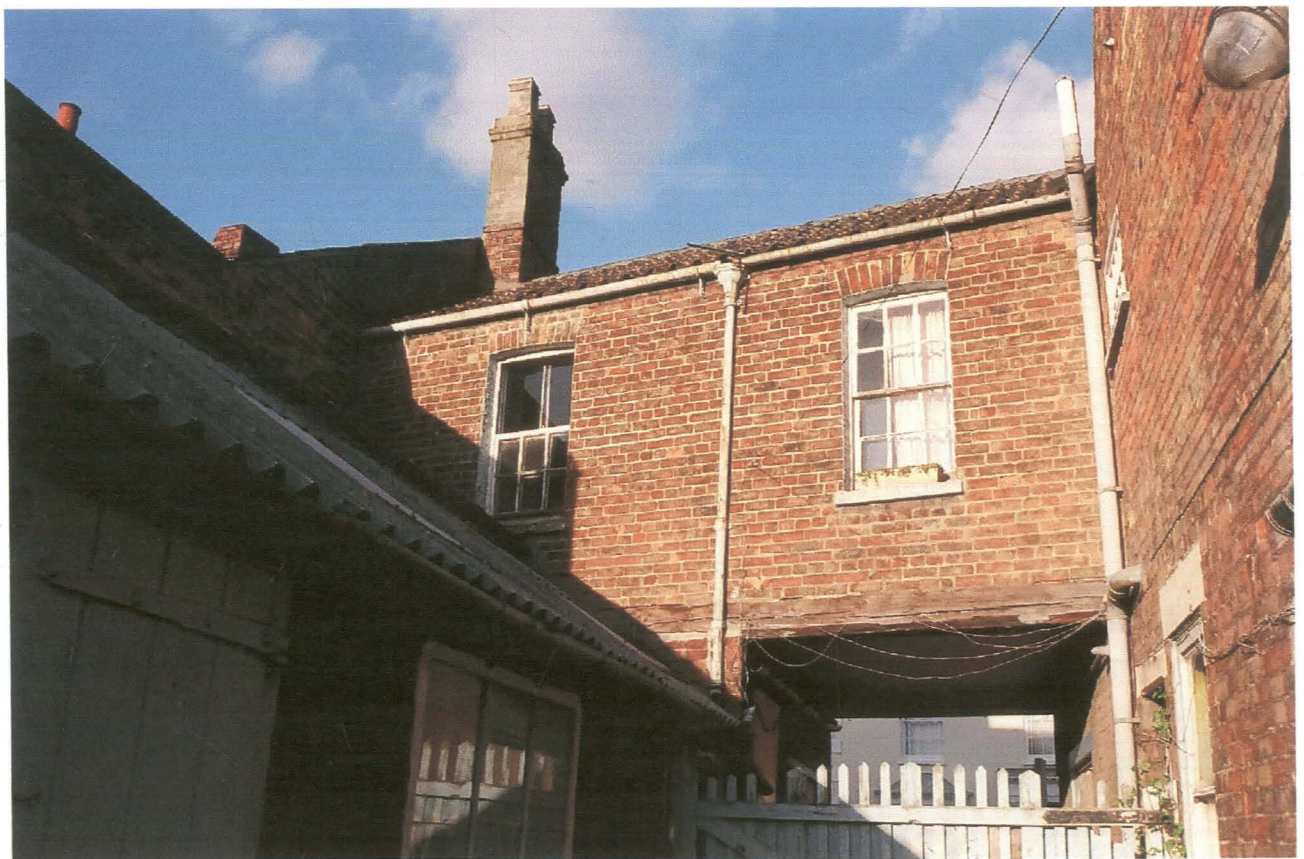
The rear elevation was mainly masked to the west by 10 and 8, and to the east by 9 (Pl. 32). The pitched pantile roof was aligned west-east, parallel to the street but at an angle to the rear extension. The original gutter and downpipe was present. At first floor level were two windows, with brick lintels and stone sills. Both were original, although the upper panel had been replaced in the west window. They had a vertical sliding sash; each half had eight lights. There was a stack at the west end of the building, and this part of the property may have been eighteenth century in date.

PI. 32 Building 11, south elevation, masked by Building 10 to left and Building 9 to right.

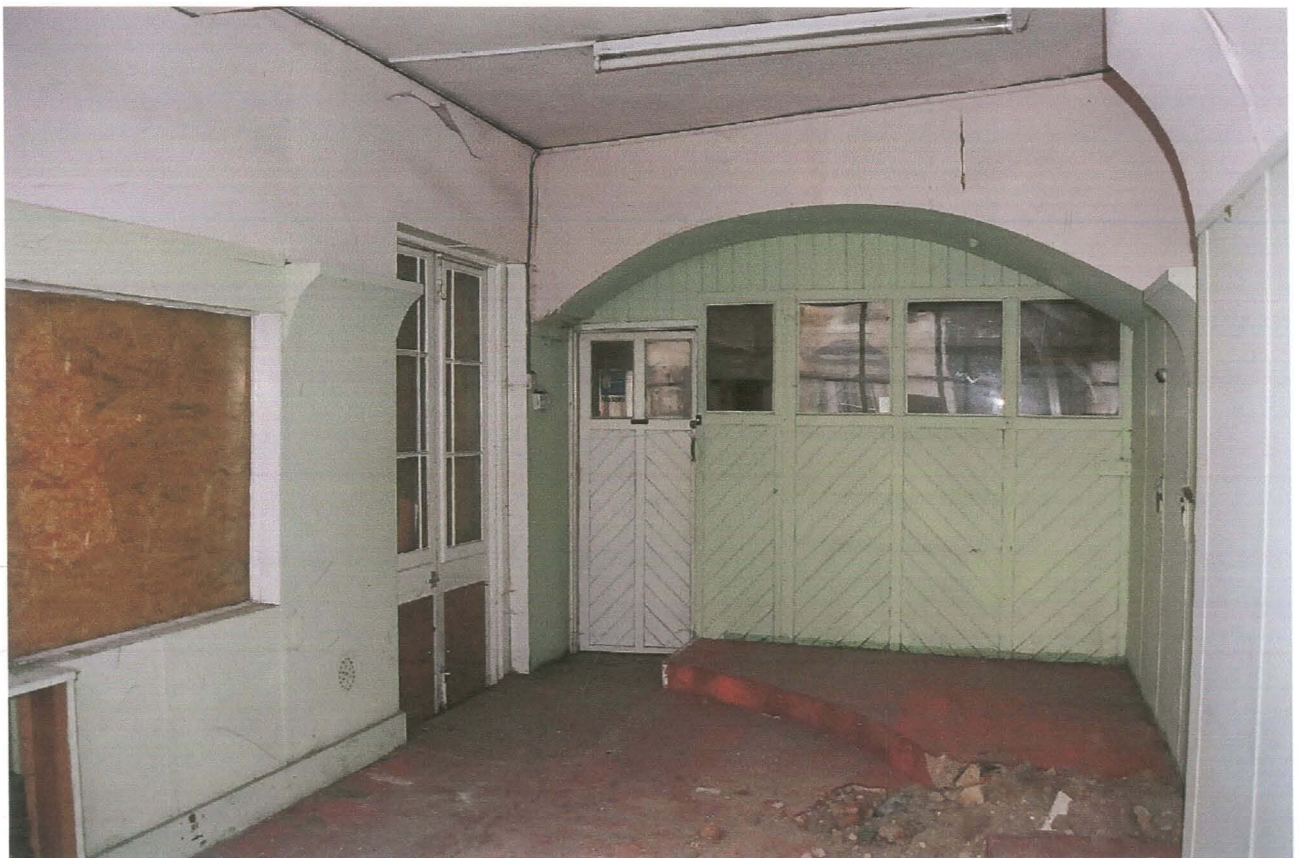
PI. 34 Building 11. Ground floor, east room, showing hardboard cladding concealing brick arch, with French windows in east elevation. Looking south.

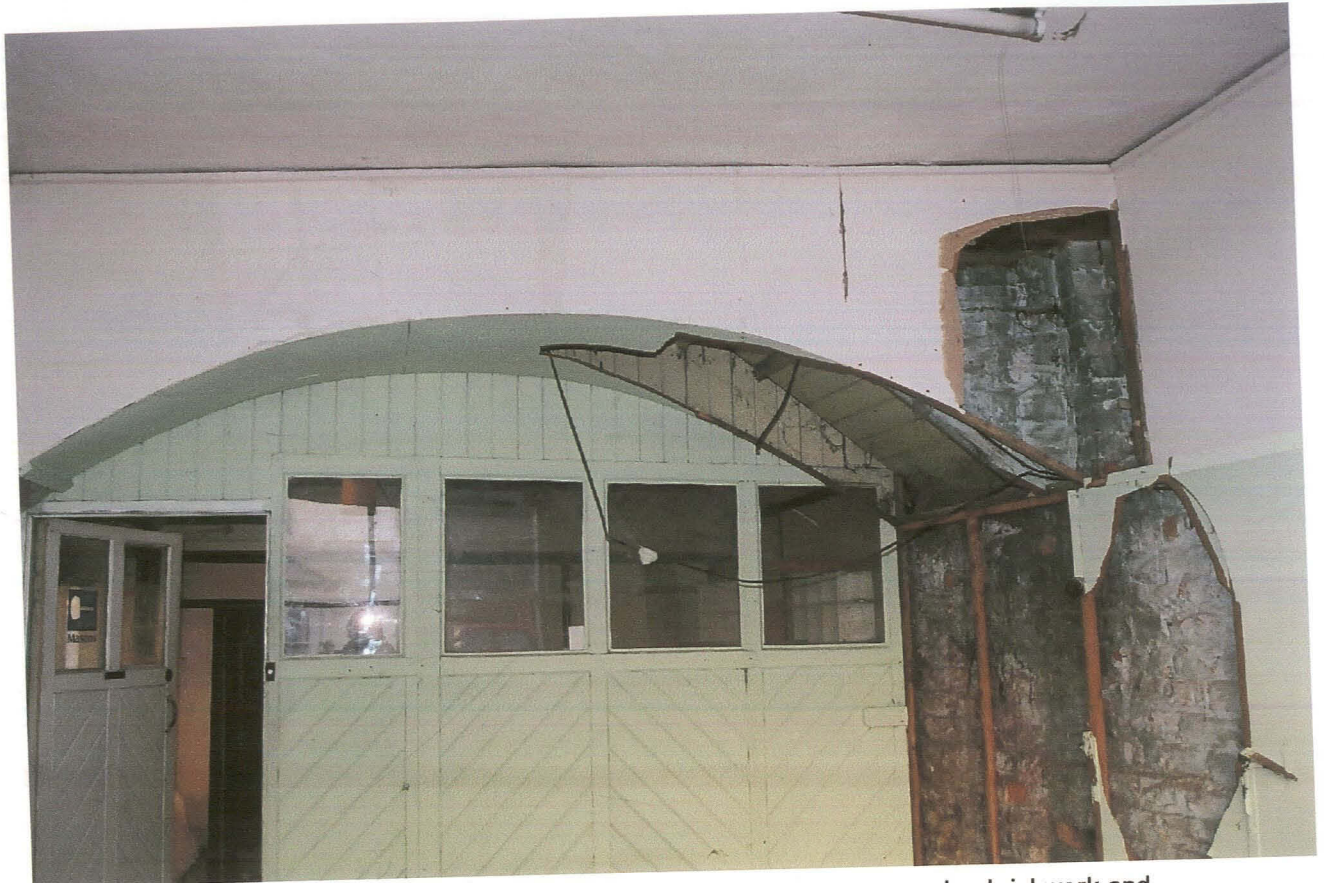
PI. 35 Building 11. Ground floor, east room, after removal of cladding, exposing brickwork and base of first floor fireplace.

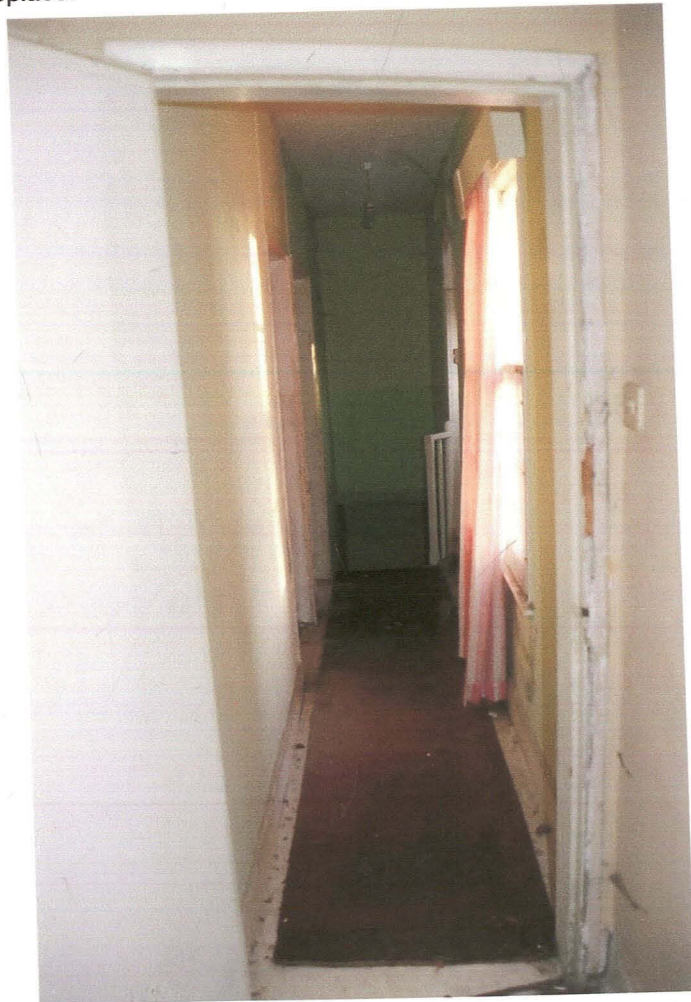
At first floor level, the stair on the east side of the building led to a corridor along the rear of the building which led to three rooms overlooking the Market Street frontage (Pls. 30 and 36). The roof was leaking above all the rooms, and was in an unsafe condition. The east bedroom had a nineteenth century fireplace, with an internal stack and alcoves to either side (Pl. 37). The original window was overlooking the frontage, with a vertical sash in two halves, each with six lights. The middle room had been converted to a kitchen, but its original window remained, as in the eastern room (Pl. 38). The doors were original and panelled, with plain bakelite handles. The west bedroom retained original windows to both front and rear (Pl. 39). There was a 1950s fireplace with an internal stack, and alcoves to either side. The door was clad in hardboard.

PI. 36 Building 11, first floor corridor, looking west.

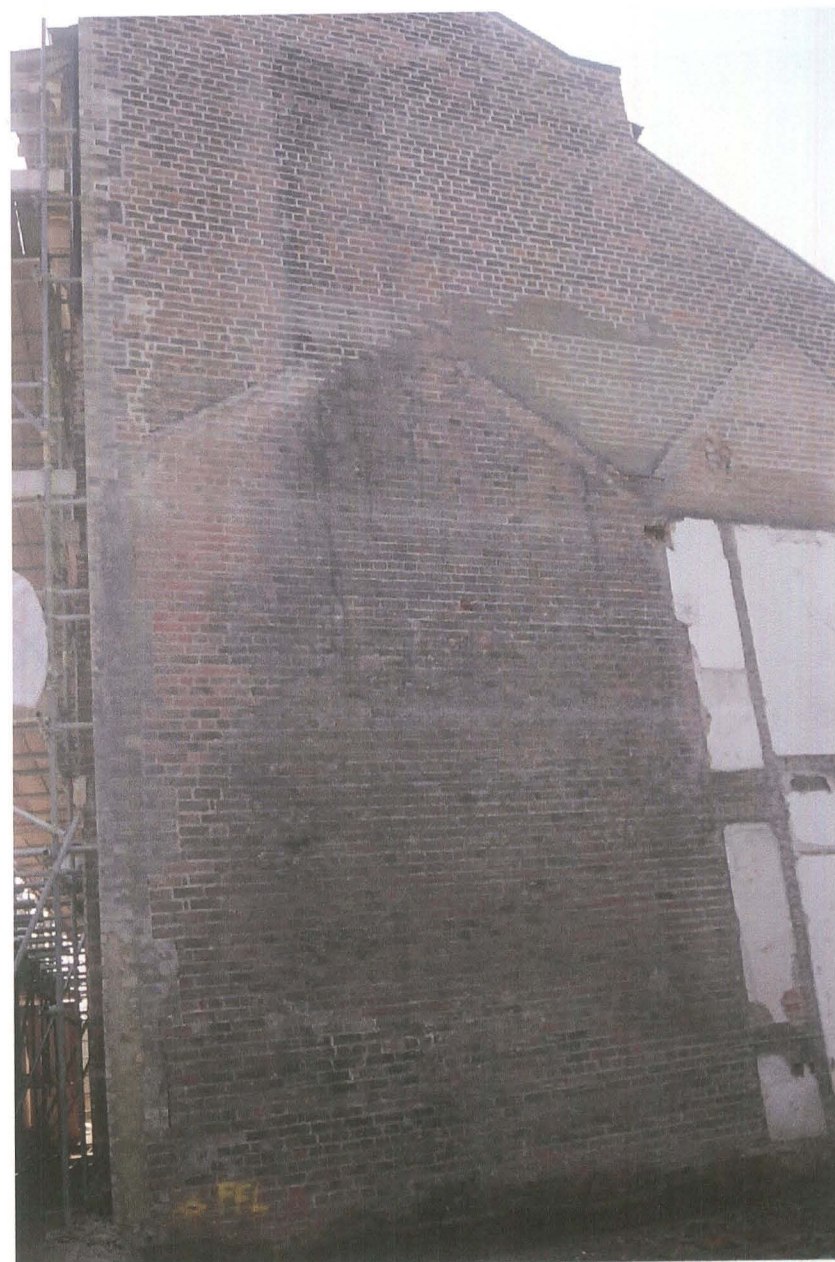
The Market House/Corn Exchange was built in 1856, and waste from the York Stone architectural embellishments was incorporated into the cellar foundations of No. 11 Market Street. The finishing of the western gable end of The Market House indicates that it was constructed before No. 11, but the presence of available construction debris suggests that No. 11 was constructed shortly afterwards. No trace of similar debris was associated with the early element of No. 13. The Ordnance Survey 1889 1:10,560 map indicates that No. 11 Market Street had been built by then.

Pl. 40 Western gable end of the Market House, showing the outline of the demolished No. 11 Market Street (looking east).

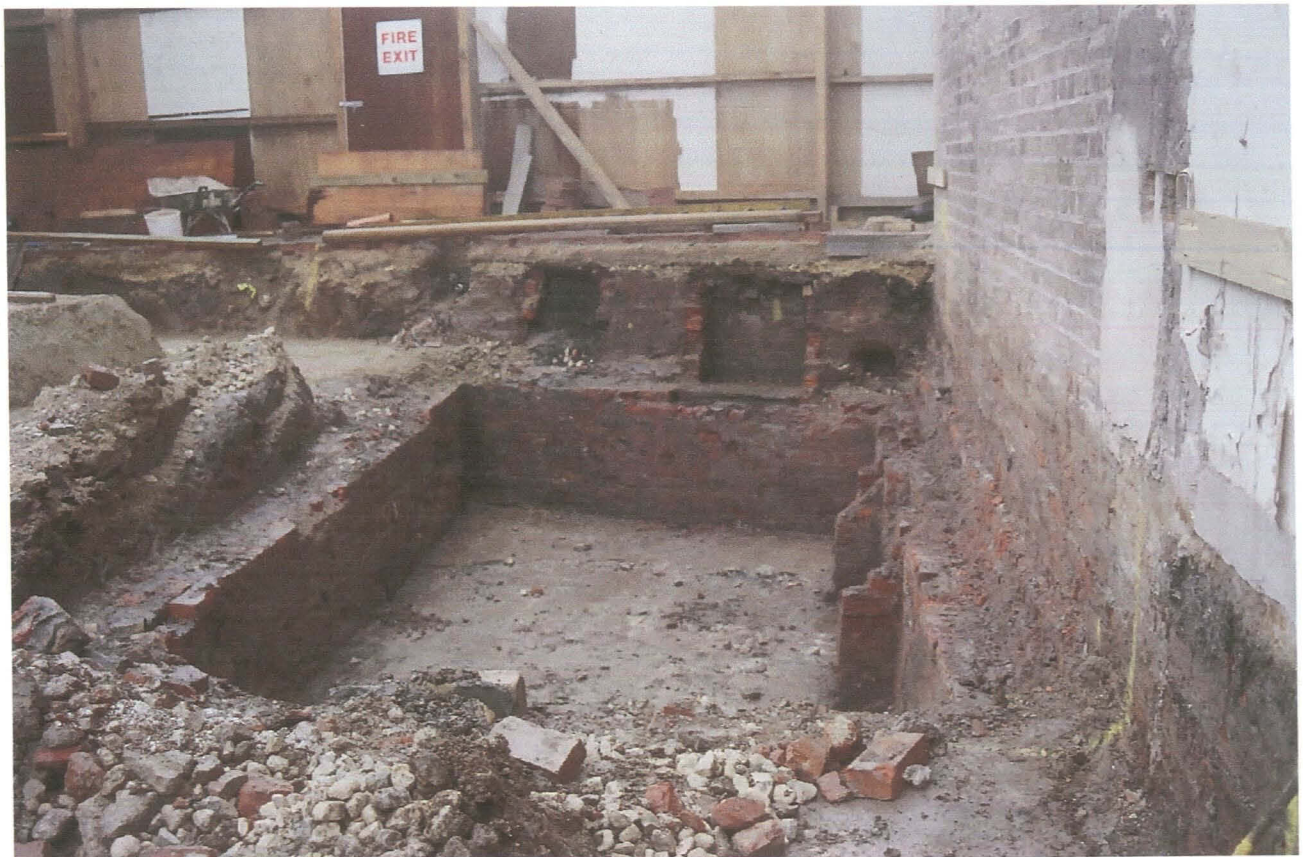
This 3.6m wide house had been constructed alongside the existing Market House. The external wall of the Market House had been well pointed, which would only have been possible before No. 11 was built. The 1.5 brick wide foundations of No. 11 were constructed with frogged red bricks, with dimensions of 240mm x 120mm x 72mm, and bonded with a grey ashy mortar, with a row of stretchers alongside a row of headers. The area within the foundations contained loose brick rubble with fragments of inscribed marble from the monumental masons' business. This rubble backfilled a cellar, which was emptied at a later stage (Pl. 42).

PI. 42 Cellar below No. 11 Market Street (looking north).

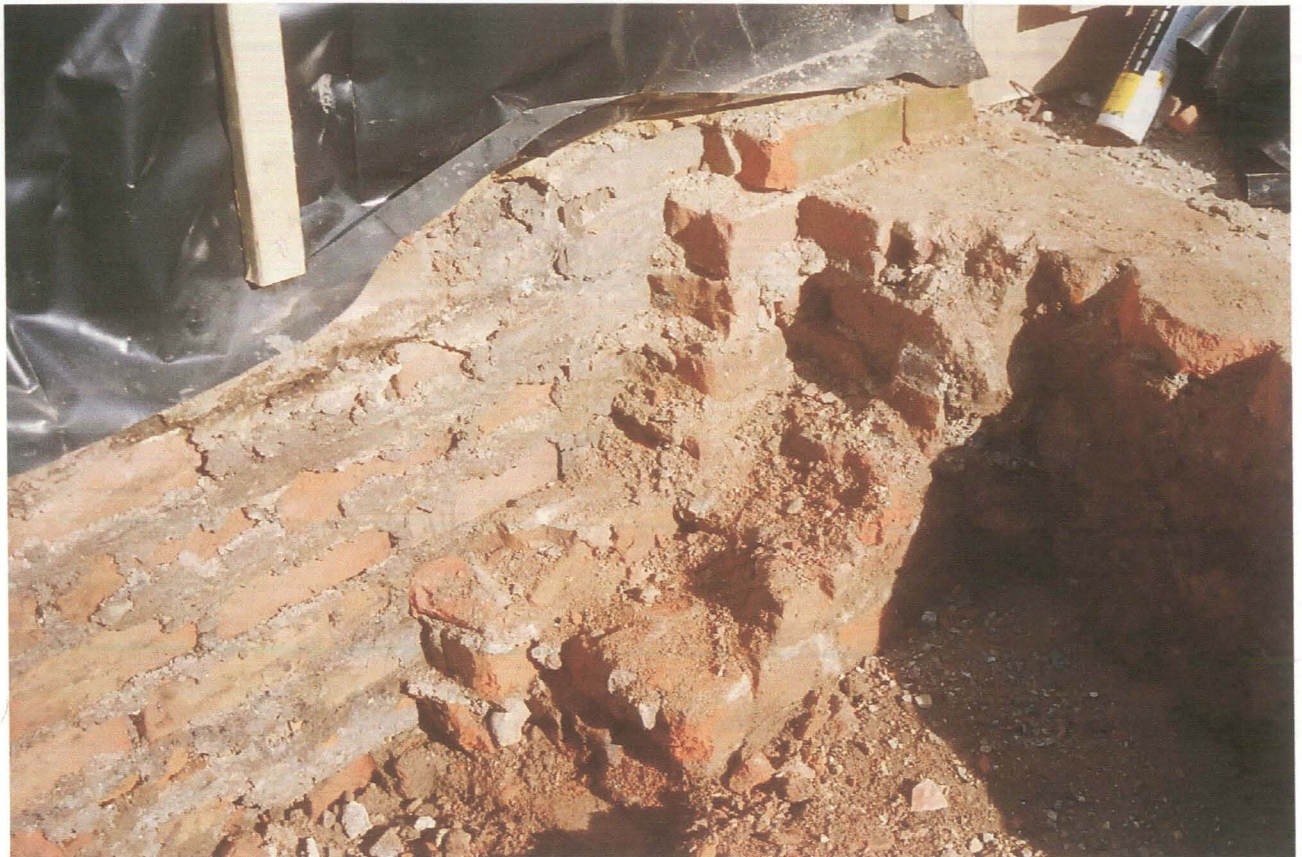
This property was 4.95m wide at the street frontage, slightly narrower to the rear. The foundations of the front room of No. 13 Market Street were 2.5m to the west of No. 11, and the front, eastern and western wall foundations were constructed with similar bricks (dimensions of 240mm x 120mm x 72mm) and used the same grey ashy mortar and bonding pattern. The adjacent building, No. 15, had been built with its foundations riding over those of No. 13 (Pl. 45).

PI. 45 Brick foundations for western wall of No. 13 Market Street, abutted by later wall of No. 15 Market Street (looking west).

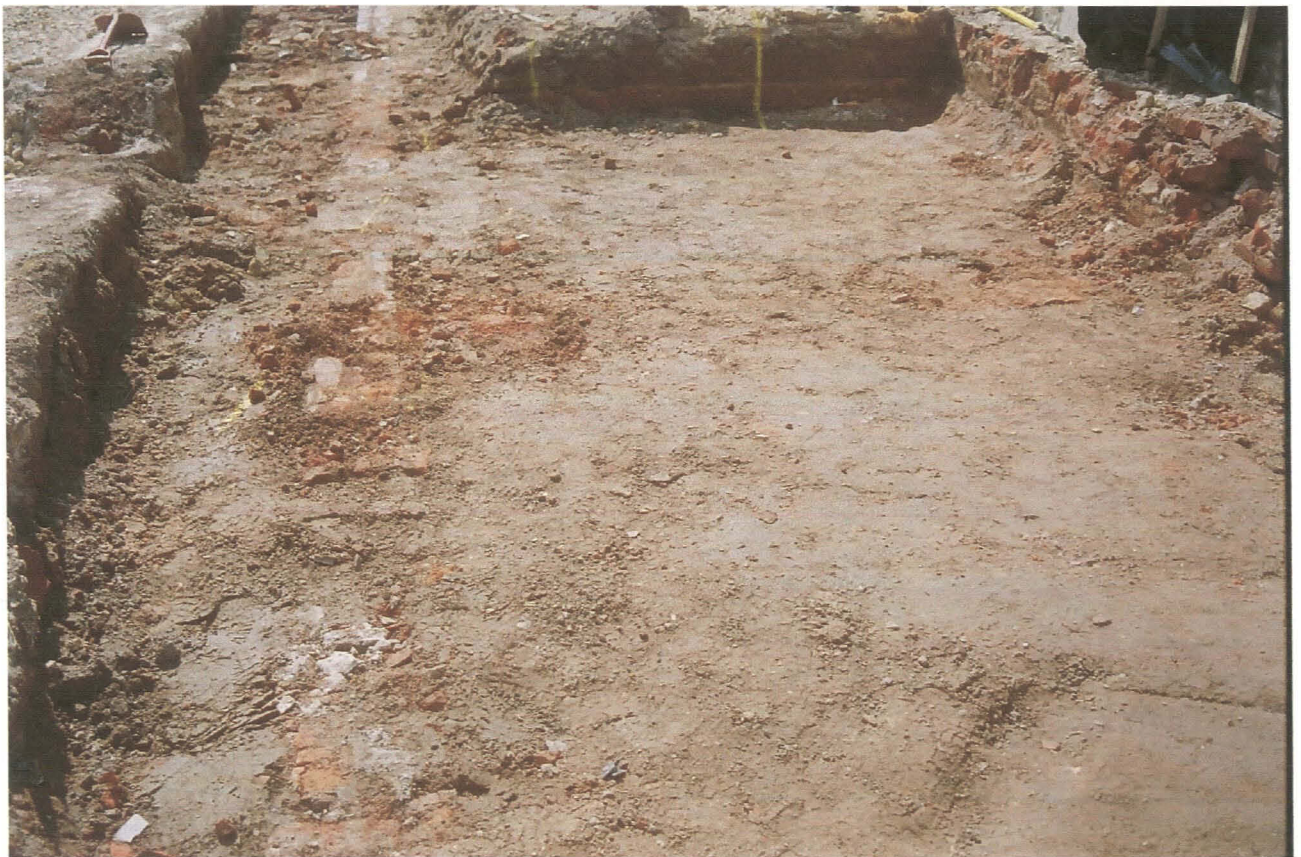
No. 13 had no cellar, and the ground behind the frontage wall foundation was silt. Examination of the foundations showed that the front room was a later addition to the original brick property, which had been set back about 4m behind the street frontage (Pl. 46). The ground in front of the original building had probably been a garden.

PI. 46 Reduced surface below No. 13 Market Street, showing the brick internal wall foundation, formerly a front wall (looking south).
