**Market House, 11-13 Market Street,
Long Sutton, Lincs.**

Archaeological Building Survey and Watching Brief

LAS Report No. 773

October 2004

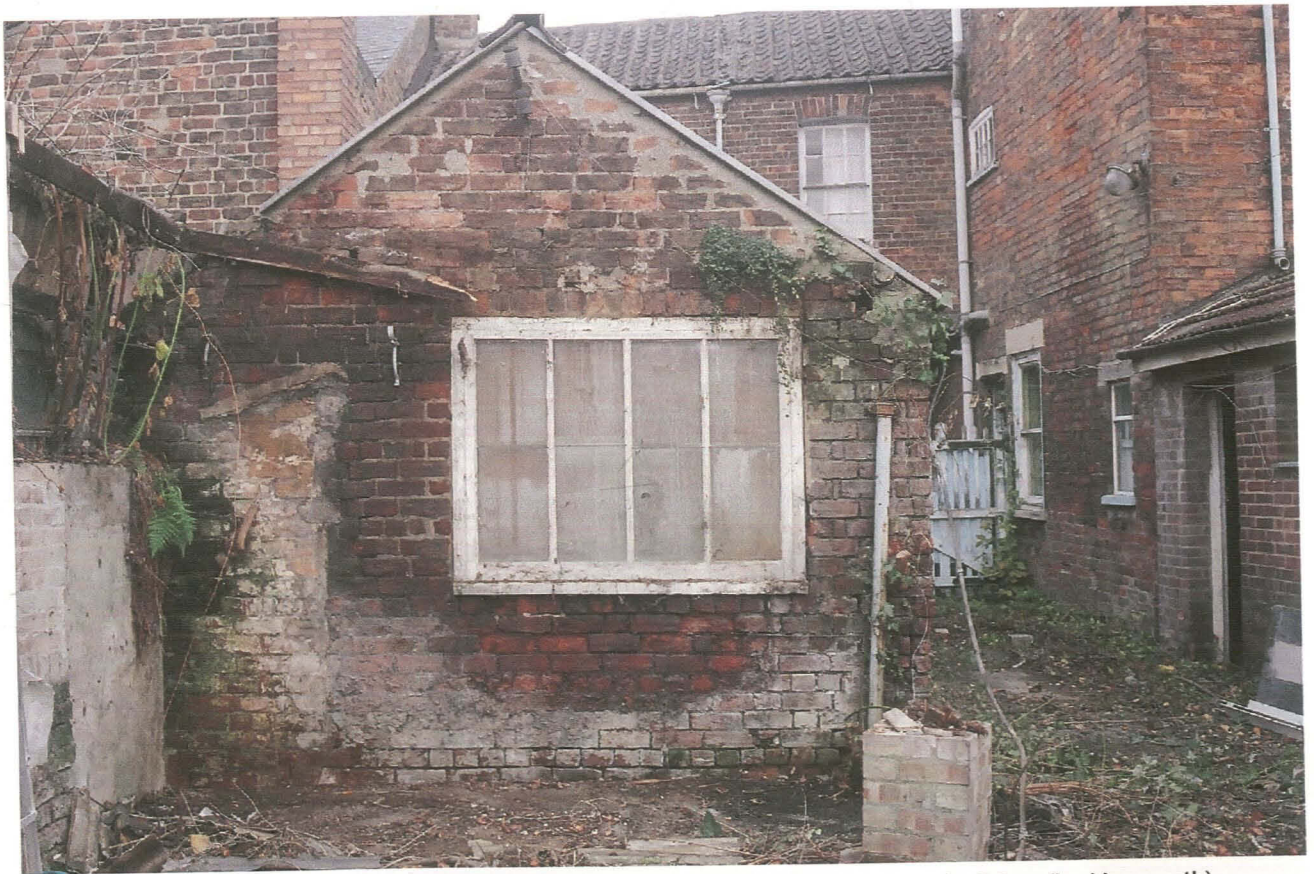
PI. 50 Rear wall of No. 13 Market Street, showing scar of demolished lean-to building (looking north).

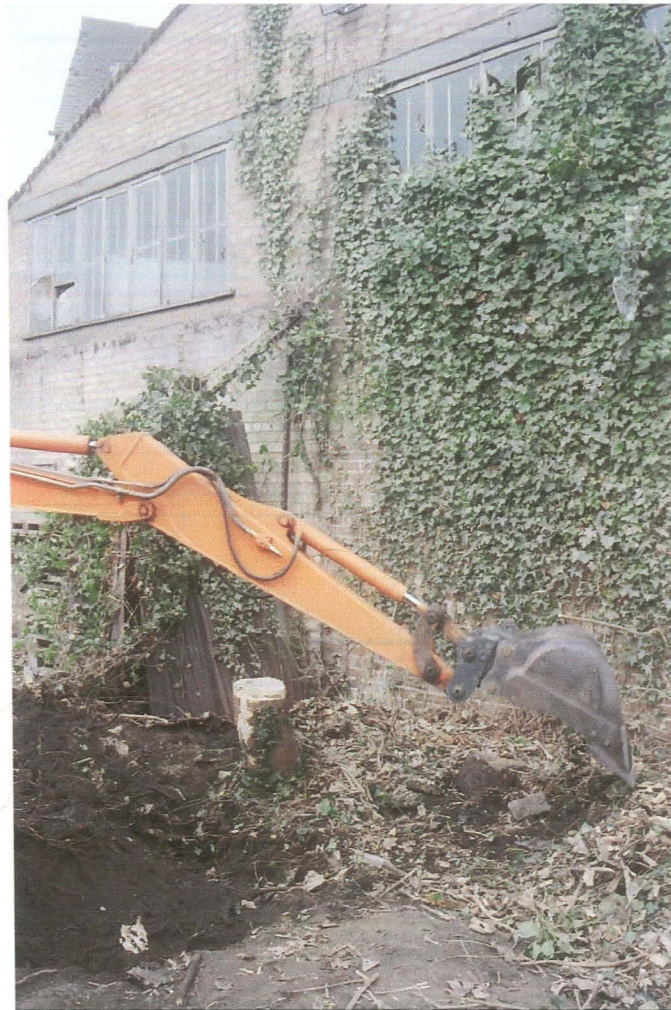
The rear wall of No. 7 Market Street (the former Shell service station) is of mid-late twentieth century build, but a short section of older boundary wall behind No. 5 Market Street (with brick dimensions of 220mm x 110mm x 62mm) contains evidence of an earlier wall, either on a different alignment or extending further towards Bull Lane (Pl. 52). Below ground level, a single brick thick foundation (context 54) was found 6m to the SW of that join (Fig. 3). The foundation was aligned NW-SE, with brick dimensions of 210mm x 105mm x 70mm (Pls. 53 and 54).

PI. 53 Location of buried wall foundation, behind No. 7 Market Street (looking north-west).

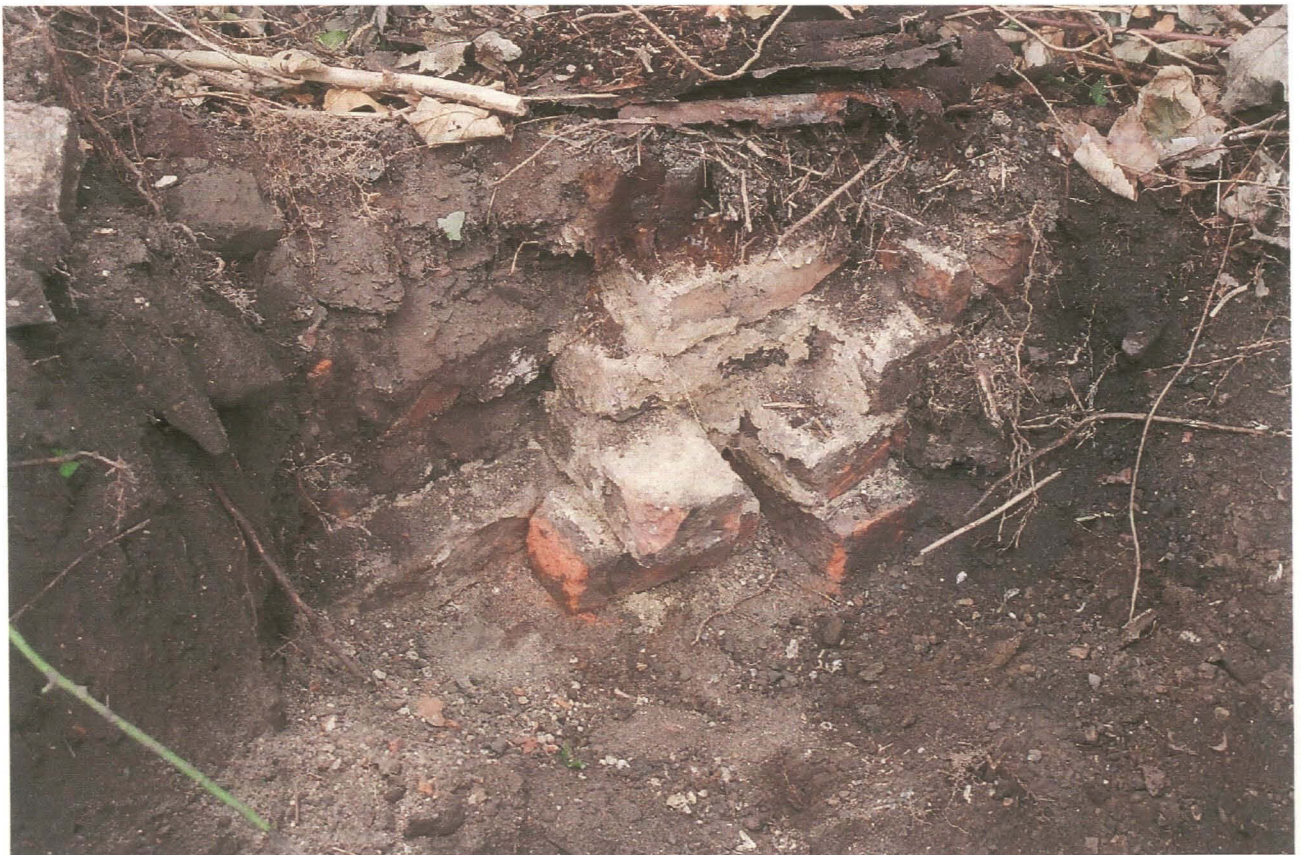
PI. 54 Buried wall foundation to rear of No. 7 Market Street.
