THE OLD RISING SUN HAGWORTHINGHAM

Building Recording

Beryl Lott,
Lincolnshire County Council
August 2001

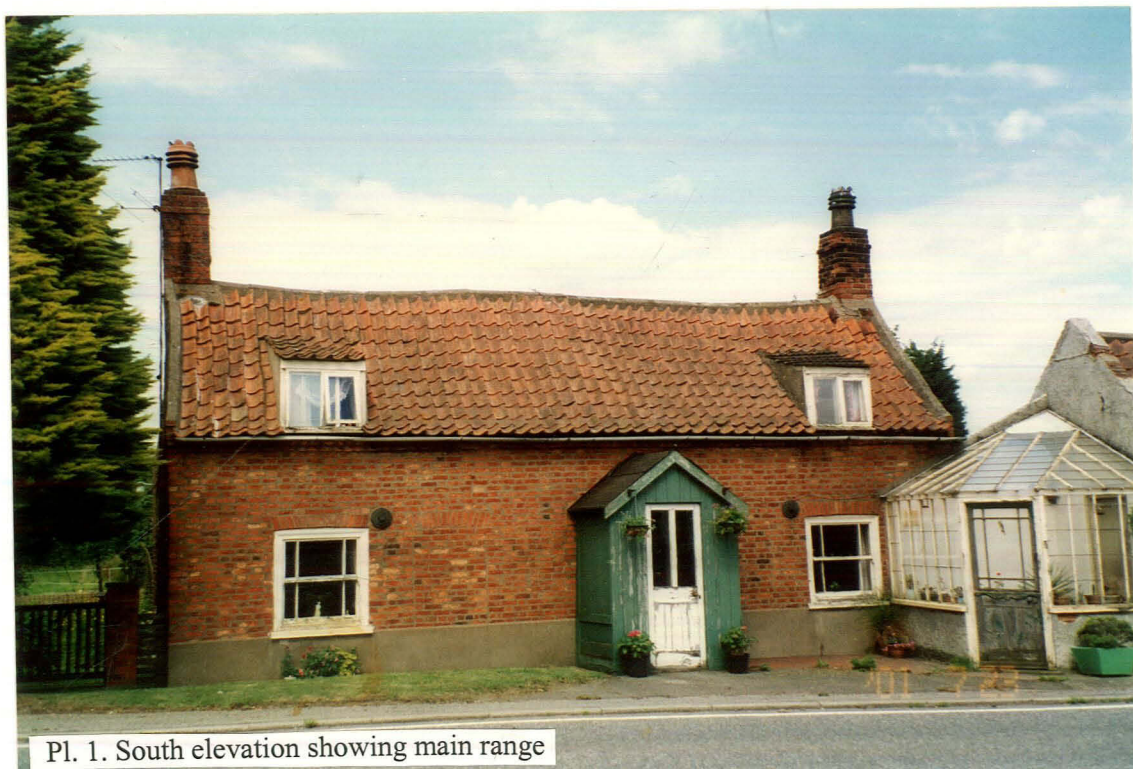
Pl. 1. South elevation showing main range

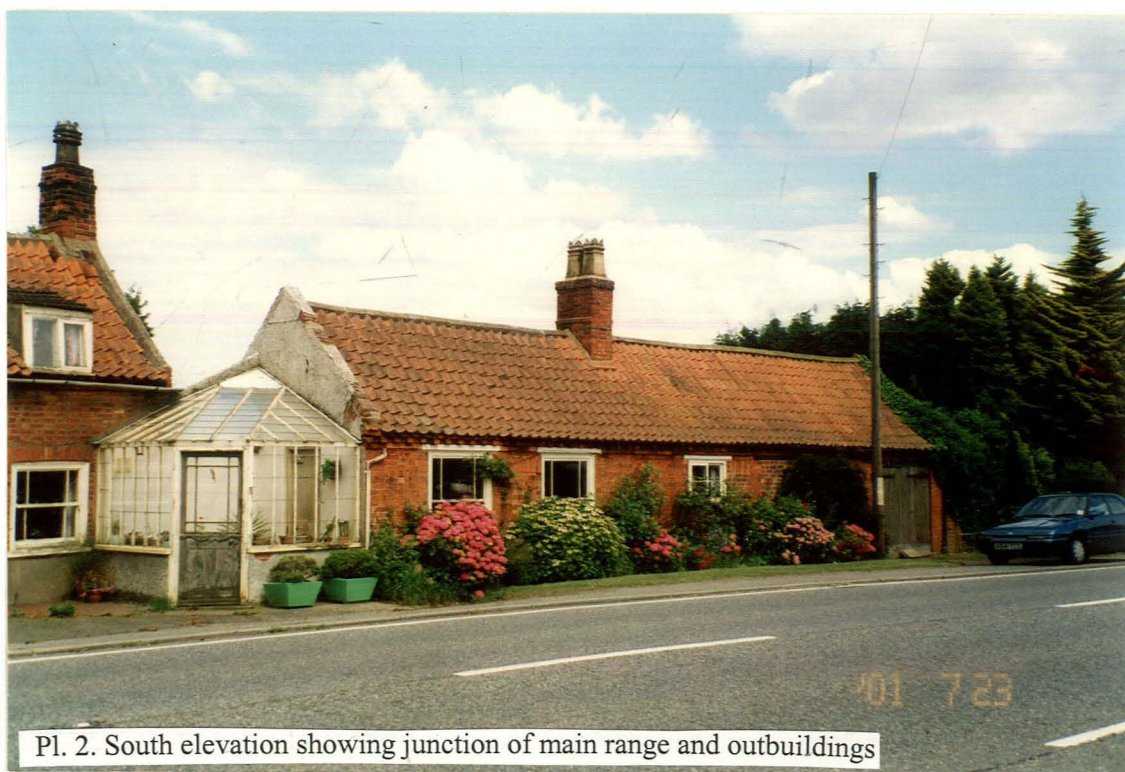
Pl. 2. South elevation showing junction of main range and outbuildings

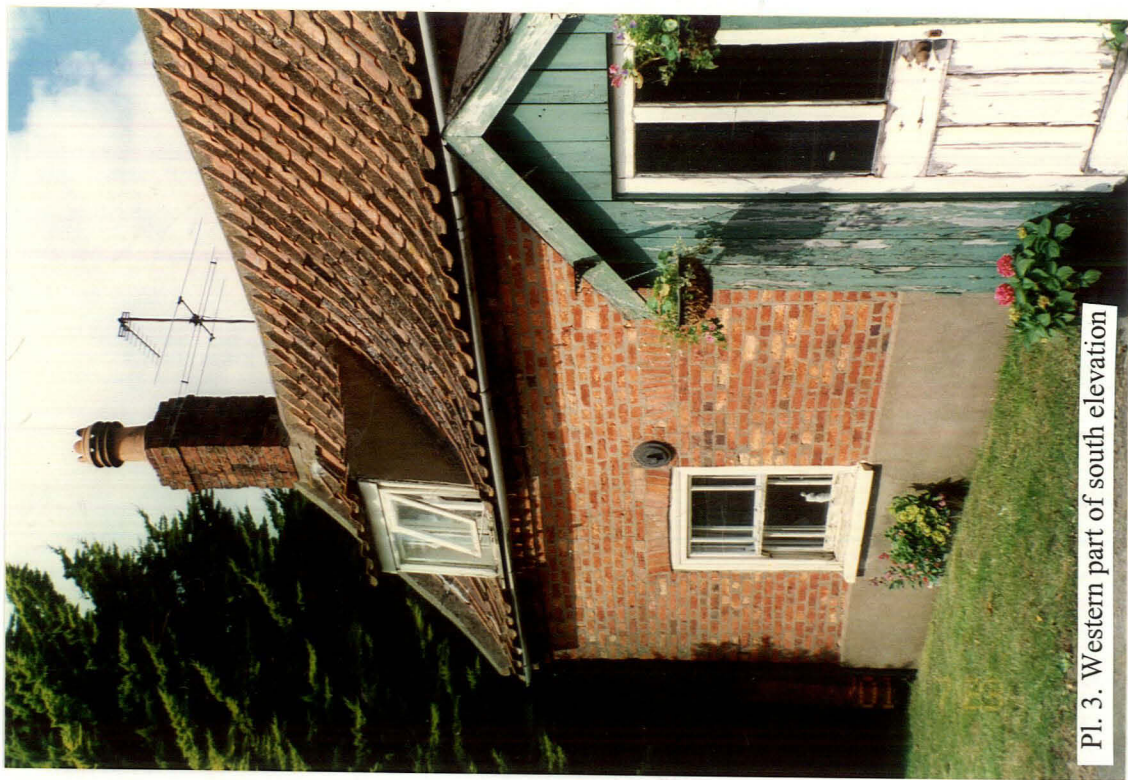
Pl. 3. Western part of south elevation

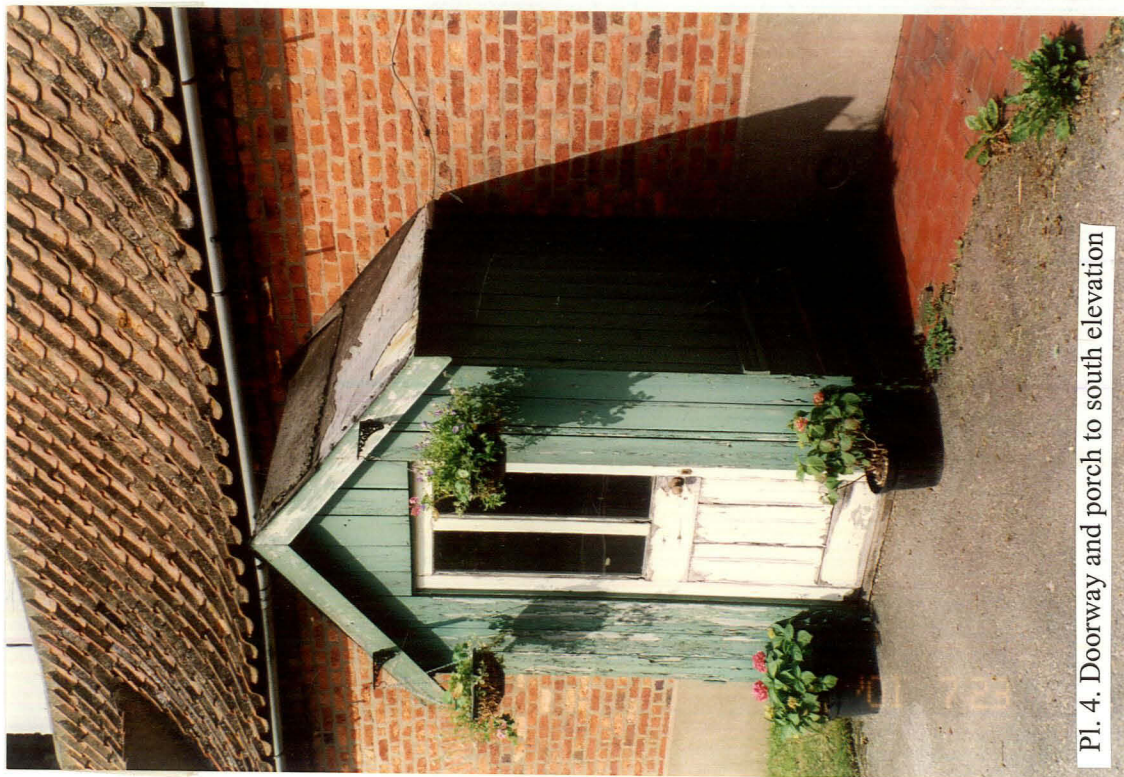
Pl. 4. Doorway and porch to south elevation

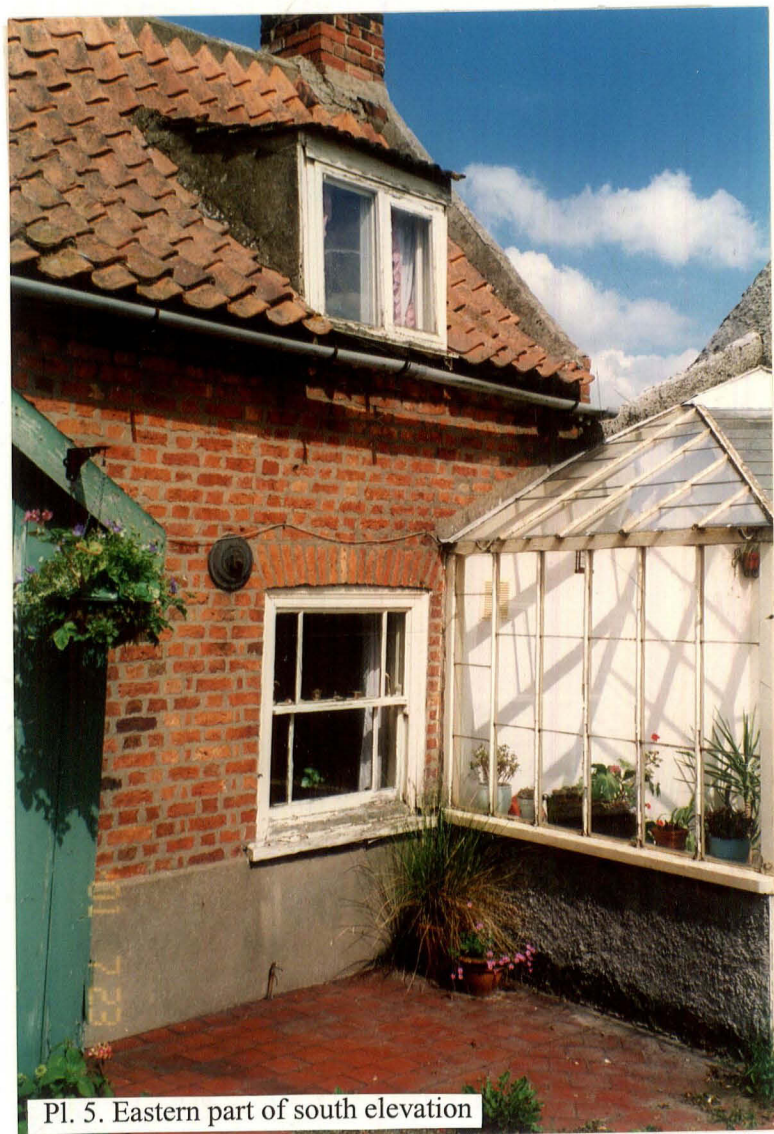
Pl. 5. Eastern part of south elevation

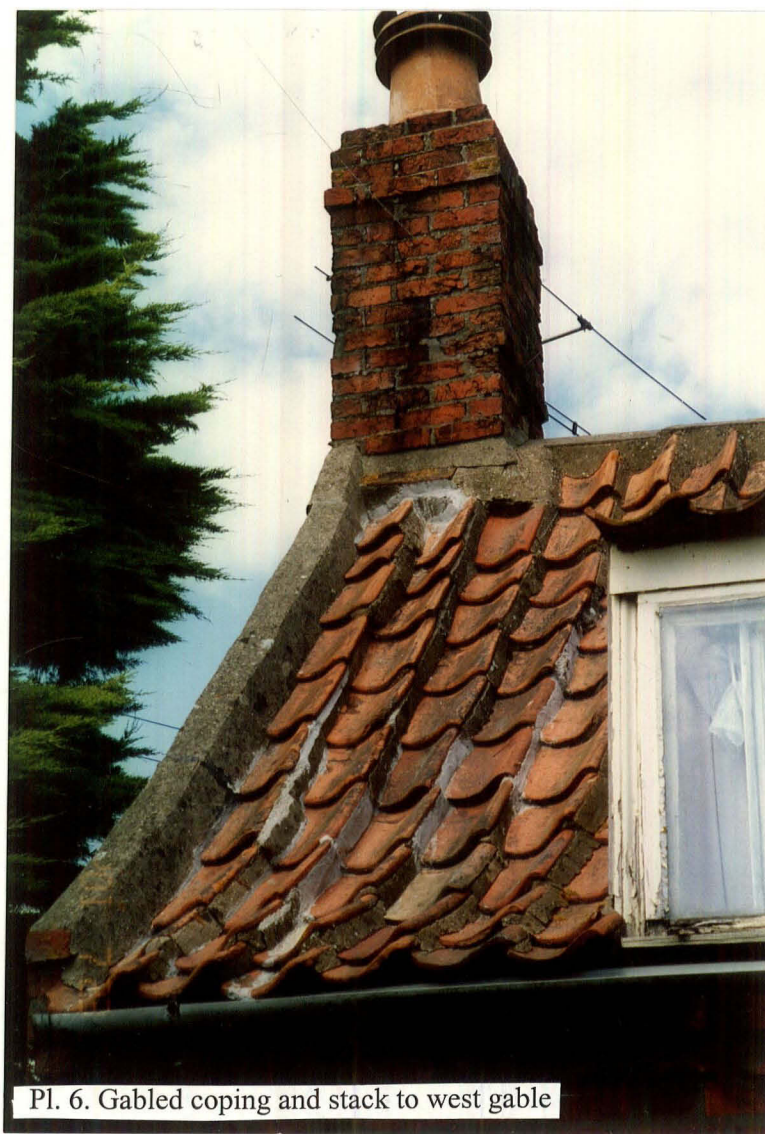
Pl. 6. Gabled coping and stack to west gable

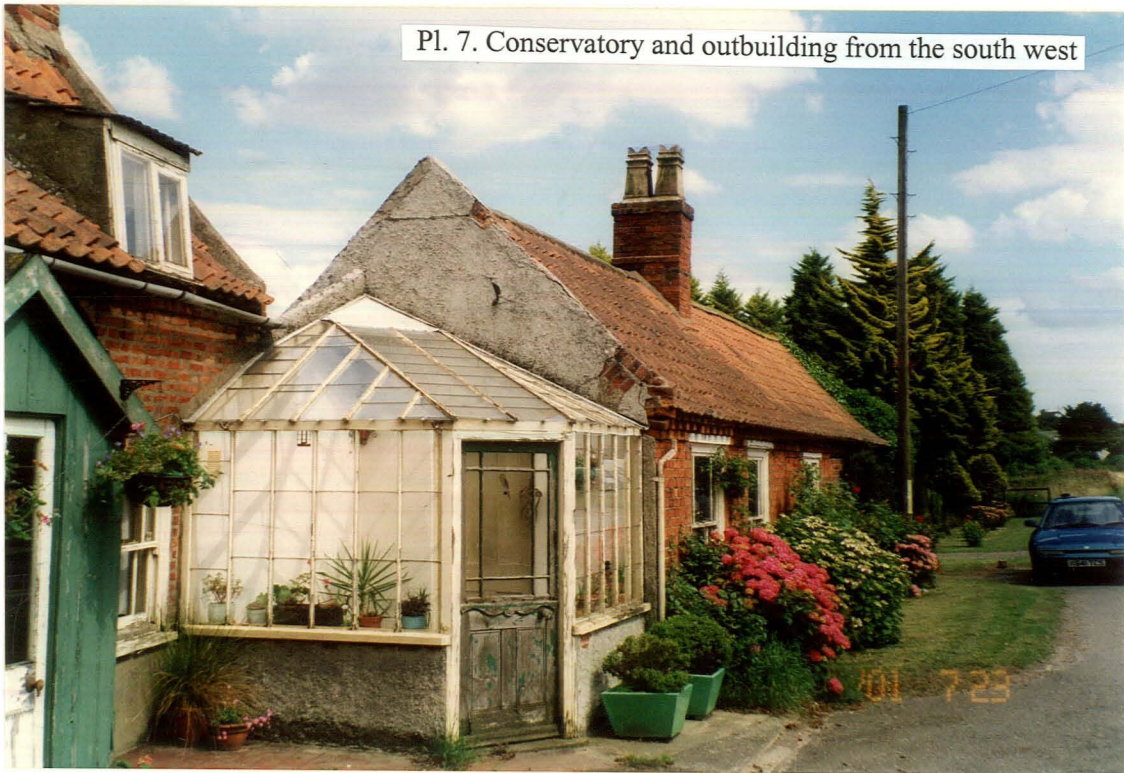
Pl. 7. Conservatory and outbuilding from the south west

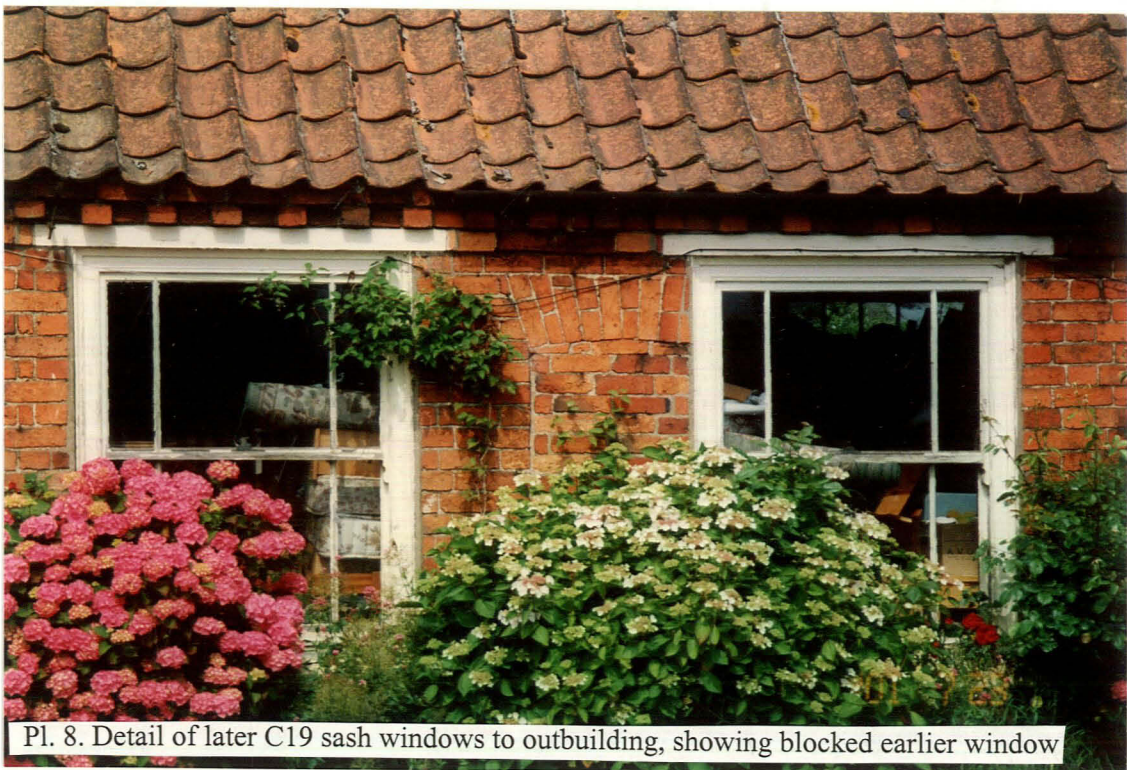
3. More changes were made in the later 19th century. The lower windows to the front of the building date to the late 19th century on their style and they probably replaced earlier small pane sashes or horizontal sliding sashes. New large windows of a similar style were inserted into the outbuildings at this time which would have converted them to a more domestic nature and the conservatory linking the two buildings is also of similar style and gives separate access to the newly created room. This was also accessed directly from the main house by a new corridor created between the adjacent corners. This would appear to create a room which had separate external access and which was serviced from the main house. These would conform with the idea that this end of the outbuildings was converted to a saloon for an alehouse.

Pl. 8. Detail of later C19 sash windows to outbuilding, showing blocked earlier window

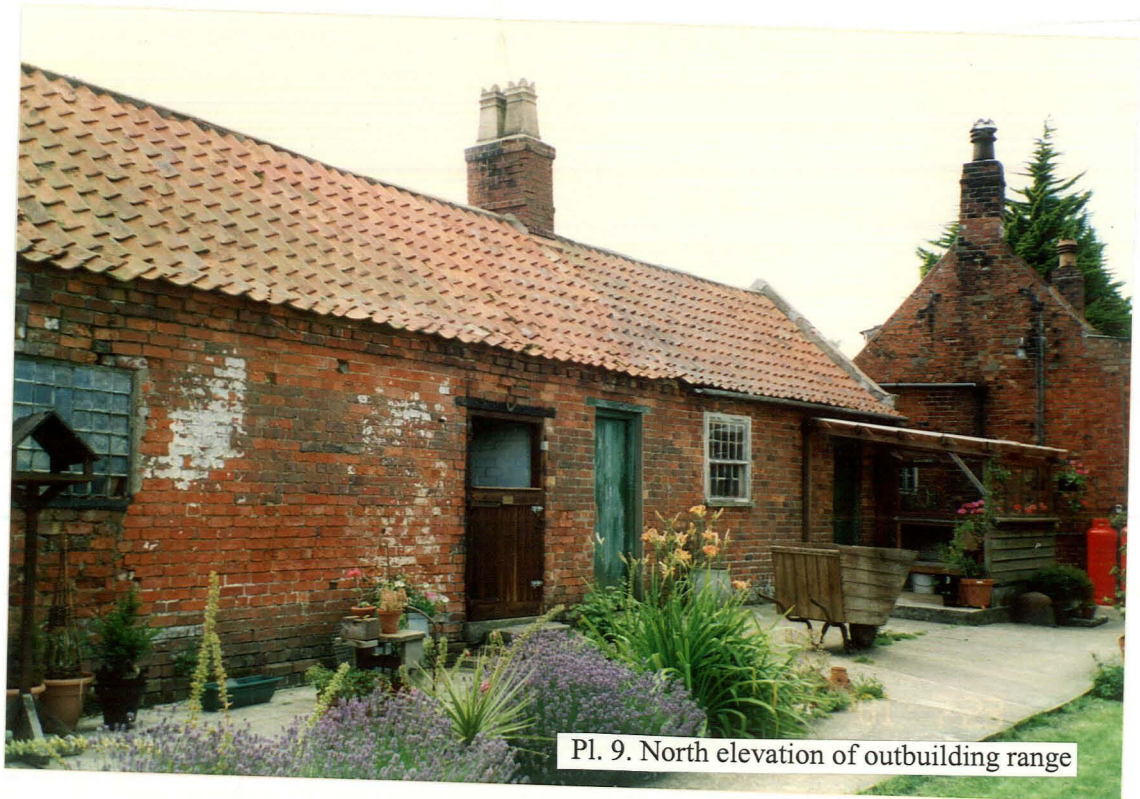
Pl. 9. North elevation of outbuilding range

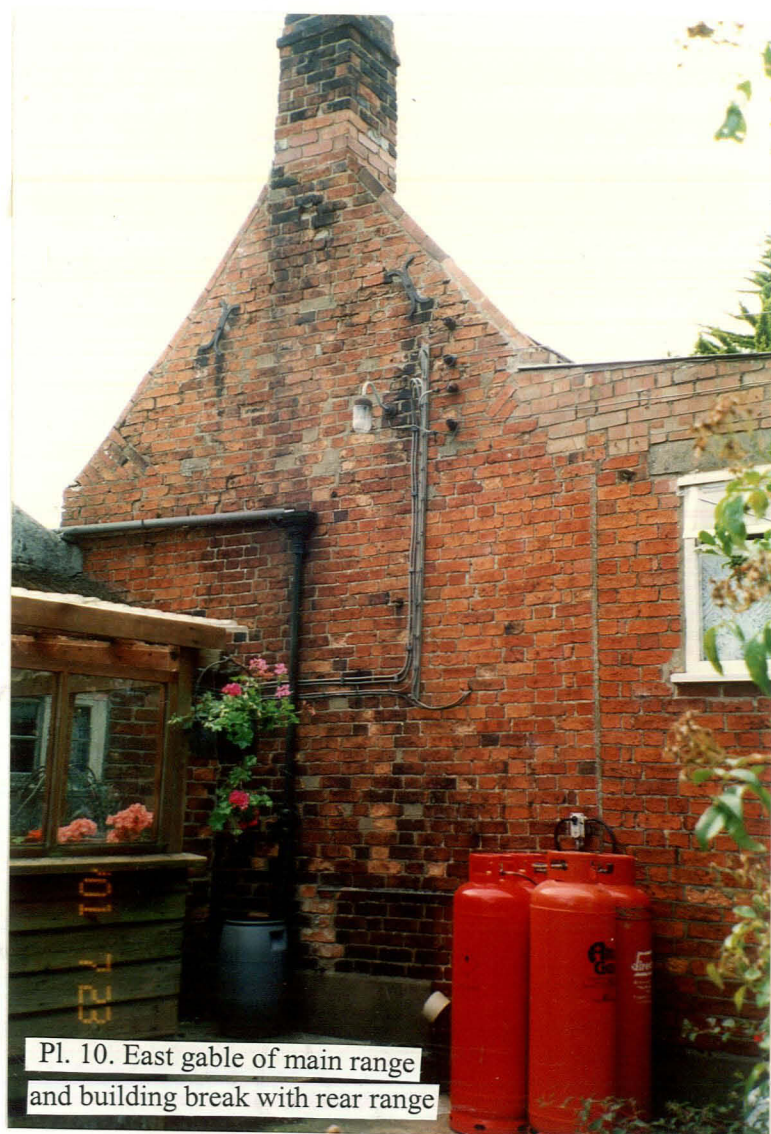
The two cottages were made into one and a service range beneath a lean-to roof was added across the rear of the whole building at a lower level. There are visible building breaks to both the east and the west gables showing where the addition was made. There are few remaining architectural details in this range. The front range must have had the stair access altered at this time which is a most unusual arrangement, it does not easily fit into its downstairs bay and the stairs form almost a pyramid with steps down to lower floor and down to the new rear range with awkward access to the original upper rooms. It is possible that previously there were ladder stairs adjacent to the gable fireplaces or that there was a different central arrangement. Further detailed scrutiny might suggest the previous arrangement. The present cupboard by the fireplace in the eastern room has beading of early 19th century date.

Pl. 10. East gable of main range
and building break with rear range

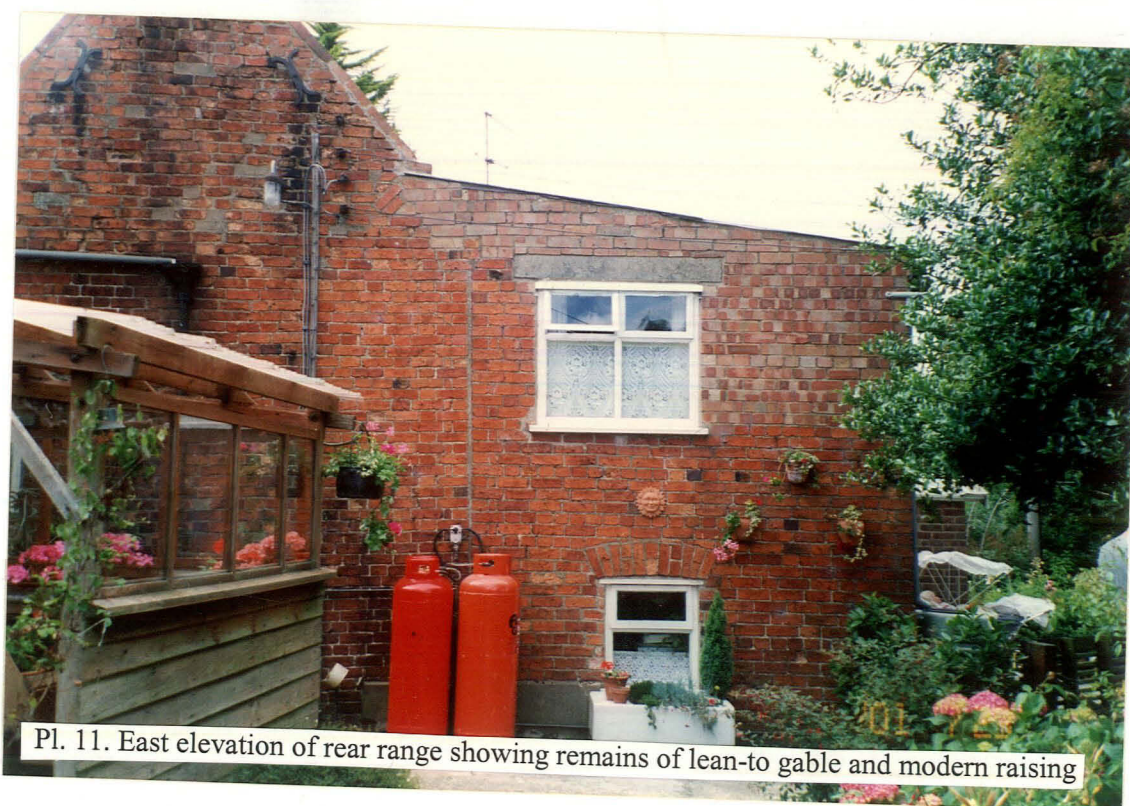
Pl. 11. East elevation of rear range showing remains of lean-to gable and modern raising

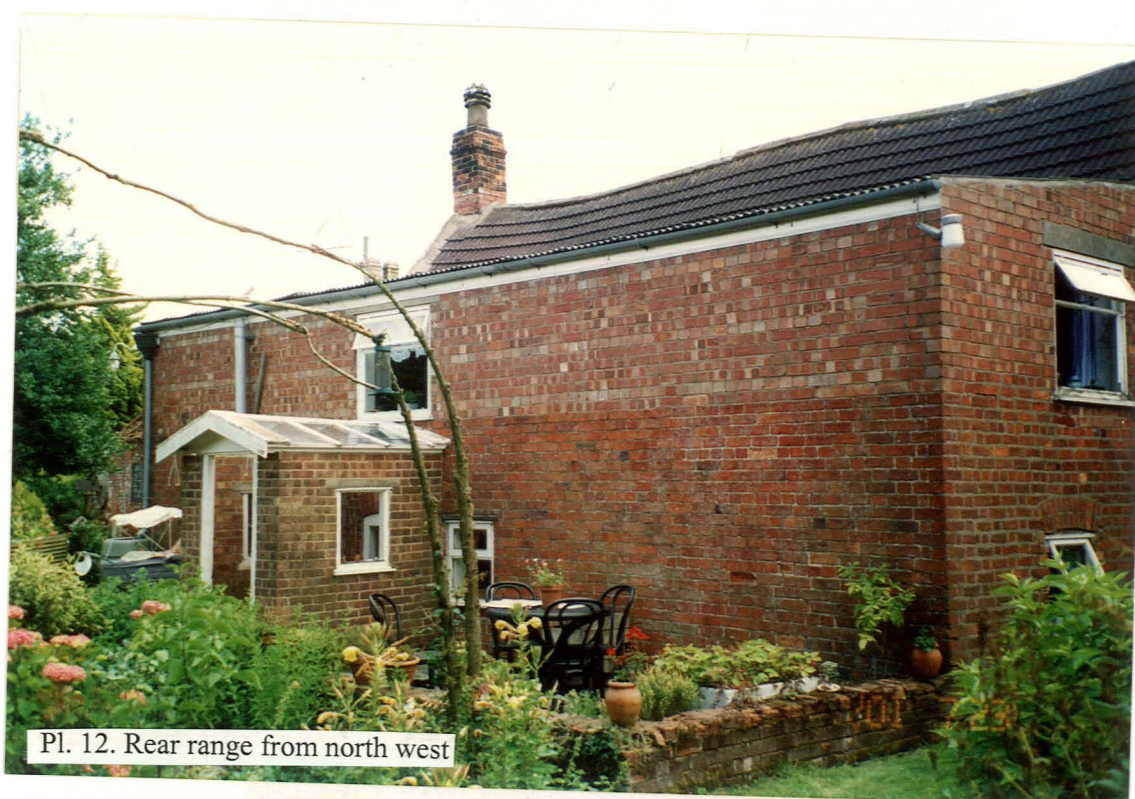
Pl. 12. Rear range from north west

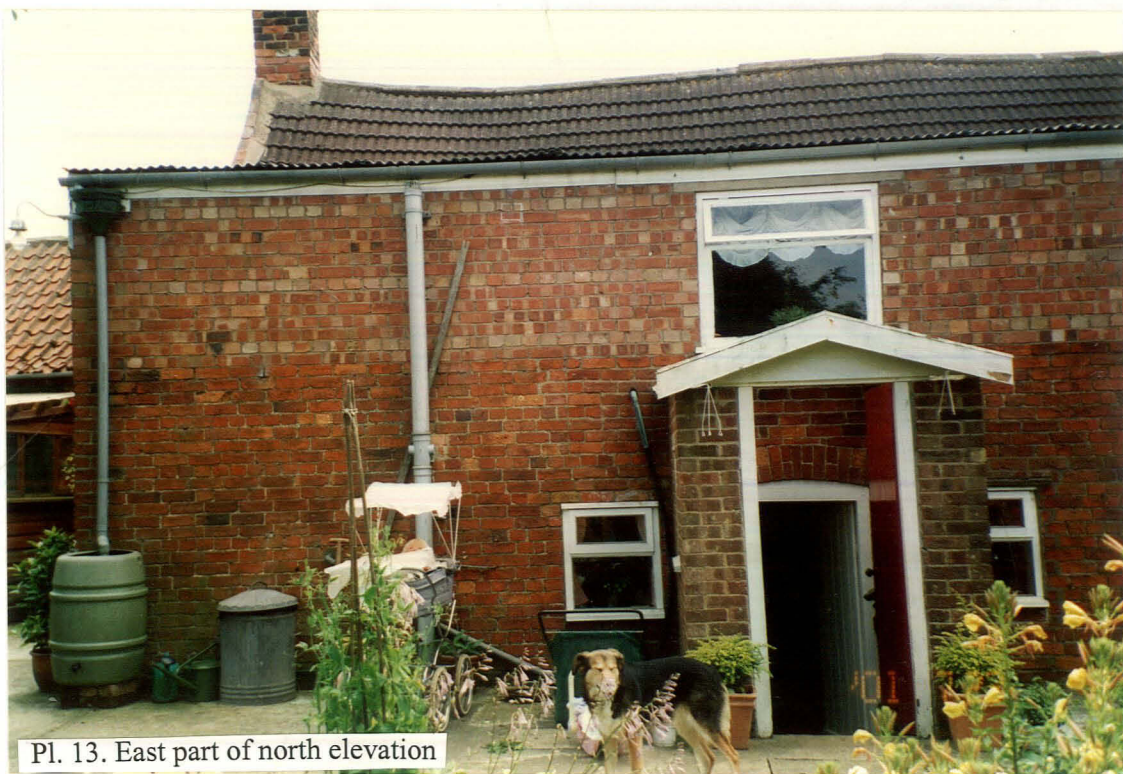
Pl. 13. East part of north elevation

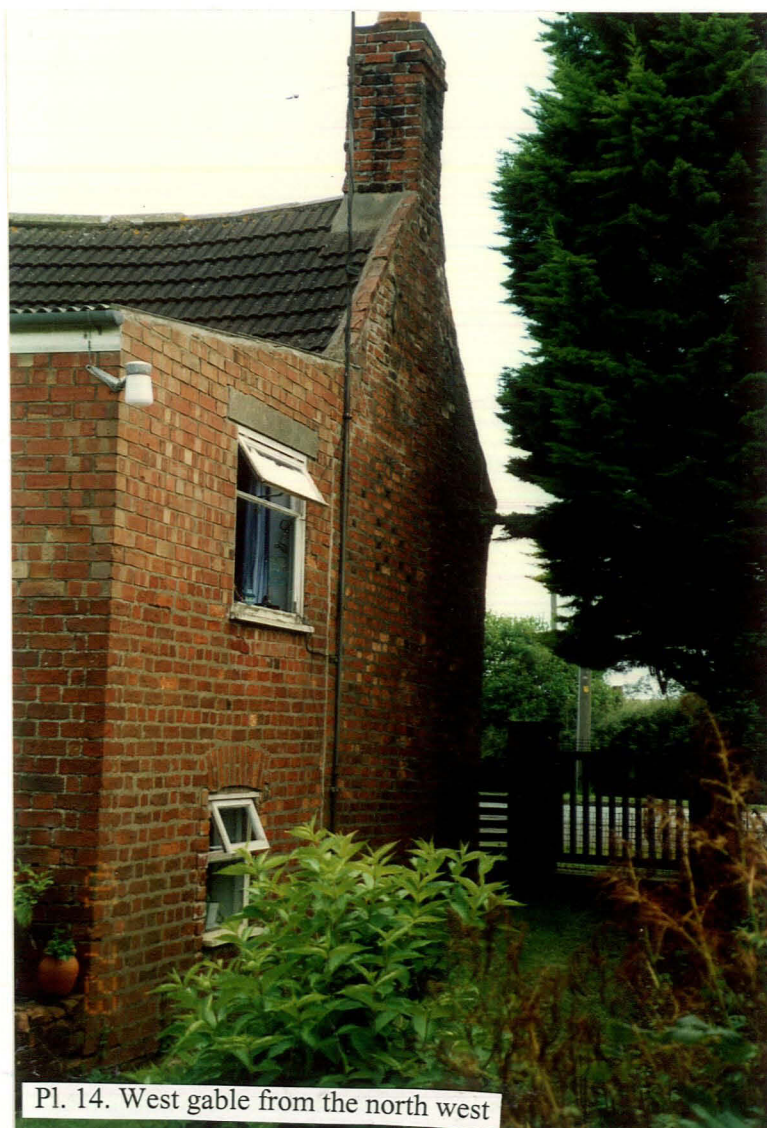
Pl. 14. West gable from the north west

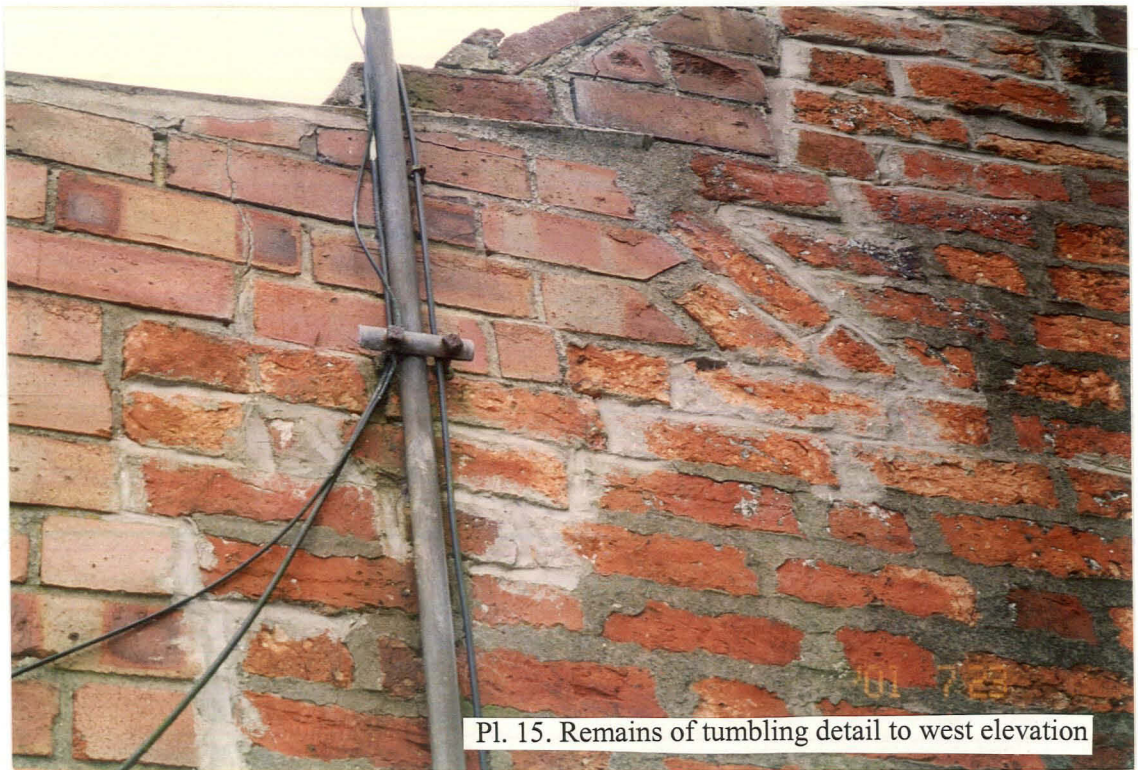
Pl. 15. Remains of tumbling detail to west elevation

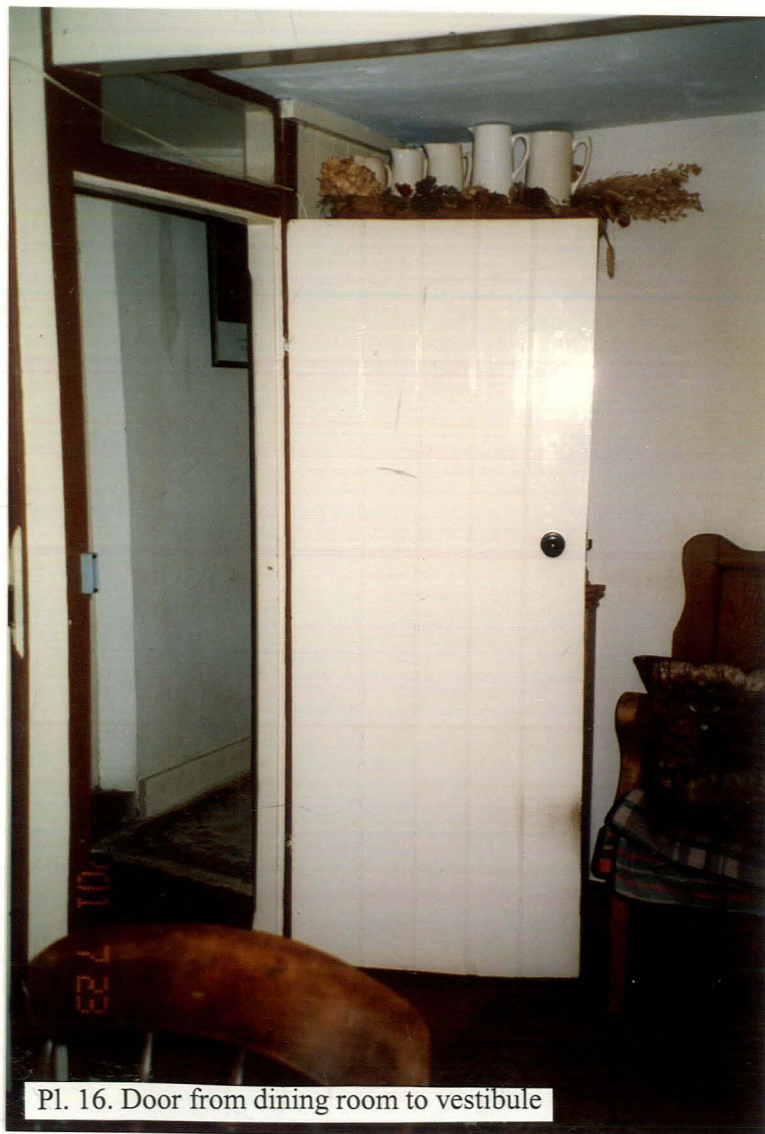
Pl. 16. Door from dining room to vestibule

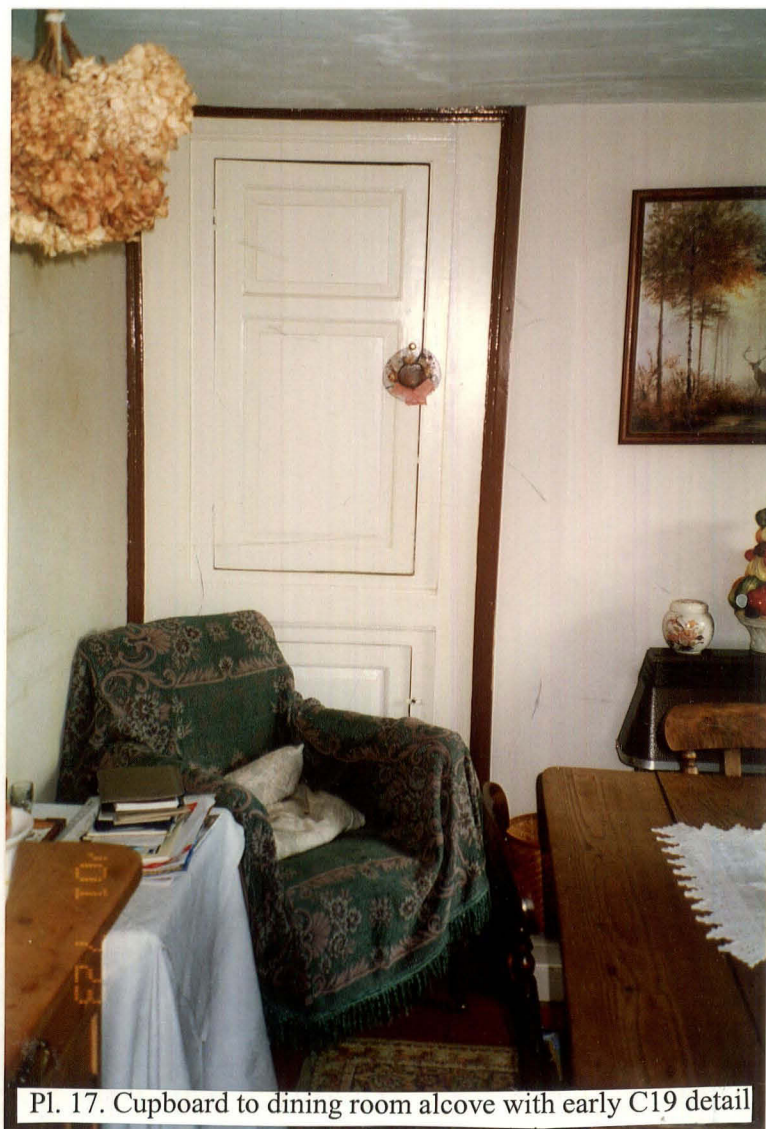
Pl. 17. Cupboard to dining room alcove with early C19 detail

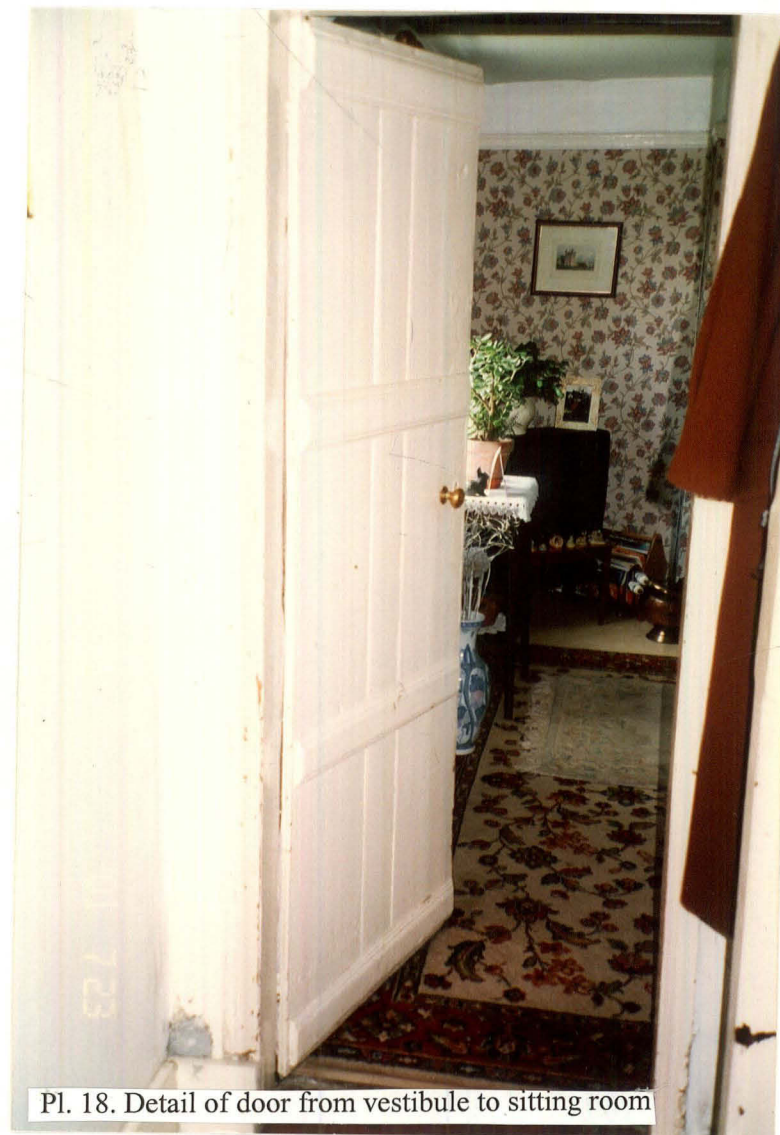
Pl. 18. Detail of door from vestibule to sitting room

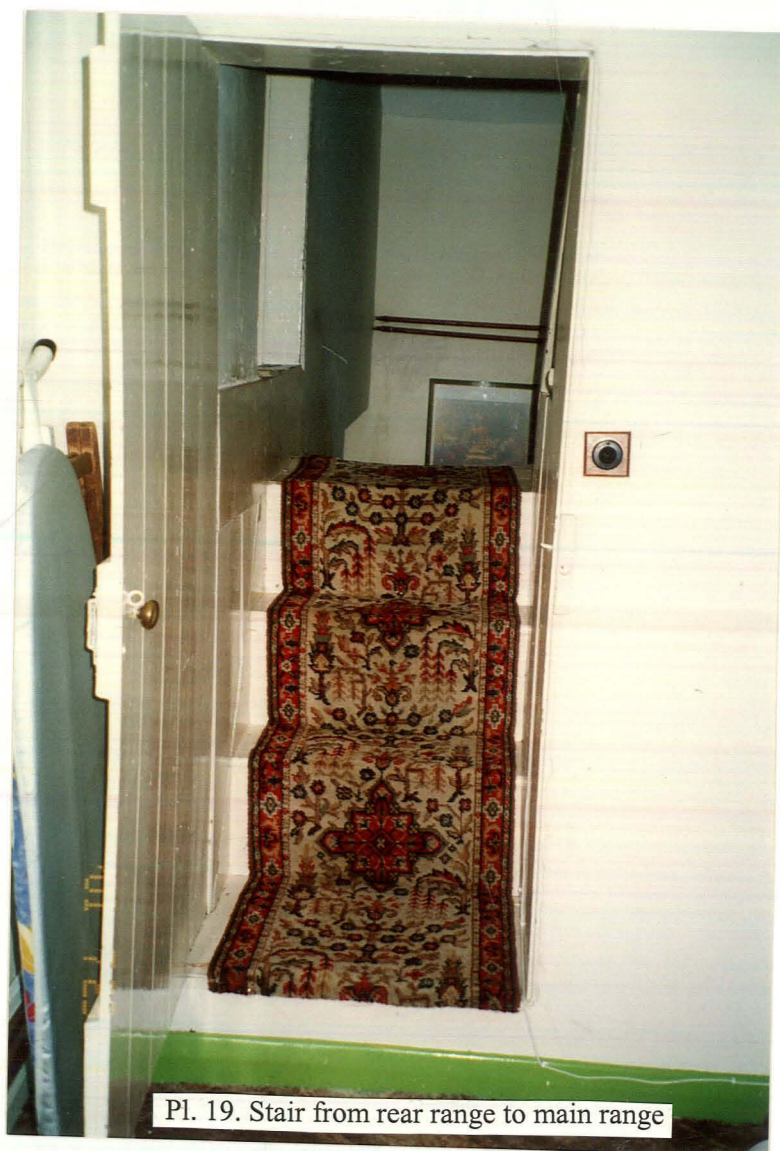
Pl. 19. Stair from rear range to main range

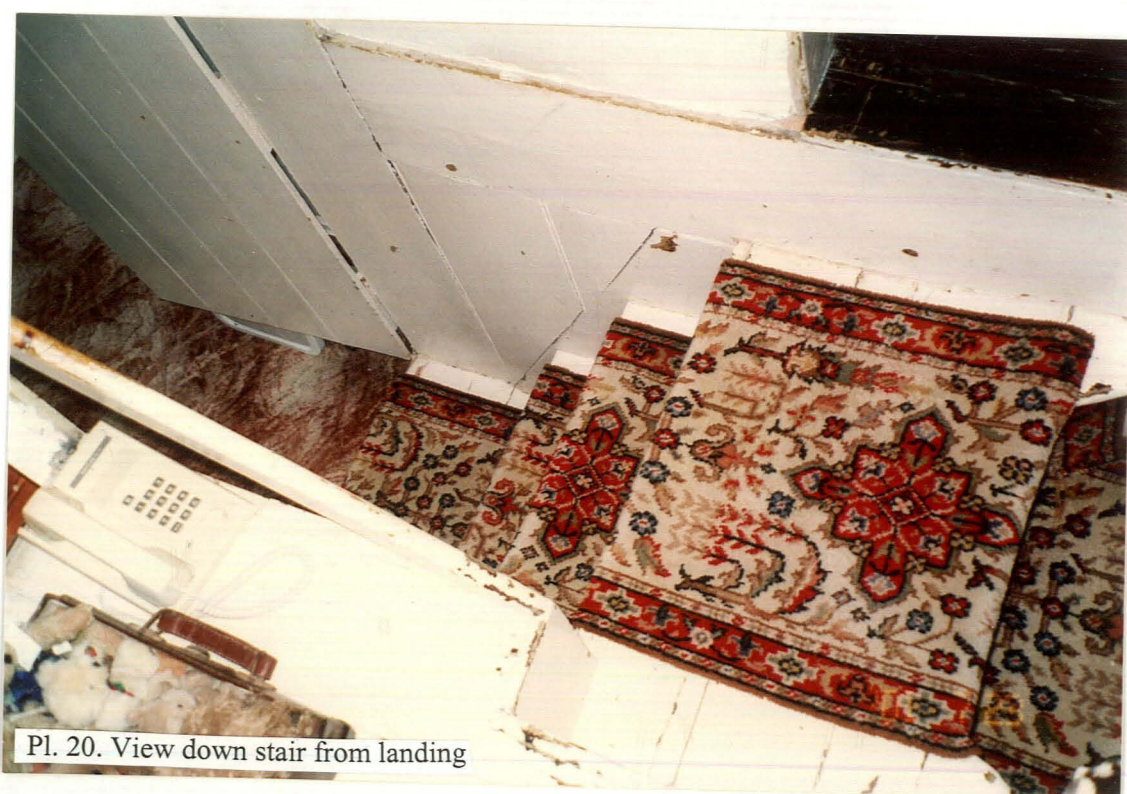
Pl. 20. View down stair from landing

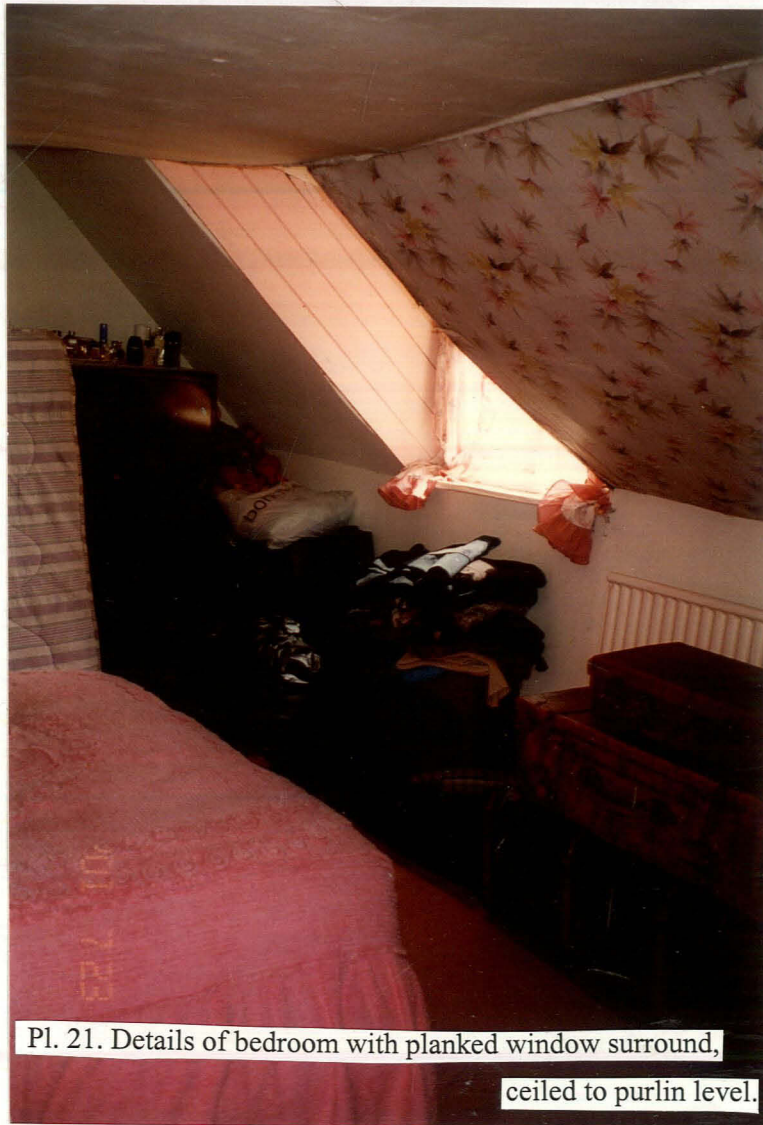
Pl. 21. Details of bedroom with planked window surround,
ceiled to purlin level.
