**PHOTOGRAPHIC SURVEY REPORT:
BARNs AT SWINTHORPE, LINCOLNSHIRE**

Planning Reference: 122174
NGR: TF 0630 8060
AAA Site Code: SWIN 08
LCCM Accession Number: 2008.168
Oasis reference: allenarc1_50974

Allen Archaeological Associates
Report Number 2008/060

November 2008

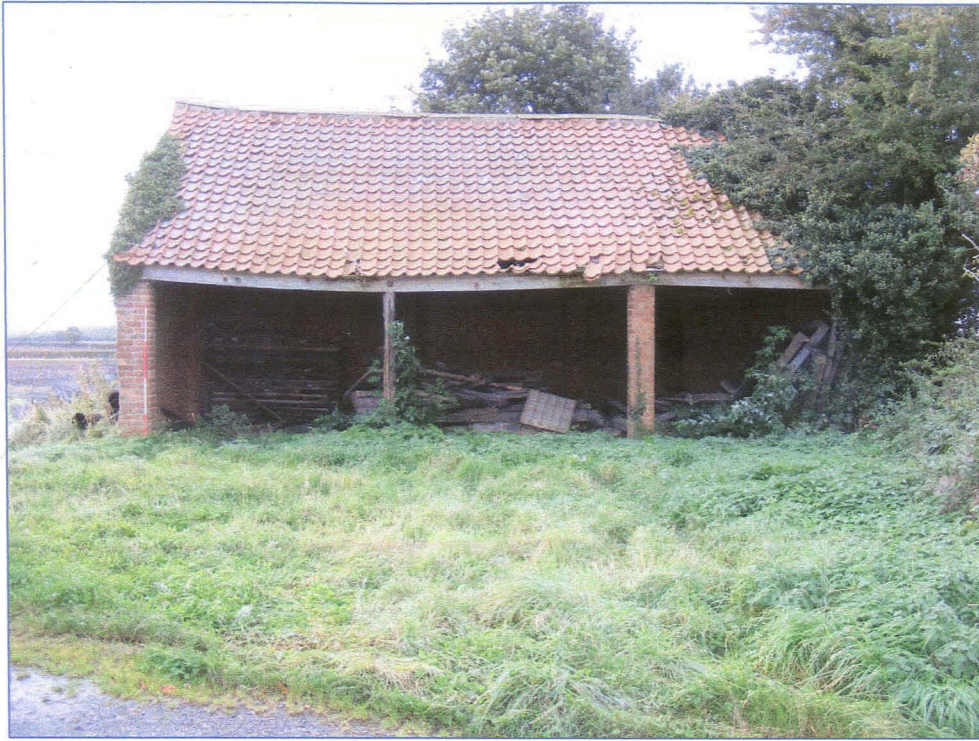
- 5.1.1 The cartshed is a free standing structure located to the west of a farm track off the adjacent road. It is a three bay structure built in English Garden Wall Bond brickwork with a double pitched gabled roof of ceramic pantiles. It is open on its north elevation, allowing access to the road to the north. The central and western bays are divided by a brick column of bull-nose bricks, with a single wooden timber replacement between the eastern and central bays, over which the wooden lintel supporting the roof and the roof itself are sagging noticeably (Plate 1).

Plate 1 (Shot 1): North elevation of the cartshed, looking south-south-east

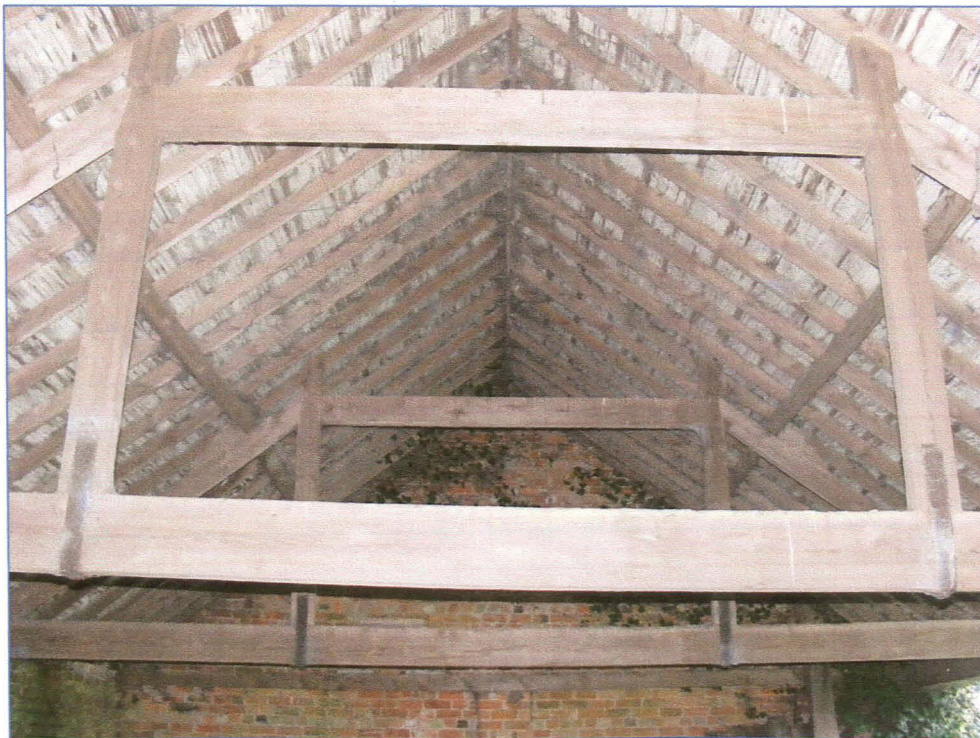
- 5.1.3 The internal roof structure is of laid-on purlin construction, with the principal rafters supporting the side purlins, supported by a pair of roof trusses, each with a tie beam supporting two vertical struts connected by a collar beam that extend to abut the rafters (Plate 2).

Plate 2 (Shot 3): Roof structure of the cartshed, looking west-north-west

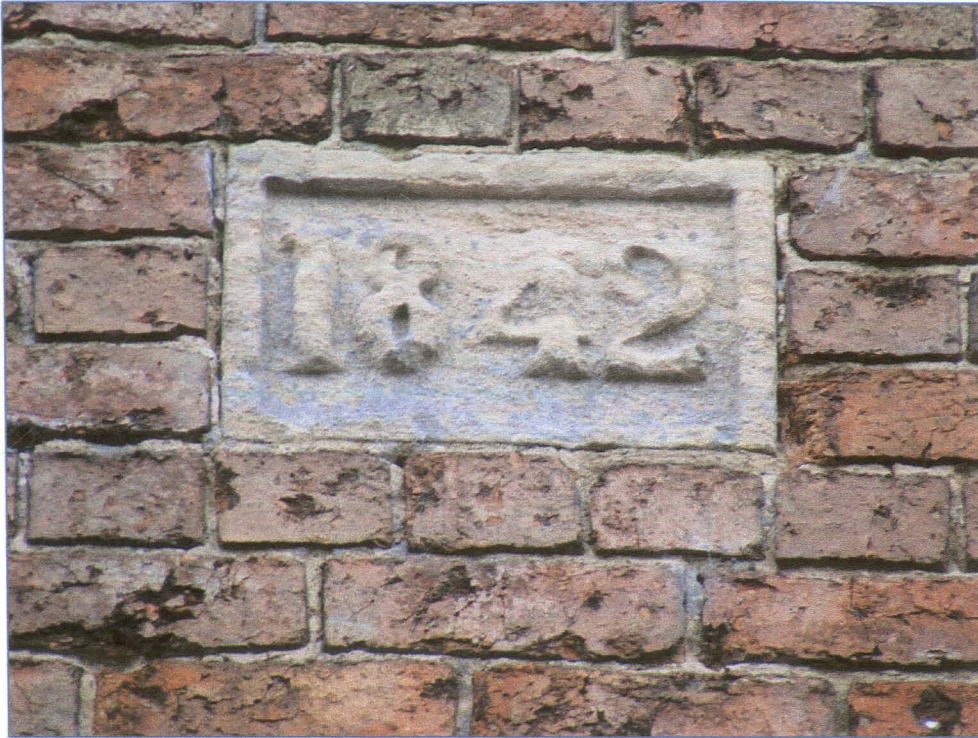
Plate 3 (Shot 43): Carved datestone in west elevation of Block A, looking east-north-east

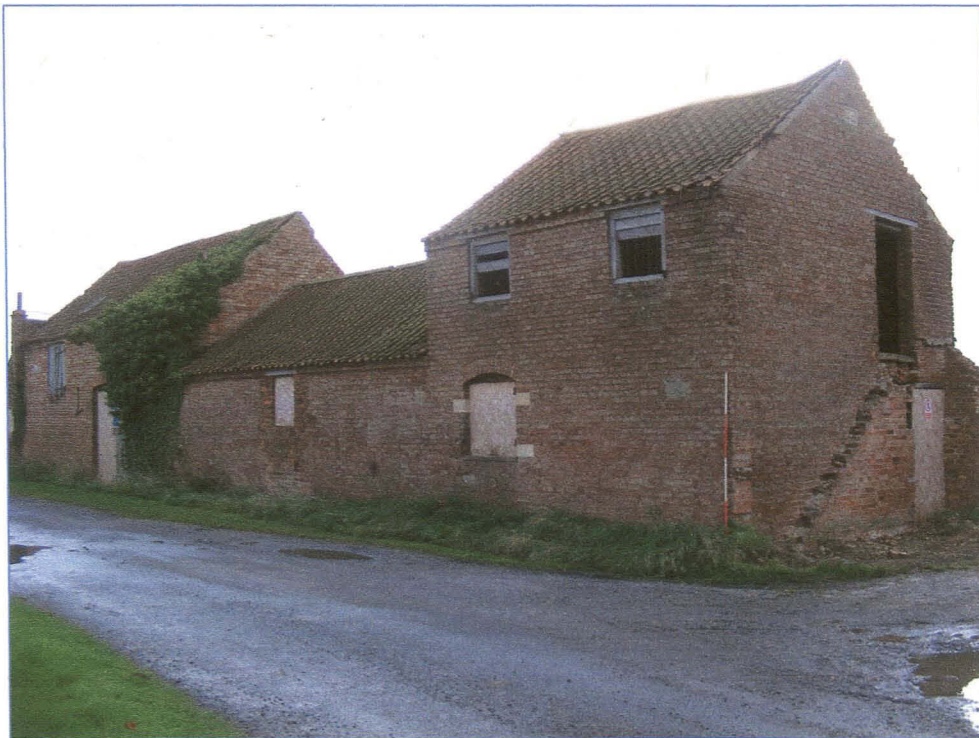
datestone the wall retains clear evidence for a former external staircase to an upper doorway allowing access to the first floor granary, with another doorway below accessing the ground floor of the building (Plate 4).

- 5.2.3 On the north elevation, there is a single ground floor window with a stone sill and a segmental arch of alternating headers and stretchers. There are two square pitching holes on the first storey directly below the roof line, with internal jambs of bull-nose bricks (Plate 4).

Plate 4 (Shot 6): North and west elevations of Block A, looking east

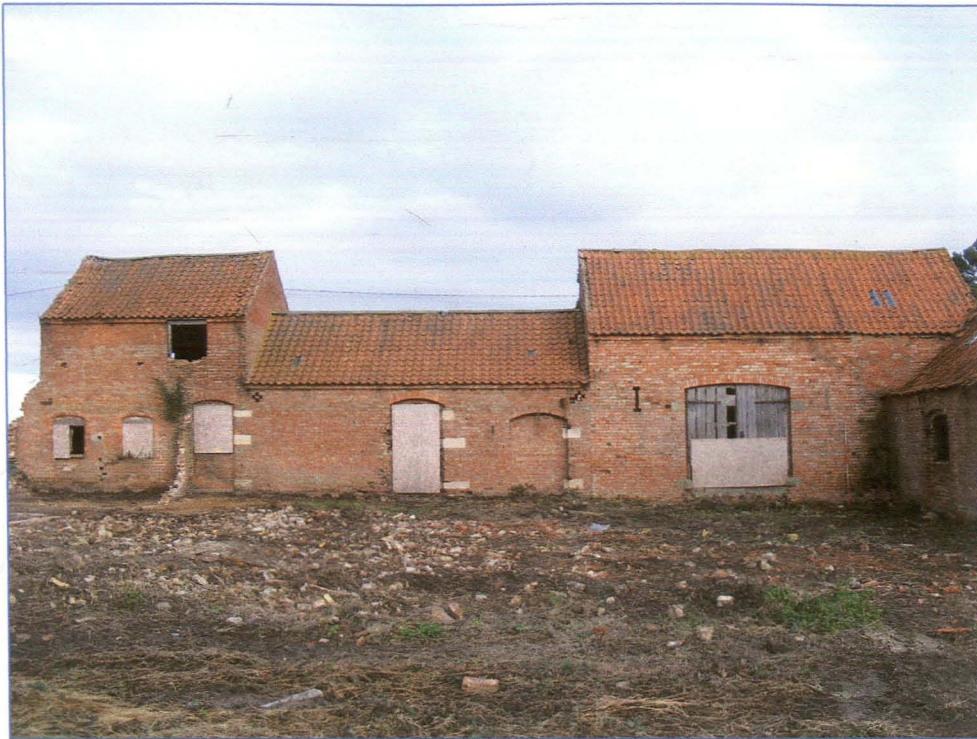
- 5.2.4 The south elevation has two windows, each with bull-nose brick jambs and a basket arch, also of bull-nose bricks (Plates 5 and 6). A load-bearing wooden lintel is visible inside each window, supporting the brickwork above. To the east is a partially bricked up doorway with a segmental arch of alternating stretchers and headers, with the eastern jamb formed of bull-nose bricks and three unevenly spaced chamfered stone blocks. The partial blocking of the doorway has formed a window in the pper part of the former doorway. The western side of the doorway is abutted by a brick wall that is a remnant of a demolished range of buildings extending to the south. A roof scar for this range of buildings is also evident, suggesting a two storey, double pitched gabled roof structure, the apex of which is immediately below the roof line of the existing building (Plates 5 and 7). Given the position of the windows in the existing buildings, it seems likely that the demolished range was added later. This hypothesis is supported by the position of the single pitching hole in the first storey of the south elevation. The location of the pitching hole, directly over the east wall of the demolished range would have made it very difficult to use after this range was built. This range is evident on the historic maps consulted (Figure 5), and was therefore constructed before 1890, and demolished after 1948.

- 5.2.14 The south elevation also exhibits a possible roof scar that is quite evident to the east of the doors but very faint to its west (Plate 5), which may indicate a covered yard, for which there is some documentary evidence on the historic maps in Figure 5. The 1890 map shows three ranges of buildings arranged around a yard enclosed on its south side, with a central partition dividing this area in two, and another partition dividing the western half of the yard into two smaller blocks. These partitions probably reflect differing areas of activity within the yard such as storage of manure or to corral cattle and other livestock. By 1907, the easternmost range is depicted as double its earlier width, extending to the former central partition. There is no evidence to suggest an additional range of buildings was constructed at this time, it is more likely that a roof was built to provide additional shelter for animals, and protection for the valuable resource of manure, a practice being widely advocated by farm designers towards the end of the 19th century (Wade Martins 1991). The structure appears to have been extant at the time the 1948 map was compiled.

Plate 5 (Shot 11): South elevation of Block A, looking west-north-west. The roof scar of the former western range is visible to the left of the shot. Note the position of the pitching hole directly above the demolished structures

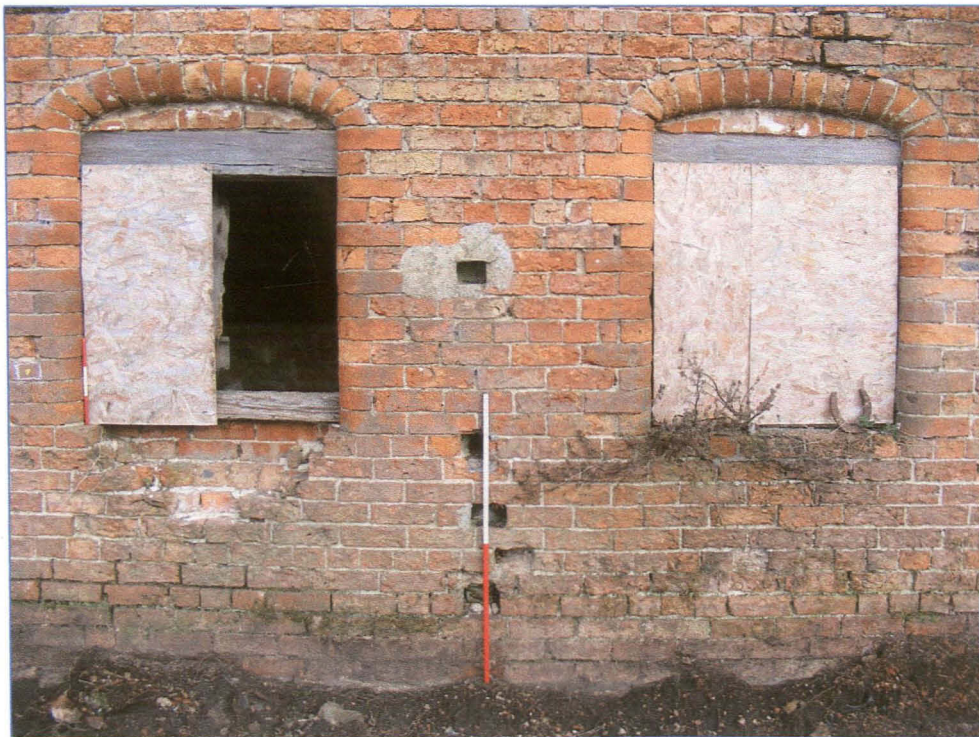
Plate 6 (Shot 14): Detail of basket arch windows in south of elevation of possible stable and granary building (Room A1). Looking north-north-west

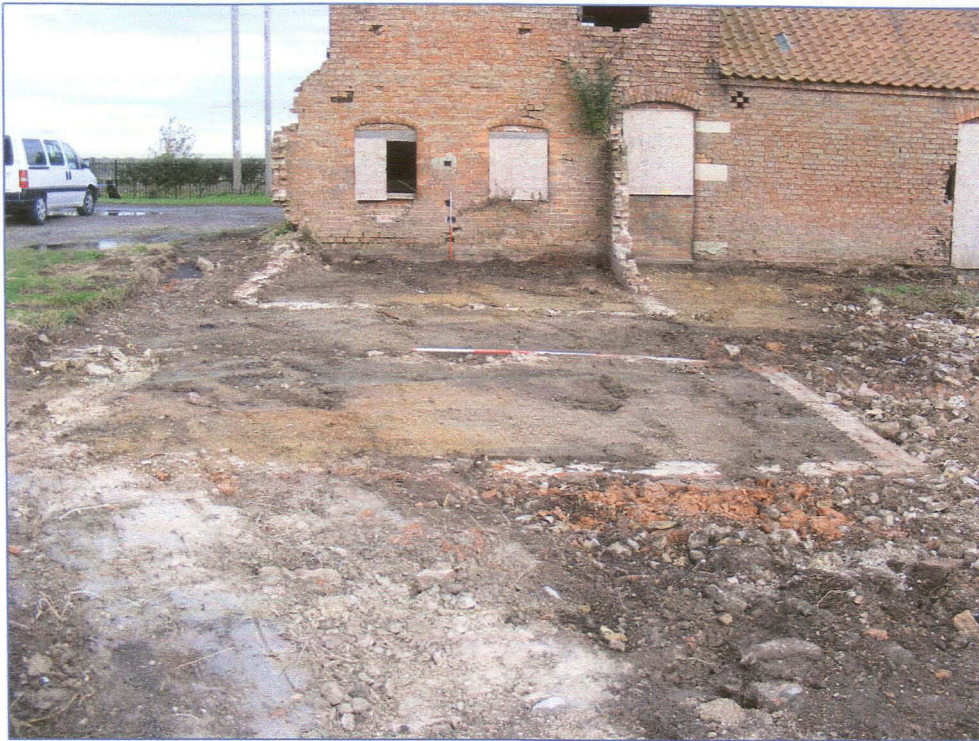
Plate 7 (Shot 15): West end of the south elevation of Block A, showing the remnants of the former western range of buildings.

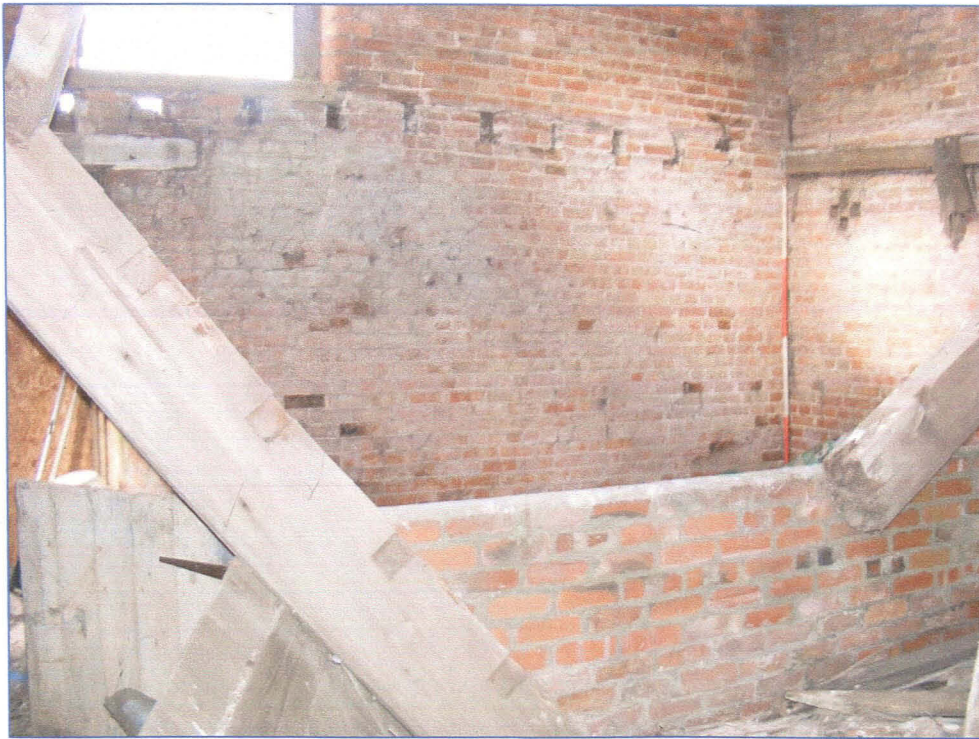
Plate 8 (Shot 36): Interior of Room A1, looking north-west from the doorway to Room A2.

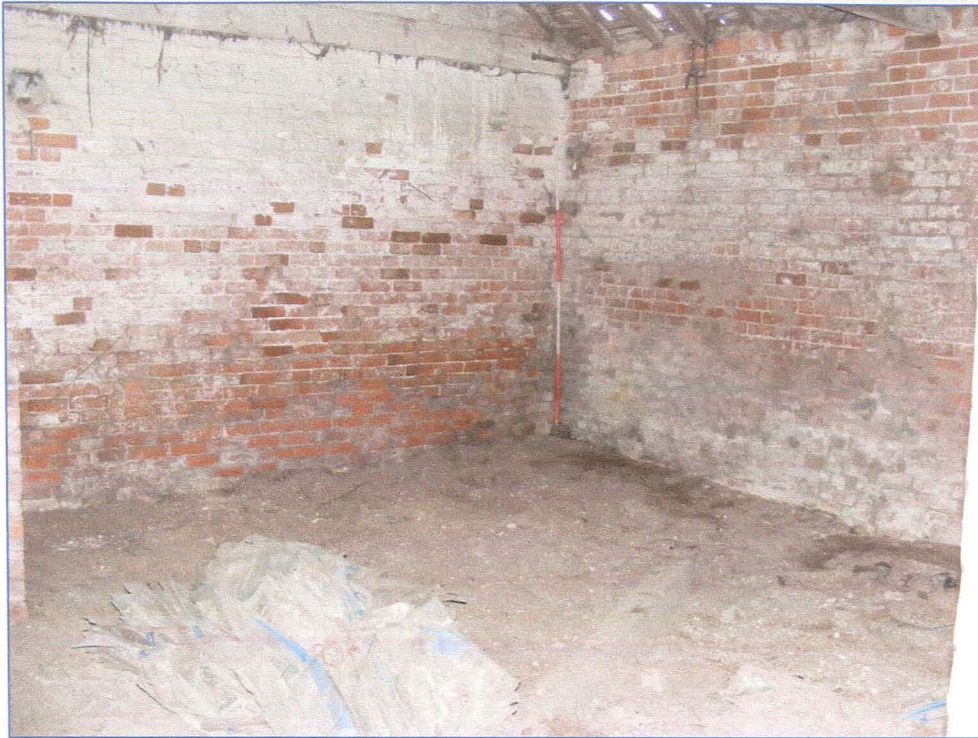
- 5.2.9 Room A2 is the larger of the two, and is entirely open (Plate 9), with no architectural features of note other than a low brick wall extending east from the west elevation, adjacent to the adjoining doorway into Room A1.

Plate 9 (Shot 34): Interior of Room A2, looking north-west from the doorway to Room A3.

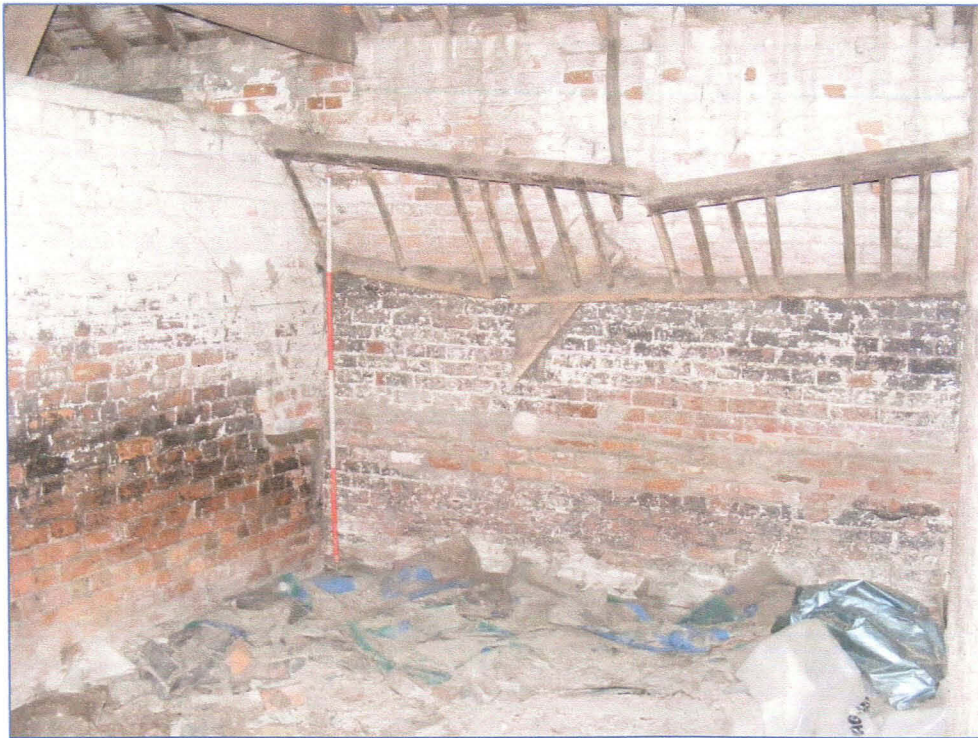
- 5.2.10 Room A3 has a wooden hay rick on its north wall, below which there is a wall scar evidencing a probable feeding trough (Plate 10). Curved recesses in the east and west walls of this room also indicate the presence of the probable former troughs.

Plate 10 (Shot 33): Interior of Room A3, looking north-west from the doorway to Room A4. There is a wooden hay rick on the north wall, with a scar below indicating a former feeding trough. A curved recess on the western partition wall, immediately to the left of the scale as indicates the presence of the former trough.

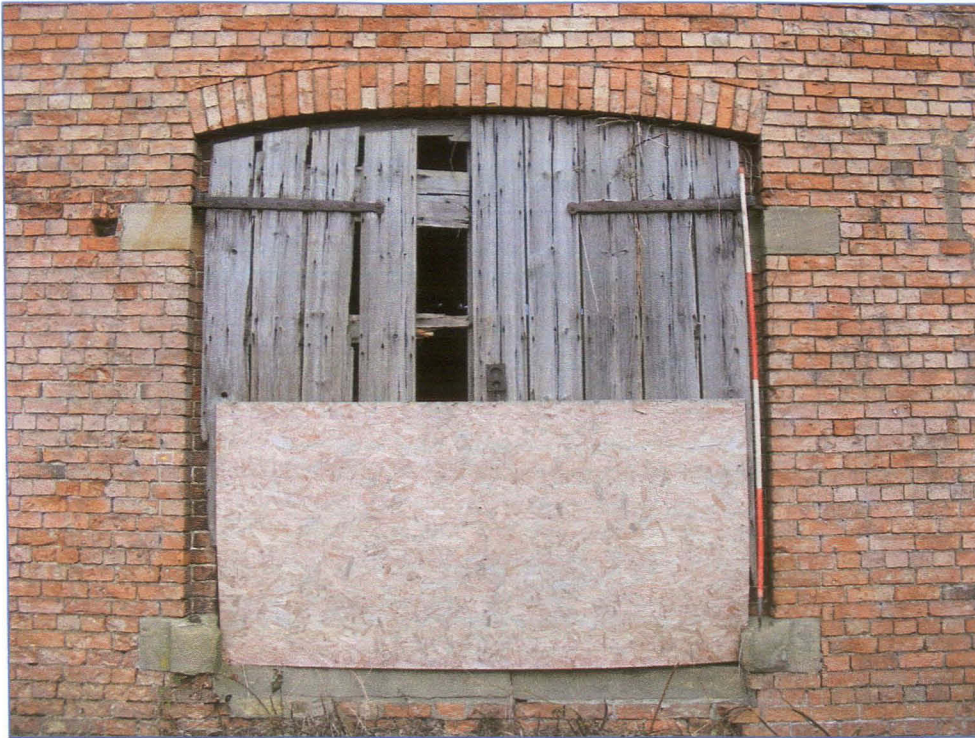
- 5.2.12 The large double doors in the north and south elevations are both below segmental arches of alternating headers and stretchers, with wooden lintels and stone sills. The door in the south elevation still has the original rounded stone mortise blocks to receive a pivot hinge, and the strap hinges on the upper part of the existing doors are attached to dressed stone blocks that are also probably original features (Plate 11).

Plate 11 (Shot 18): Double doors in south elevation of threshing barn (A4). The stone mortise blocks are still in situ, and the stone blocks with metal strap hinges are also visible. To the right of the shot is a blocked ventilation slit. Looking north-north-west.

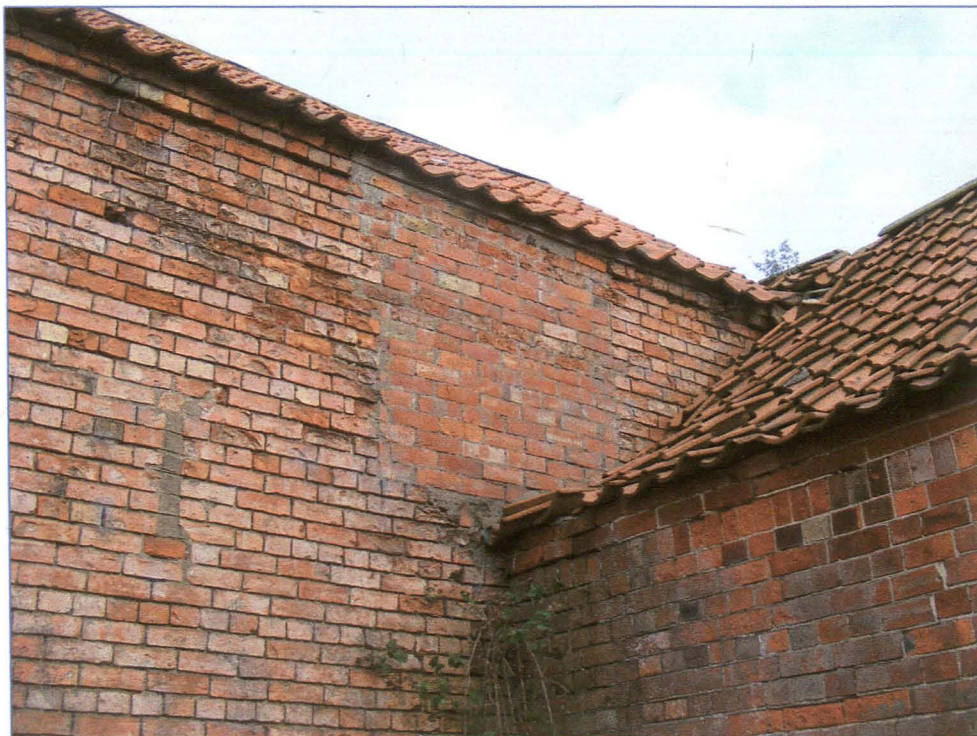
- 5.2.13 There are two pitching holes to the east of the double doors, one in the north elevation and one in the south elevation, both located directly below the roof line. The pitching hole in the south elevation has been bricked up, probably at the time of, or soon after the construction of the adjacent Block B. Similar to the granary (See Section 5.2.4 above), the roof line of Block B is directly below the pitching hole (Plate 12).

Plate 12 (Shot 20): Blocked pitching hole in the south elevation of the threshing barn. It seems likely that it was blocked during the construction of the adjacent Block B. This shot also shows a possible roof scar for a former covered yard.

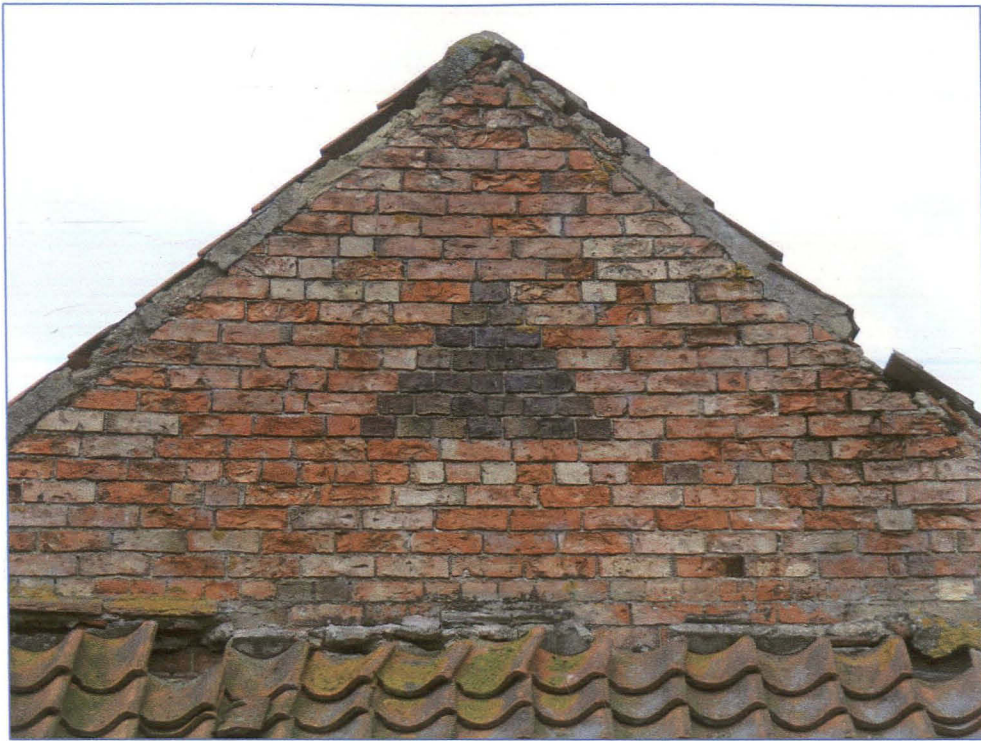
- 5.2.16 Much of the east elevation is masked by a later structure (B3), although a small area of brick detailing is evident, in the form of a triangular pattern of black engineering bricks in the upper part of the wall (Plate 13). This is a purely decorative feature facing towards travellers using the road from Snelland to Snarford, mirrored by the 1842 datestone at the opposite end of the range.

Plate 13 (Shot 47): Brick detailing below apex of east elevation of Block A, looking west-south-west

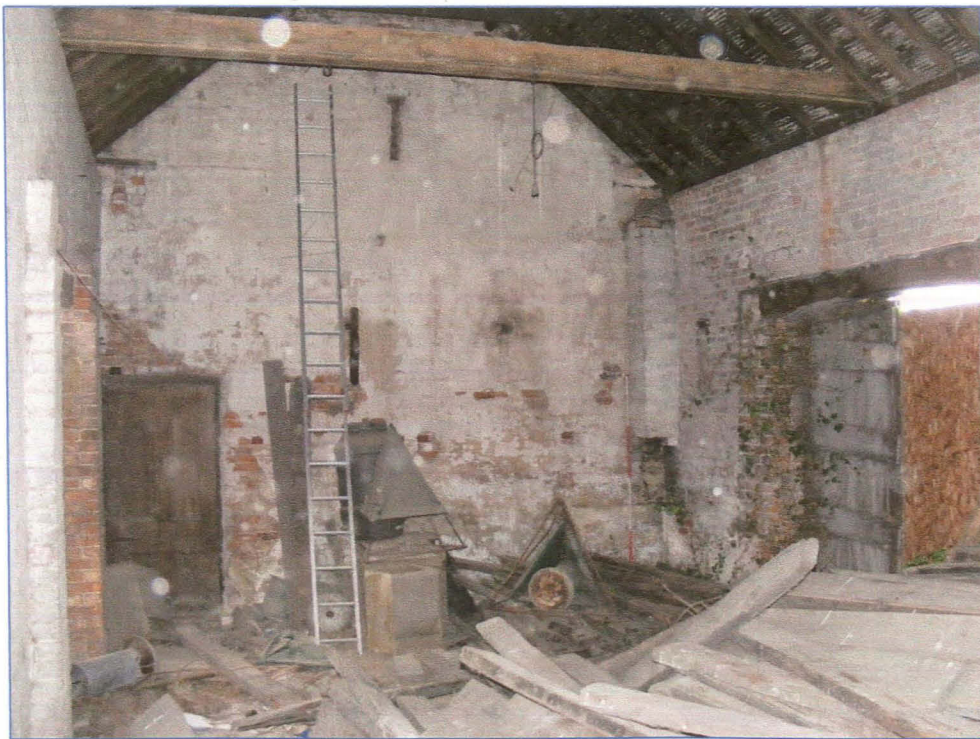
5.2.17 There are few architectural features of interest internally (Plate 14). A wooden door allows access to the adjacent stable block to the west, with another door in the south elevation connecting with Block B to the south. There is a brick chimney stack in the north-west corner of the building that is likely to be a later addition to the building, the exact function of which is unclear. The exterior of the chimney is largely masked by a growth of ivy, but it can be seen to project from the north-west corner of the building, just above the roof of the adjacent cow-shed. The chimney is topped by a cylindrical ceramic pot.

Plate 14 (Shot 30): Interior of threshing barn (A4), looking west from the south-east corner. The chimney is visible in the north-west corner of the building, as well as a blocked ventilation slit above the roof line in the west wall.

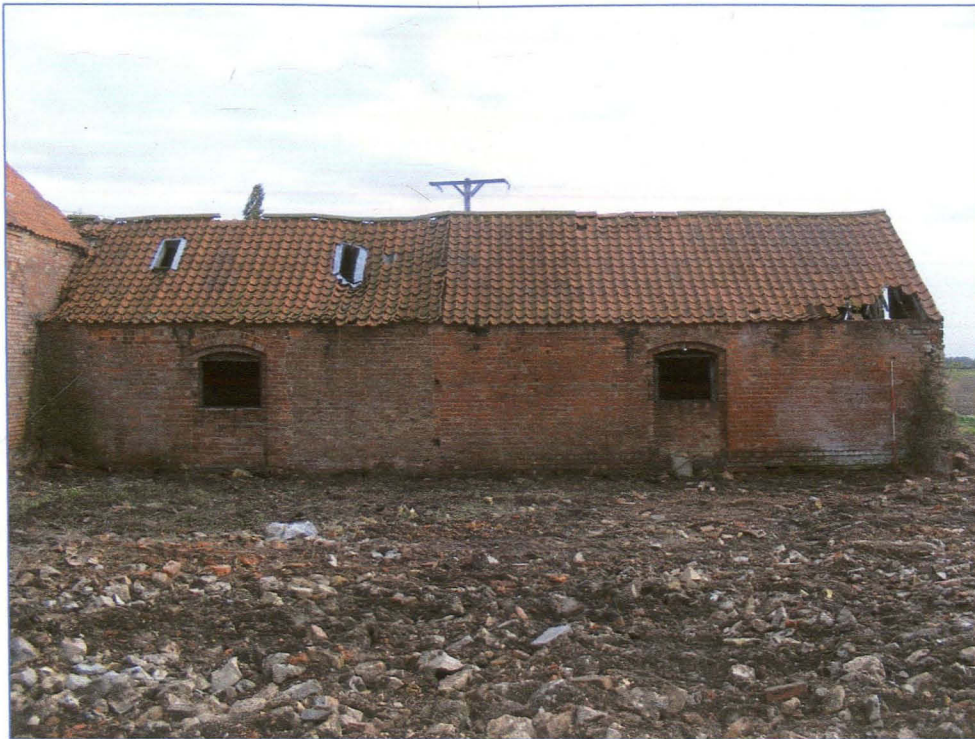
5.3.4 Rooms B1 and B2 both have a single partially bricked up doorway on the west elevation, each below a segmental arch of two header courses. Both doorways have been blocked to form a square opening with a wooden frame and a steel mesh grille (Plate 15). An area of brick rebuilding was evident to the south of the northernmost door, which is more likely to represent a repair rather than the blocking of a doorway or window (Plate 16). At the south end of the range, the remnants of a brick wall extend westwards, suggesting a boundary wall which enclosed the south side of the yard (Plate 15), and is evident on the historic maps of the site (Figure 5).

Plate 15 (Shot 10): West elevation of Block B, looking east-north-east. The remnants of a possible boundary wall are visible to the right of the shot, extending from the south end of the building.

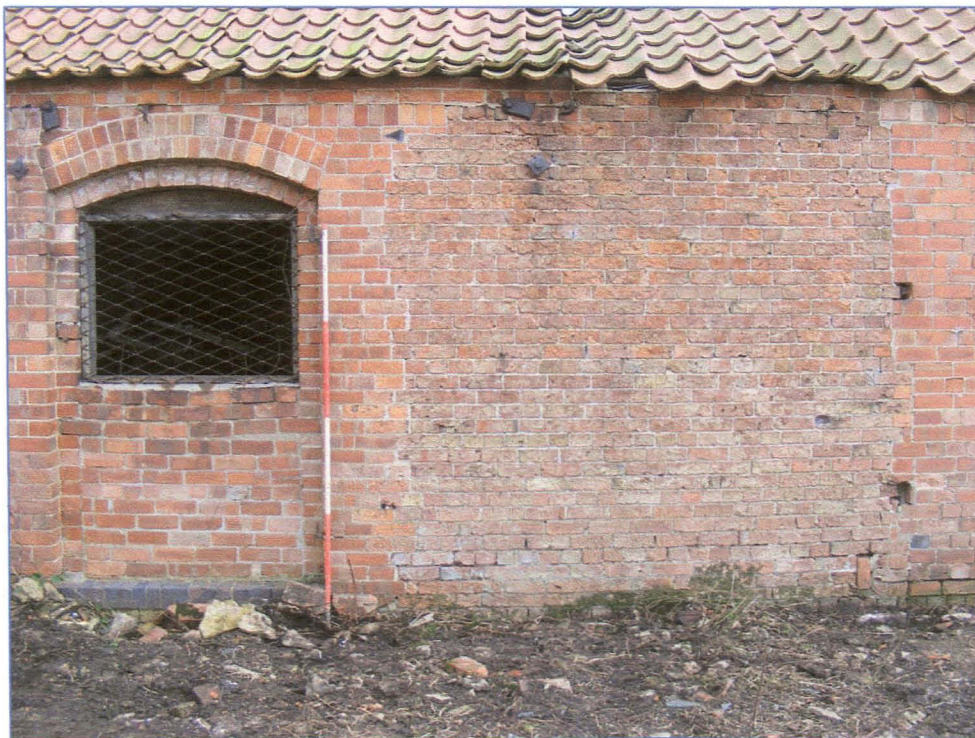
Plate 16 (Shot 19): Detail of repair to brickwork and blocked doorway in west elevation of Block B. Looking east-north-east

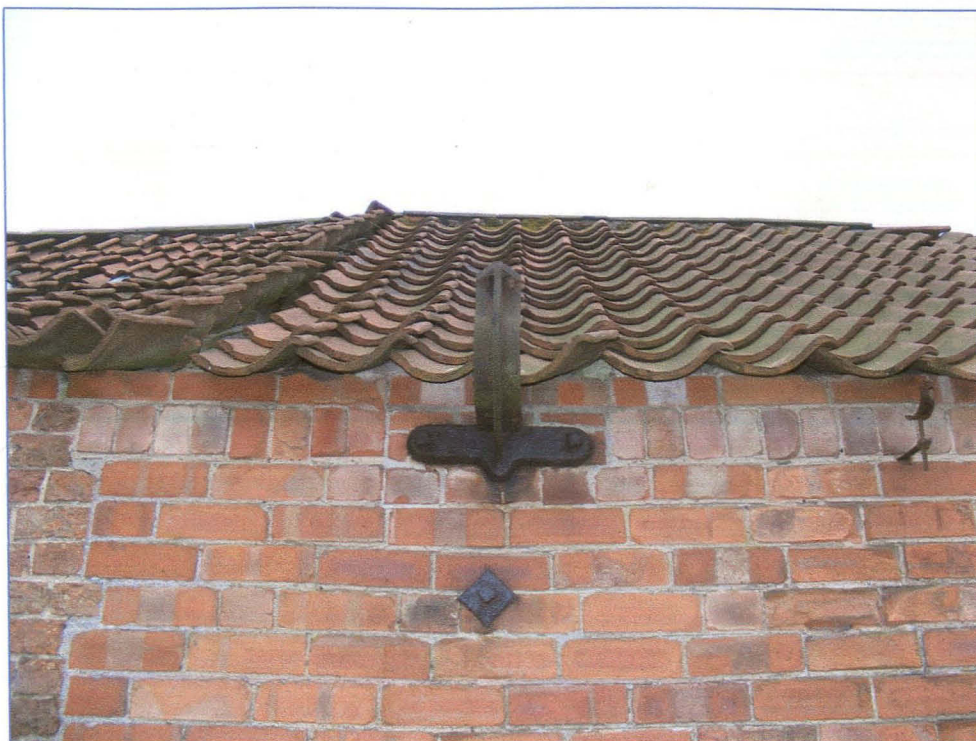
5.3.5 A series of broken cast iron objects were observed running along the west elevation, just below the roof line. A single intact example of one of these gutter brackets has survived (Plate 17).

roof support
for structure
shown on
1907 figure 6?

Plate 17 (Shot 44): Detail of cast-iron gutter bracket on west elevation of Block B, looking east-north-east. Another smaller, probably later bracket is visible to the right of shot

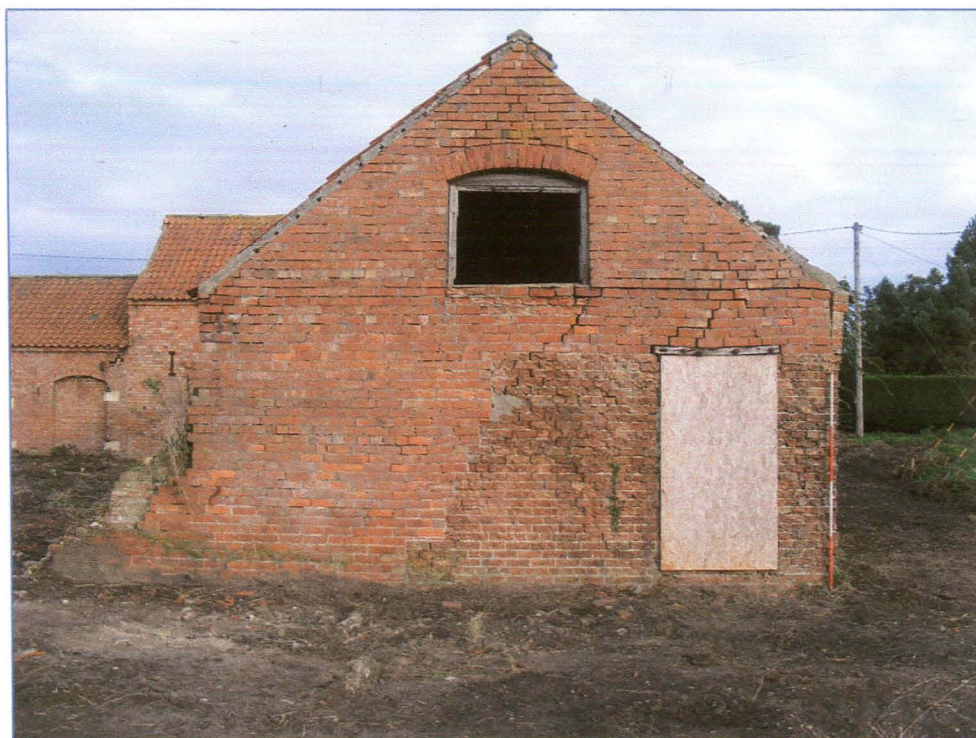
5.3.6 The southern gable of the range has a single doorway towards its east side, and a square pitching hole with a wooden frame and a segmental arch of brick stretchers (Plate 18). The area around the door is in a different brickwork indicating an episode of repair, possibly occasioned by the insertion of the door. This appears to have been a poorly executed rebuilding, as the wall has slumped and cracked above the door frame, suggesting that insufficient load-bearing capability has been built into the doorway. The pitching hole meanwhile indicates that the range had an upper storey or hay loft, although there is no other evidence for this internally.

Plate 18 (Shot 9): South elevation of Block B, showing the pitching hole and the area of repair around the doorway. Note the area of collapse above the door.

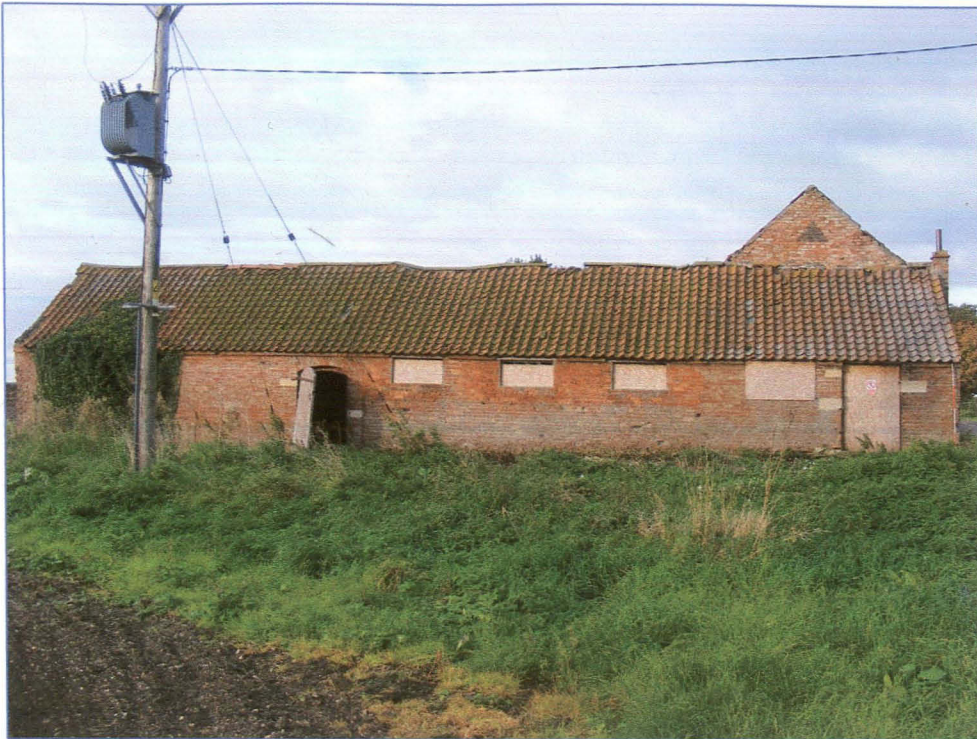
5.3.7 On the east elevation of B1 and B2, there is a single doorway into Room B2 with a segmental arch of alternating brick headers and stretchers (Plate 19). The two rooms have four identical windows, three in Room B1 and in one B2, the exterior of which is masked by ivy. The three windows in B1 are surrounded by a different brickwork to the remaining building, and it is possible that the insertion of these windows, and the window in B2 represents an episode of rebuilding intended to improve lighting and ventilation, as part of the gradual drive to improve

Plate 19 (Shot 8): East elevation of Block B, looking west-south-west. The area of brick rebuilding around the three identical windows in Room B2 suggests a single phase of redevelopment

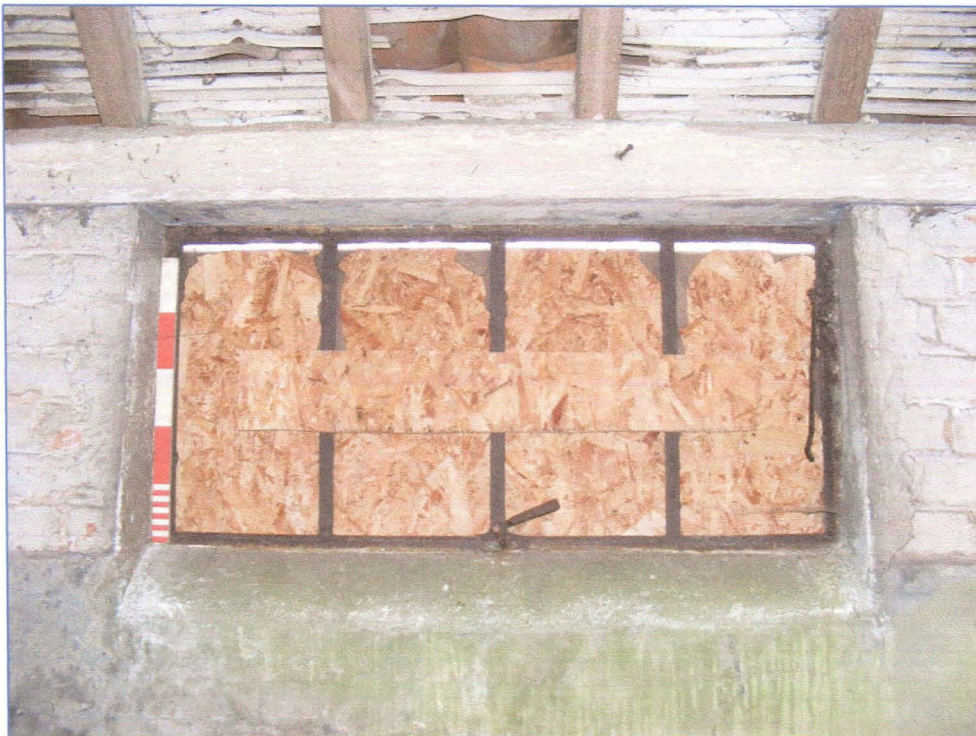
accommodation for cattle during the later 19th and early 20th centuries (Wade Martins 1991 and 2002). The windows are top-hung casement windows which open outwards and have a metal frame with three vertical metal muntins (Plate 20).

Plate 20 (Shot 48): Internal view of window in east elevation of Room B1, looking east-north-east

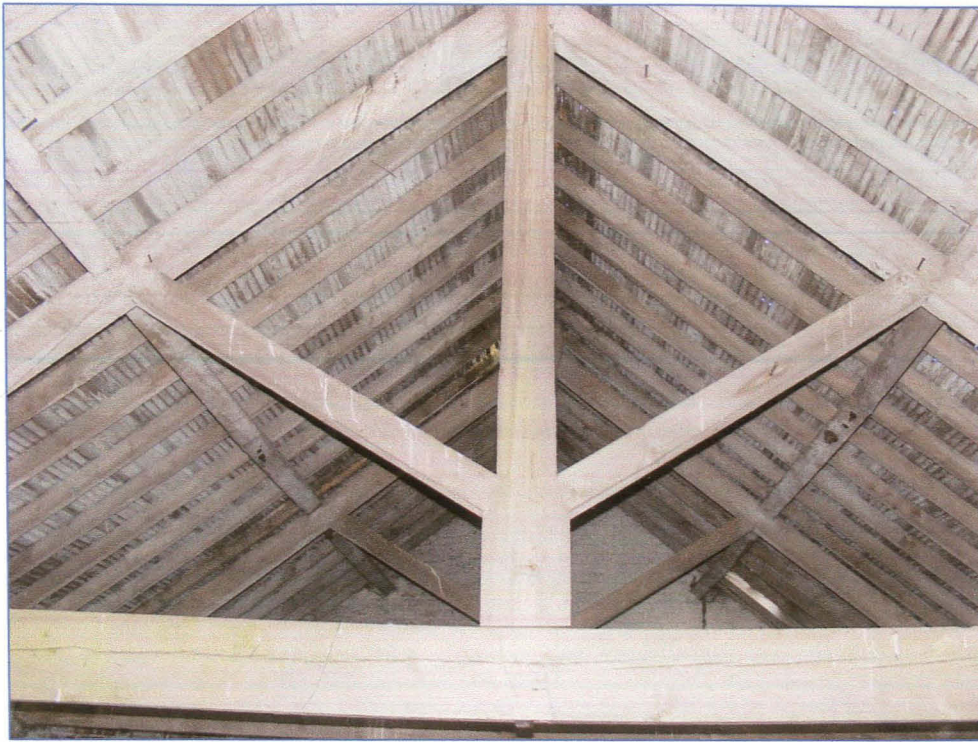
- 5.3.8 The internal roof structure of B1 and B2 is identical, with trenched purlins and tie beams supporting a king post with diagonal struts between the king post and the principal rafters (Plate 21). The two rooms also have the same general layout in plan, with a central raised concrete floor and a walkway running along the west side of the building, adjacent to a concrete feeding trough that also runs the length of the building. A tubular steel framework also runs the length of the building, to harness the cattle during milking (Plates 22 and 23). These features are all likely to represent 20th century alterations to the building, as a result of the mechanisation of the milking process.

Plate 21 (Shot 26): Roof structure of Rooms B1 and B2, looking north-north-east from the south end of B2

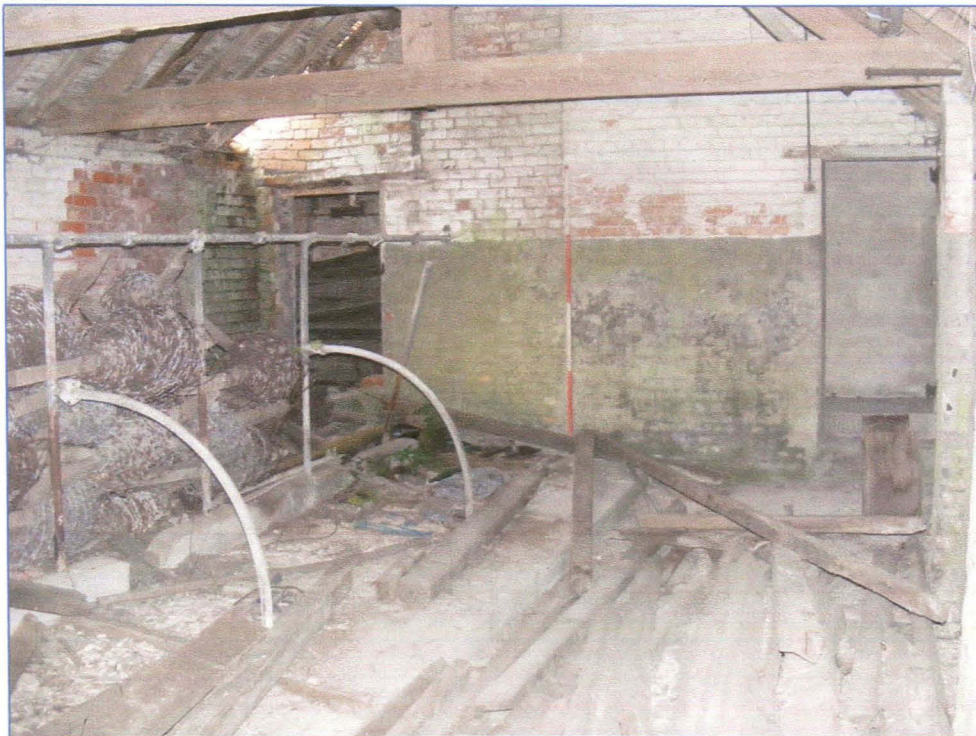
Plate 22 (Shot 27): Interior of Room B1, looking north-north-west from the eastern doorway into B2, showing the steel frame of the milking stalls to the left of shot and the concrete platform. At the far end of the room, adjacent to the scale can be seen the abutting walls of the threshing barn to the west and outbuilding B3 to the east.

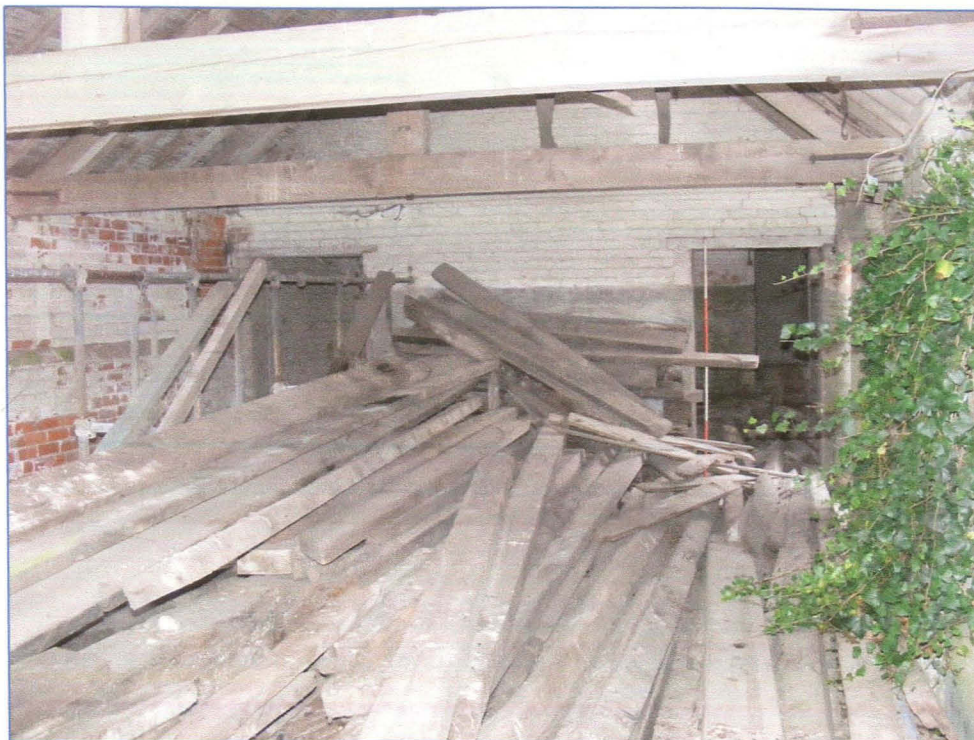
Plate 23 (Shot 25): Interior of Room B2, looking north-north-west from the south-east corner. The steel frame of the milking stalls is visible to the left of the shot, adjacent to a walkway running along the length of the building.

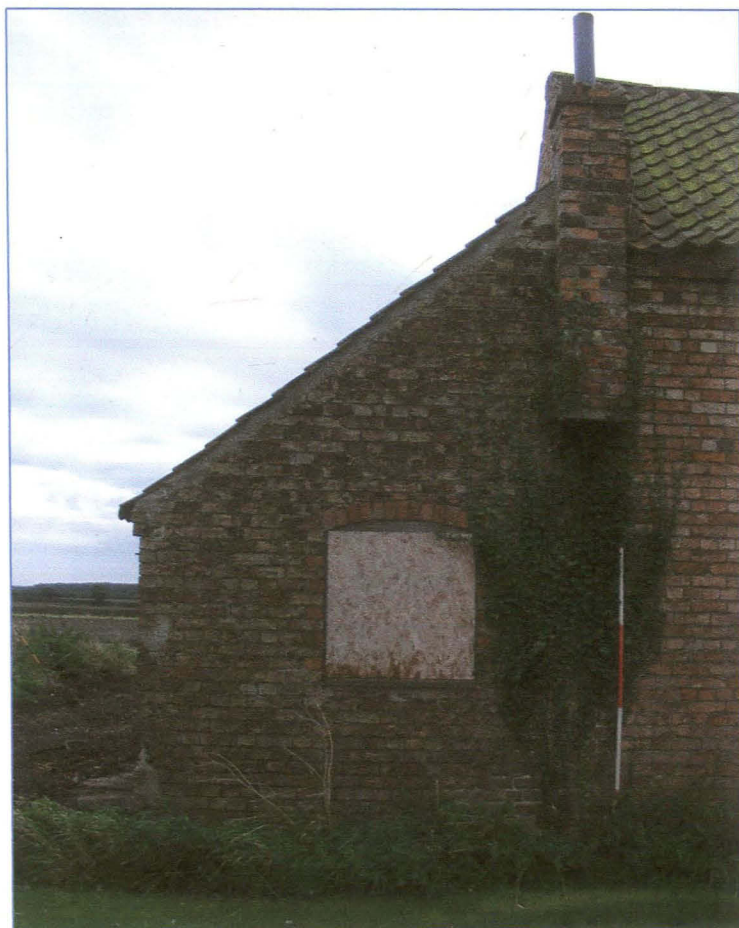
- 5.3.9 At the north end of the range, abutting the east end of the threshing barn is a small outbuilding with a single-pitched pantile roof, Room B3. It is accessed from B1 by a door in the south elevation, with another door in the east wall. It has two windows, one in the north elevation (Plate 24) and one in the east elevation (Plate 19). The window in the north elevation has a segmental arch of brick headers and the window in the east elevation is a simple square opening positioned directly below the roof line. A square chimney stack with a cylindrical ceramic pot is apparent on the external north elevation (Plate 24), but is not visible internally.

Plate 24: (Shot 23): North elevation of outbuilding B3, looking south-south-east

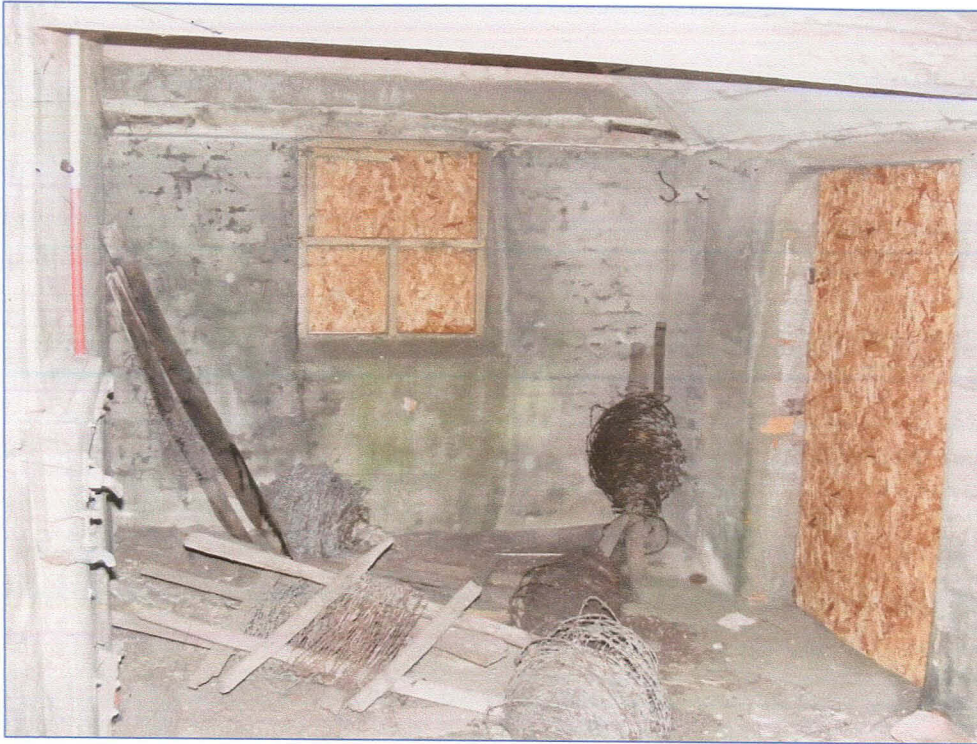
Plate 25 (Shot 25): Interior of Room B3, looking north from the doorway into B1.

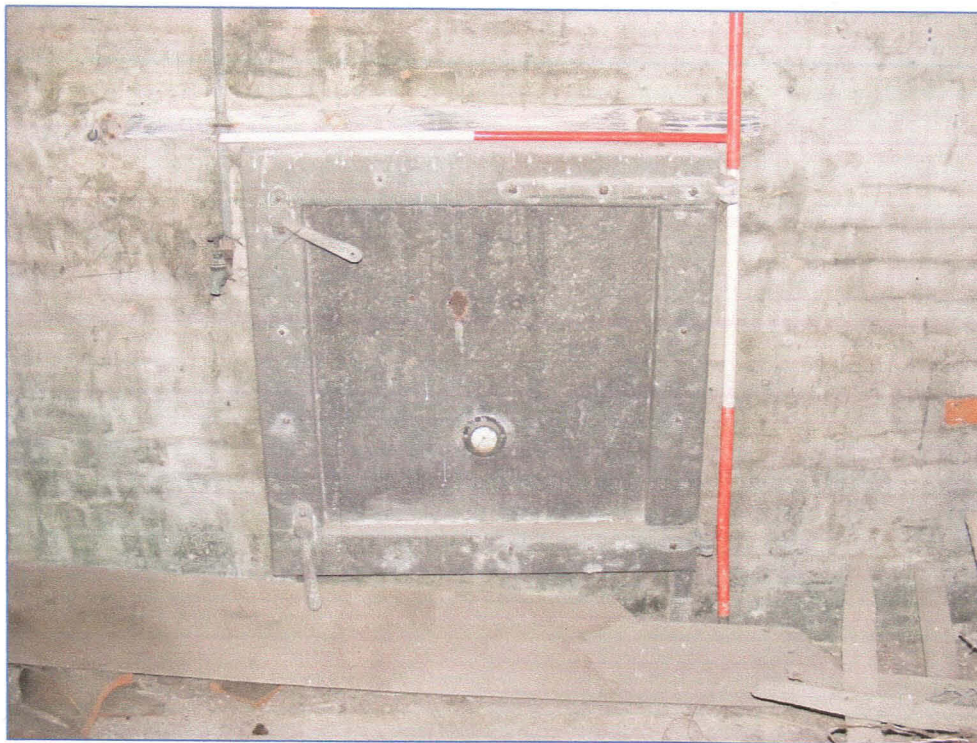
Plate 26 (Shot 39): Possible steam sterilising chest in west wall of Room B3.
Looking west-south-west
