**PHOTOGRAPHIC SURVEY REPORT:  
THE USHER GALLERY, DANESGATE, LINCOLN**

Planning References: 2007/0560/CAC and 2007/0564/LBC  
NGR: SK 97767 71636  
Site Code: LUSH 09  
LCCM Accession Number: 2009.133  
OASIS Reference Number: allenarc1-65064

Report prepared for Focus Consultants (UK) Limited

By  
Allen Archaeology Limited  
Report Number 2009051

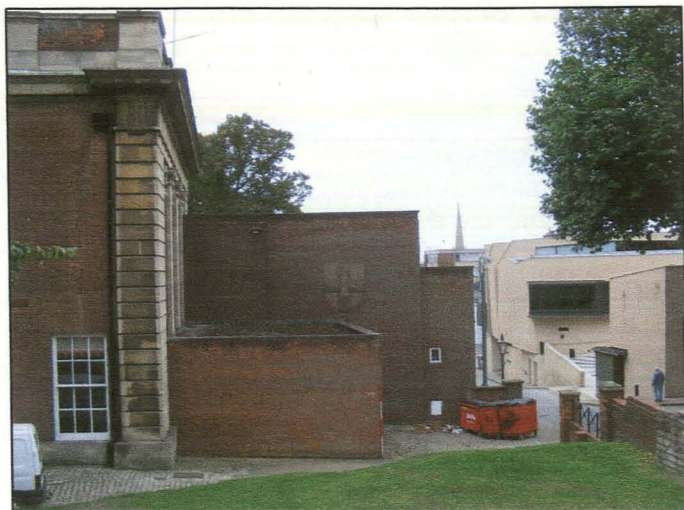
- 6.2.2 The north elevation is partially obscured by the Coin Gallery. The remainder is built in Flemish Bond brickwork, and is in three bays. The eastern and central bays are higher than the bay to the east, to accommodate a lift shaft and the hallway connecting the building to the Usher Gallery. The central bay of the elevation protrudes slightly from the adjacent sections and has an architectural embellishment in the form of a two-tone brickwork representation of the City of Lincoln's coat of arms (Plate 1).

**Plate 1 (Shot 1):** North elevations of the Coin Gallery and Curtois Gallery, looking north. The main Usher Gallery is to the left of shot

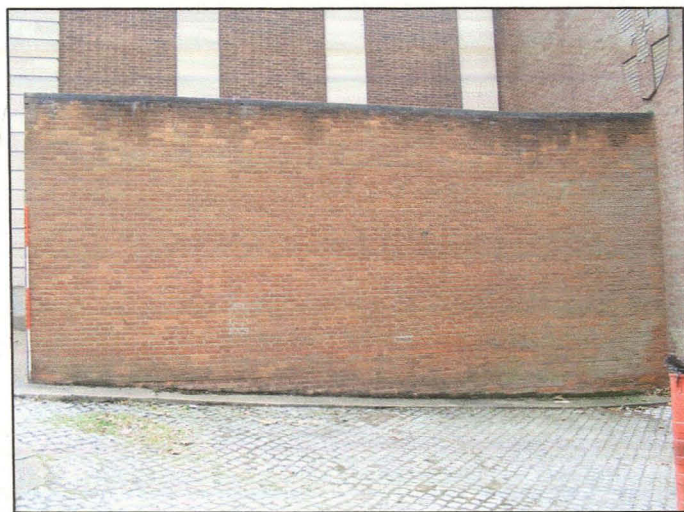
**Plate 2 (Shot 3):** West elevation of the Coin Gallery, looking east from Danesgate

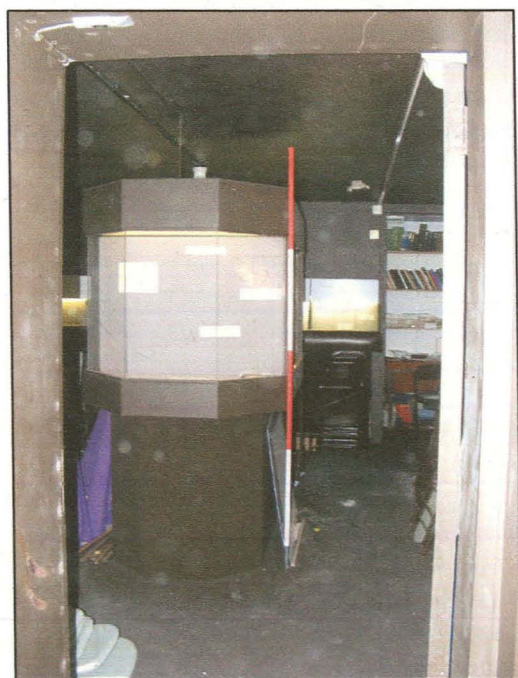
- 6.1.2 The interior of the Coin Gallery is accessed from its southern end, via a hallway running between the Usher Gallery and the Curtois Gallery. It has a small entrance lobby with a sliding sash doorway, beyond which is a heavy steel security door. The room beyond is a (currently disused) display area, with a central display case and further display cases along the north, east and west sides of the room. The walls are covered with wood panelling with a plasterboard ceiling, all painted dark brown (Plate 3).

**Plate 3 (Shot 24):** Interior of Coin Gallery, looking north

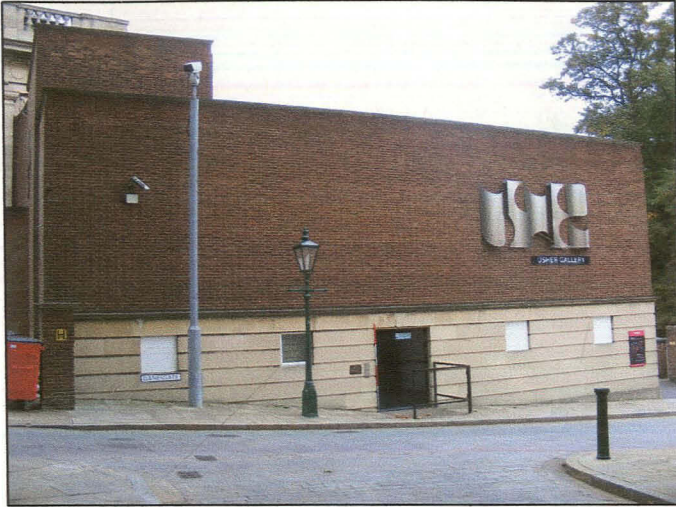
- 6.2.4 The lower part of the west elevation (Plate 4) is in dressed limestone blocks, with horizontal banded rustication, imitating elements of the main Usher Gallery building (such as the central bay of the south elevation). This is separated from the Flemish Bond brickwork above by a moulded concrete string course. There is a single double doorway in the centre of the wall, flanked by four square single light windows, all confined to the lower limestone element of the elevation. Three of the windows are blocked with wood panels; the fourth has frosted glass reinforced with wire, with an internal steel grille visible.

**Plate 4 (Shot 4):** West elevation of the Curtois Gallery, looking east-north-east. The door allows access to the basement.

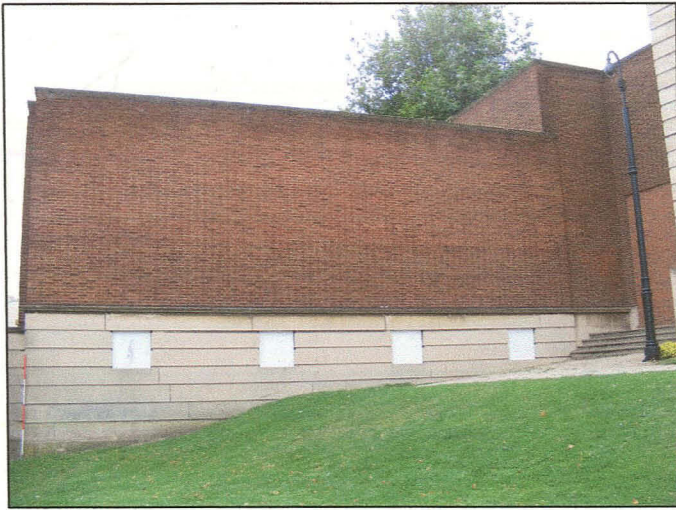
- 6.2.5 The same pattern of brickwork and rusticated stonework with a dividing string course is reflected in the east elevation (Plate 5), which also has four square windows, all of which have been blocked with wood panels. To the north, this elevation abuts the south elevation of the connecting corridor between The Usher Gallery and the Curtois Gallery (Plate 6). This elevation is also in Flemish Bond brickwork, resting on a stone plinth that extends to the height of the

**Plate 5 (Shot 8):** East elevation of the Curtois Gallery, looking west-north-west. Note the terracing of the ground to provide a level surface for the building

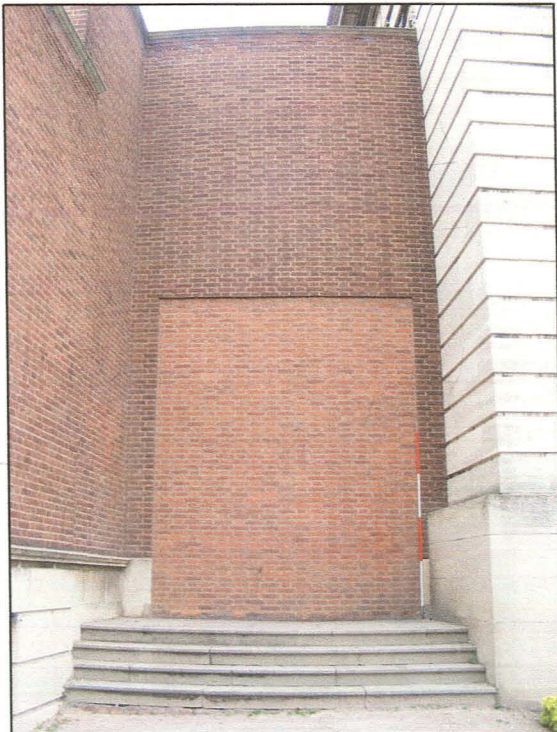
- 7.2 Alterations to the buildings since their construction are few in number and of limited interest. There is a blocked doorway in the south elevation of the connecting corridor between the Curtois Gallery and the Usher Gallery, the doorway probably being sealed when the Coin Gallery was built onto the north side of this corridor. This would also have necessitated the opening of a new access into the Curtois Gallery at this time.

**Plate 6 (Shot 9):** South elevation of the Curtois Gallery, looking north-east, showing blocked doorway into the corridor between the Usher Gallery and Curtois Gallery

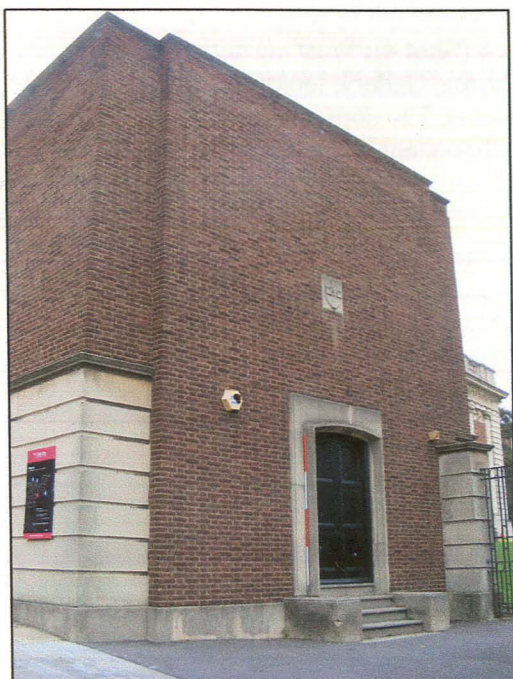
- 6.2.6 The south elevation of the Curtois Gallery is in three bays (Plate 7). The central bay, which occupies the majority of the elevation, protrudes slightly and is built in Flemish Bond brickwork on a stone plinth. A flight of three steps flanked by stone buttresses leads up to a pair of panelled wooden doors with a moulded stone door case and a cast concrete City of Lincoln coat of arms above the door. In the westernmost bay, the rusticated stonework and concrete string course is continued from the west elevation of the building, with brickwork above. There is a rusticated stone gatepost attached to the eastern bay, with a pair of wrought iron gates between the Curtois Gallery and the administrative bungalow to its south.

**Plate 7 (Shot 6):** South elevation of the Curtois Gallery, looking north-east. The doors in this elevation allow access to the basement.

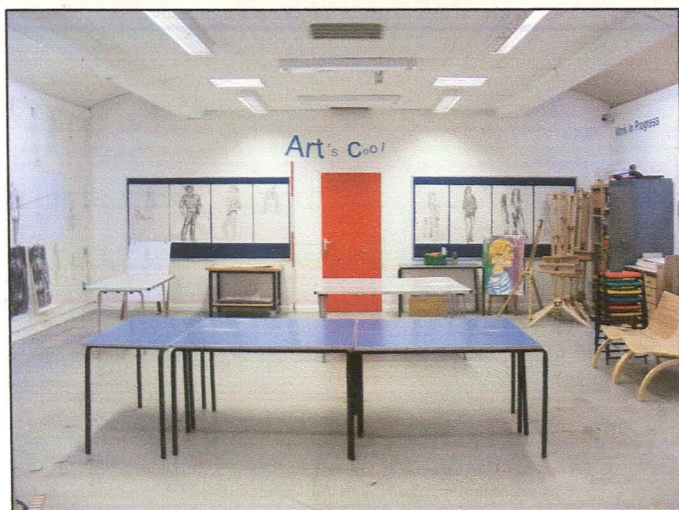
- 6.2.9 To the south of the hallway is the main gallery space, currently in use as an art studio accessed by a single large doorway (Plate 8). The central part of the building has a suspended ceiling, flanked by two rows of skylights inserted into a sunken roof above. There is a timber framed partition wall with a central door at the south end of this room, allowing access to a storage area.

**Plate 8 (Shot 28):** Interior of Curtois Gallery, looking south. There is a storage area behind the timber framed partition wall at the south end of the room.

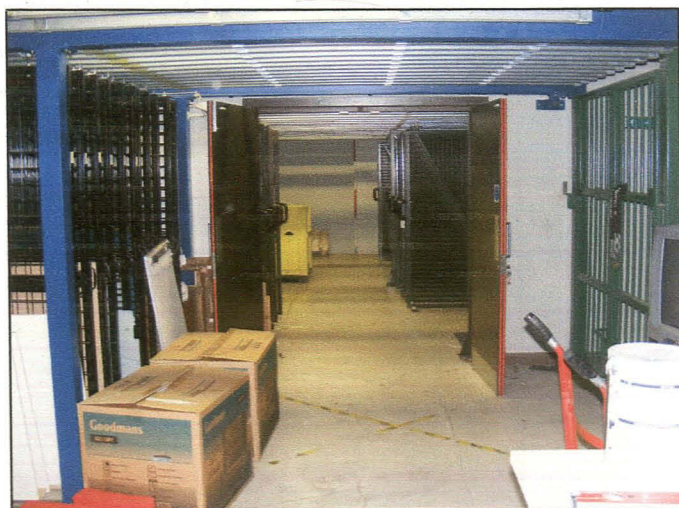
- 6.2.12 The remainder of the basement comprises two further storage areas separated by large double doors, both of which contain moveable steel racking for storing artwork (Plate 9). The southernmost store room has another set of double doors in its south elevation allowing external access. The northern room has a set of double doors surrounded by a steel security cage, which allows access onto Danesgate.

**Plate 9 (Shot 32):** Basement of Curtois Gallery, looking south. The double doors at the end of the room give access into the grounds of the Usher Gallery, while the green cage to the right encloses a disabled access onto Danesgate.

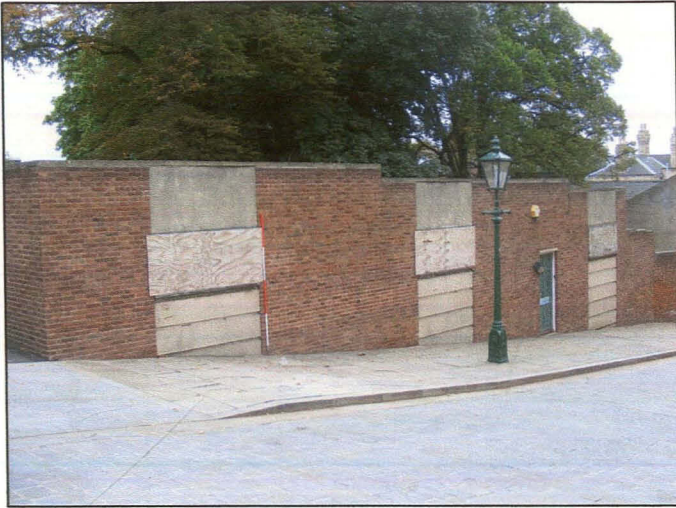
**Plate 10 (Shot 11):** West elevation of administrative bungalow, looking south-east from Danesgate. This shot illustrates the three levels on which the building has been built, and also shows the banded rustication below the windows

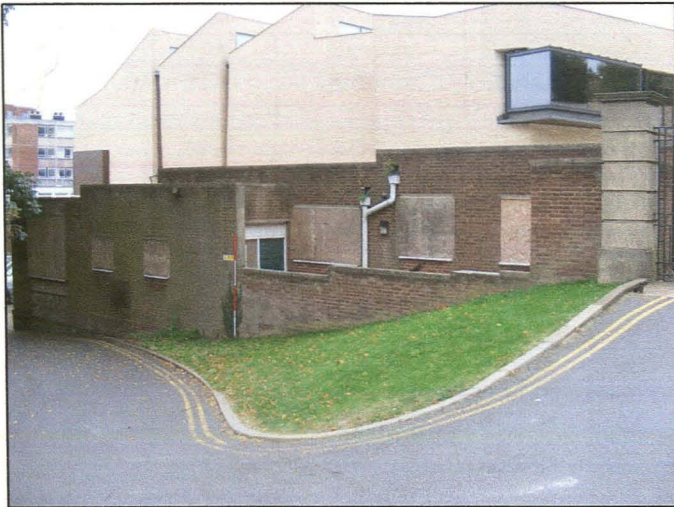
There is a single example of a window of this type in the south elevation, and another in the east elevation of the southernmost block of the building. The east elevation of the southern block has two further square windows, while the same elevation of the two remaining blocks contains three large windows, all blocked with wood panelling (Plate 11).

**Plate 11 (Shot 13):** East elevation of administrative bungalow, looking south-west

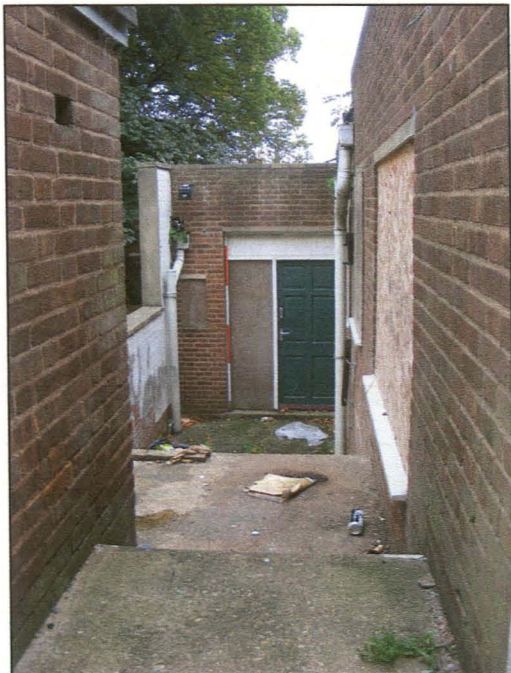
- 6.3.3 The north elevation of the northern block has no openings or architectural embellishments. There is a small brick outbuilding immediately to its east and a stone gatepost with wrought iron gates corresponding with an identical post on the Curtois Gallery to the north. A brick boundary wall extends southwards from this point. To the west of this boundary wall steps lead down to a panelled wooden door in the north elevation of the south block (Plate 12).

**Plate 12 (Shot 12):** View along east side of administrative bungalow, looking south, showing steps down to door into southern part of the building

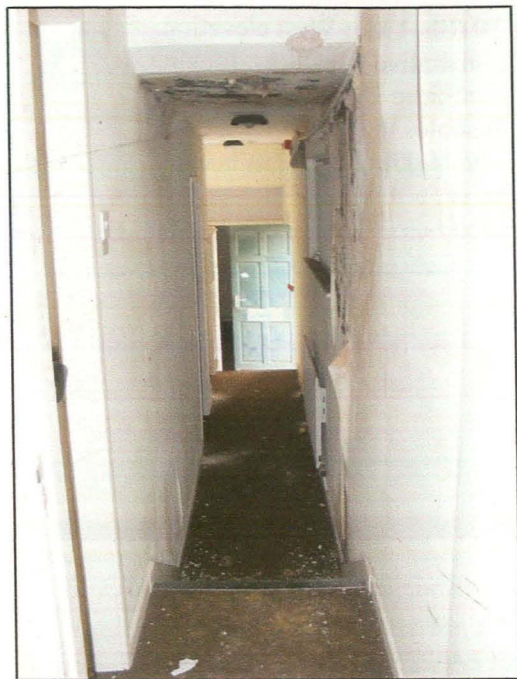
**Plate 13 (Shot 27):** Corridor along west side of bungalow, looking south. Note the steps down into each of the three sections of the building.

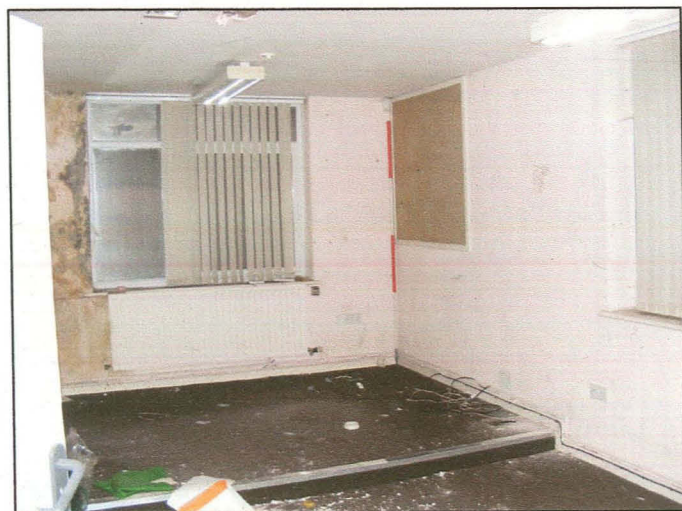
**Plate 14 (Shot 18):** Office room at south end of administrative bungalow building, looking east-south-east

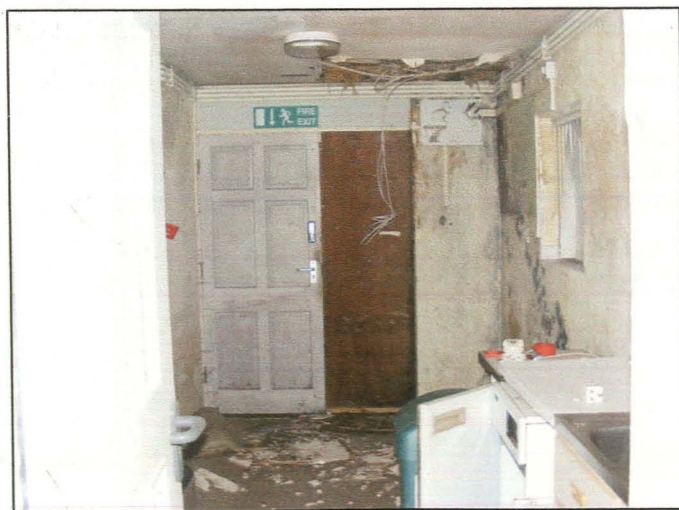
**Plate 15 (Shot 19):** Kitchen area in administrative bungalow, looking north
