Wash Banks Tidal Defences – Hobhole to Butterwick Low

**Archaeological Watching Brief and Pillbox Recording
at Freiston Shore and Boston Haven**

**Report for Halcrow UK
(on behalf of The Environment Agency)**

LAS Report No. 501

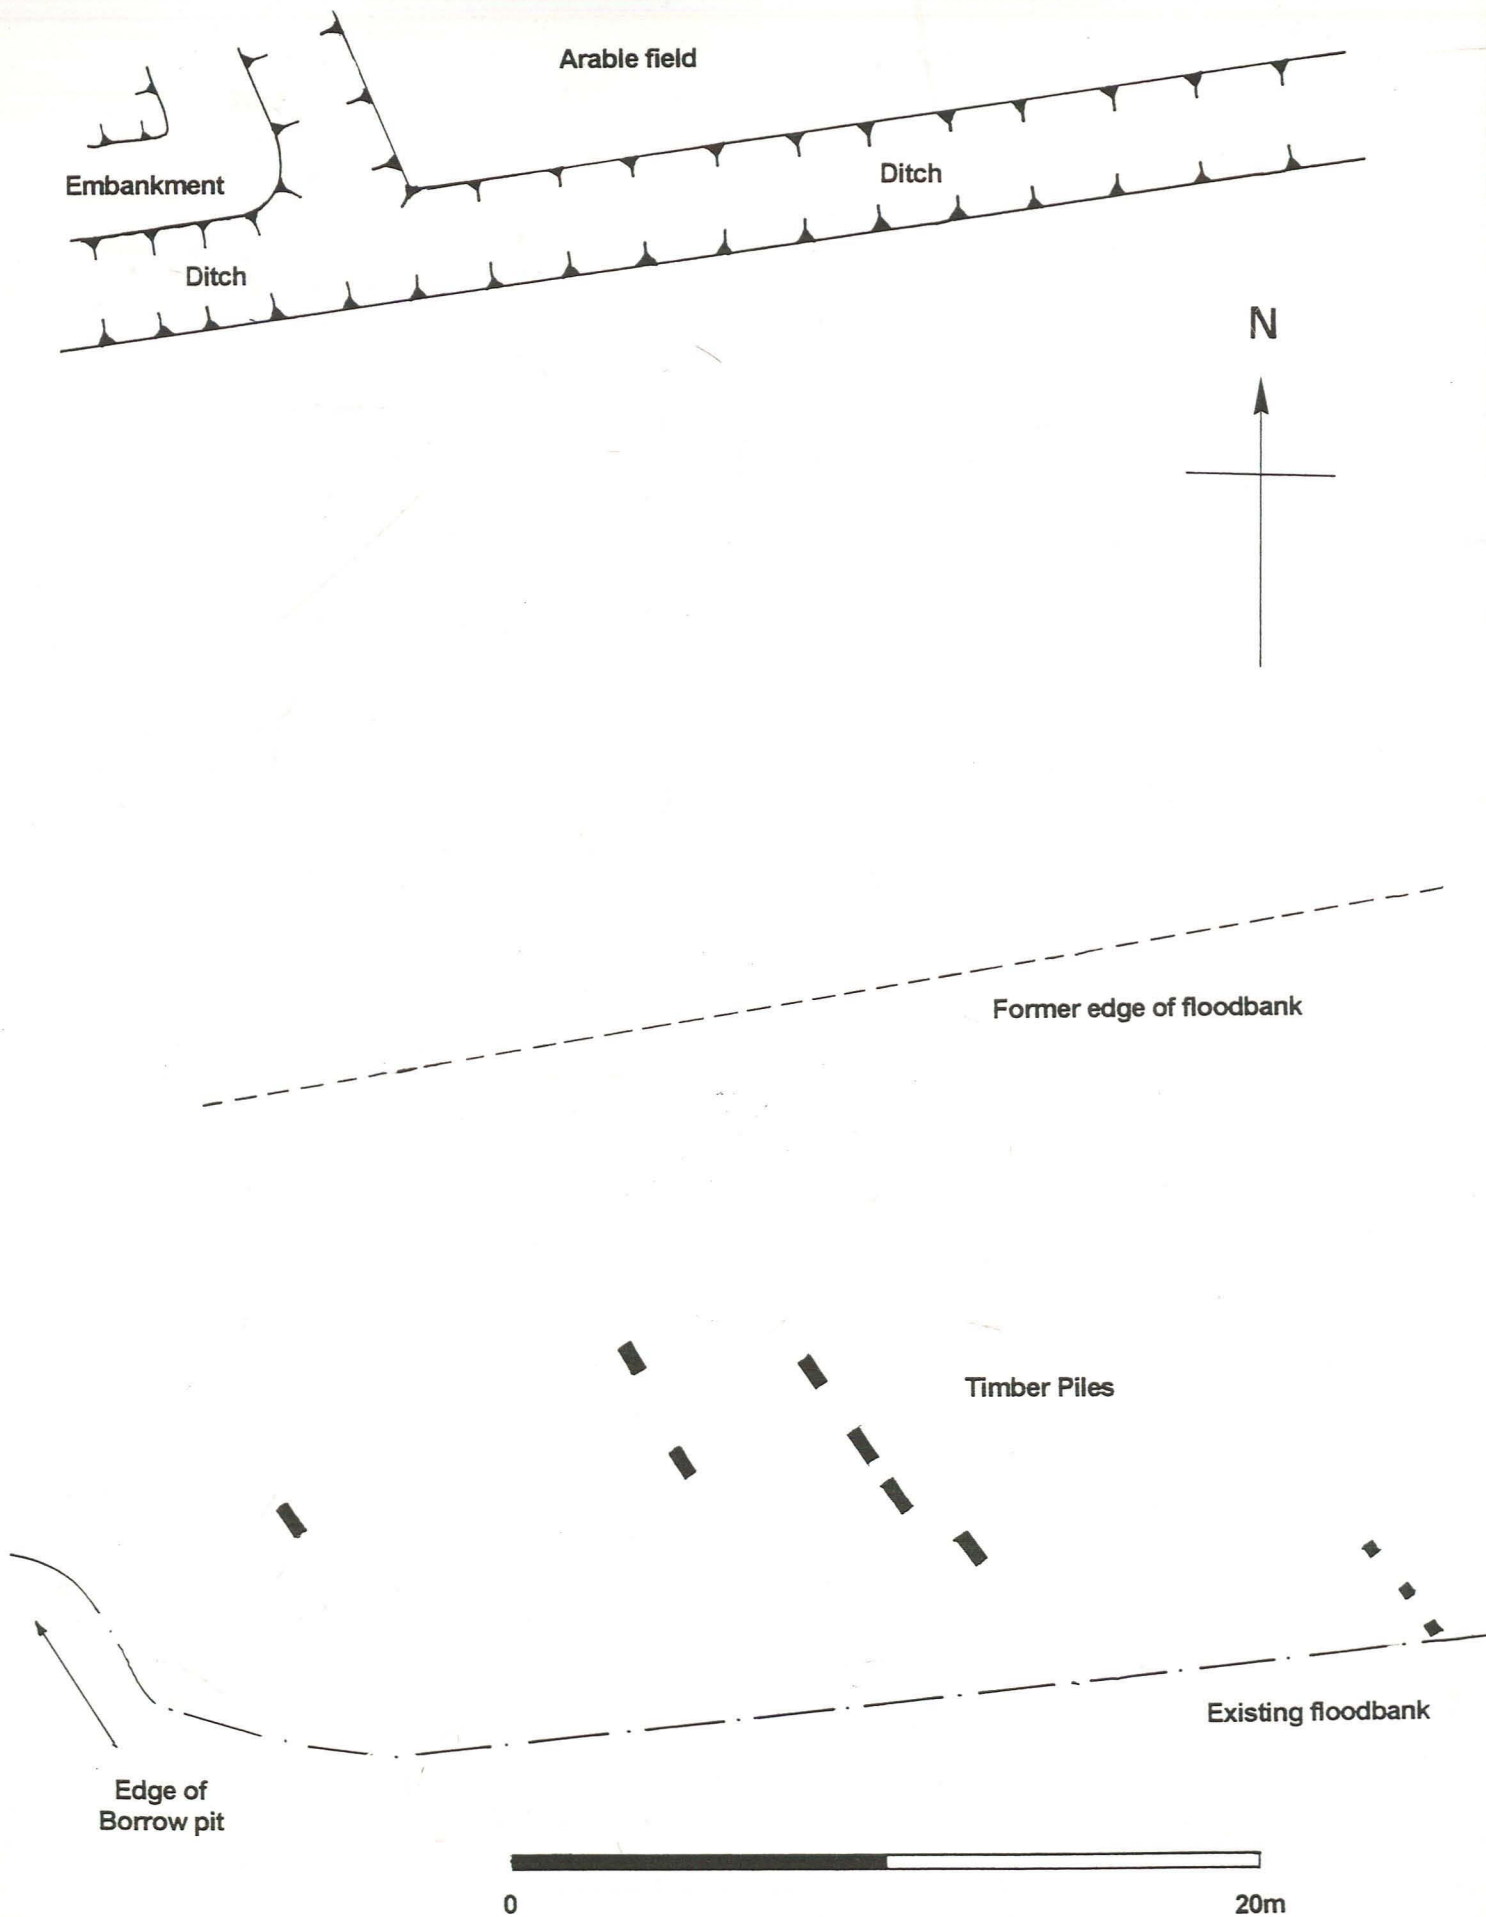
The mechanical excavators had produced a 2.2m high cutting edge into the upcast material of the existing bank. Along about 30m of bank, at least ten upright timber piles had been exposed, and there were indications that others had been removed from the same alignments before their potential significance was appreciated (Fig. 4; Pl. 12). The visible timbers were in four NW-SE aligned rows, with the spacing between rows varying from 10m to 4m. Within each row, the post spacing was irregular, with posts as close as 0.65m and as far apart as 2.25m (excluding areas where timbers may have been

removed). The row alignments were not sufficiently uniform to indicate that they were contemporary features, but the similarity of the posts suggested that they had served a common function and were probably of fairly similar date. The lack of uniformity of the post spacings could result from frequent replacement or reinforcement of the features.

Fig. 4 Sketch plan showing approximate positions of timber piles revealed during removal of silt from the Haven floodbank (McDaid, after Tann).

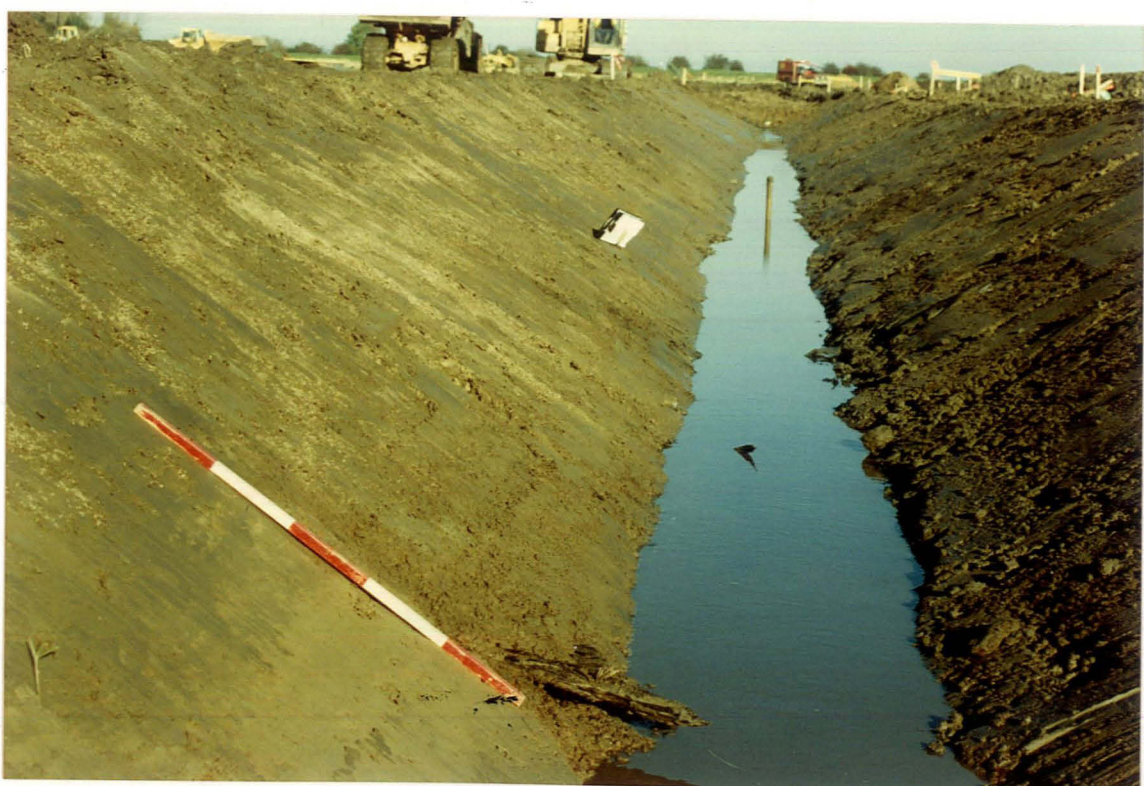
A ditch was excavated along the landward side of the trial bank, in order to connect existing drains and drainage ditches. At the southern end of this ditch, at a depth of about 1.8m below ground level, a cluster of square-cut and rectangular-cut timbers **3** were exposed at the ditch base, aligned roughly horizontally (Pls. 6 and 7). The timbers were visible across a 12m length of the ditch. Around the timbers, the silt was darker and clayier than the fine brown silt away from them; the darker soil extended vertically close to the upper horizon of the subsoil. This colour and texture difference is presumably the result of the timbers trapping heavier silts, coupled with the organic matter from the rotting timbers.

It was reported that two wrecked coal barges had been known on the salt-marsh east of Freiston Shore before the prison floodbank was built in about 1979. The timbers found in the trial bank ditch were assumed to be from one of those vessels, probably *in situ*.

Pl. 6 New drainage ditch north of the trial bank, with timbers of a buried wreck visible between the white board and the 1m red/white scale (looking NE).

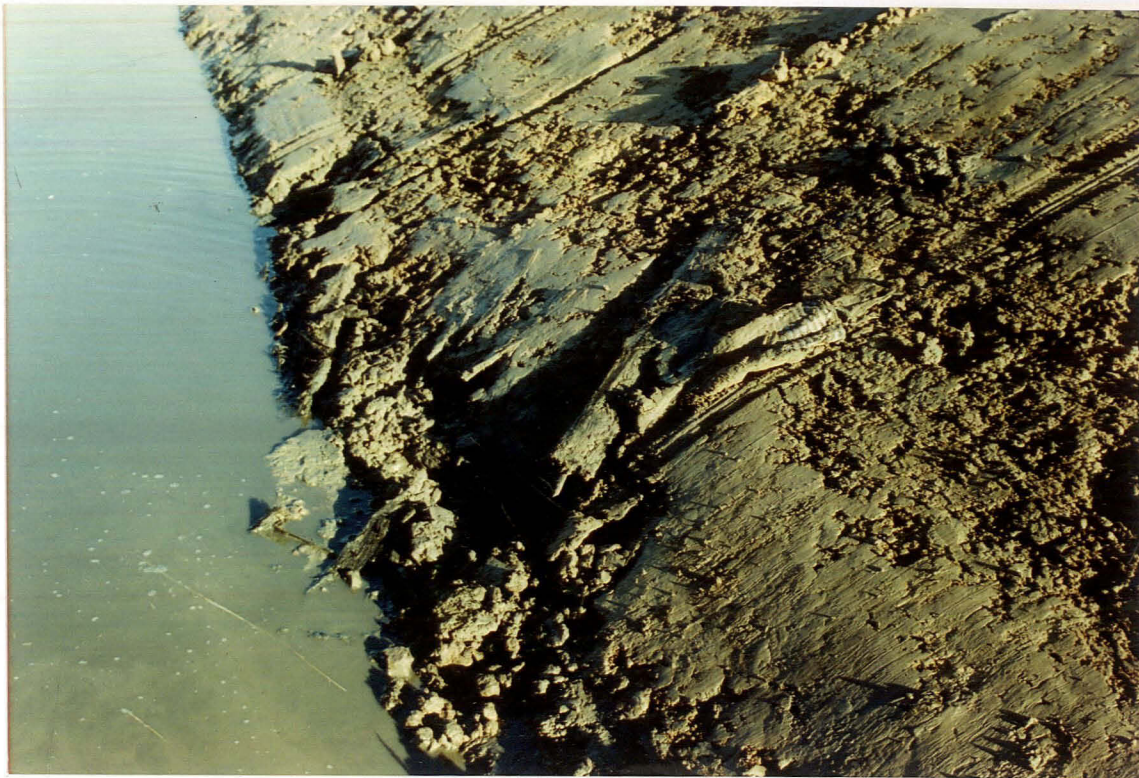
Pl. 7 Machine-damaged timbers exposed near the ditch base.

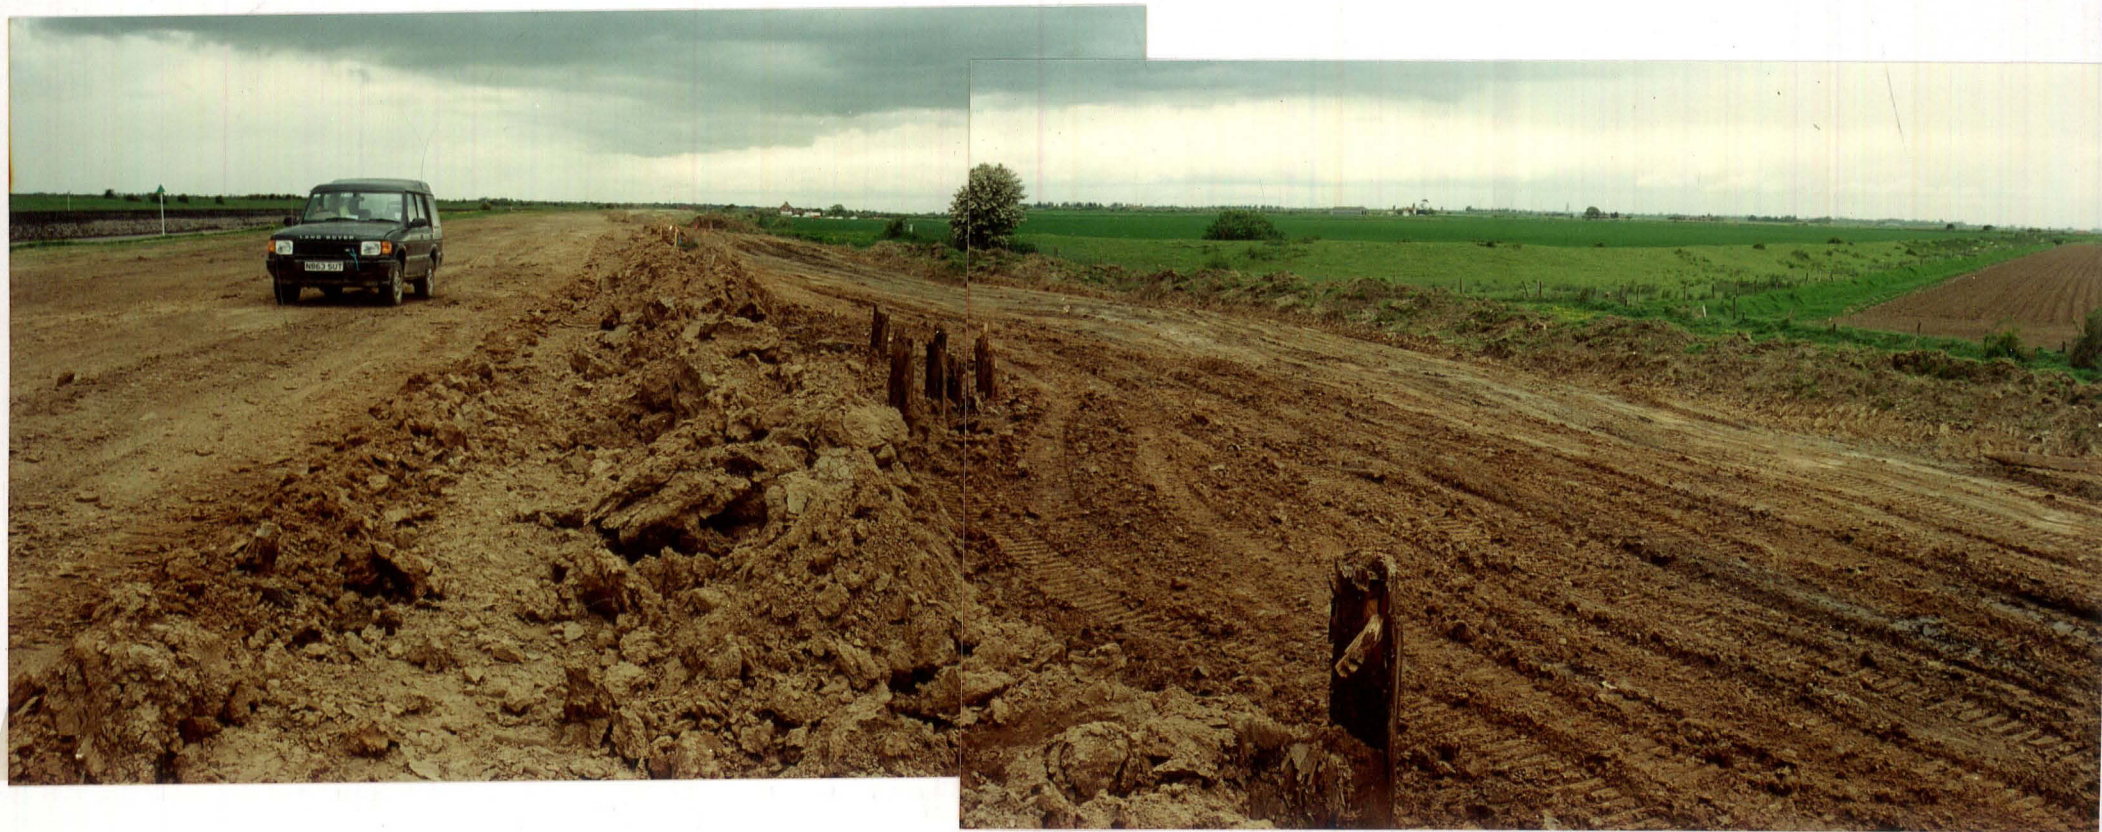
On 16th May 2000, LAS was informed by Mike Hastings that some vertically driven timbers had been exposed by machines excavating material from behind the Haven floodbank near to the end of Cut End Road. The king piles were about 0.3m square, and apparently positioned diagonally to the water's edge. It was suggested that they represented a former landing stage (Pl. 11). A site visit was made by G. Tann.

Pl. 11 Timber piles exposed by removal of material from the existing floodbank near Hob Hole (looking north). The houses are on Cut End Lane.

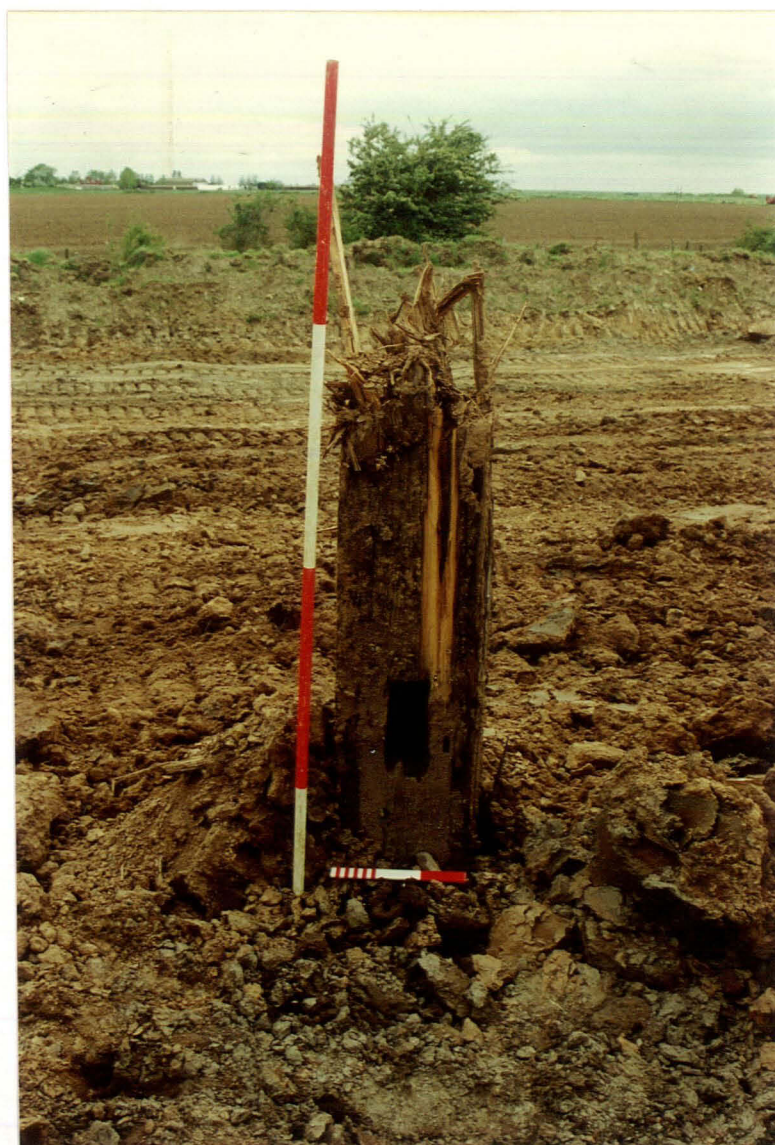
One of the piles had a 0.09m x 0.19m cut slot, suggesting either that it derived from an earlier structure, or that it had been braced or attached to other posts (Pl. 13). This was the only evidence of linking timbers within the cluster of piles.

Pl. 13 Timber pile with slot within the Haven floodbank (looking north). Scales 2m and 0.3m.

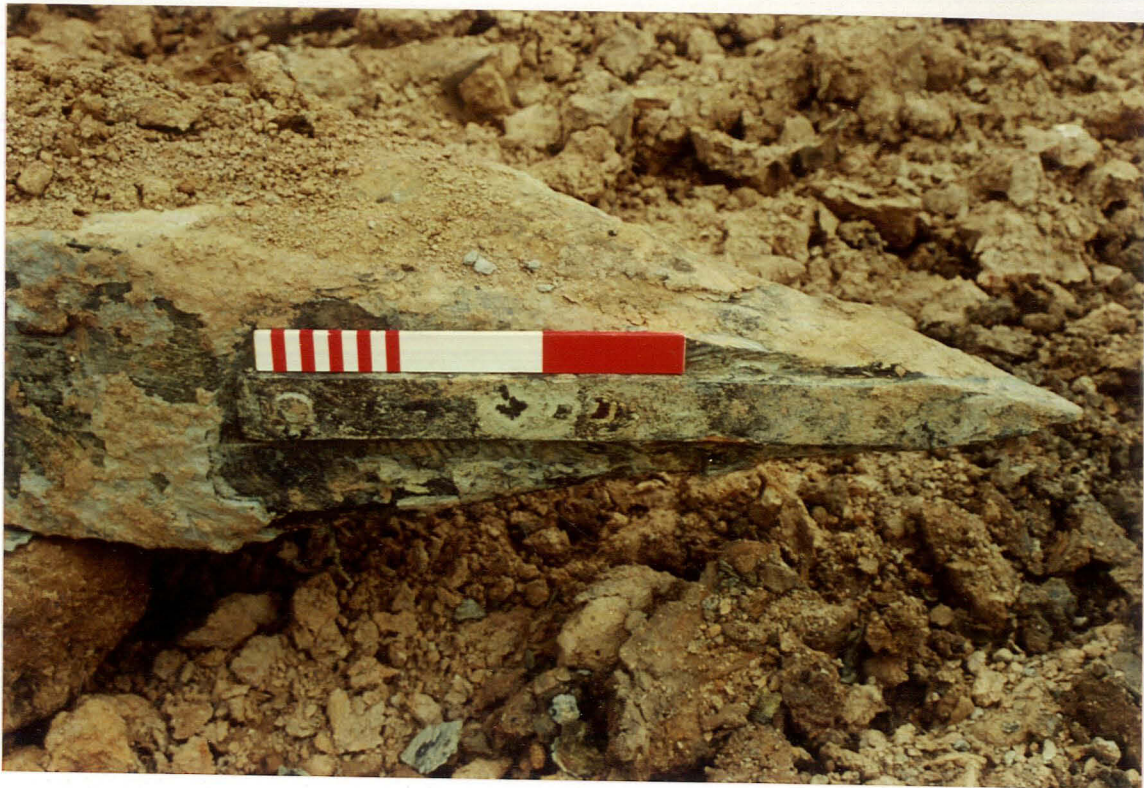
At least two timbers had metal attachments. One had an iron bolt through it, while another (removed by machine) had a 0.65m long narrow iron or steel plate attached to the post's pointed base (Pl. 14). The metalwork was no earlier than the post-medieval period, and may have been nineteenth century or slightly later in date.

Pl. 14 Metal plate reinforcing the tip of an uprooted timber pile. Scale 0.3m.

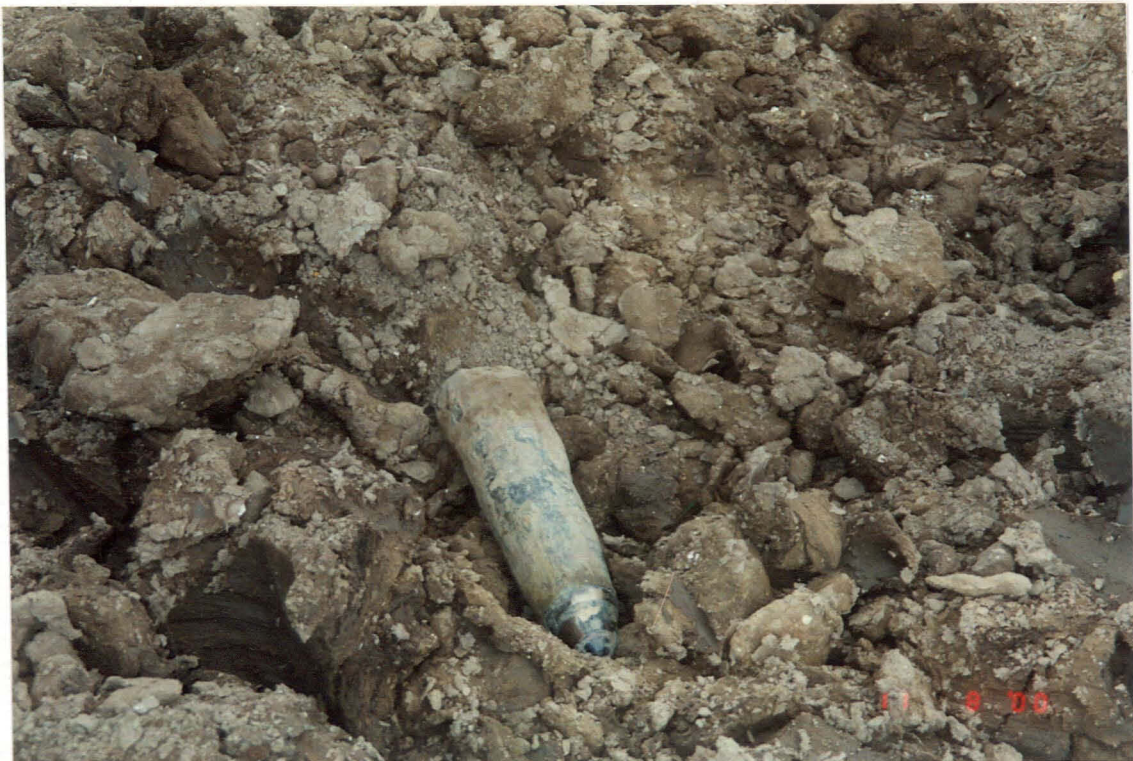
No further discoveries were reported from the position of the floodbank until 11th August 2000, when a brass-headed cylindrical object with bullet tip was found in the silts by a machine operator. The object was 250mm long and 75mm diameter, and was identified as a potentially dangerous item of military ordnance (Pl. 15). G. Tann was advised of the find, but did not make a site visit. Photographs were taken of the shell before it was disposed of by controlled explosion, and a report was produced by Mike Hastings.

Pl. 15 Shell found in Haven floodbank, August 2000. (Photograph supplied by Mike Hastings, Halcrow UK).

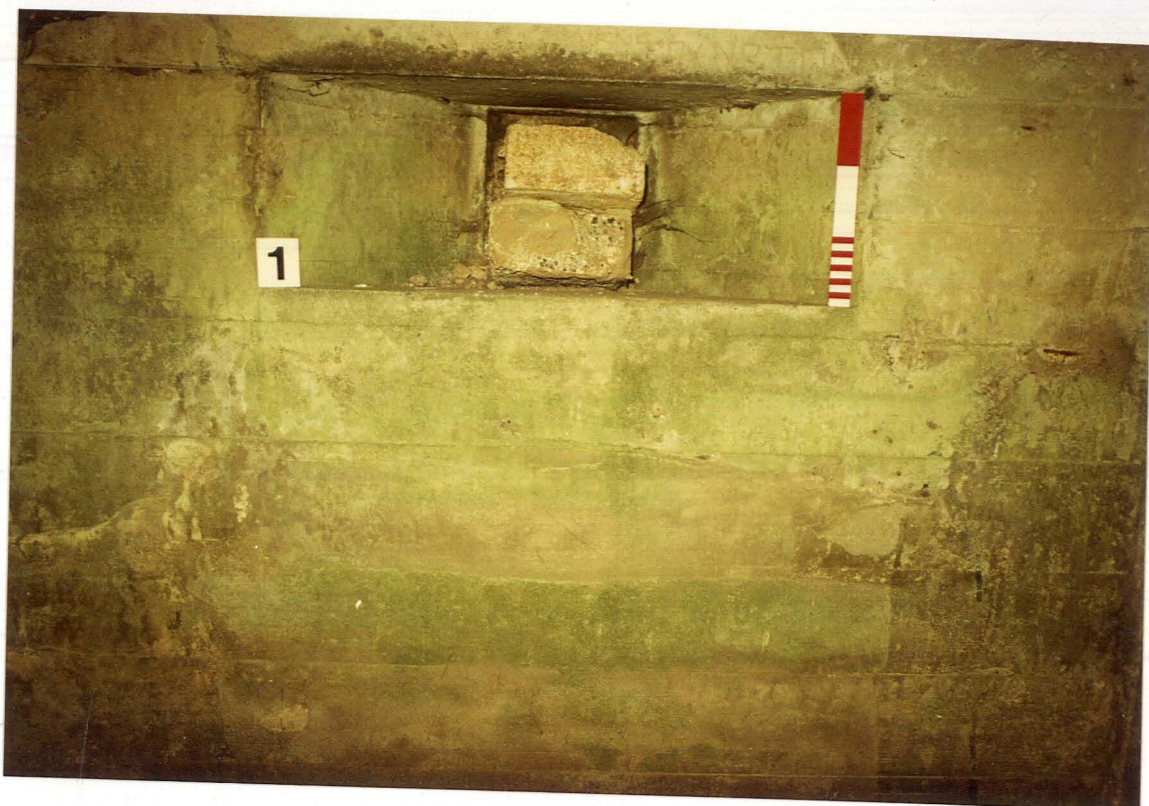
There was clear evidence that the existing floodbank had been constructed or raised after this pillbox was built. Gun embrasures facing the bank had been blocked to prevent soil entering the structure, and the floor level was higher than outside the pillbox (Pl. 18). The date for this section of floodbank is 1942, and it seems likely that the pillboxes were built shortly before the bank, or on an existing low bank.

Pl. 18 Blocked gun embrasure, pillbox 1. Scale 0.3m.

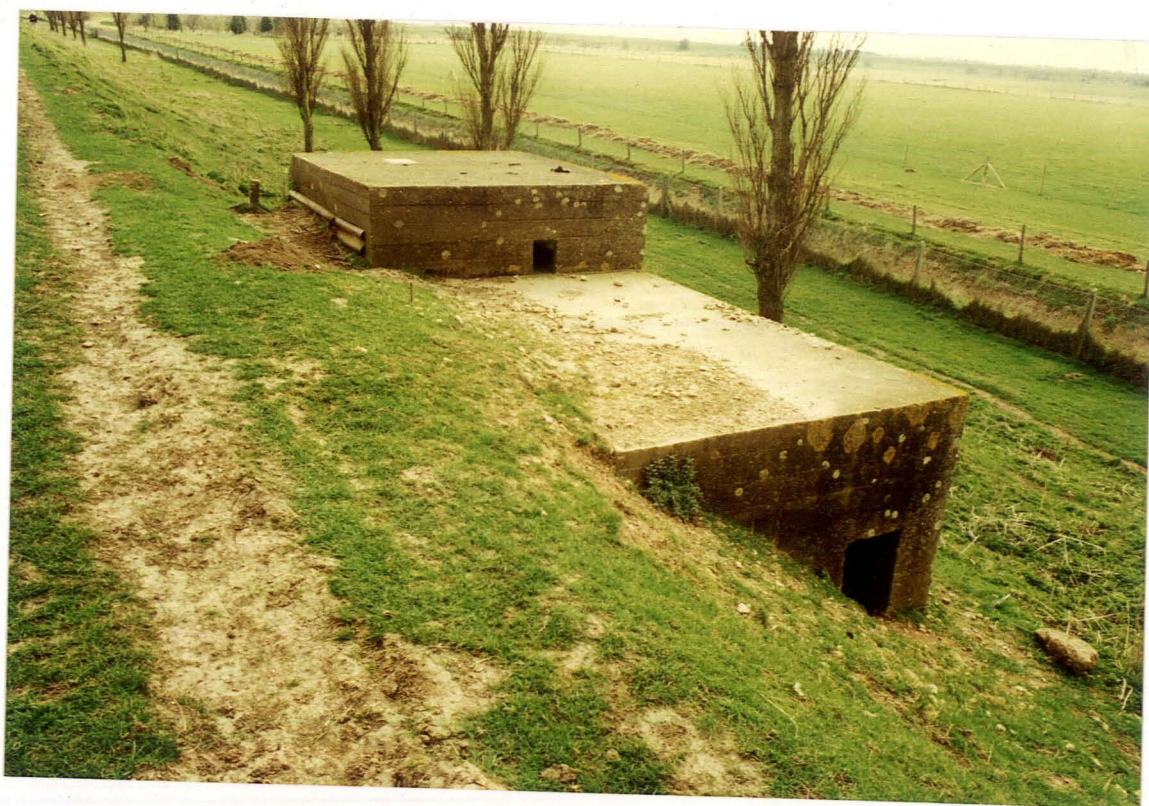
This pillbox also appeared to pre-date the floodbank, with shuttering preventing soil entering one embrasure. On the roof of the building, some graffiti was noted which appeared to date from construction of the pillbox (Pl. 22). It was transcribed as

Pl. 19 Pillbox 2, showing corrugated shuttering blocking seaward facing embrasure (looking south).

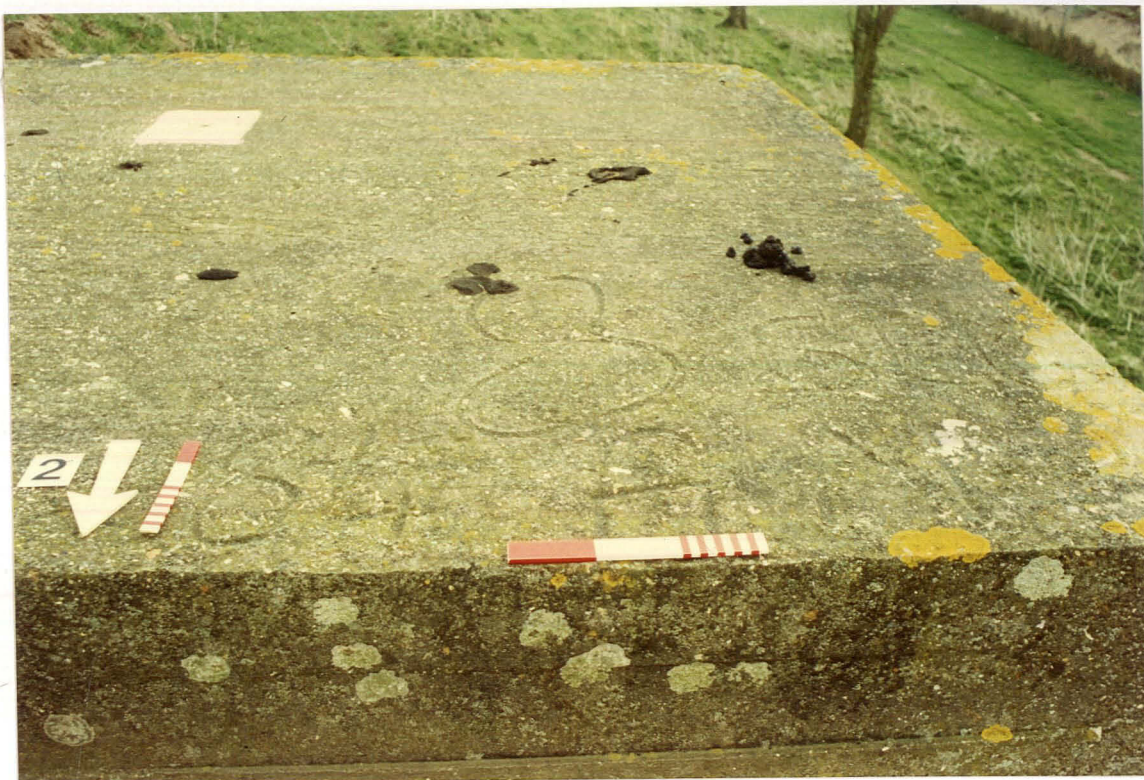
Pl. 22 Graffiti in concrete roof of pillbox 2.
