ST LEONARD'S HOTEL, STONEHAVEN PHOTOGRAPHIC SURVEY

Cameron Archaeology 6 May 2011

ST LEONARD'S HOTEL, STONEHAVEN, AB39 2DD PHOTOGRAPHIC SURVEY

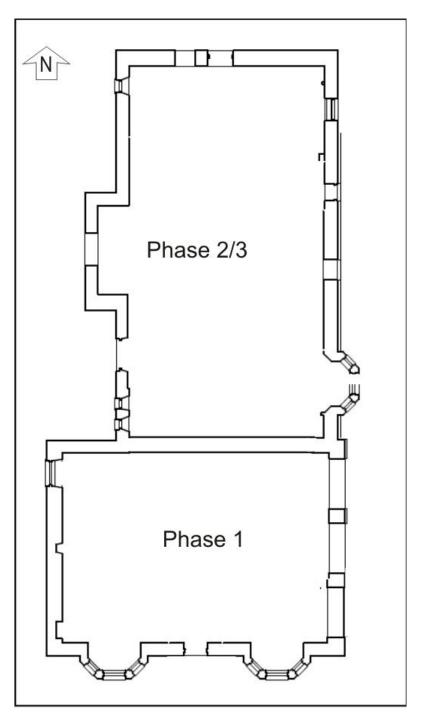
III 12 Phase plan

The hotel was originally built as a double fronted house (Phase 1) and additions to the rear (north) were added in Phases 2 and 3 (III 12). A roof scar on the exterior of the former north wall of the house indicates that the south area of the building is earlier than the north end (III 13). The finials over the Phase 1 first floor windows are square and over the Phase 2/3 first floor windows are round indicating that these portions of the building were constructed at separate times. A scar of a former roof line on the exterior of the former north wall of the Phase 1 house confirms that the southern portion of the current structure was constructed before the northern portion.
