Land at Dungman's Tack, Montrose,  
Angus, DD10 8SJ  
Evaluation of an area of proposed  
redevelopment

Cat Peters  
Cameron Archaeology  
1 June 2011

# **Land at Dungman's Tack, Montrose, Angus, DD10 8SJ**

## **Evaluation of an area of proposed redevelopment**

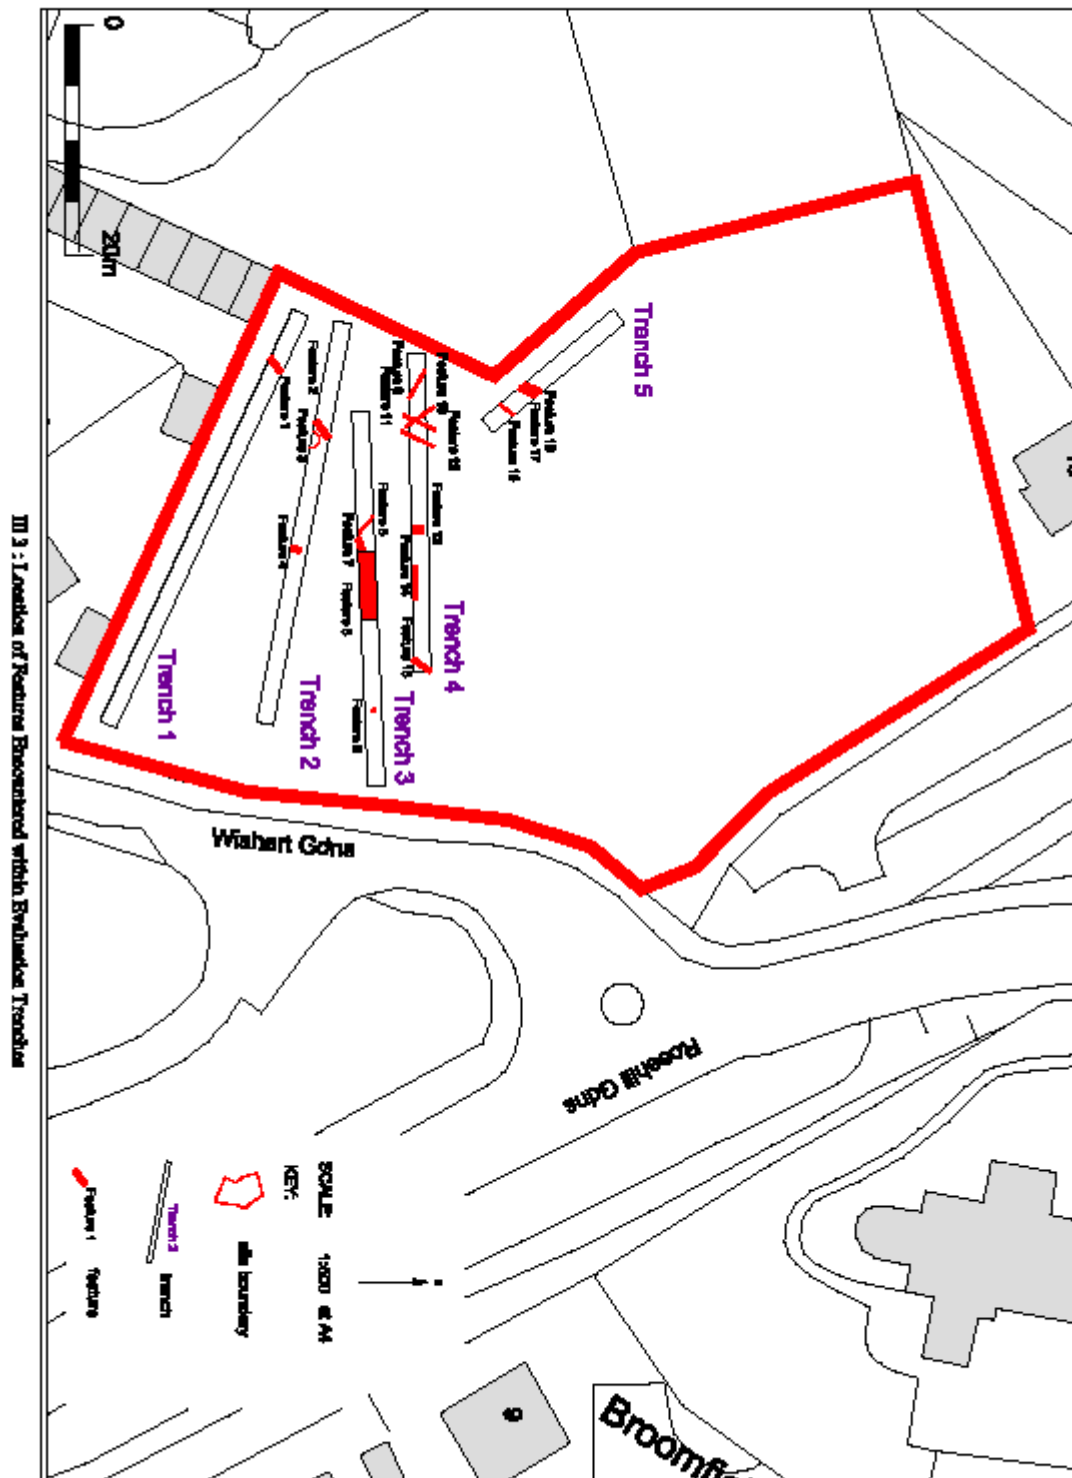
### III 3 Location of features encountered within evaluation trenches

The trenches are discussed individually in the text below III 3, which summarises the key features found within each trench.

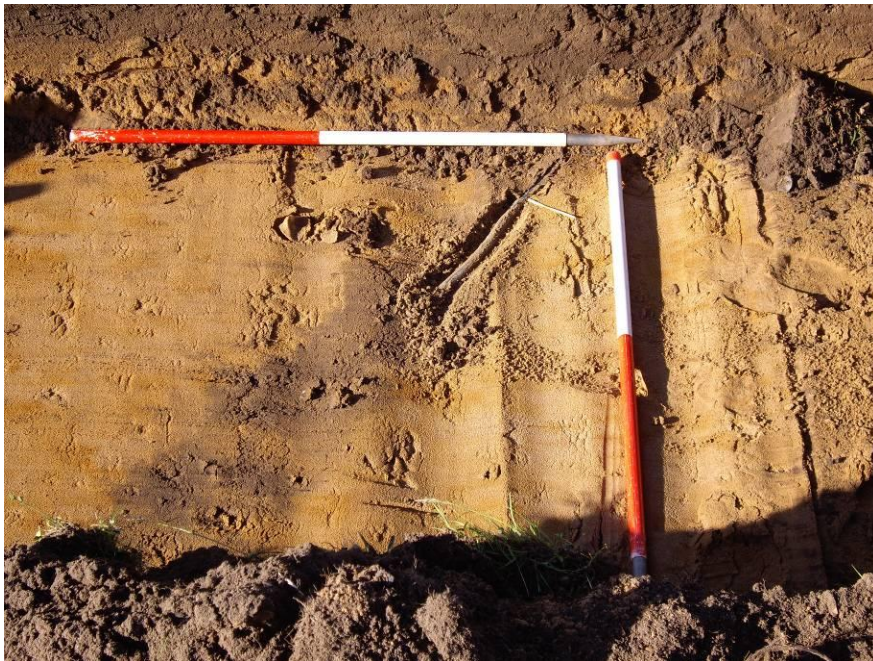
Ill 4 Photograph showing Feature 1

The trench was 1.5 by 42m in size with an average of 0.32m of mid-brown loose sandy topsoil, which lay above a loose orange sandy natural subsoil. The maximum depth reached was 0.85m. A narrow linear feature was located 5m from the western edge of the site (Feature 1). Further investigation revealed a lead pipe, 0.05m in diameter, residing at its base (Ill 4).

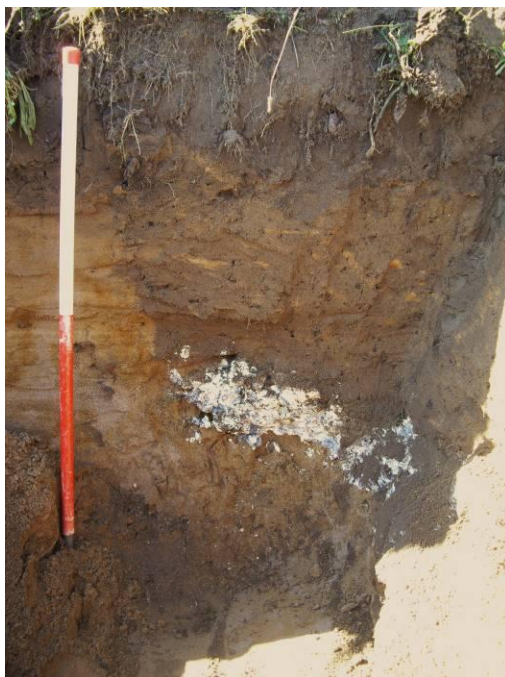
III 5 Photograph showing Feature 3

Trench 2 was 1.5m by 36m and located to the north of Trench 1. Feature 2 was a lead pipe located within a mixed backfill of 0.05 diameter, and located at a depth of 0.5m. It is likely to have been the same lead pipe encountered within Trench 1 (Feature 1). Feature 3 was located 11m from the western edge of Trench 2, and consisted of a hard white deposit with stone inclusions of 0.21m thickness beneath a mixed backfill mid brown sandy deposit of 0.75m thickness. This was interpreted to be a modern dump of possible hazardous material which was immediately recovered with soil. The material had the appearance of corroded batteries (Gary Brown, A&S Brown pers comm).

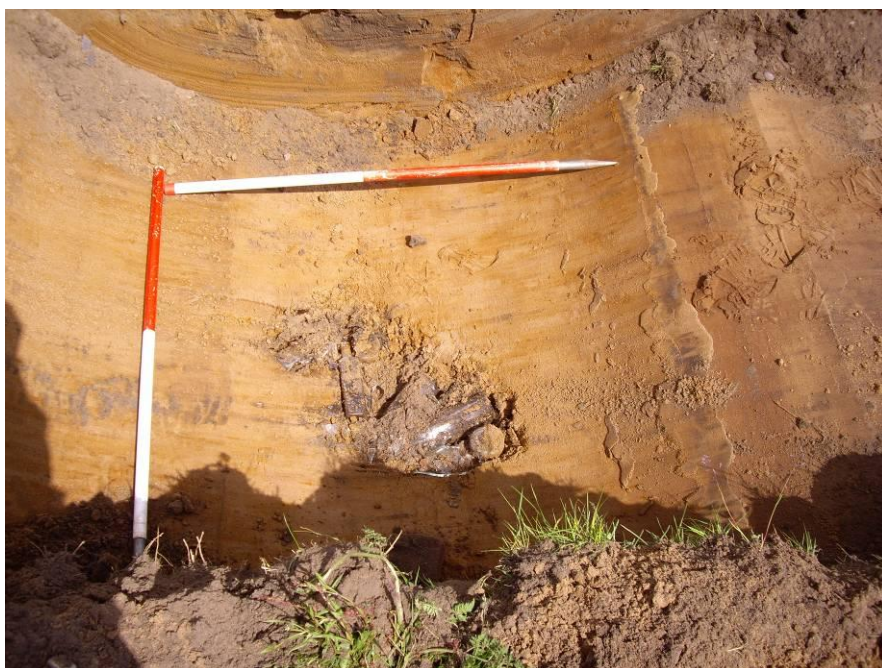
III 6 Photograph showing Feature 5

Trench 3 was 1.5m by 33m located on an approximate east to west alignment. A pit full of glass bottles and a few tins was located at a depth of 0.6mm 6.5m from the eastern extent of the trench (Feature 5; III 6). One of the tins contained Red Cardinal Polish, a polish commonly used for outside steps, even in the 1970s.

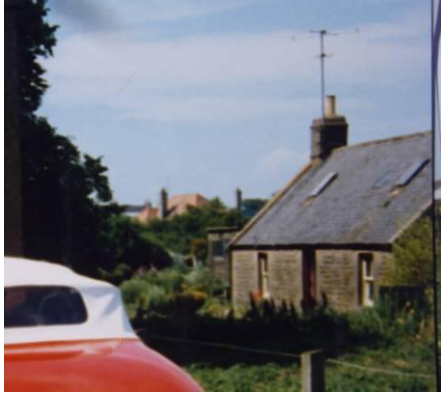
Towards the centre of the trench, remnants of bricks and stone within a grey sand deposit was located. This could relate to the demolition of the earlier house, the digging out of the foundations and the backfill of this area of the site with the crushed remains. No further evidence of the building was located during the evaluation, although a neighbour kindly provided a photograph of it in existence in the 1980s (Ill 7).

Ill 7 Photograph of the building once located within southern part of site

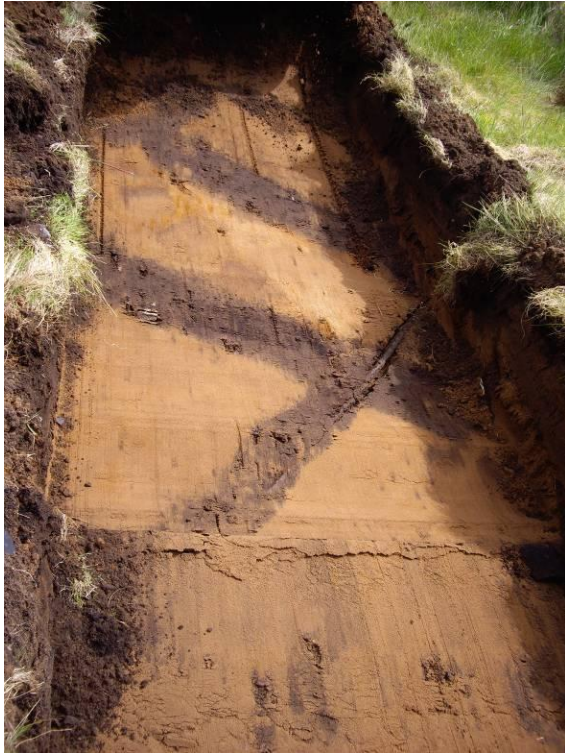
III 8 Photograph showing Features 10, 11 and 12

Trench 4 was 1.5m by 28m and orientated east to west. Features 9, 10, 11 and 12, located within the western half of the trench were all linear features consisting of a mixed backfill visible in the sandy subsoil, and are all likely to have related to services in the area linking pre-existing buildings in the vicinity (Ill 8). Feature 13 was a square hole, encountered beneath and concrete plinth, and is likely to have represented a washing pole, associated with the pre-existing decanted dwellings located within this northern half of the site from around the 1990s. A sewer pipe (Feature 15), located at the far eastern edge of the trench is also likely to have related to earlier buildings. A small deposit of grey sandy mixed deposit with some building material was noted close to the eastern edge of the trench, at the southern extent (Feature 14) and this is likely to be a continuation of the demolition debris encountered in Trench 3 (Feature 6).

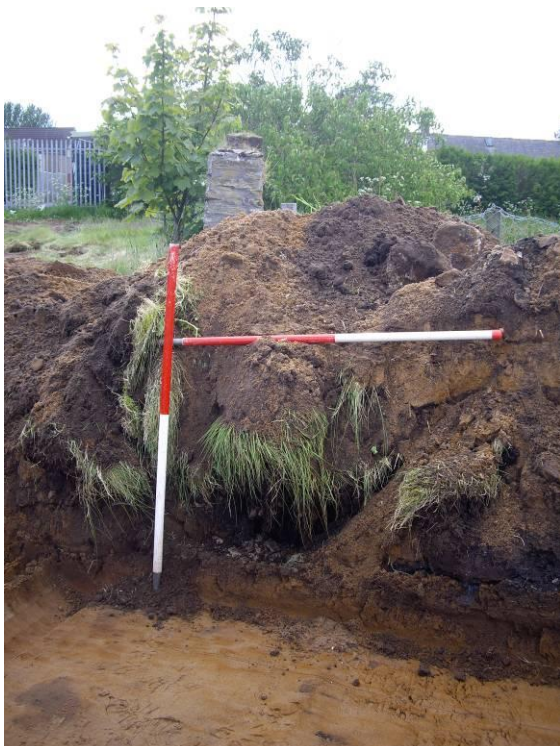
### III 9 Photograph showing Feature 17

Trench 5 was 1.5m wide and 15m long. Feature 16, located close to the southern extent of the trench was a further narrow linear feature, likely to relate to services. Feature 17, only surviving to a depth of 0.12m consisted of poorly preserved stone, which may be a trace of an extension of the extant wall, surviving along the south western extent of the site (III 9).

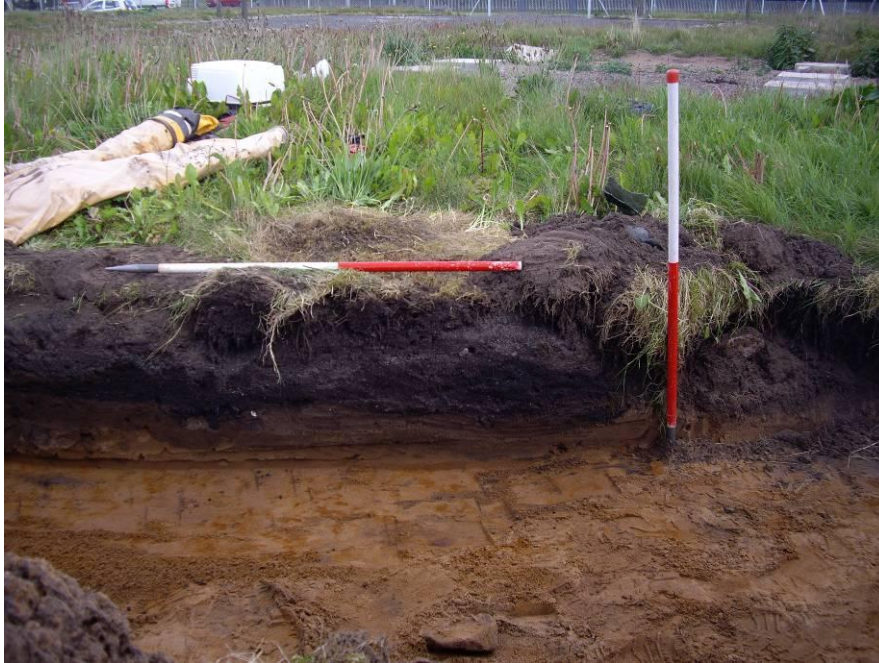
### III 10 Photograph showing Feature 18

Adjacent to Feature 17, on the northern side was an ashy deposit seen in section on both sides of the trench at a depth of 0.3m (Feature 18). This may relate to an old pathway which ran alongside the wall (III 10).
