**Report on the standing building survey
6 Balgownie Road, Bridge of Don
Aberdeen AB23 8JP**

Alison Cameron
Cameron Archaeology Ltd
8 March 2012

Report on the standing building survey, 6 Balgownie Road, Bridge of Don, Aberdeen AB23 8JP

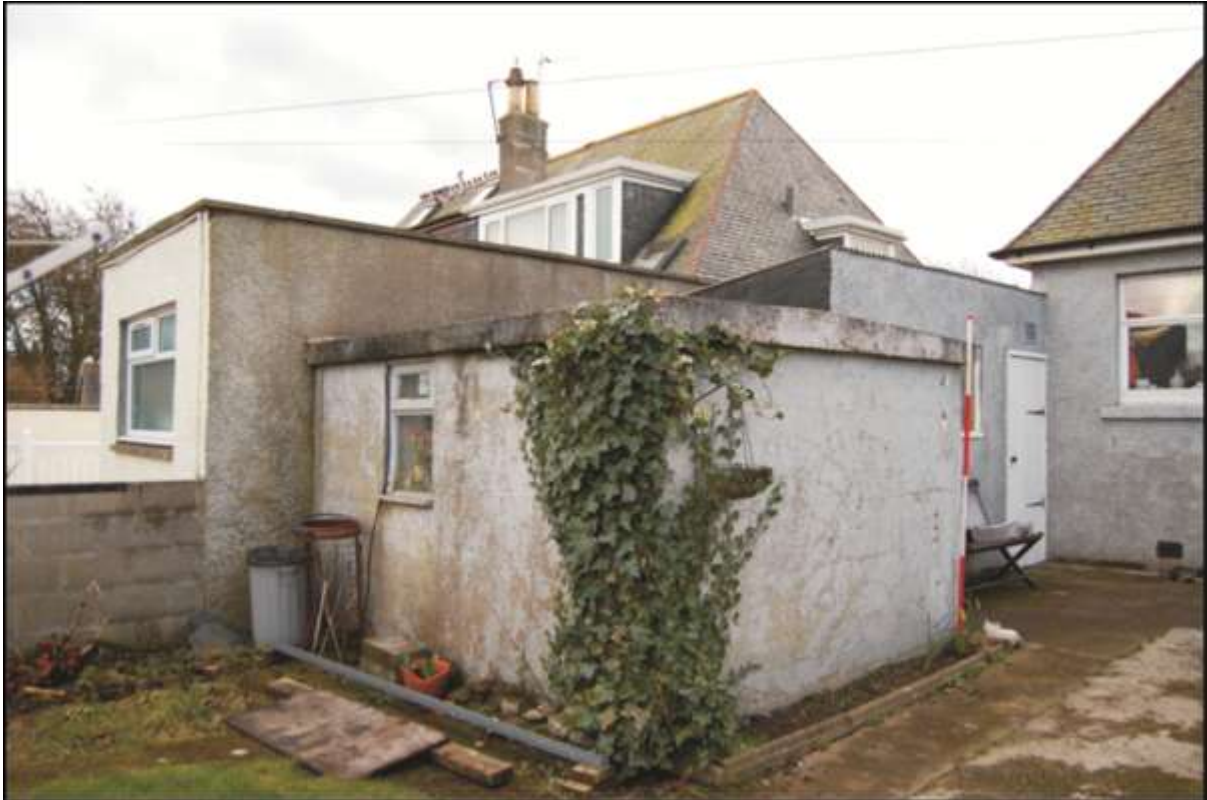
Cover Air raid shelter facing south east

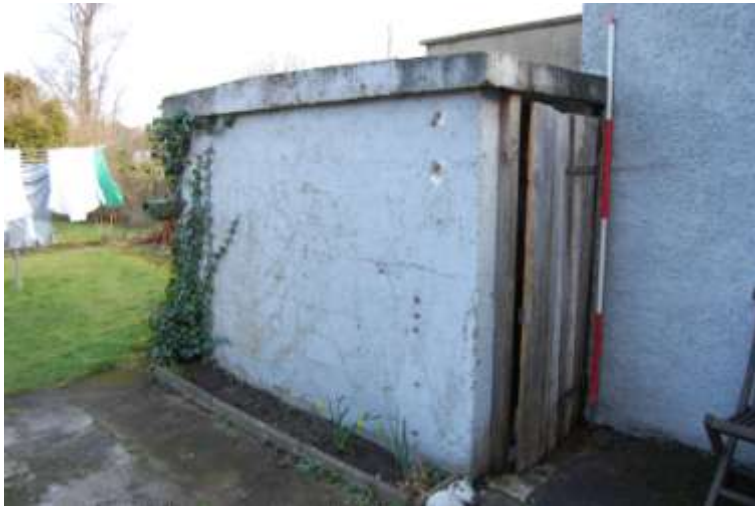
Illus 4 The shelter from the SW showing entrance into corridor

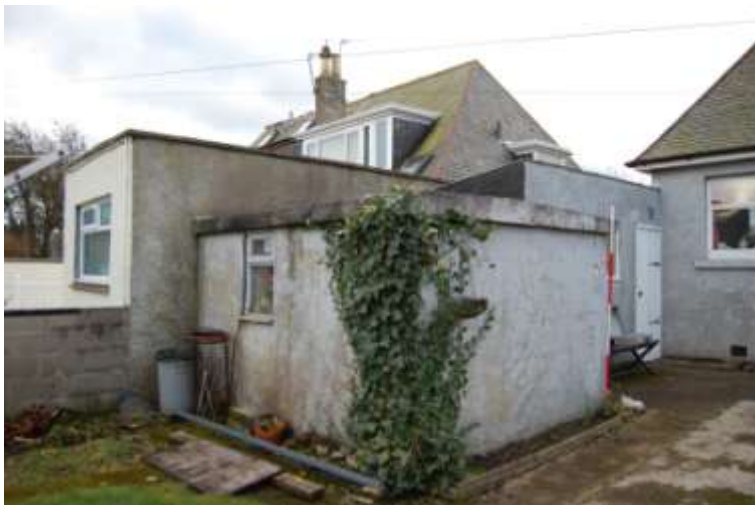
Illus 5 The shelter from the NW

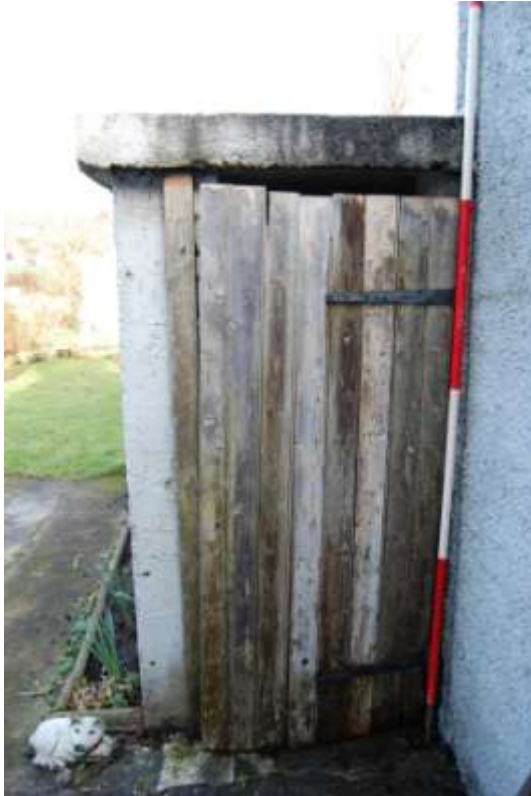
Illus 6 Entrance to the shelter in south wall

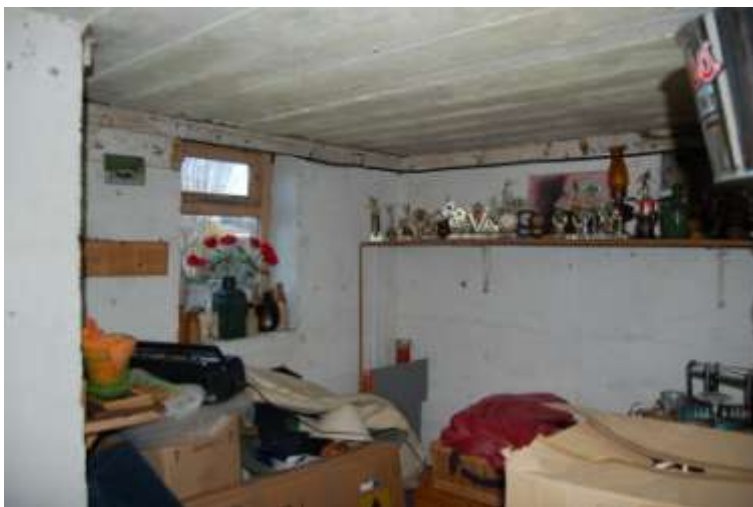
Illus 7 Main shelter facing NE showing Window 1 and shuttering marks on roof

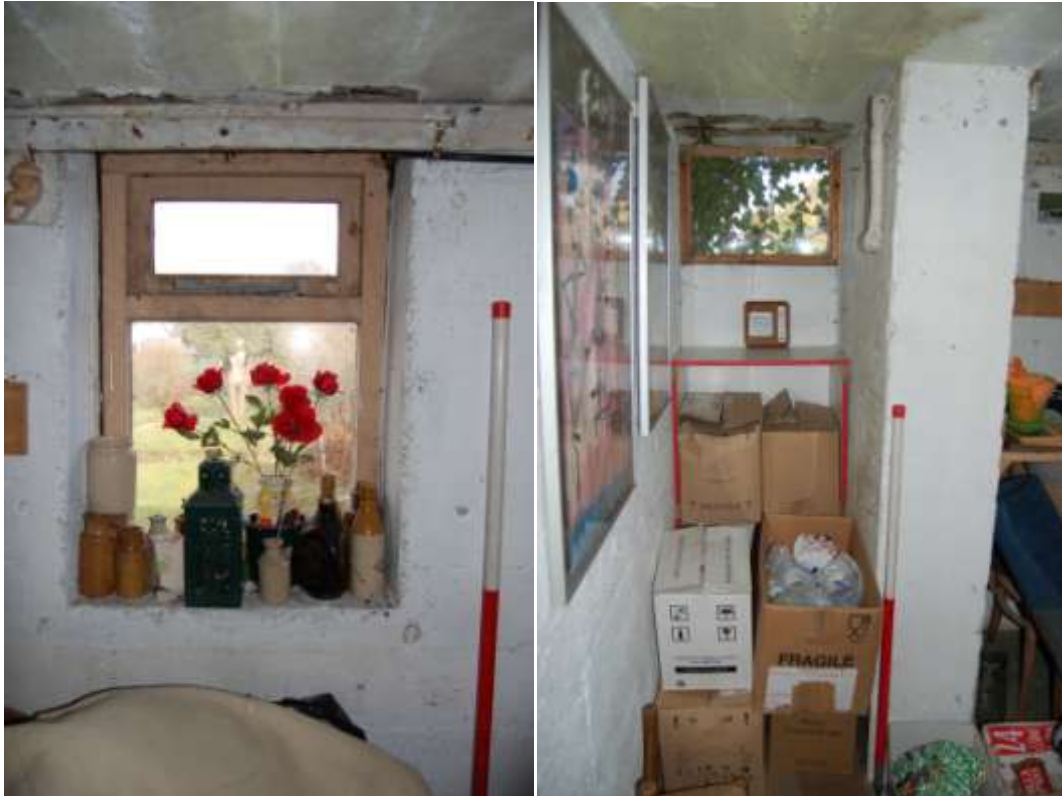
Illus 8 Window 1 (left) Window 2 (right) in north wall

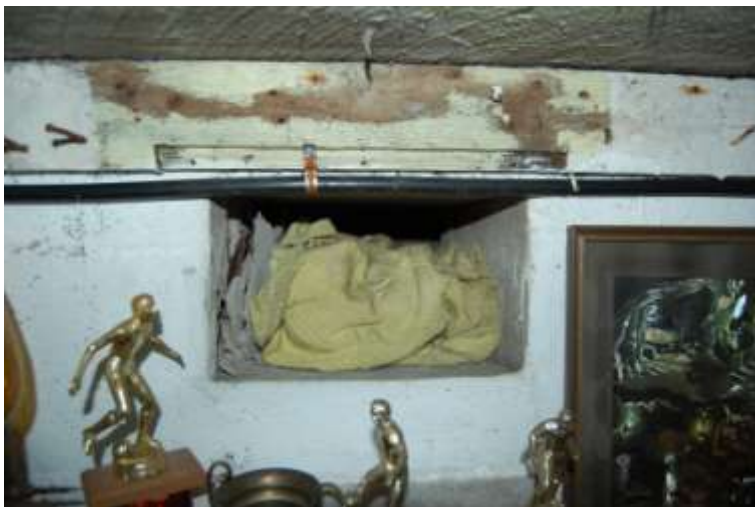
Illus 9 Vent in east wall of shelter

Fittings survive where both the inner and outer door would have been hung. A vent in the east wall (Illus 9) would have been the only source of ventilation when the shelter doors were closed.
