# Davidson's Mill, Mugiemooss Road, Aberdeen, AB21 9NQ

Archaeological evaluation and standing building survey

Alison Cameron  
Cameron Archaeology  
13 April 2012

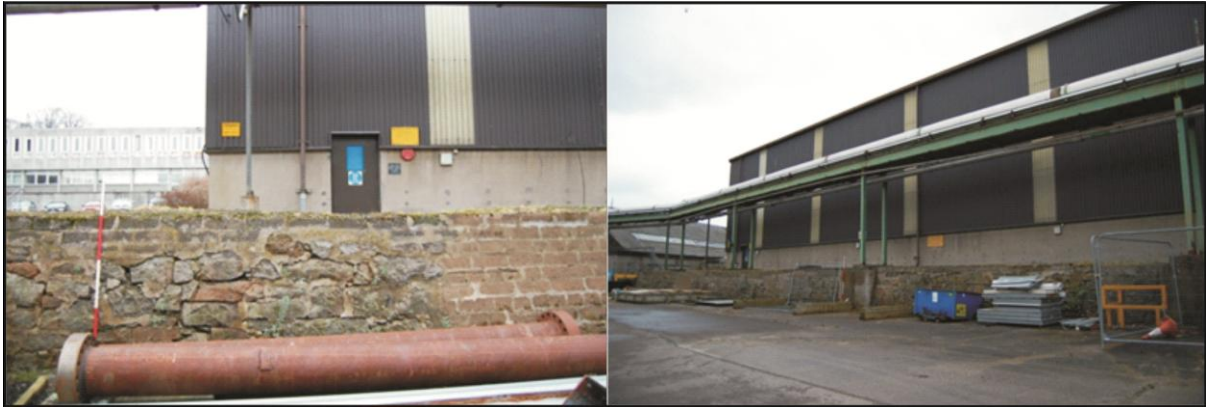
Structure 3 is the remains of a retaining wall (Illus 14). It survives to 49m in length and has been cut through to provide brick and latterly concrete foundations for Building B19 and the overground pipework running along the north side of B19.

Illus 14 Building 3 (foreground left) with B19 and overground pipework (background; right detail of B3 facing south

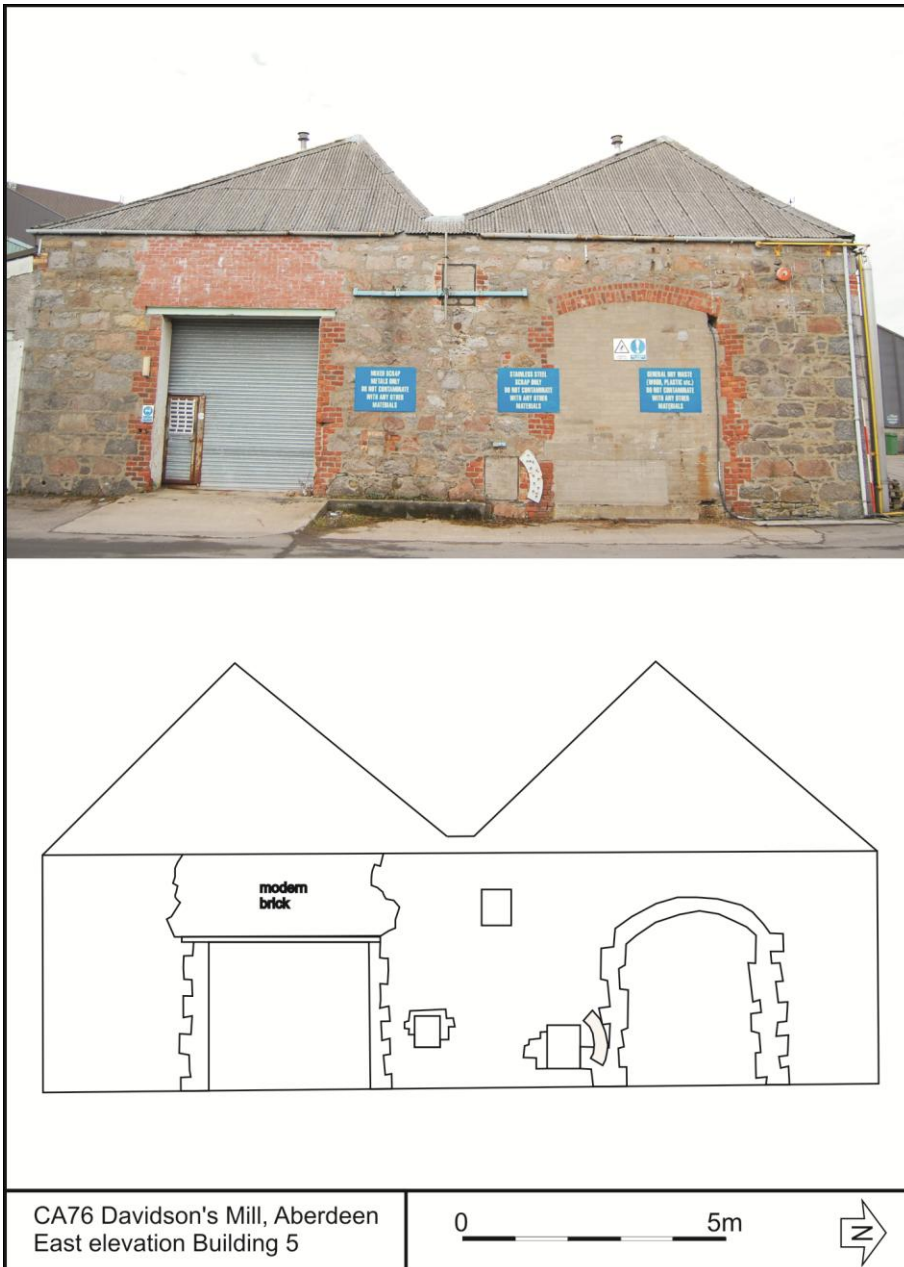
Illus 18 Building 5: east facade showing original brick doorways; the doorway on the left has been altered and a metal door inserted.

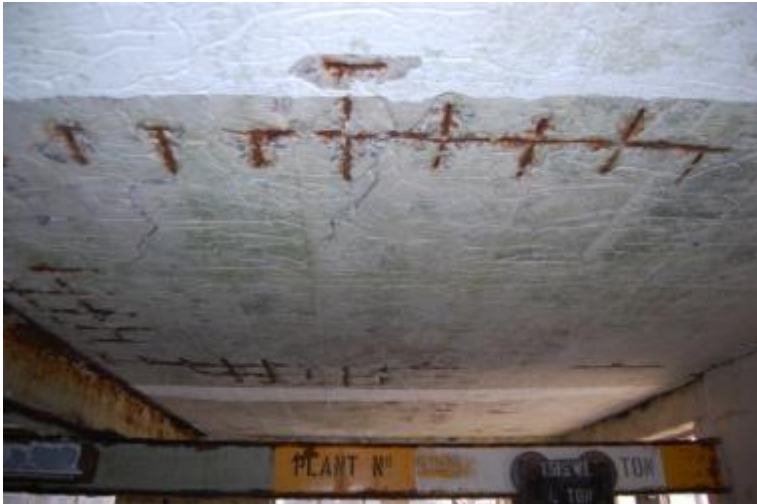
Illus 22 Building 6a: roof showing plank marks from shuttering and reinforcing bars rusting and appearing through the concrete

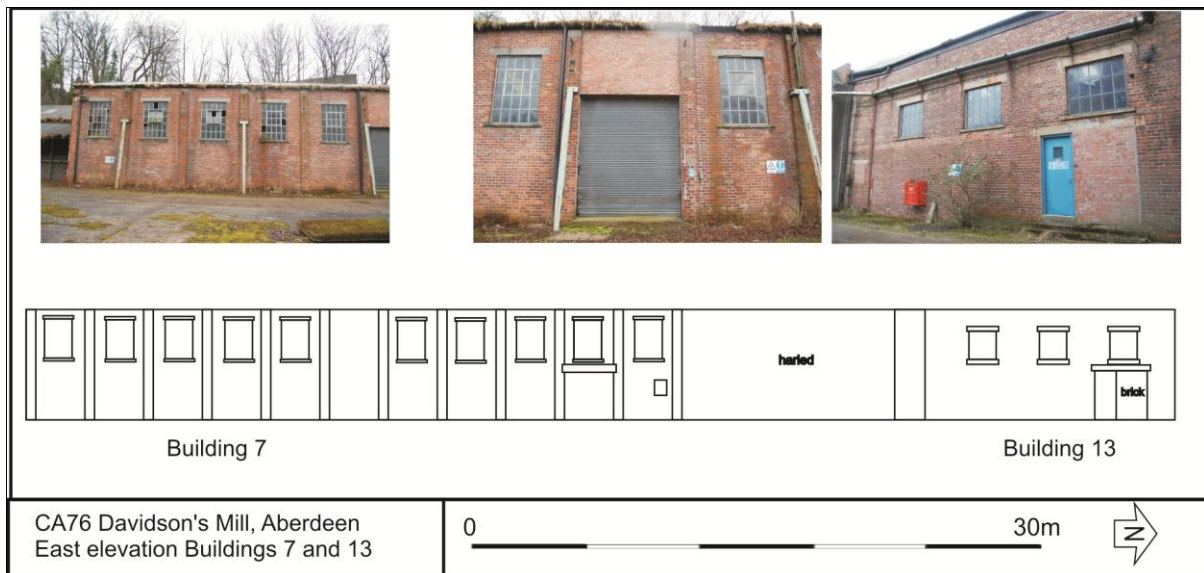
Building 7 is adjacent to the river Don (Level 1) at the east of the complex. It is brick built and probably one of the early mill buildings. It is 45.6m long and 4.05m wide. It has modern extensions at the south end (7a and 7b). At the north end there is a harled section of the building which then joins onto Building 13 (Appendix 2). B7 is the dispatch area for products of Machine No 3 (B13). Trench 24 was located SE of this building.

Illus 25 Building 7: east elevation

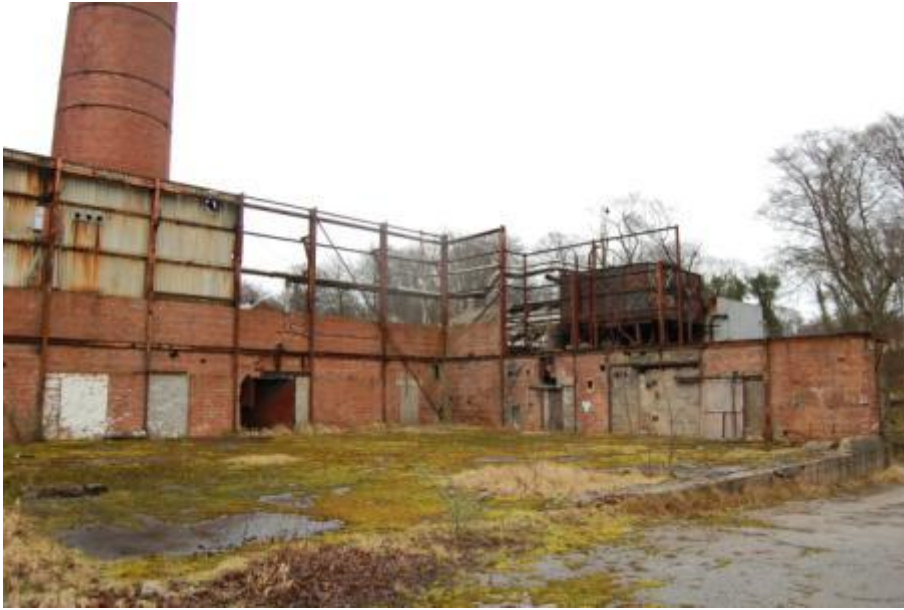
Boiler House for machine No 2 and attached to chimney B11 by vent (Illus 26-30). Only the north and east walls of Building 10 survive; the building was 31.9 x 20.7m in size and had brick walls and a concrete floor. A cast iron-lined vent links this building with Chimney B11 suggesting B10 was furnaces. This building was still extant in 1972 (Illus 34) and has a full cellar under the south half where ashes dropped on to a conveyor and were loaded into trucks for disposal.

Illus 26 Chimney (B11) with B10 (foreground); facing NNW

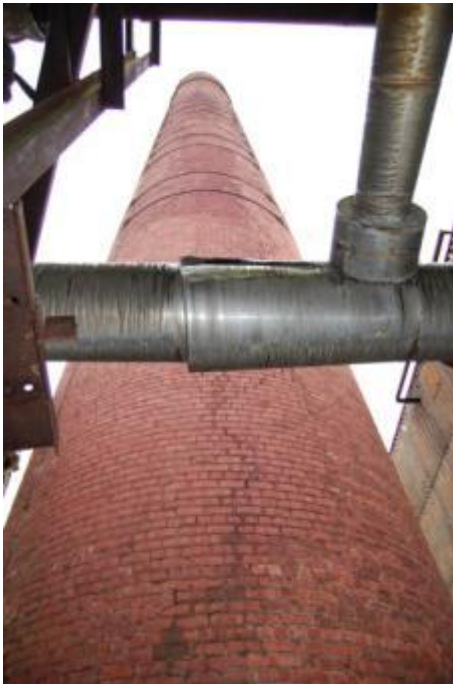
The open area between B11 and B26 house Machine No 2 prior to going out of use c 1975 and demolition. The chimney has been reduced in height and banded in the recent past for health and safety reasons.

Illus 28 Chimney B11 from west

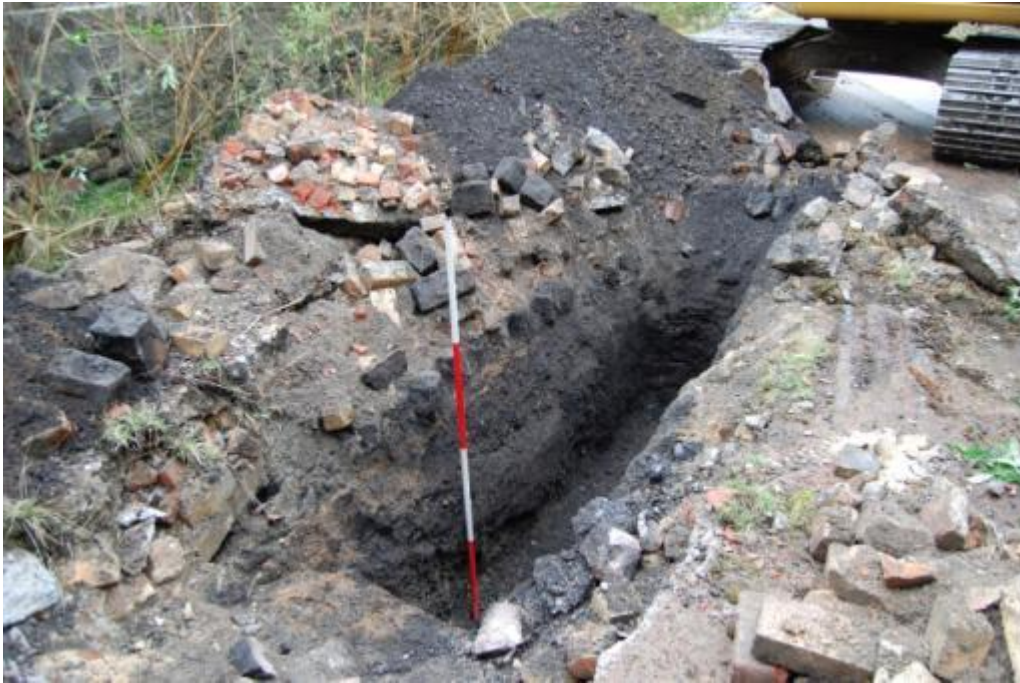
Illus 48 Trench 23: section through surfaces F23 and F24 and ash layer 7 dumped to raise level of area above high water level

Two trenches in the south end of Area D produced evidence that the area had been increased in height by at least 1.5m using ash and rubble presumably from the early mill workings. It is therefore possible that structural remains will survive in this area and further trenches should be excavated when the companies leasing buildings have vacated them or in association with the demolition work. Further work will be required in this area after demolition and before further construction.

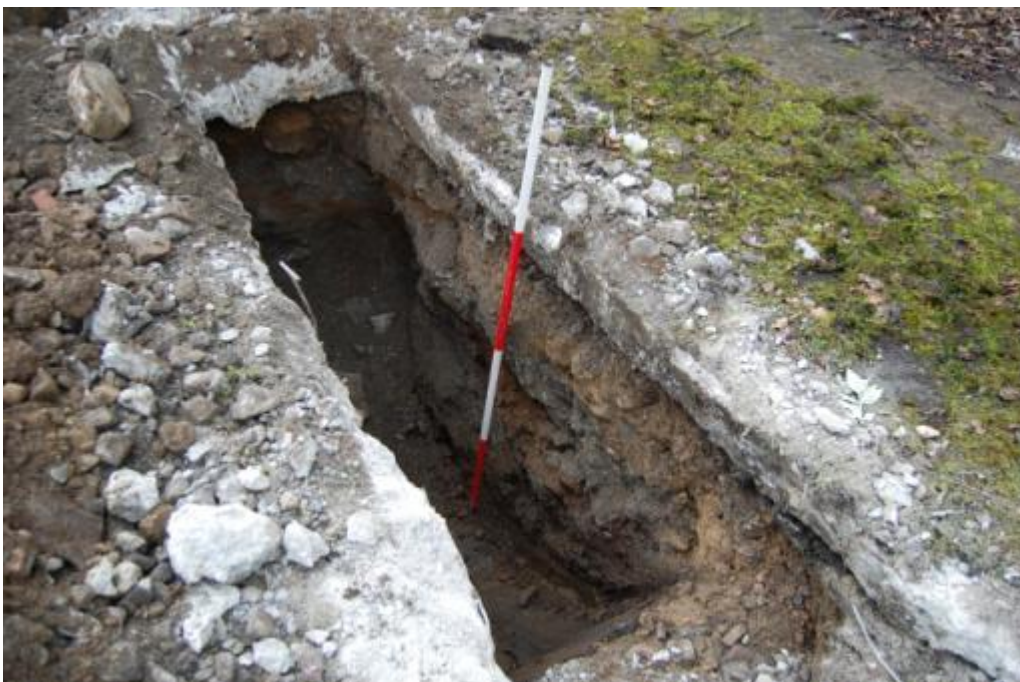
Trench 24 was located SE of Building 7 in an area where there were no observed or CAT detected services. The concrete was reinforced but of an age where metal fatigue had weakened it. Below the concrete, layers of upfill (9-11) included fragments of brick, ash and redeposited natural subsoil up to 1.3m deep but no specific dating evidence. It is likely that this layer of dumped material had come from the earliest mill workings and had been deposited there to raise the level of the ground to above the high water table.

Illus 49 Trench 24: section through layers of dumped material to raise level of area above high water level
