Pittrichie Home Farm steadings and doocot
Pittrichie, Oldmeldrum, Inverurie, AB51 0AE

Alison Cameron, Cameron Archaeology Ltd
June 2012

A level 2 survey was carried out on the steading buildings and doocot. It is recommended that no further archaeological work is required during the current development subject to agreement by Aberdeenshire Archaeology Service.

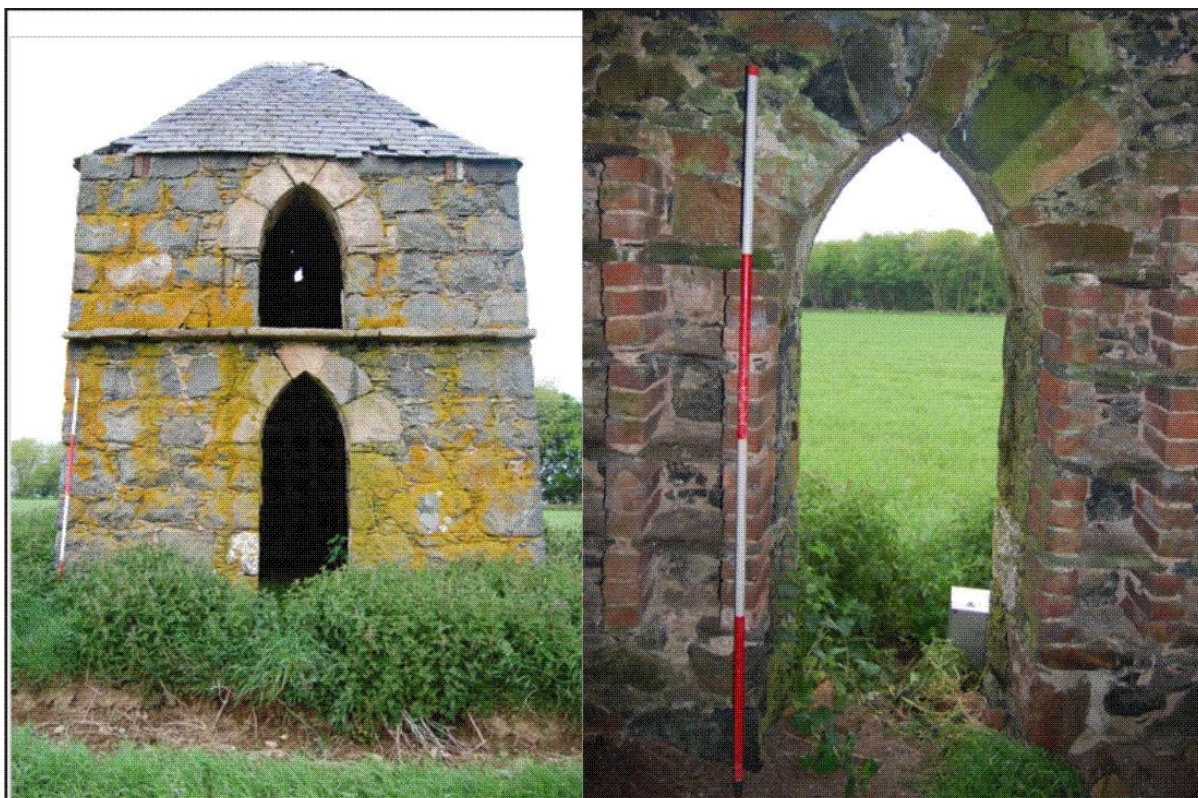
Illus 3 (left) South facade showing door 1 (below) and Window 1 (above) (right) Door 1 showing use of grey, pink and black granite and quartz blocks; note the nesting boxes surround the door

The doocot at Pittrichie is in a field SE of the Home Farm and is 4m x 4m in size externally. Inside each wall is 3m long and the building is constructed of large dark grey granite blocks with roughly dressed quoins (Illus 3). It is two storeys high and has an arched door (D1) in the south face of the ground floor and window on the first floor (W1) above. These are constructed of red granite and white quartz blocks in contrast to the grey granite walls. The door frame retains hinges but no door is present. On the south face above the door and forming the sill of the upper window is a perching ledge (sometimes wrongly termed a rat-ledge).

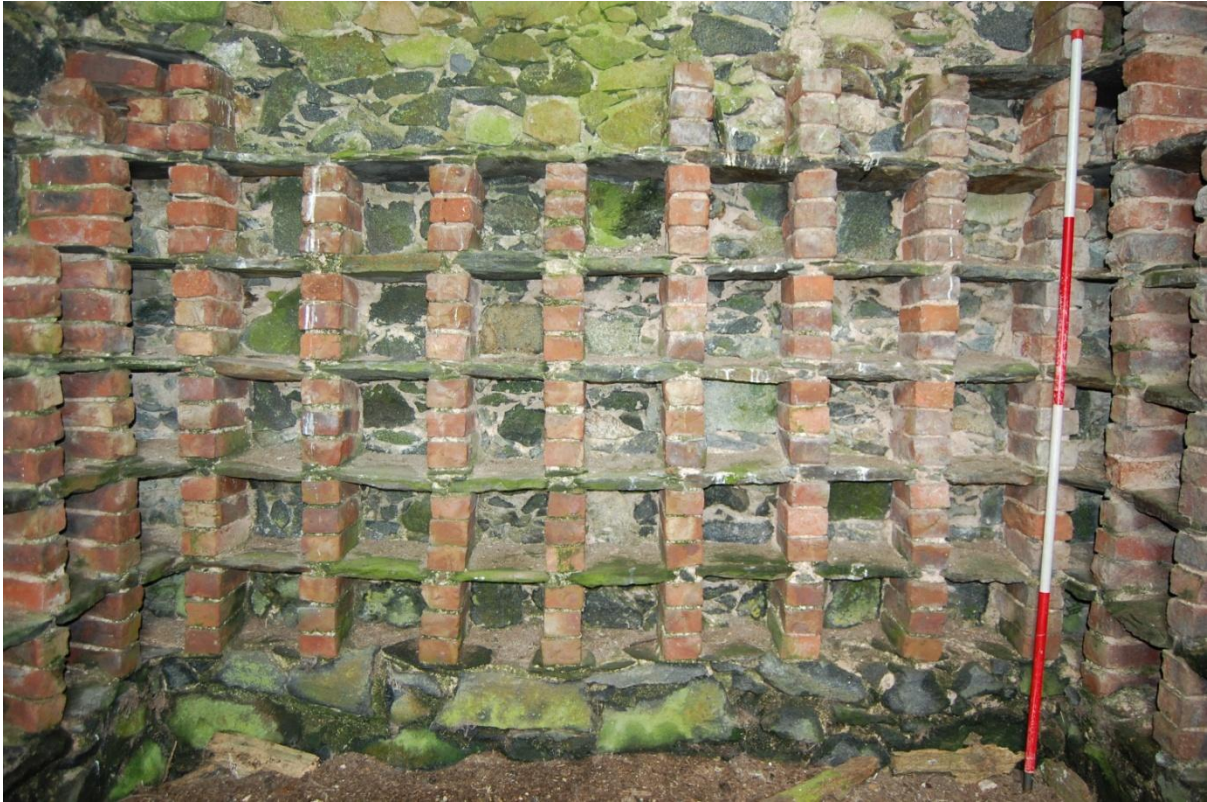
Under half of the original nesting boxes survive as they were originally at least 7 nesting boxes high. They are constructed of stone slate shelves and brick risers consisting of three hand-made local bricks in each stack forming the sides of the nesting boxes. All gaps have been filled with mortar. The space has been maximised by forming corner boxes (Illus 6). The boxes are c 25cm wide and 30cm high with the openings of the corner boxes being less. Many of the boxes have collapsed and Illus 6 shows how many boxes survive in each stack. The boxes are built on a stone shelf (Illus 4) to raise them above the damp ground and the guano (of which there is a layer on the floor); this ledge and the deep thick foundations also helped to protect the building from rats. The doocot has been dated to the early 19th century (1818-1825: Shepherd 2006, 206).

Illus 5 Brick and stone slate nesting boxes on the interior of the east wall

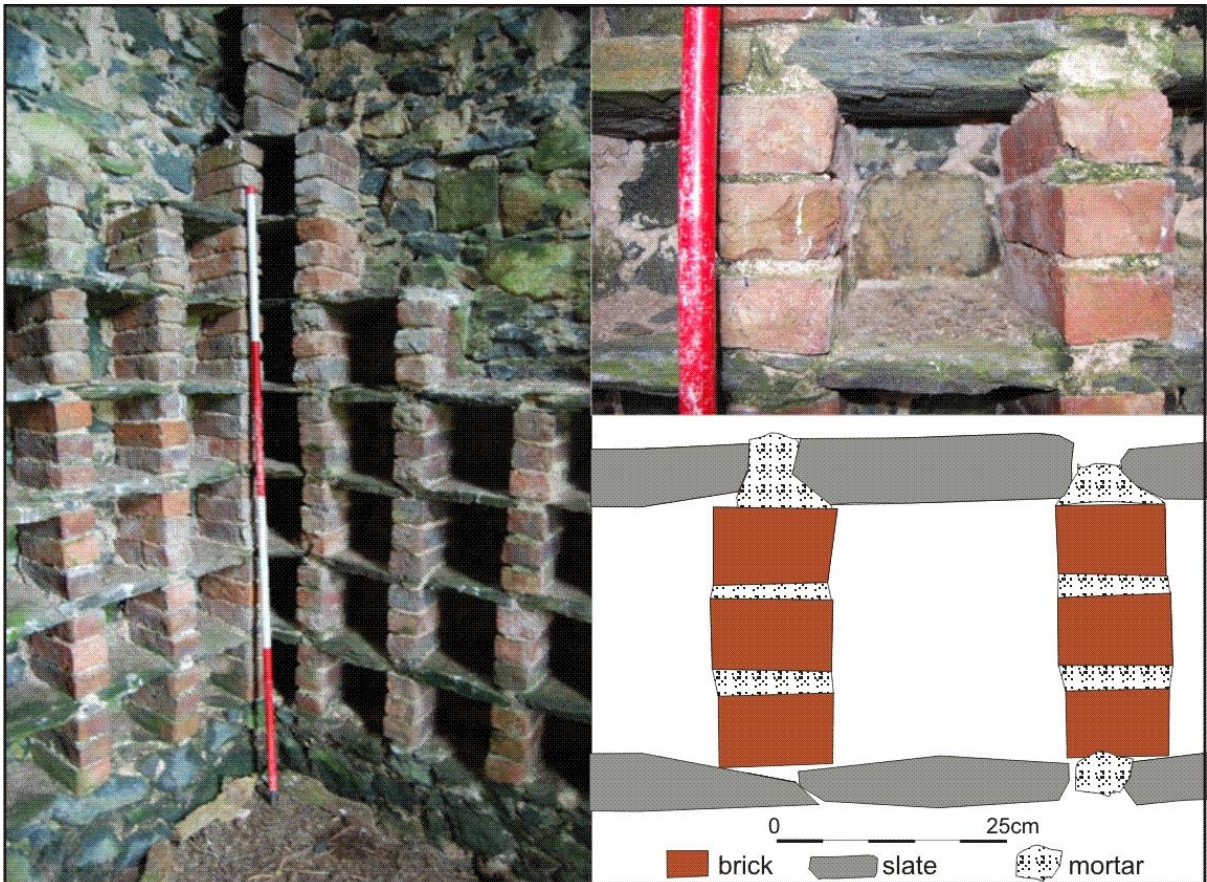
Illus 6 (left) nesting boxes in NE corner; (top right) detail of nesting box construction (bottom right) nesting box construction

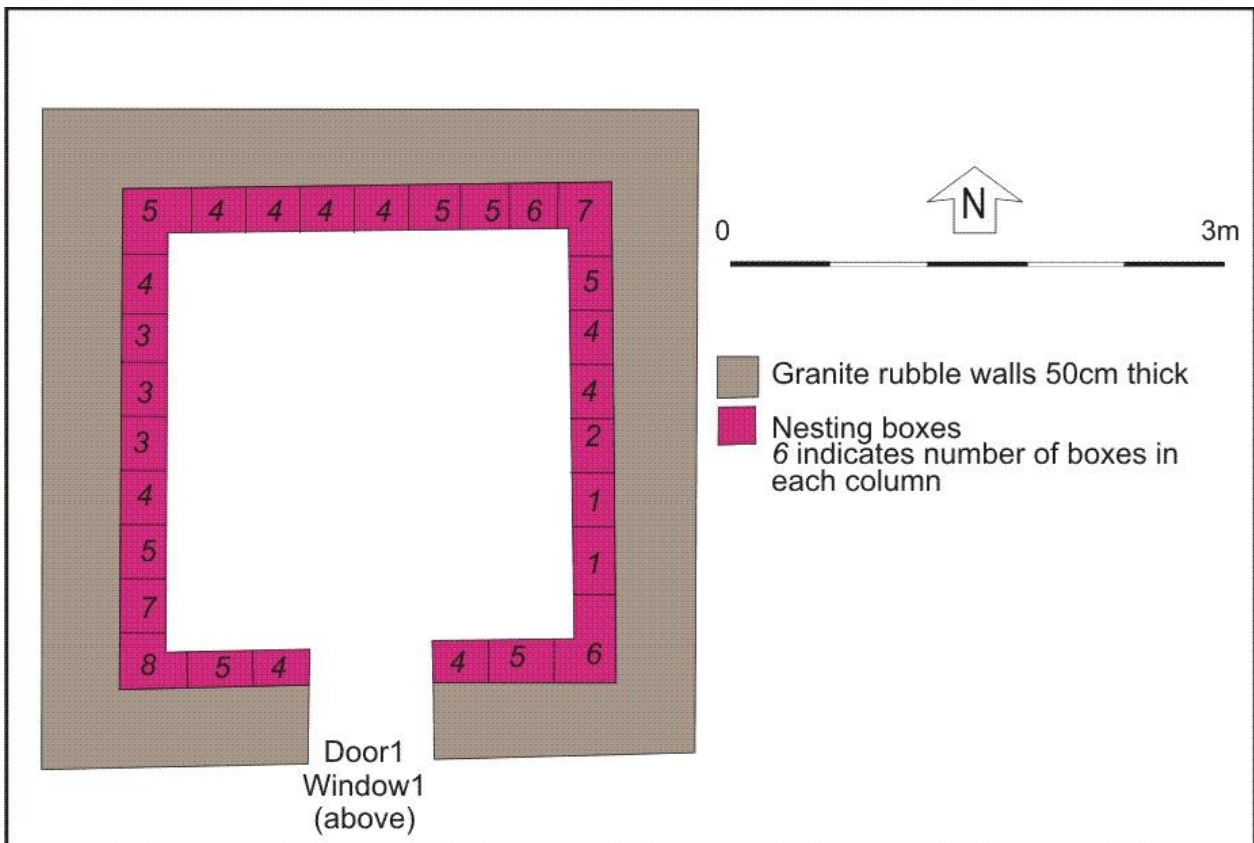
Illus 7 plan of nesting boxes with details of how many survive.

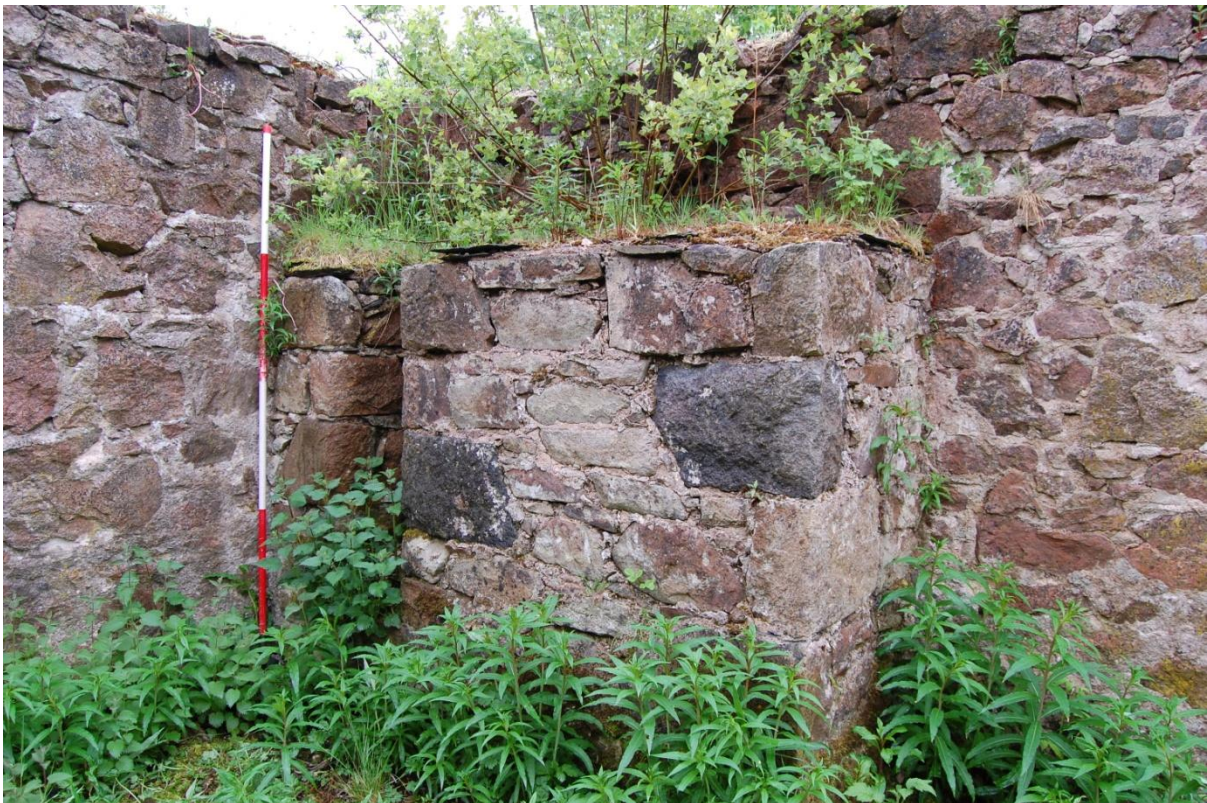
Rooms 4 and 5 form the north side of the courtyard. Room 4 is small with a large door on the north side; it has been partitioned off from the remainder of the building or this wing may have originally been constricted as a series of small rooms which have since been combined. Room 4 has a granite plinth (F1; Illus 9) in the SW corner and this may have been the base for a water tank. The water may have been pumped from the well to the west of the complex and gravity fed into the building. Metal pipes survive at the rear of F1 and also through the wall to the exterior (F3).

Illus 9 Room 4 granite plinth F1

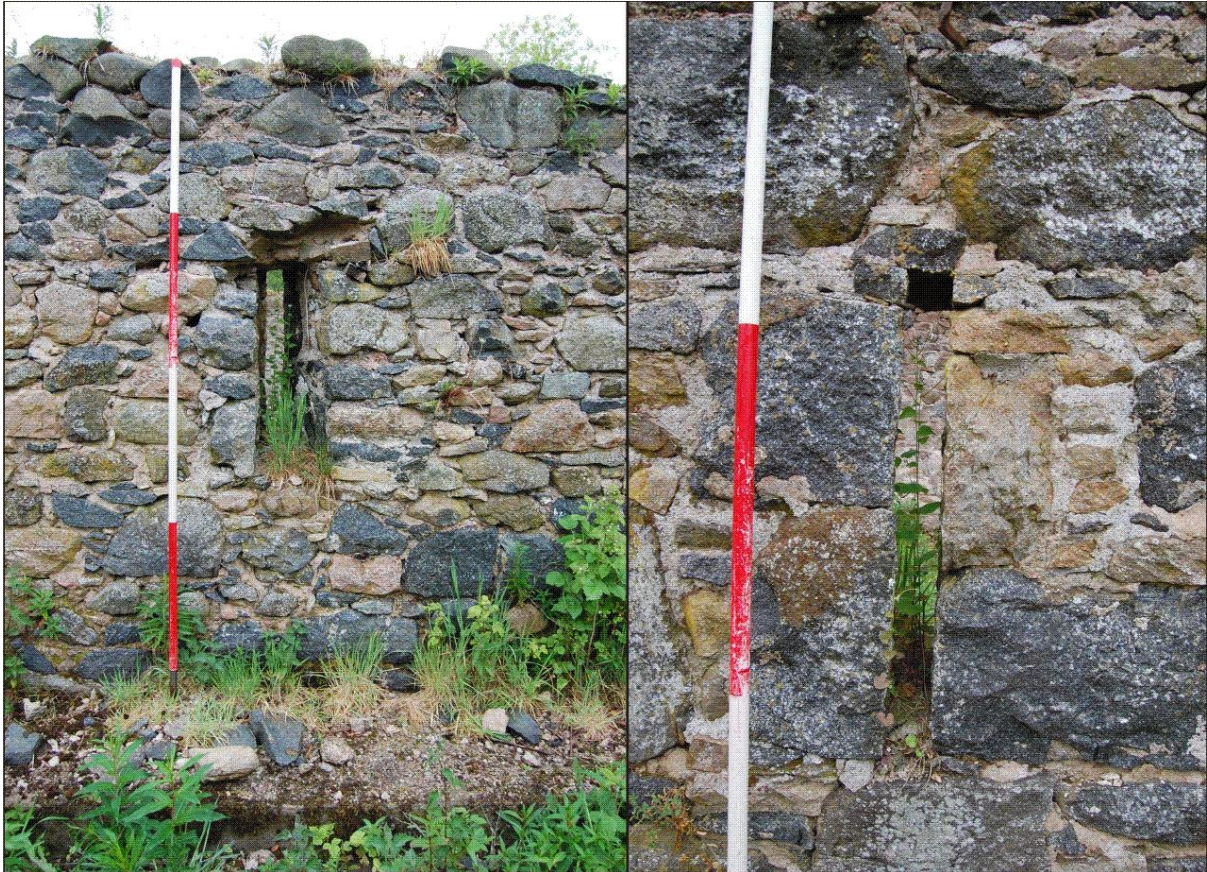
Illus 10 Window 11 interior (left) and exterior (right)

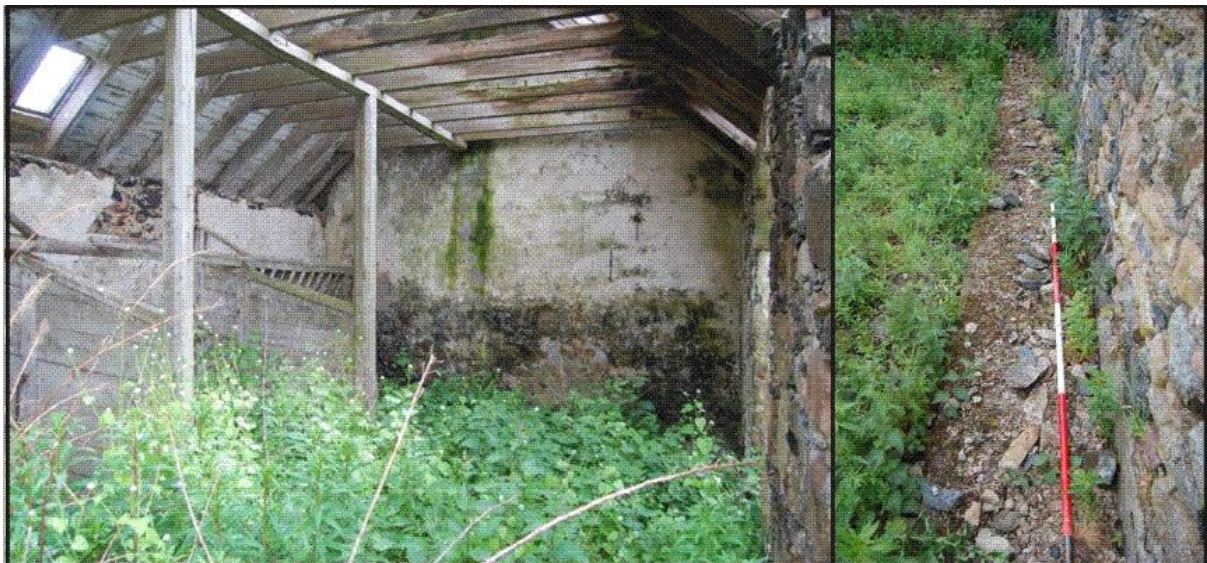
Room 5 is a large room with doors to Room 4, a door to the courtyard, one to the north and two small slit windows facing north. Along the interior of the north wall is a stone and concrete foundation (F2) probably a foundation for feeding troughs for cows. In Room 5A wooden stalls for horses survive suggesting that this is a recent use of the room (Illus 11). The two small windows facing the north (and there is one in the south wall, W15) are 70cm high and 30cm wide internally and 6cm wide externally (Illus 10). Windows of this type are not common on vernacular buildings but are common in castle and other defended buildings where they are known as loop-holes or arrow slits. On a building of this type they are for adding light and ventilation; there is one on the steading at Craignish Castle in Argyll and Bute which is of the more common cross-shape. The building is constructed of large blocks of dark grey granite with fieldstones. There are several areas of rebuilding and the height of the roof appears to have been raised by adding an extra course of stones to the top of the wall. The quoins on the corners of this building and the lintels are all of fine-grained light grey sandstone suggesting a high quality building. Bricks around both doors 5 and 7 indicate that they have probably been altered in size.

Illus 11 (left) Room 5a showing wooden horse stalls and plastered walls (right) F2 foundation for feeding troughs

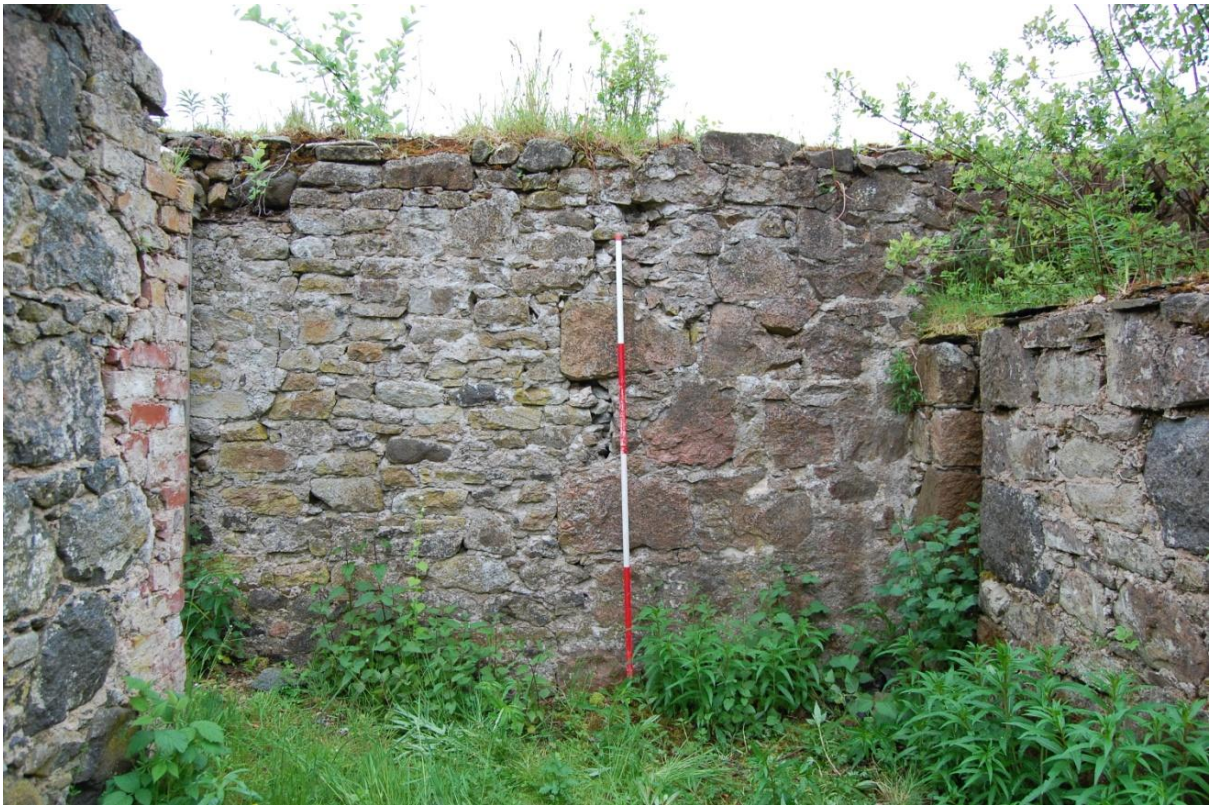
On the south wall of Room 2 is a scar (F6) between the pink quartz-rich granite to the west and grey granite fieldstones to the east. This section of wall appears to have been added on to the main building and it is possible that this range was extended to the west or was repaired and rebuilt (see phase plan Illus 28).

Illus 12 Room 4 south wall scar F6 between the pink quartz-rich granite (right) and grey granite fieldstones (left)

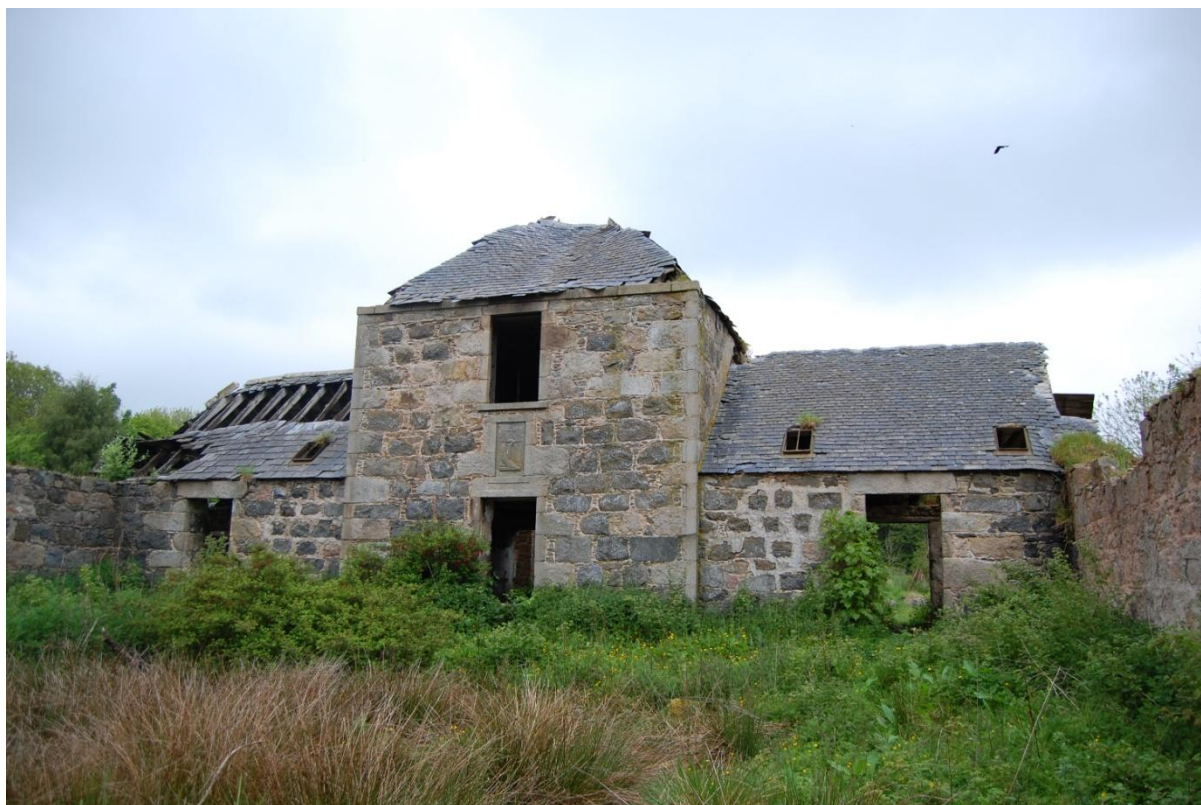
Rooms 6, 7 and 8 form the east side of the range of buildings. Room 6 is the only domestic space identified during this survey. Unfortunately this room (and the one above) was inaccessible as the roof is collapsing but the features were recorded through the door and window. The windows and doors of this range have the same fine-grained grey sandstone lintels and quoins as the north wing. Room 6 has a wooden staircase to the room above and a fireplace in the NE wall and the walls are plastered. An additional room (Room 7) has been added on to the east side of this room; it has granite quoins and lintels of a poorer quality than those of the main building. It is likely that this block was residential accommodation for farm workers, possibly the farm manager.

Illus 14 Room 6 (centre) with Room 5A (left) and Room 8 (right)

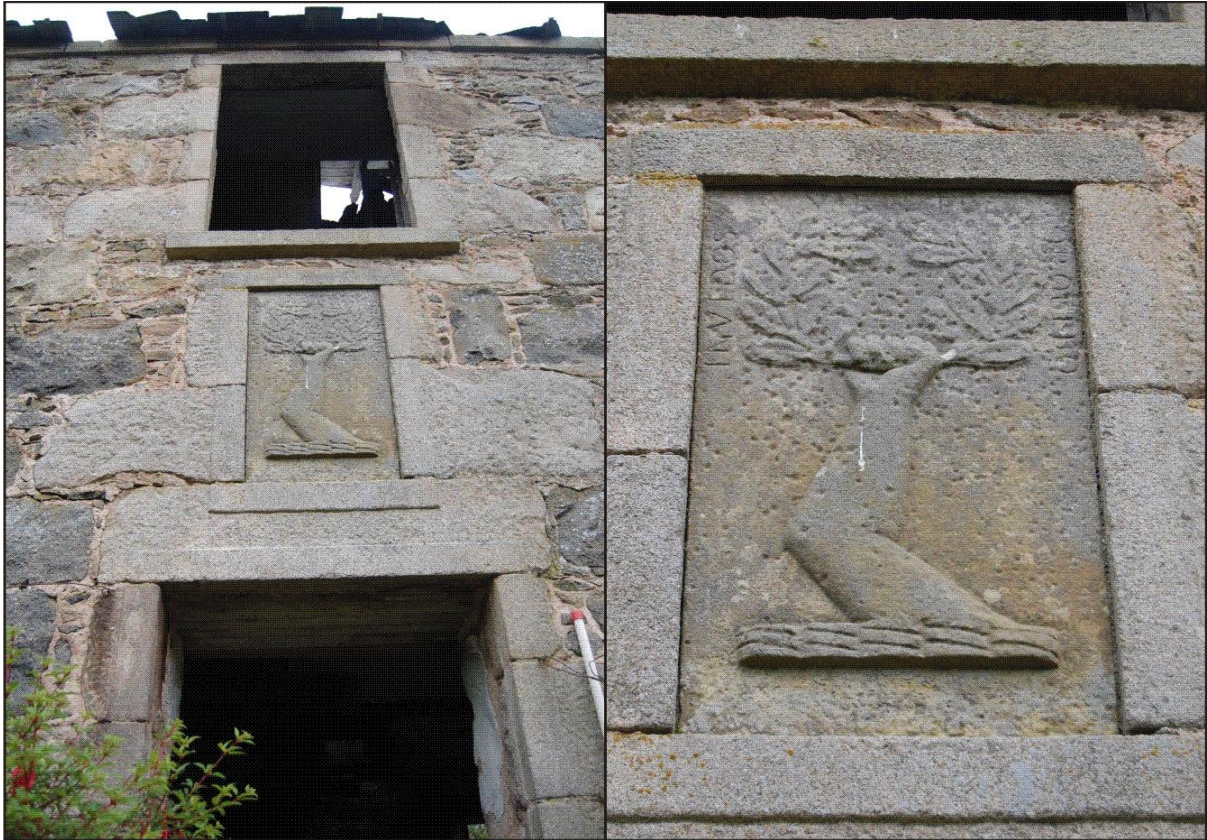
Above Door 20 is a sandstone plaque with raised relief decoration. It shows a dexter arm holding a garland of laurel (Illus 15) and an inscription INVIDOS VIRTUE TORQUEBO 1823 (RCAHMS online). Some of the inscription including the date is difficult to read but the image is clear. Research by Austin Heritage has revealed that this is the crest and motto of a branch of the Mackenzie family and may have been adopted by James William Mackenzie who succeeded his father as owner of the estate in 1816 (Austin 2012, 5)

Illus 15 Room 6 Door 20 with Window 13 (above) and sandstone plaque

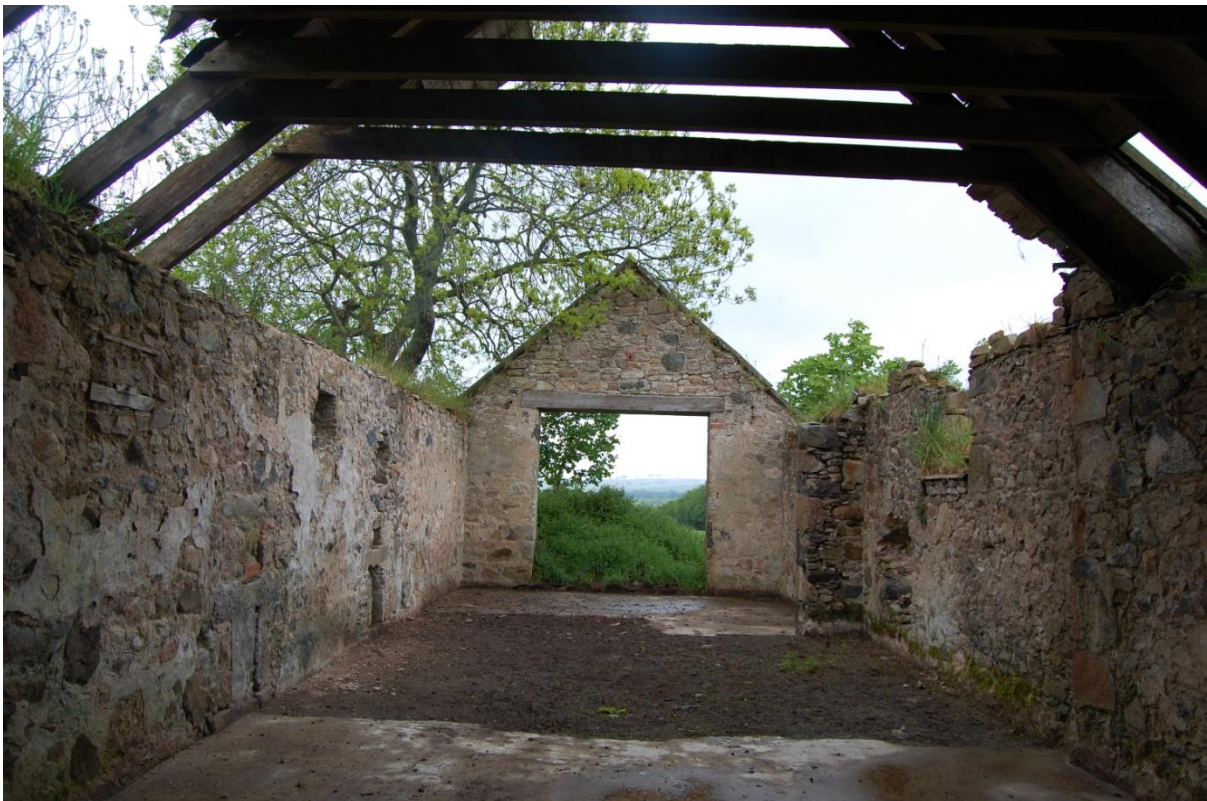
Illus 16 Room 8 showing apertures A1-A6 (left) and wall stub (middle right) the original south end of this room

Room 8 is now a long narrow barn but has had several alterations over the years. It was originally about 3m shorter and there is a wall stub (F8) where the original south wall of this room was located. It may originally have been shorter (see Phase plan Illus 28). This room originally had an upper floor and stubs of upper windows survive (Illus 13). A circular sunken area (F10) east of the building is the remains of a horse-gang or house mill; it appears on the First and Second Edition Ordnance Survey maps. Apertures in the east wall (Apertures 1-6 Illus 17) survive where the mechanisms of the mill including the drive shaft and belts linking cog-wheels went through the wall into Room 8. The mill probably powered a threshing machine but no evidence of the internal mechanism survives as the room was cleared when it was extended and changed in use. In the centre of the circular area F10 there should be a fitting for an axle and it is likely that foundations for low walls survive.

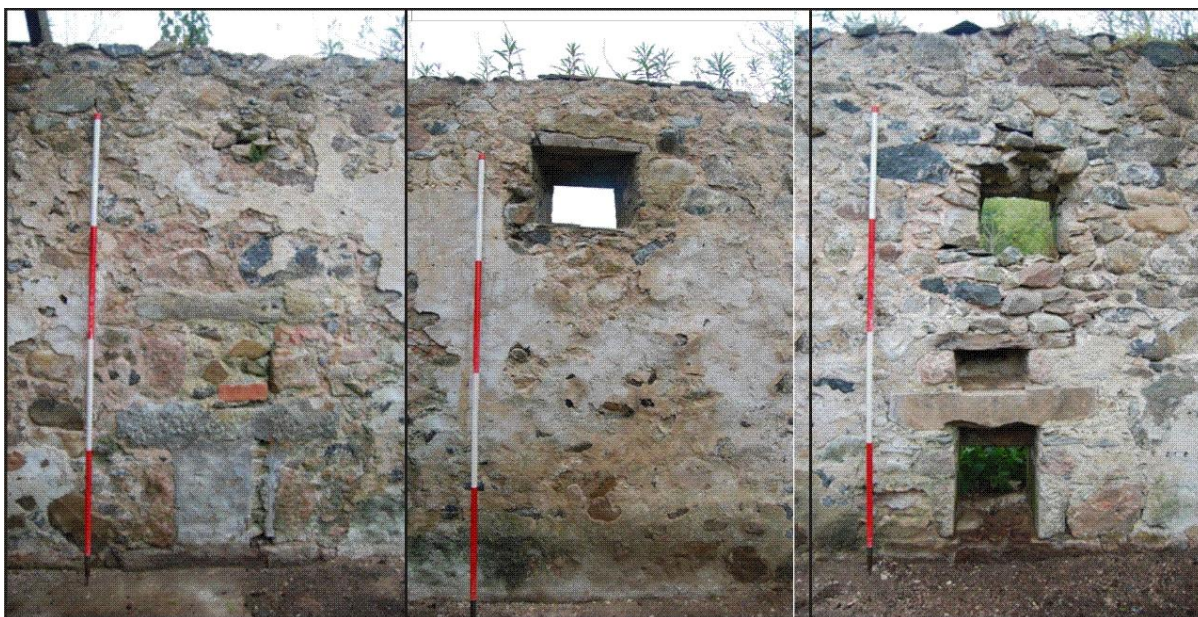
Illus 17 (left) Aperture 1 (top) 2 (bottom); (middle) Aperture 3 (right) Aperture 4 (above) 5 (centre) and 6 (below) with fine-grained sandstone lintel

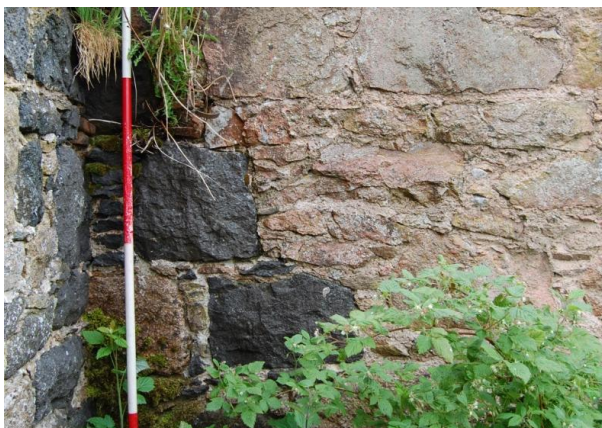
On the south side of the courtyard are a series of three rooms 9, 10 and 11 (Illus 19). They are constructed of pink quartz-rich granite blocks and these rooms have been butted onto the east wing; a scar (F7; Illus 18) shows the earlier black and dark grey granite structure and this later pink granite addition.

Illus 18 Scar F7 between black granite wall (left) and pink quartz-rich granite (right)

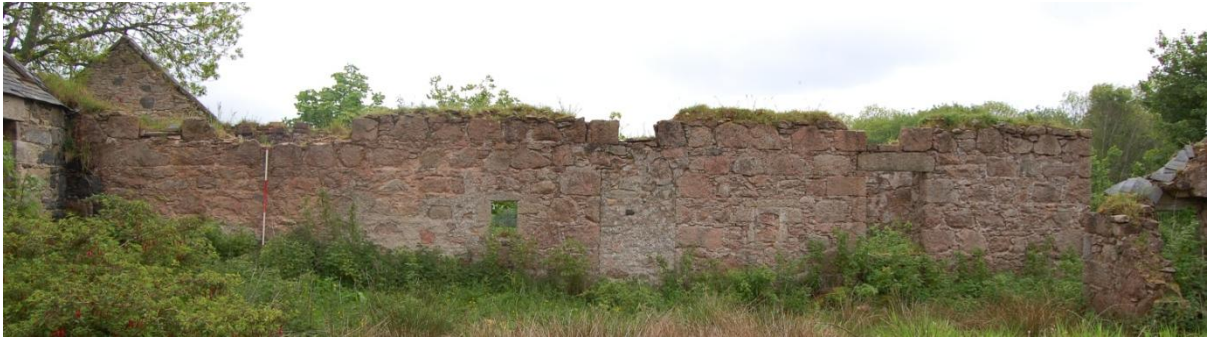
Illus 19 NW elevation of south wing showing wall junction F7 (left)

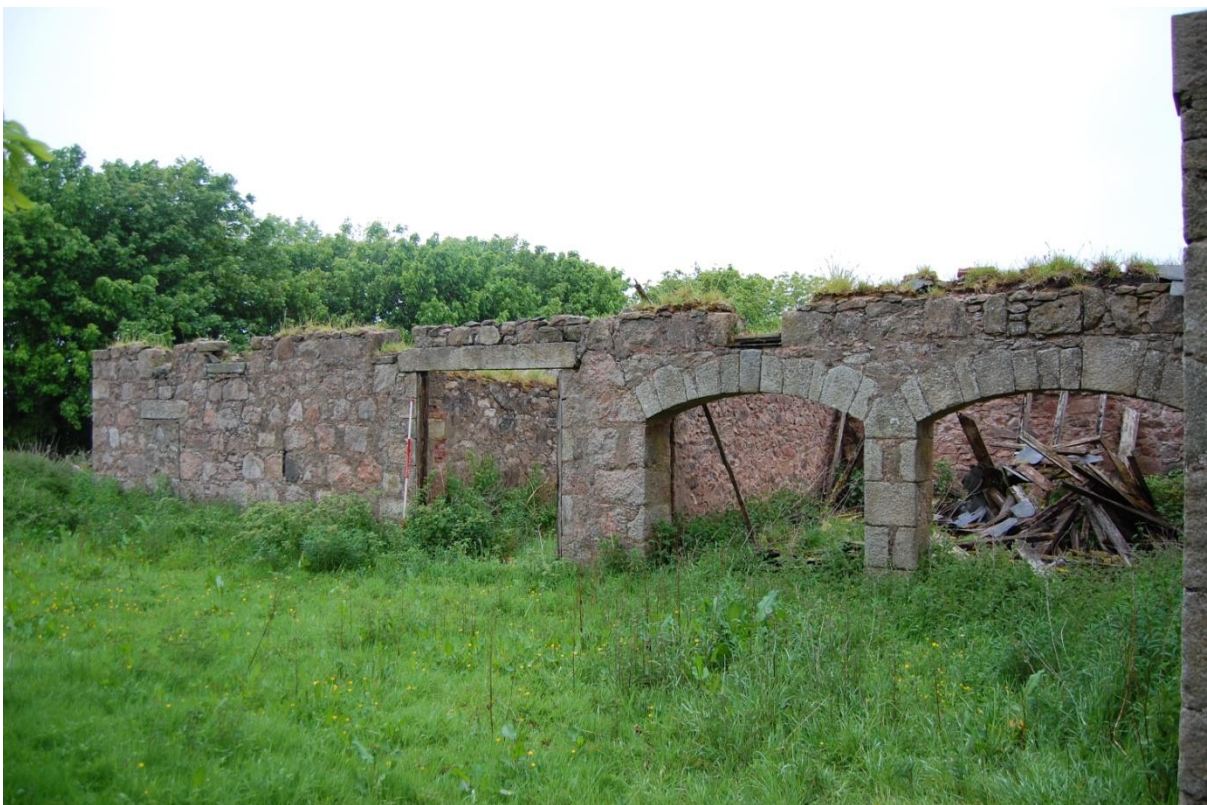
The three rooms of this wing originally had two storeys and beam slots are present on the north walls of all three rooms. Room 9 was inaccessible due to the poor state of the roof but there is a small aperture (W16) in the north wall. The south wall of this room has been altered after construction and two arched coach doors (D13 and D14) added (Illus 20). These are at least 2m in height which is a common height for these doors (eg see Cameron 2010 for standing building of steadings of similar type and date at Pittodrie House Hotel). On the south wall of Room 11 there is a slit window similar to those on the north wall of Room 5. There are also windows to the courtyard from Rooms 10 and 11 and an original blocked door in the south wall of Room 11 and these rooms may originally have had a domestic use.

Illus 20 South wall of south wing with Door 12 (centre) and coach doors D12 and D13 (right)

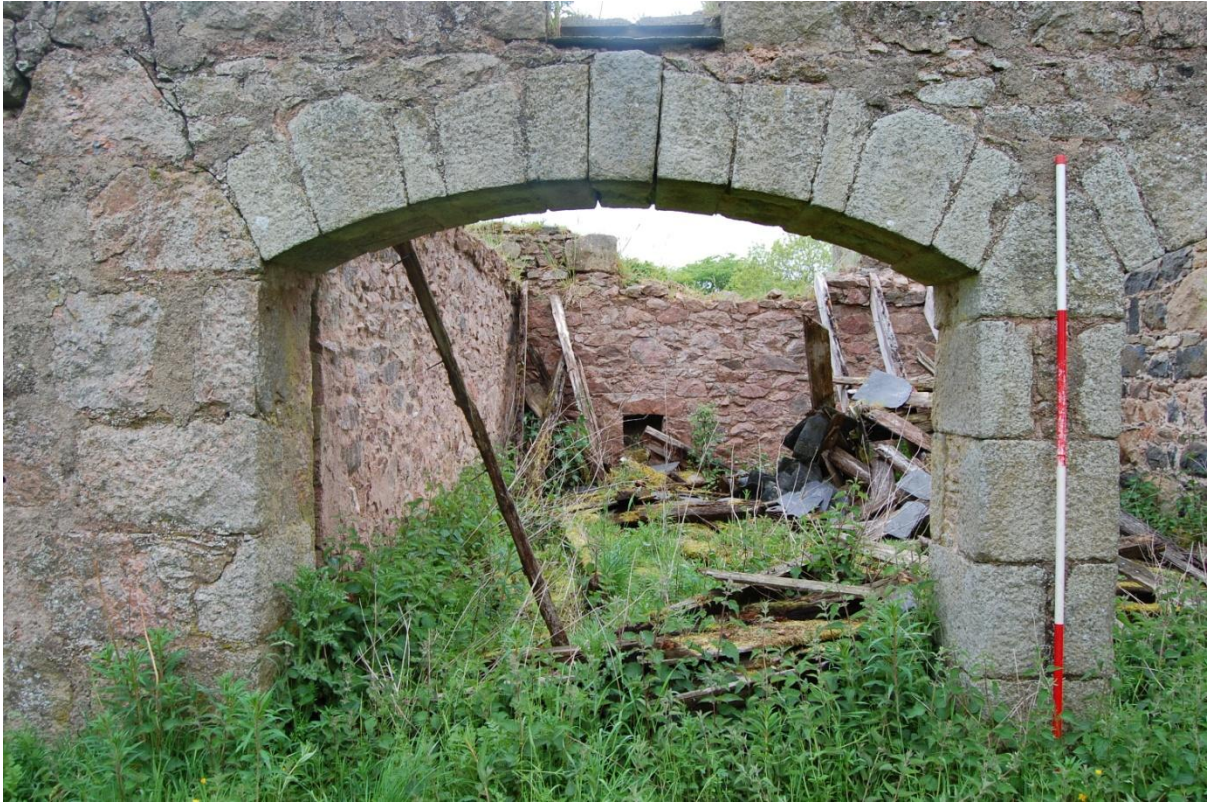
Illus 21 Coach Door 13 with window 14 above

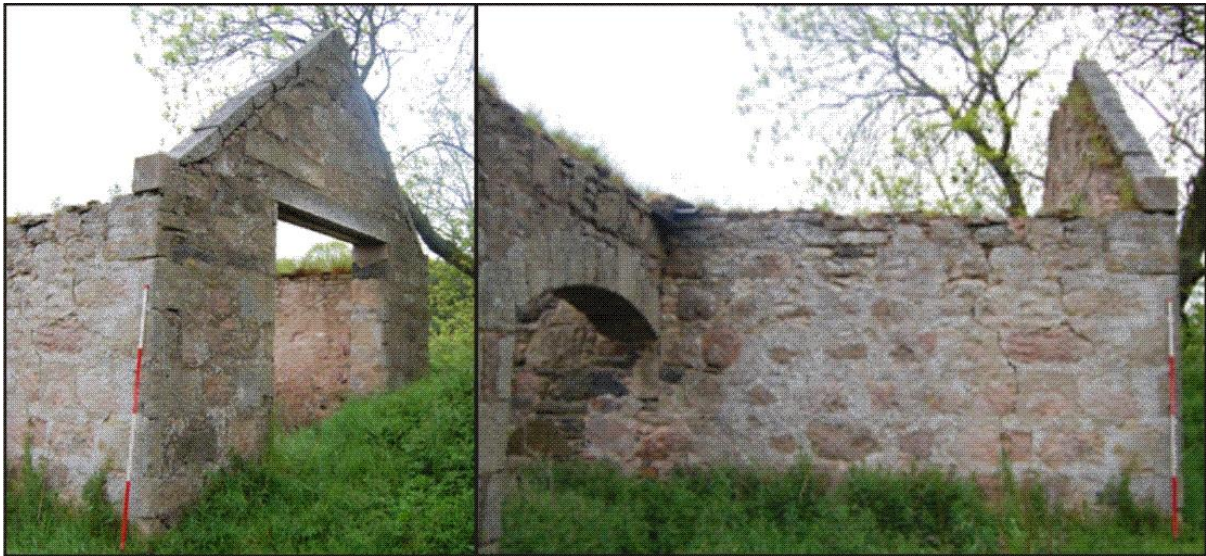
Illus 23 Extension south of Room 8 (left) Door 16 (right) Door 14; built between 1899 and 1924 OS maps

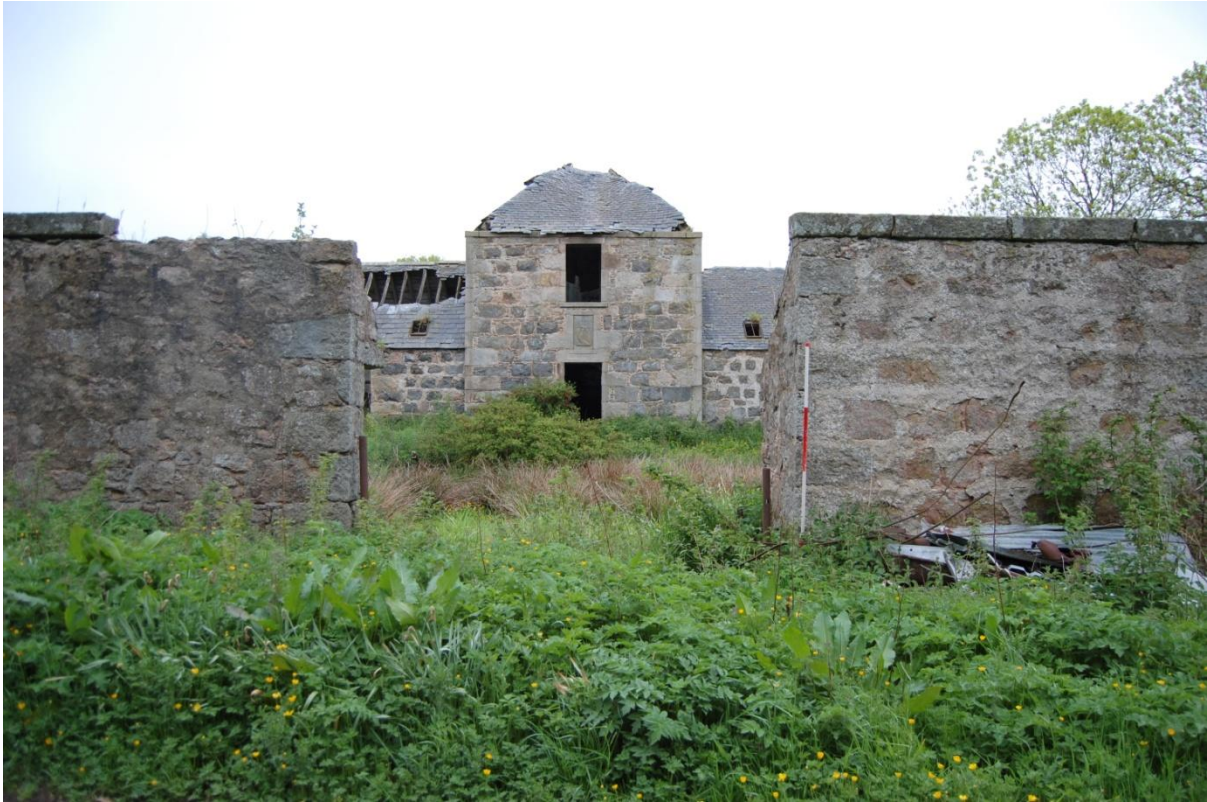
Two small rooms (12 and 13) formed the west side of the courtyard; they are constructed of pink quartz-rich granite like the other rooms on that side of the courtyard. They are difficult to access and in poor condition; both are leaning to the west. Room 13 has a door on both north and south walls and Room 12 just on the south side. Their interpretation is difficult but it may be that they housed grooms and other staff who would greet visitors to the house (who would have had to pass this building on the way to the main house). They may also have been used for storage and the spaces in between them are wide enough to allow carriages into the courtyard. It may also be that they are part of an earlier structure which was then incorporated into the newer building and this might explain why they are in much poorer condition than several of the other buildings.

Illus 24 Room 13 (left) and Room 12 (right) with courtyard behind

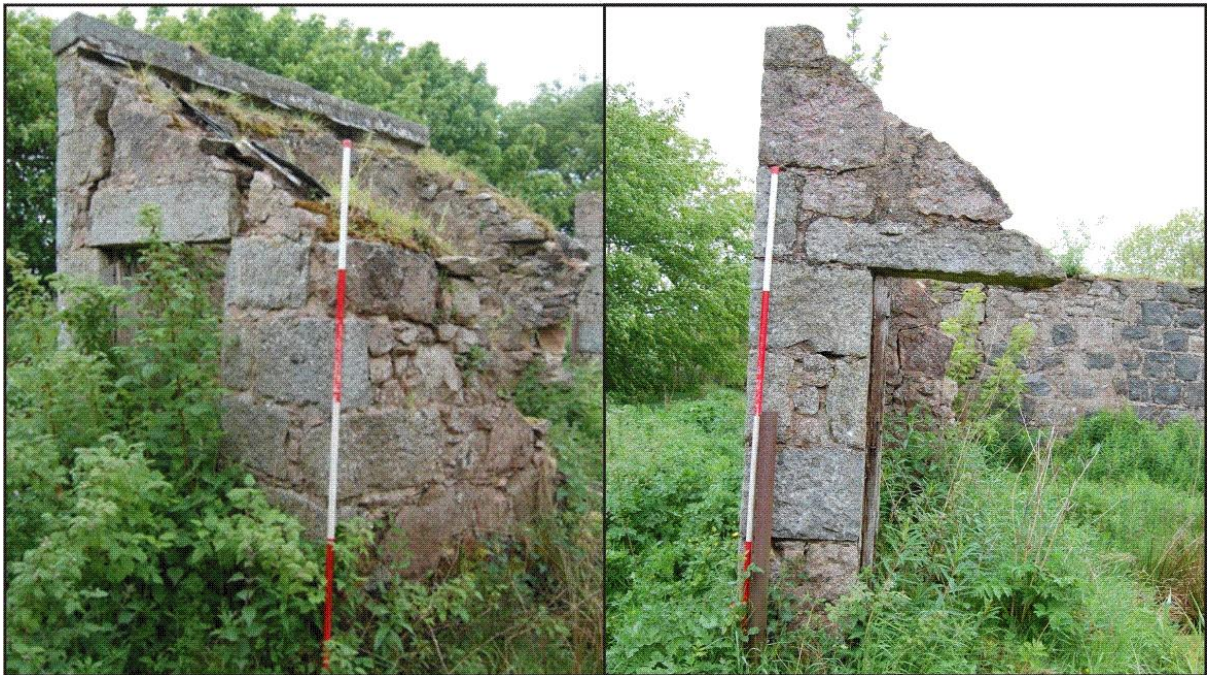
Illus 25 (left) Room 12 showing Door 21 (right) Room 13 Door 22

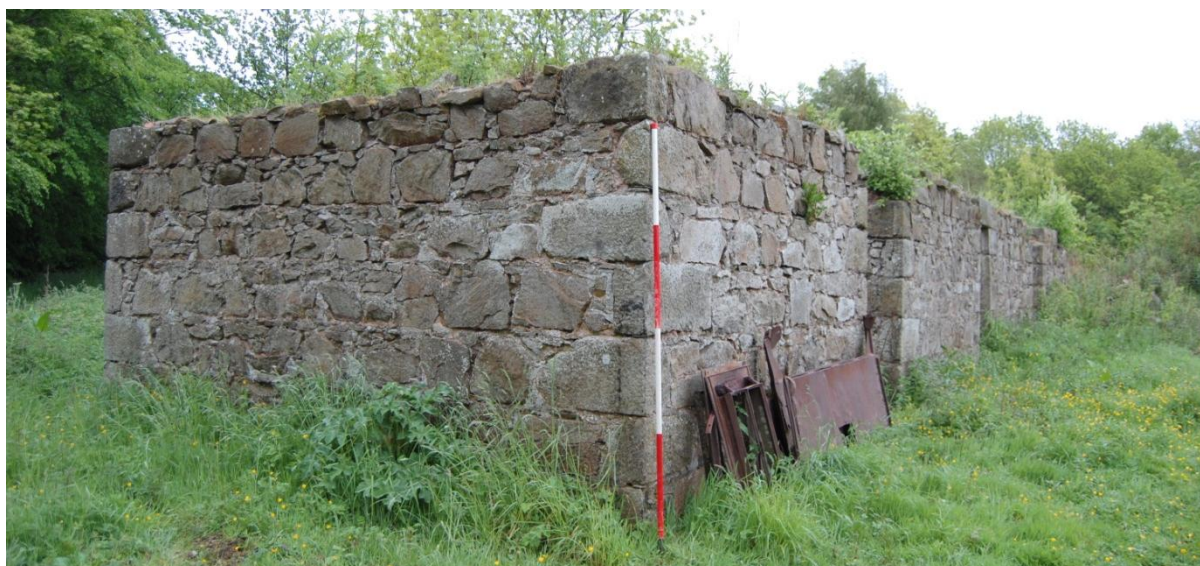
North of the main steading are a group of three rooms (Rooms 1-3). The buildings are granite rubble and there is a door in the NE end into the NE room and a door into each of the other rooms in the SE wall. There had originally been four rooms and there is a wall scar on the north wall (F5) where an internal partition wall has been removed. On the 2nd and Third Edition OS maps (1899-1924) there is another building attached to the SW end and one on the NW side (Illus 28) although there is no evidence for these buildings on the ground or on the standing structure suggesting that they were temporary structures, possibly in wood or not actually attached to the stone structure. This indicates that there was a maximum of six rooms in this wing in the late 19th and early 20th century. The lack of fireplaces and windows in this range suggests an agricultural use.

Illus 26 Room 1 (foreground), Room 2, Room 3
