Bowbutts Farm, Strachan,  
Banchory AB31 6NN

Alison Cameron  
Cameron Archaeology  
23.8.12

# Bowbutts Farm, Strachan, Banchory, AB31 6NN

## Report on Standing Building Survey

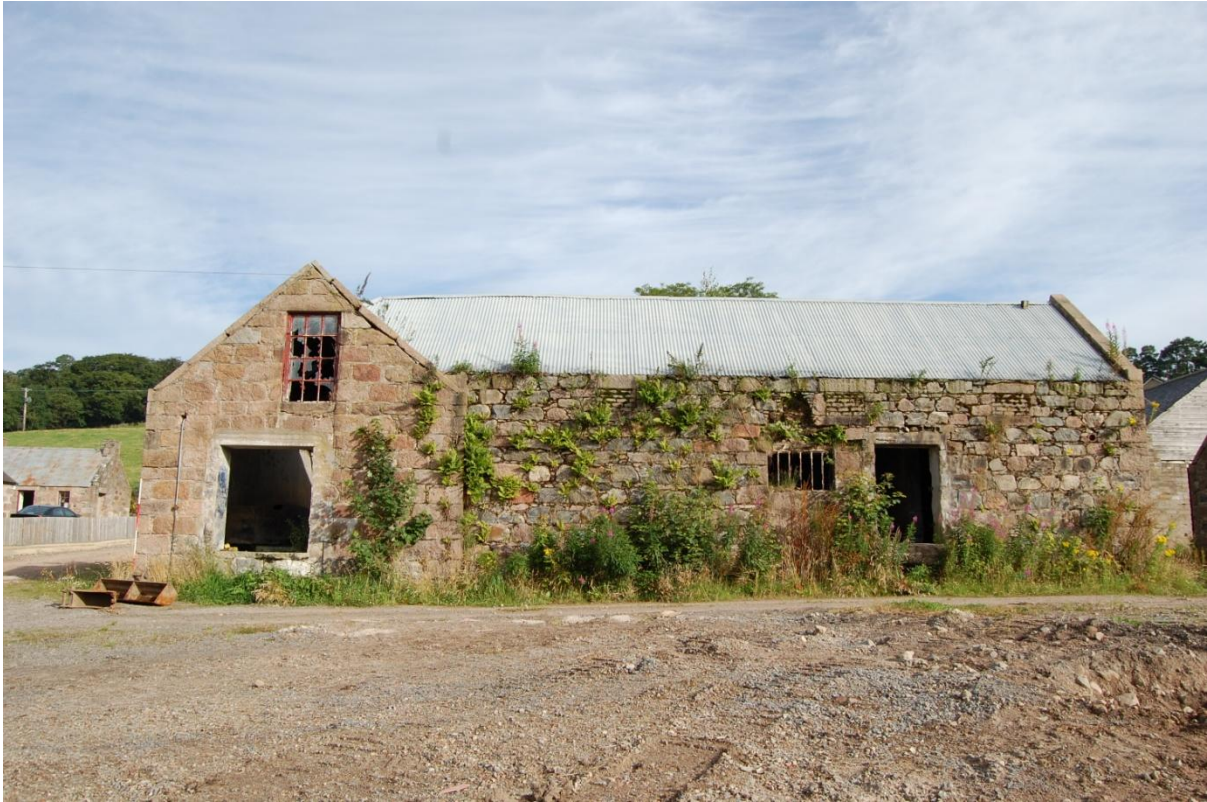
Illus 5 Phase 1 Room 1 (left) and Room 2 (right) substantially altered in Phase 2

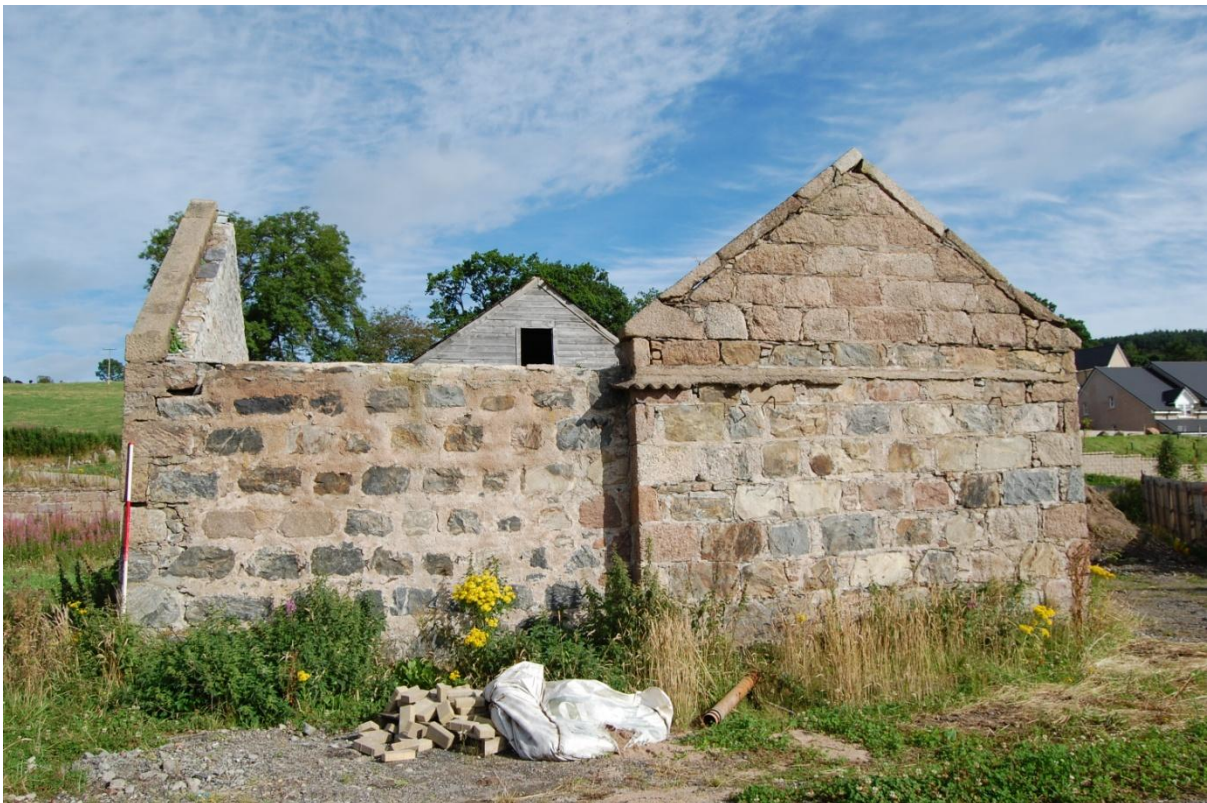
Illus 6 Phase 1 gable (left) constructed of large pink granite blocks, and Phase 2 (left). The Phase 1 gable had a door (F6) which was blocked in Phase 2

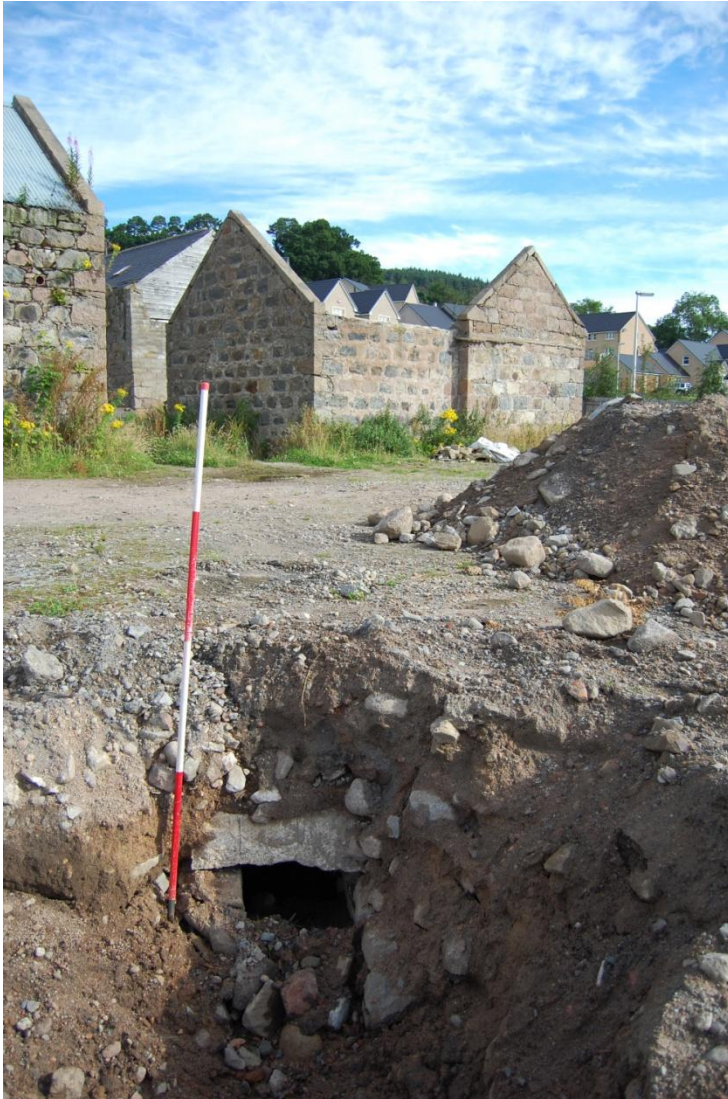
Illus 9 Stone drain F3 leading to SW corner Room 3

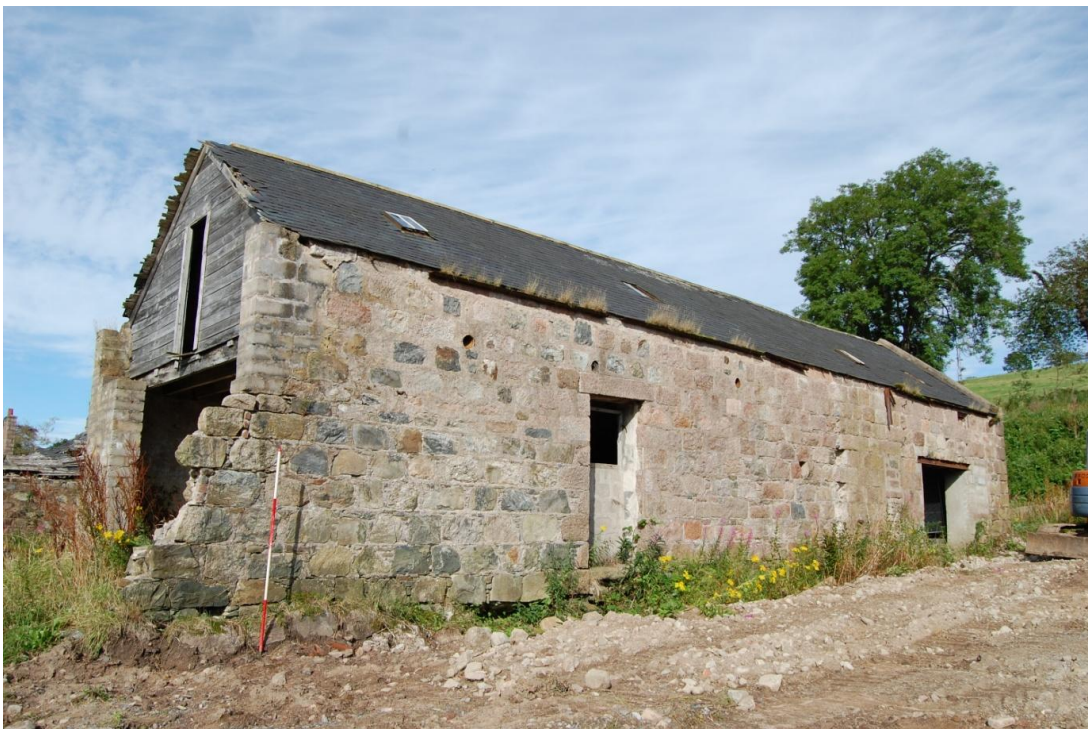
Illus 10 Room 4 east elevation; the threshing mill wuld have been attached on to the right hand side of this photograph

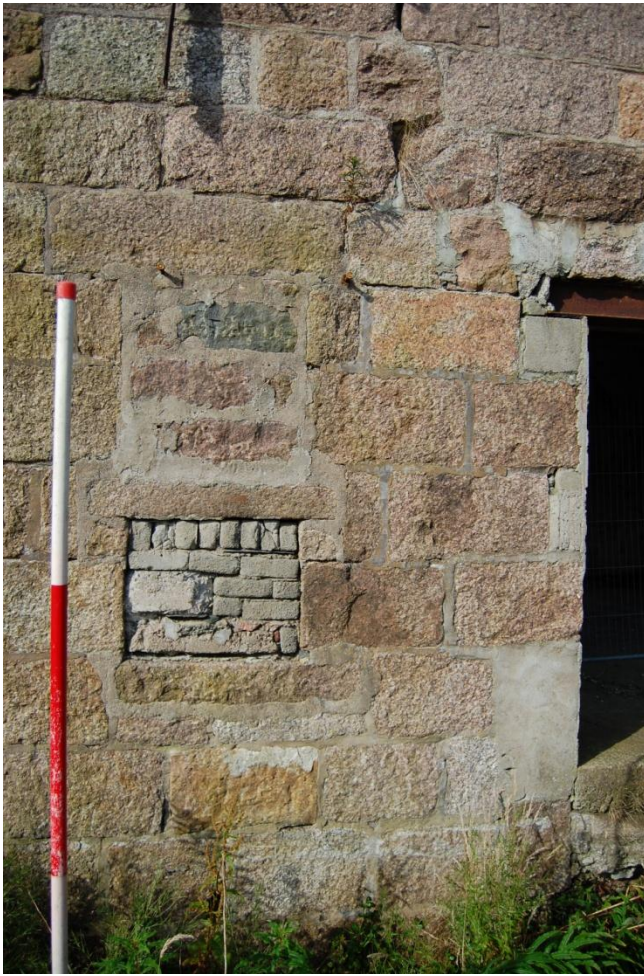
Illus 11 Room 4 east elevation detail showing threshing mill apertures W6 (above) W7 (bottom) and D14 (right).

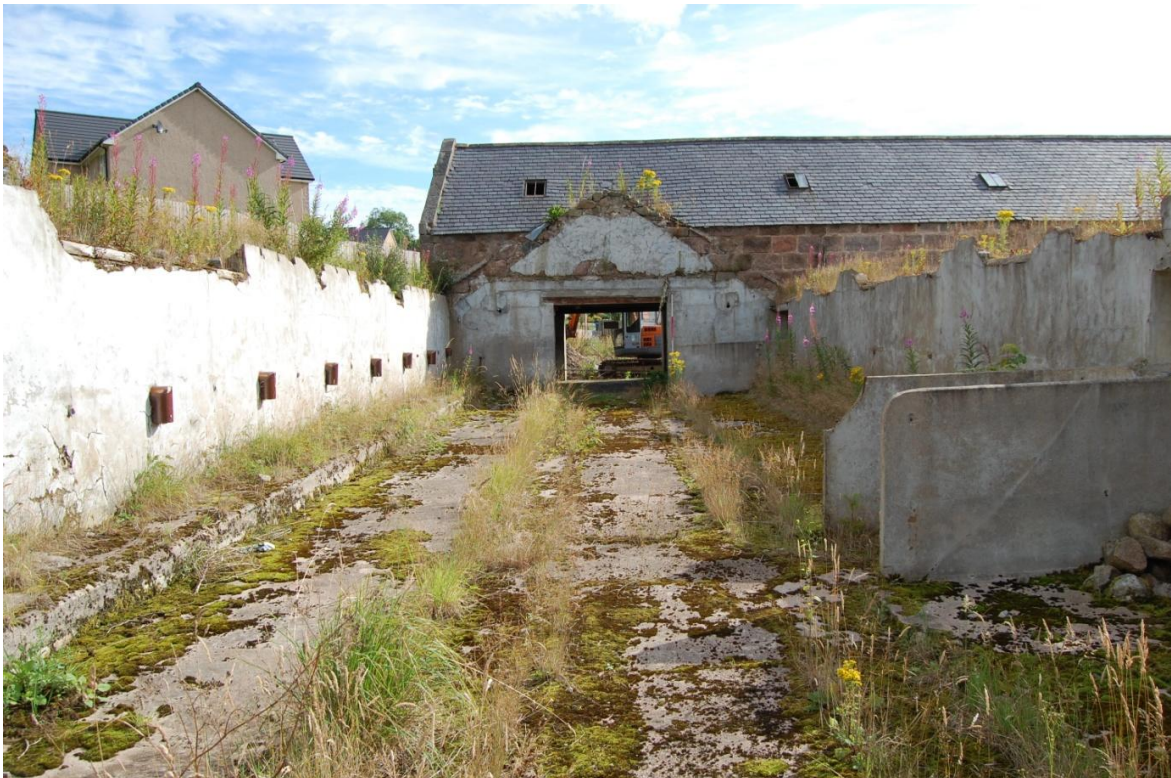
Illus 12 Room 5 interior; this room was extended and the internal fittings replaced in Phases 2 and 3

Various alterations have taken place including refitting Room 5 with reinforced concrete byre partitions and fireclay ventilation system. The south part of Room 4 was also demolished creating an access to the east of the steading and other walls were demolished.

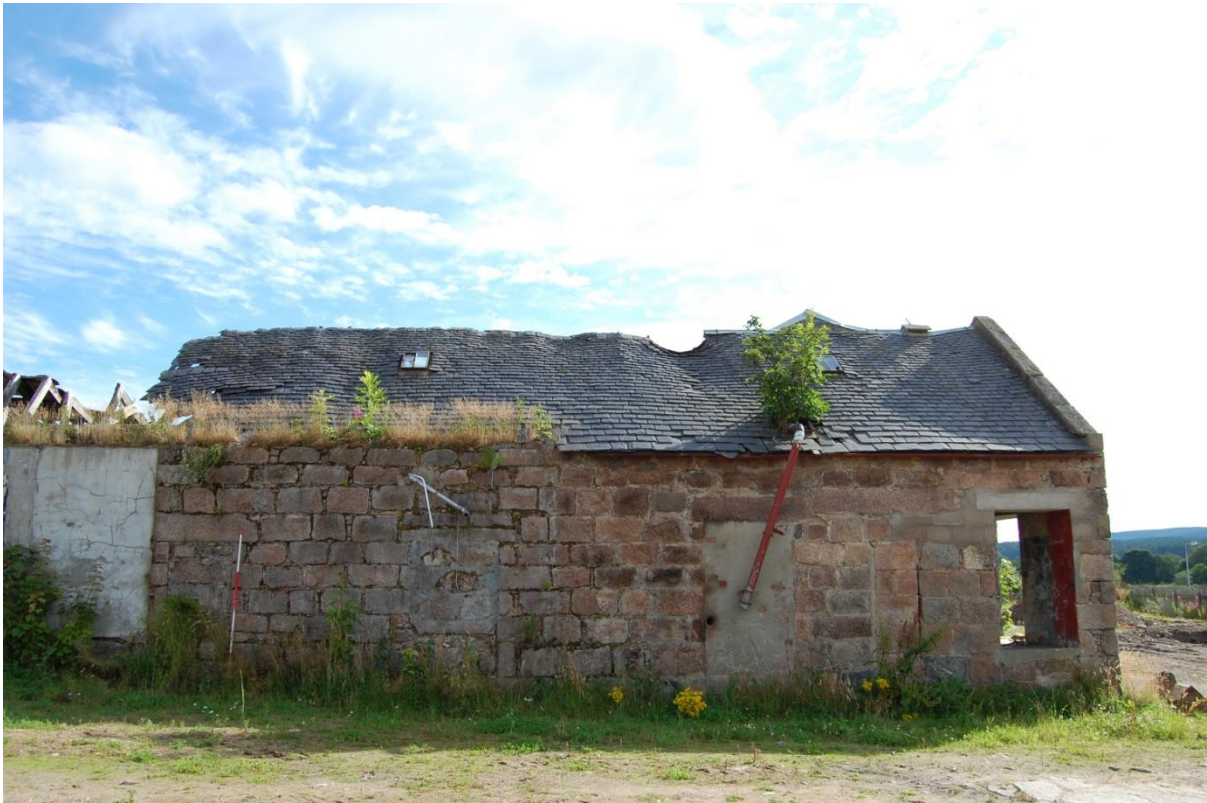
Illus 13 Room 1 west wall showing several blocked apertures
