Standing Building Survey and Watching Brief Contlaw Mains Steading, Milltimber AB13 0ES

Alison Cameron
Cameron Archaeology
24 August 2012

Standing Building Survey and Watching Brief Contlaw Mains Steading, Milltimber, AB13 0ES

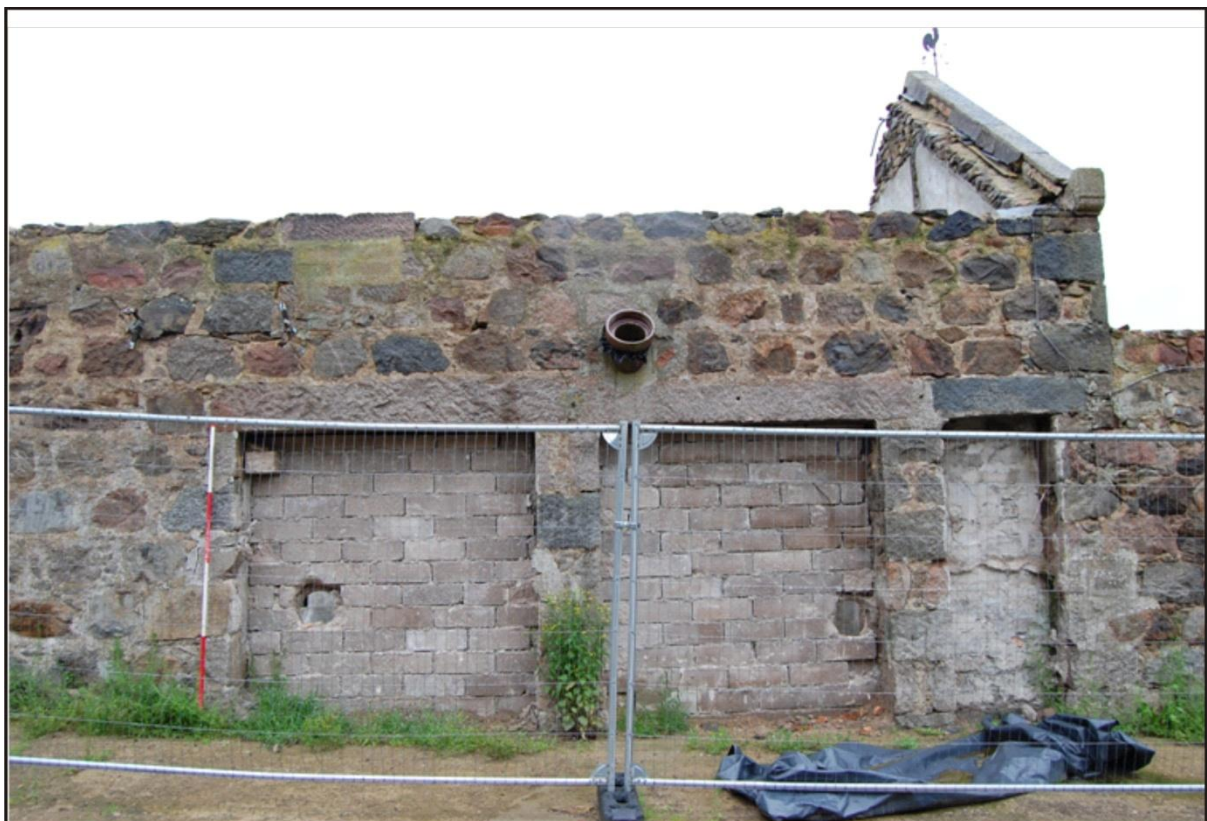
All the buildings appeared to be single storey apart from Room 1 and 2 which have had second floors; Room 1 has upper floor window W2 and Room 2 has W11 (above D12) and beam slots (Illus 12). Room 2 had two carriage doors (D13 and D14) off the courtyard and access road to the south of the property

Illus 7 Phase 1 west arm of steading showing Doors D12, D13, D14

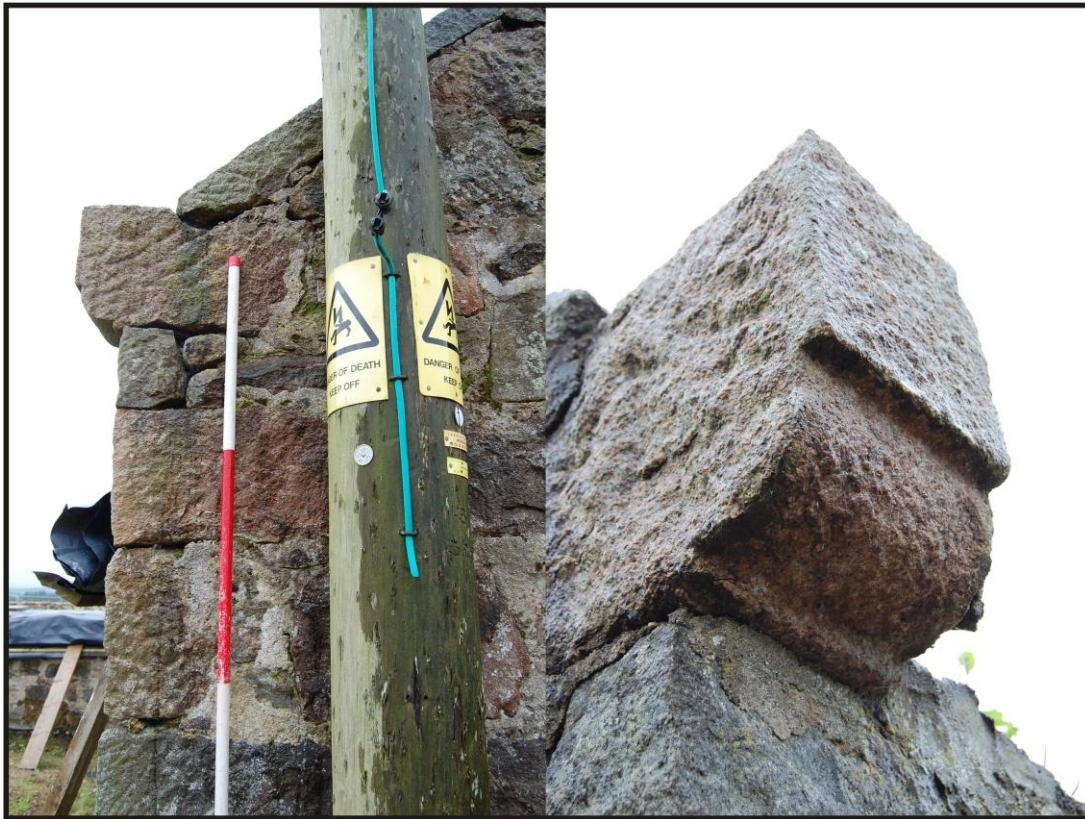
Rooms 2, 3 and 4 were constructed in one phase; decorative corbels (Illus 6, 8) on the corners of these buildings suggest that they were built on one phase. The horse-mill may date to this phase as it was sited next to one of the northern buildings on the First Edition Ordnance Survey (Illus 5).

Illus 8 Corbel on NE corner Room 1

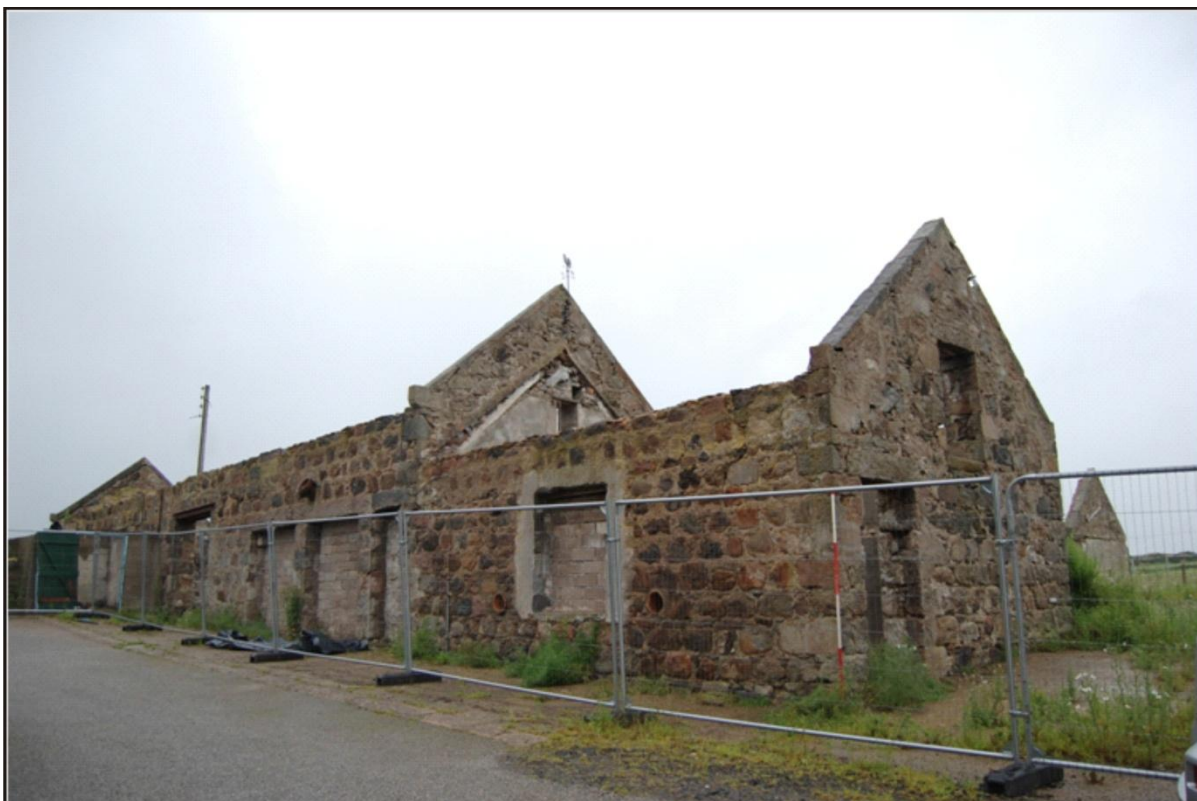
Illus 10 Room 1 (right) and Room 2 (left) from SW

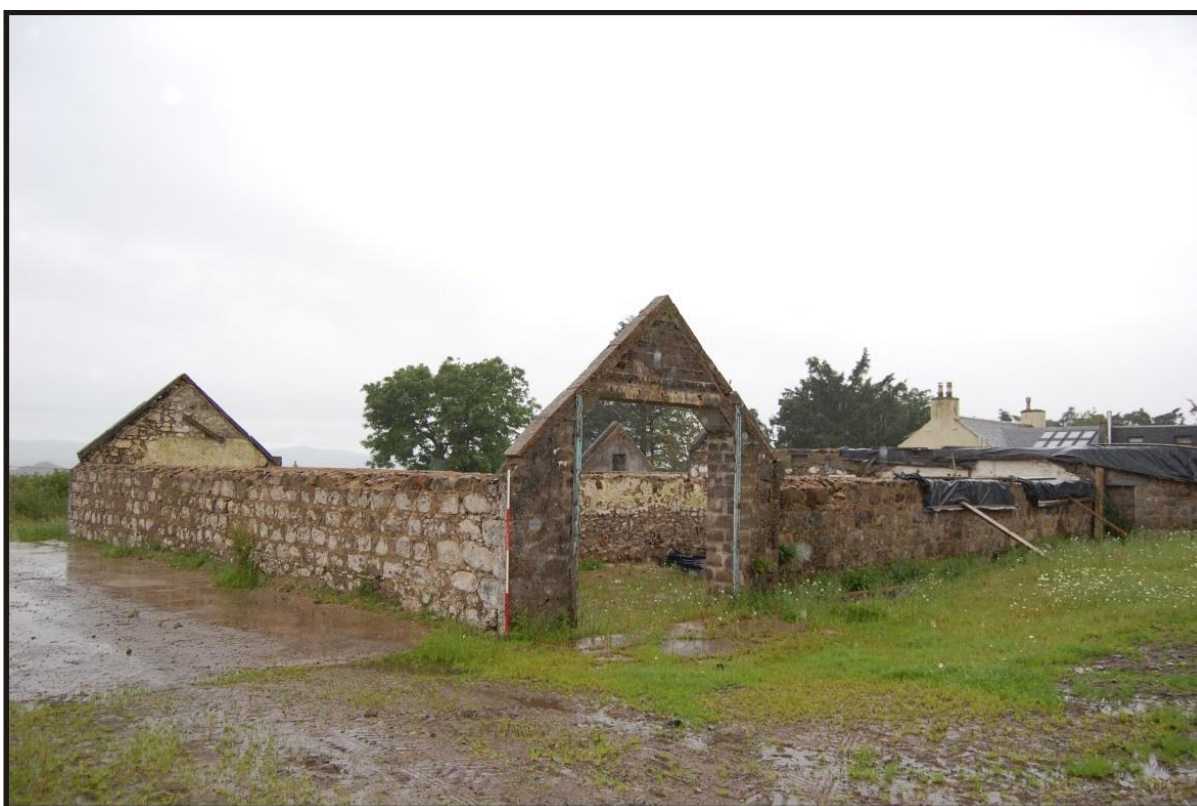
Illus 11 Room 4 (left) and Room 3 (right) from NE

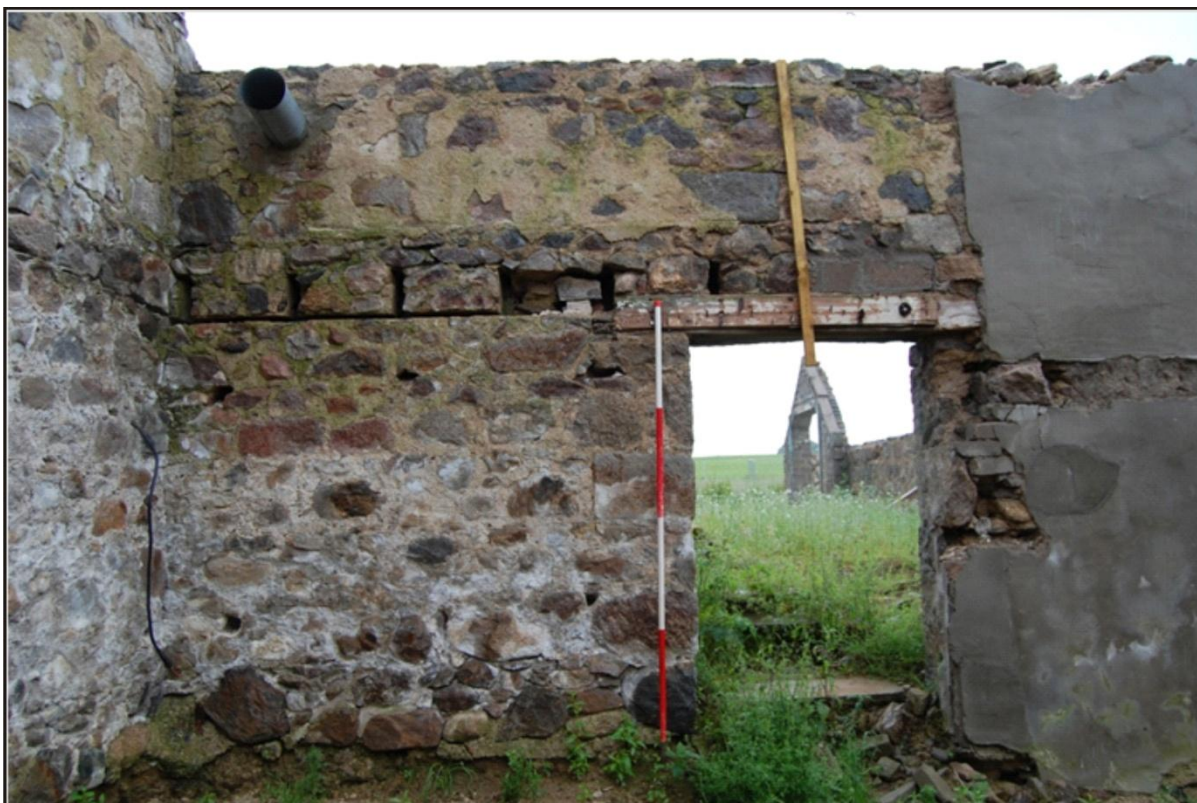
Illus 12 North end east wall Room 2 with D10 showing beam slots

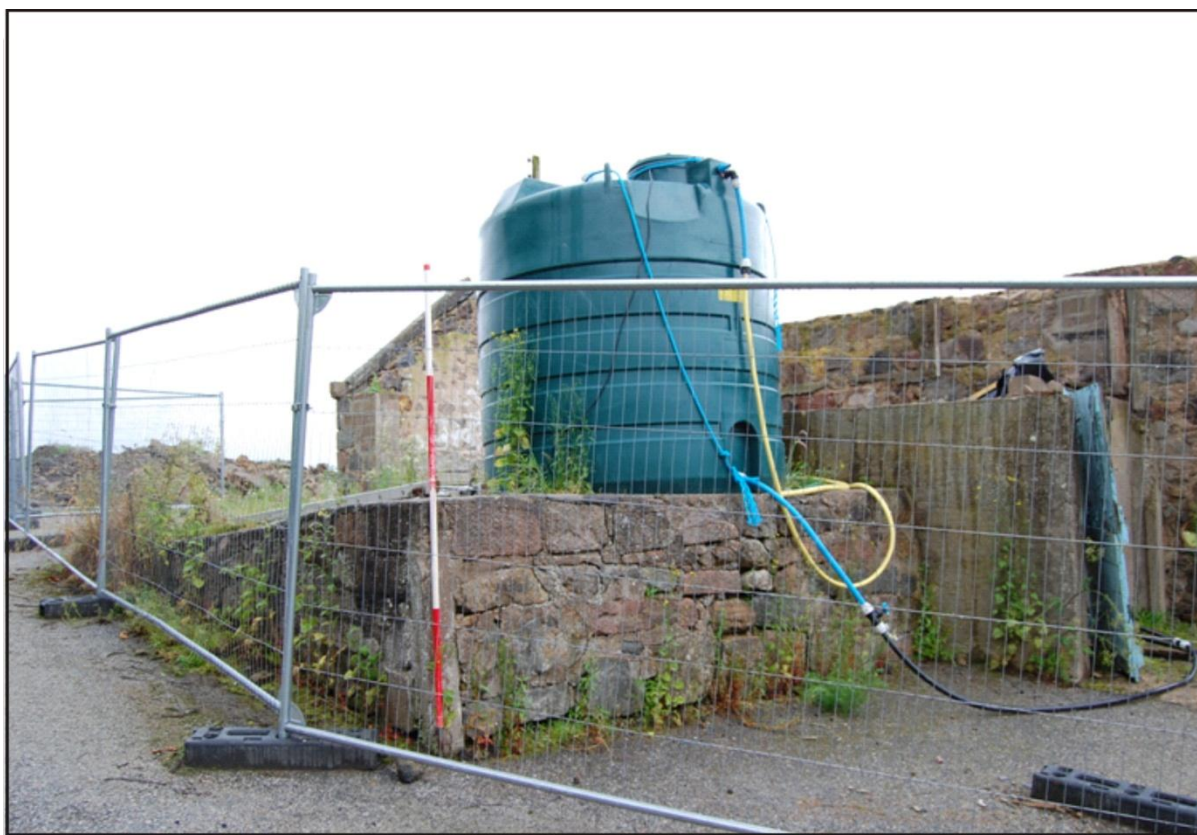
AA is the remains of a horse mill (Illus 5, 13) or stands on the site of one seen on the Second Edition Ordnance Survey map (Illus 5). It was cut through by Room 5 and is now being used as a base for a water tank.

Illus 13 AA the remains of a horse-mill with Room 5 (right)

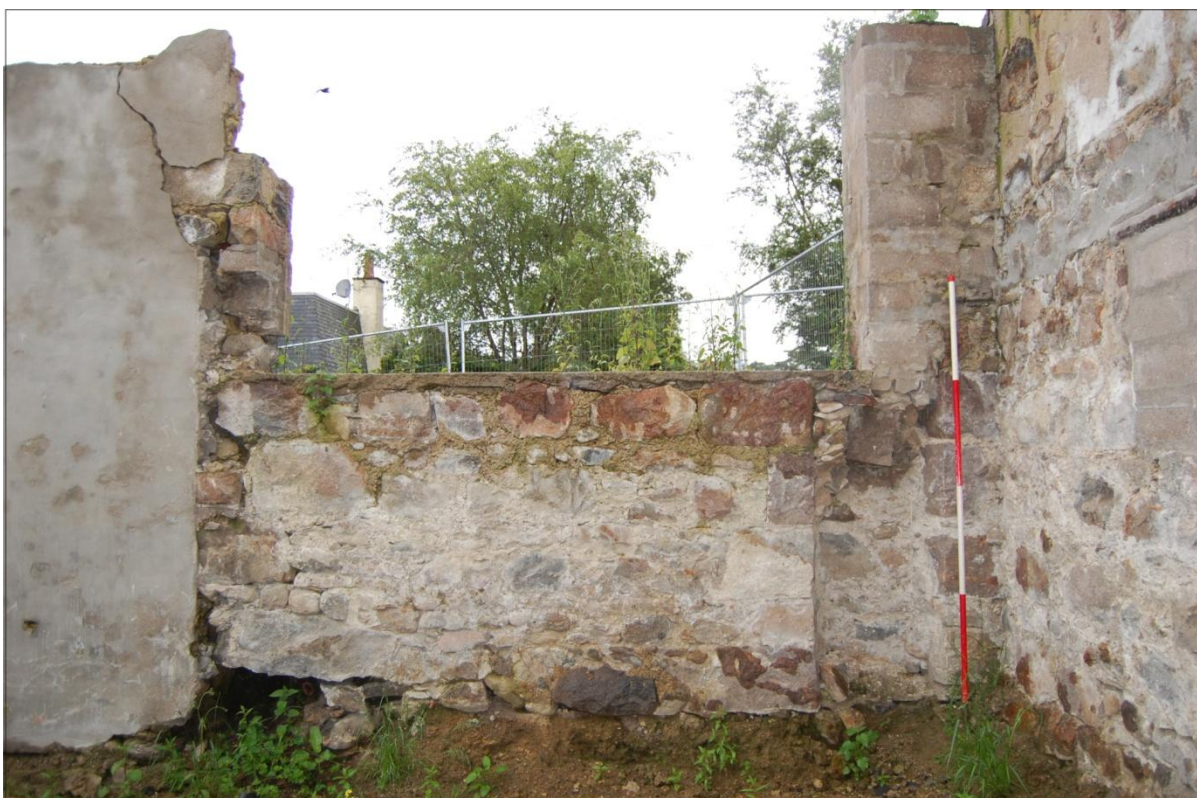
In the NW corner of the interior of Room 2, recess AB (Illus 6) housed a fitting; it is immediately adjacent to Window W3 and may have been associated with providing running water to the buildings. This may have been domestic accommodation but any further evidence of this has now been lost.

Illus 14 Recess AB (right; to left of ranging rod) with remains of Window W3 (centre)

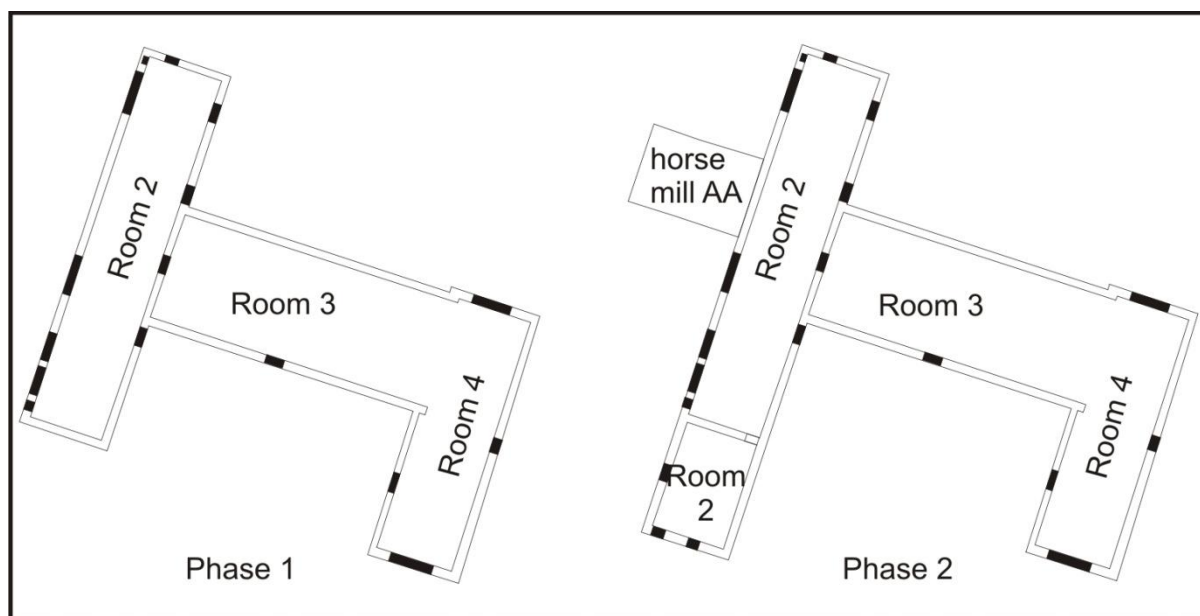
Room 1 added to south after the construction of Room 2. It is in stone and may not have been built long after the original building.

In the late 20th century other structures such as a roof for the cattle court and Room 5 were added but these were mostly removed prior to the survey. Latterly Rooms 1, 2 and 3 had been fitted out with animal stalls and the remains of these could be seen as scars in the cement rendering.

Illus 15 Phase 1 buildings with Phase 2 later extensions

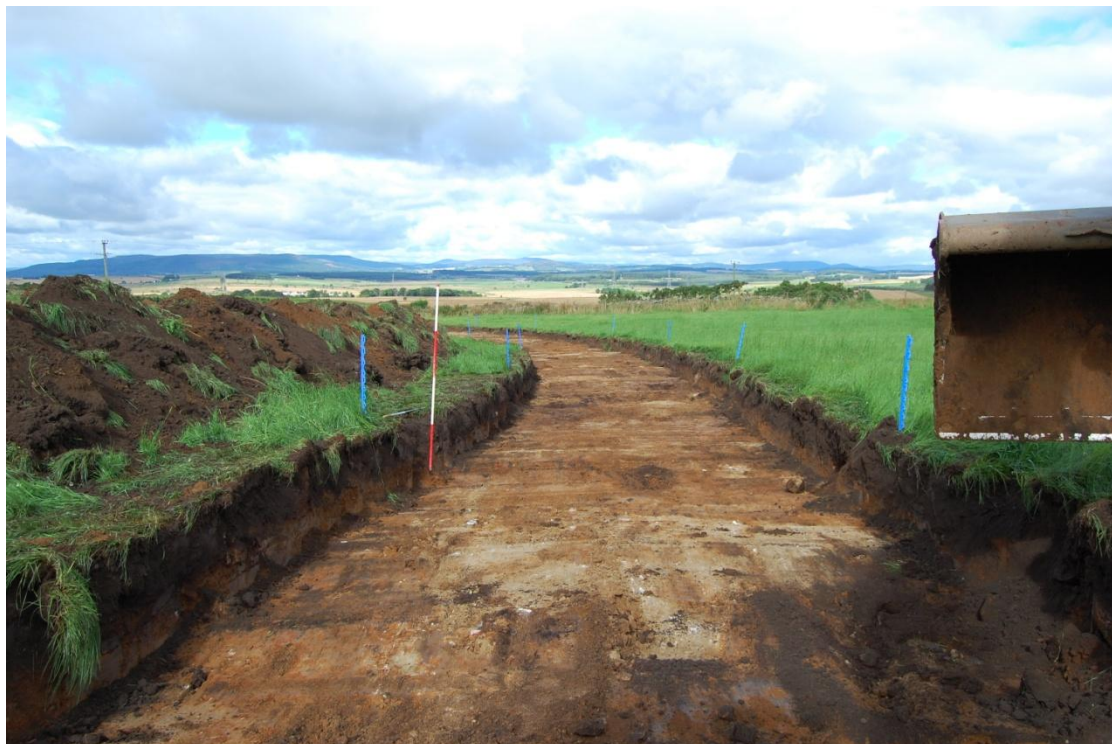
The soil strip for a new access route (Illus 2) was observed on 22 August 2012. The topsoil varied from 0.4m depth at the west end of the field to 0.2m at the top (east end). Two stone drains were recorded at the west end near the field boundary and a disconnected electric cable in a shallow trench was uncovered near the steading. No significant archaeological features were identified.

Illus 16 Watching brief area; facing NW
