**Victoria House, 84 West North Street, Aberdeen, AB24 5HT**  
**Standing Building Survey and watching brief**

**Alison Cameron**  
**Cameron Archaeology Ltd**  
30 November 2012

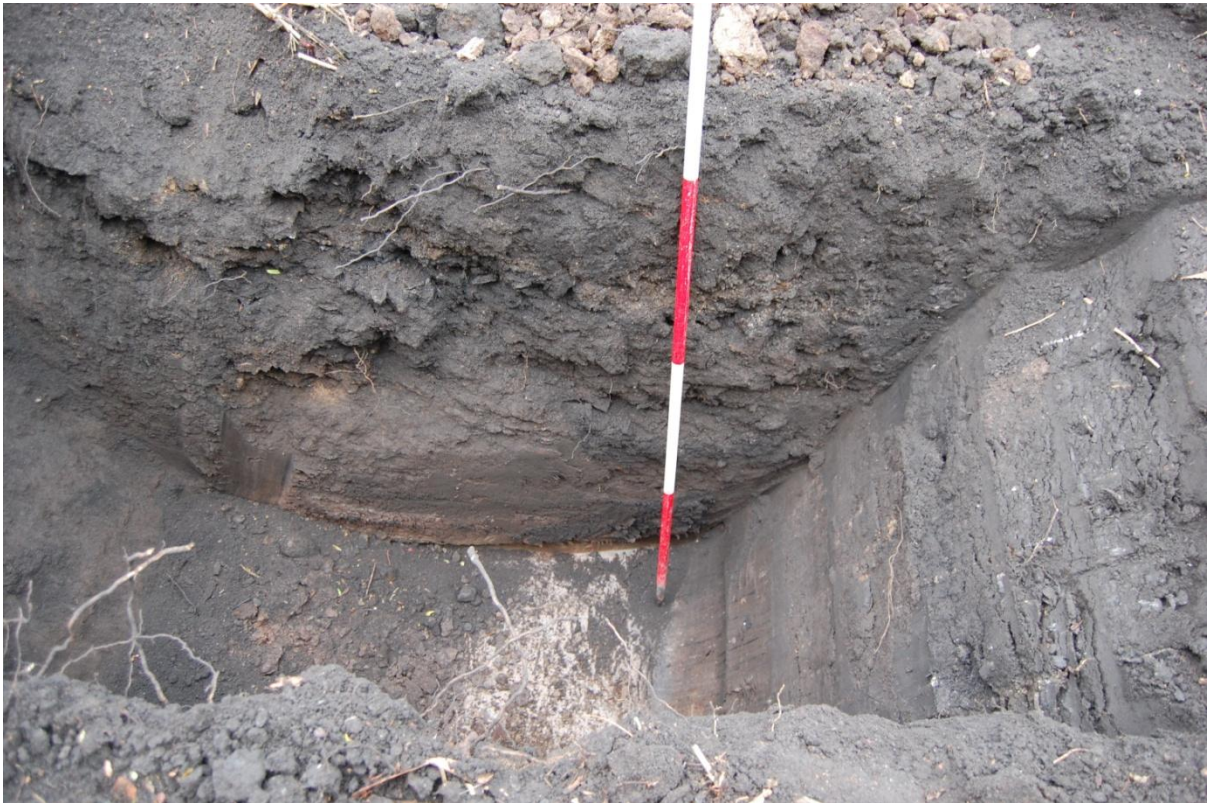
In TP2-4 in the rear garden there was 0.7m wet garden soil above the clay natural subsoil but this did not contain any finds. Above this 0.8m very dark grey enriched light garden soil contained sparse 19th-20th-century finds including a dog skull and ceramic sherds. In TP3 a dump of brick, stone and mortar below the topsoil was probably from building or demolition work at the site; the north wing was partially demolished in the late 19th century as was part of the brick garden wall. TP4 contained a dump of stone, brick, mortar and plaster (7) including hand-made bricks 225 x 110 x 65mm in size in a pit cut down to the natural subsoil. This had also come from a building or demolition event at the site.

Illus 4 TP 2 showing enriched garden soil above a heavy clay garden soil below

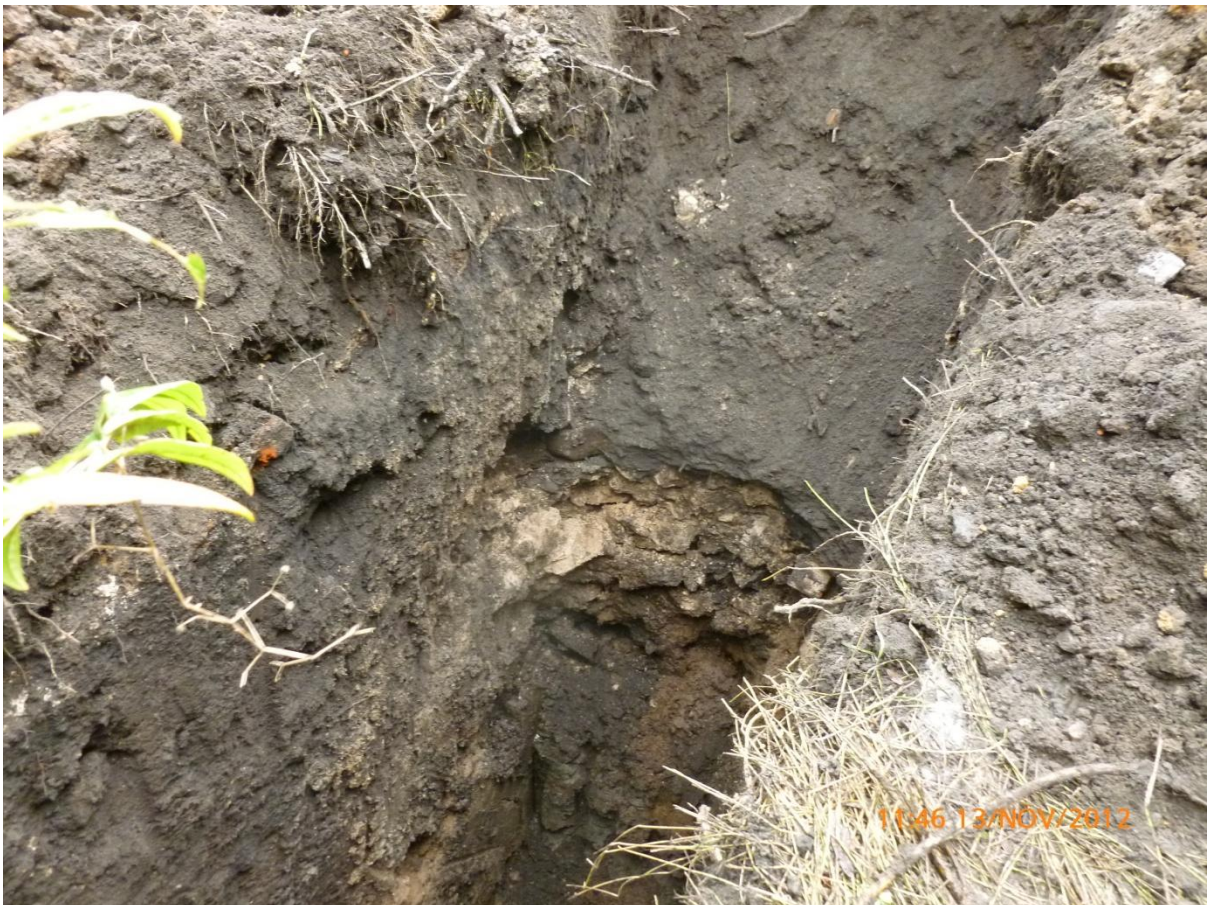
Illus 5 TP3 dump of brick, stone and mortar (7)

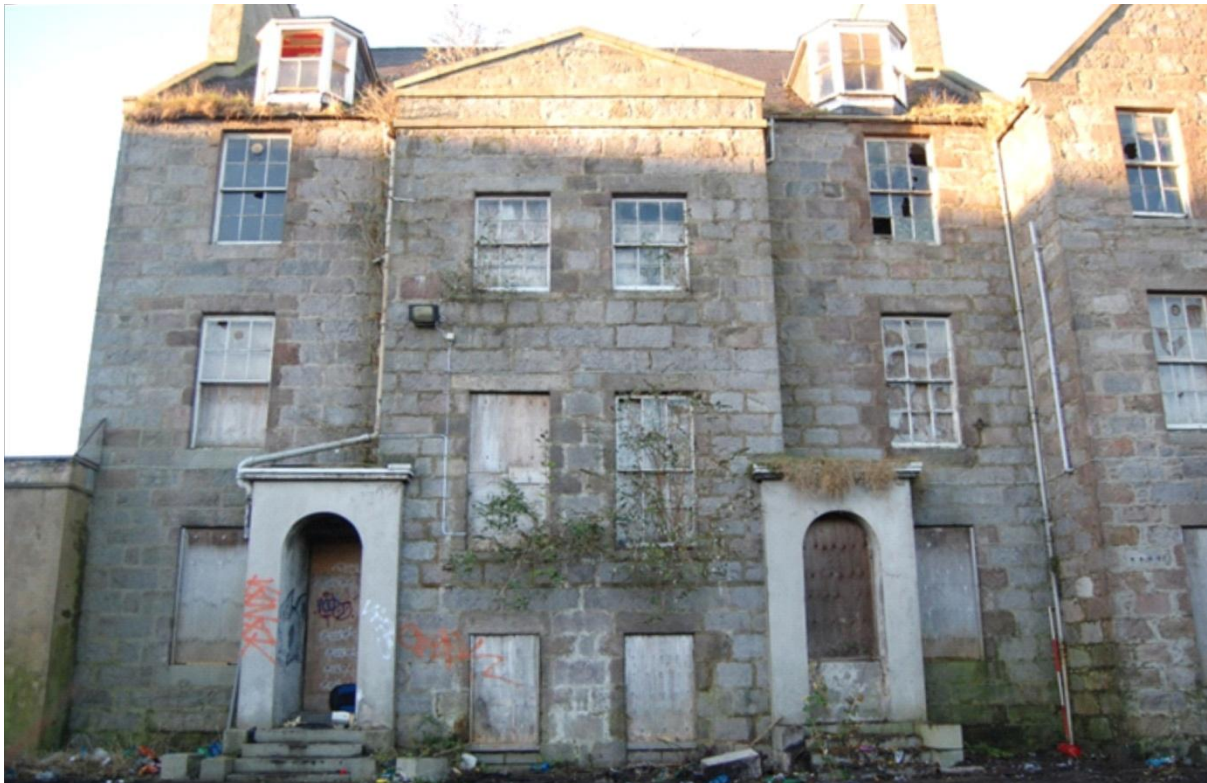
Building 1 was 16.3m long and 12.5m wide and the front (east) facade is constructed of roughly worked grey granite blocks with pink grey granite blocks around the windows. The side and rear walls are of plain grey granite blocks. The building has a two bay centrepiece and William Adam-style portico (Illus 6). The building had a single-storey wing at each end and one survives at the SE end. It is of brick and sandstone construction (Illus 8) and is entered from the SW by balustraded steps to the basement (Illus 10). This wing is constructed of a lean-to shed with a single-thickness wall facing onto the front (east) side which creates an impressive facade from King Street (Illus 9).

Illus 6 Building 1 with Door 2 (left) and Door 5 (right)

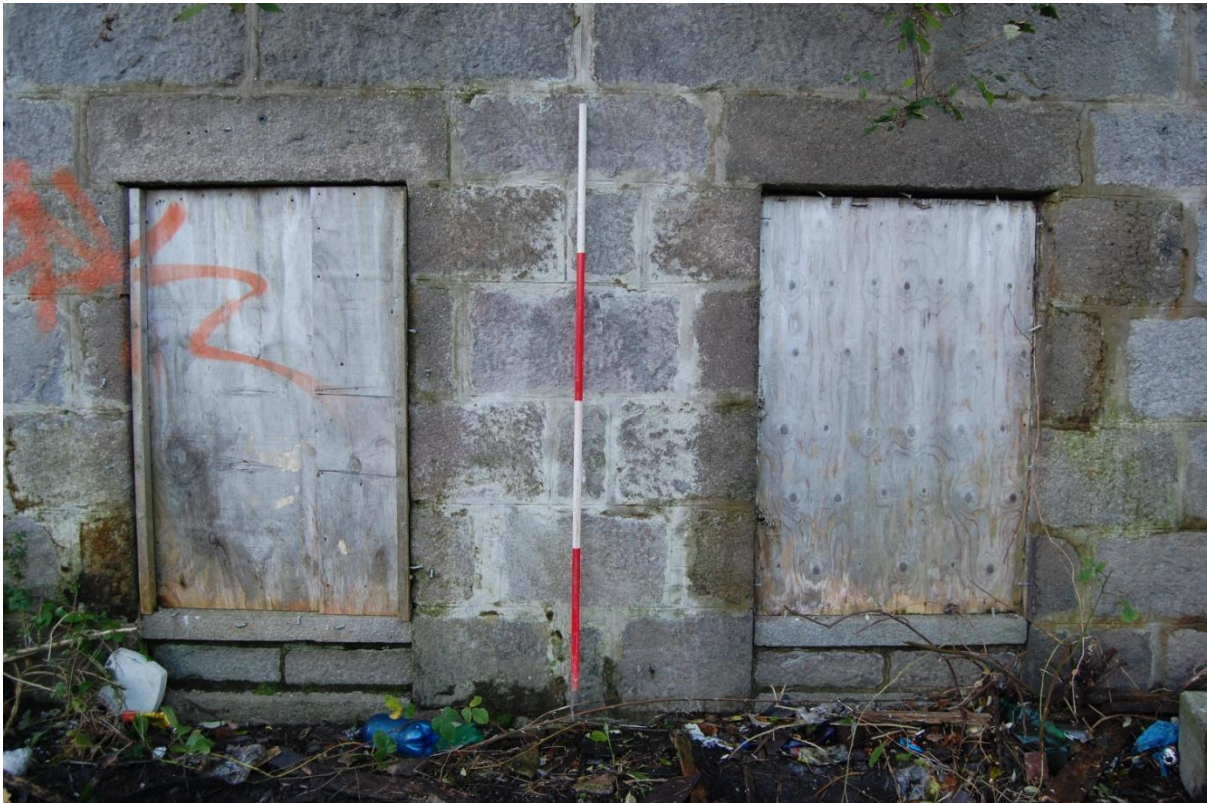
Illus 7 Building 1 NE 'front' facade facing on top King Street. Door 3 (left) and Door 4 (right) later converted to windows (W1/W2) after the insertion of poured concrete doors D2 and D5

During the first phase of the house two doors (D2 and D5) were added to the NE facade (Illus 14, 15) and Doors 3 and 4 which had been used for access to the garden were converted to windows and steps removed (Illus 7). Doors 2 and 5 are constructed of poured concrete on a metal frame (Illus 15) and probably date to the late 19th century. They appear to have been constructed to 'modernise' the front of the house and create impressive features of these doors.

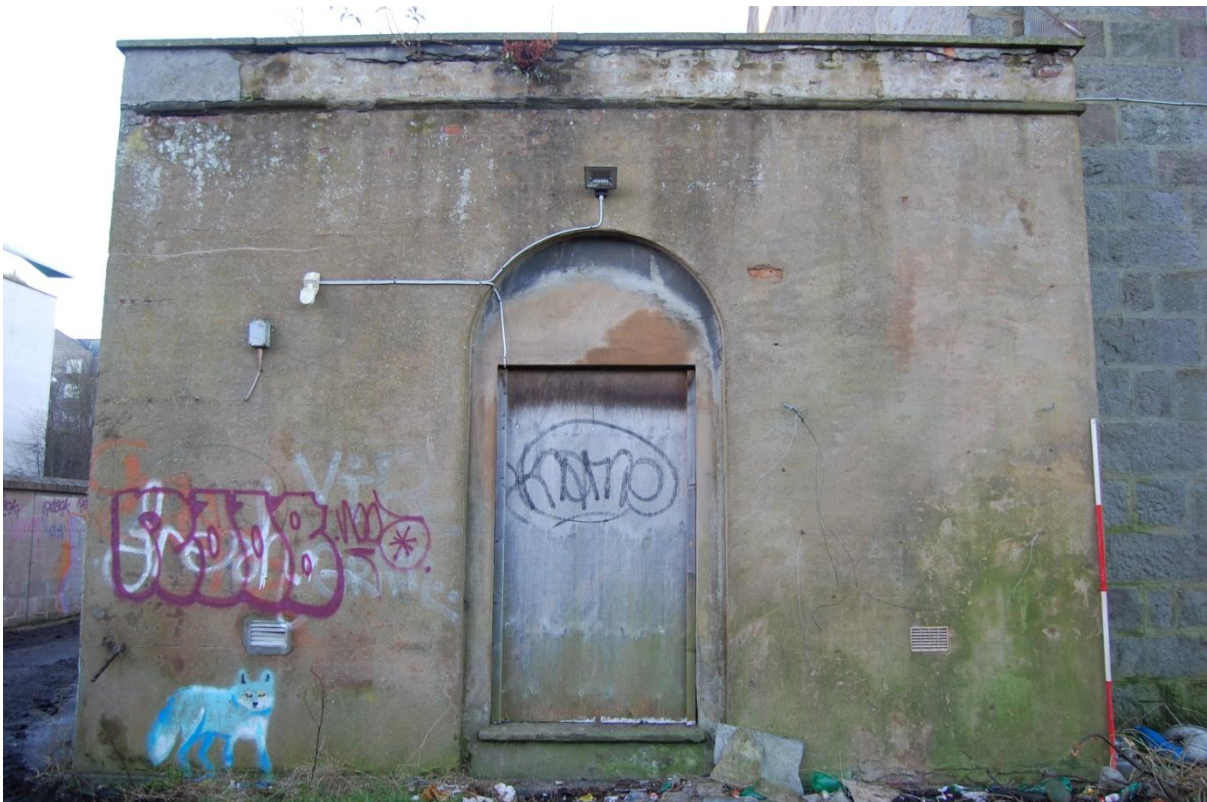
Illus 8 Building 1 SE wing with D1

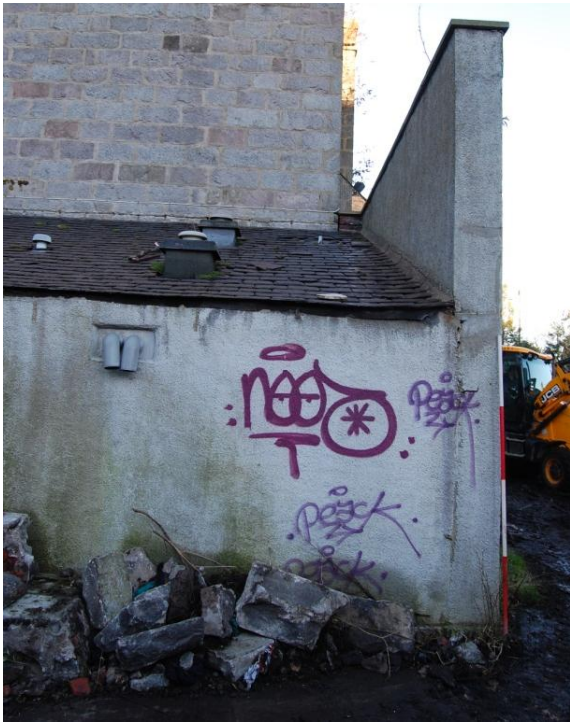
Illus 9 Building 1 SE wing showing facade wall (right) fronting on to the King Street front facade

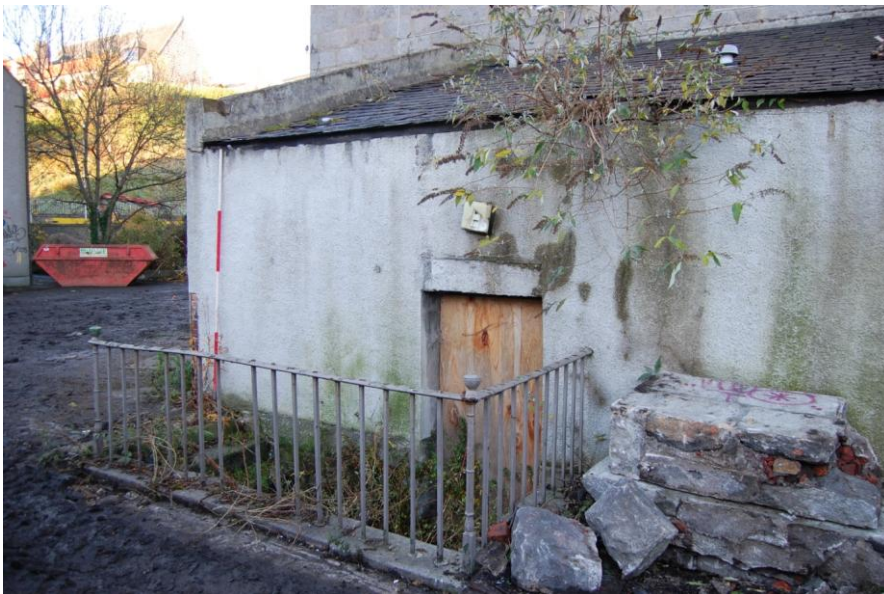
Illus 10 Building 1 SE wing with D7, steps and cast iron balustrade; this building is partly below ground level.

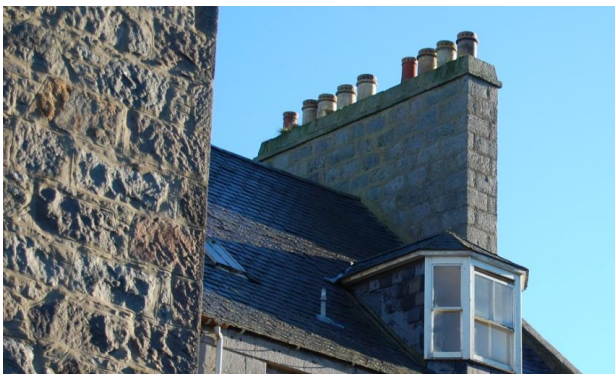
The facade of this building and the Georgian style chimney stacks suggest that the building might originate in the 18th century.

Illus 11 Georgian chimney on SE gable Building 1

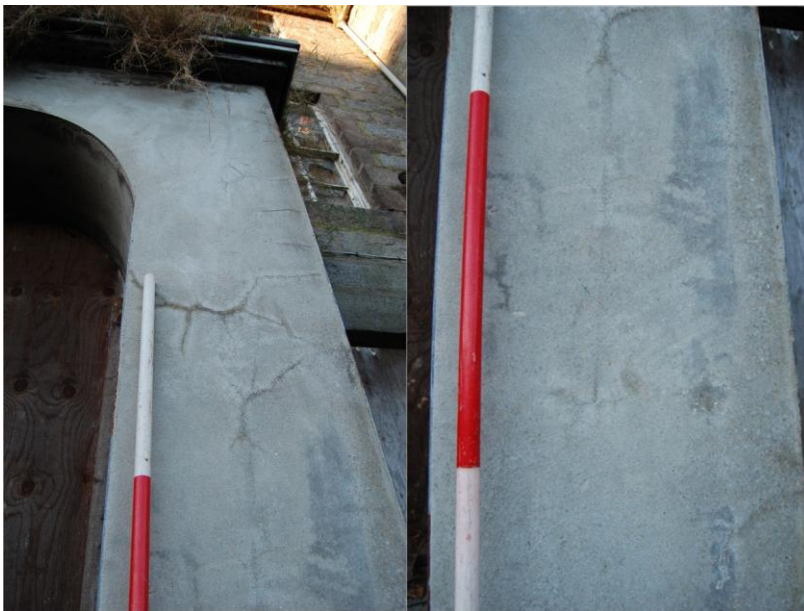
Illus 15 Building 1 Door 2 detail showing metal frame (extreme left and right) into which concrete was poured before being smoothed.

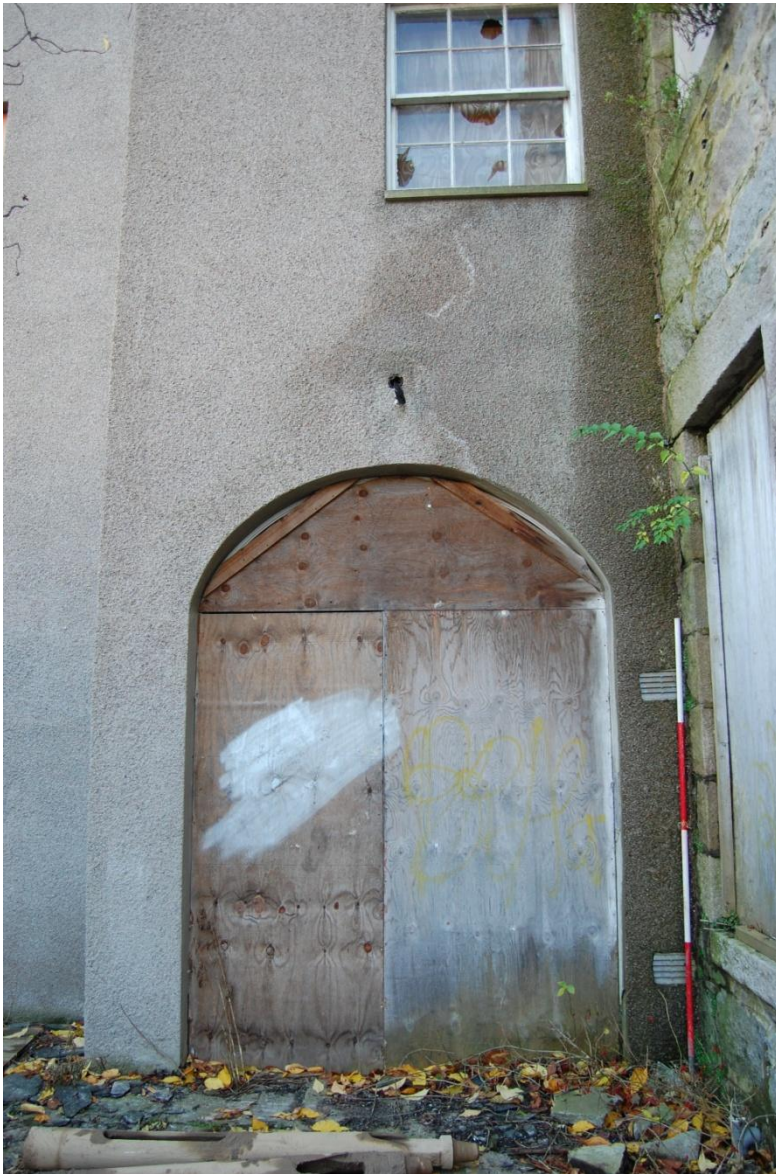
Illus 16 Remnant of NW wing? Door 12

The L-shaped section of wall with Door 12 (Illus 16) at the NW end of the house may be part of an older wing which has been truncated by the later extension or, more likely, a door created in the late 19th-century, possibly at the same time as poured concrete doors D2 and D5.

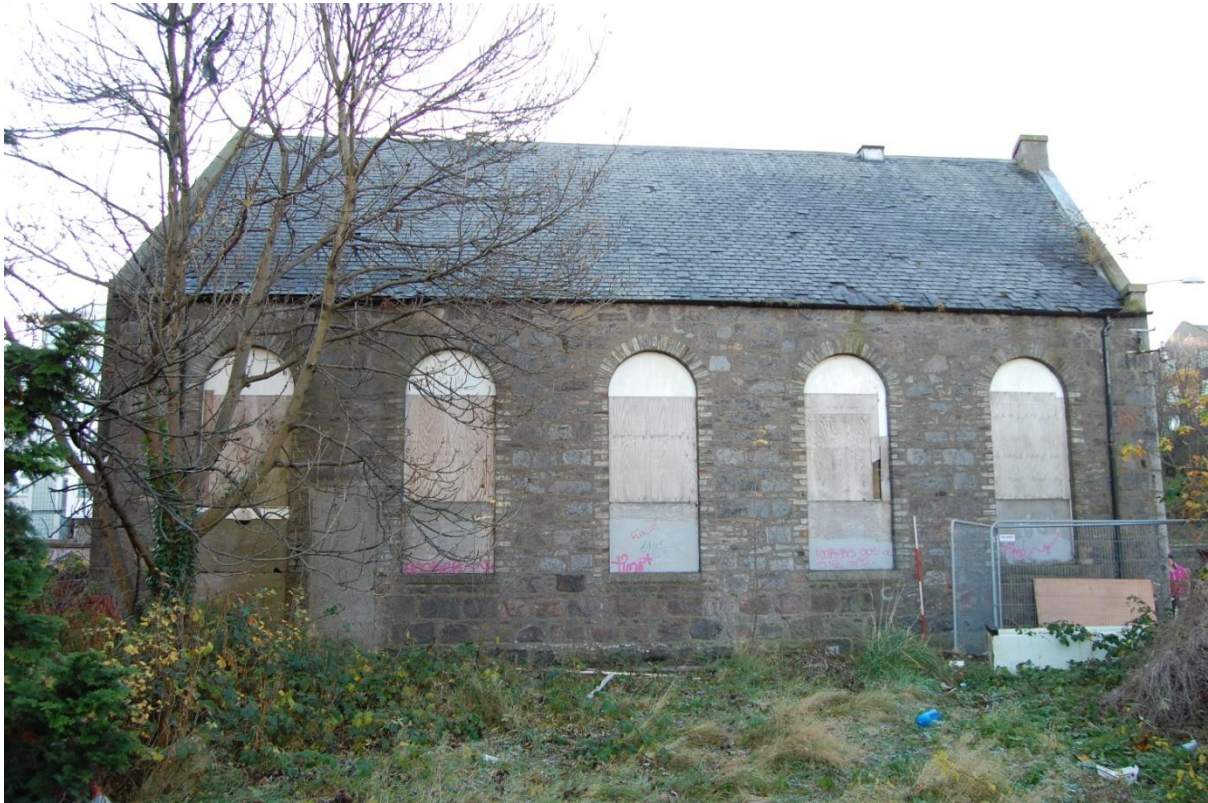
Building 2 is a hall and is on the First Edition Ordnance Survey map. It is probably 19th century in date and is 15.4-20.5m long and 12m wide and is constructed of grey and red granite roughly dressed fieldstones with cherry cocking (Illus 19-20). The building has been constructed to fit into the corner of a trapezoid-shaped corner; the NW facade has four arched windows and one door constructed of fireclay bricks 220 x 100 x 80mm in size. The SW facade on West North Street is of grey granite blocks with a central door, flanking pairs of windows and a circular window near the top of the gable.

Illus 19 Building 2 NW facade

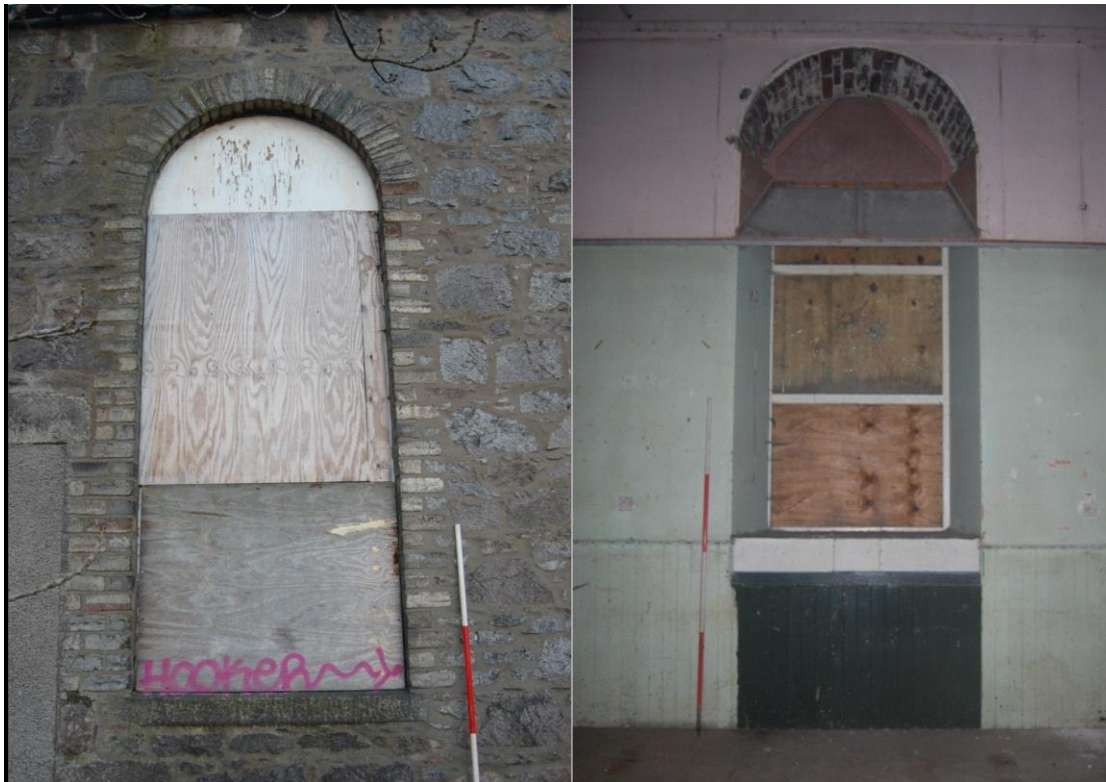
Illus 20 W17 exterior (left) and interior (right) showing red brick arch

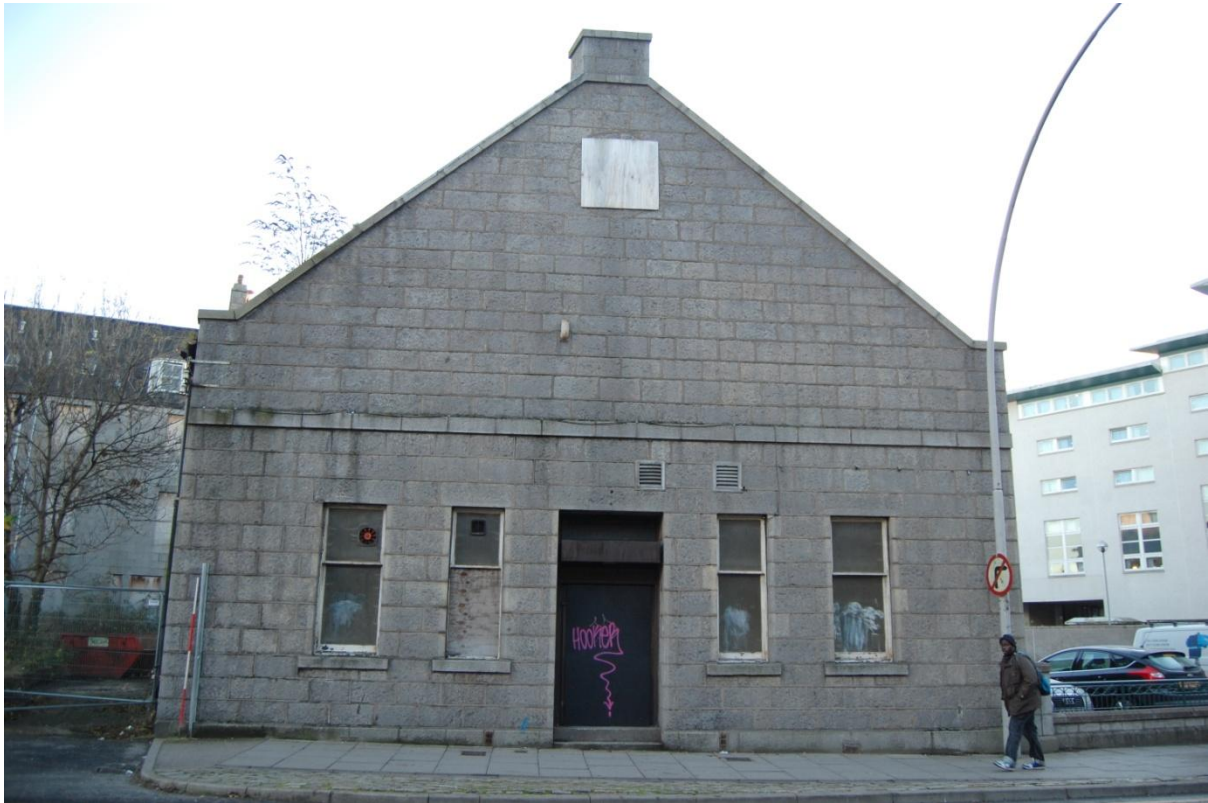
Illus 21 Building 2 SW facade

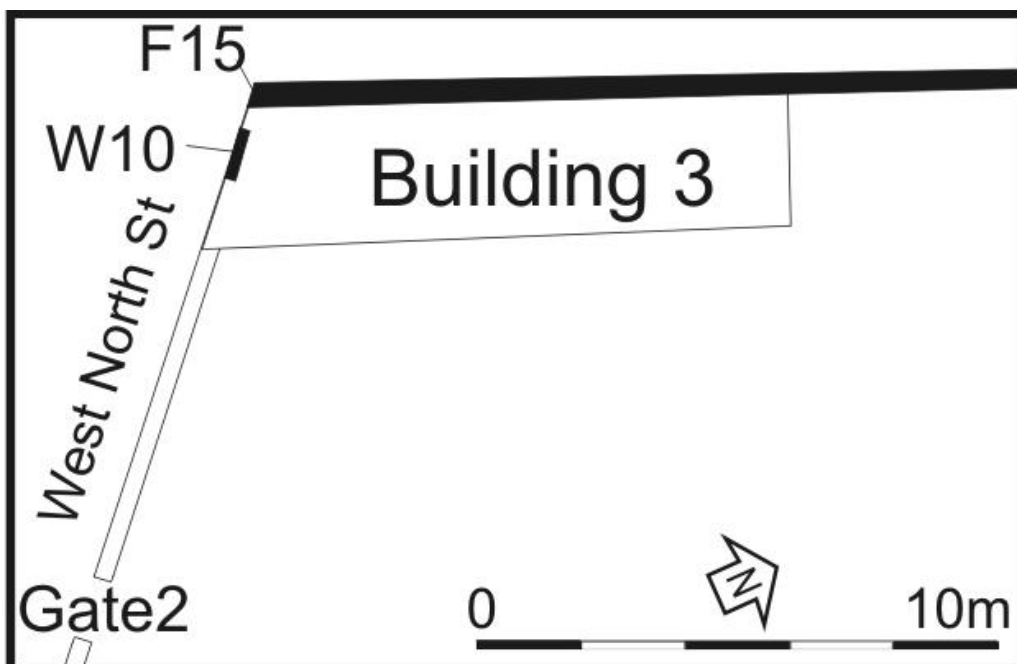
Illus 22 Building 3

Building 3 is 10m long and 2.8m wide and is of harled brick and stone construction. It would have been in the rear garden of the original house and was probably a gardeners building. It is built against brick wall F15 and originally had a brick window in the SW wall (Illus 24) which is now blocked.

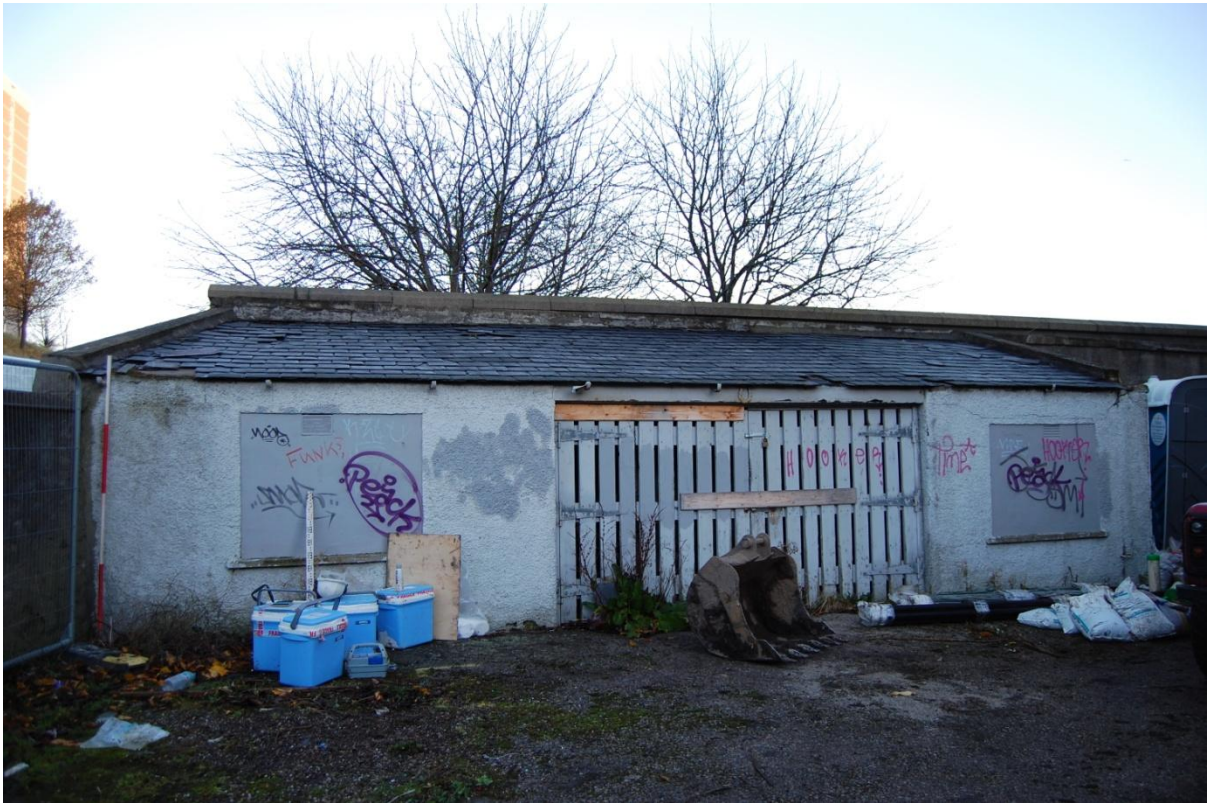
Illus 23 Building 3 in rear (west North Street) garden; SE facade

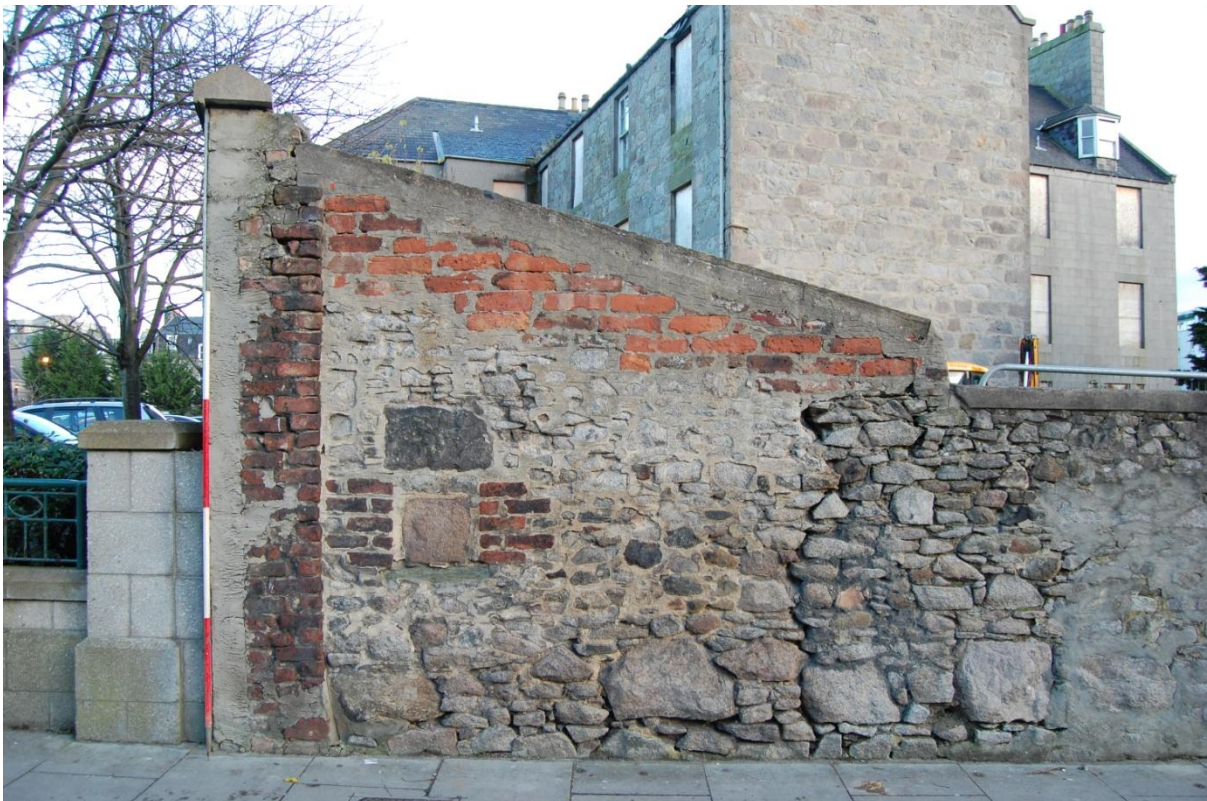
Illus 24 Wall along West North Street showing 18th-century local hand-made brick wall (F15; left) with blocked window W10 (centre); facing NE

Along the NW edge of the site (and only visible on West North Street) is a wall made from hand-made 18th-century bricks 200-220mm long, 70mm high and 100mm wide (Illus 24). Around the north and east of the site is a buttressed brick wall of machine made bricks 230mm long, 120mm wide and 70mm high (Illus 25). The buttresses are 0.47m long and 0.24m wide and the wall is 2m high.

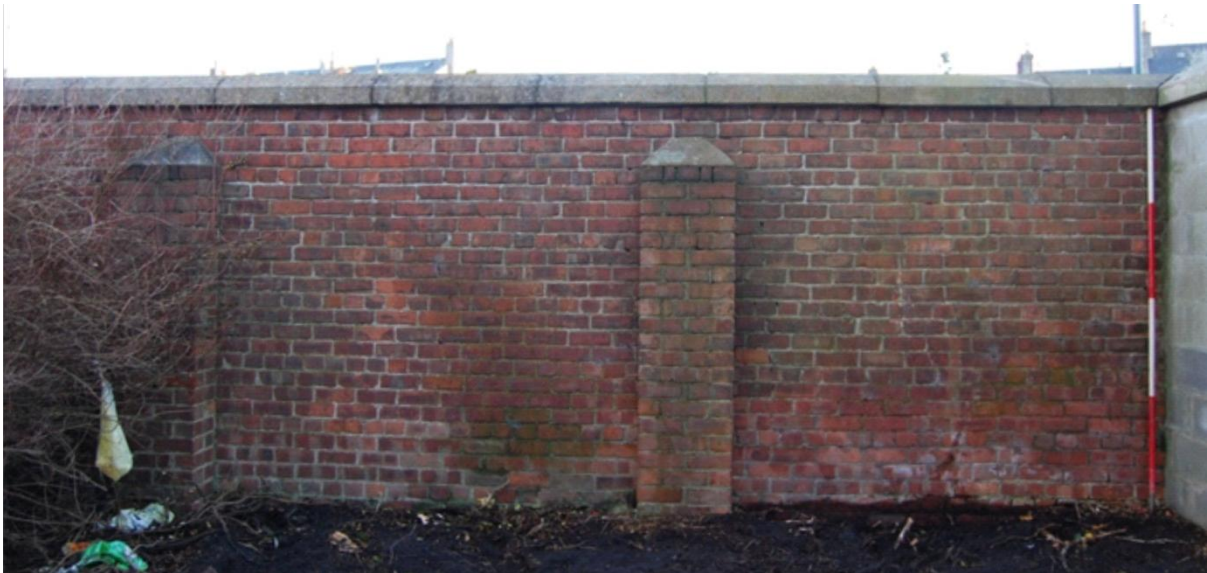
This is a replacement wall built in a tradition style when the garden was partitioned and split from properties on King Street.

Illus 25 NE boundary wall with brick buttresses
