**Easter Tulloch
Aberdeenshire, AB51 7NB
Report on the Standing Building Survey**

**Alison Cameron
Cameron Archaeology
5 April 2013**

A Level 1 standing building survey was carried out on 26 March 2013 and it is recommended that no further work is required during this development.

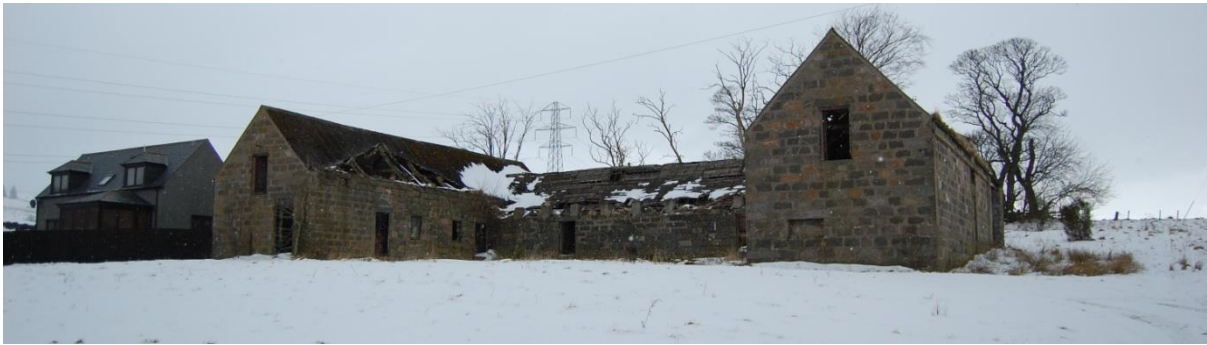
Illus 4 Building 1 from the NE showing north wing (right) and modern house (left; not included in this application)

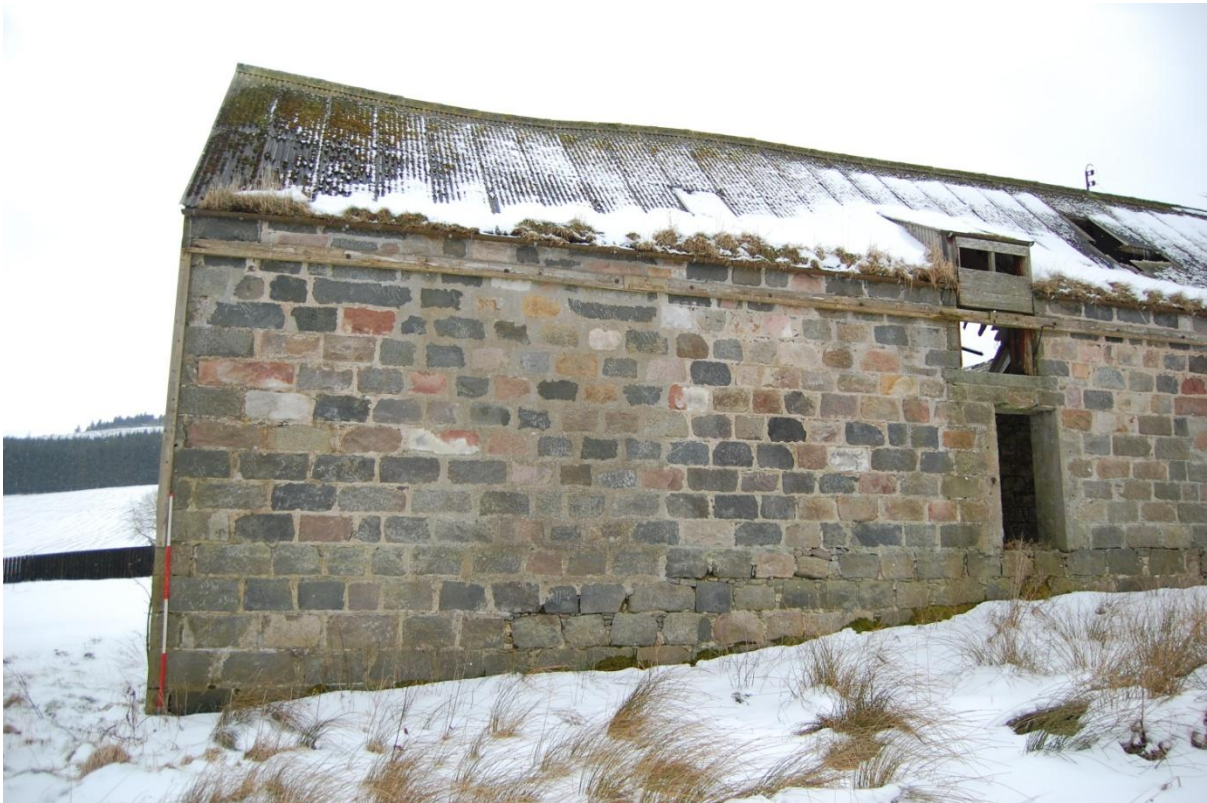
Illus 6 Building 1 north wing north wall; facing south

Building 1 appears to have been built in one phase and the north wall of the north wing has two blocked apertures which may have originally held mechanism for a threshing mill. No evidence of that exists in the maps of the farm. There are several replacement doors in the north wing and this has undergone a partial rebuild, probably after the mill mechanisms were removed.

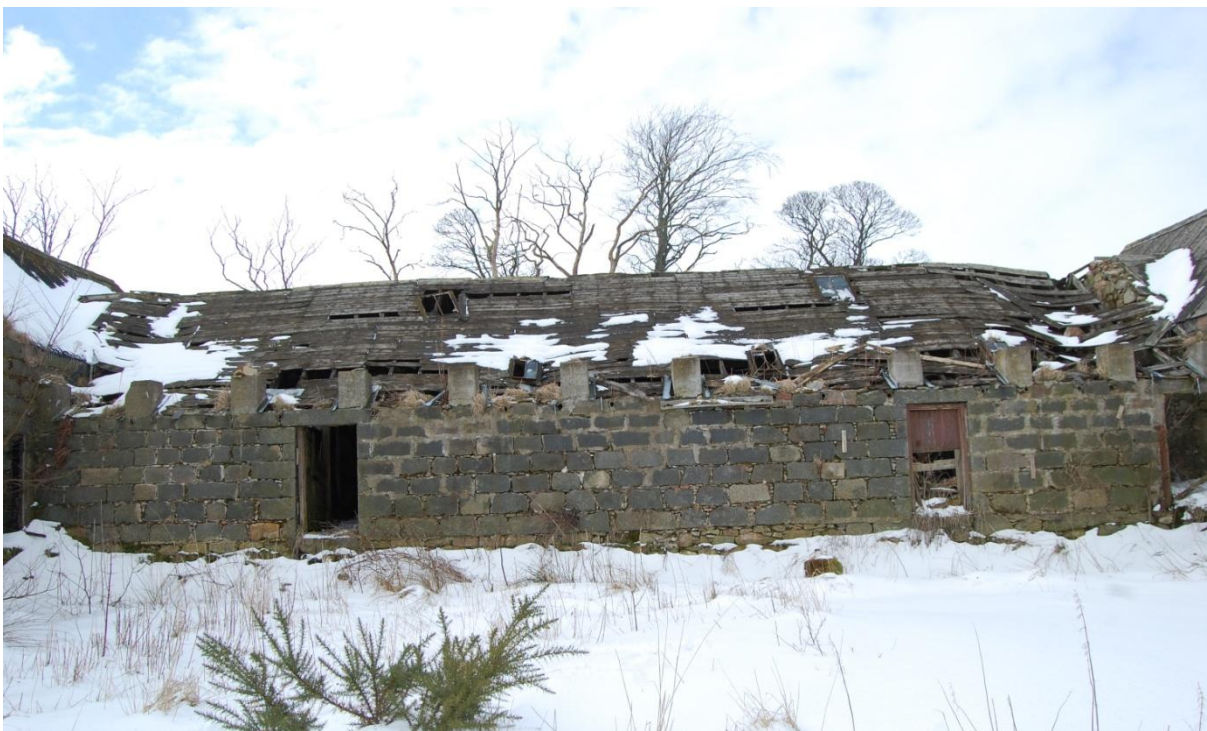
Illus 7 Building 1 courtyard west wall; facing west

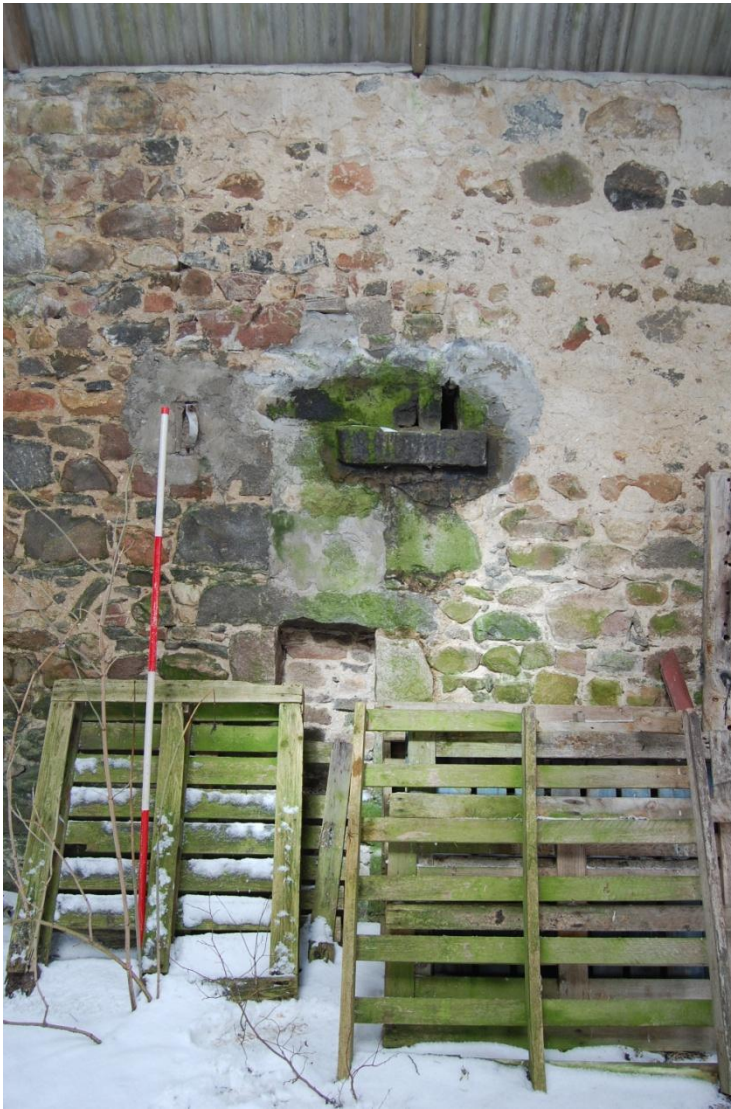
Illus 8 Building 1 north wing north wall interior showing apertures for mill mechanism

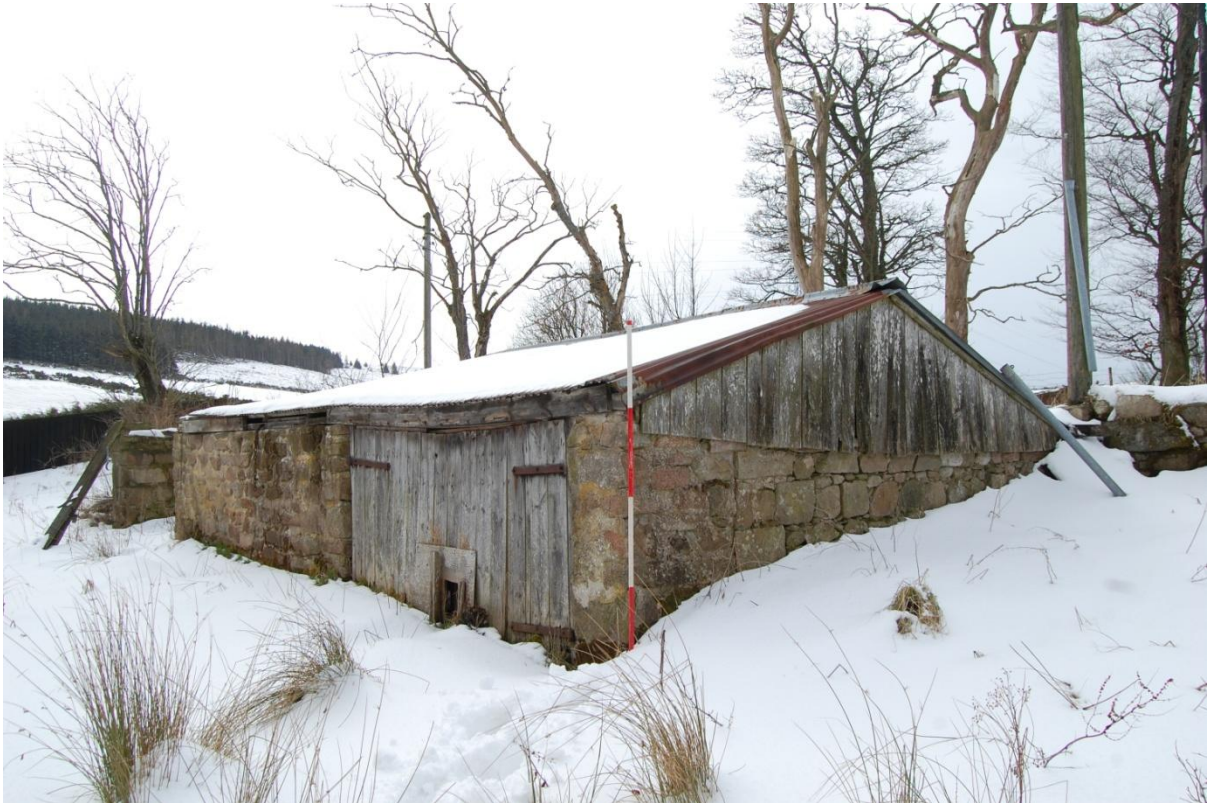
Building 4 is a narrow N-S building immediately west of Building 1 (Illus 9, 10). It is 9.5m long, 5.5m wide with walls 1.5m high and it is in a very poor state of repair. It is constructed of granite blocks with a tin roof and has two large doors in the east wall. The west half of the building is obscured by a bank of soil and building materials and the interior is in poor condition and was not accessed. This building is due for demolition during this project. The large doors suggest that the building was used for machinery store.

Illus 9 Building 4 facing SW showing bank on the west side and poor state of repair

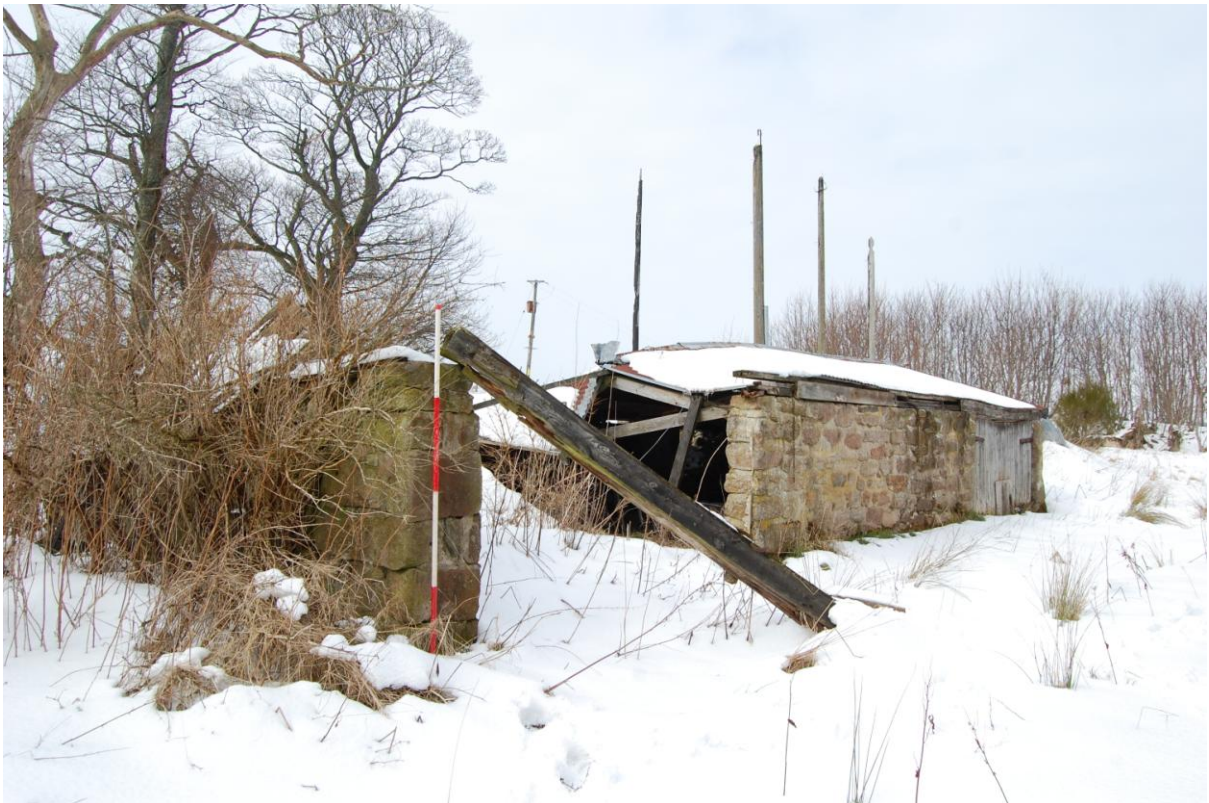
Illus 10 Building 4 facing NW showing door at south end of east wall and poor state of repair of roof and interior
