Standing Building Survey
'The Granary', Ennets Farm, Tornaveen
Torphins, Banchory, AB31 4PE

Alison Cameron
Cameron Archaeology
2 May 2013

Standing Building Survey

The Granary, Ennets Farm, Tornaveen, Torphins, Banchory, AB31 4PE

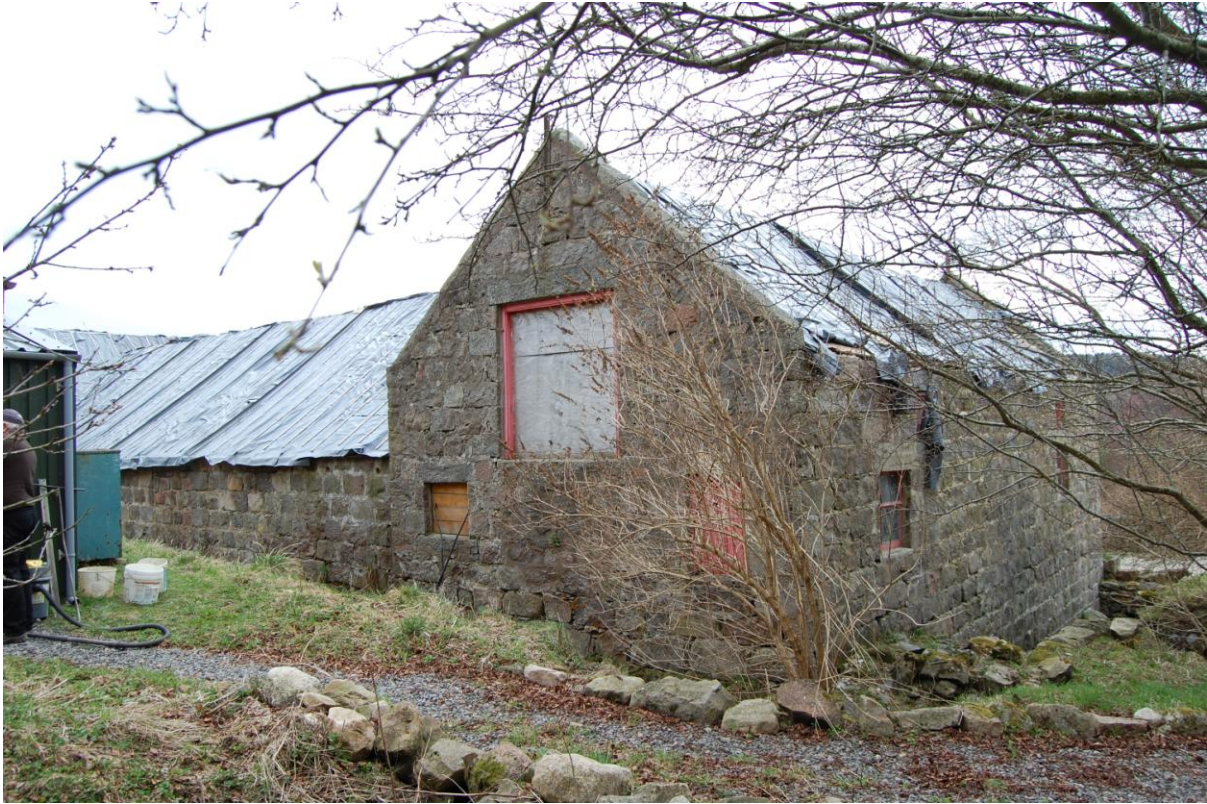
Illus 4 Room 3: the mill building latterly converted to a steading; facing SE.

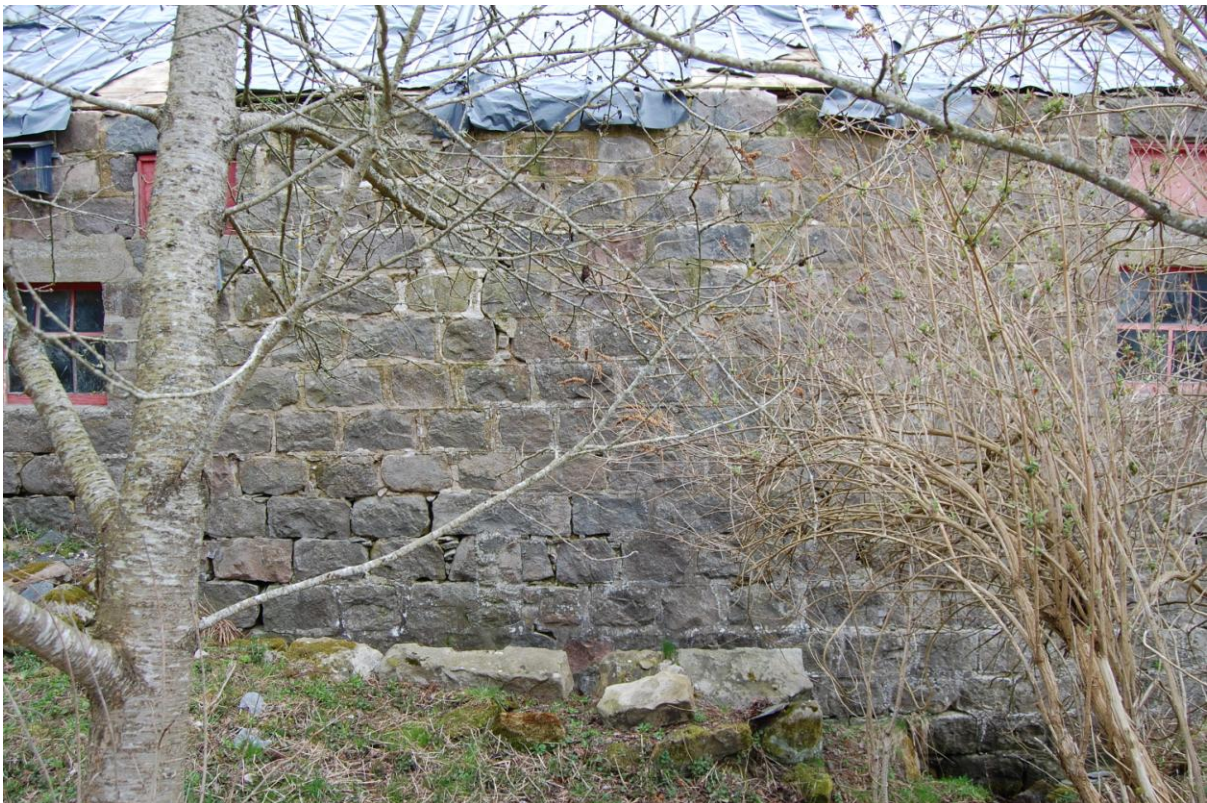
Illus 5 Room 3 location of former mill wheel in the centre of the west wall; facing east.

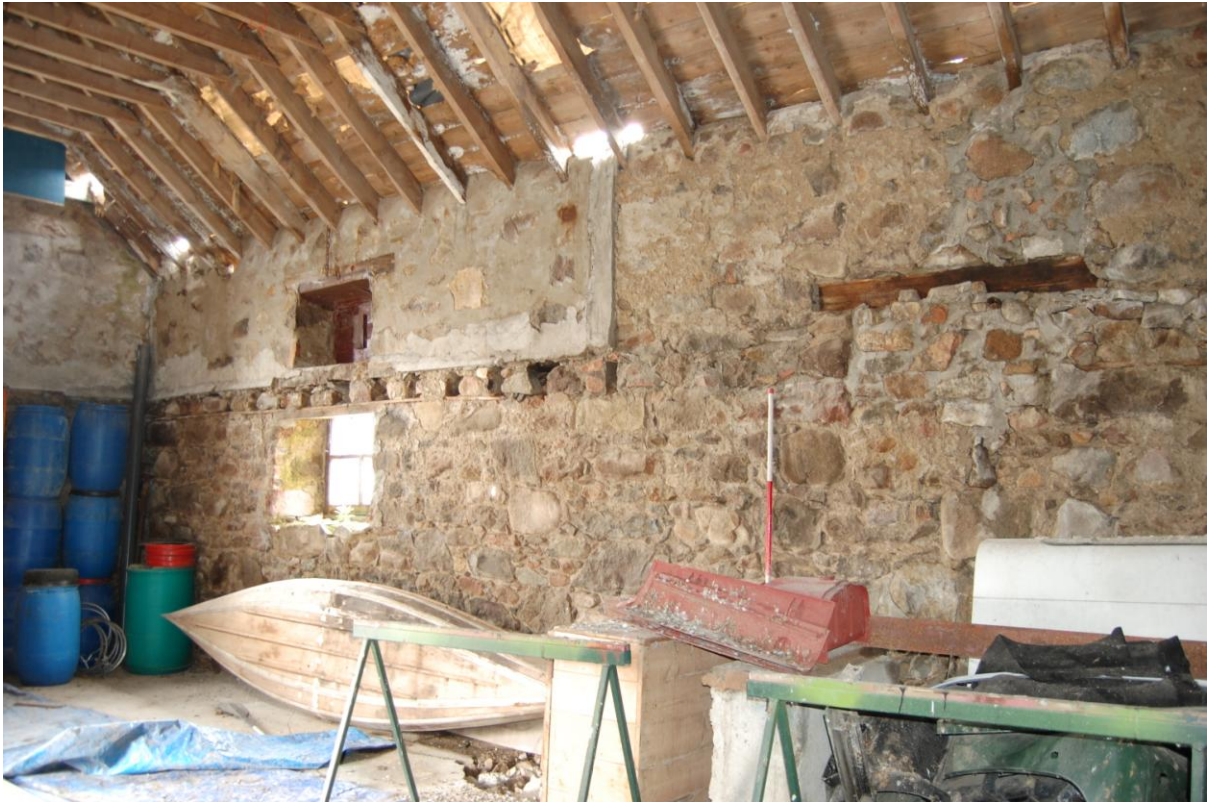
Illus 6 Room 2 west wall showing blocked aperture for mill mechanism (right) and beam slots for upper floor (left); facing SW.

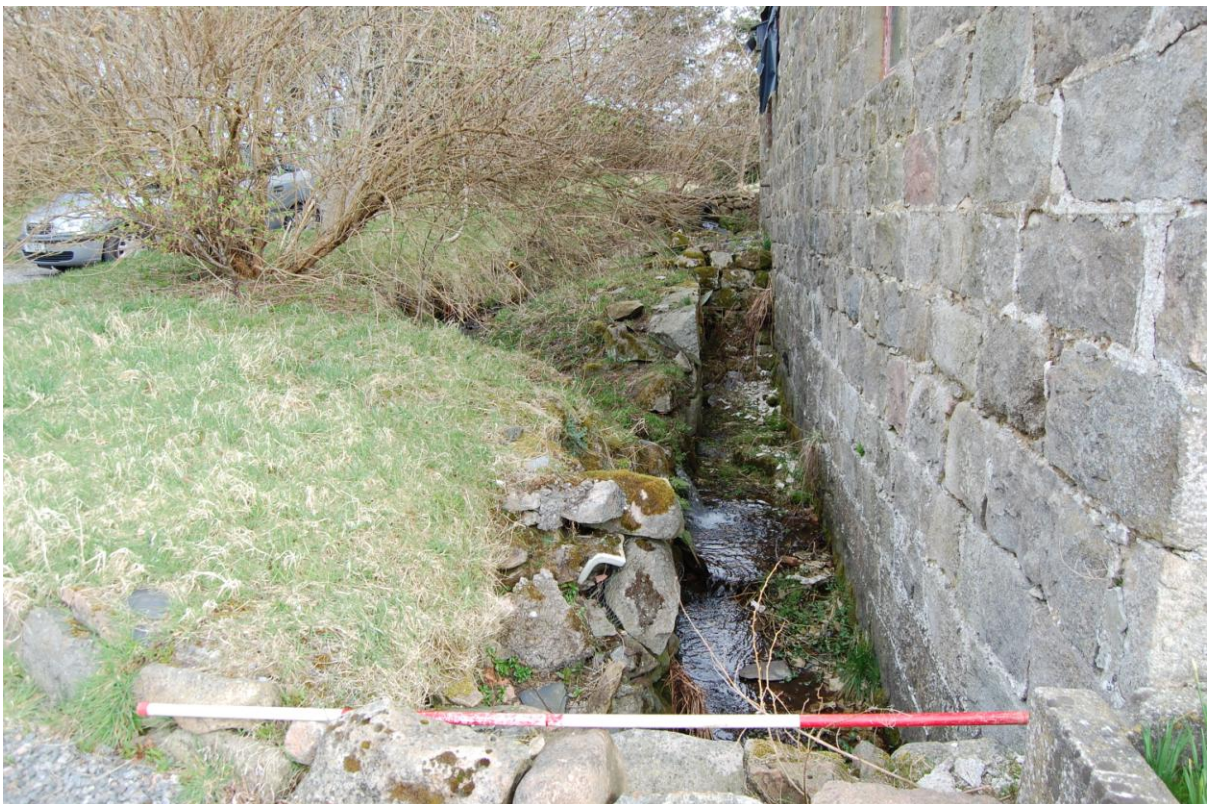
The mill was powered by a lade from the Beltie Burn to the east of the property which also power the Mill of Ennets to the east. The lade has subsequently been diverted west but originally ran immediately west of Room 3. The stone race survives (Illus 6) and the mill wheel would have been on the exterior of the west wall where blocked apertures survive (Illus 5, 6); the lade is now culverted to the south of the property. The wheel was then removed and the door in the north wall of Room 2 and the windows in the east and west wall so that building were also blocked.

Illus 7 Room 3 west wall showing mill race and stream; facing north

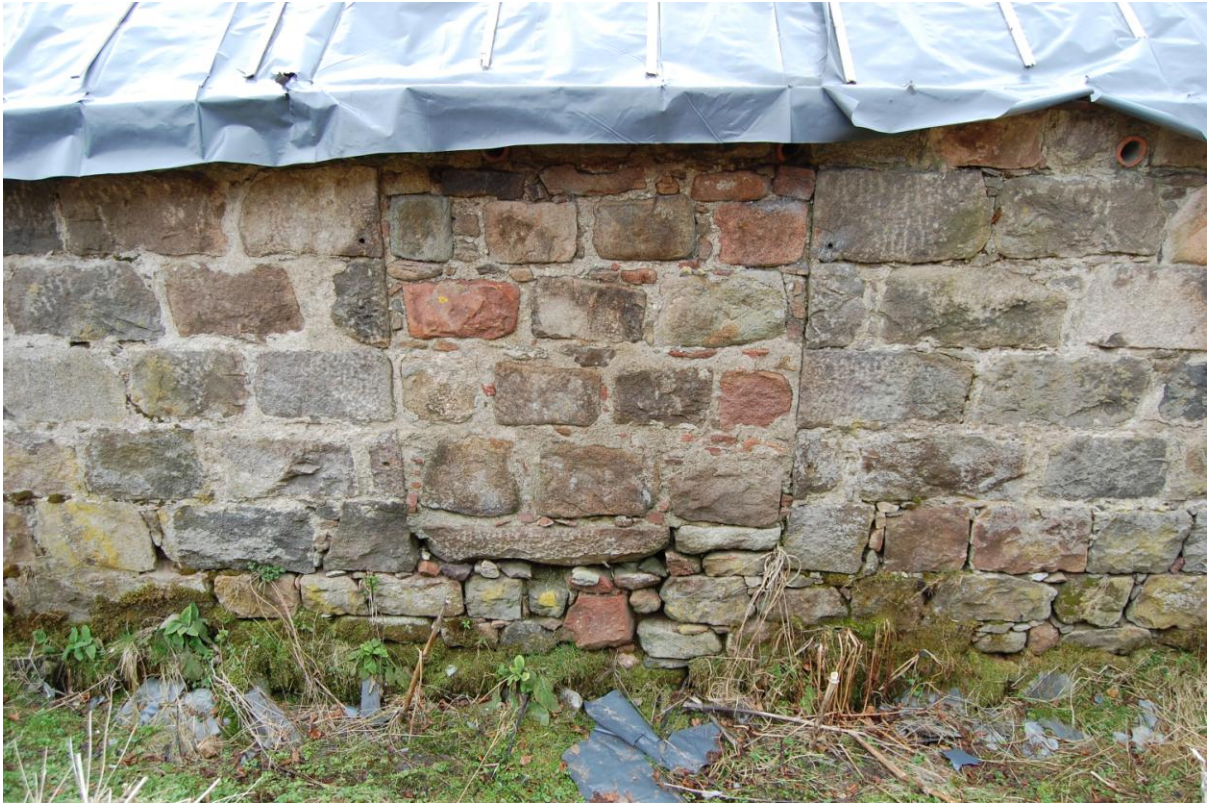
Illus 8 Room 2 north wall showing blocked door; facing south.

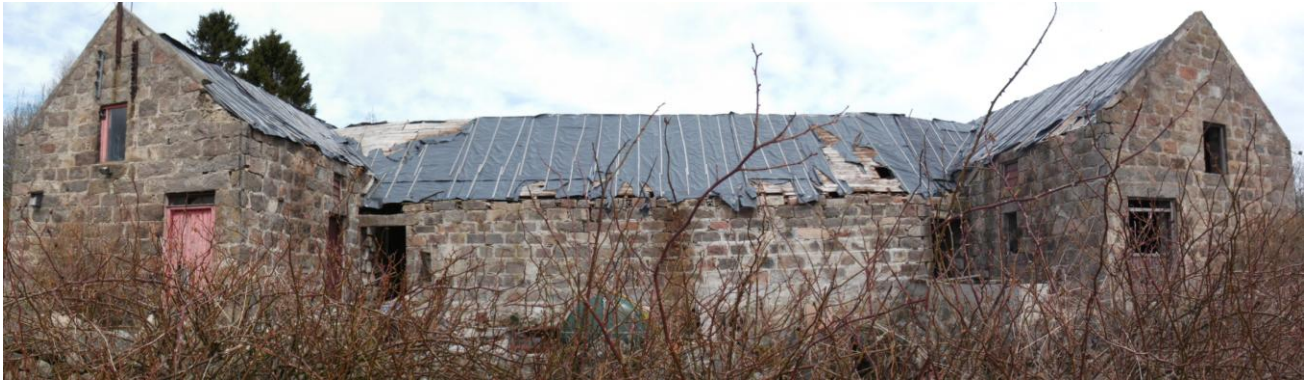
Illus 9 Room 3 (left), Room 2 (centre), Room 1 (right); facing north.

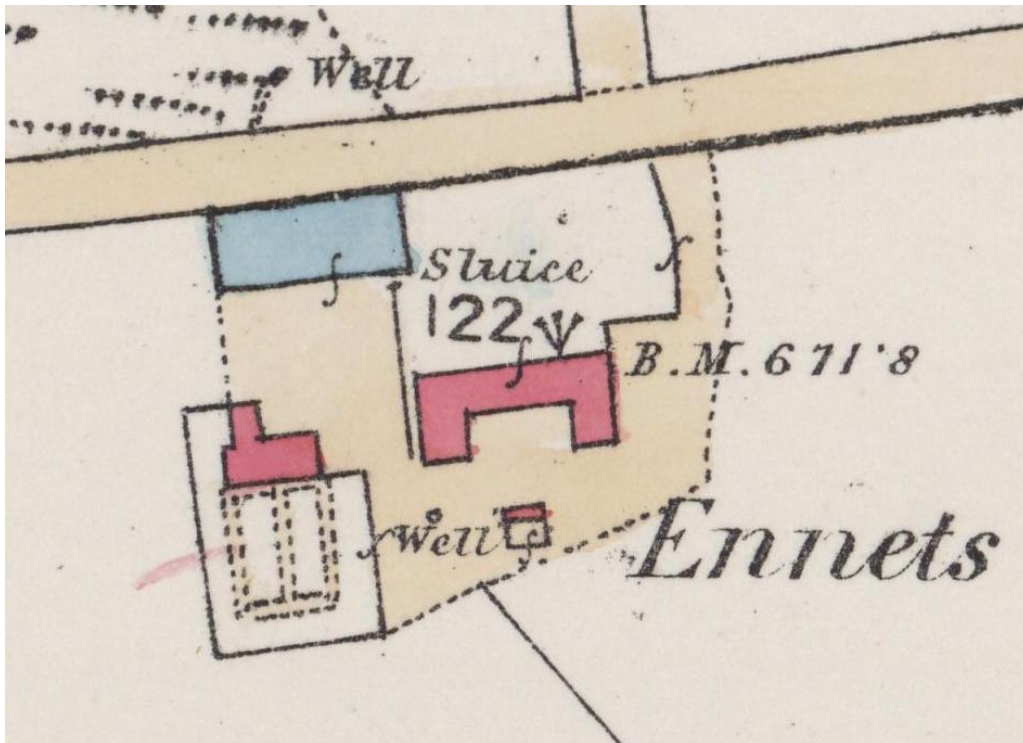
Illus 12 First Edition OS map (copyright National Library of Scotland).
 Title: Aberdeen Sheet LXXII.9 (Kincardine O'Neill)
 Survey date: 1865 Publication date: 1869

The First Edition OS map (Illus 9) shows a well at the south of the property which is no longer visible. The buildings which probably date to the early to mid-19th century were built in one phase and there is no evidence of an earlier phase on construction.
