# Standing Building Survey Achath Farm steading, garage and bothy Castle Fraser, Kemnay, AB51 7LJ

Alison Cameron Cameron Archaeology 4 November 2013

# **Standing Building Survey**

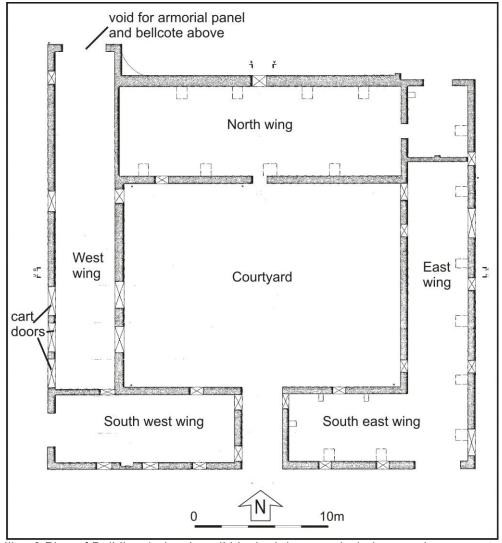
Building 1 is a C-shaped steading with a central courtyard (Illus 2). The buildings are constructed of large blocks of grey and pink granite with cherry cocking and are 30m N-S and 33m E-W. The complex has an east, north and west wing and a narrow entrance 3m wide in the south wing to access the courtyard and this was built in one phase.

Illus 2 Plan of Building 1 showing all blocked doors and windows and new apertures (copyright EH New Forest)

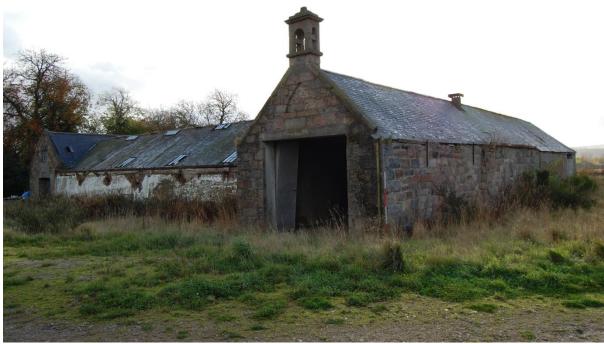
Illus 3 Building 1 west wing (right) showing bell-cote and void for armorial panel; facing SE

Above the north gable of the west wing are a bellcote and a void which would have held an armorial panel (Illus 3, 4). The bellcote is constructed of sandstone and was probably for a single bell. The void for the armorial panel is a pointed arch; the panel was probably made of marble or sandstone and may have been removed when the owners moved or sold the property.

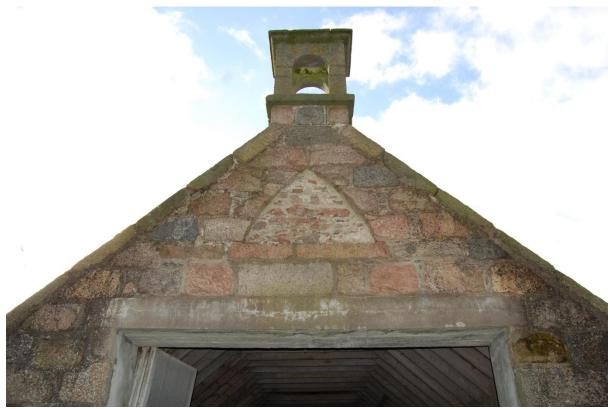
Illus 4 Building 1 west wing bellcote and void for armorial panel; facing south

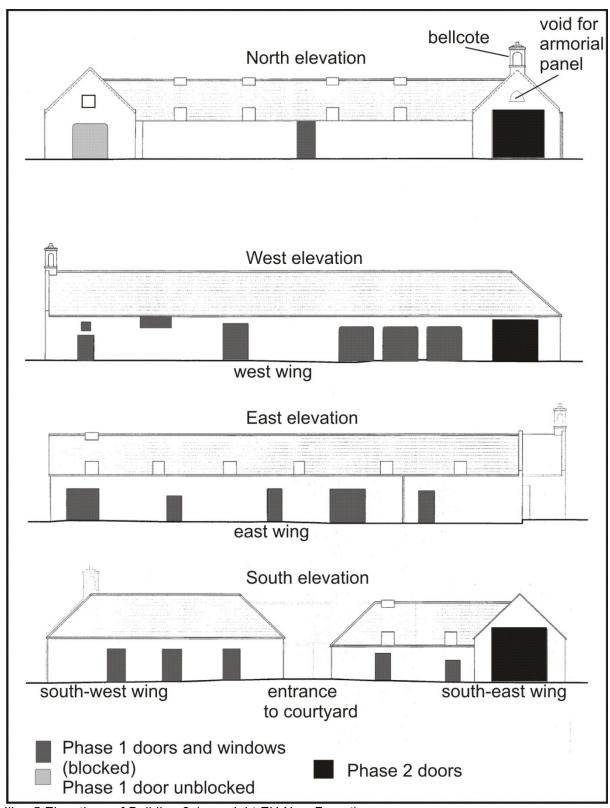
Illus 5 Elevations of Building 2 (copyright EH New Forest)

Building 1 was converted for use as a piggery and as a result there are no internal fittings or architectural details visible. A series of original doors and windows have been blocked and new apertures created including large doors in the SE wing (Illus 5). A separate building (seen on the Second Edition OS map; Illus 12) was recently removed from the exterior of the north wall and evidence of this can be seen on this wall (Illus 3).

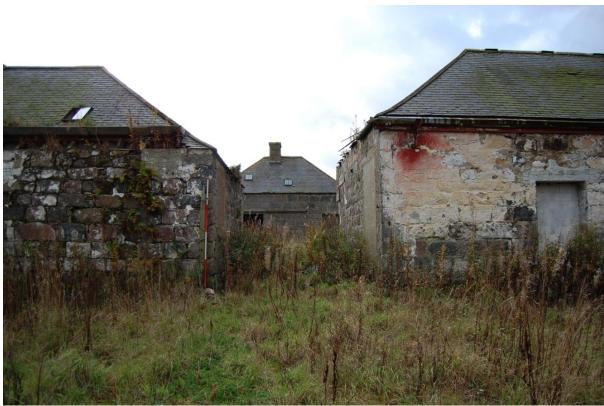
Illus 6 South elevation showing entrance into courtyard; facing north

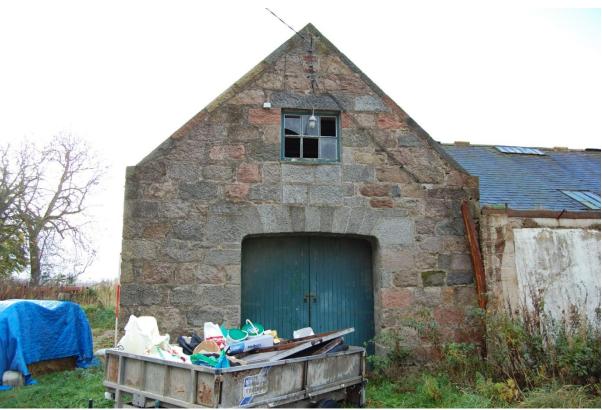
Illus 7 North gable of east wing showing original cart door with granite arched top

The south half of the west wing has three cart doors (now blocked; Illus 8) which are of the same construction as the cart door at the north end of the east wing (Illus 7); the arches of these door are constructed from dressed granite blocks forming a flat-topped arch.

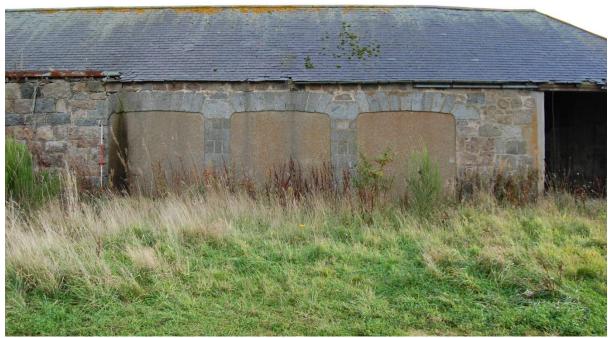
Illus 8 Cart doors on the west elevation; facing east

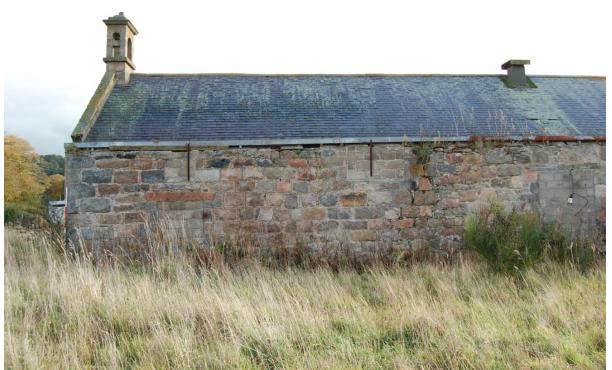
Illus 9 North end of west elevation showing repairs to wall following removal of horse mill; facing east

The First and Second Ordnance Survey maps (Illus 12, 13) show a horse mill attached to the west side of the west wing adjacent to the bell-cote. This building does not survive but there is evidence on the wall that repairs have taken place, probably after the removal of this mill (Illus 9). The mill was probably used for threshing.

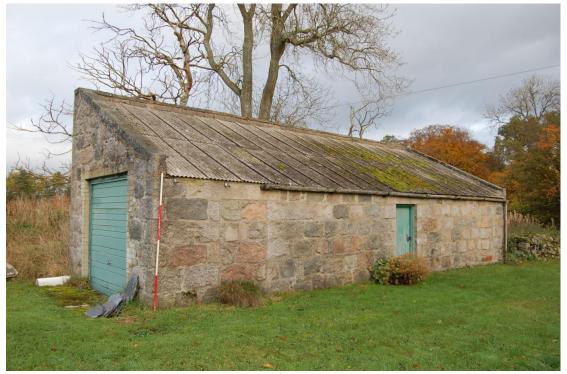
Illus 10 Building 2 used latterly as a garage; facing NNE

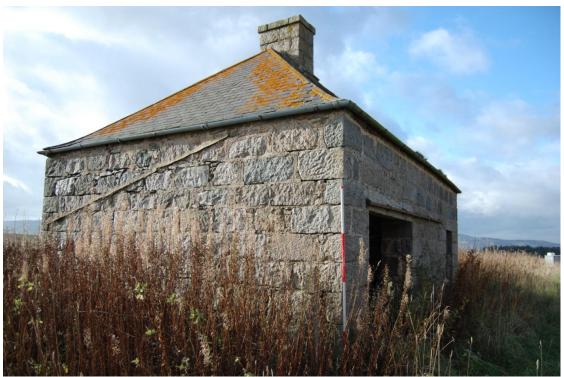
Illus 11 Building 3 facing SW
