FYVIE CASTLE, AB53 8JS Watching brief on garden wall repair FYC13/1

Alison Cameron Cameron Archaeology 21 March 2014

From 27th September - 28 October 2013 an archaeological watching brief was maintained during the repair of a garden wall. The wall was recorded and characterised but no reused stonework was identified and the wall was then repaired and restored. It is recommended that no further archaeological work is required during this work.

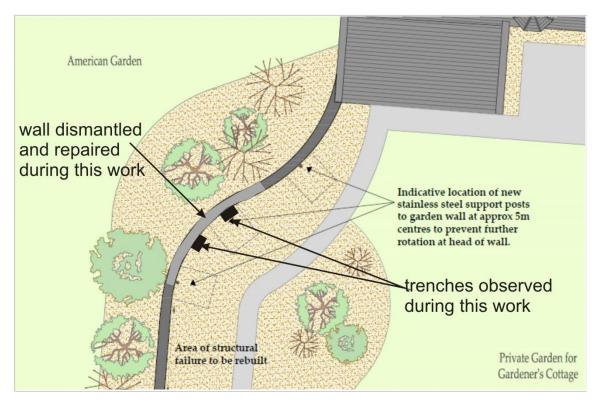
Illus 3 Plan showing location of observed trenches and wall repairs (NTS OS licence 100023880).

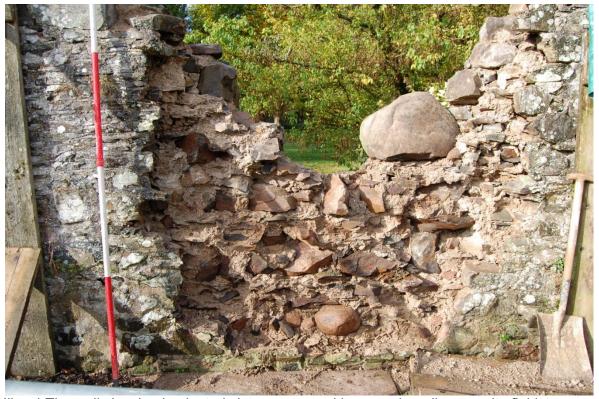
The wall is 2m high and 0.45m wide and is constructed mainly from small and medium fragments of slatey stone which formed much of the facade of the wall and some of the core. Large and medium granite fieldstones were also used in the wall (Illus 4). As a result of the poor quality of the stone and its proportions there were areas which required to be dismantled and rebuilt. Several areas were dismantled and the stone were inspected but no red sandstone or other reused stone was identified.

Illus 4 The wall showing laminated slatey stone and large and medium granite fieldstone construction; facing west

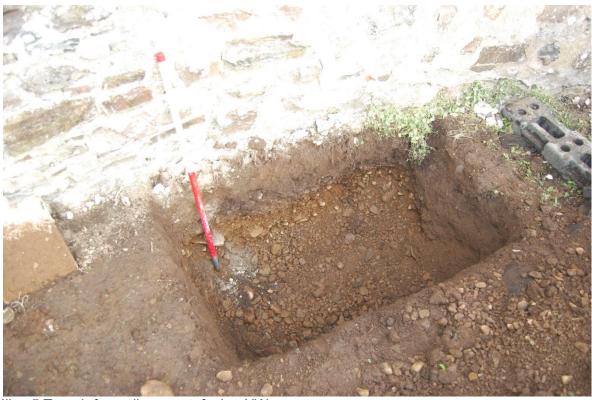
Two trenches (1 x 0.5m and 0.4m deep) dug for new supports revealed a layer of loamy topsoil 0.2-0.3m deep on top of compact reddish brown stony natural subsoil. No archaeological features or finds were identified.

Illus 5 Trench for wall support, facing NW
