**MILTON OF GARLOGIE, GARLOGIE, ABERDEENSHIRE,  
AB32 6SD  
LEVEL 2 STANDING BUILDING SURVEY REPORT**

**Alison Cameron  
Cameron Archaeology  
12 June 2014**

The Level 2 Standing Building Survey was carried out on 10 June 2014. A full series of photographs were taken and architects plans and illustrations used to chart several phases of development.

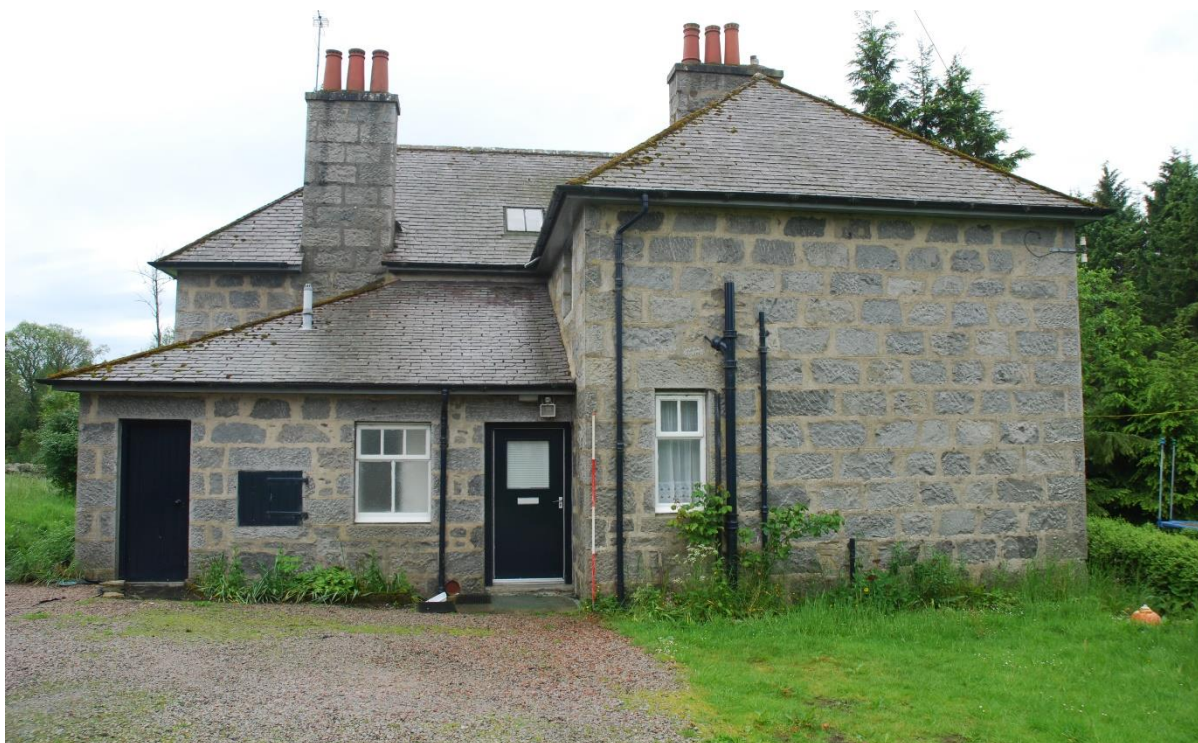
The Mill House (Illus 2) is constructed of large dressed granite blocks and is 12.10m NW-SE and 10.2m NE-SW. It was constructed after the Second Edition OS map (1900) and in the same style as the south extension to Building 3 and the lean-to extension at the south end of Building 2.

Illus 2 The mill house; facing SSW

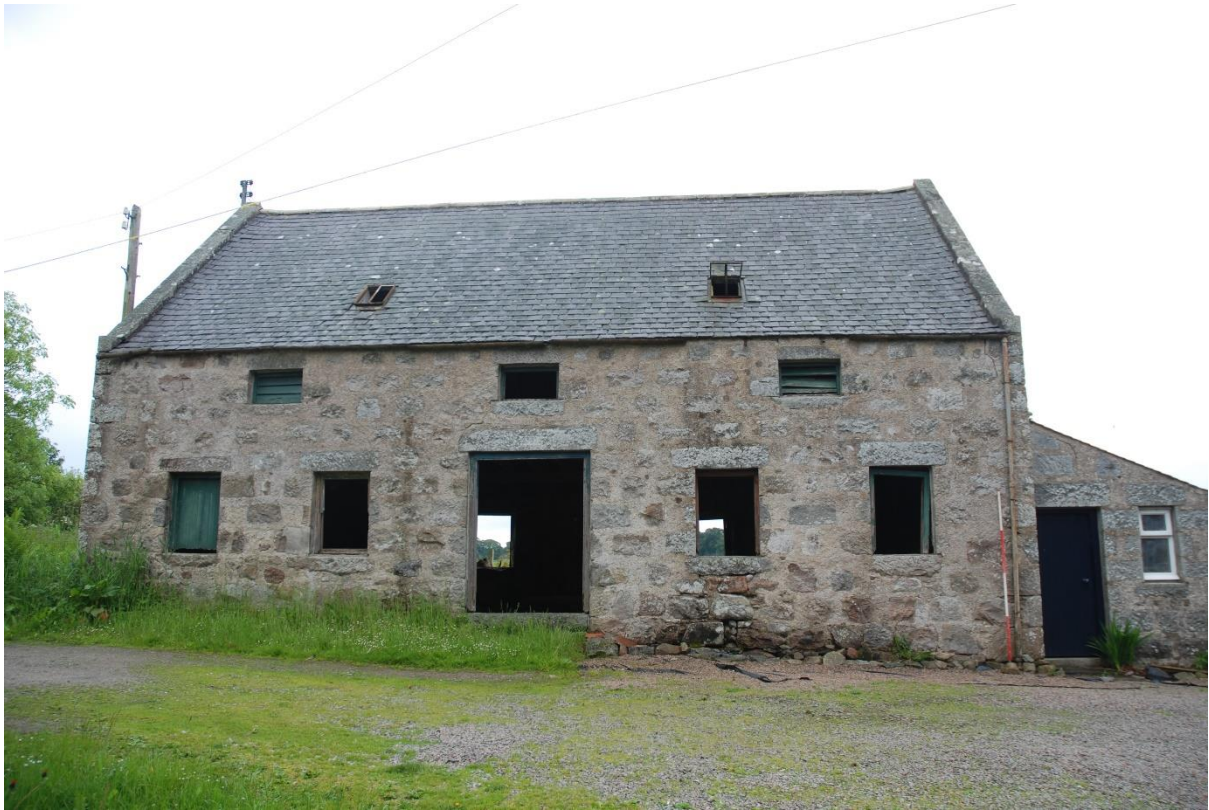
The Granary building is 12.15m long NE-SW and 7.2m wide (Illus 4). It is a two-storey building constructed of roughly faced granite blocks with cherry cocking and granite lintels, sills and quoins. It has a wide central door on the front NW facing façade with large lower windows and smaller first floor ventilation windows with wooden slatted shutters. It doubled in size between the 1<sup>st</sup> and 2<sup>nd</sup> OS Editions (Illus 34, 35) and it would appear to have been completely rebuilt between those dates. It has the date '1881' incised in the lintel above the main ground floor door (Illus 6). The interior has a cobbled floor with a cobbled drain running along the inside of the NW wall (Illus 7). There is a pulley wheel mounted on the exterior above the first floor window on the NE gable. There is a lean-to extension on the SW gable which is probably contemporary with Building 1 and the south extension of Building 3.

Illus 4 NW facing façade of Building 2 the granary with later extension (right); the date stone is above the central door

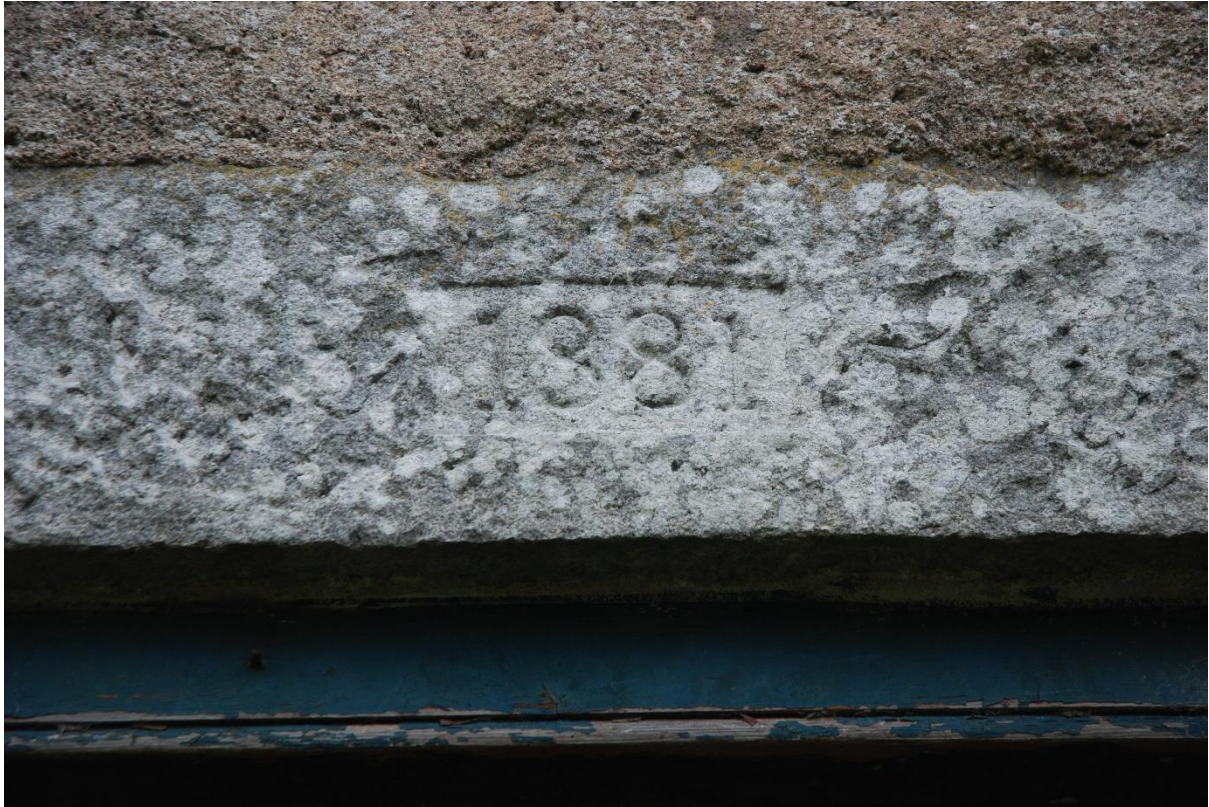
Illus 6 Building 2 lintel above door with '1881' incised

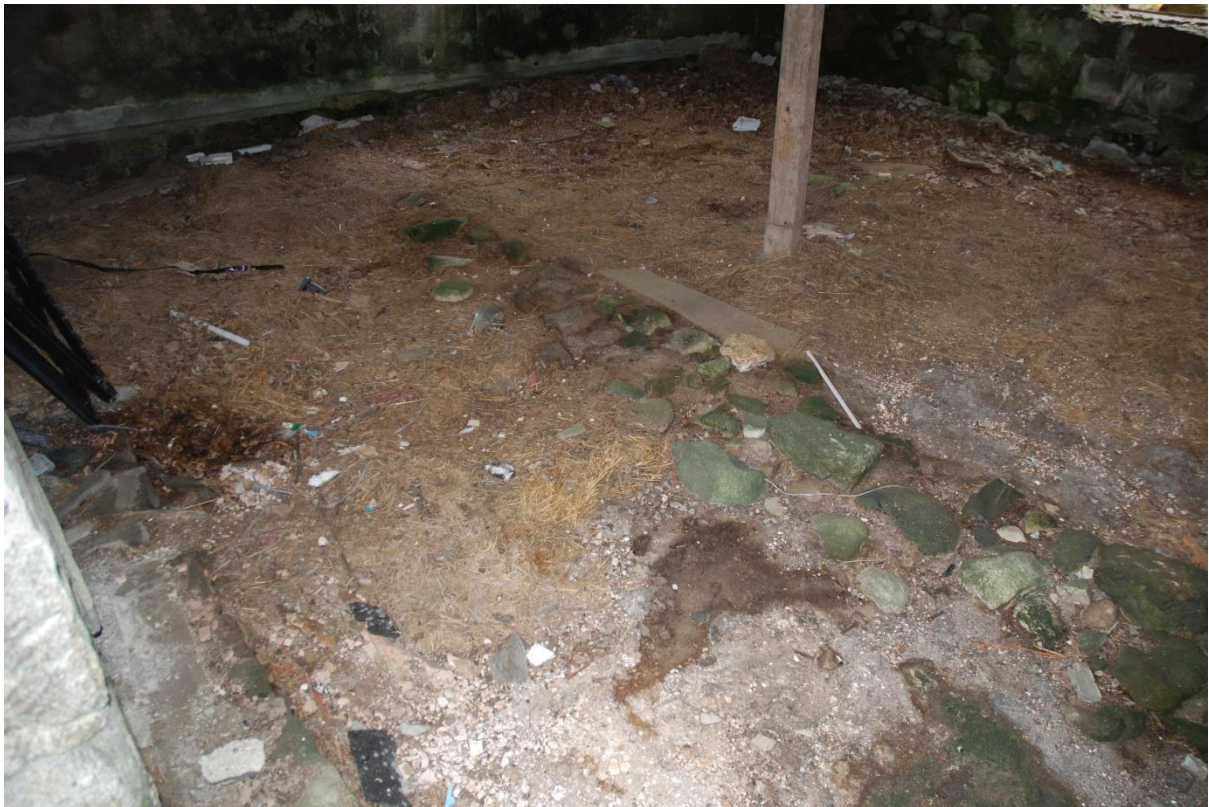
Illus 7 Building 2 interior showing cobbled floor and cobbled drain (left)

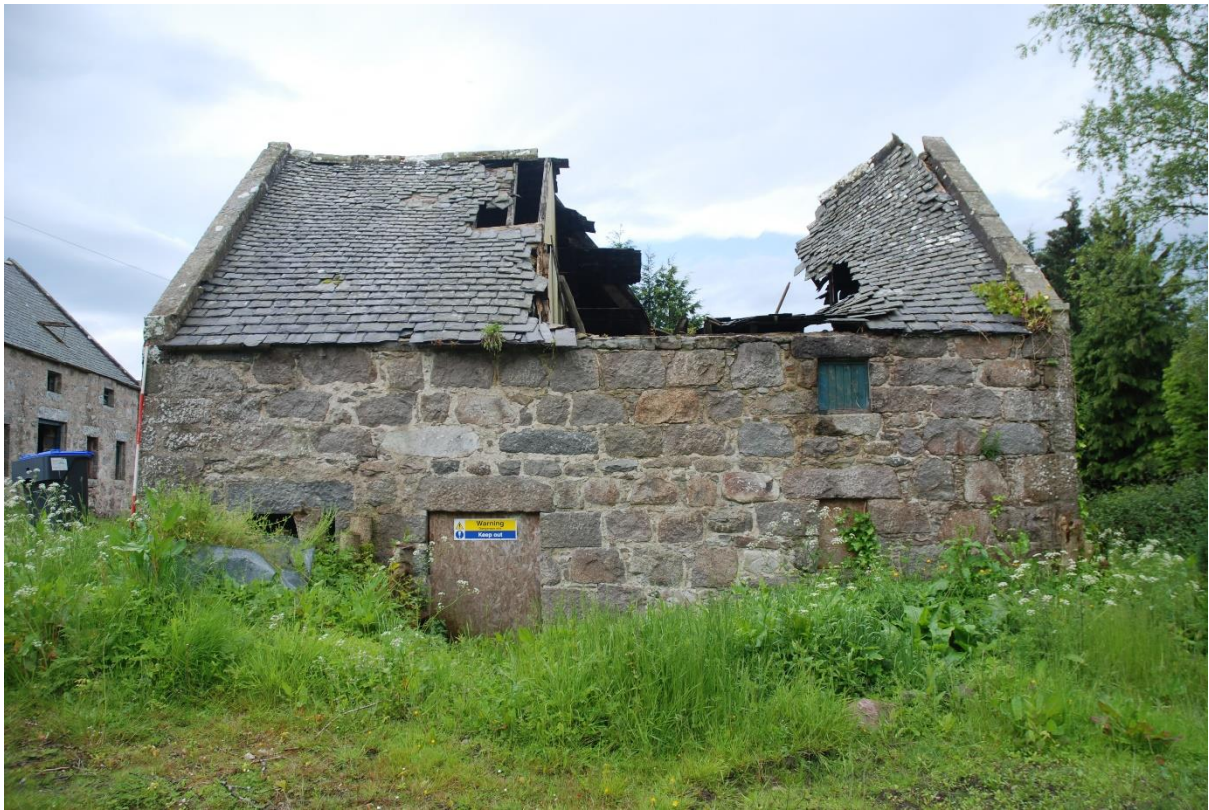
The old mill building is in very poor condition with collapsing roof and therefore no access to the interior. The older section of the building on the NE is 6.2m wide and 10.3m long (Illus 8) and constructed in a similar style to Building 2 with roughly faced granite blocks and cherry cocking. When it was originally constructed it was twice the length and originally ended adjacent to the lade (now infilled) where there was presumably a mill wheel. The NW end of the surviving building (Illus 10-11) shows a scar in concrete of a lower roofline where the NW end of the building has been removed. This wall has a central arched doorway (mostly obscured by boards), two low doors on either side, a large upper doorway and two grain chutes from the first floor to the ground floor. The northern example is wood and the southern example is concrete (Illus 11). There is a post-1900 extension on the south side of the building. A mill wheel is lying at the east end of the building (Illus 12).

Illus 9 NE façade of mill Building 3; facing SW

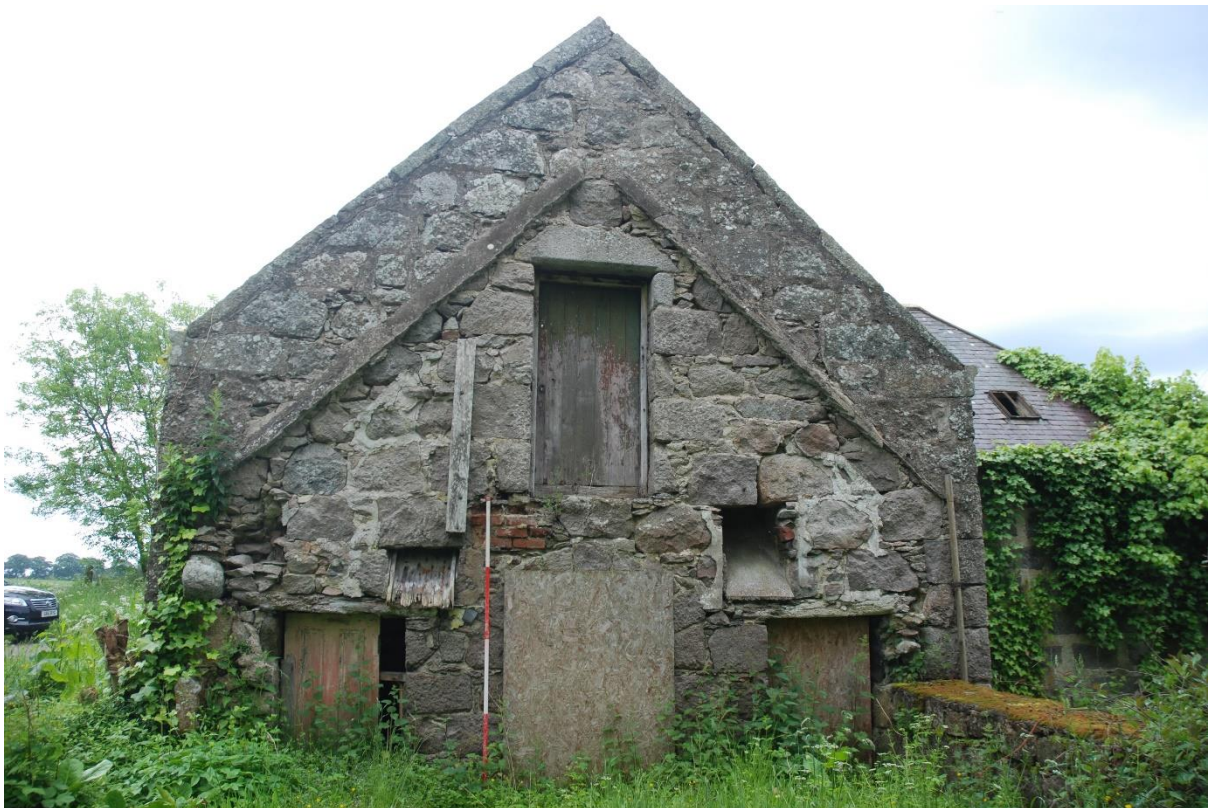
Illus 10 NW end of Building 3 showing central arched door, grain chutes, upper door and roof scar from extension now demolished; facing SE

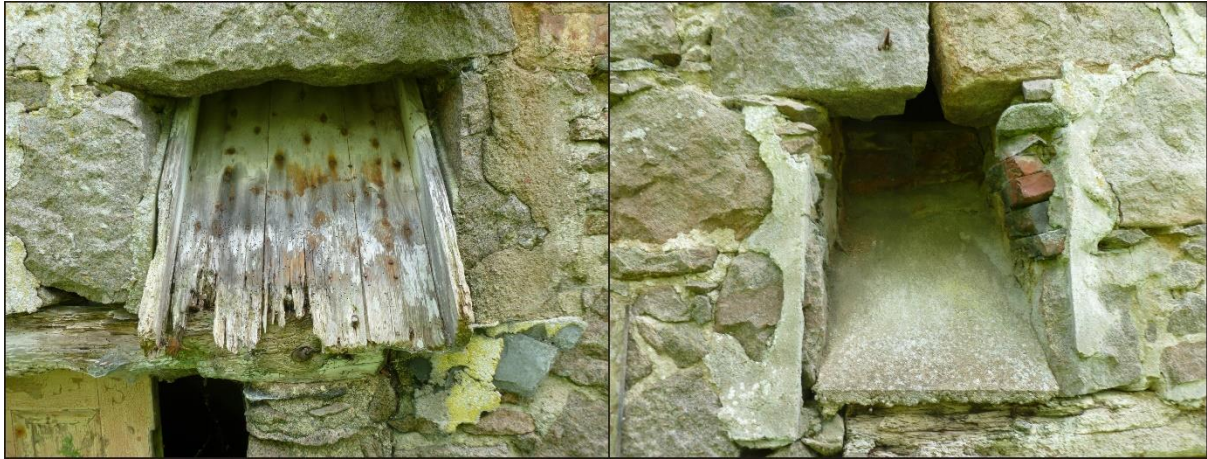
Illus 11 Wooden (north) grain chute (left) and southern concreted chute (right); facing SE

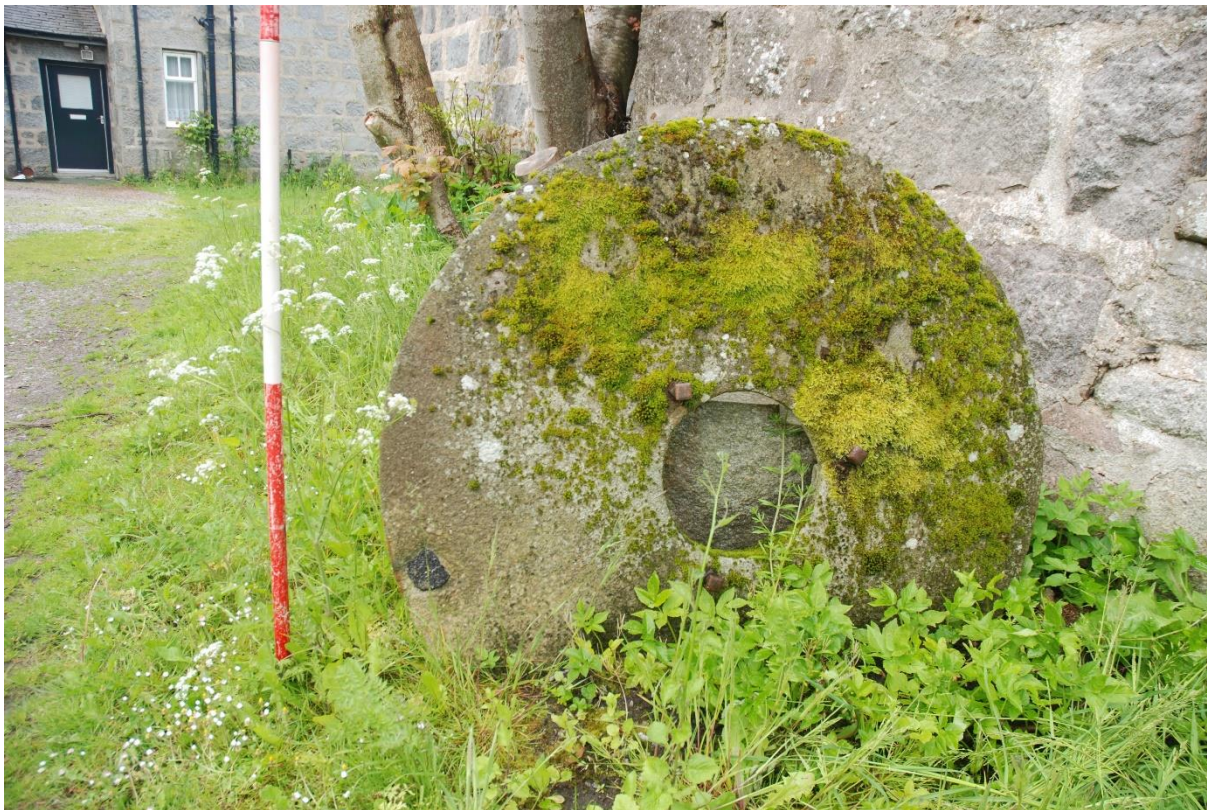
Illus 12 Millwheel lying at SE end Building 3

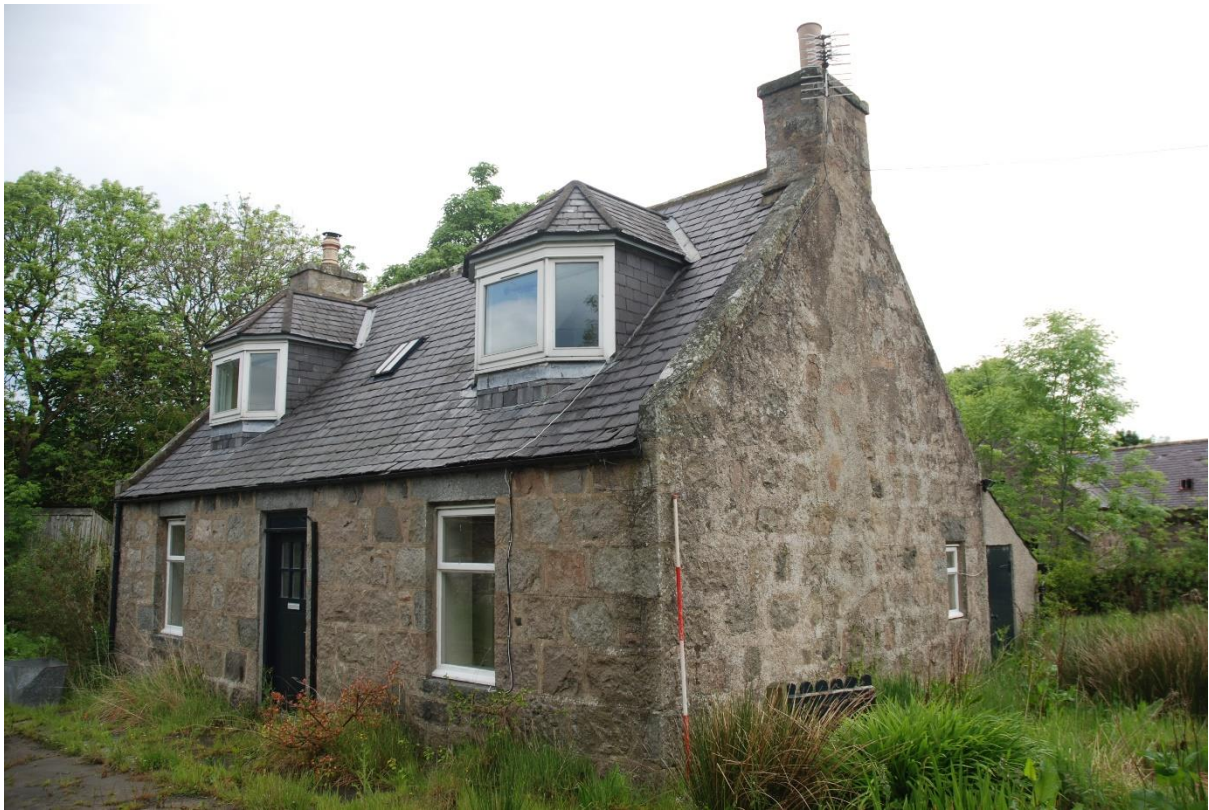
The mill cottage is a small one and a half-storey cottage with lean-to extension to the north (Illus 13). It was built from large roughly shaped granite blocks with cherry cocking and is 8.4m W-E and 6.4m N-S. A smaller version appears on the First Edition OS map but the cottage appears to have been completely rebuilt prior to the Second Edition (Illus 32, 34, 35).

Illus 13 Mill cottage; facing NW

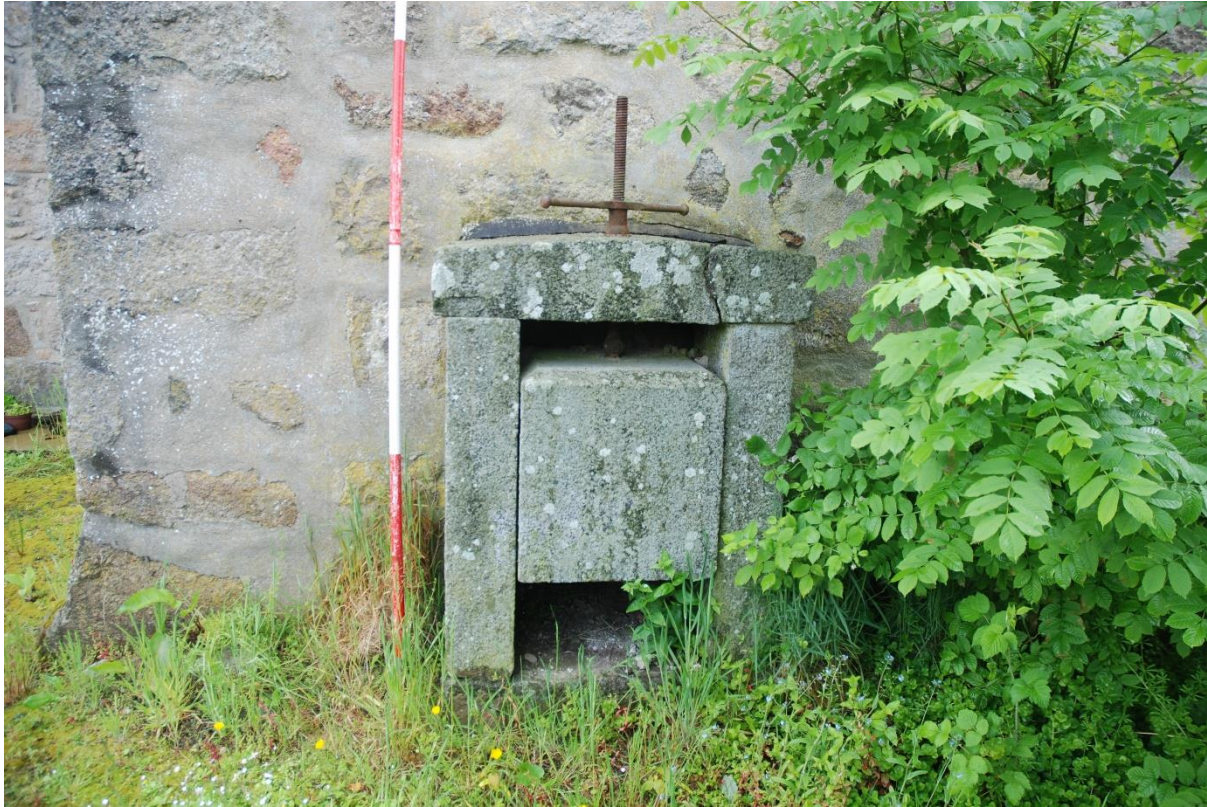
Illus 16 Cheese-press against west gable Building 5

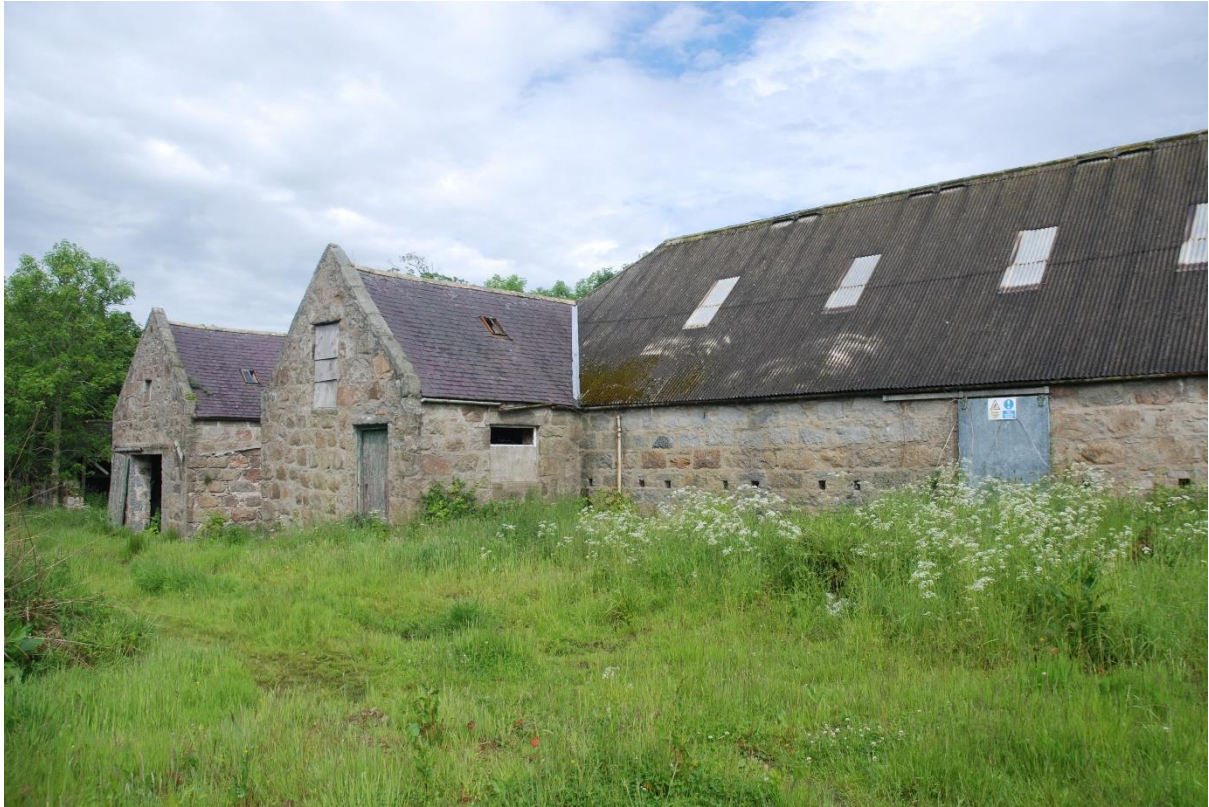
Illus 19 Building 6 from SE showing conversion to steadings; facing NW

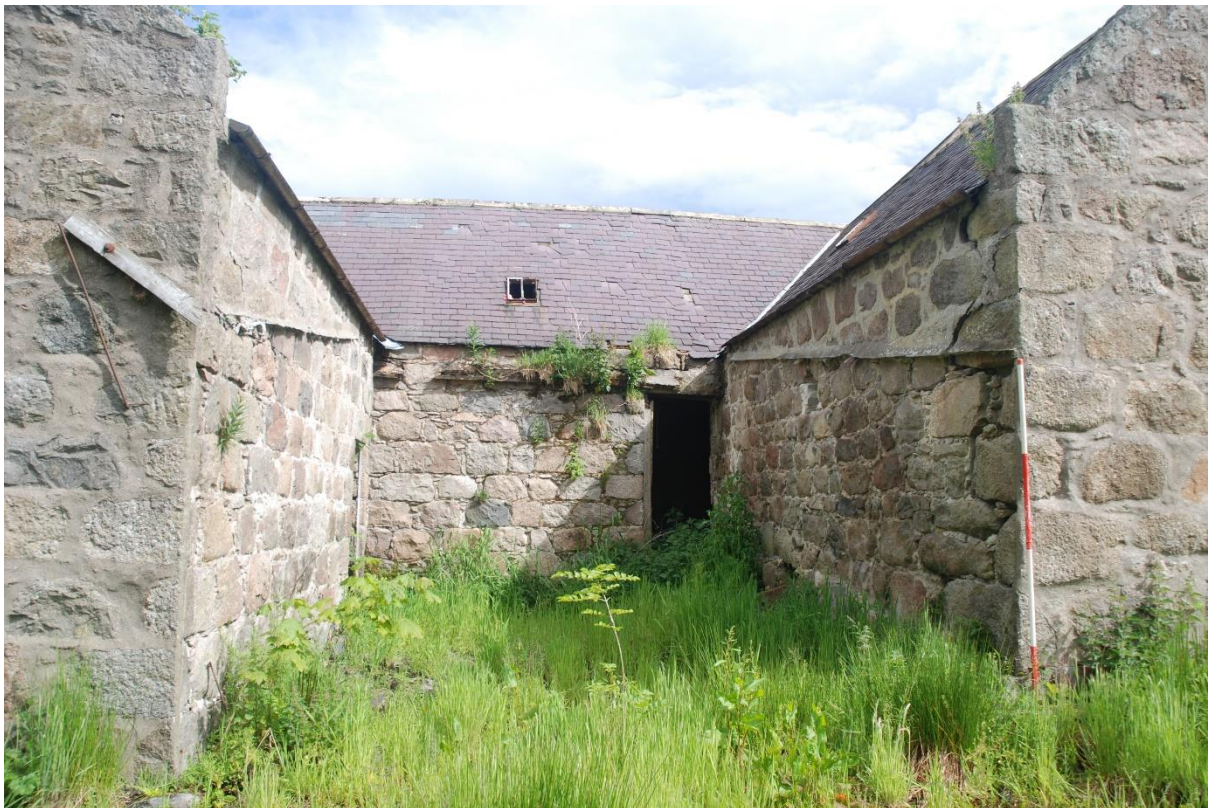
Illus 20 Courtyard on south side showing scar where building has been infilled in small courtyard (see Second Edition OS); facing N

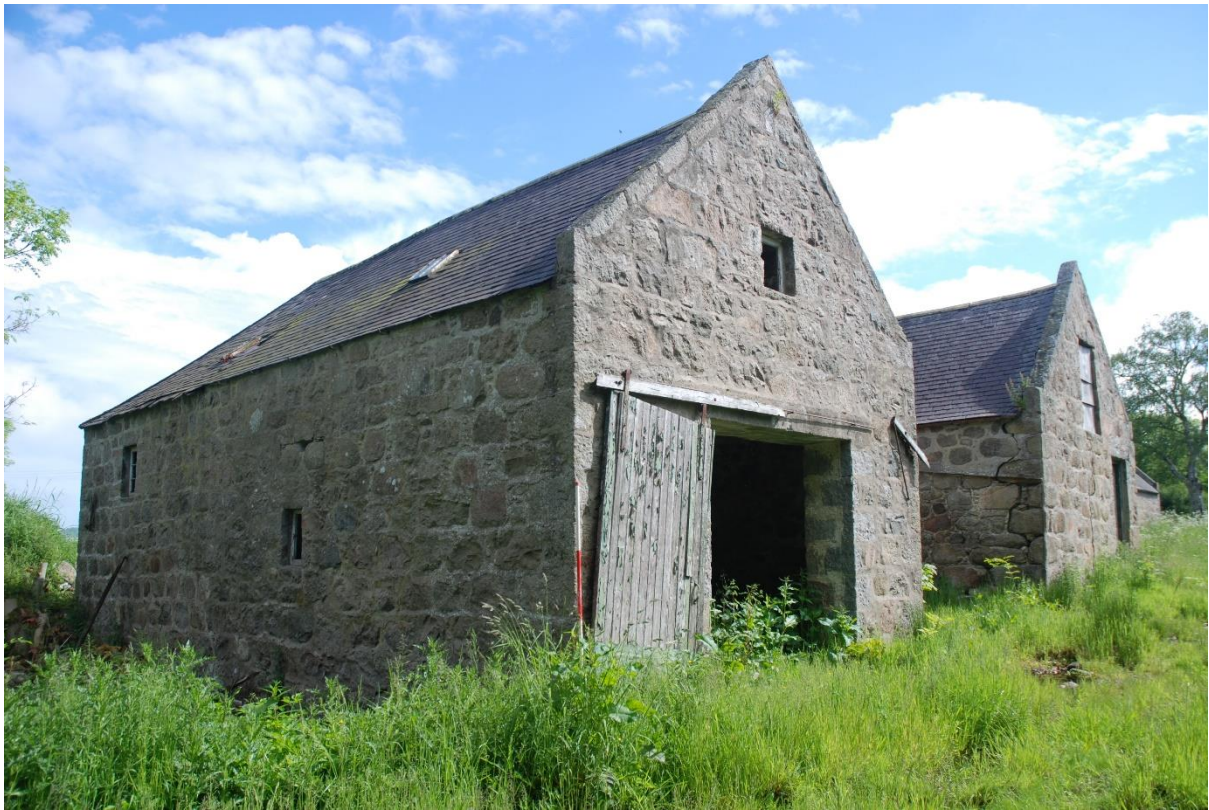
Illus 21 Steading Building 6 showing double gabled south side with infilled lade (left); facing NE

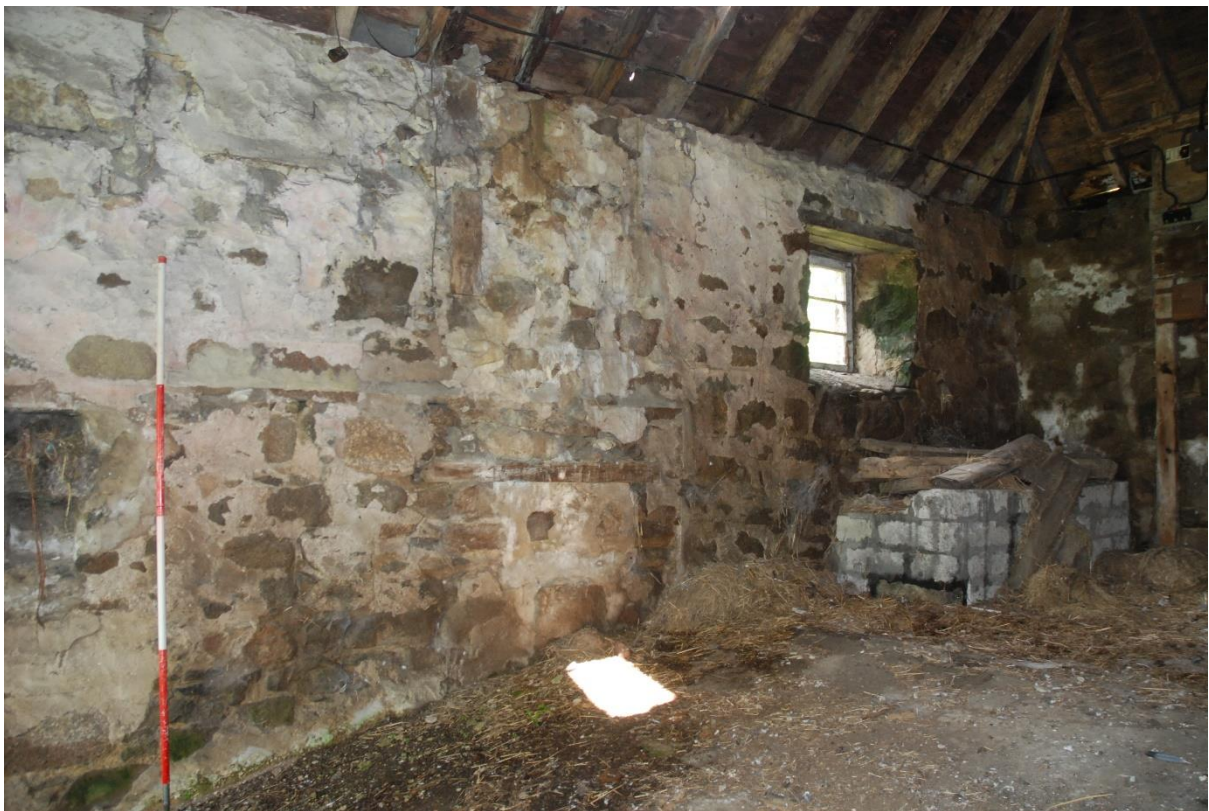
Illus 22 Interior of west wall showing infilled aperture (centre) possible location for former millwheel; facing NW

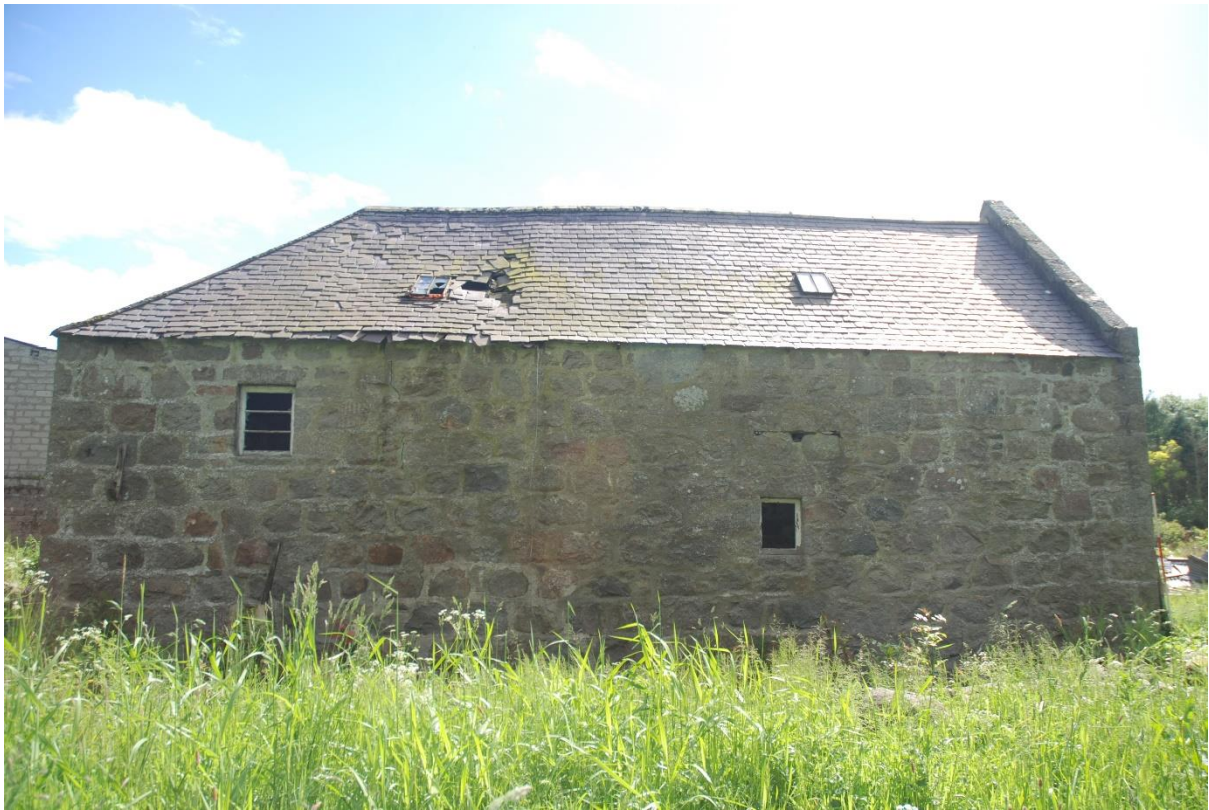
Illus 23 Exterior of west wall showing former location of millwheel (centre); facing E

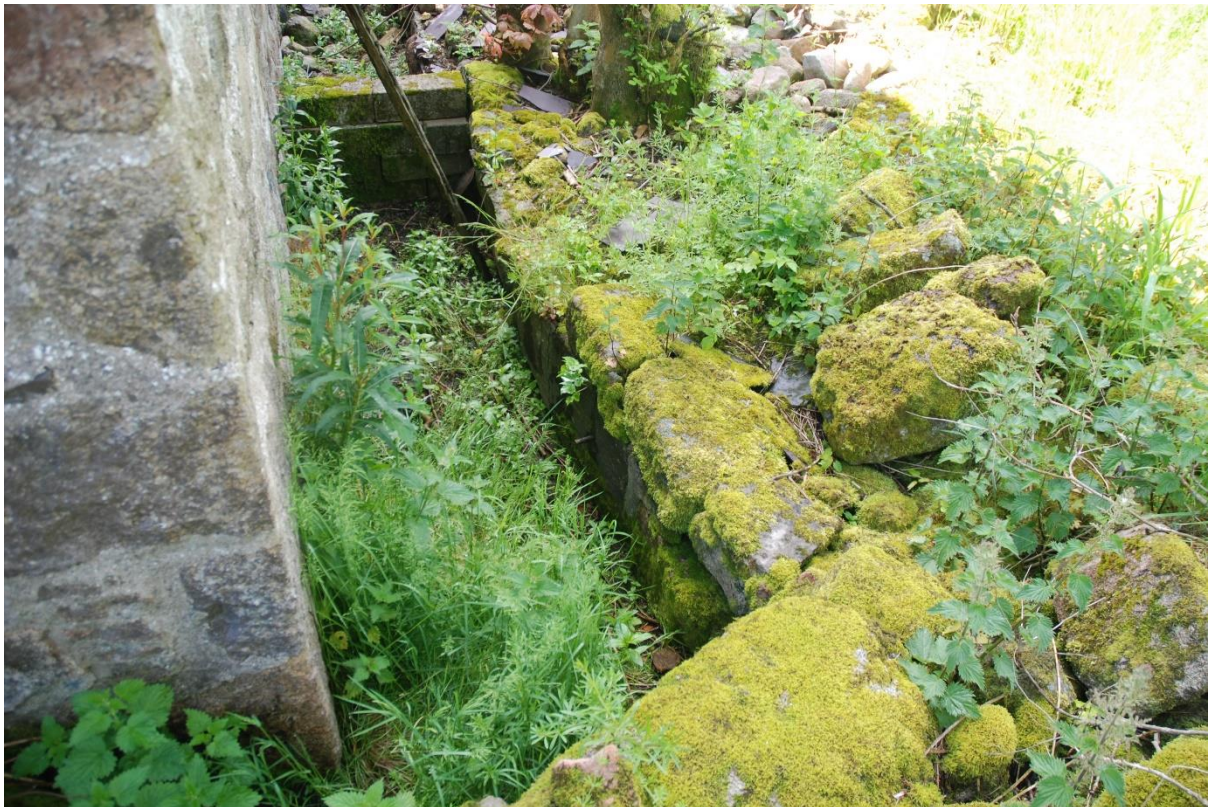
Illus 24 Partially re-excavated mill race on north end of west wall; facing S

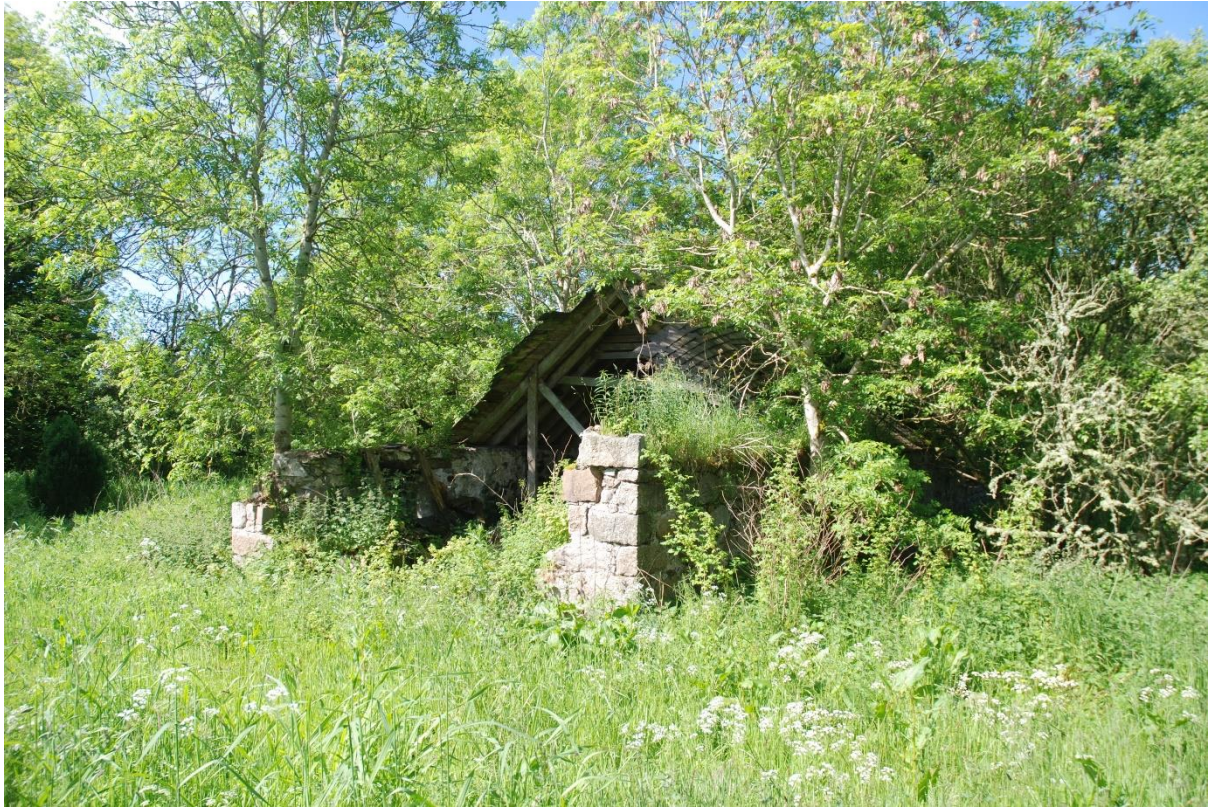
Building 7 is in a very poor condition, very overgrown and with no access to the interior. It was originally at least 24m long and 6.7m wide and constructed of granite roughly dressed blocks and cheery cocking. The walls of the east half of the building survive but there has been partial demolition of the west half and rebuilding in wood. There is an exposed chimney on the central wall (Illus 25, 28). This building is on the First and Second Edition OS maps between the east and west branches of the mill lade (Illus 34, 35).

Illus 26 Building 7 east end showing poor condition and overgrown vegetation on the interior of the building; facing SW

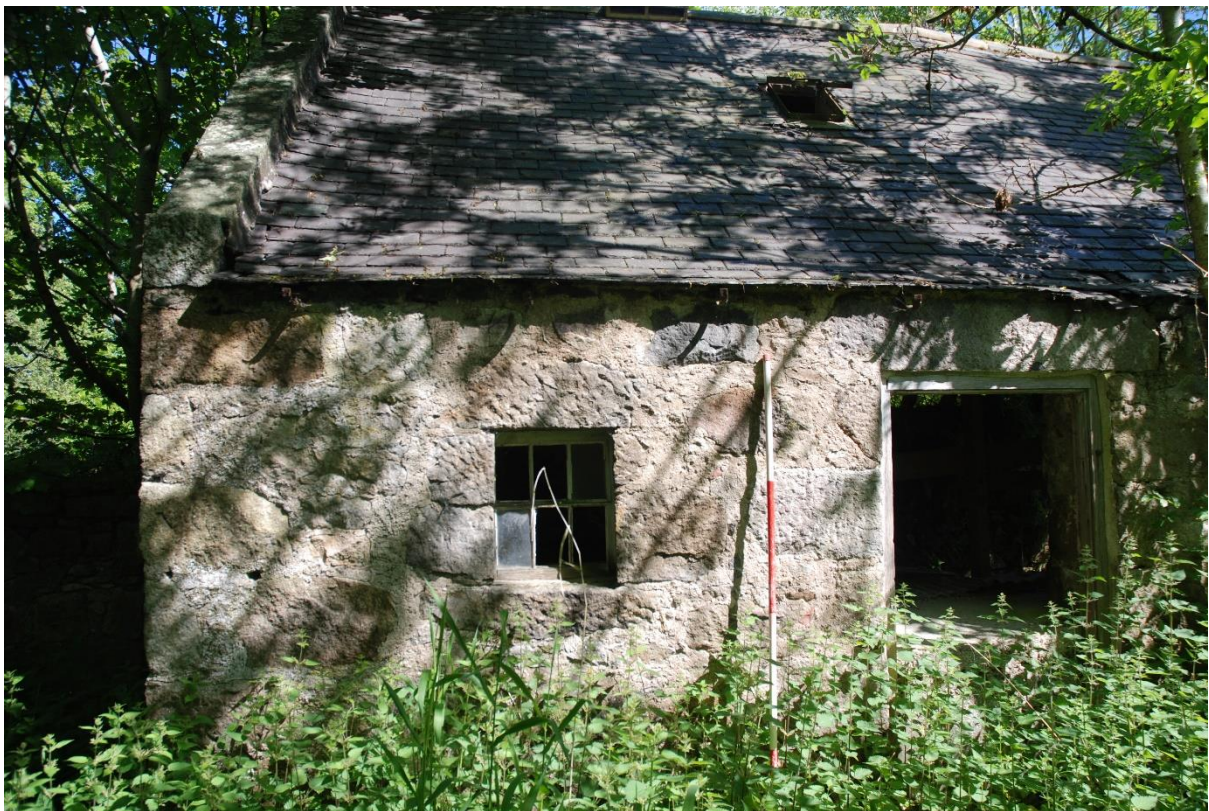
Illus 27 Building 7 south façade; facing N

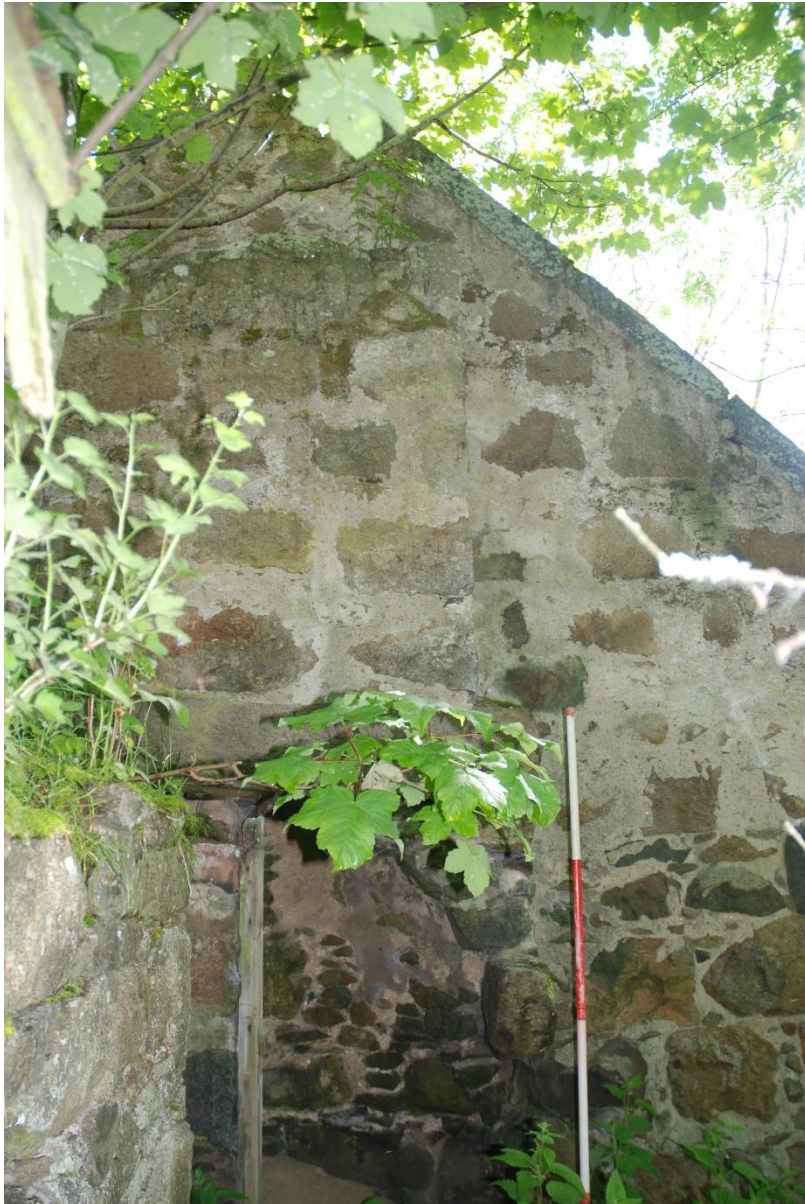
Illus 28 Building 7 west gable showing exposed chimney (centre); facing E

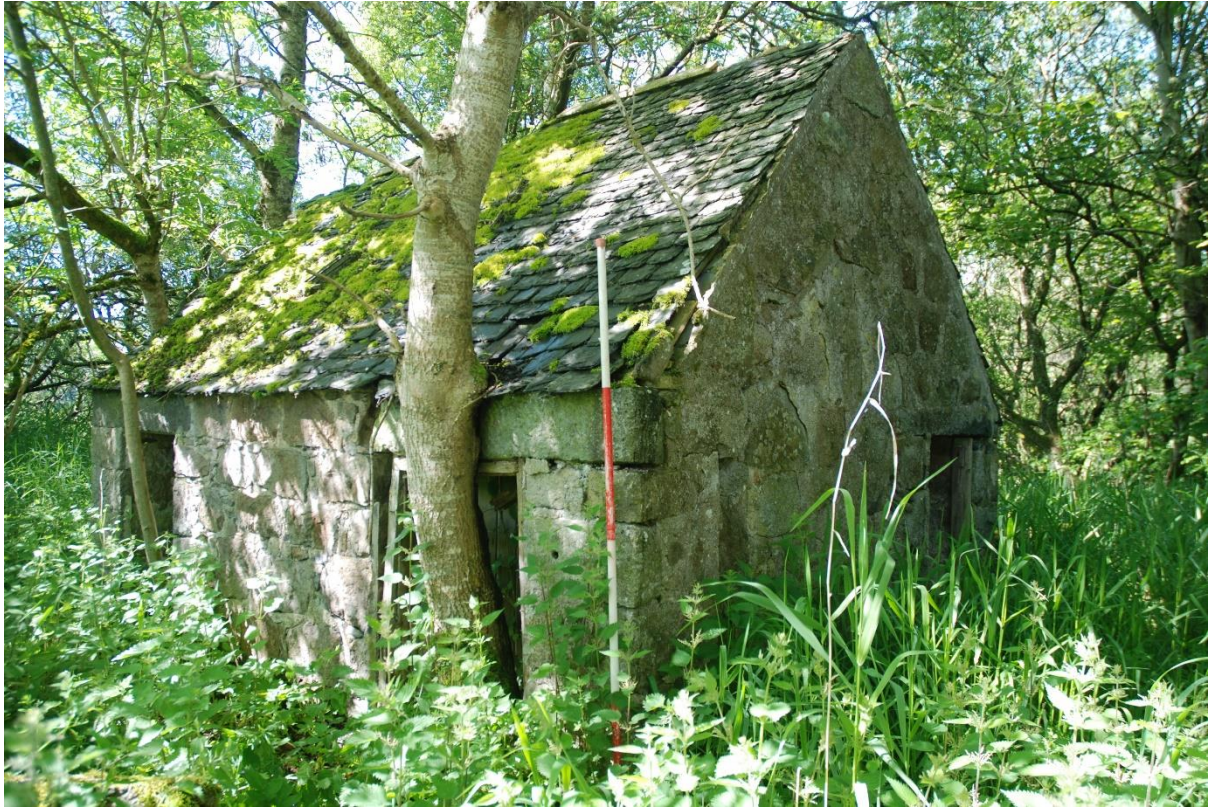
Building 8 is in a very poor condition, very overgrown and with no access to the interior. It is 5m long N-S and 4m E-W and constructed of granite blocks and cherry cocking (Illus 29). It was constructed after the First Edition OS map and prior to the Second Edition.

Illus 29 Bothy Building 8; facing SW

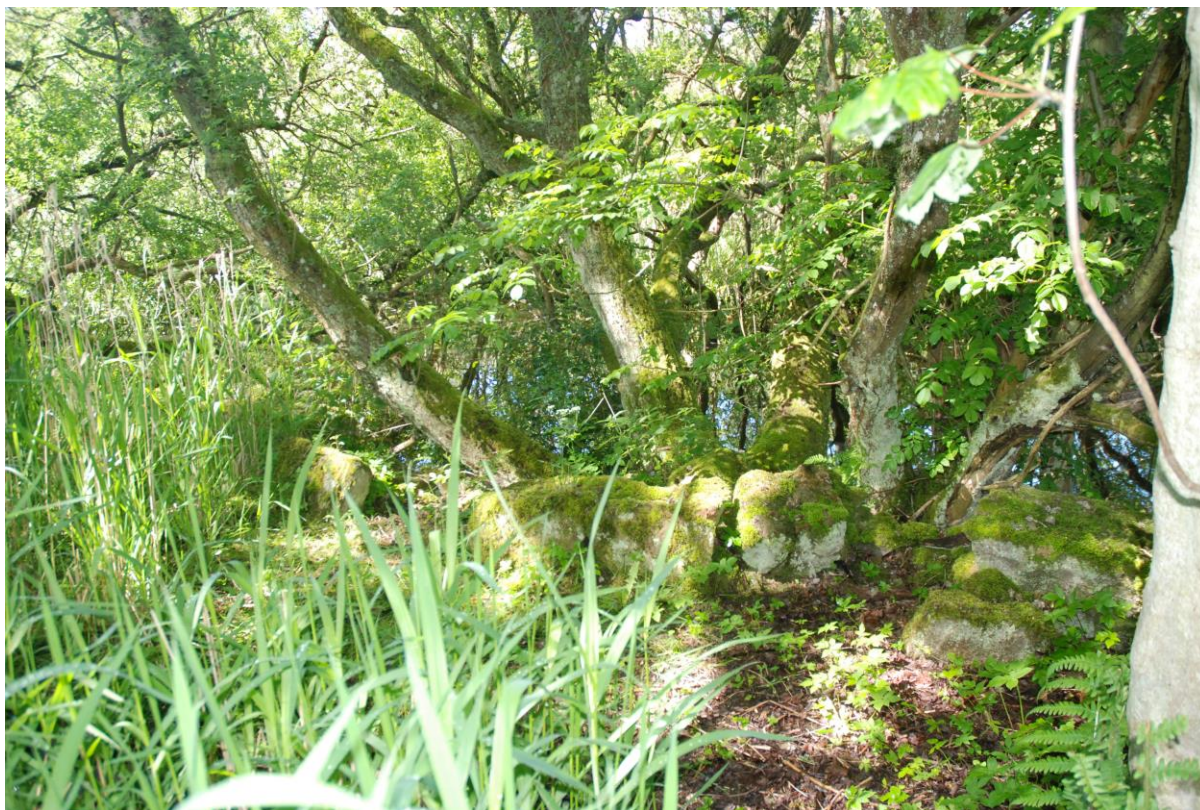
A small walled enclosure on the west side of Building 8 survives in undergrowth as 0.5m (max) high walls (Illus 31). It was constructed prior to the Second Edition OS map.

Illus 31 North wall Structure 9; facing N
